Site: 4A East Hill, Colchester

Reason for Watching Brief: Redevelopment (two houses)

Date: 20th November 2000

Summary

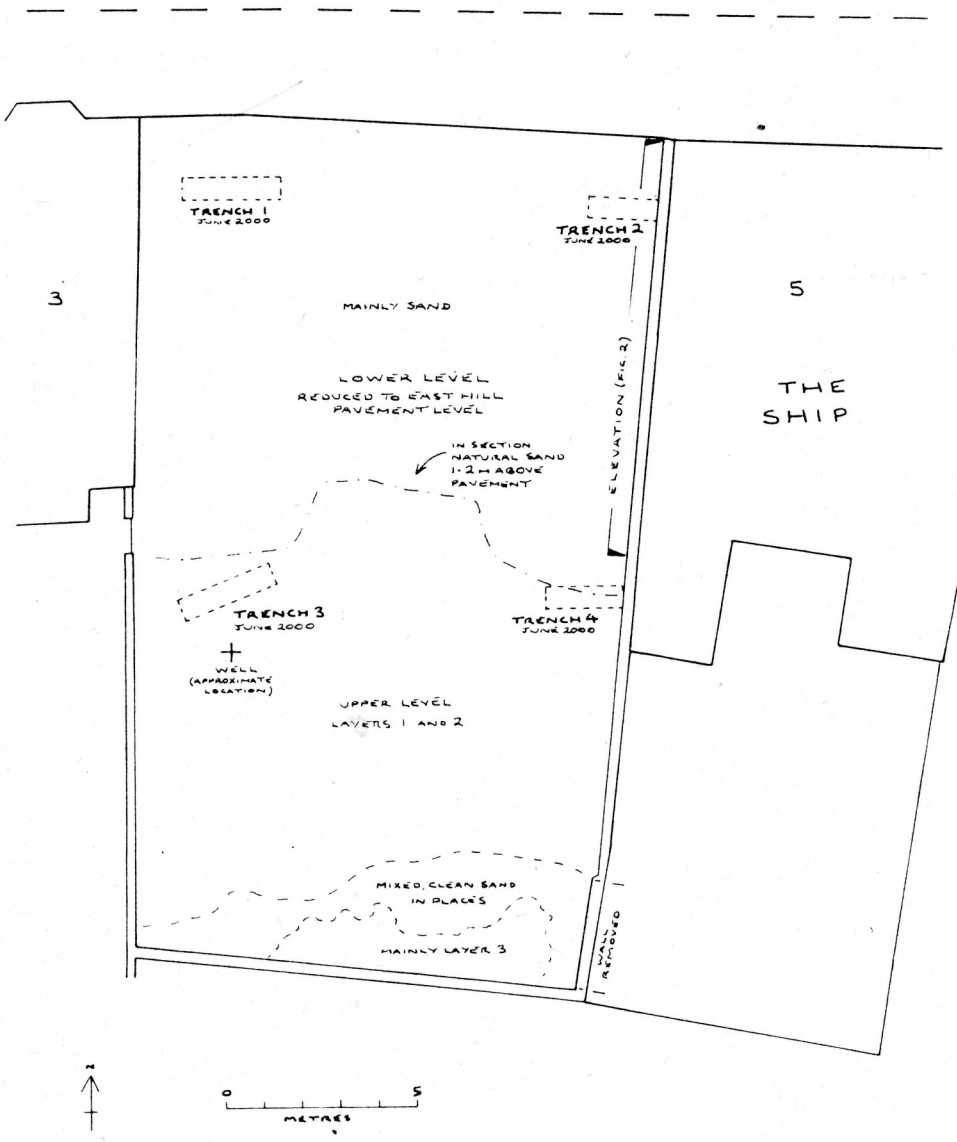
FIGURE 1: LOCATION PLAN

A brick-lined well said to be almost 30m deep was uncovered in the southern part of the site. The approximate location is shown in figure 1. No further details are available since the find spot was covered by a spoil heap when reported by the contractor.

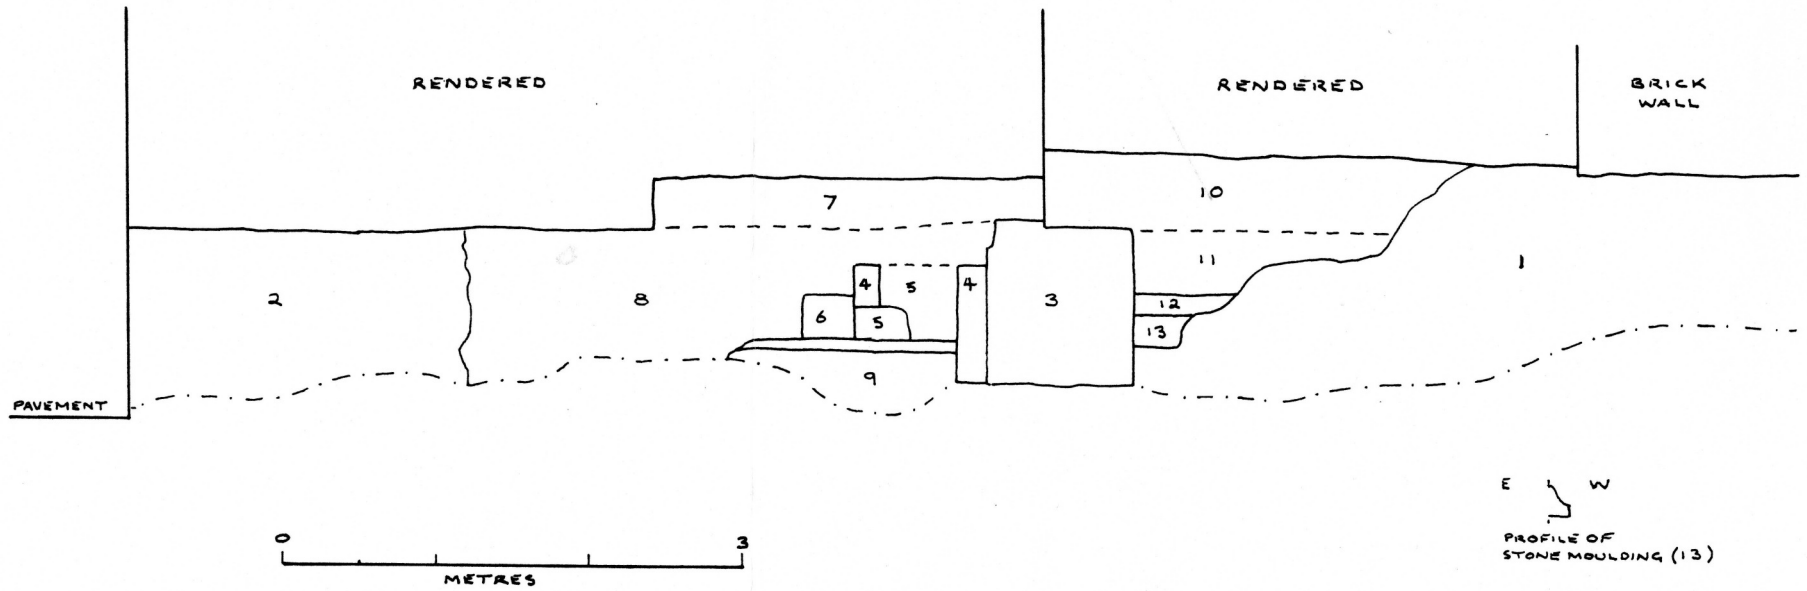
FIGURE 2. ELEVATION: SIDE OF 5 EAST HILL

At the side of 5 East Hill the groundworks cut into the lower part of the building, revealing a patchwork of materials. In the elevation, Figure 2, the freshly exposed walling consisted of the following:

- [1] Rubble-faced wall, mainly flint and septaria, with very rare fragments of soft red brick, 2" thick.
- [2] Red brick, 9" x 4 1/2" x 2 1/2"
- [3] Coursed red brick, 9" x 4 1/2" x 2 1/2" thick.
- [4] Red brick, 8 x 4 x 1 1/2".
- [5] Infill of brick fragments. The bricks were 4" wide, 2 1/2" thick, length unknown.
- [6] Brick fragments laid on their sides. Brick dimensions: 4" x 1 1/2" thick
- [7] Red bricks, 2 1/2" thick x 4 1/2" wide roughly coursed and laid as headers.
- [8] Mixed broken red brick, variously 3 1/2" x 1 1/2" thick, 2" thick and 2 1/2" thick, roughly mortared and coursed, with occasional stones.
- [9] Broken brick, 1 1/2" x 4, roughly coursed.
- [10] Same as 7, with occasional stretchers.
- [11] Same as 8.
- [12] Stone slab.
- [13] Stone moulding, with profile as shown inset in fig.2.

When originally exposed, the curved side of an oven-like brick feature represented by [4] projected 25cm from the wall. This was later cut, exposing the brick rubble infill [5]. No frogged brick was discernible among the scatter of rubble broken away from the side of the building.

At the south-east corner of the site, the boundary wall with 5 East Hill, [1] in fig.2, was breached to create an access into Priory Street. Its construction was the same as elsewhere with additionally occasional small fragments of peg-tile in evidence.
