Historic building record of barn and cart lodge at Sparrow Hall Farm, Sparrow Lane, Needham Green, Hatfield Broad Oak, Essex October 2010

> report by Richard Shackle for the Colchester Archaeological Trust on behalf of Mr and Mrs R N Broad

CAT Report 581 February 2011

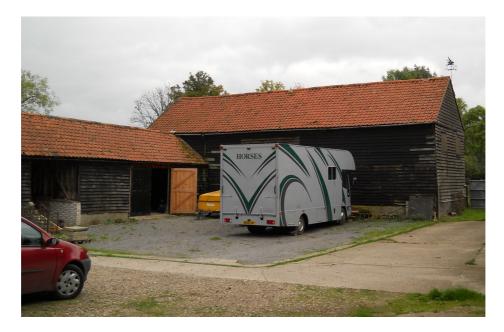
Plate 1 Large barn (E) with attached building (D), viewed from northeast.

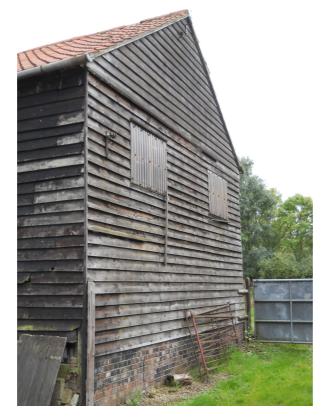
Plate 2 Large barn (E), north-west gable, exterior, viewed from north.

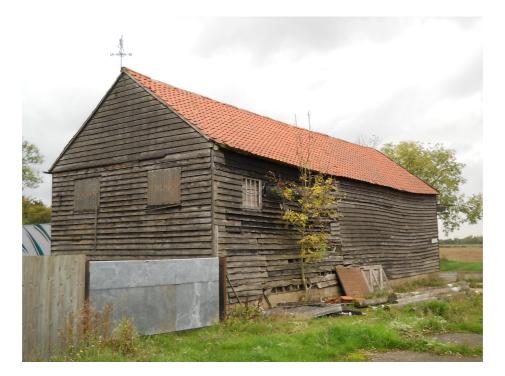
Plate 3 Large barn (E), south-west wall, exterior, viewed from west.

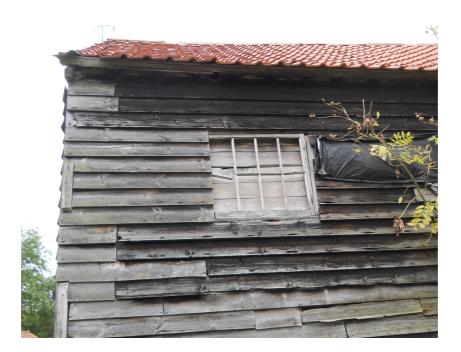
Plate 4 Large barn (E), detail of south-west wall, exterior, showing glazed window.

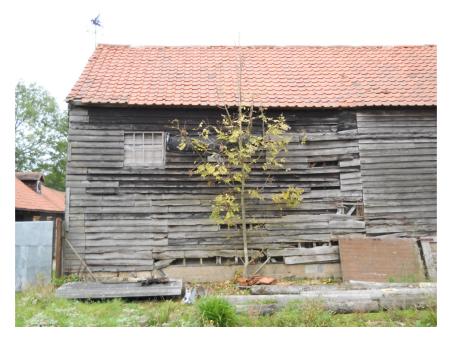
Plate 5 Large barn (E), south-west wall, exterior, showing position of former lean-to.

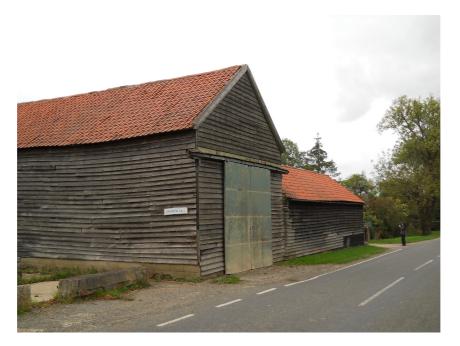
Plate 6 Large barn (E), south-east wall, exterior, showing modern double doors, viewed from south.

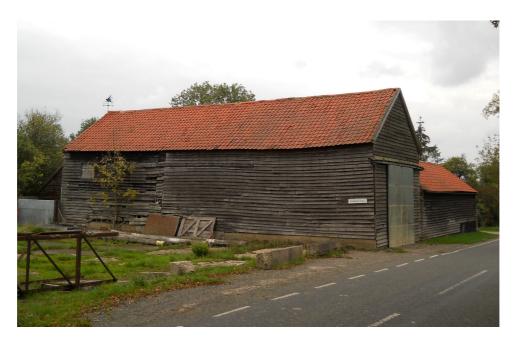
Plate 7 Large barn (E), south-west wall and south-east wall, viewed from south.

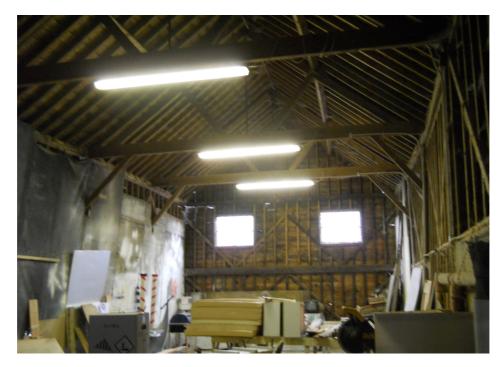
Plate 8 Large barn (E), interior.

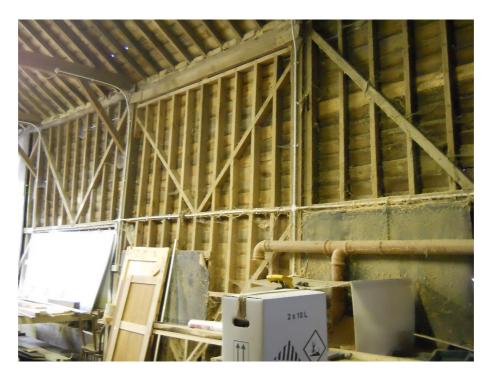
Plate 9 Large barn (E), interior, north-east wall, showing blocking of central door by matching framing.

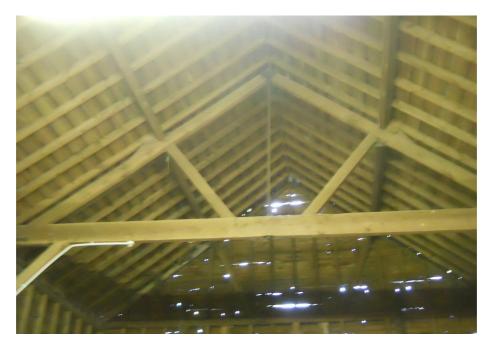
Plate 10 Large barn (E), interior, roof truss with part of down brace to post.

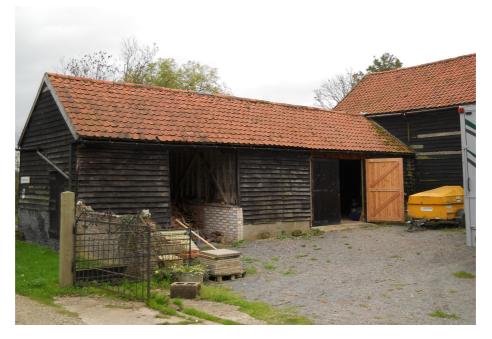
Plate 14 Building attached to large barn (D), viewed from south-east.

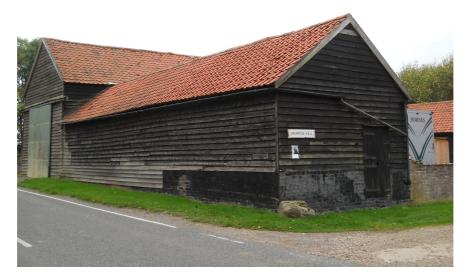
Plate 17 Building attached to large barn (D), viewed from south-east.

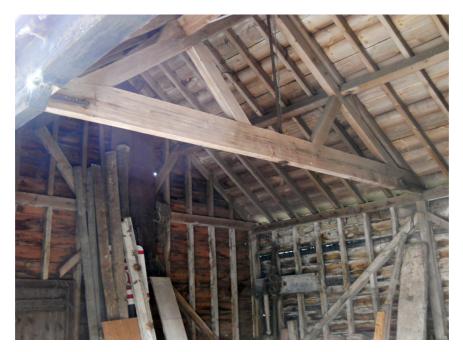
Plate 20 Building attached to large barn (D), looking from gig house into stable.

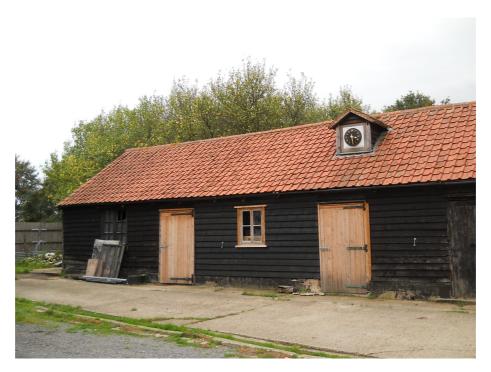
Plate 29 Loose box/stables (F), viewed from south-east.

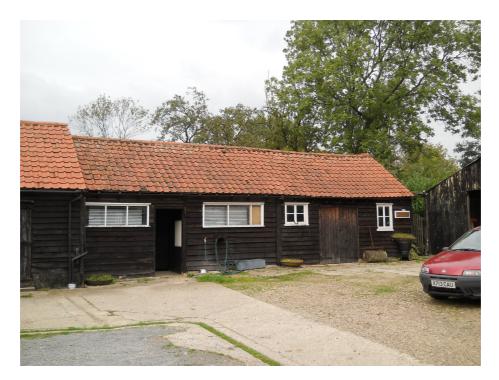
Plate 31 Cart lodge attached to stables (G), viewed from south-east.

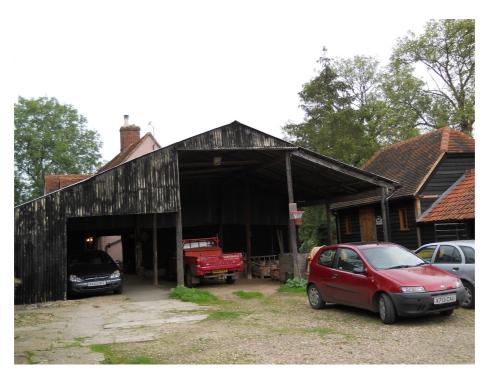
Plate 50 Pole barn (H), viewed from south-west.

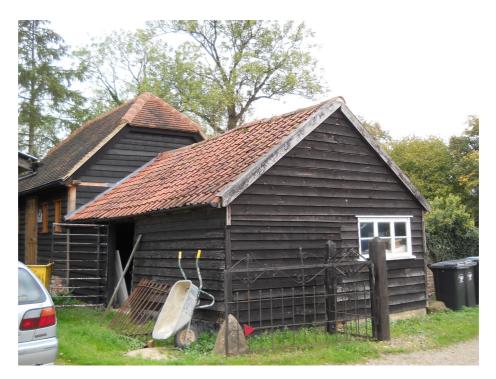
Plate 54 Building attached to granary (C), viewed from west.

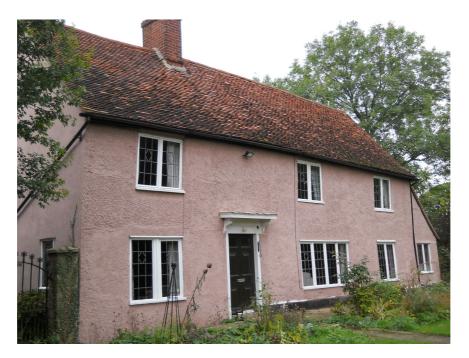
Plate 58 Farmhouse (A), front elevation, viewed from south-east.
