**Historic building recording at Front Lodge, Moor
Place, Much Hadam,
Hertfordshire, SG10 6BS
November 2015**

**report prepared by
Mark Baister**

**commissioned by
Foxley Builders**

CAT Report 934
April 2016

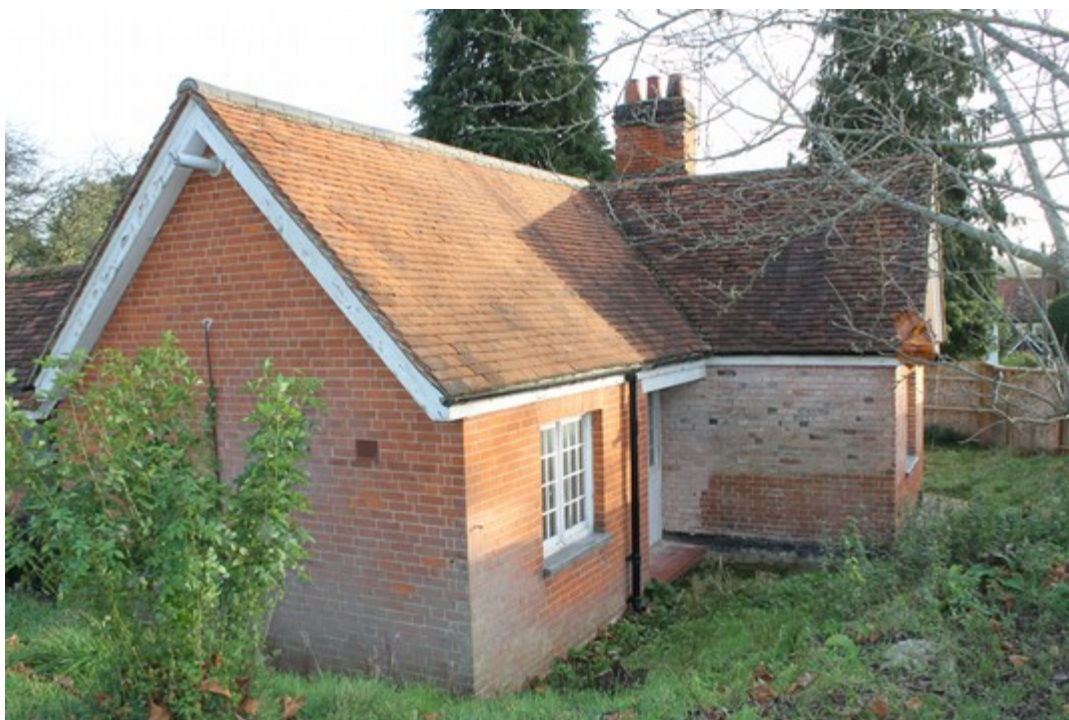
Plate 1 West elevation with 20th century extension in foreground - view north-east.

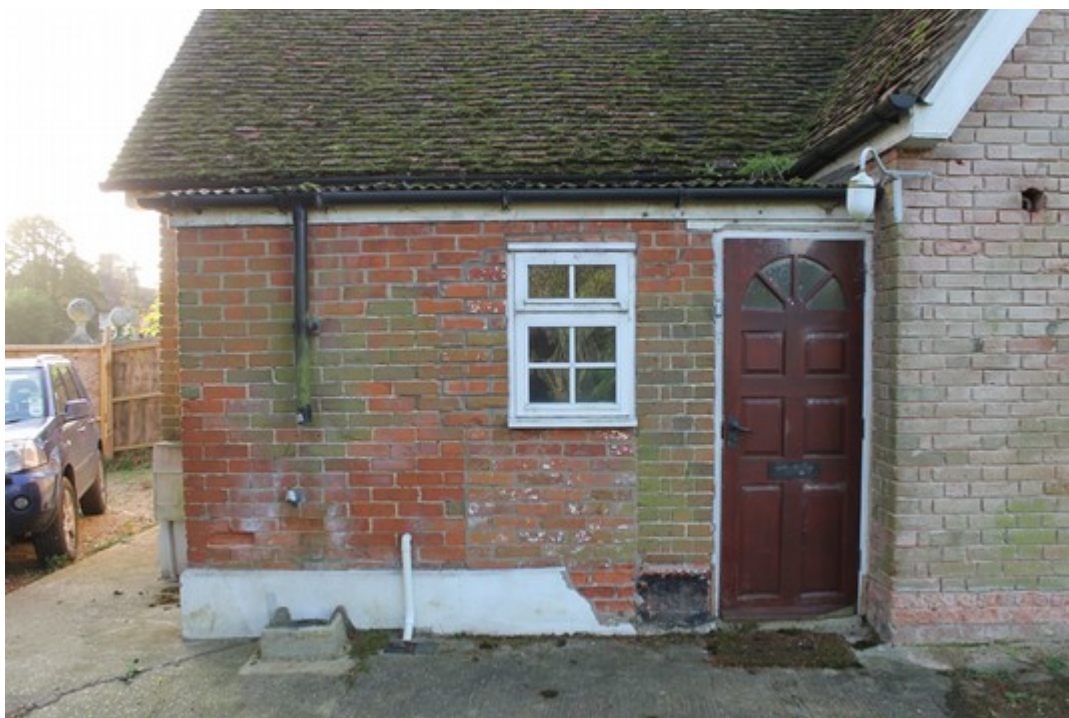
Plate 2 North elevation of the lean to, showing 20th century additions and inserted door and window – view south.

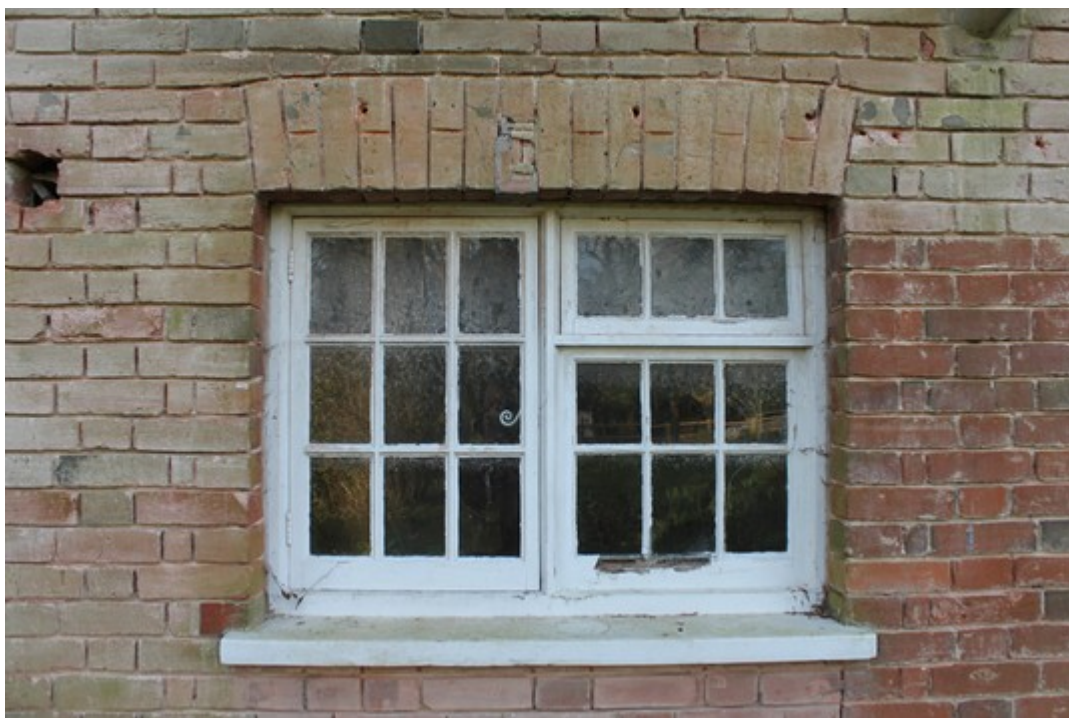
Plate 3 Replacement casement/fly window in north gable end of original lodge. Repaired and damaged arch visible – view south.

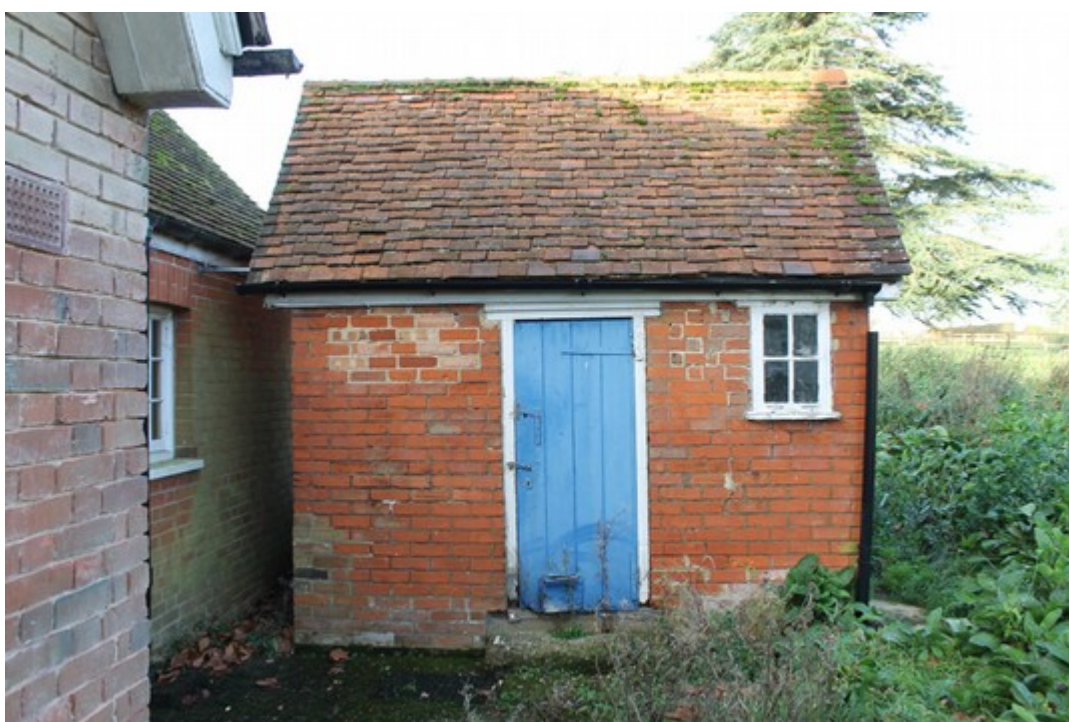
There is an entrance on the eastern elevation with a wooden lintel and sill and a 20th-century replacement door with concrete steps leading up to it (Fig 7, Plate 4). Also on the eastern elevation is a small timber-framed four-light casement window – likely a replacement. It appears very similar to the windows in the lodge, suggesting a similar date (mid 20th-century).

Plate 4 East elevation of the outbuilding – view west.

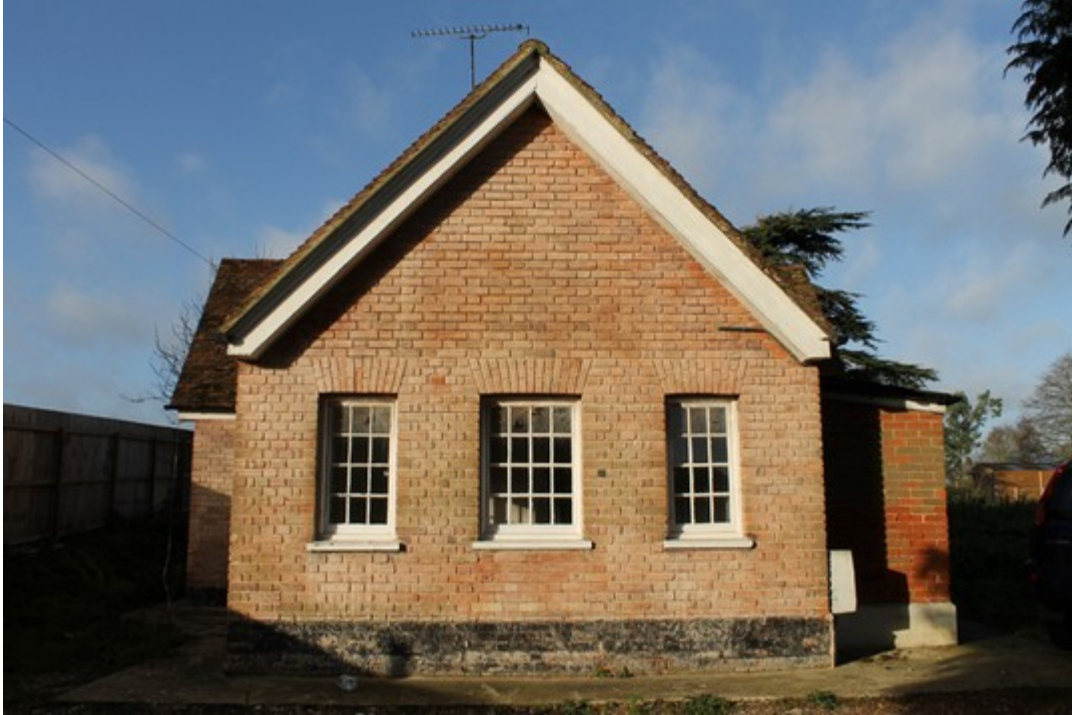
Plate 5 East elevation of the lodge, showing blocked up original entrance and replacement windows – view west.

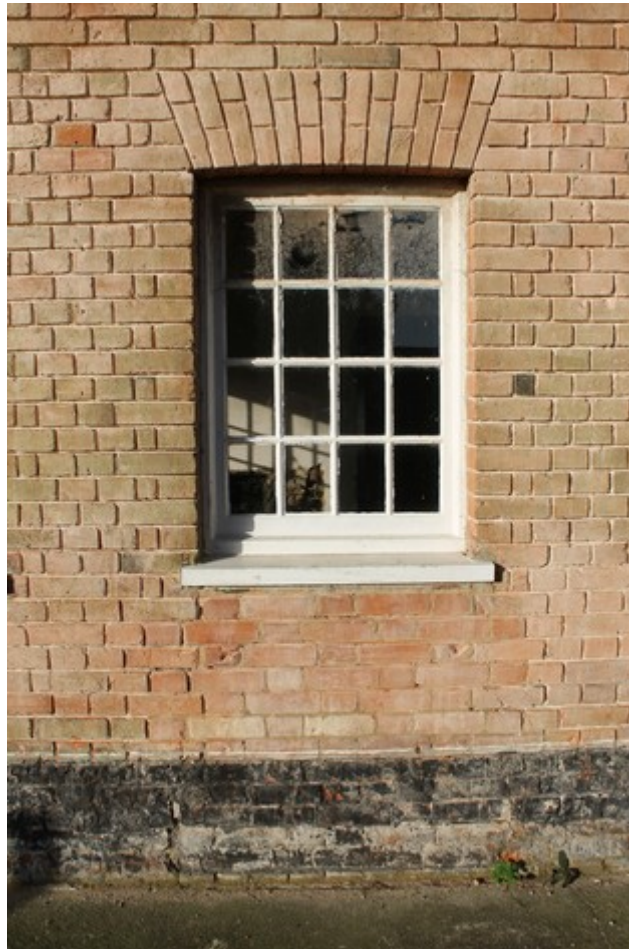
Plate 6 Detailed shot of blocked up doorway and inserted window in east elevation – view west.

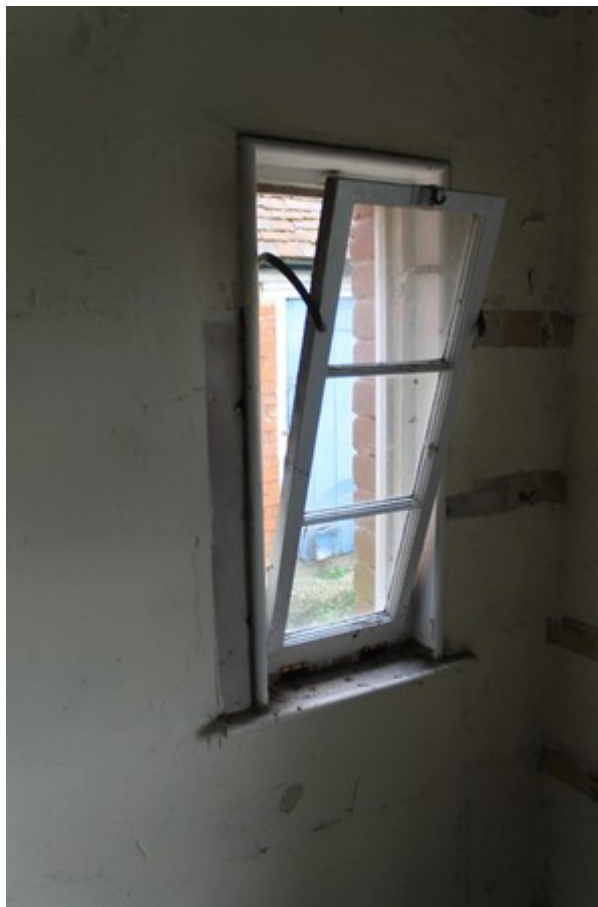
Plate 8 Mid 20th-century hopper window in Room 3 – view north-west.

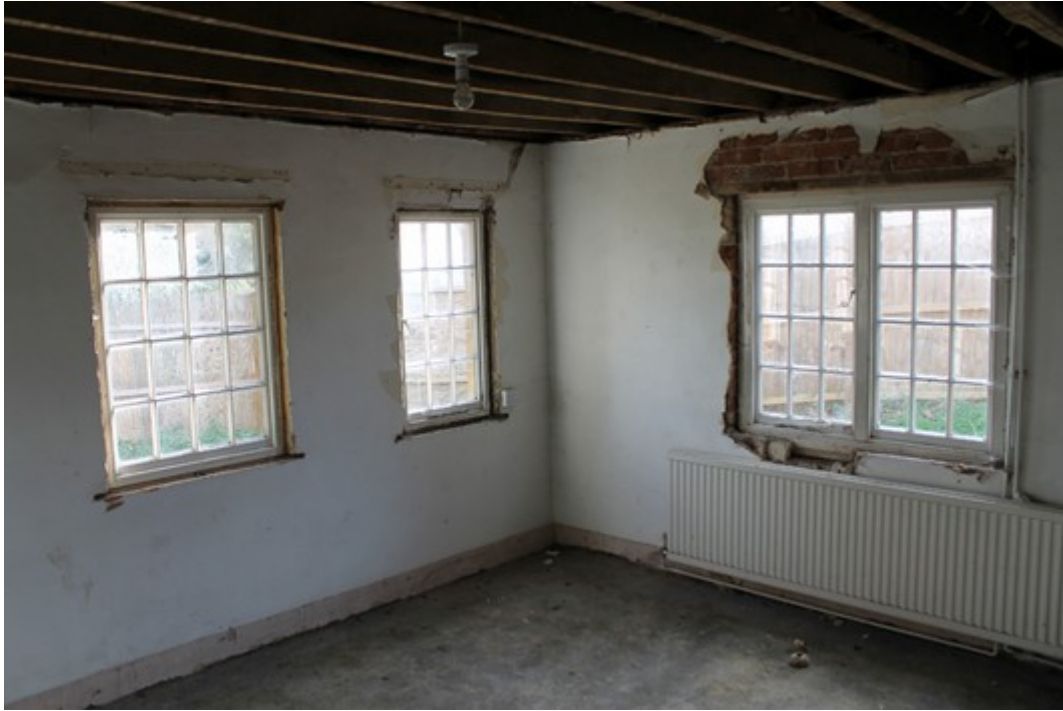
The original lodge contains four rooms, all with inserted modern concrete floors. Room 1 is the largest and is located at the eastern end of the building (Plate 9). Originally this room

Plate 9 Interior shot of Room 1, with inserted window through original doorway to the left – view south-east.

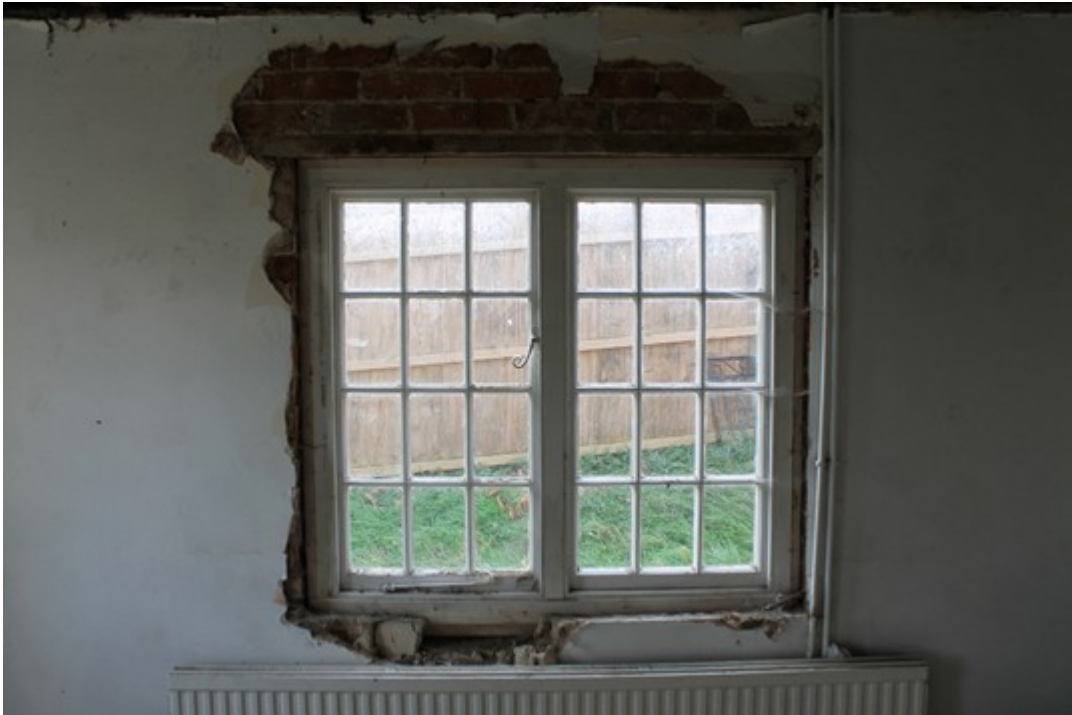
Plate 10 Detailed shot of replacement window on south wall of Room 1. Wooden lintel clearly visible – view south.

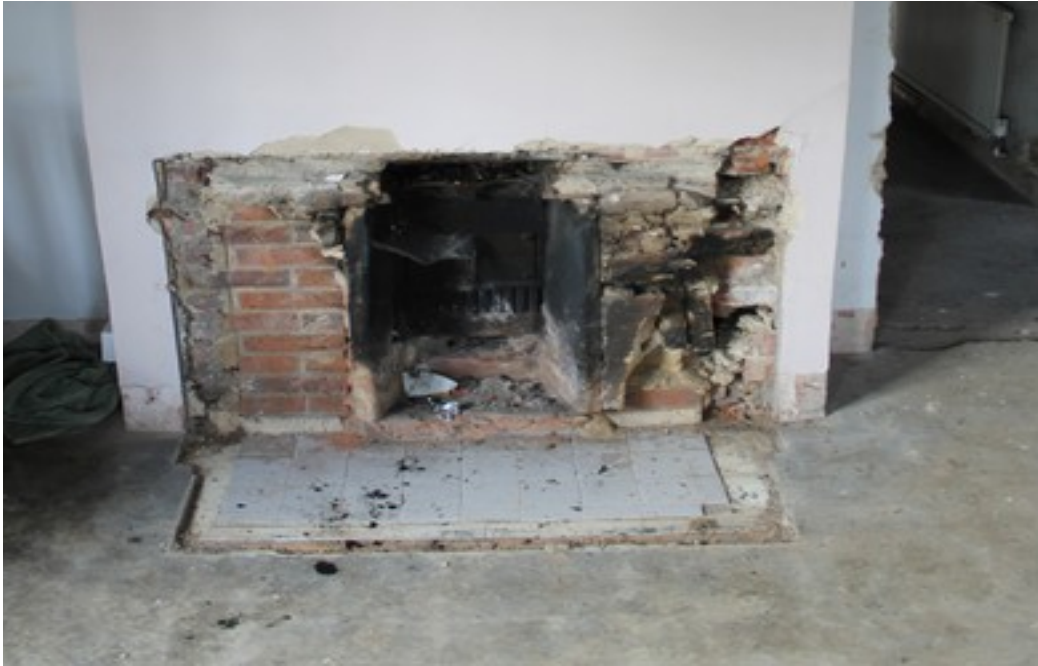
Plate 11 Fireplace in Room 1 with mid 20th-century grill and back boiler inserted – view west.

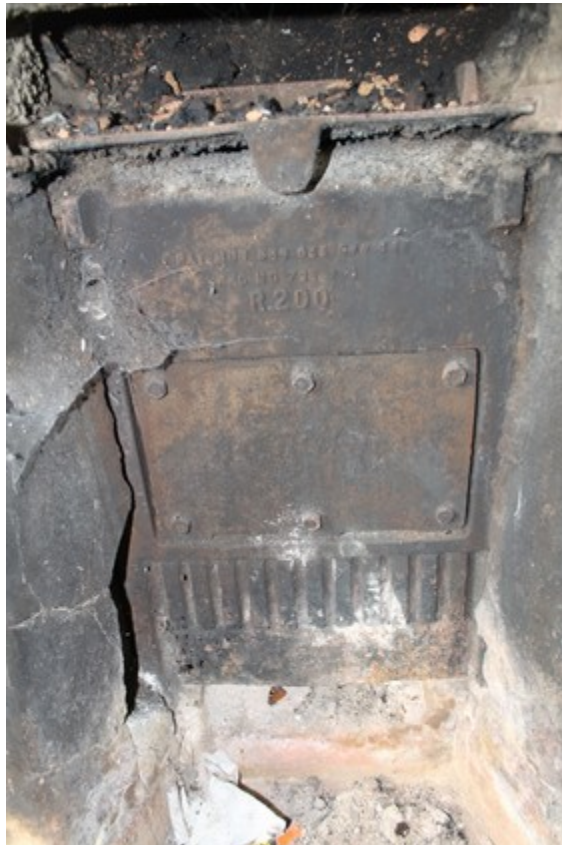
Plate 12 Detailed shot of back boiler, just visible is the brand name "RedFyre" - view west.

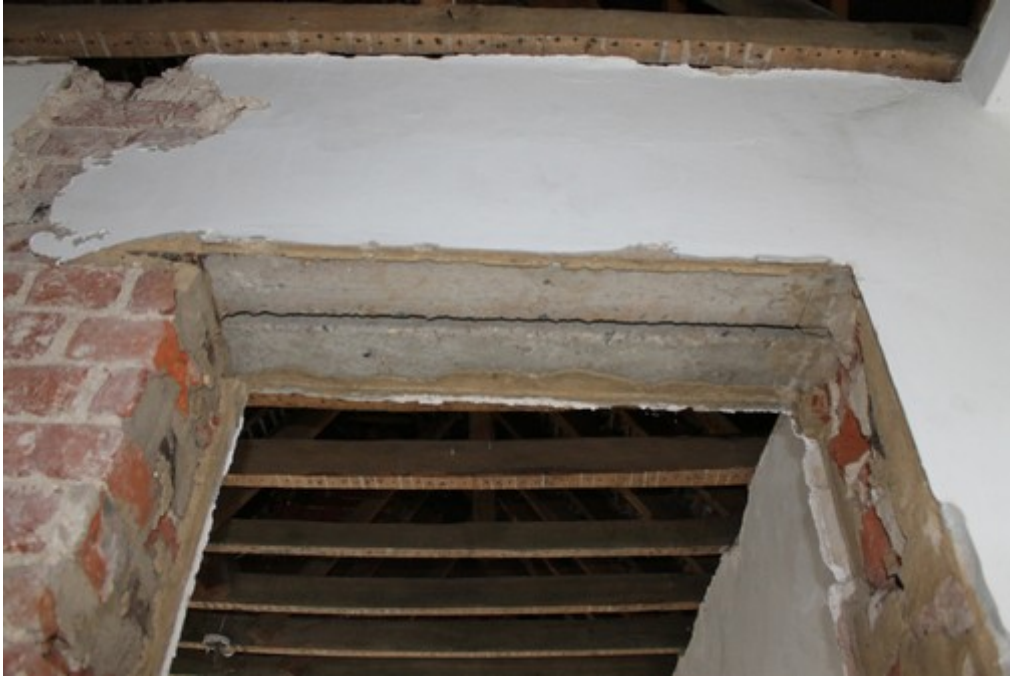
Room 2 is located at the south end of the original lodge. The current entrance into Room 2 (from Room 3) is a later insertion – the lintel above it is made of concrete (Plate 13). The original entrance would have been from Room 1 to the east: this doorway has subsequently been blocked (Plate 18, Fig 2). A modern radiator is attached to the north wall of this room. Next to this is a plastered over and blocked up fireplace. Upon investigation through a hole made in the plaster it was ascertained that there was no surviving grate.

Plate 13 Inserted doorway between Room 2 and 3. Concrete lintel and truncated bricks clearly visible – view south.

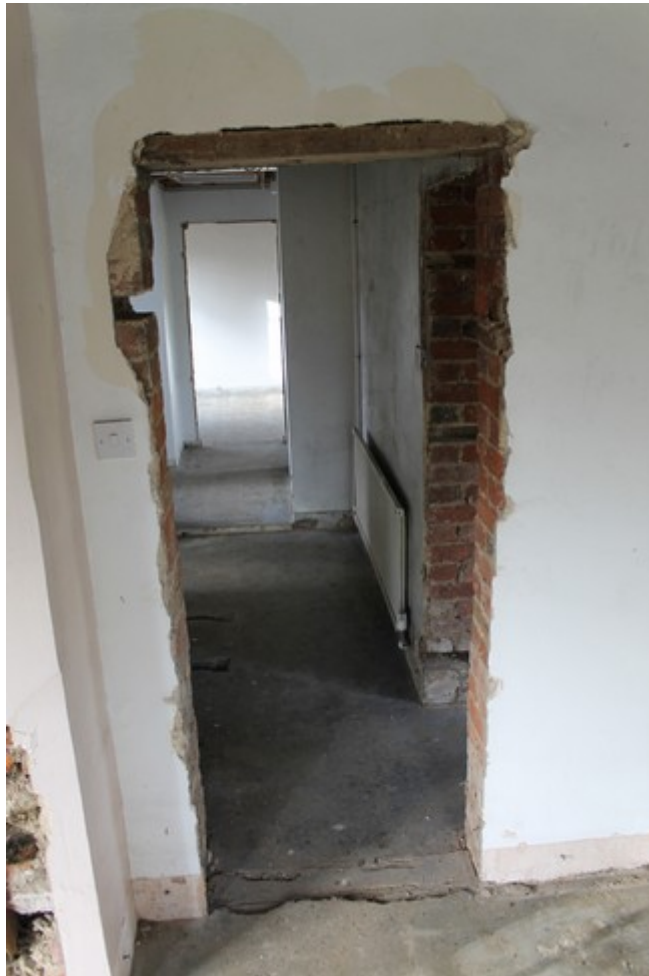
Plate 14 Original doorway between Rooms 1 and 3. Wooden lintel visible – view west.

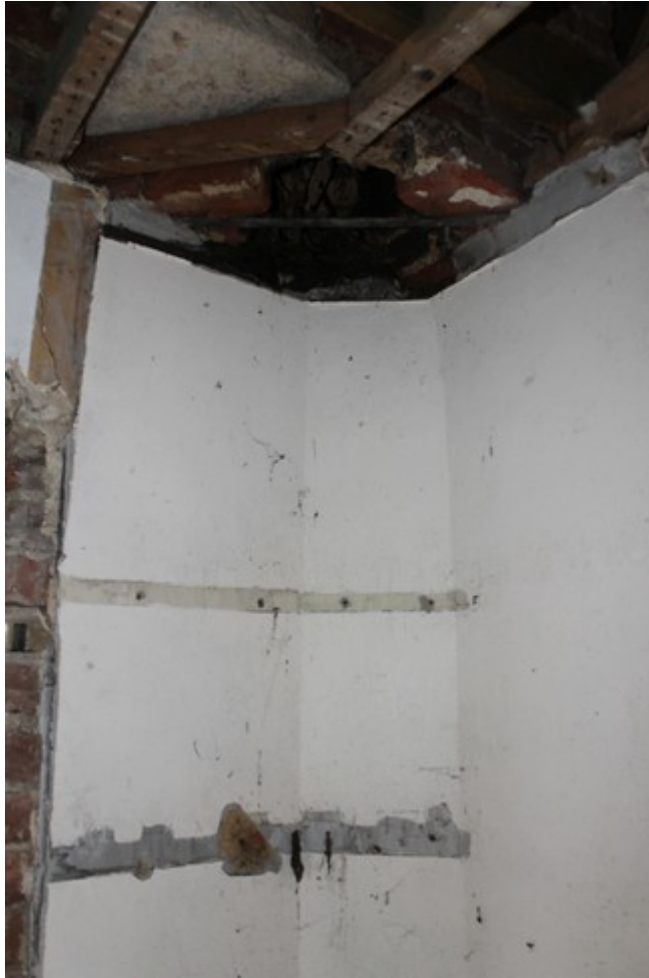
Plate 15 Location of removed fireplace in Room 3.
Flue up to chimney visible – view south-east.

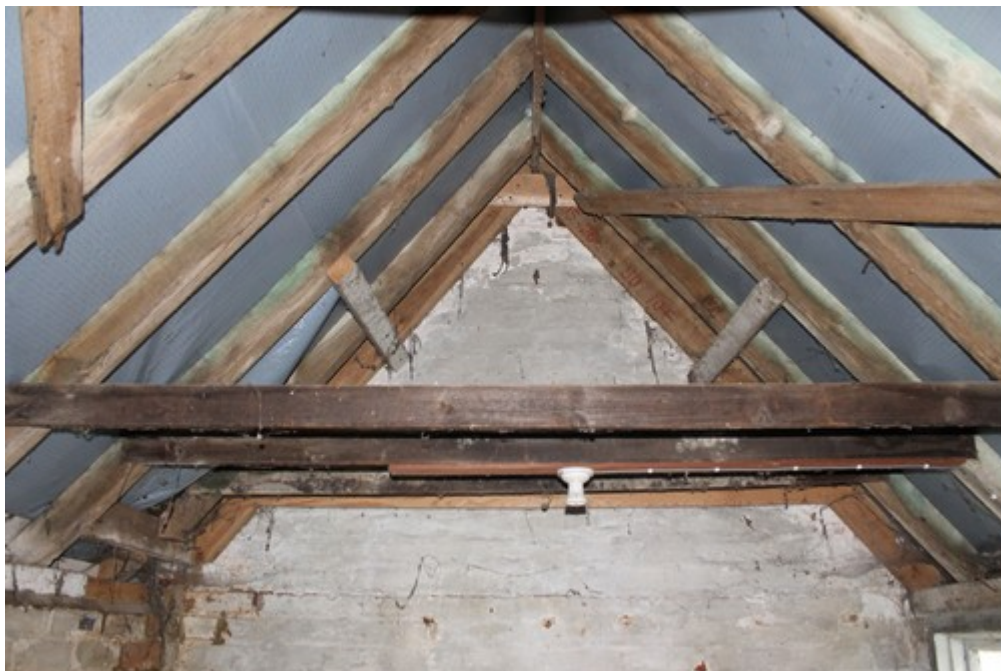
The interior of the outbuilding is currently in use as a builder's store. It has a concrete floor, similar to the lodge (Plate 17). The roof has been entirely remade from machine cut timbers rising to a ridgeboard with multiple braces and tie beams (Plate 16). Above the rafters there is an underlay obscuring the battens to which the plain tile roof is attached.

Plate 16 Rebuilt roof of outbuilding, showing machine cut timbers and underlay – view north.

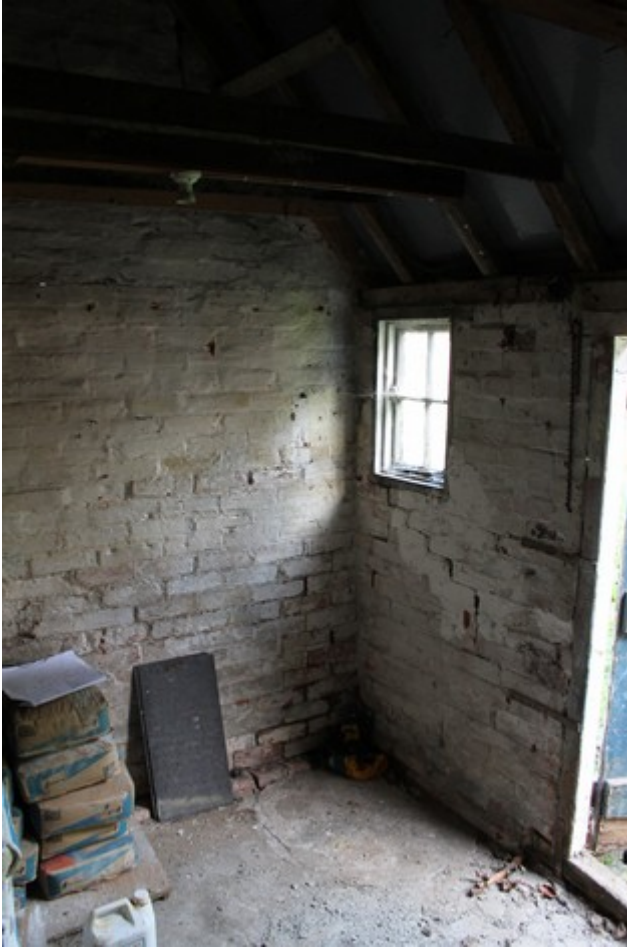
Plate 17 Interior shot of outbuilding – view north-east.

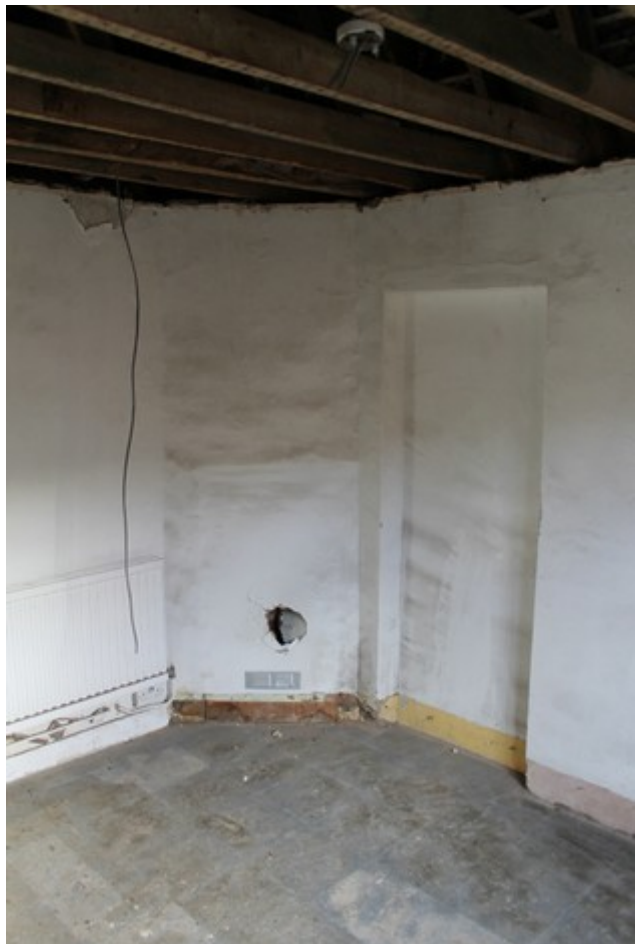
Plate 18 Interior shot of Room 2, showing blocked up doorway into Room 1 and fireplace – view north-east.

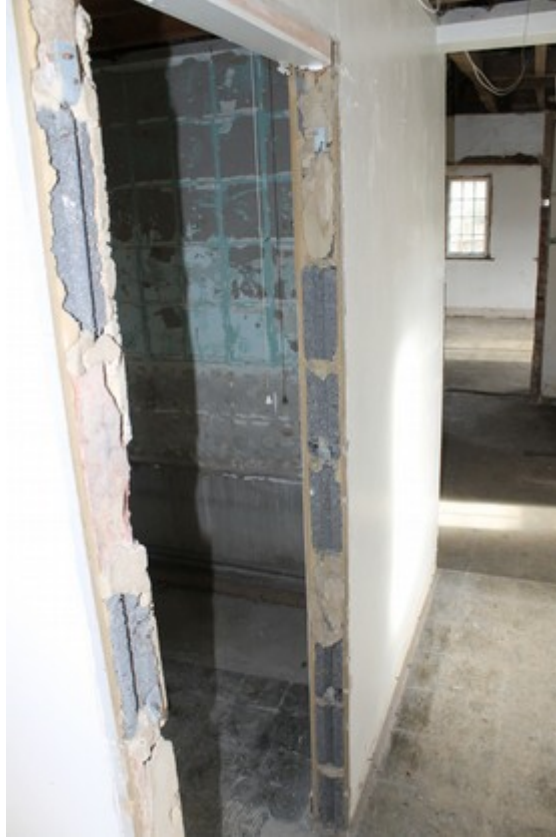
The extension contains three rooms, all of the floors of which appear to have been tiled until recently. All dividing walls in the extension are constructed out of breeze blocks covered with wood panels and plaster (Plate 19).

Plate 19 Interior shot of 20th-century extension, showing internal wall construction of breeze blocks and wooden panels – view north-east.

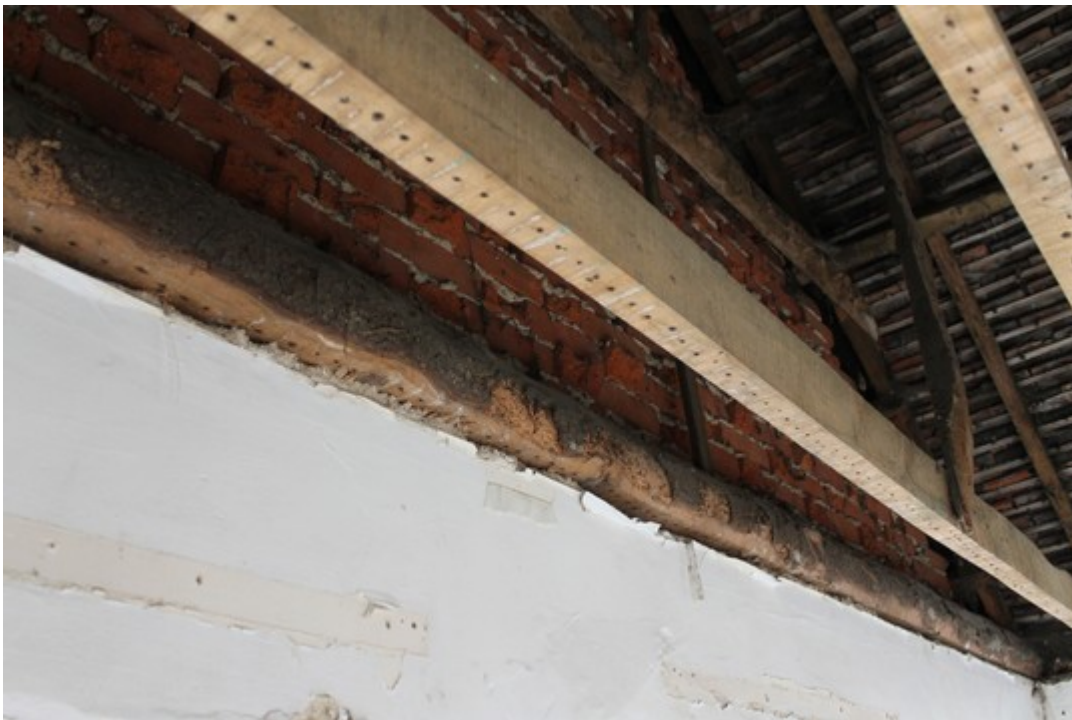
The roof of the original lodge is constructed from hand-sawn timbers rising to a ridgeboard from a series of tie beams. From each tie beam there are staggered inclined queen posts rising to either one of the pairs of rafters above (Plate 21). Collar braces are nailed to principal rafters at each gable end and around the central chimney stack (Plate 21). A single purlin runs through the centre of each roof pitch and is clasped by the collars, providing additional support. The plain tile roof is wooden pegged and supported on battens. Of some interest at the east gable end is a partly worked tree trunk in use as a wall plate (Plate 20).

Plate 20 East gable end of lodge, showing partly worked tree trunk in use as a wall plate – view south-east.

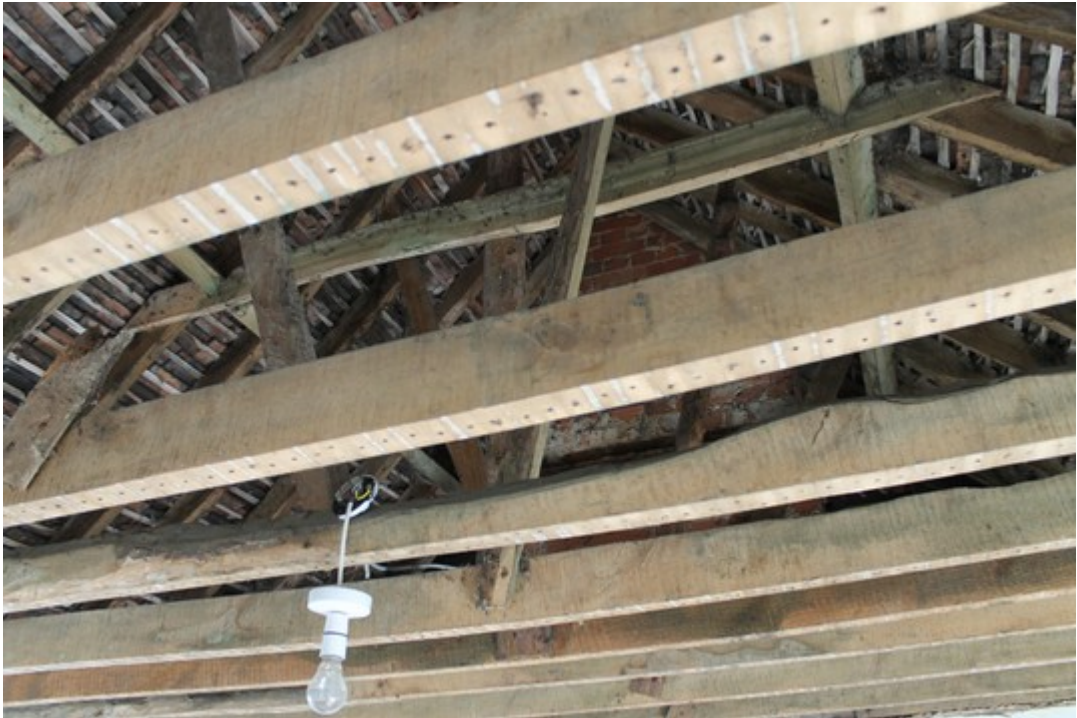
Plate 21 Roof trusses above Room 1, staggered inclined queen posts and collar visible – view south-west.

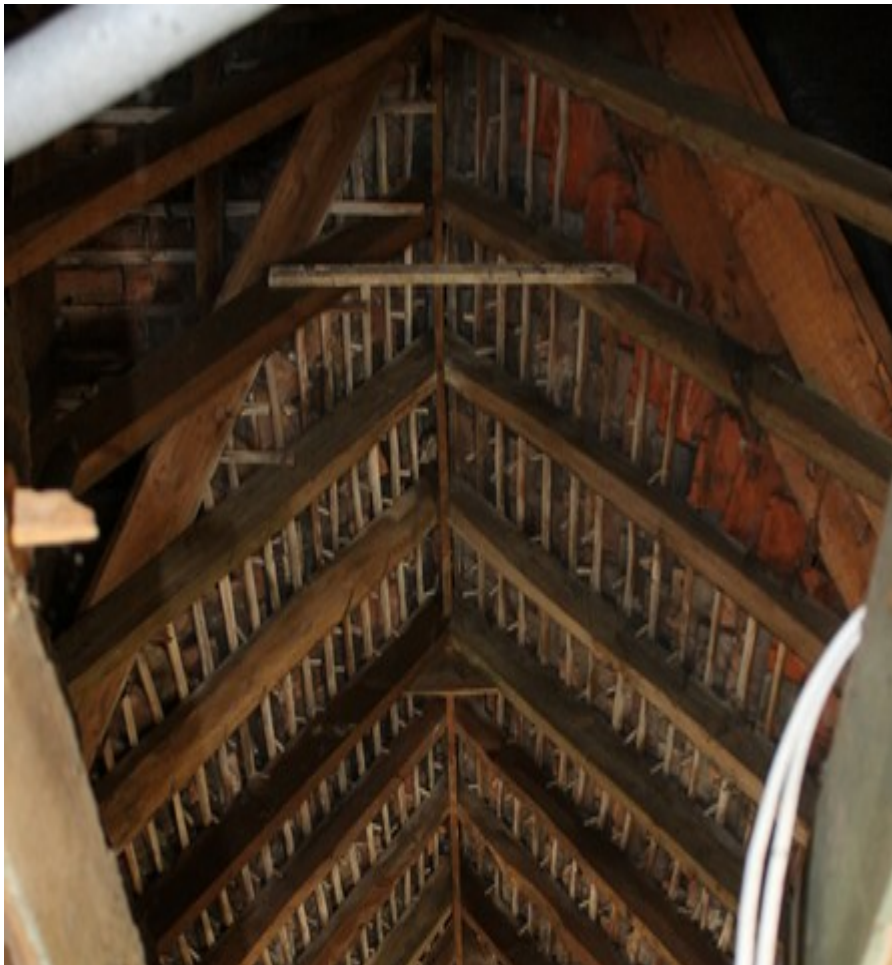
Plate 22 Roof structure leading to south gable end above Room 2. Visible to the right are 20th-century tiles joining from the extension – view south.

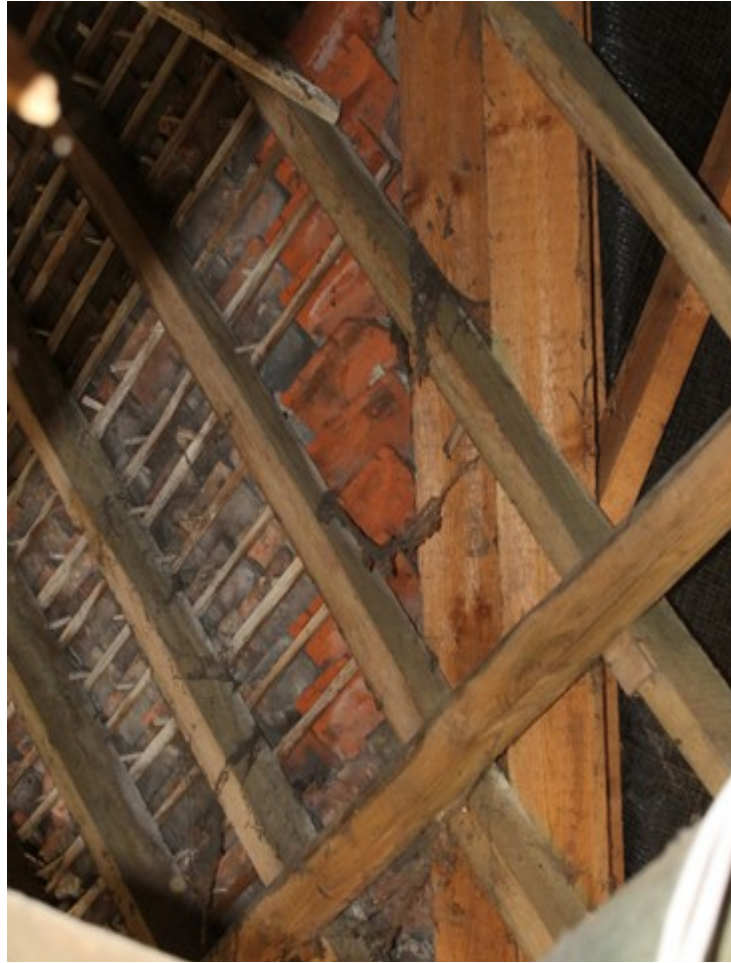
Plate 23 Detailed shot of 20th-century tiles. They are hung rather than pegged onto the battens – view south-west.

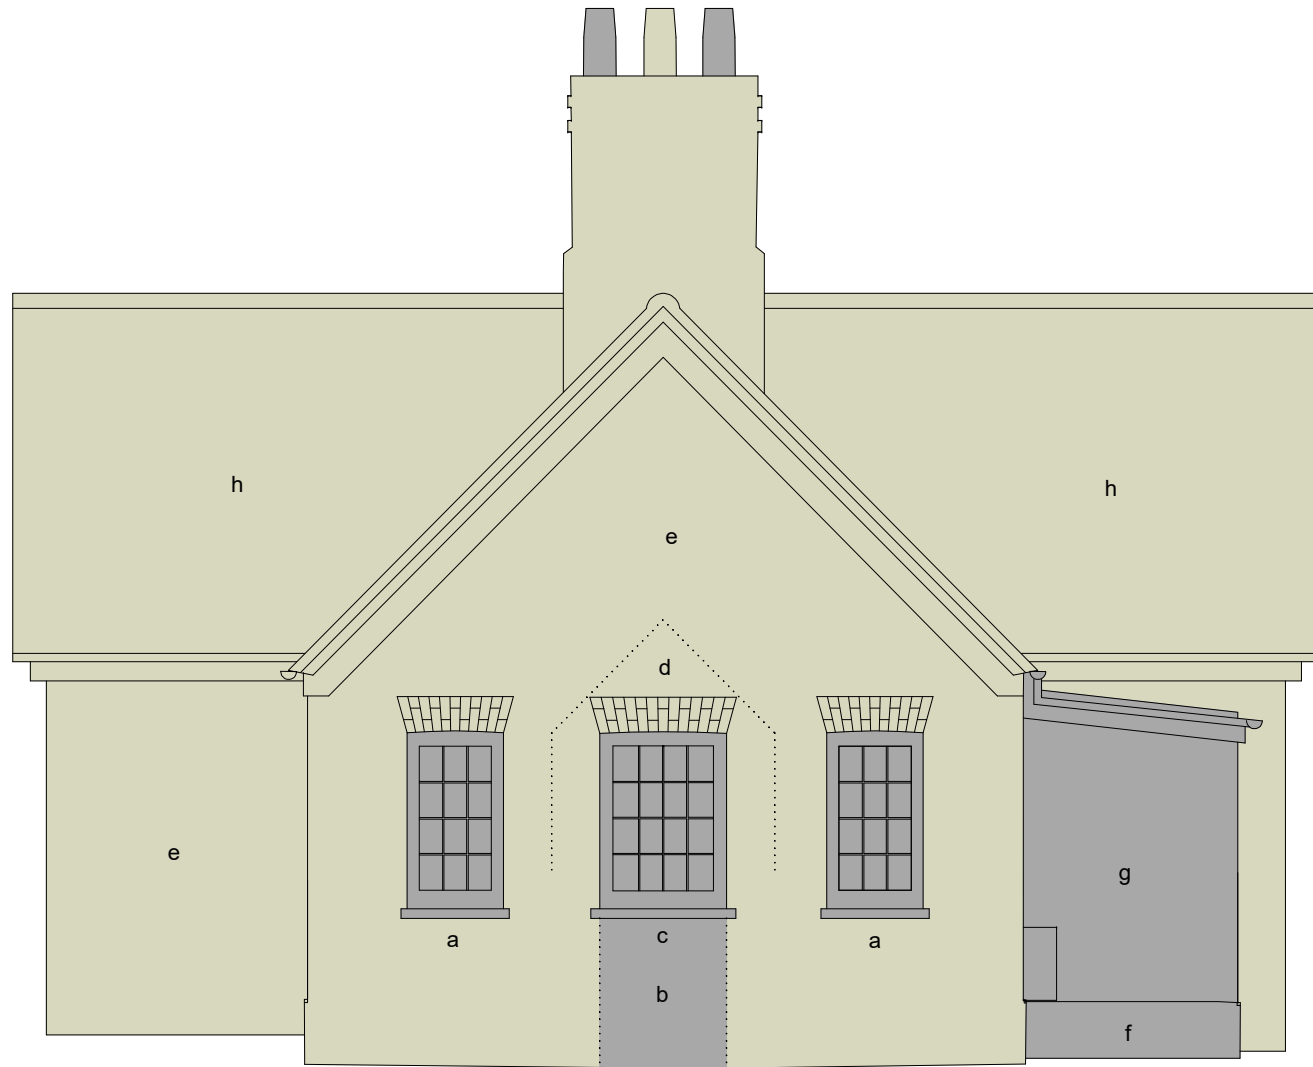
Fig 3 East elevation of lodge.

The original entrance to the lodge was located in the centre of the east elevation, underneath a porch (Plate 24, Fig 3). This entrance has since been replaced with a timber-framed sixteen light fixed window and is flanked on each side by timber-framed twelve-light casement windows. All of these windows are mid 20th-century replacements, probably

- a - 20th-century replacement timber-framed window
- b - blocked up original entrance
- c - inserted 20th-century timber-framed window
- d - faint scars showing outline of porch
- e - brickwork laid in Flemish bond
- f - modern render
- g - brickwork laid in Stretcher bond (20th-century alteration to lean-to)
- h - original plain tiles

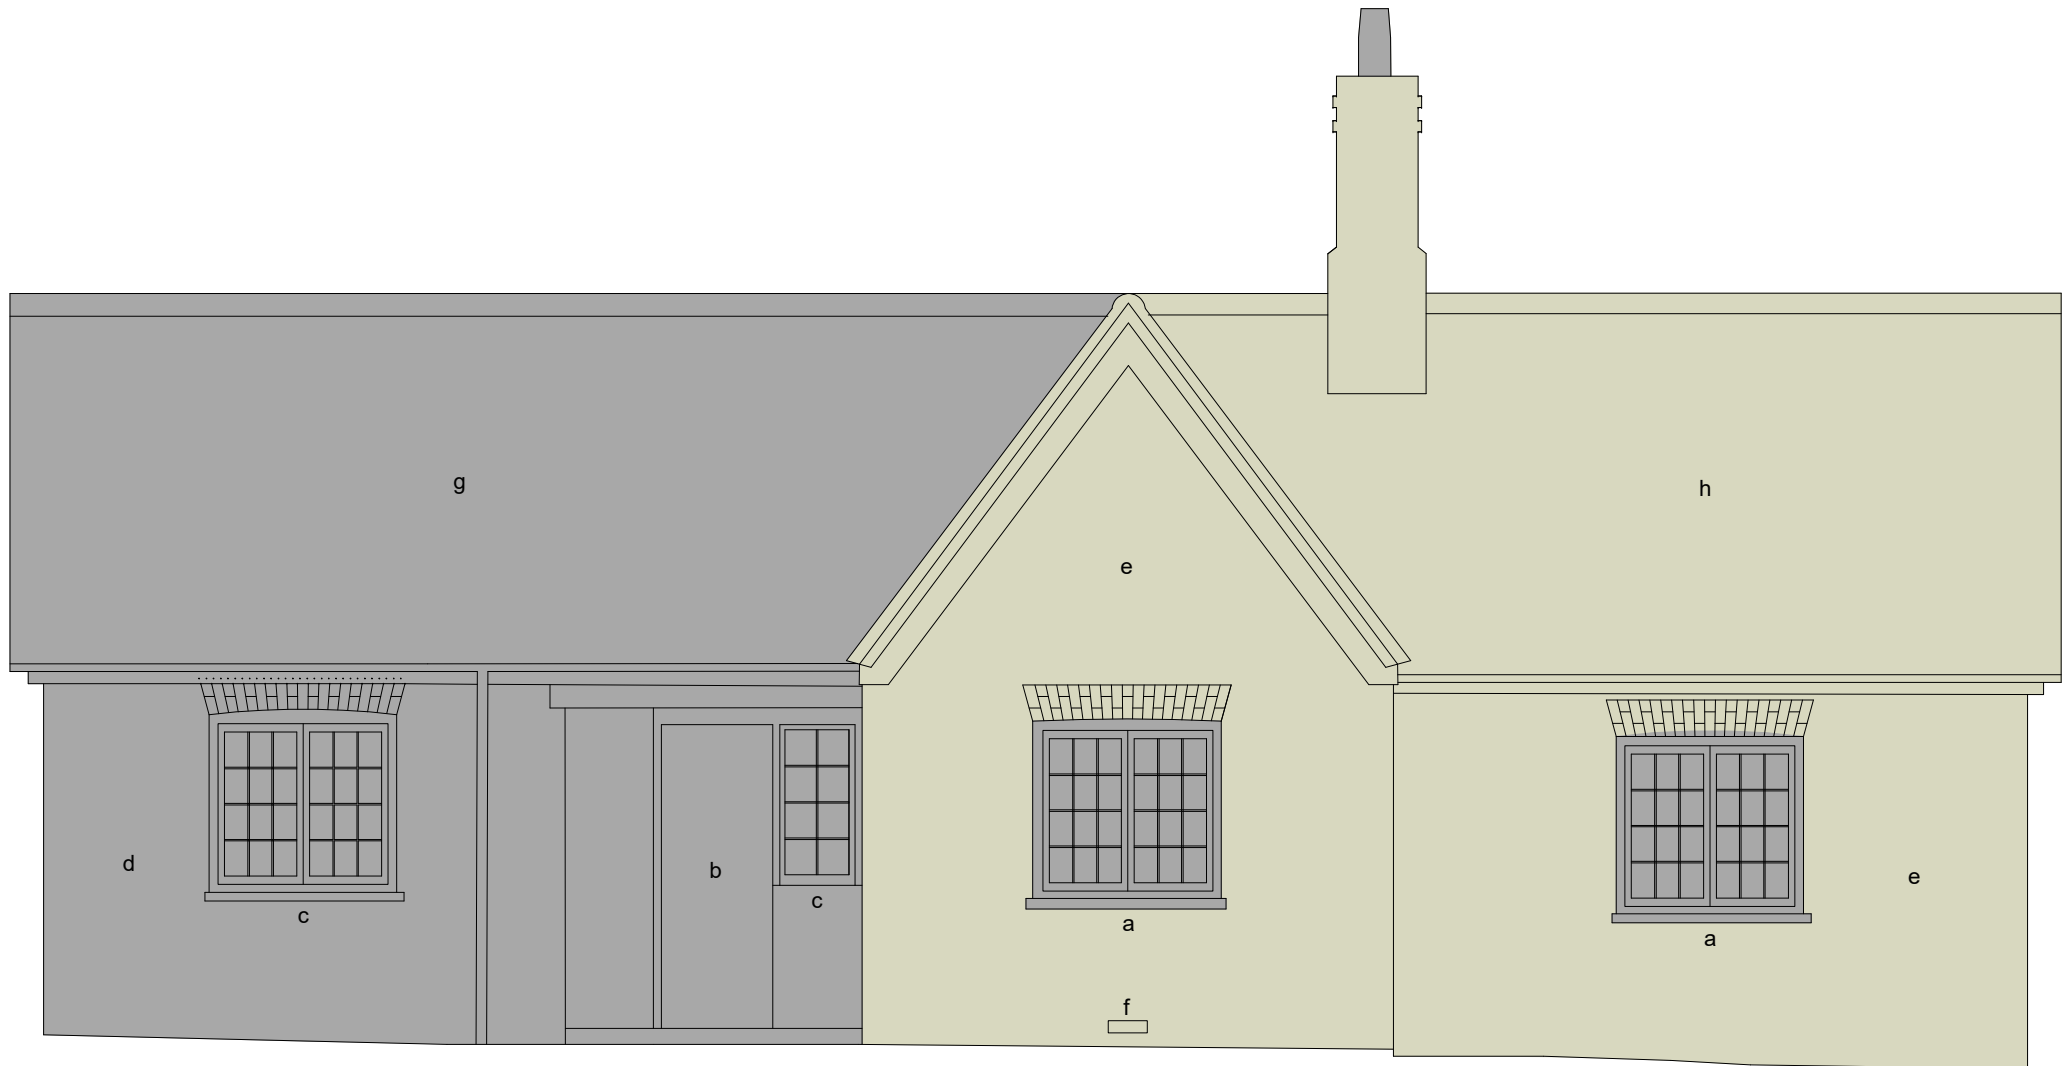
Fig 4 South elevation of lodge.

- a - 20th-century replacement timber-framed window
- b - 20th-century wooden door
- c - 20th-century timber-framed window
- d - brickwork laid in Sussex bond (20th-century extension)
- e - brickwork laid in Flemish bond
- f - original metal vent
- g - modern plain tiles
- h - original plain tiles

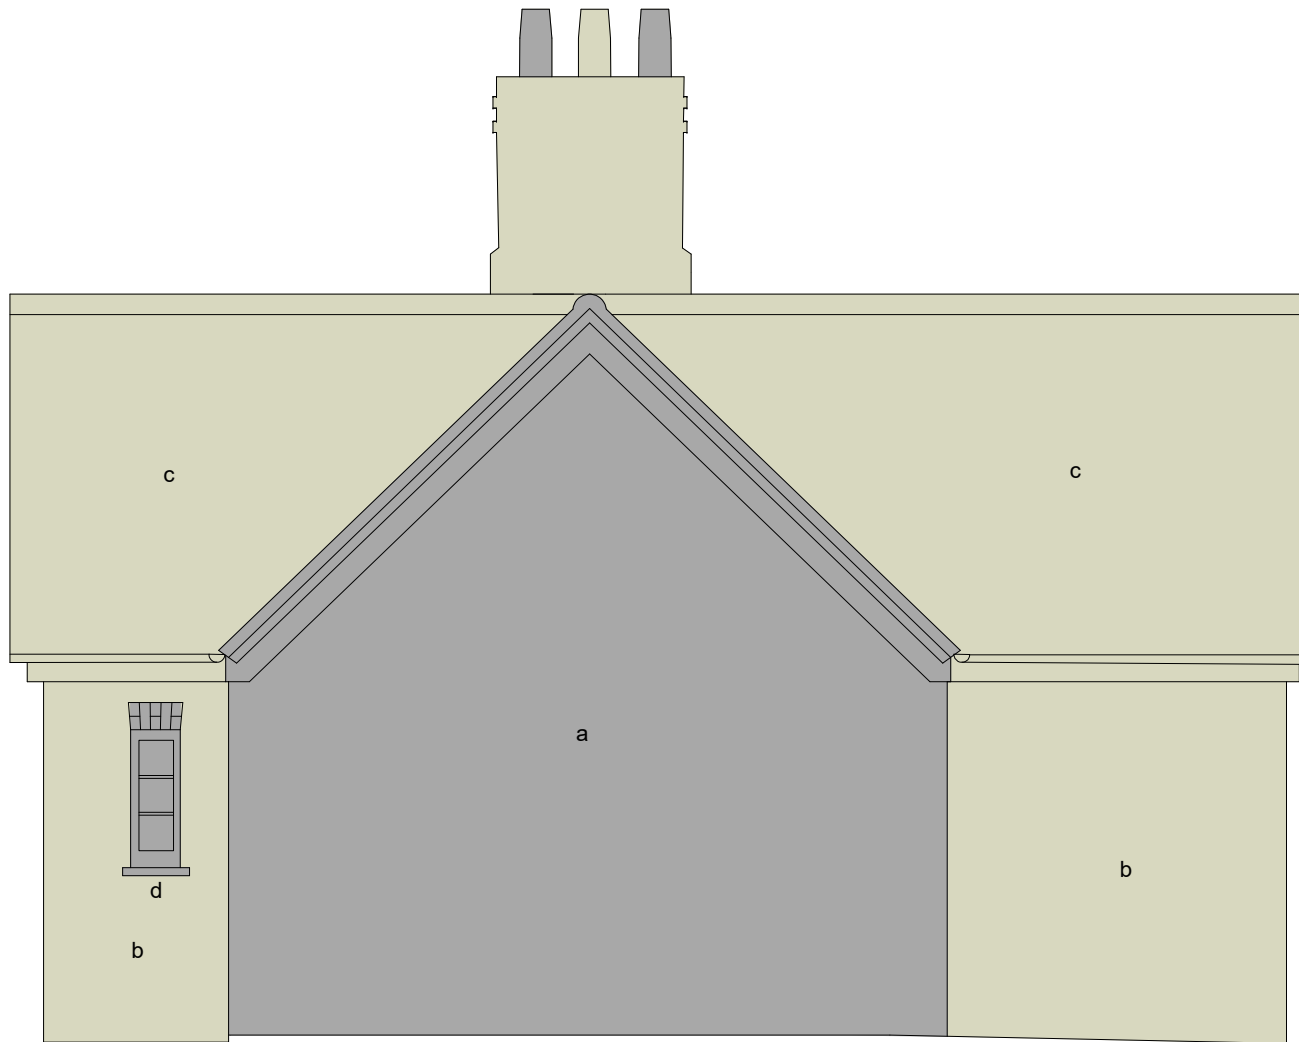
Fig 5 West elevation of lodge.

The western elevation of the original lodge is almost totally obscured by the 20th-century extension. The only thing of note is a three light hopper window that has been inserted at the north end. This was probably inserted at the same time as the extension was built and the windows replaced (Plate 8). As with the original window openings, this inserted window has a faux cambered arch above it. This arch is cut at a different (almost vertical) angle and varies slightly in appearance from the original window openings (it resembles the faux arches on the extension - see below).

a - brickwork laid in Sussex bond (20th-century extension)
 b - brickwork laid in Flemish bond
 c - original plain tiles
 d - inserted mid 20th-century hopper window
