**Historic building recording at Front Lodge, Moor
Place, Much Hadam,
Hertfordshire, SG10 6BS
November 2015**

**report prepared by
Mark Baister**

**commissioned by
Foxley Builders**

CAT Report 934
April 2016

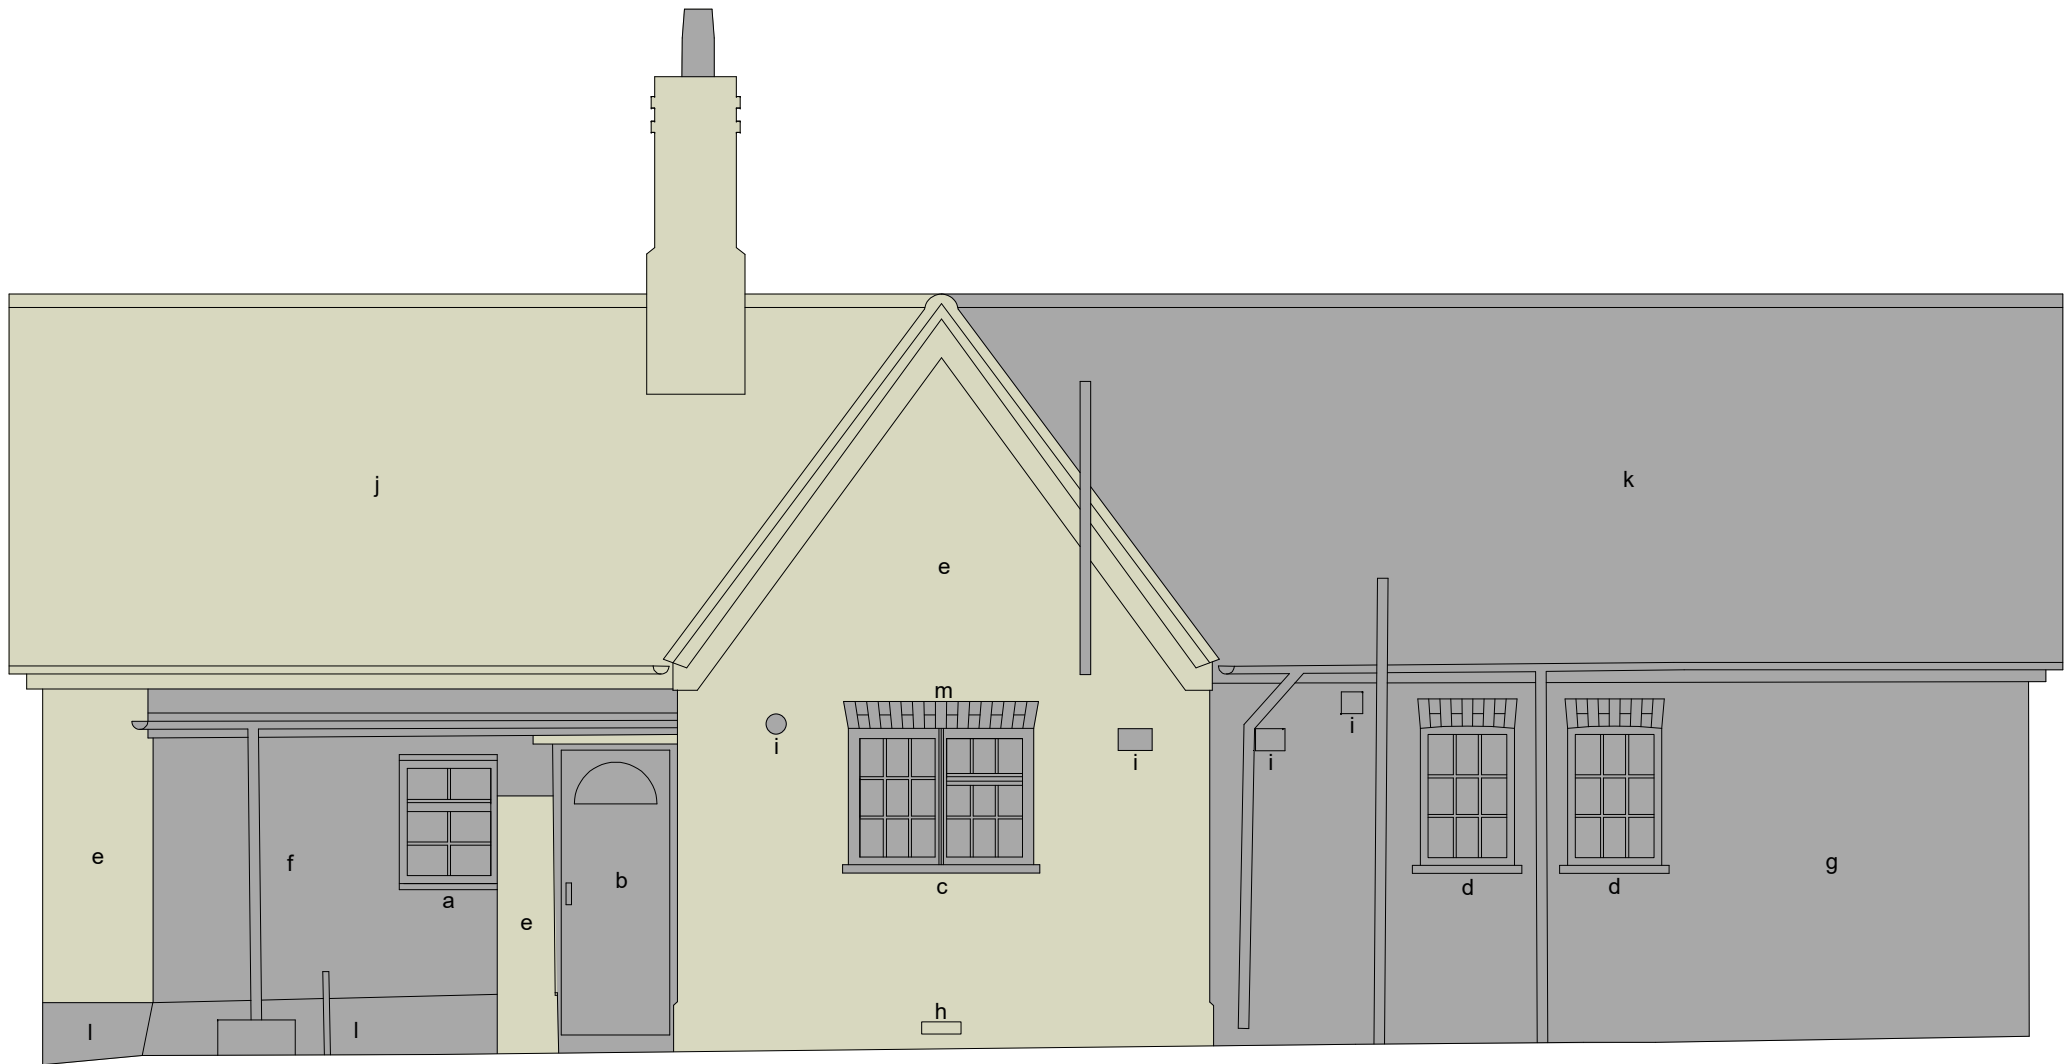
Fig 6 North elevation of lodge.

The lean-to has been extended and heavily altered in the early 20th-century (Fig 6). Only a small section of original brickwork remains and the modern alterations are all made of red brick laid in stretcher bond. The approximate dimensions of these bricks are 225mm x 110mm x 65mm. Based on the surviving queen closers and the internal wall, when it was first constructed the lean-to would only have been about a third of the size it is today (Fig 2). The extension of the lean-to probably took place in the early 20th-century, and is visible in a photograph from the period (Plate 25). The modern plastic window is inserted through this extension to the lean-to and partially blocks up a doorway (Plate 2). The wooden door is inserted through the original brickwork of the lean-to and likely replaces a smaller original door. It appears that when it was initially constructed the lean-to was only

- a - modern plastic-framed window
- b - 20th-century replacement wooden door
- c - 20th-century replacement timber-framed window
- d - 20th-century timber-framed window
- e - brickwork laid in Flemish bond
- f - brickwork laid in Stretcher bond (20th-century alteration to lean-to)

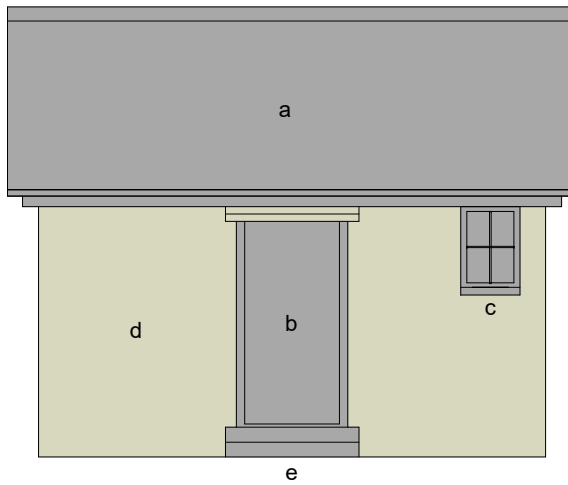
- a - plain tiles (original and relaid?)
- b - 20th-century replacement wooden door
- c - 20th-century replacement timber-framed window
- d - brickwork laid in Stretcher bond
- e - 20th-century concrete steps
