**Historic Building Recording
at Hutton Parish Hall, Rayleigh Road, Hutton,
Brentwood, Essex**

**report prepared by
Mark Baister**

CAT Report 973
August 2016

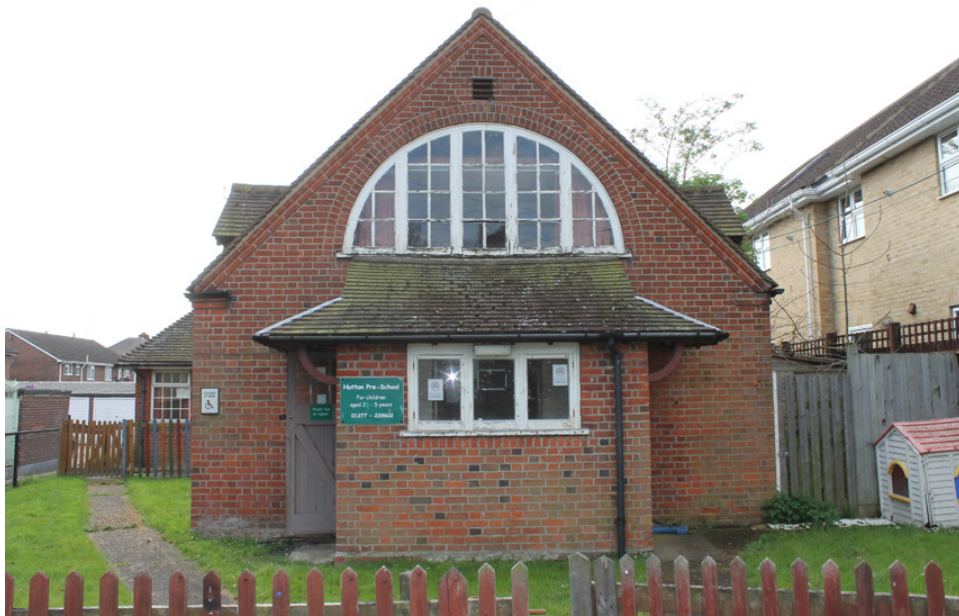
Photograph I Front of building, showing original porch. Shot taken facing south-east.

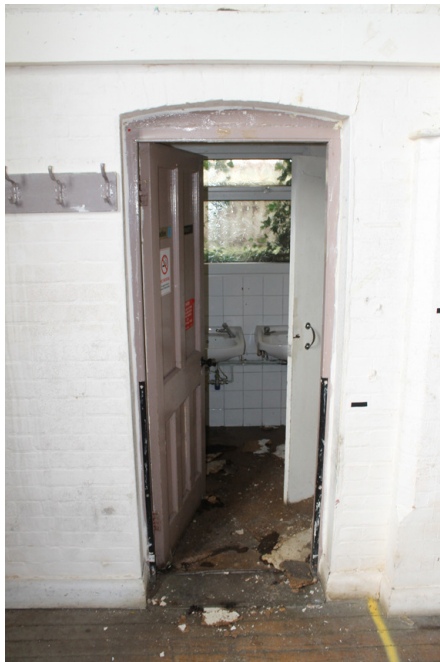
Photograph II Original doorway, now leading into the third extension, Shot taken facing south-west.

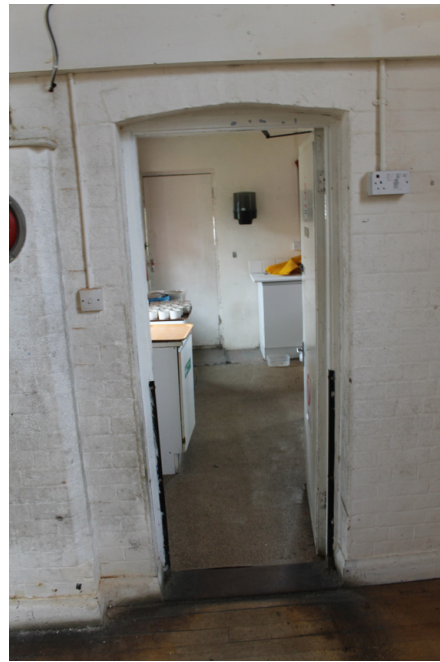
Photograph III Original doorway, now leading into the first extension, Shot taken facing north-east.

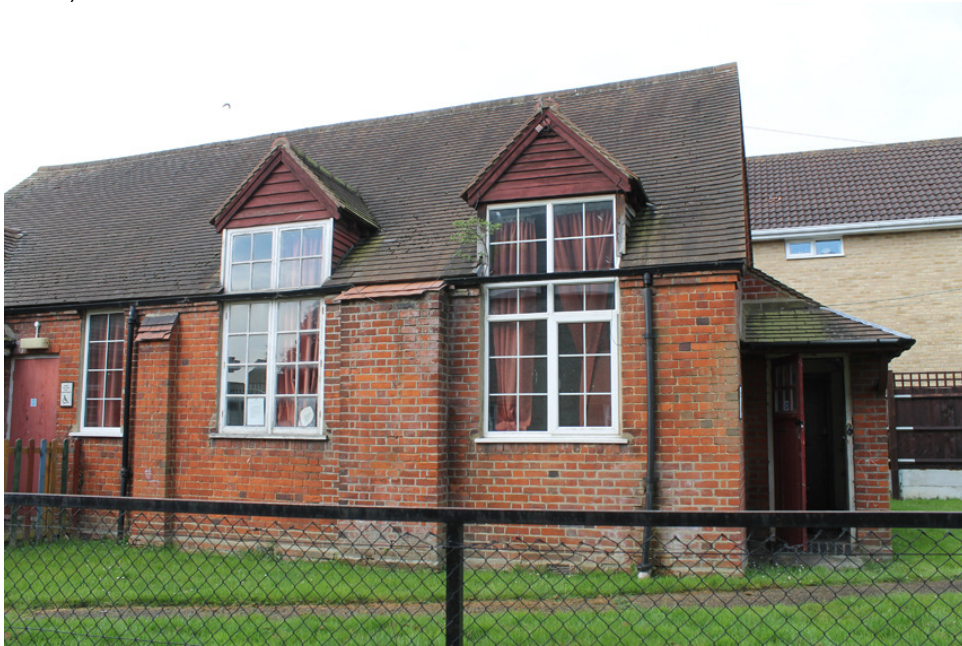
The main building (disregarding extensions) has nine total windows, one in each gable, three on each long elevation and one on the porch. The windows in the gables and on the porch are original to the building, but the other six are replacements (although some have been more recently replaced than others – there is a mix of plastic and wooden-framed windows). Although not all the windows are original, all of the window openings appear to be. Most have been enlarged or modified however and have lost their associated queen closers as a result. In particular the central window opening on each long elevation has been raised and originally would have been lower down in the brickwork (Photograph IV) – this

alteration would have occurred when the dormers were added to the building (see below).

Photograph IV North-east elevation of building. Three replacement windows and inserted dormers visible. Central window opening has been raised – with replaced brickwork below.

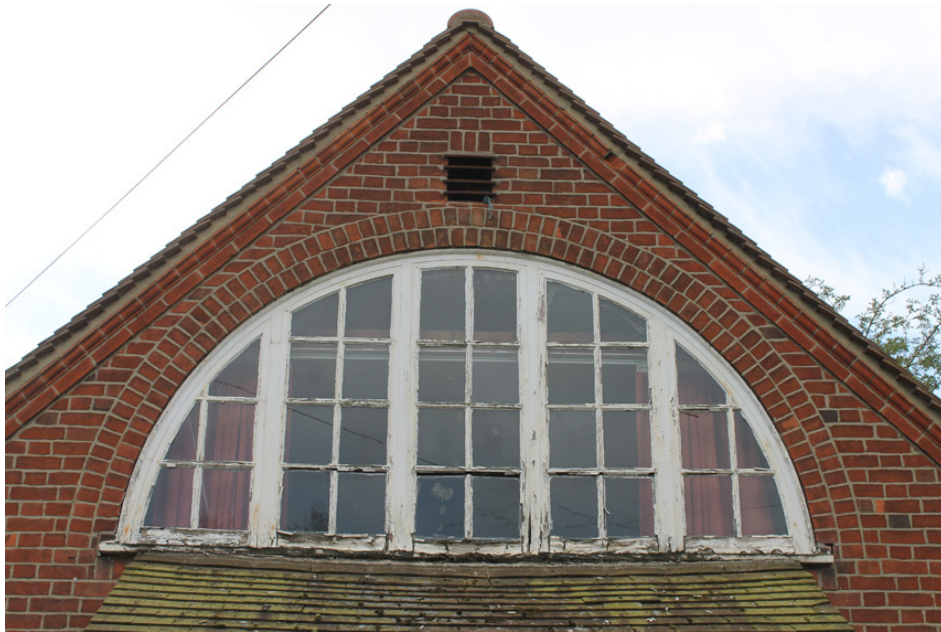
Photograph V Original north-western gable end window. Inserted ceiling panels visible. Shot taken facing south-east.

The north-western gable end contains an original thirty-three light semi-circular fixed wooden-framed window, situated just above the porch (Photograph V). The porch itself has an original three-light casement window facing the road. The two long elevations of the hall have symmetrical window placement, with two large twenty-four light casement windows and one smaller eight-light fixed window on each elevation (Photograph IV). All of these windows are later replacements, and are plastic-framed (apart the central windows on each elevation which are wooden-framed). The south-eastern gable end contains an original twenty-light fixed

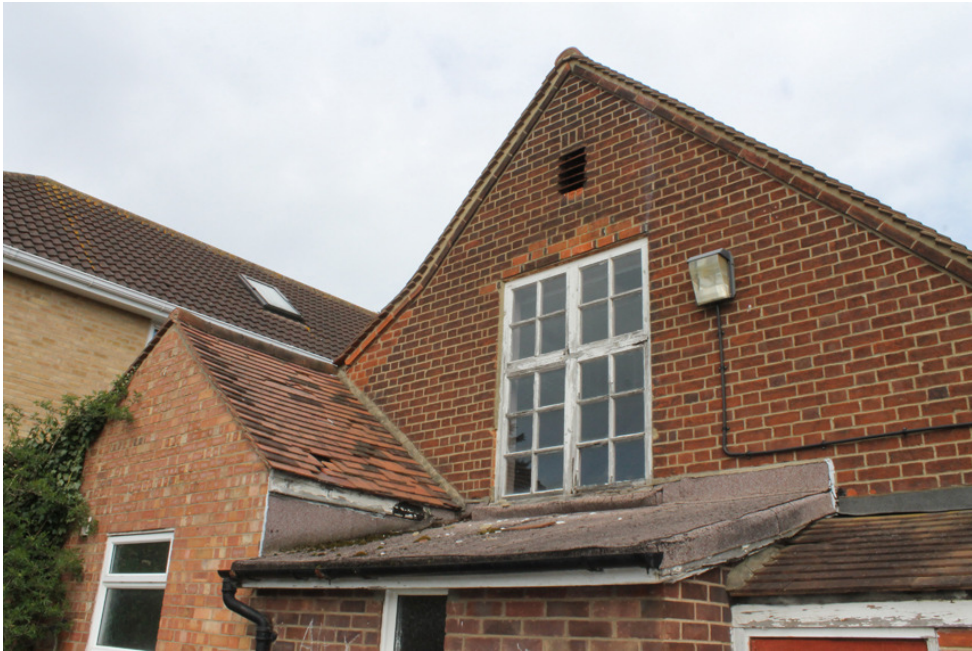
wooden-framed window (the brickwork above this window appears to have been disturbed, possibly suggesting that the lintel had to be replaced at some point – Photograph VI).

Photograph VI South-eastern gable end of building. Original window visible with evidence of possible replaced lintel. Extension of tile roof to cover second extension also visible. Shot taken facing west.

The third extension is a modern toilet block and wraps around the side of the building. It is 6.15m x 5.1m in size and covers 19.4 square metres. It is constructed from engineering bricks with dimensions of 220mm x 105mm x 65mm. The extension contains two plastic-framed fixed windows with awning windows above. It is roofed with machine-made modern plain tiles. The entrances into this extension from the main building are both original doorways. When this extension was added the tile roof of the main building was re-angled and extended to partially cover it, resulting in an additional pitch (Photograph VI).

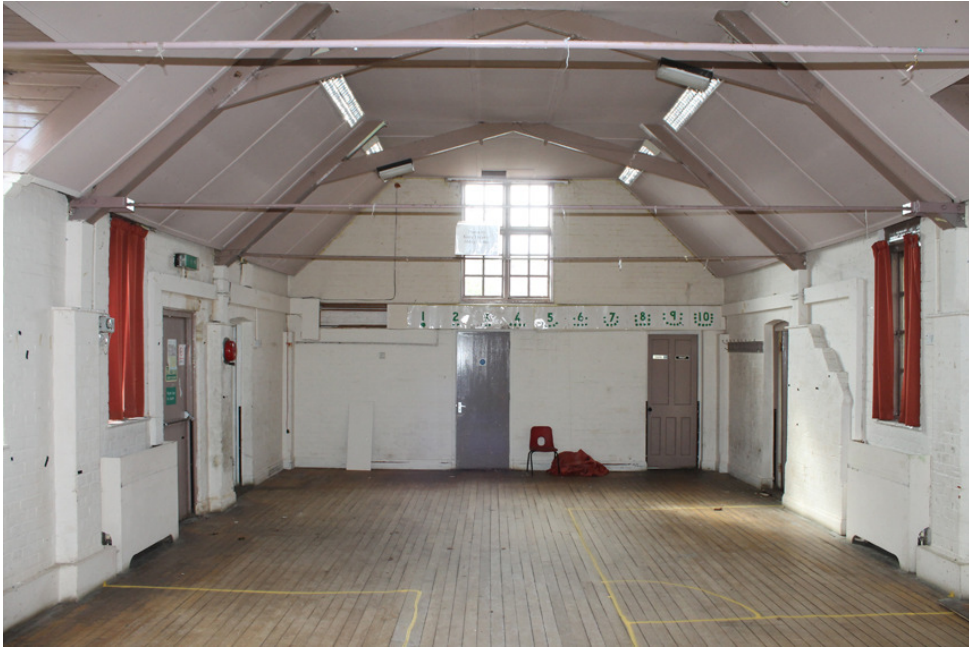
The roof of the building is supported by a composite truss, with a series of wrought-iron tie rods (Photograph VII). The entire interior is covered with suspended ceiling panels (which are clearly a later insertion as they partially block the northern gable end window – Photograph V) which mask most of the roof timbers – but some details are discernible. Although not visible, the common rafters are obviously supported by the brick walls. In contrast, the principal rafters are supported by short posts embedded into brick plinths within the building (Photograph VIII). There are diagonal braces from the principal rafters that are partially hidden by the ceiling panels, but are either scissor braces (crossing diagonally between each pair of principal rafters) or join with a collar.

Photograph VII Interior of building. Composite truss and inserted ceiling panels visible. Shot taken facing south-east.

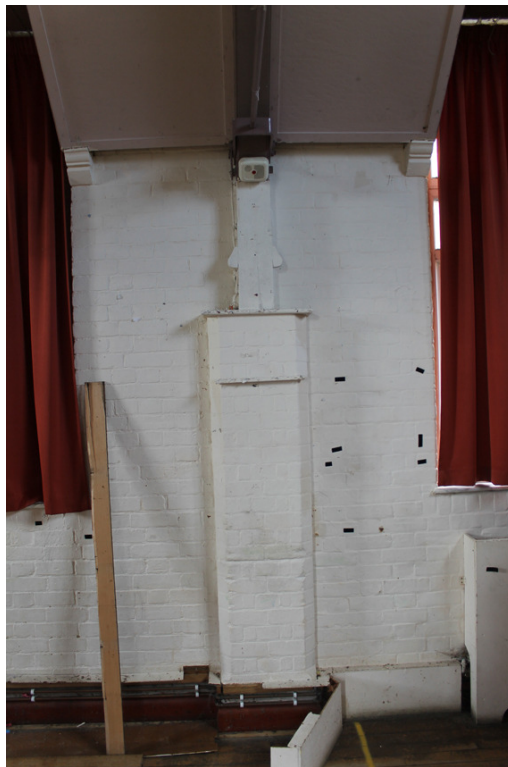
Photograph VIII Brick plinth supporting principal post and truss above. Shot taken facing south-west.

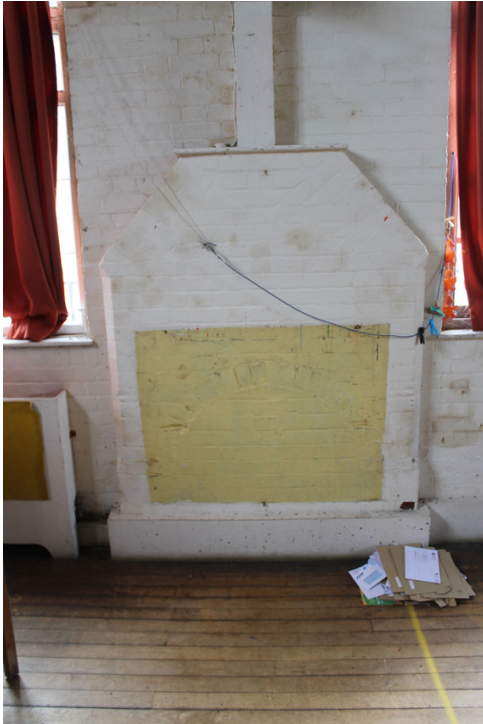
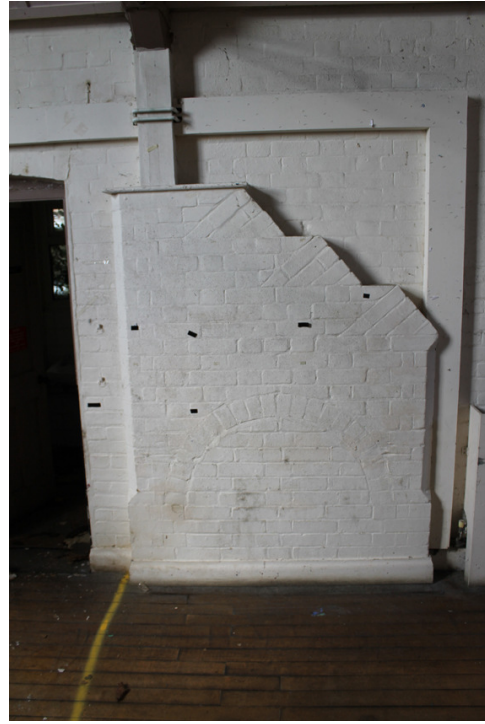
Two of the posts supporting the principal rafters are embedded in and supported by brick-built fireplaces with reinforced buttressing (Photographs IX and X). This is a peculiar design choice and would likely have caused some strain on the trusses above these fireplaces – even with the buttressing. This may have been a contributing factor to the eventual removal of the chimneys and blocking up of the fireplaces (see below).

Photograph IX Blocked reinforced fireplace with principal post rising to truss. Shot taken facing north-east.

Photograph X Blocked fireplace with buttressing supporting principal post rising to truss. Shot taken facing south-west.

The only architectural aspects of note are the reinforced brick fireplaces supporting two principal posts – a curious construction choice and one that probably contributed to the eventual decision to demolish the chimneys and block up the fireplaces.

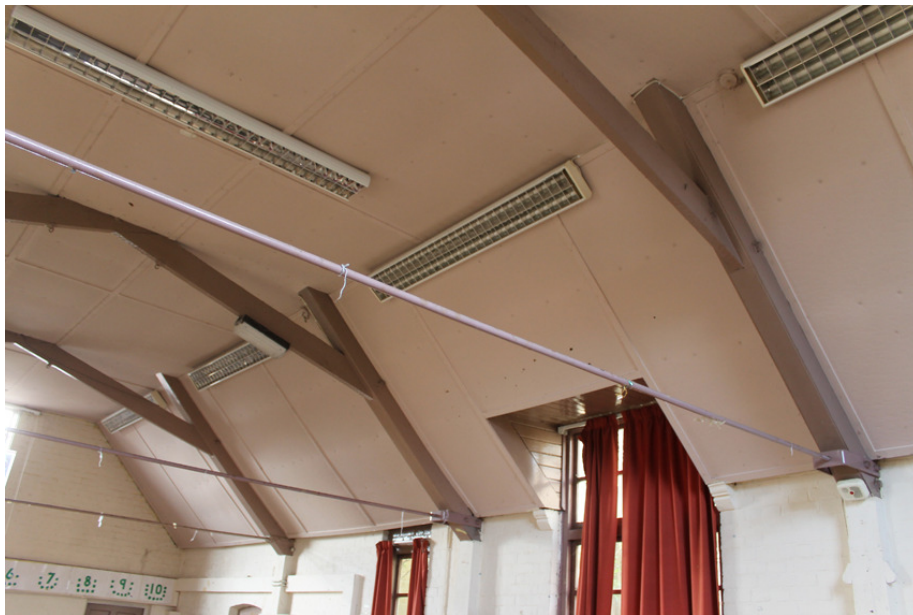
Photograph XI Shot showing roof trusses and supporting brackets for inserted ceiling panels. Shot taken facing south.

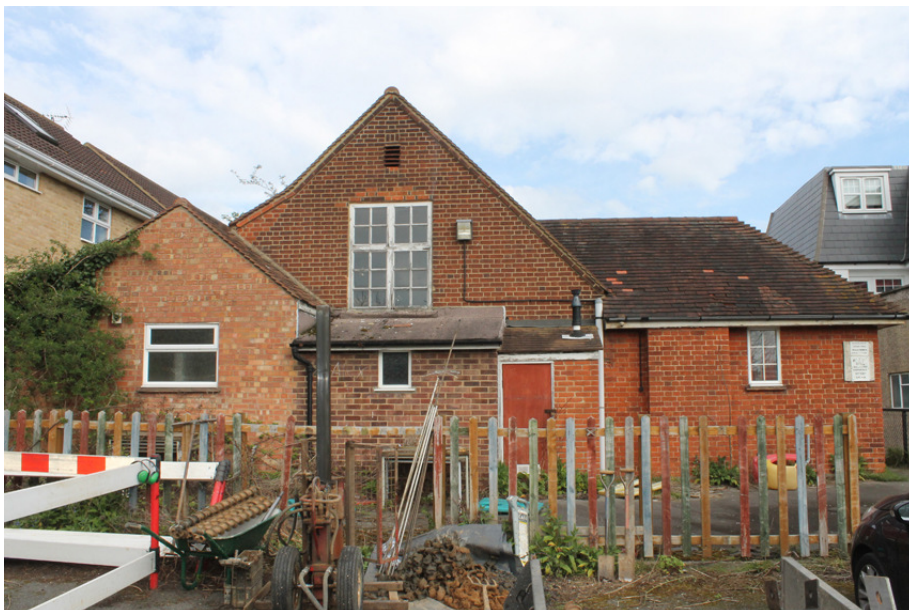
Photograph XII Rear of building, showing all four extensions. Shot taken facing north-east.

The second extension was clearly constructed after the annexe's demolition, and indeed is likely to have been part of the reason it was demolished – to make way for a modern toilet block. The third extension seems to have been constructed after the second, given the interlocking bricks at the joining point between the two (Photograph XII).

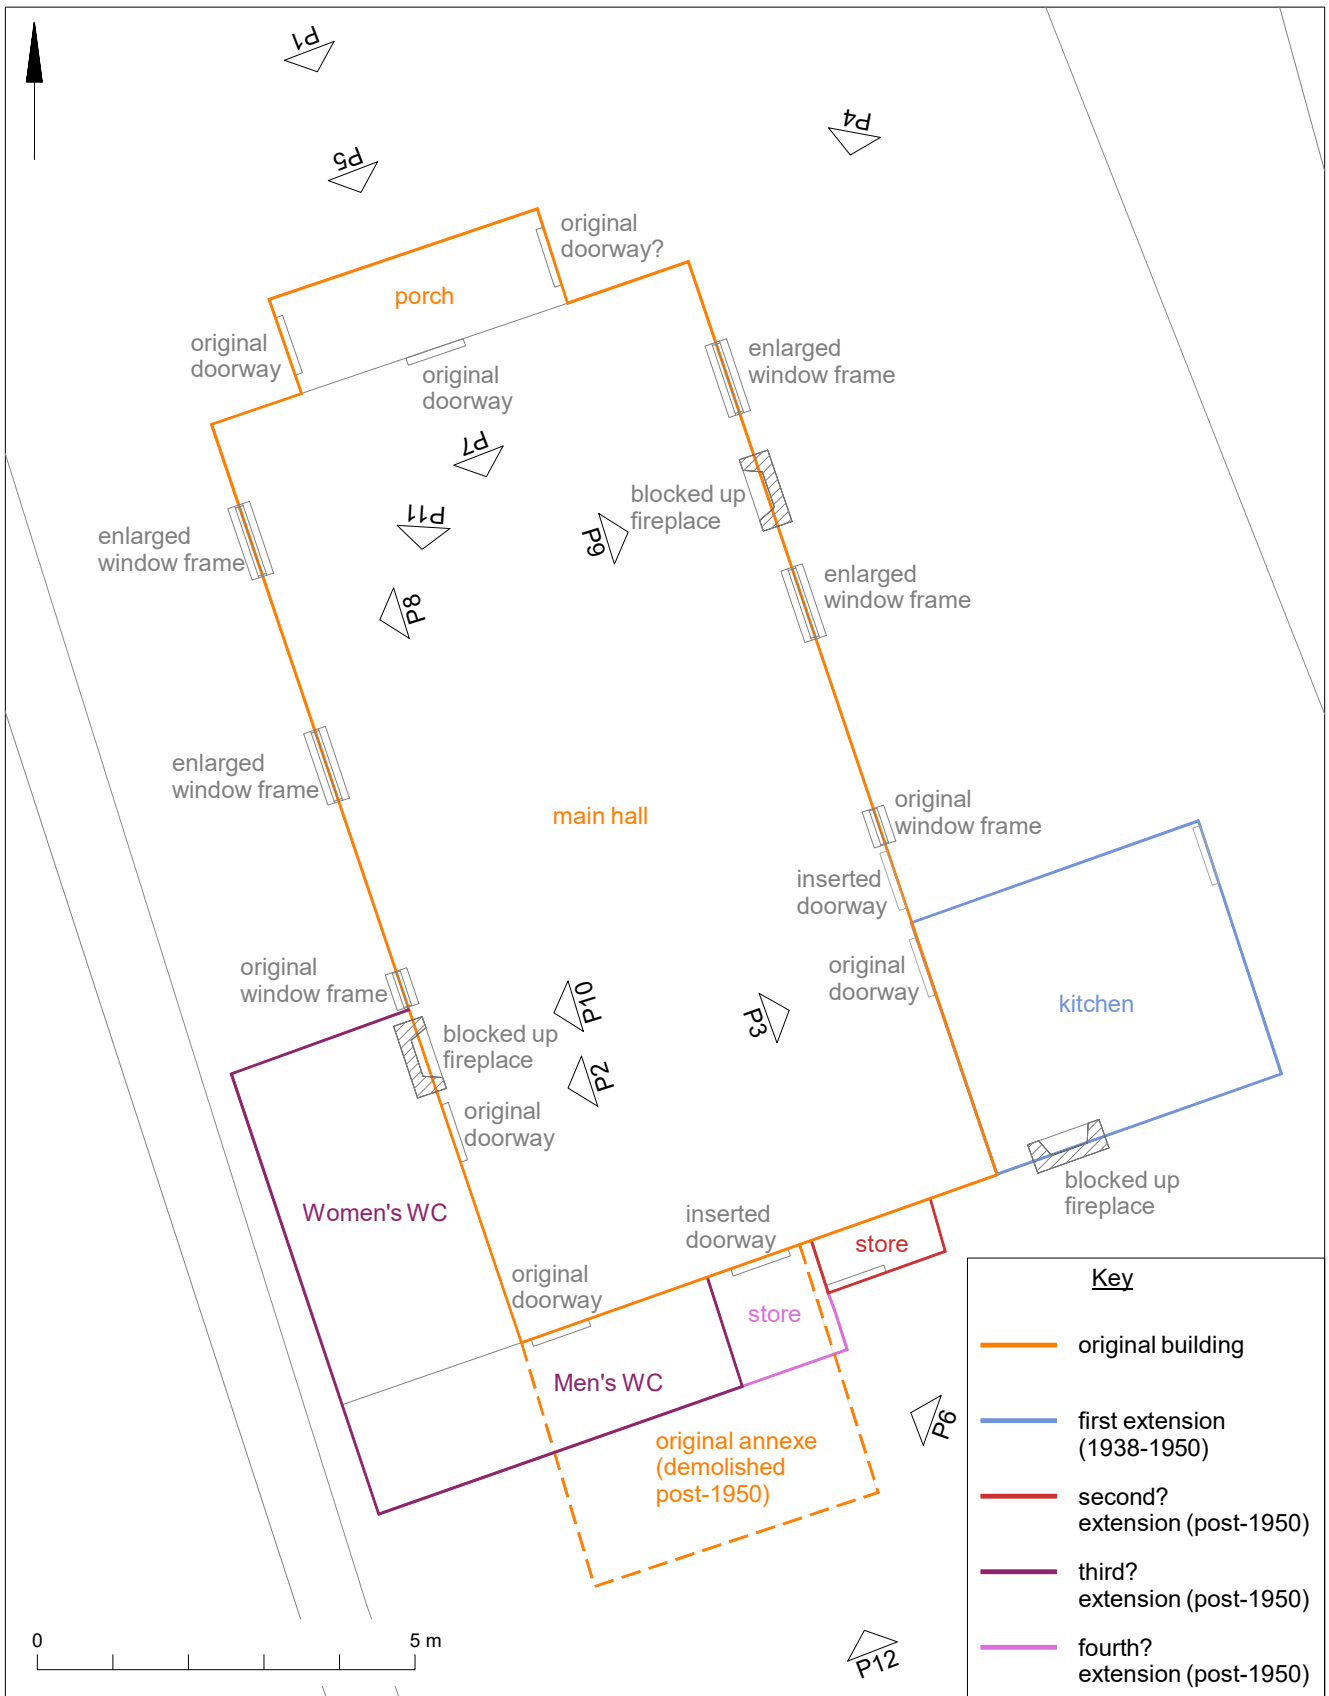
Fig 2 Detailed plan of building, showing current room uses, internal walls, features and different phases of construction. Arrows indicate the location and direction of photos in the main text.

A modern plan of the building (Fig 2) shows that the southern annexe has been demolished and replaced with three modern extensions. These all date from the latter half of the 20th-century.

These three post-1950 extensions are difficult to date in relation to each other but it seems likely that they were constructed in the order listed above. The first extension seems the most in-keeping with the original building, using red brick and a tiled roof, and even could have been constructed prior to the demolition of the buildings original annexe, given its location (Fig 2).
