**Historic building recording at
the White Hart Hotel, 1 High Street,
West Mersea, Essex CO5 8QD**

August 2018 and April 2019

CAT Report 1324
May 2019

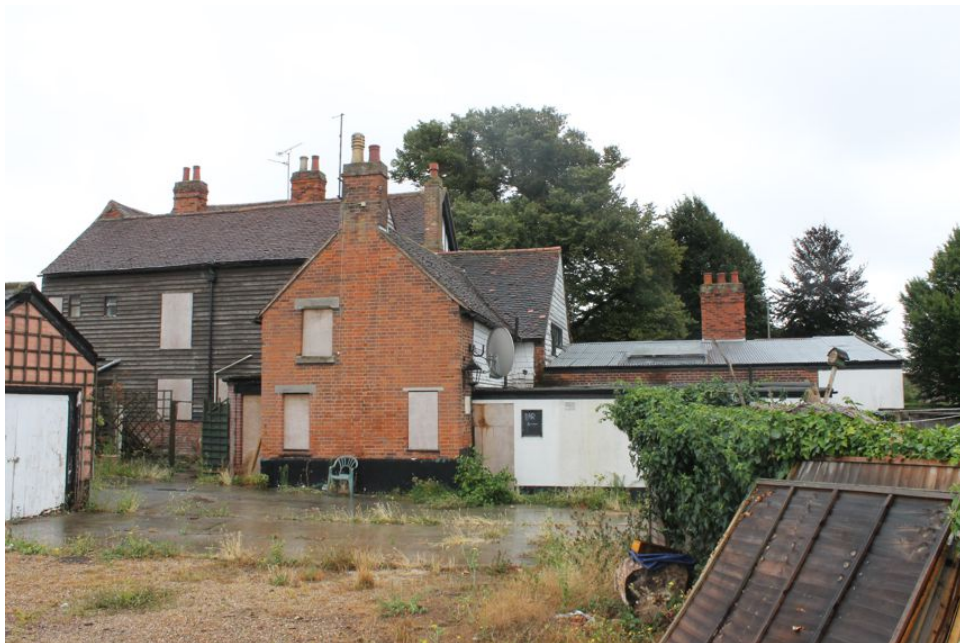
Photograph 8 North-west elevation of the White Hart. Photograph taken facing east.

The two windows on the ground-floor are six-light sashes with horns. The two smaller windows on the first-floor are modern awnings with two lights each. The two larger windows are twelve-light sash windows with no horns. This disparity of horned sashes on the ground-floor and hornless sashes on the first-floor suggests that the ground-floor windows are later insertions or replacements of the original windows (horns on sash windows being a later development; Historic England 2017).

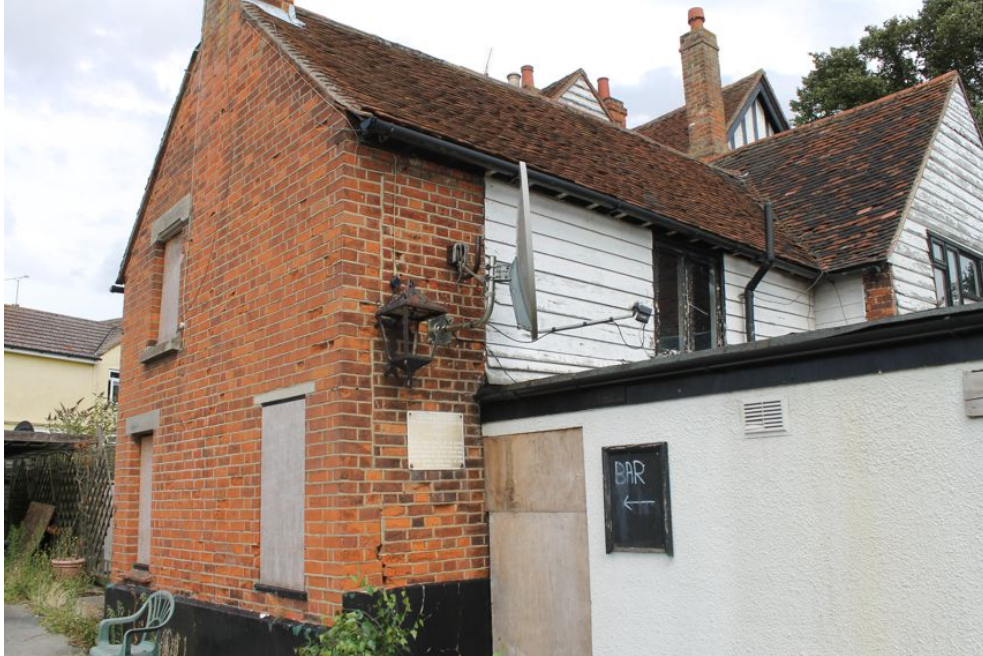
Structure B is constructed of red brick on this elevation (although on others it appears to be timber-framed, see below). The bricks are laid in a variant on Flemish-bond and bonded in lime mortar. They have dimensions of 230mm x 105mm x 65mm. The brickwork becomes irregular and mismatched when it joins with the timber-framing on the other elevations (Photograph 9).

Photograph 9 North-west and south-west elevations of Structure B, showing mismatched brickwork adjacent to timber-frame. Photograph taken facing east.

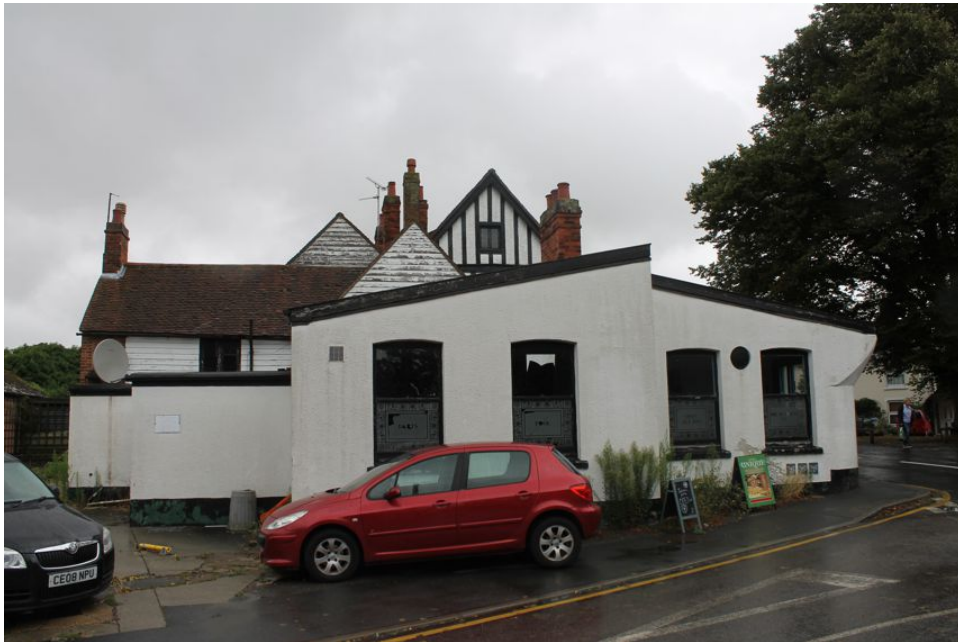
Structures E, F and G on this elevation are all brick-built and rendered in white-painted pebble-dash. Structures E and F are single-storey buildings and each have two two-light sash windows on this elevation, each with a frosted lower pane (Photograph 10).

Photograph 10 South-west elevation of White Hart. Photograph taken facing north-east.

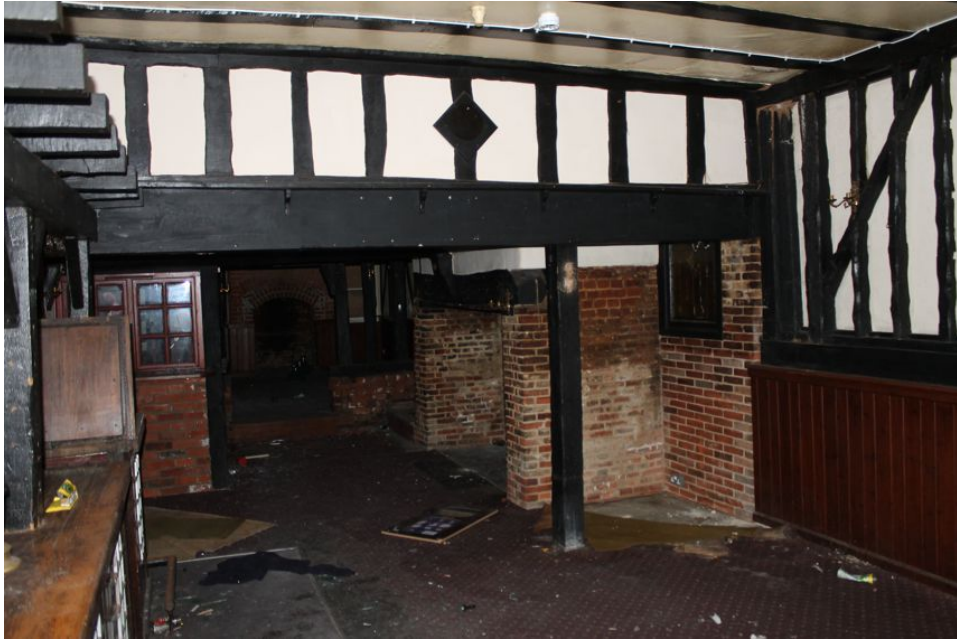
Very little remains on the ground-floor of Structure A. The original south-east and south-west ground-floor walls of the building are almost entirely absent, and in these locations the first-floor is supported by inserted modern brickwork associated with Structure E and an inserted beam and post associated with Structure F (Photograph 13).

Photograph 13 South-east elevation of Structure A from interior of Structure F. Inserted beam and post visible. Photograph taken facing north-west.

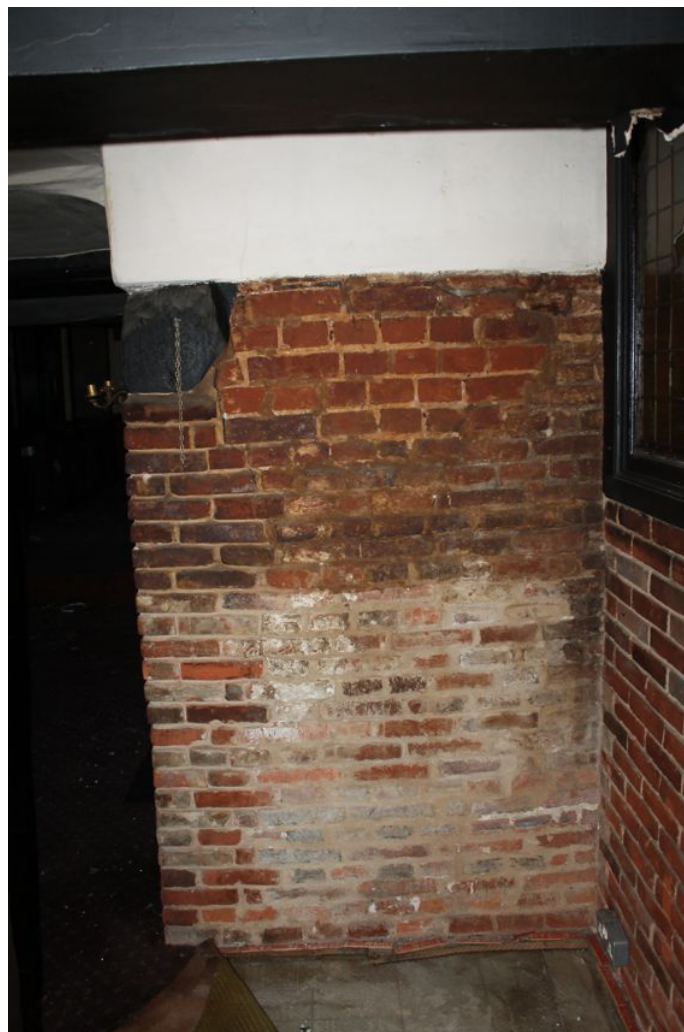
Photograph 15 South-east side of fireplace, showing rebuilt areas compared to original brickwork. Photograph taken facing north-west.

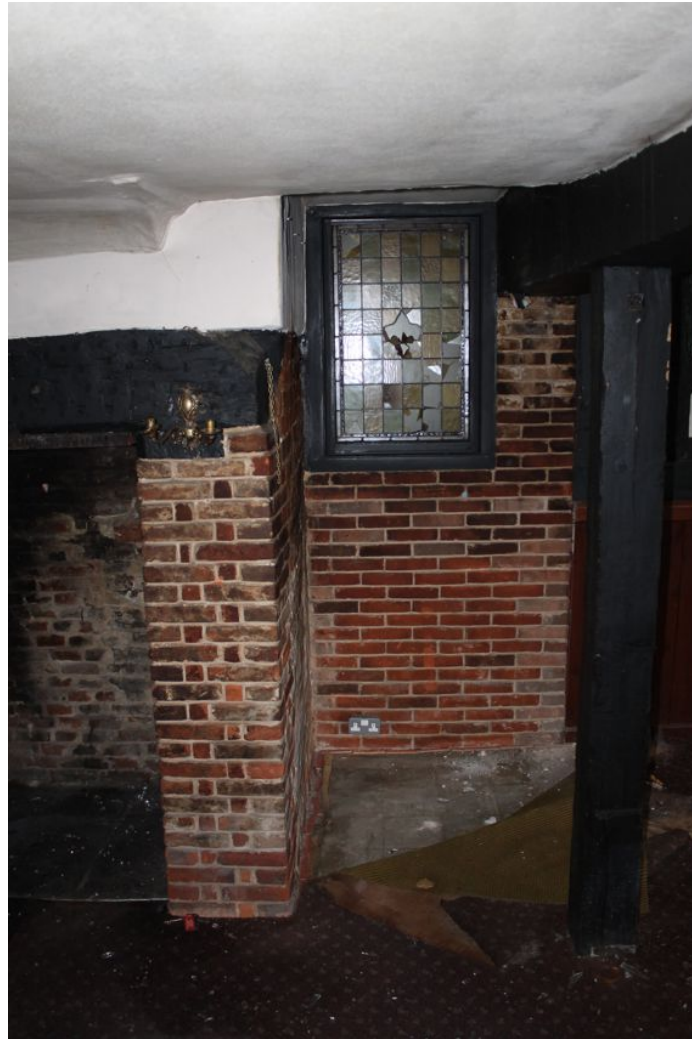
Also in the north-east wall on the ground-floor is a section of brickwork surrounding a stained-glass window. This brickwork is laid in stretcher-bond and bonded in lime mortar, and has dimensions of 220mm x 50mm. The window is leaded with a wooden-frame and a *fleur-de-lys* motif in the centre (Photograph 16).

Photograph 16 North-east ground-floor wall to Structure A, showing inserted brickwork and stained-glass window. Photograph taken facing north-east.

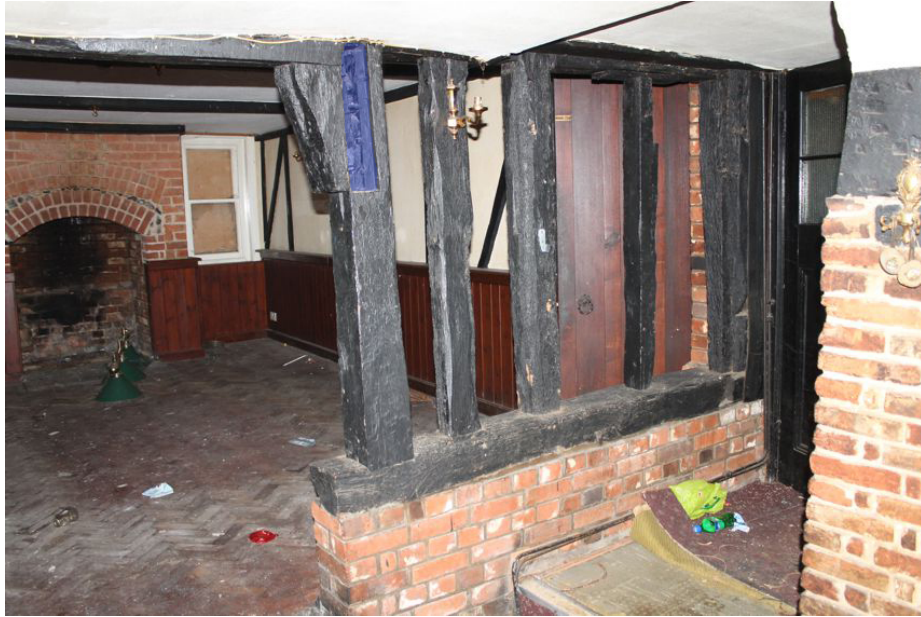
The north-west wall of the ground-floor has a small section of stud-work comprising hand-sawn timbers (Photograph 17). Although heavily altered (the brick plinth has been raised and rebuilt, and the sill-beam is clearly a later addition) these studs appear to be part of the original timber-frame of Structure A. Within this small section is a clear gap in the stud-work filled with an un-morticed modern timber and with an original hand-sawn wooden header (Photograph 18). This is the location of an original doorway into the building and is in line with a doorway observed on the south-east elevation (see below).

Photograph 17 Section of surviving original stud-work in north-west wall of Structure A. Modern inserted timber blocking doorway second from right. Mortise for brace supporting original first-floor highlighted in blue. Photograph taken facing north.

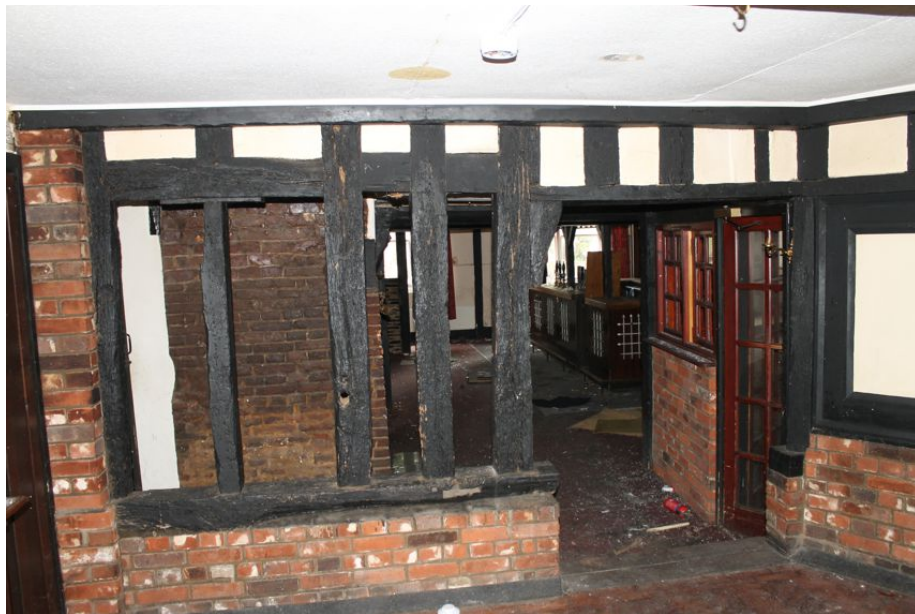
Photograph 18 Original stud-work viewed from Structure B. Inserted modern timber clear, as is original header for doorway. Photograph taken facing south-east.

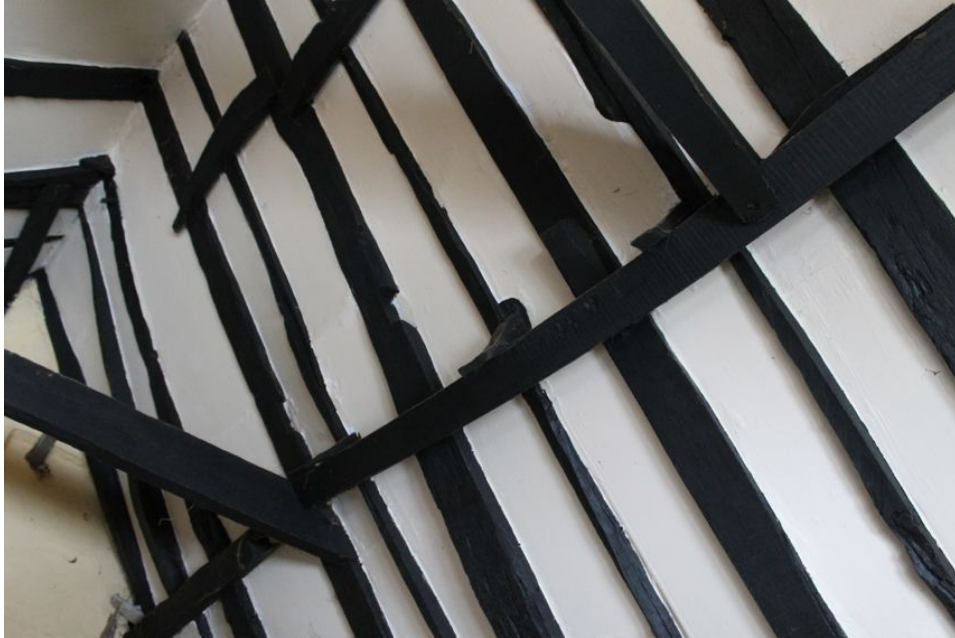
Each roof pitch has a purlin, which are supported by two upper collars. Close inspection of these was unfortunately not possible, but they appear to be machine-cut and later additions to the roof structure. There are several other additions to the roof, predominantly in the form of *ad hoc* bracing between rafters (Photograph 24). Additionally, in some locations rafters appear to have been replaced entirely.

Photograph 24 North-west pitch of Structure A's roof. Showing later bracing, collars and purlin. Photograph taken facing west.

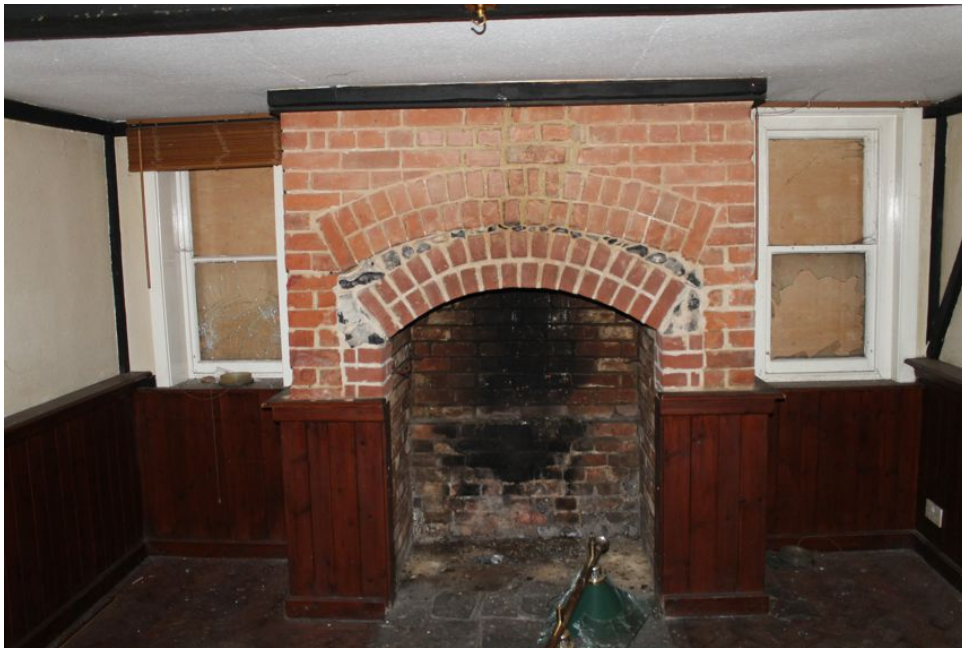
Photograph 27 Repaired fireplace on north-west ground-floor elevation of Structure B. Photograph taken facing north-west.

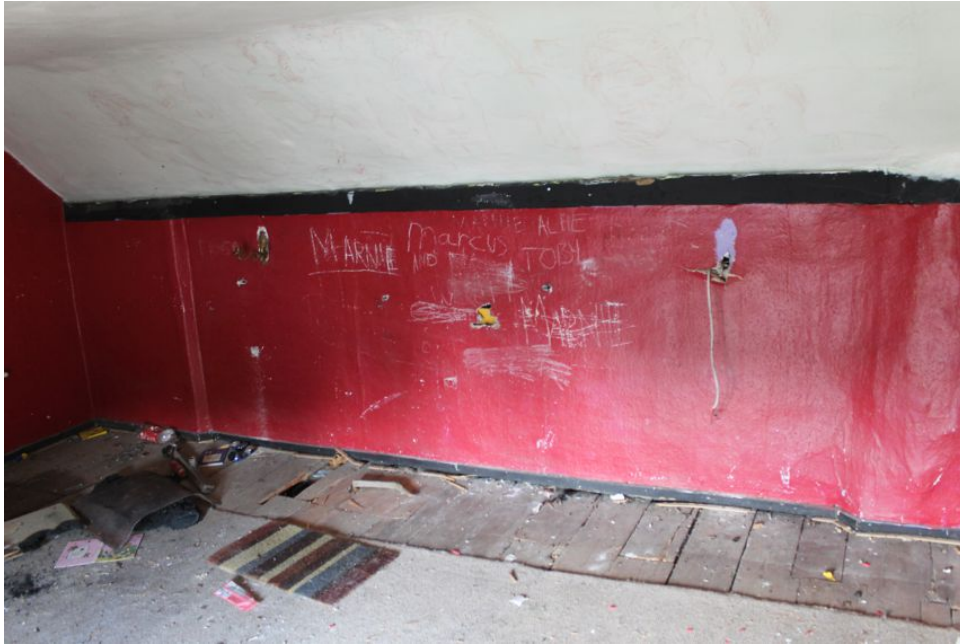
Photograph 28 North-east first-floor elevation of Structure B. Rendered over, but shows end of brickwork (to left) and timber-framing. Photograph taken facing north.

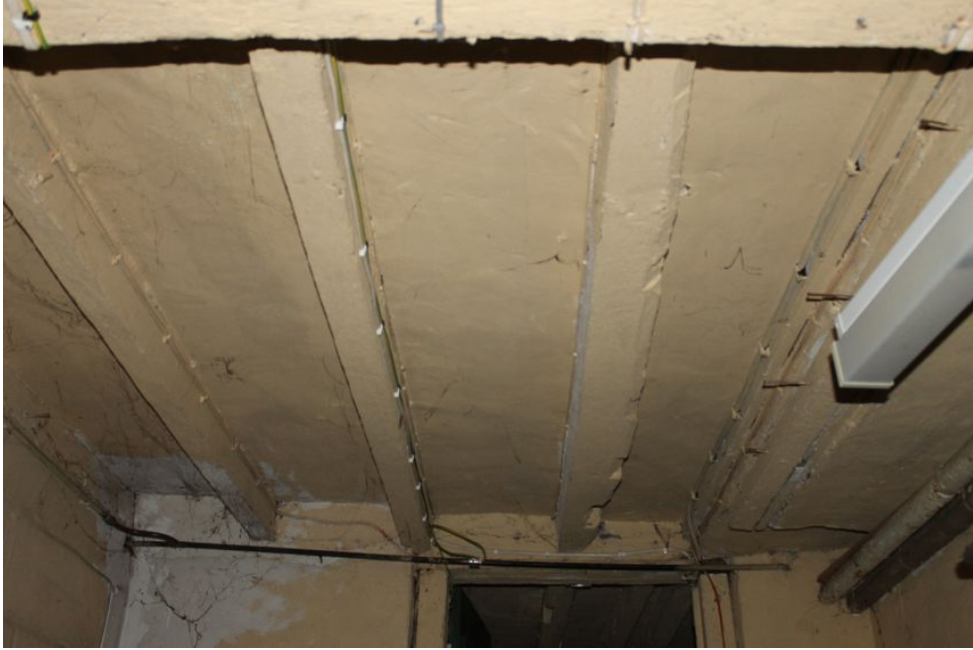
Photograph 31 Underside of ground-floor of Structure C, observed from cellar. Re-used timbers visible. Photograph taken facing north-west.

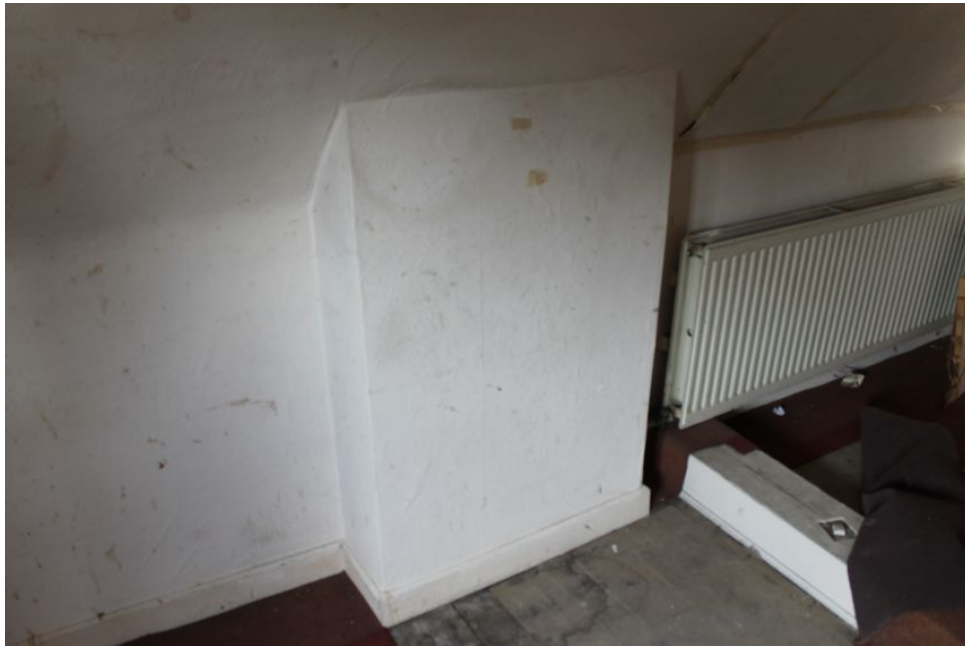
Photograph 33 Blocked fireplace and exposed tie-beam on second-floor of Structure C. Photograph taken facing north.

The second-floor of Structure C is a converted attic space, accessed from the first-floor of Structure D (Fig 6). It contains two modern divisions and a modern kitchenette, as well as a fireplace (Photograph 33). The fireplace and associated chimney were probably added to Structure C when this second-floor was inserted into the attic space. The roof timbers of Structure C were observed through a loft hatch and found to be machine-cut, with the rafters pegged at the apex and no ridgeboard (Photograph 34).

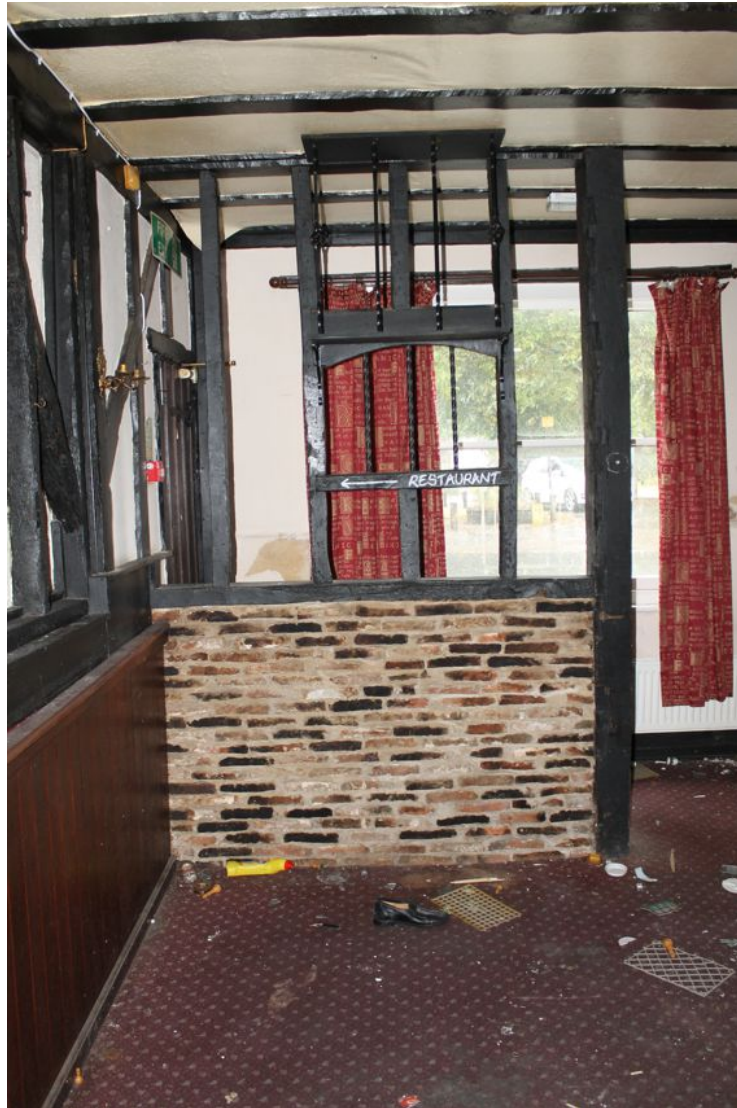
Photograph 39 Modern wall in Structure F consisting of re-used bricks and a re-used tie-beam (to right). Photograph taken facing south-east.

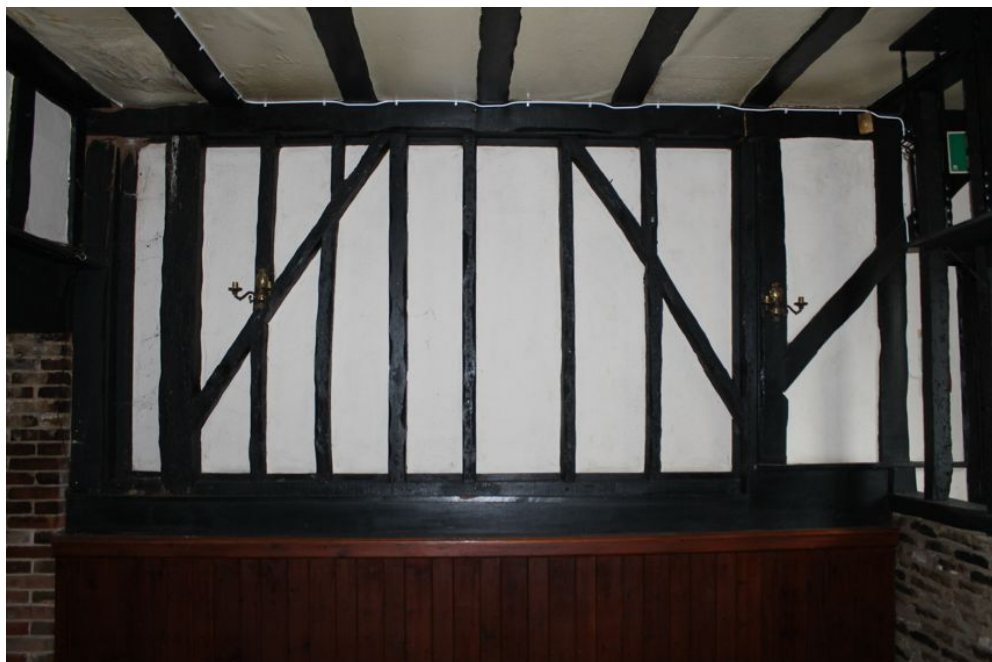
Photograph 40 Stud-work on north-east elevation of Structure F, including some re-used timbers. Photograph taken facing north-east.

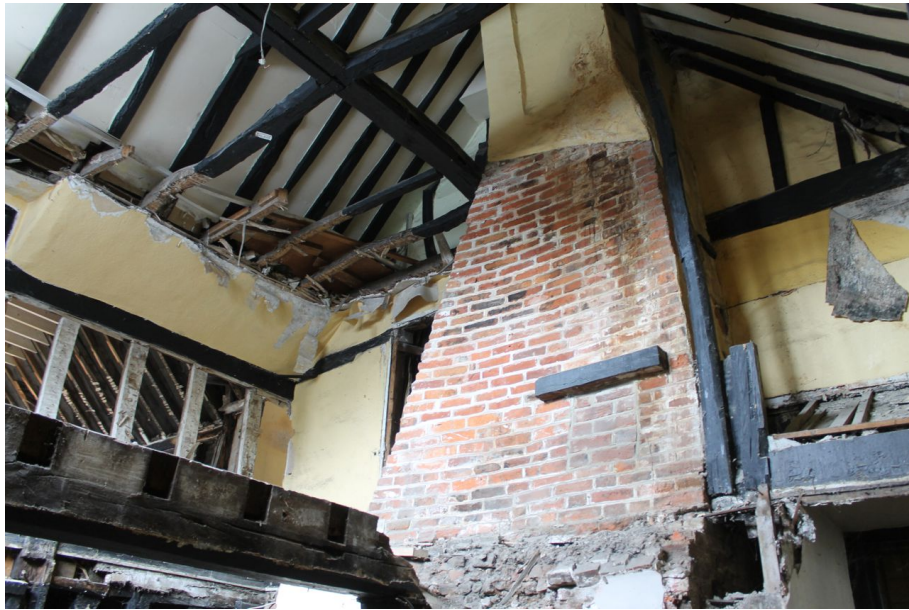
The removal of the first-floor of Structure A, prior to the second visit, allowed the chimney and fireplace to be examined in more detail (Photograph 41). It was clear, once observed in its entirety, that the fireplace had been extended and rebuilt, possibly coinciding with the lowering of the floor of Structure A (see below).

Photograph 41 Chimney stack in Structure A after soft strip. Photograph taken facing north.

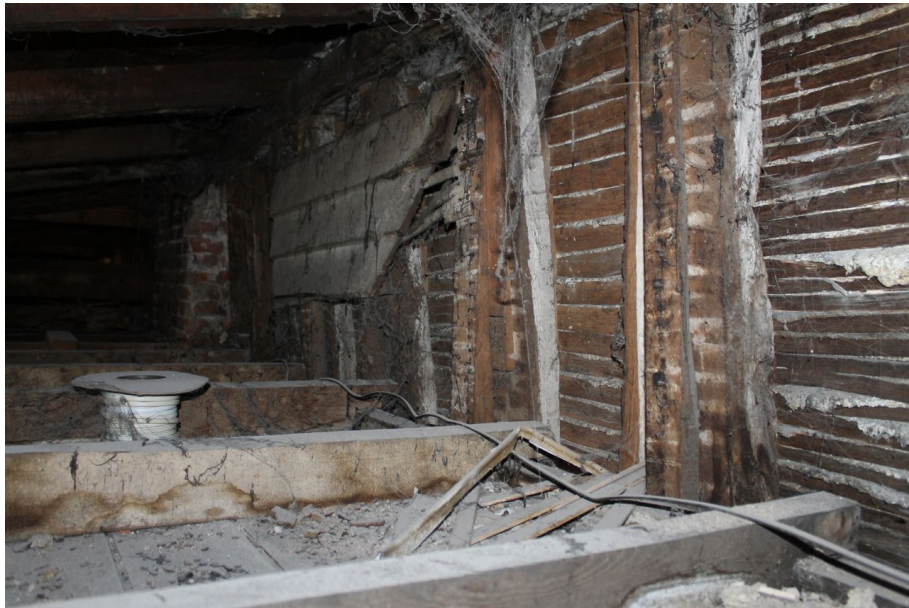
The upper register of Structure A was observed in the roof space of Structure F during the second visit to the building and showed no evidence of grooves in either the studs or the upper face of the girding-beam (Photograph 45). This suggests that originally the upper register of Structure A was weatherboarded on the exterior, and indeed, a section of weatherboarding survives (although is probably not original).

Photograph 45 Upper register of Structure A's south-east elevation, showing surviving weatherboarding. Photograph taken facing west.

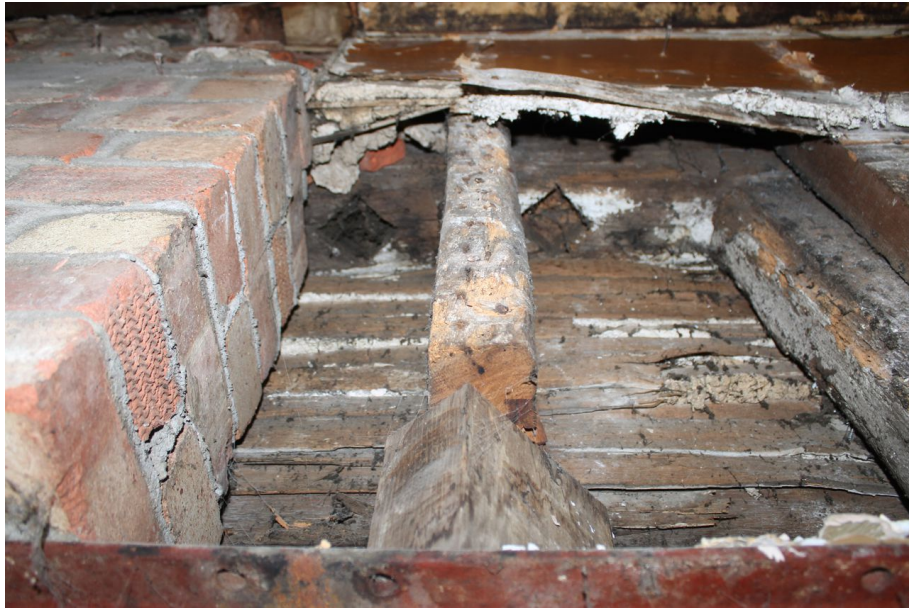
The mortices for diamond mullions observed on the underside of Structure A's south-eastern girding-beam (pg 19) provide further dating evidence, representing as they do the location of an unglazed opening (Brunskill 2000, 132). Unglazed openings were common until the 16th century, when window glass began becoming cheap and common enough to be used in lower-status houses, rather than exclusively ornate public buildings or high-status homes (Historic England 2017, 8).

Photograph 47 Detail of diamond mullion mortices on underside of Structure A's south-east girding-beam. Photograph taken facing north-west.

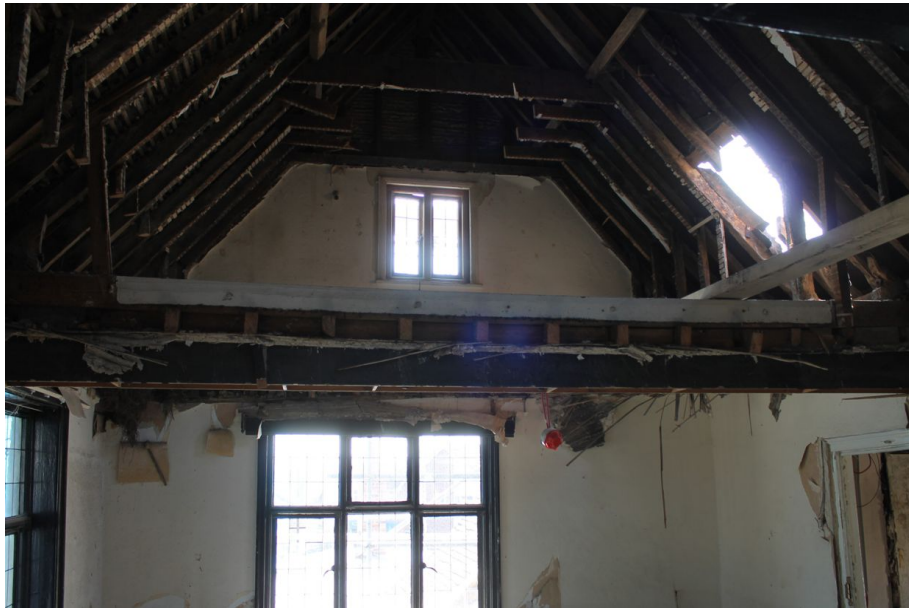
Photograph 56 Southern-most tie-beam in Structure C, showing secondary modern timber attached to its upper face for reinforcement. Photograph taken facing south-west.

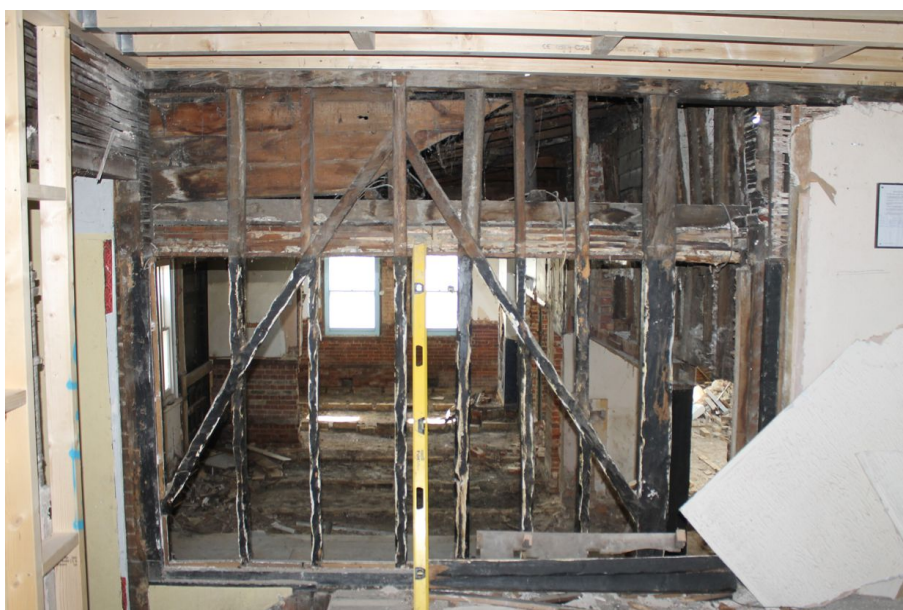
Photograph 59 Timber-framing in north-east end of Structure F, showing machine-cut timbers that have been altered to appear hand-sawn. Photograph taken facing south-west.

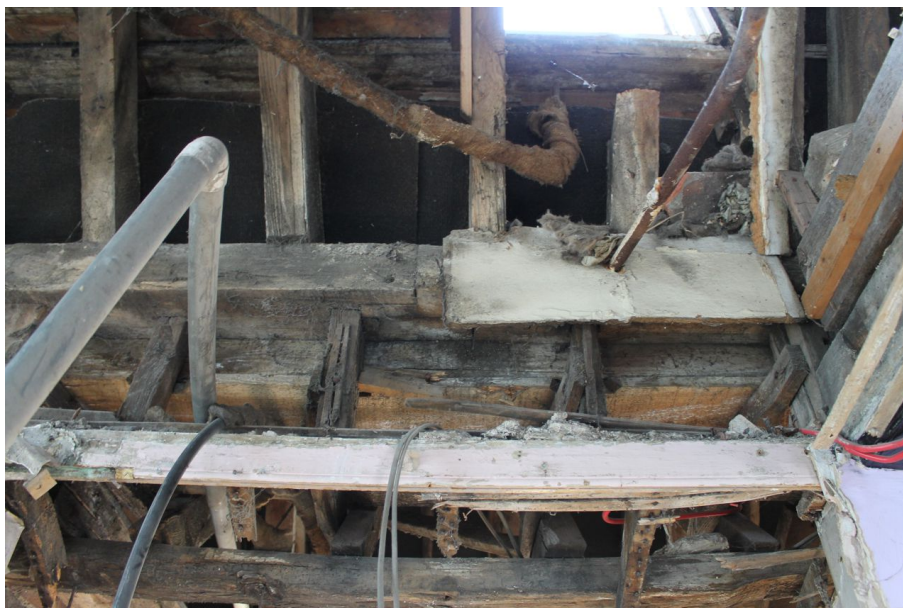
During the second visit far more of the timber-frame of Structure C was exposed and it was possible to make further observations. Several principal timbers had evidence of reuse in the form of empty mortices, and were hand-sawn. Additionally, each of the three tie-beams were reinforced on their upper face by reused inverted hand-sawn knee braces, bolted to the beam and the wall-plate at each end (Photograph 55). Two of the tie-beams were further strengthened by a secondary modern timber attached to their upper face, apparently as a result of the failure of the main tie-beam (Photograph 56). Several carpenter's marks were also visible within Structure C, although how many of these are original to the structure and how many are the result of the reuse of timber is uncertain (Photograph 57). Multiple scarf joints on the wall-plate of Structure C were also visible, they were all face-halved and bladed with four edge-pegs (Photograph 60).

Photograph 60 Detail of scarf joint on north-west wall plate of Structure C. Photograph taken facing north-west.
