**Historic building recording at
161 Shrub End Road,
Colchester, Essex CO3 4RG**

December 2018

CAT project ref.: 18/12f
NGR: TL 9740 2351 (c)
Planning reference: 181865
CHER number: ECC4292
Colchester Museum accession code: COLEM 2018.129
OASIS project id: colchest3-336825

CAT Report 1384
February 2019

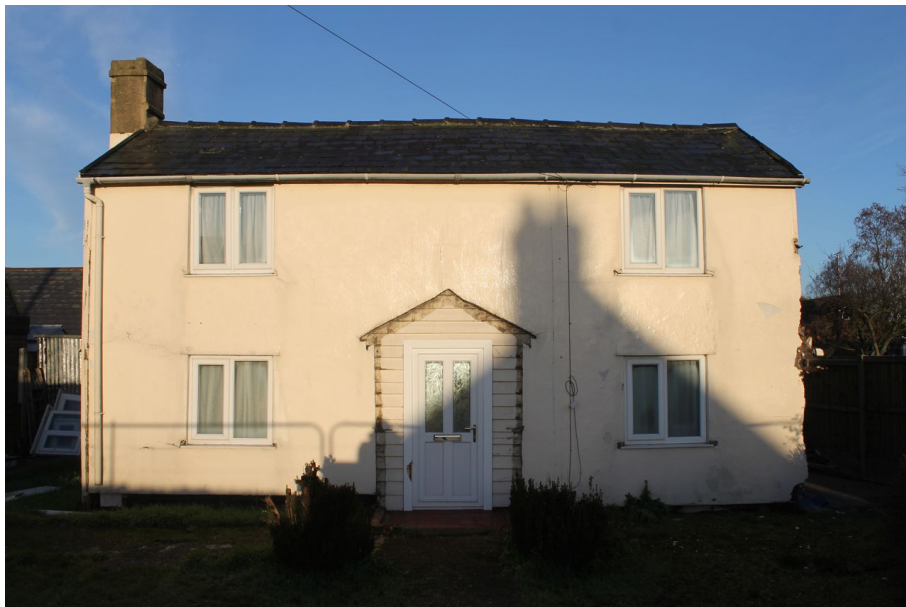
Photograph 1 South-east elevation of building. Modern windows and door visible, along with scar left by demolition of porch.

The building is rendered on this elevation (Photograph 1). It has four windows, two on the ground-floor and two on the first-floor. A modern half-glazed PVC door provides access into the building from this elevation, although it is in an original doorway. The scar of the recently demolished porch is visible around the door; interestingly in the location of the porch the building is not rendered but weatherboarded (see pg 17).

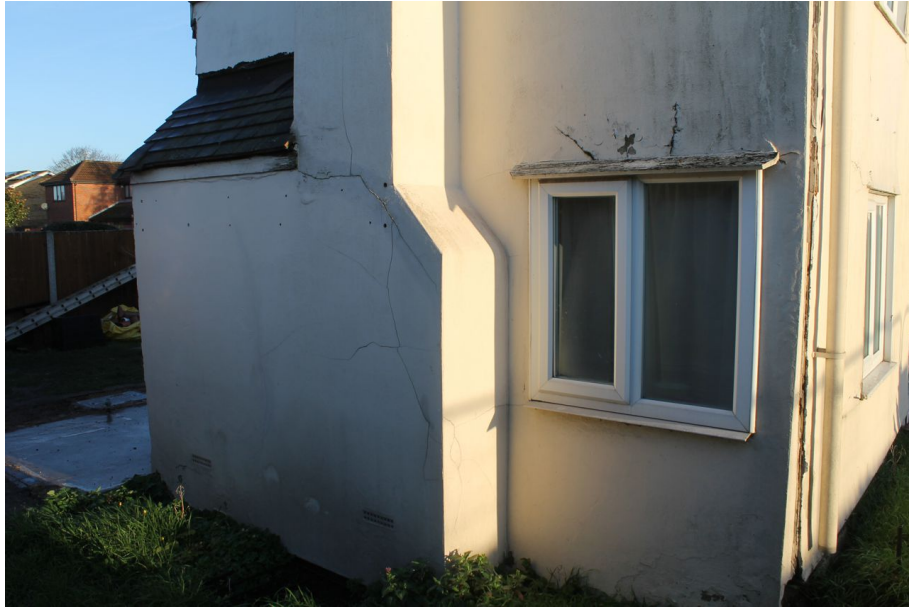
The building is rendered on this elevation (Photograph 2). It has a single window on the ground-floor. The building's original chimney is on this elevation, as is the small cupboard extension, roofed in peg-tile. The south-west elevation of the W.C. extension comprises the surviving chimney and interior wallpaper of the recently demolished kitchen extension (Photograph 4).

Photograph 2 South-west elevation of building. Cupboard extension visible to left. Photograph taken facing north.

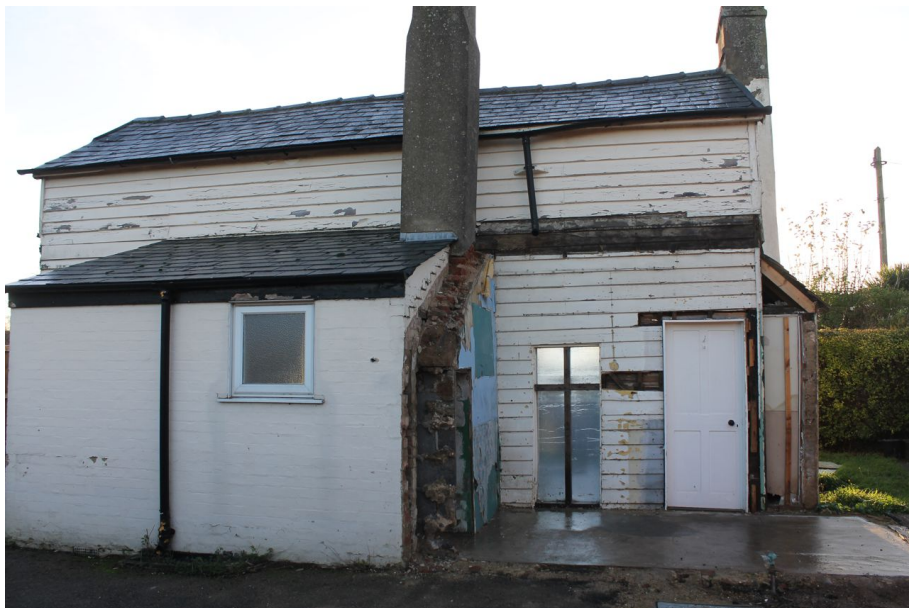
The main building is weatherboarded on this elevation (Photograph 3). The brick-built W.C. extension is constructed of bricks measuring of 220mm x 100mm x 65mm and has a single modern plastic awning light on this elevation.

Photograph 3 North-west elevation of building. Demolished kitchen extension visible to right. W.C. extension visible to left. Photograph taken facing south-east.

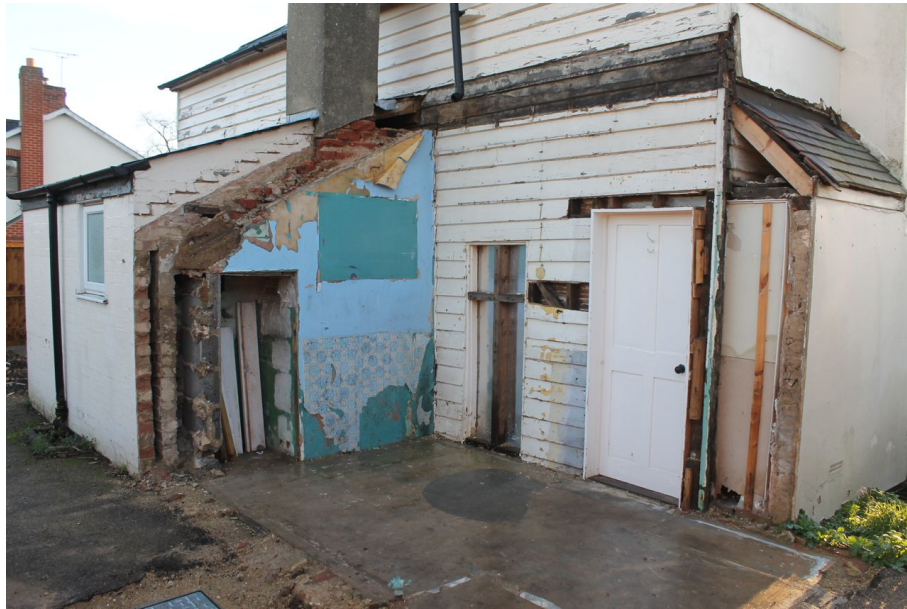
Photograph 4 Location of demolished kitchen extension. Four-panel door visible, as well as brick chimney of kitchen. Photograph taken facing east.

A four-panelled wooden door leads from the main building into what was until recently the kitchen extension. This doorway could have been added to the building when the kitchen extension was constructed (see historical background above). Alternatively it is original to the building and would have led outside prior to the construction of the extension. Adjacent to this door is another opening which has been blocked with timbers and insulation (Photograph 4). This may be an earlier doorway, although it is considerably smaller than the current one.

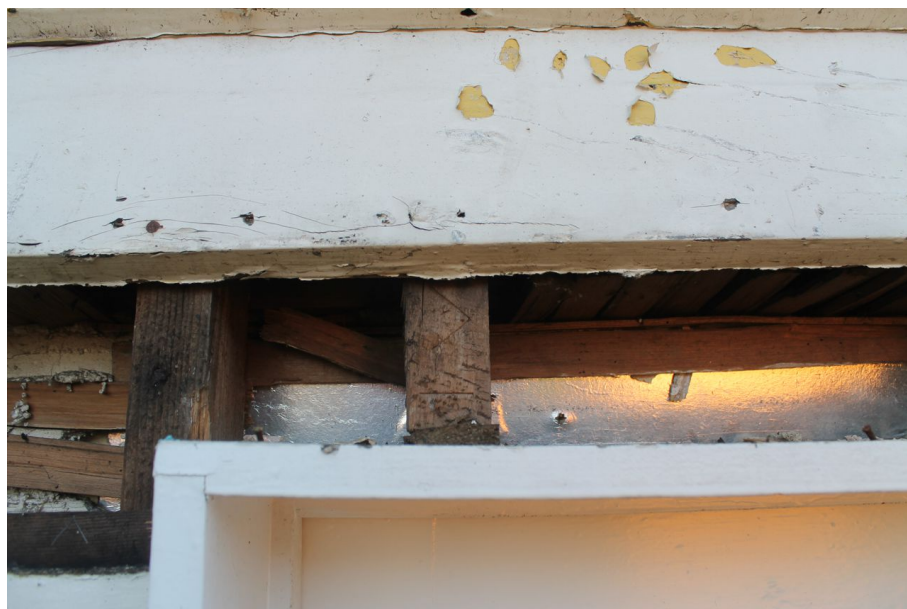
In areas where the weatherboarding has been removed on this elevation are several studs with chiselled carpenter's marks (Photograph 5). Although not all of these carpenter's marks are fully visible, they appear to be consistent with the timbers placement in the frame (i.e. they are original studs and not reused). All the timbers visible on this elevation are machine-cut.

Photograph 5 Detail of chiselled carpenter's mark "IV" on stud above four-panel door on north-west elevation. Photograph taken facing south-east.

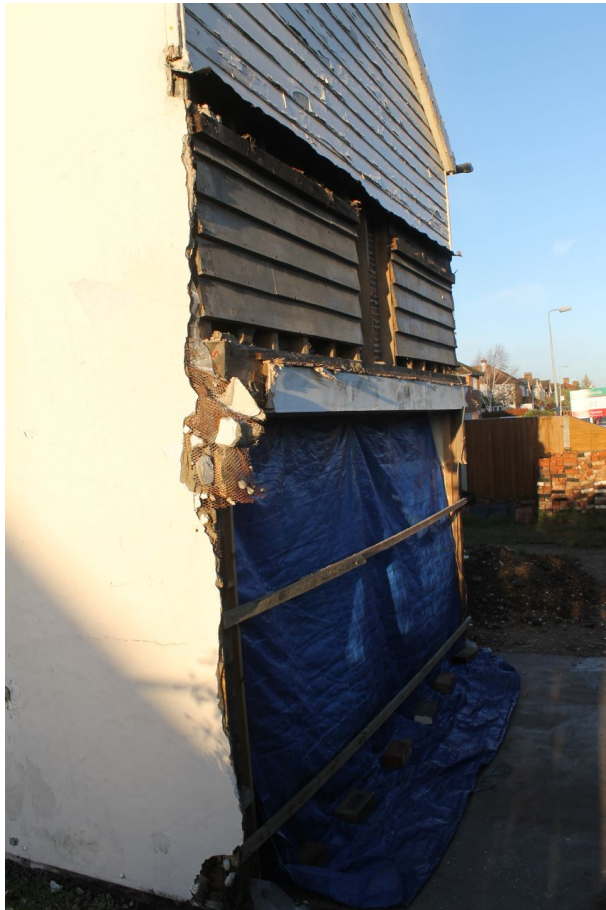
Photograph 6 North-east elevation of building. Lower register entirely removed, timber framing partially visible on upper register. Photograph taken facing west.

The main building is weatherboarded on this elevation, while the W.C. extension is painted brick. The lower register of the north-east gable end is entirely absent and would have until recently been the entrance into the demolished extension on this elevation (Fig 2 and Photograph 6).

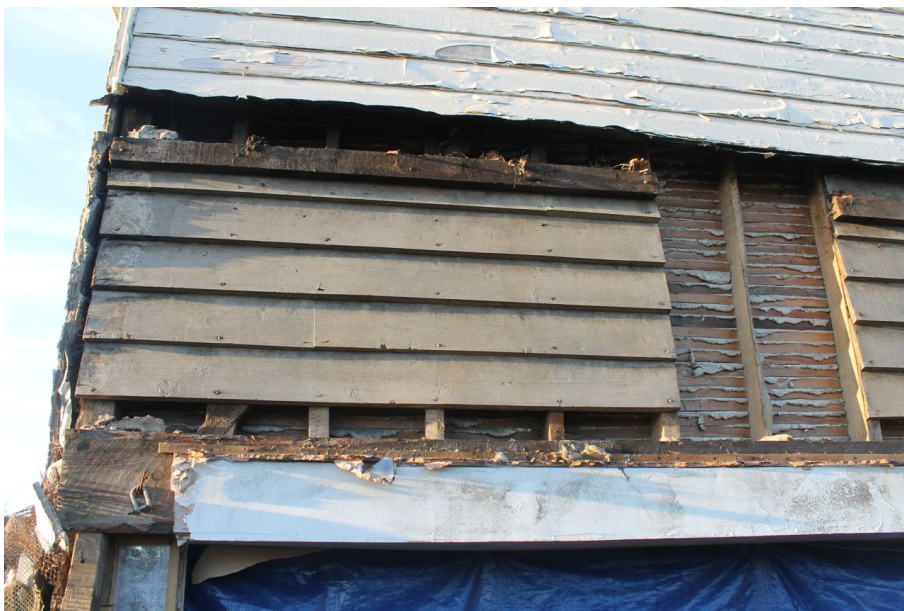
Immediately above the removed lower register is a section of partially exposed timber-framing. The timber-frame, like on the north-west elevation, is visible as being constructed of machine-cut timber supported by primary bracing (Photograph 7).

Photograph 7 Detail of timber-framing on upper register of north-east elevation, showing primary-bracing. Photograph taken facing south-west.

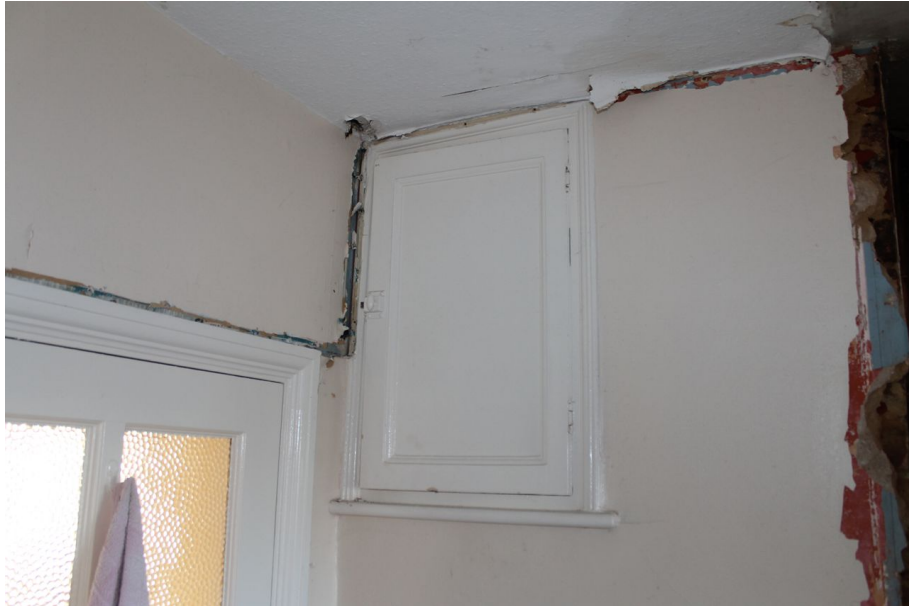
Photograph 8 Detail of cupboard in W.C. extension, built into chimney-stack. Photograph taken facing south.

The room in the W.C. extension is plastered, partially-tiled and has exposed regularly-sized floorboards measuring 110mm in width. The room has an internal cupboard built into the brickwork of the adjacent chimney accessed by a single-panel door with moulded bevelling (Photograph 8).

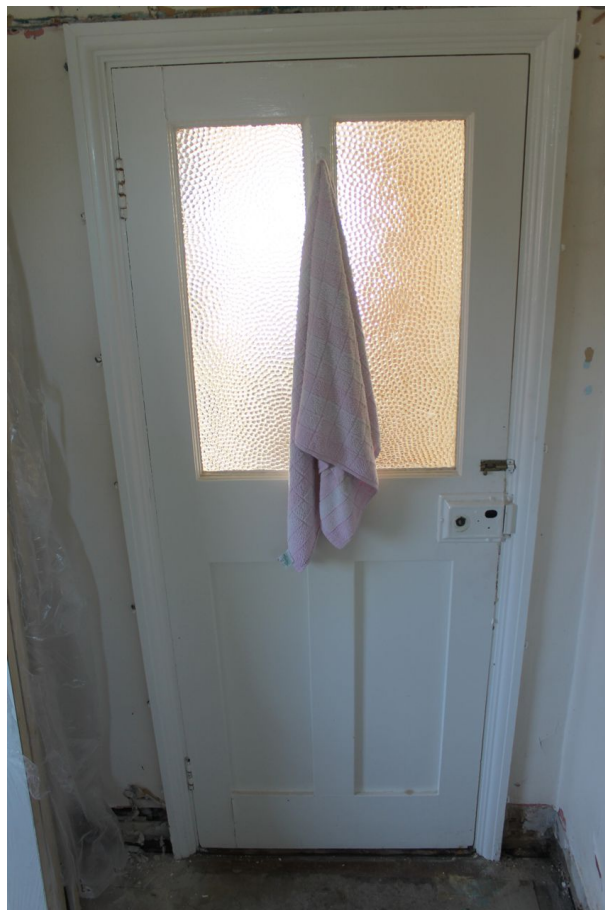
Photograph 9 Four-panel door in W.C. extension. Photograph taken facing south-east.

Between the W.C. and the entrance hall is a four-panel door that has had the top two panels removed and replaced with hammered-glass panes (Photograph 9). Like the cupboard door it has moulded bevelling around the panels. The door is secured by a lock case (although the handle has been removed).

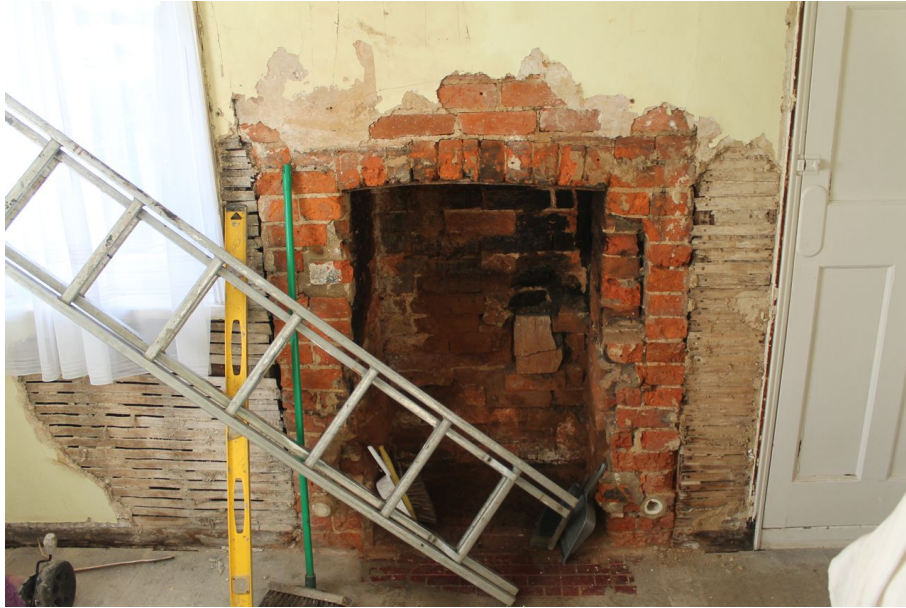
This room has a red-brick fireplace on the south-west wall constructed of bricks measuring 230mm x 110mm x 60mm and laid in lime mortar (Photograph 10). Immediately to the north-west of the fireplace is a three-panel doorway leading to the cupboard extension (Photograph 11). Unfortunately the door had warped significantly in its frame and couldn't be opened.

Photograph 10 Detail of brick fireplace in south-west room on ground-floor. Photograph taken facing south-west.

This room is plastered, although in places the plaster has fallen off revealing the laths beneath (Photograph 10). The floorboards are also exposed in this room and are a regular 160mm in width.

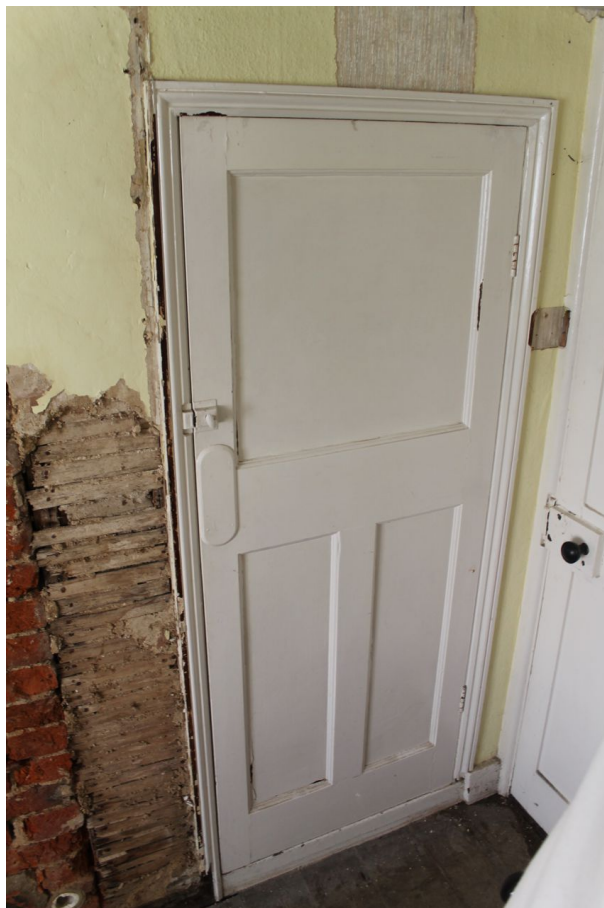
Photograph 11 Detail of three-panel door leading into cupboard extension. Photograph taken facing west.

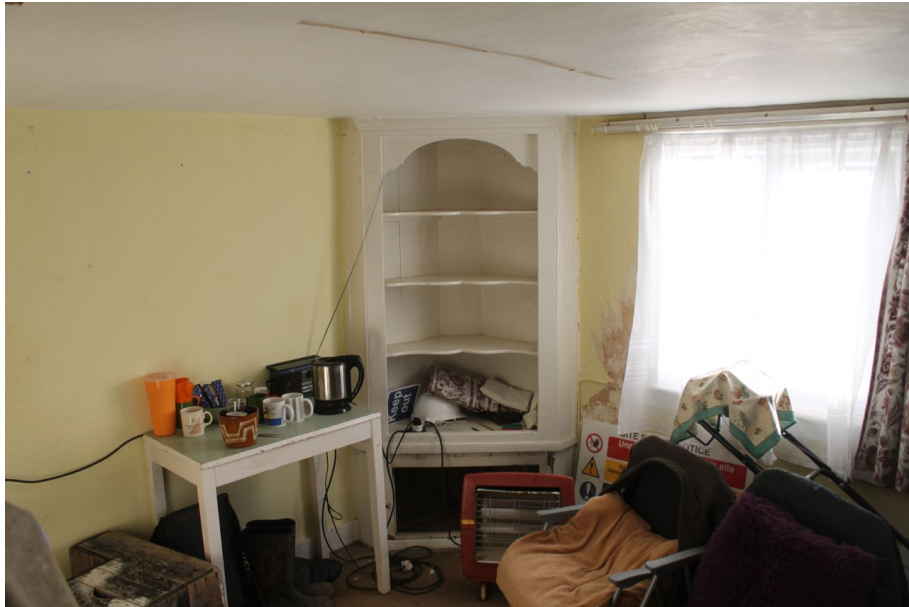
In the eastern corner of the room is a display cupboard that could be original to the building (Photograph 12).

Photograph 12 Display cupboard in south-west room on ground-floor.
Photograph taken facing east.

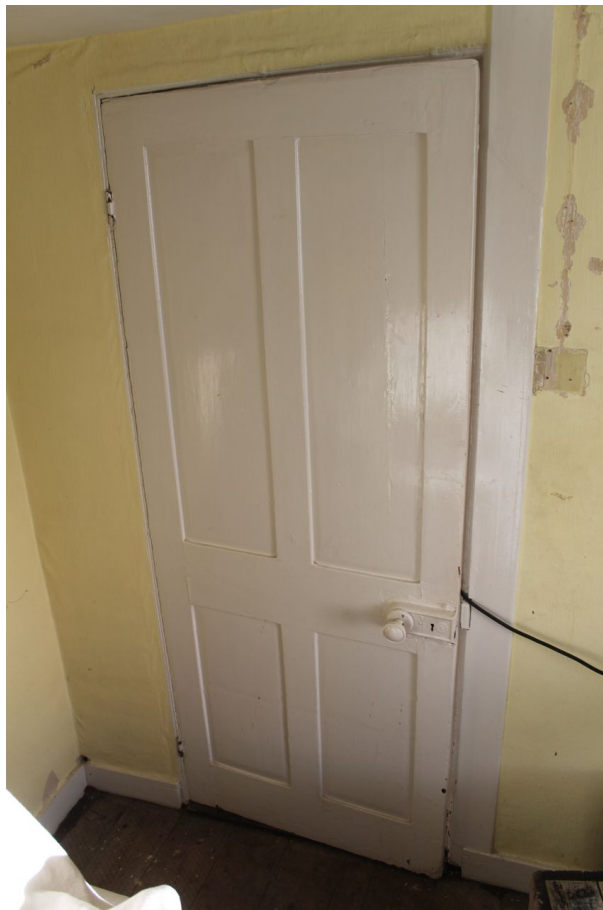
The door between this room and the entrance hall is made of four-panels and is secured by a lock case (Photograph 13).

Photograph 13 Four-panel door between south-west room and entrance hall on ground-floor.
Photograph taken facing north.

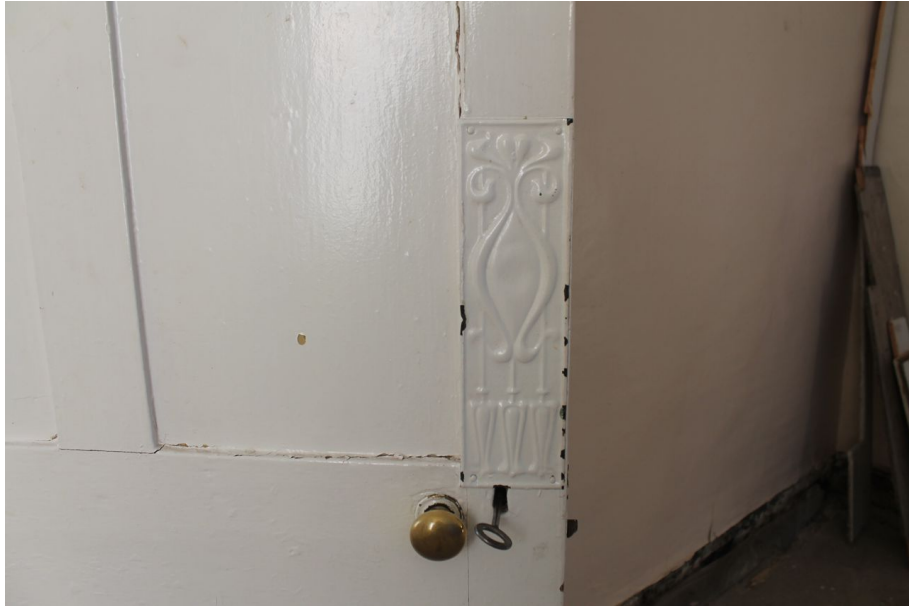
The door between this room and the entrance hall is made of four-panels and has a lock case. Also present on this door above the lock on the entrance hall side is an embossed metal panel with a decorative design (Photograph 14).

Photograph 14 Detail of embossed metal panel on door between north-east room and entrance hall on ground-floor. Photograph taken facing west.

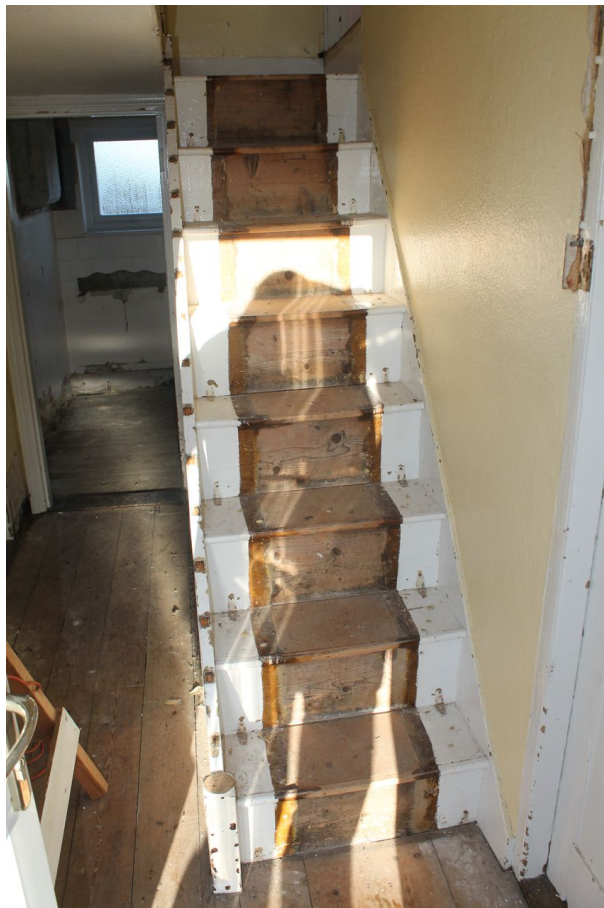
Photograph 15 Stairway in entrance hall. Photograph taken facing north-west.

This room has plastered walls and is dominated by the stairway up to the first-floor (Photograph 15) which consists of 205mm wide wooden treads and 210mm tall risers. No balusters or handrail survive. Beneath the stairway is a cupboard with no door. The floorboards are exposed in the hall and measure 160mm in width.

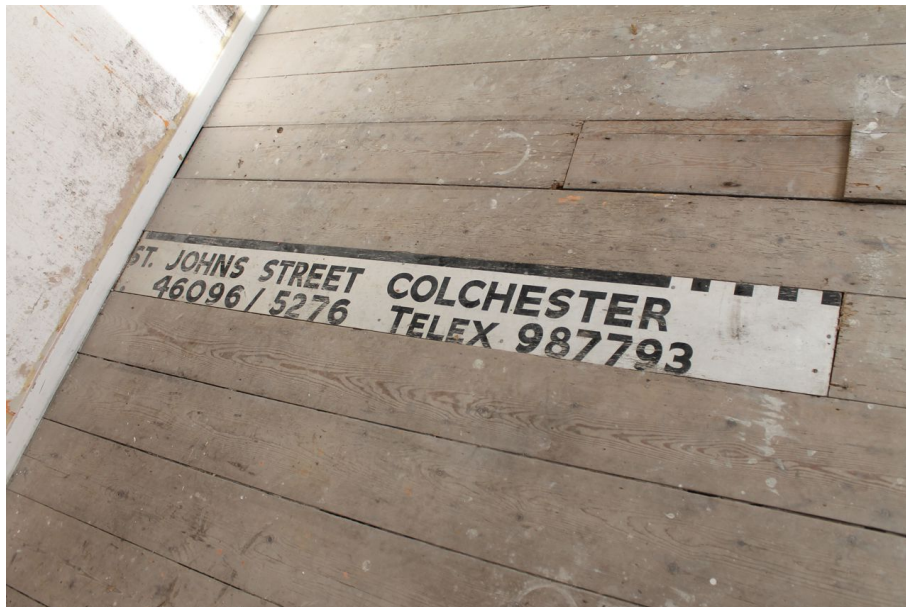
The walls of this room are plastered and the 220-230mm wide floorboards are exposed. One of the floorboards has been replaced by part of a sign advertising a business in St Johns Street in Colchester, with an associated Telex number visible (Photograph 16). This probably dates this repair to post-1945. One of the floorboards has been removed exposing the machine-cut joists beneath, which measure 120mm x 40mm in size.

Photograph 16 Detail of replacement floorboard in north-east room on first-floor. Photograph taken facing north-east.

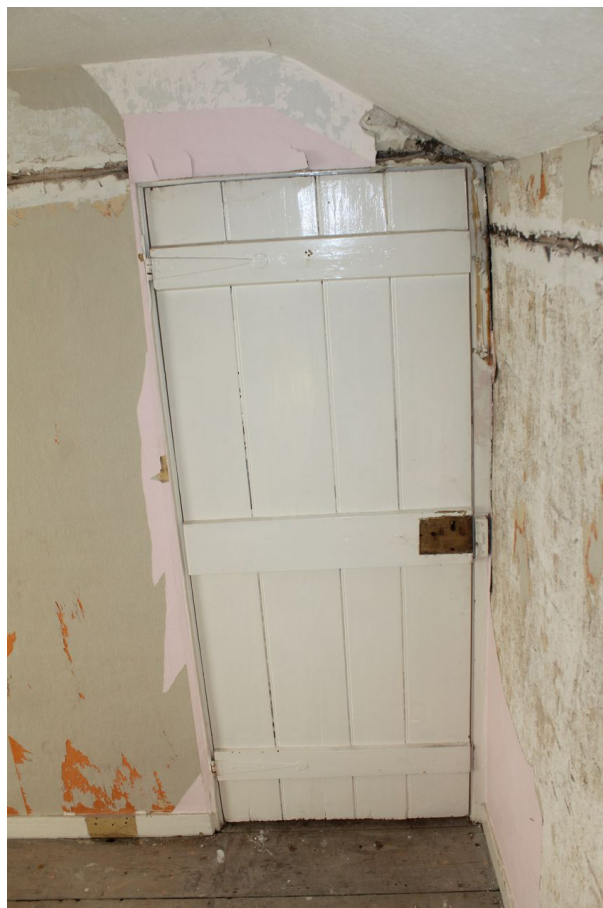
The door has a small keyplate on its exterior (outside the room), but the corresponding lock case on the interior has been removed (Photograph 17).

Photograph 17 Vertical-planked door in north-east room. Photograph taken facing south-west.

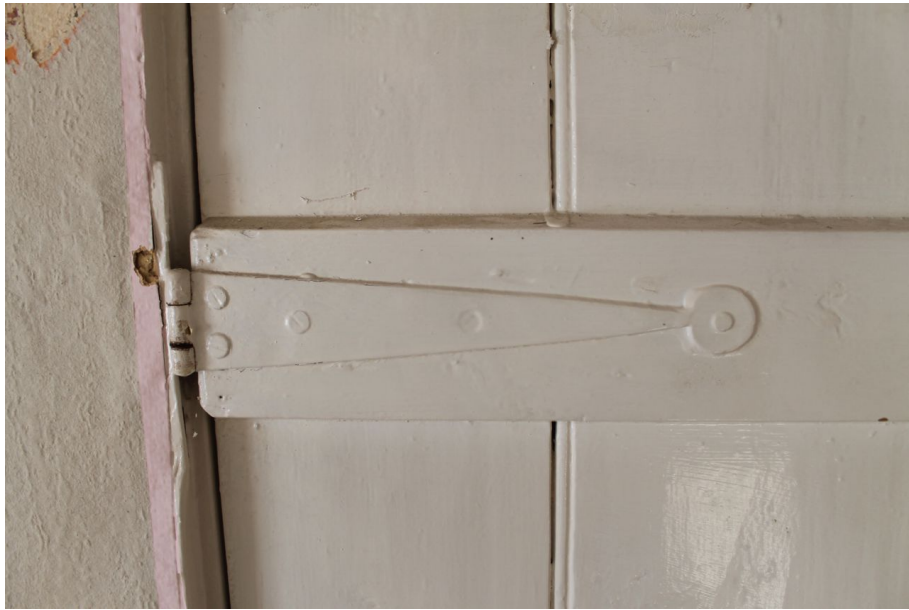
The access between this room and the landing is through an original door constructed of 4 vertical planks. These planks are rebated and have small beaded mouldings on both sides of the door (Photograph 17). The planks are held together by three battens and the door is attached to the frame by two round-end strap hinges with strong tapers (Photograph 18).

Photograph 18 Detail of hinge on door in north-east room. Photograph taken facing south-west.

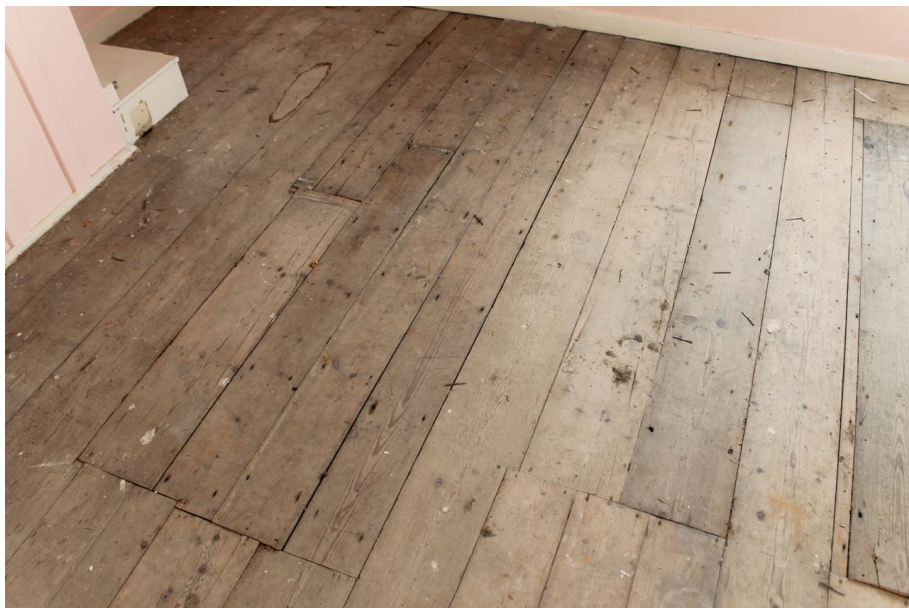
The walls of this room are plastered. The floorboards are exposed but unlike all the other rooms they vary significantly in size, suggesting the floor may have been the subject of repair work (Photograph 19). There are two types of floorboards, one type has a width of 160-170mm and one has a width of 210-270mm. One of the floorboards has been removed exposing the machine-cut joists beneath, which measure 120mm x 40mm in size.

Photograph 19 Varying floorboard widths in south-west room on first-floor. Photograph taken facing east.

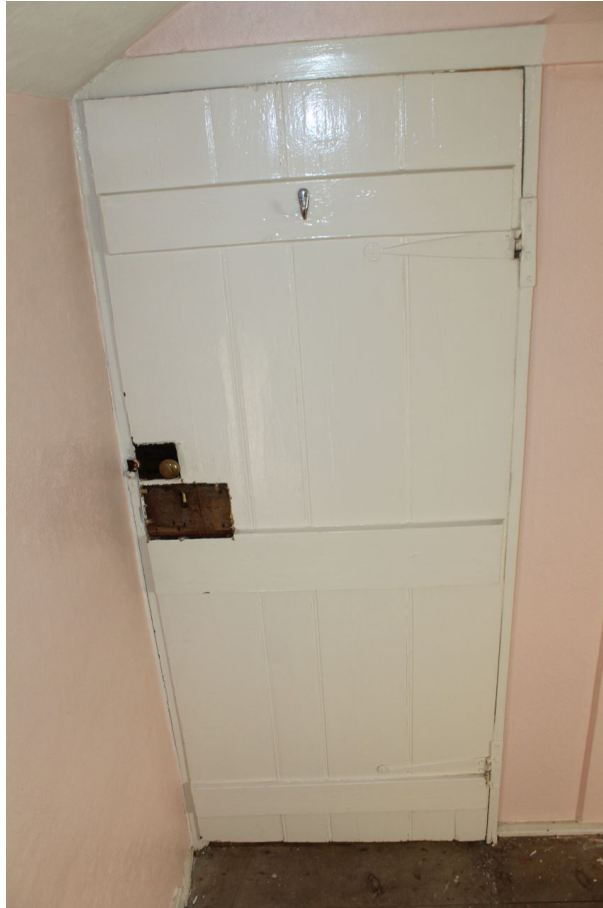
The access between this room and the landing is through an original door identical to the one in the north-east room (Photograph 20). Unlike the other door, however, it has a spring latch above the removed lock case (Photograph 21).

Photograph 20 Door in south-west room on first-floor. Photograph taken facing north-east.

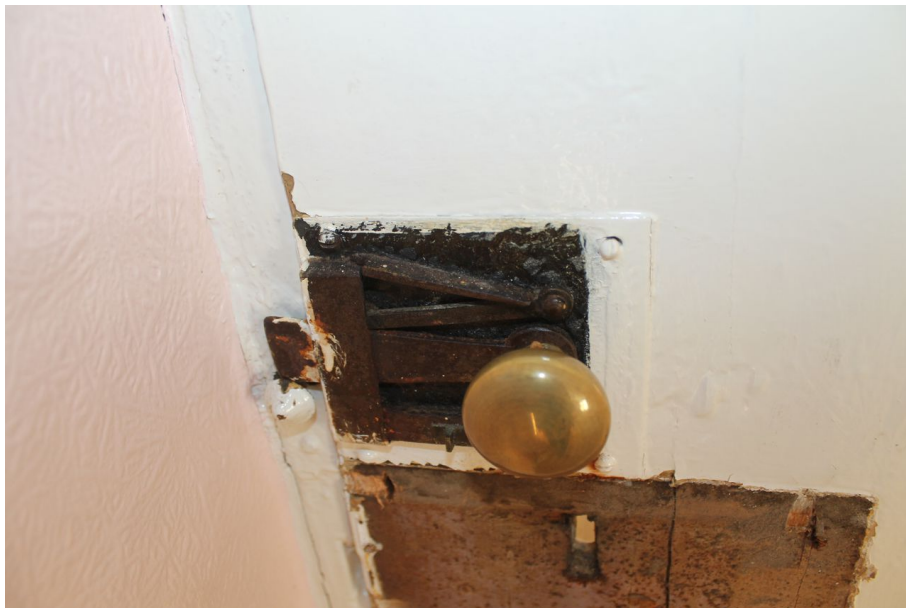
Photograph 21 Detail of spring lock on door in south-west room on first-floor. Photograph taken facing north-east.

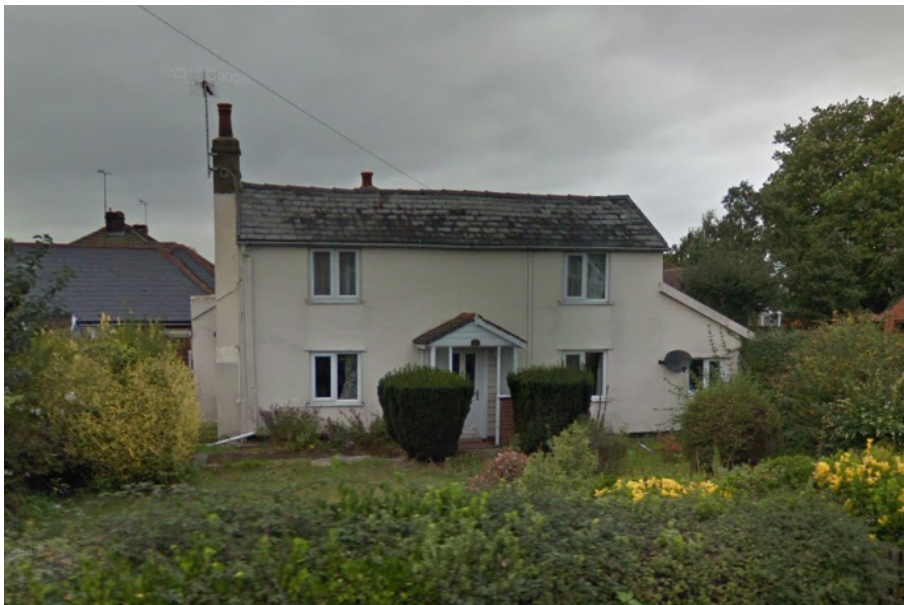
Photograph 22 South-east elevation of building prior to demolition. Porch visible, along with rendered face and modern windows of north-east extension. Photograph taken facing north-west. Copyright Google 2019, image captured September 2017.

These images appear to show the porch on the south-east elevation of the building as being of fairly modern construction, which in turn dates the rendering of that elevation as being fairly recent (as the porch was in place when the rendering was applied; see above).

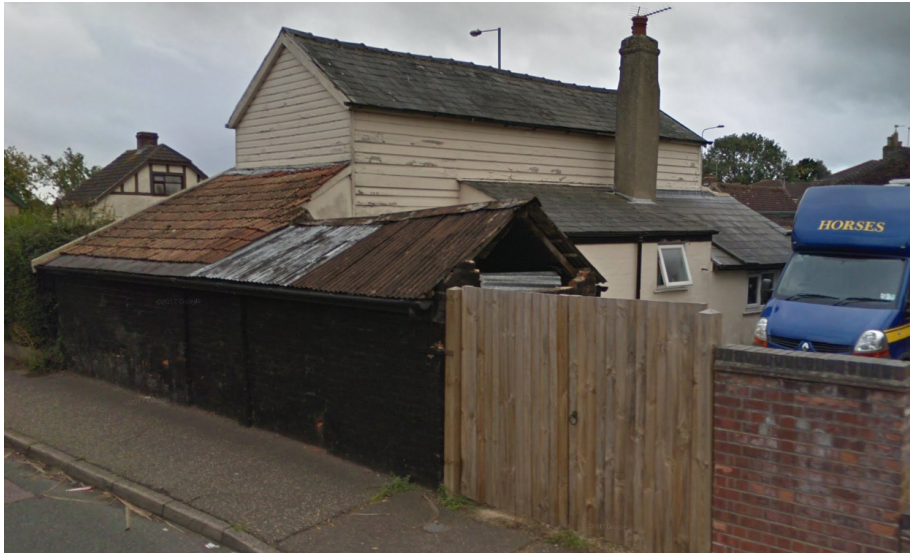
Photograph 23 North-west elevation of building prior to partial demolition. North-east extension visible as two partially(?) brick-built structures, roofed in pan-tile and corrugated metal sheeting. Apparent Flemish-bond brickwork on street frontage. Kitchen extension visible, rendered, roofed in slate and with modern? window. Photograph taken facing south. Copyright Google 2019, image captured September 2017.

The north-east extensions both have more recent roofing material than the other extensions – whether these coverings are original to the buildings or not is uncertain. Ascribing functions to these extensions is equally difficult; certainly the northernmost one appears to be open ended and may have been an external store. The larger extension projecting directly off the north-east of the cottage may have been an earlier kitchen. It is also possible that these two extensions have been entirely rebuilt and are not the same ones visible on the earlier mapping (pg 3).
