**Historic building recording at  
Hyde Farm Barn,  
Gosfield Road, Blackmore End,  
Essex, CM7 4DR**

**May 2019**

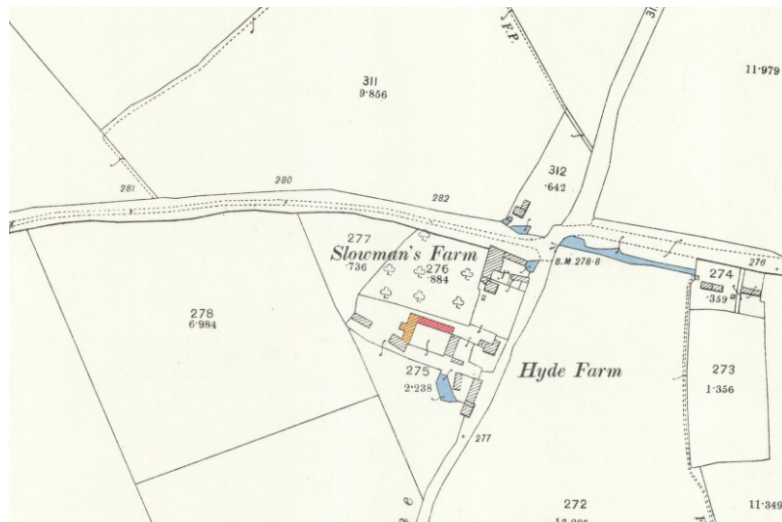
**Map 4** 25-inch OS map from 1896. Threshing barn highlighted in orange, six-bay structure in red.

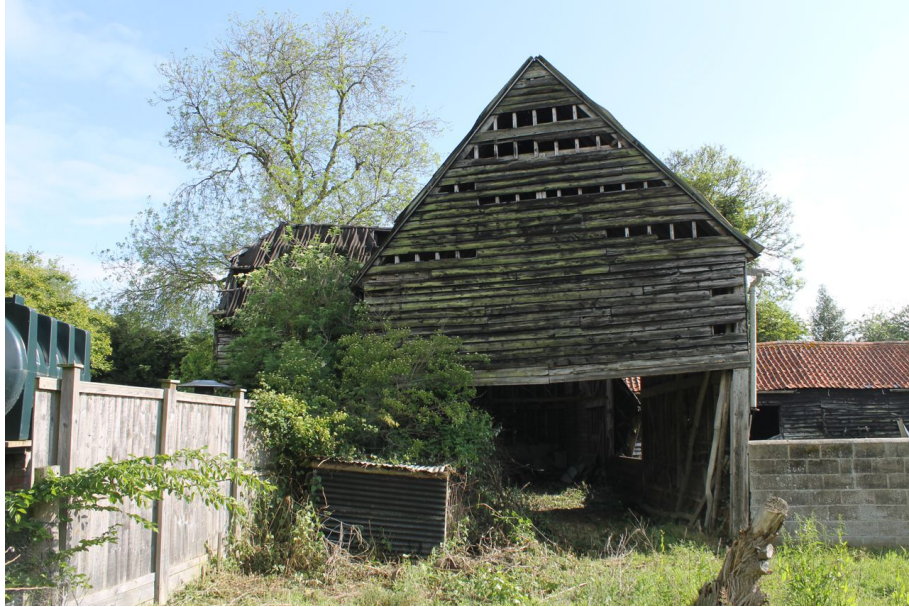
**Photograph 2** South-west elevation of threshing barn, showing open lower register. Photograph taken facing north-east.

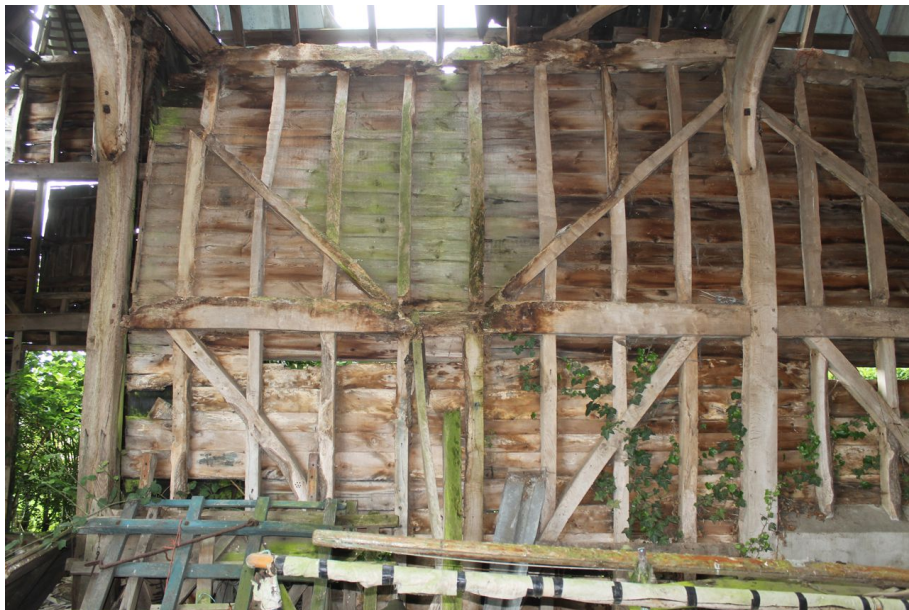
**Photograph 9** West elevation of bay 2, showing extensive water damage to wall-plate and girding-beam. Photograph taken facing north-west.

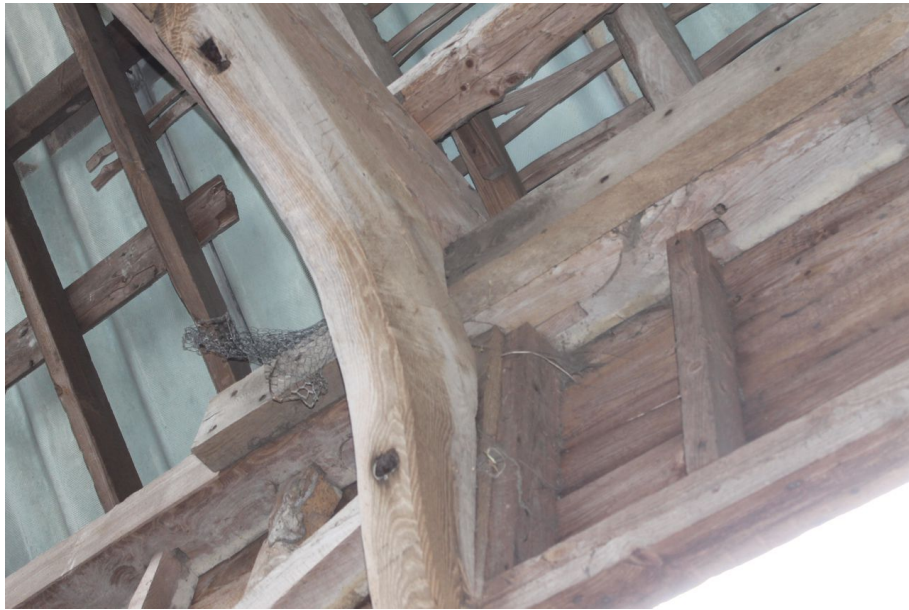
**Photograph 10** Detail of scarf joint behind east knee brace supporting tie-beam between bays 2 and 3. "II" carpenter's mark visible on knee brace. Photograph taken facing east.

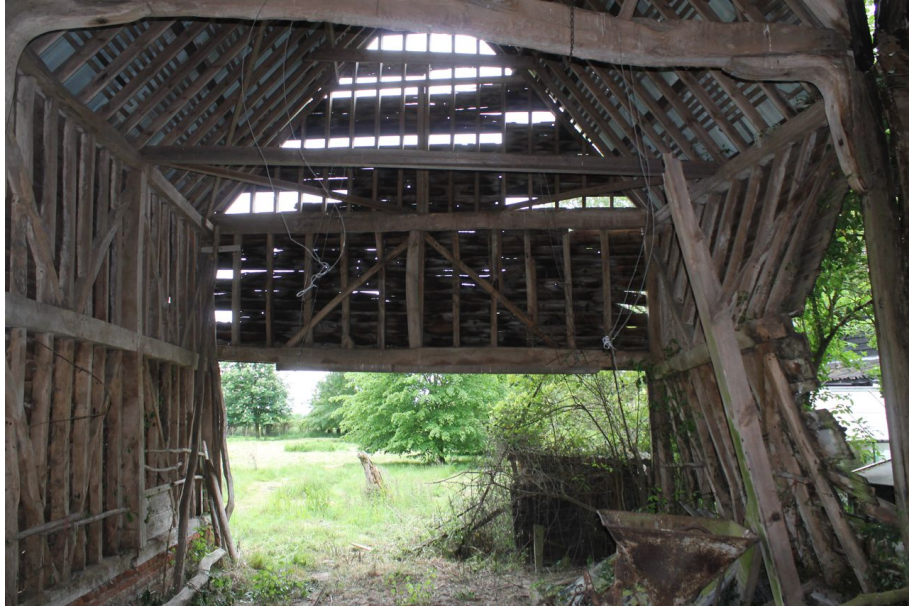
**Photograph 16** South end of barn, showing bays 4 and 5. Photograph taken facing south-west.

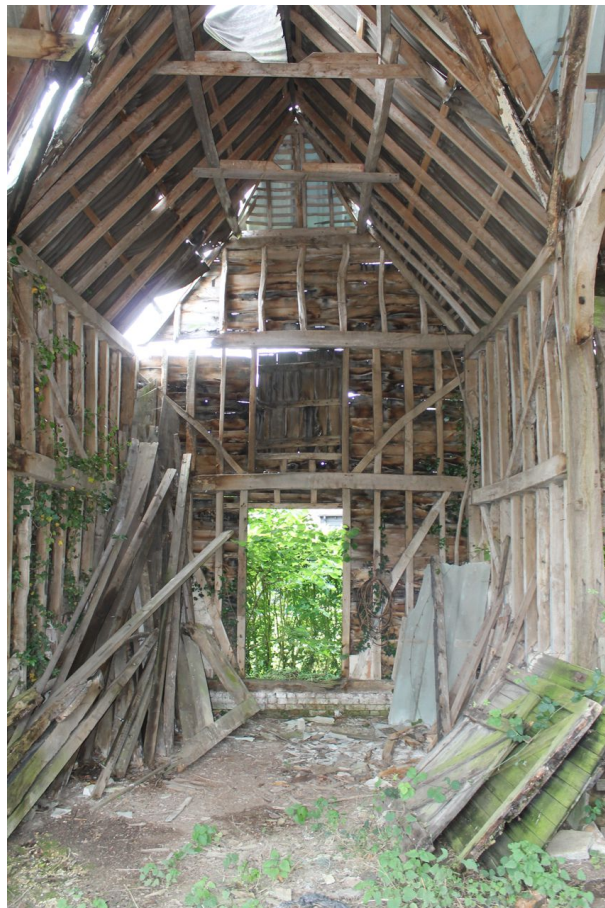
**Photograph 17** Midstrey of barn, showing inserted pitching door on upper register. Photograph taken facing north-west.

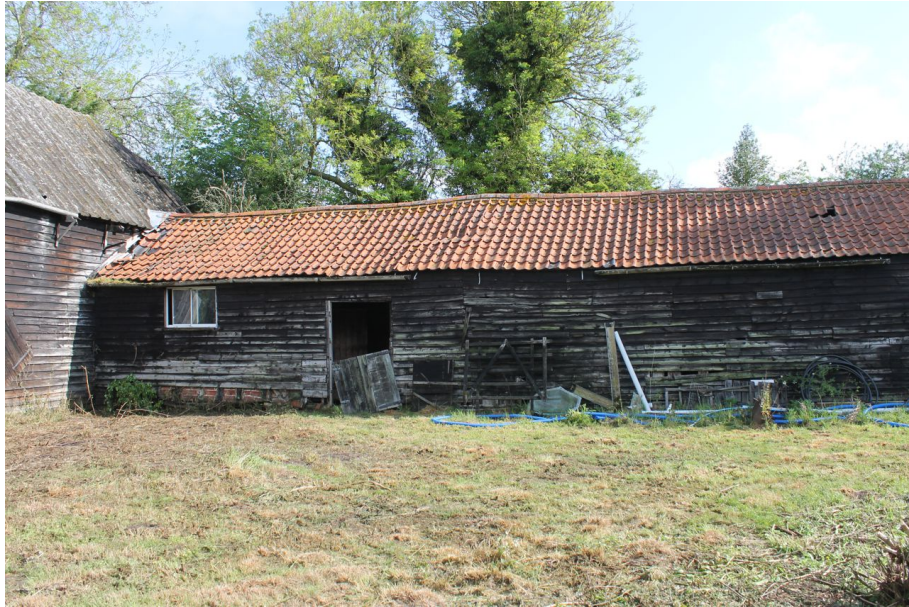
**Photograph 20** South-west elevation of the six-bay building. Inserted modern plastic-framed window visible, alongside damaged stable door. Photograph taken facing north.

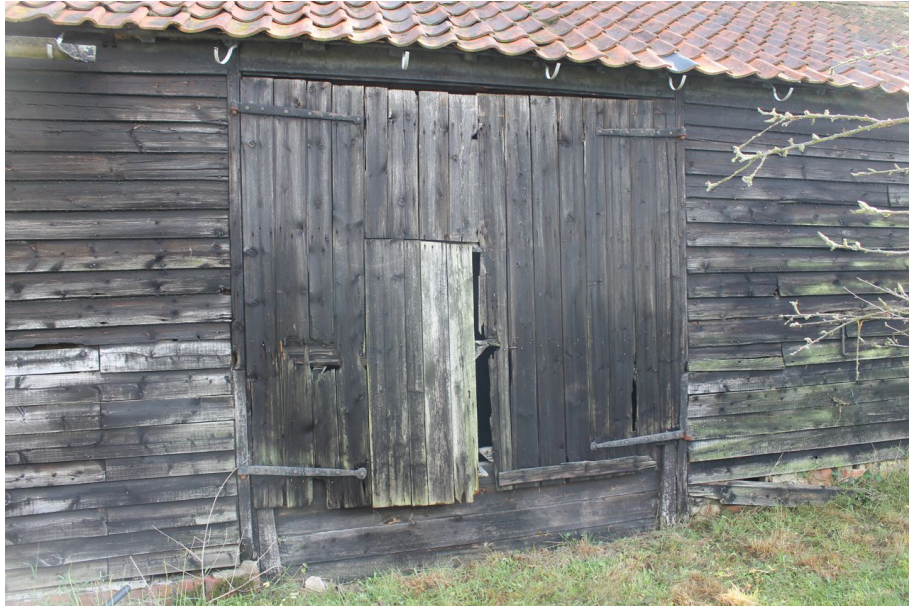
**Photograph 22** Barn door on south-west elevation of six-bay building. Photograph taken facing north-east.

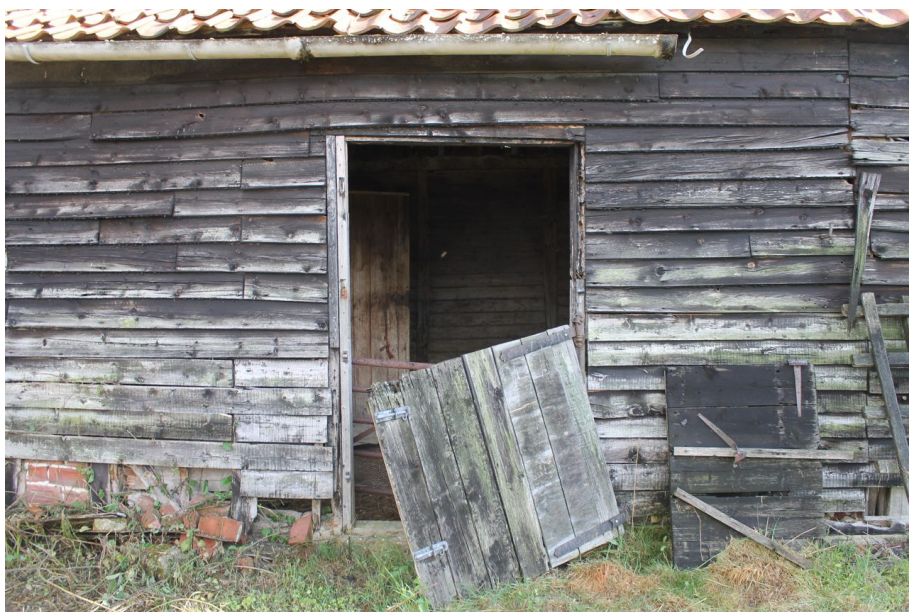
**Photograph 23** Detail of damaged stable door on south-west elevation of six-bay building. Exposed timber-frame and brick-nogging visible to left. Photograph taken facing north-east.

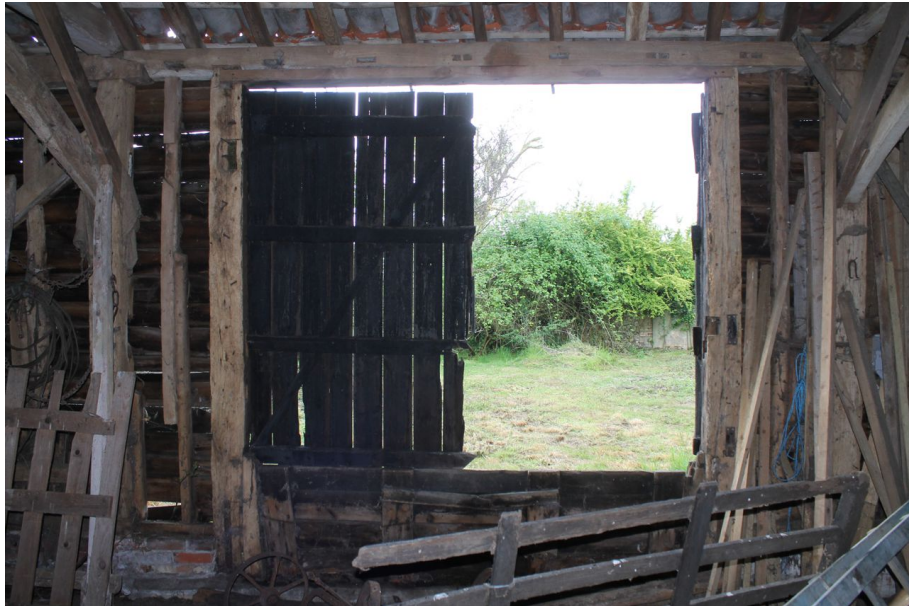
**Photograph 35** Southern elevation of bay 5, showing barn door and rudimentary scarf joints on the wall-plate, with a reused timber between. Also note the reused timber used as framing for the doorway. Photograph taken facing south-west.

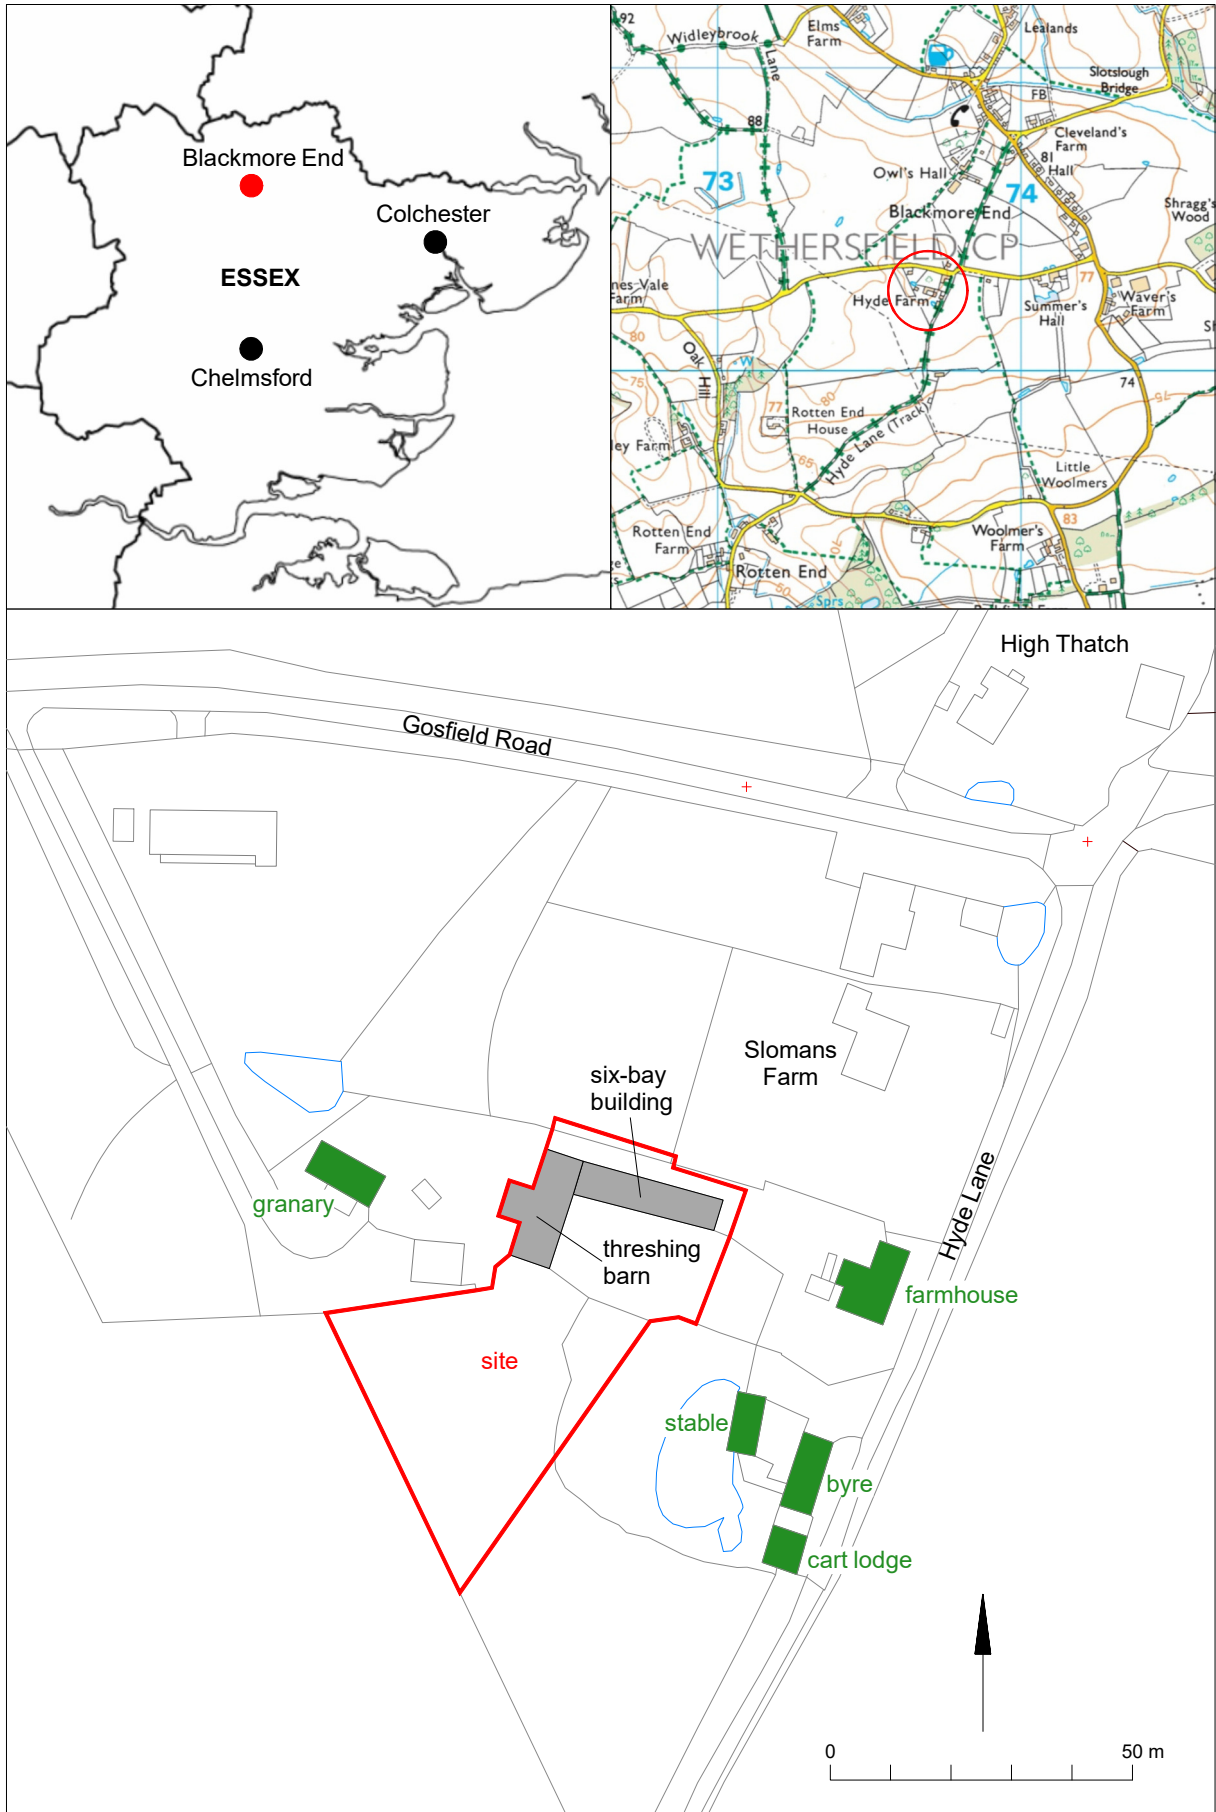
© Crown copyright. All rights reserved. Licence number 100039294.
