**Historic building recording at
land adjacent to Domus,
The Causeway, Great Horkesley,
Essex, CO6 4EJ**

September 2019

CAT project ref.: 2019/08m
NGR: TL 97857 29899 (c)
Planning reference: 180699
CHER number: ECC4371
OASIS project id: colchest3-365279

CAT Report 1484
September 2019

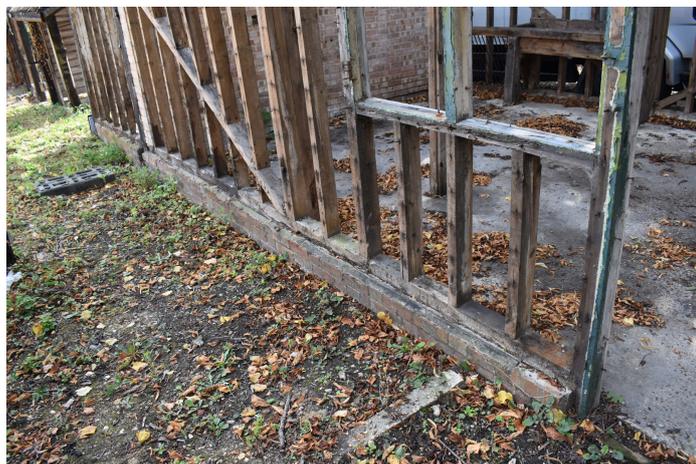
The timber-frame of the building is supported on a frogged red brick plinth, with bricks measuring 220mm x 110mm x 60-65mm. The plinth supporting the western three bays (bays 1-3) is laid in Monk-bond and the plinth supporting the five eastern bays (bays 5-9) is laid in English-bond (Photographs 3). The plinth supporting bay 4 is laid in Flemish-bond and has slightly different brick measurements of 225mm x 105mm x 65mm.

Photograph 3 Detail of brick plinth on northern elevation of bays 2 and 3. Photograph taken facing south-east.

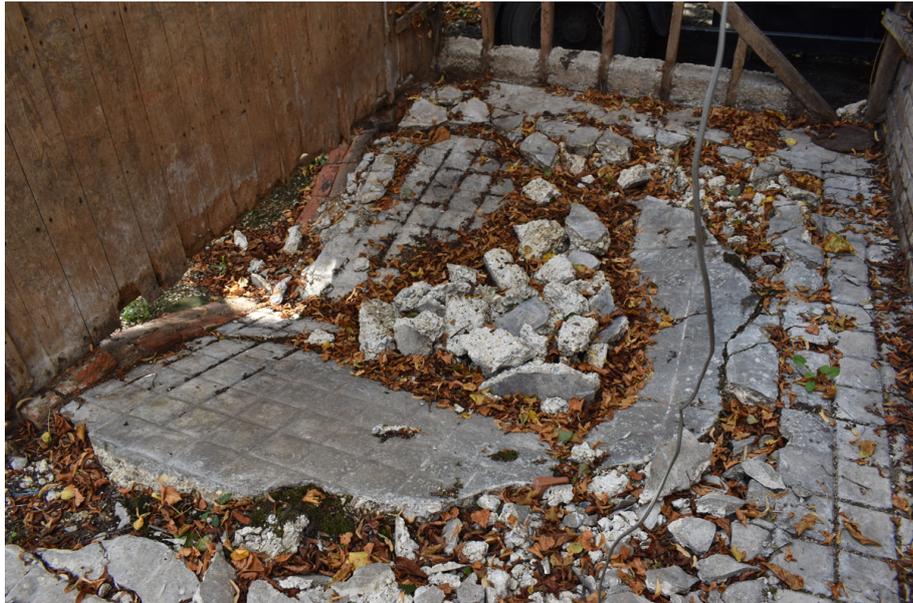
The bays have a mix of unmade and concrete floors, with bays 5-8 being unmade and the rest being concrete. The concrete floor in bay 4 has subsided significantly (Photograph 9).

Photograph 9 Subsided concrete floor in bay 4. Unfrosted red bricks visible to left of frame. Photograph taken facing south-east.

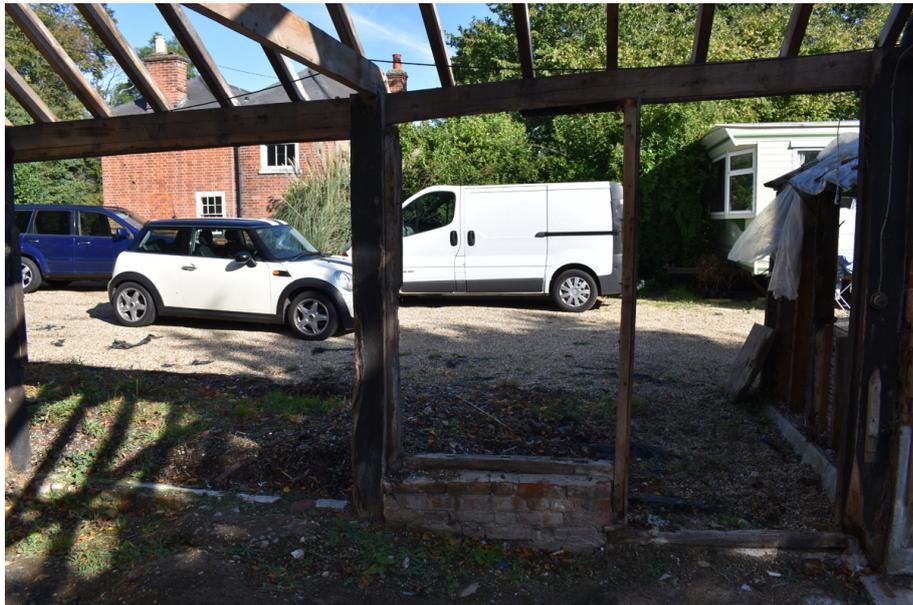
Part of the northern wall-plate of the building, from bay 5 to bay 9, appears to have been replaced (Photograph 10 and Fig 2). This probably coincided with the installation of a sliding door and the removal of much of the sill-beam on the northern elevation (see exterior description above).

Photograph 10 Northern elevation of bays 7 and 8, showing replacement wall-plate and section of original sill-beam and plinth. Photograph taken facing north.

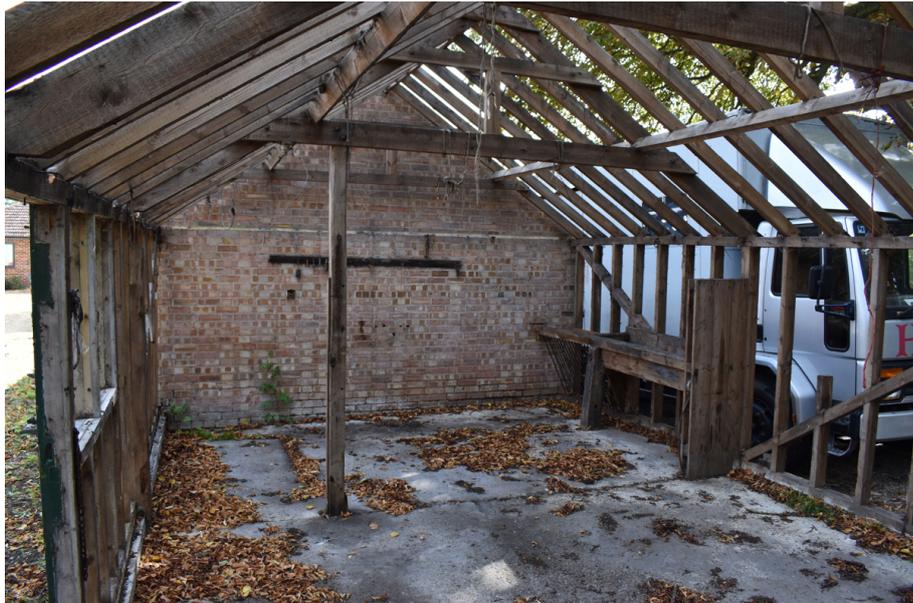
There are several subdivisions within the building. Completely dividing bays 3 and 4 is a Sussex-bond brick wall made of modern fletton bricks (Photograph 11). Between bays 4 and 5 is a half-height machine-cut timber-frame division with a stable-door at its northern end, and panelled on its western side (Photograph 12). This division is supported on a plinth of unfrosted and unmortared red bricks (measuring 220mm x 110mm x 70mm), that have, like the floor of bay 4, subsided significantly (Photograph 9).

Photograph 11 Interior shot showing bays 2 and 3, with fletton brick wall. Photograph taken facing south-east.

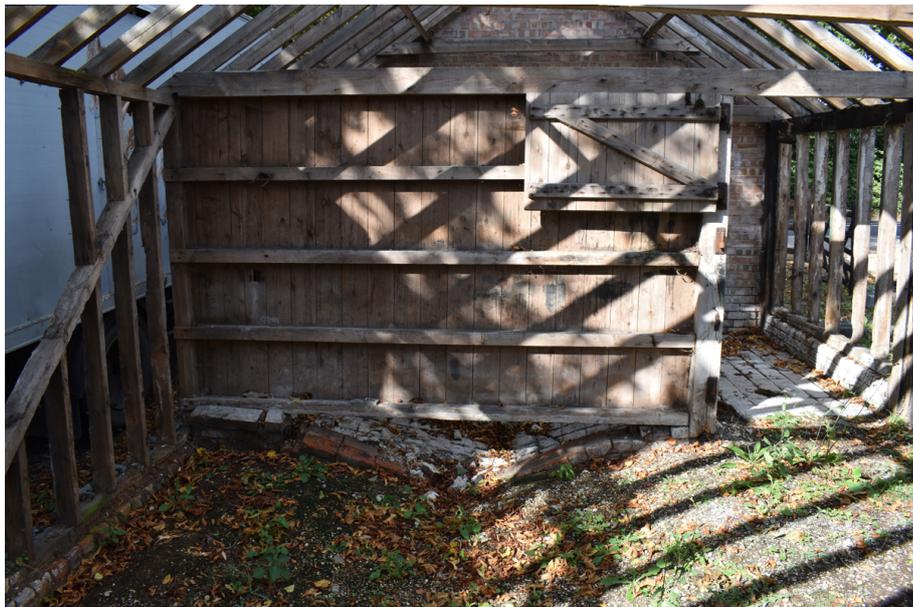
Photograph 12 Division between bays 4 and 5. Subsided red brick plinth visible below. Photograph taken facing west.

The unfrogged red bricks forming the plinth between bays 4 and 5 are the earliest elements of the building. Dating from the early 19th century, they are either original to the structure or reused from the original building that stood on this site, prior to its rebuilding.

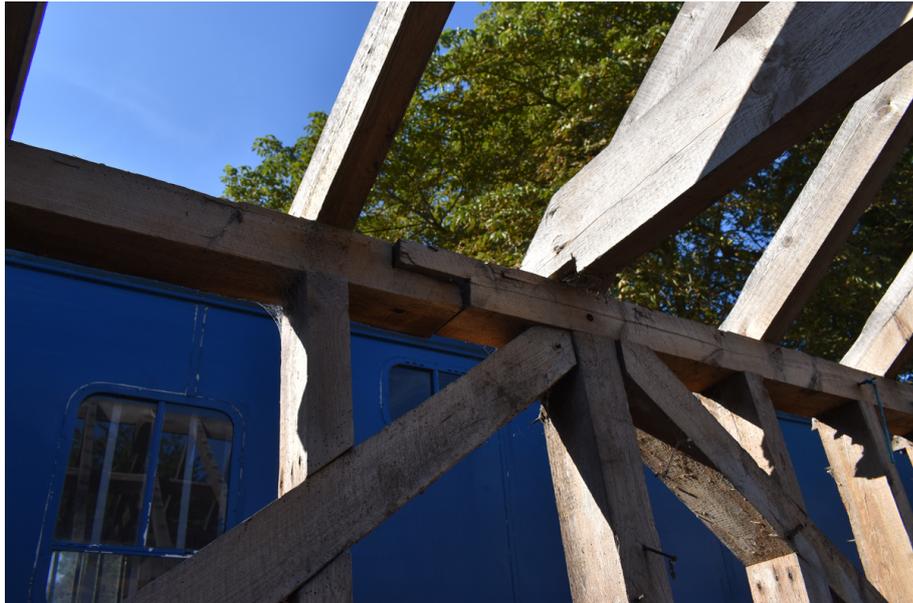
Photograph 15 Scarf joint on southern wall-plate in bay 9. Photograph taken facing south-west.
