**Historic building recording
of an outbuilding to the rear of
47-51 Newland Street,
Witham, Essex, CM8 2BD**

June 2020

CAT project ref.: 2020/05d
NGR: TL 82162 14476 (c)
Planning reference: 17/02256/FUL & 19/00051/REF
ECC code: WHNS20
OASIS project id: colchest3-395107

CAT Report 1563
June 2020

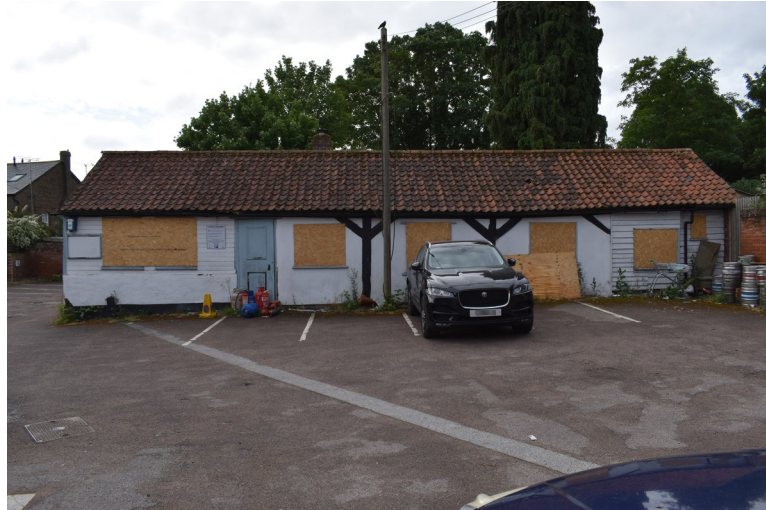
Photograph 2 North-west elevation of outbuilding. Photograph taken facing south-east.

The north-west elevation of the outbuilding contains six modern windows, all of which are later insertions into the structure (Photograph 2). They are all wooden-framed and are a mix of casement and awning windows, with several different designs (Photographs 7 and 8). Also on the north-west elevation is an inserted modern door (Photograph 3).

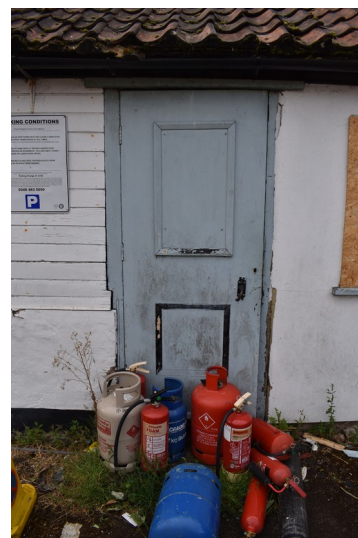
Photograph 3 Inserted modern door on north-west elevation of outbuilding. Photograph taken facing south-east.

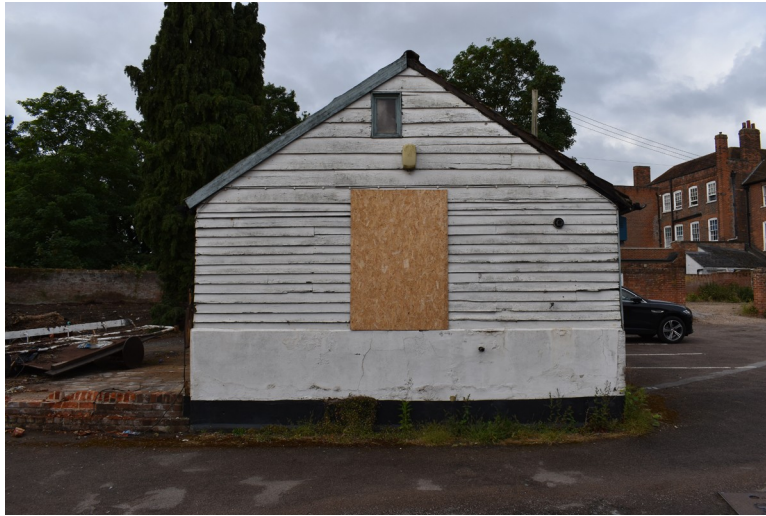
The north-east elevation of the outbuilding has two inserted wooden-framed windows, one casement and awning window and a smaller fixed window off-centre in the gable (Photograph 4).

Photograph 4 North-east elevation of outbuilding. Photograph taken facing south-west.

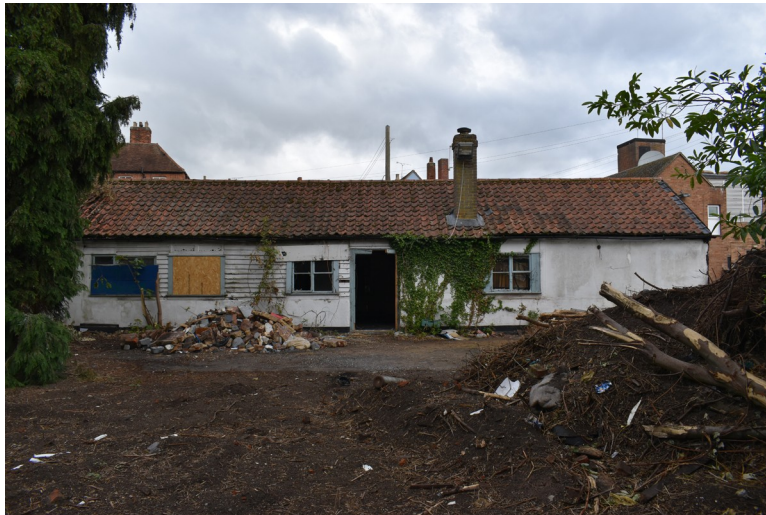
The south-east elevation of the outbuilding contains four modern windows, all with casements and awnings. The westernmost

window is wooden-framed but the rest are metal (Photograph 5). Also on this elevation is another doorway (with no surviving door).

Photograph 5 South-east elevation of outbuilding. Photograph taken facing north-west.

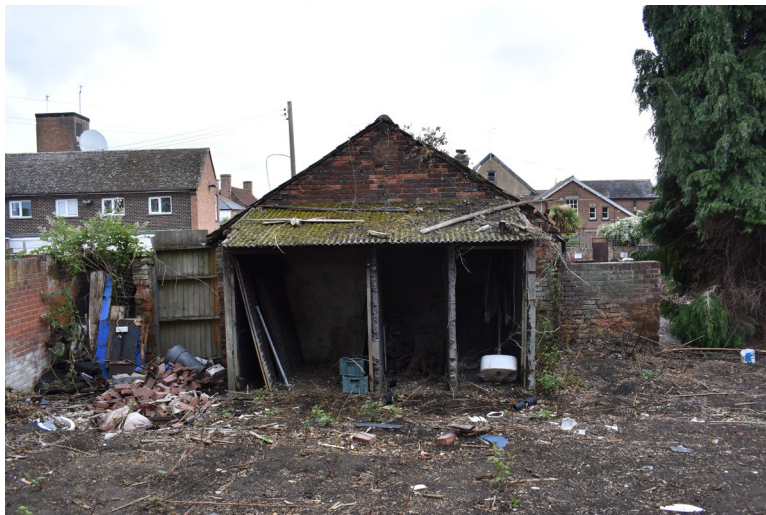
The south-west elevation of the outbuilding has a modern concrete-built lean-to projecting from it, with a corrugated asbestos roof (Photograph 6). The gable-end of the outbuilding in this location consists of exposed stretcher-bond red brickwork.

Photograph 6 South-west elevation of outbuilding, with lean-to. Photograph taken facing north-east.

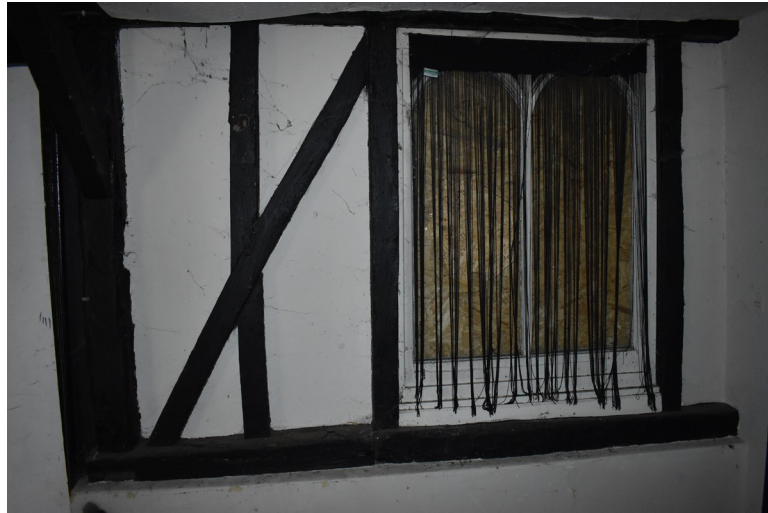
Photograph 7 Interior shot of north-west elevation of bay 4, showing fixed two-light window. Photograph taken facing north-west.

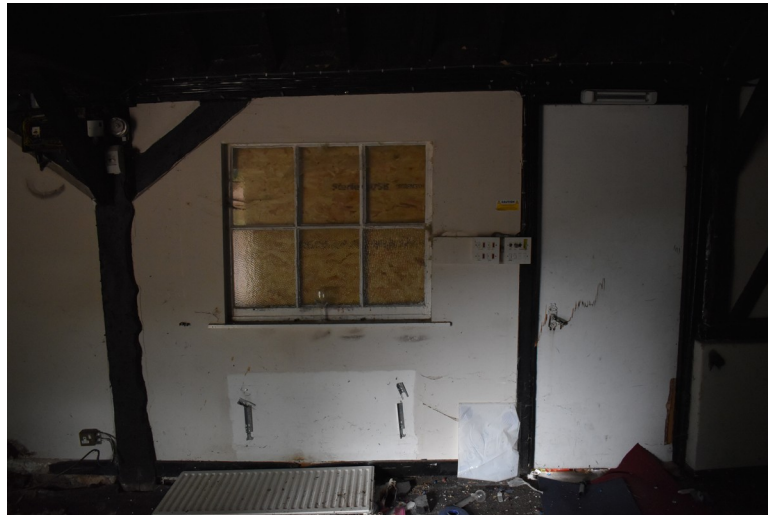
Photograph 8 Interior shot showing north-west elevation of bay 3, showing fixed six-light window. Photograph taken facing north-west.

The north-west walls of bays 1, 2 and 3 are modern brick insertions. Judging from the braces still present joining the principal-posts to the wall-plate, before the modern brickwork was added these would originally have been the locations of bay-width openings into the structure (Photograph 8).

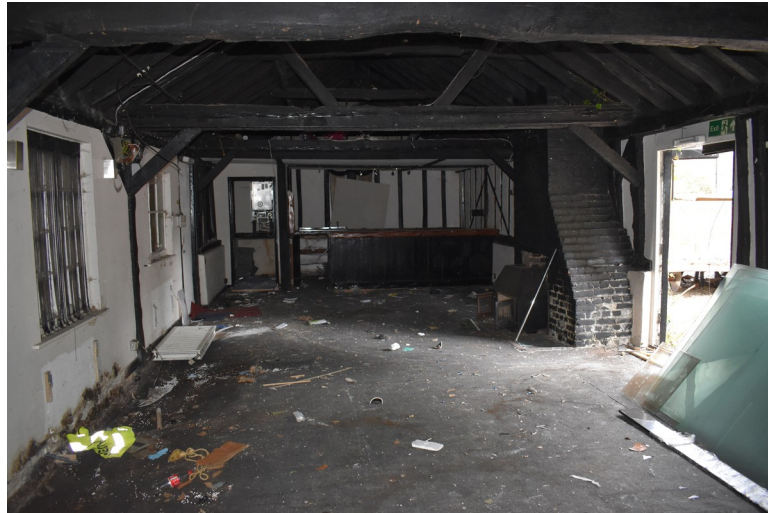
The four original bays of the building are all timber-framed (Photograph 9). Each bay is divided by a truss comprised of a tie-beam supported by straight braces at each end, with inclined struts rising from the tie-beam to a single clasped-purlin on each roof pitch. The roof is further supported by lower and upper collars at mid-bay intervals, and each pair of rafters meets at a ridge-board at the roof's apex (Photograph 10).

Photograph 9 Interior of outbuilding. Photograph taken from bay 1 facing north-east.

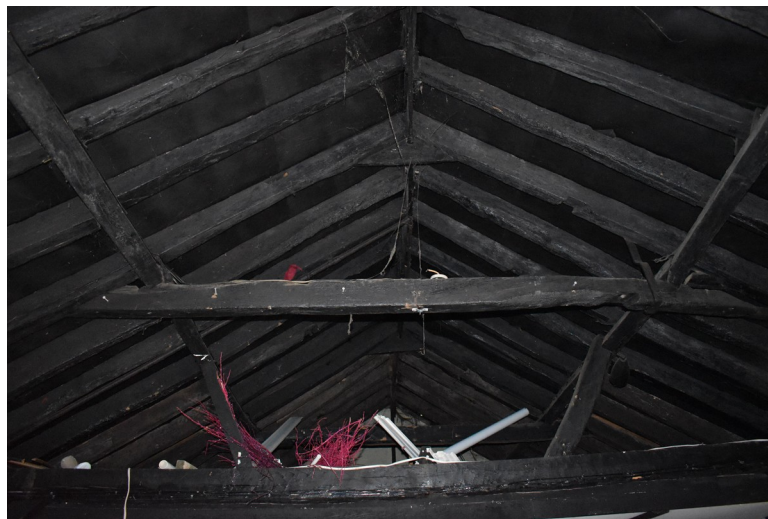
Photograph 10 Detail of roof of outbuilding above bay 4, showing struts, collars and clasped-purlins. Photograph taken facing north-east.

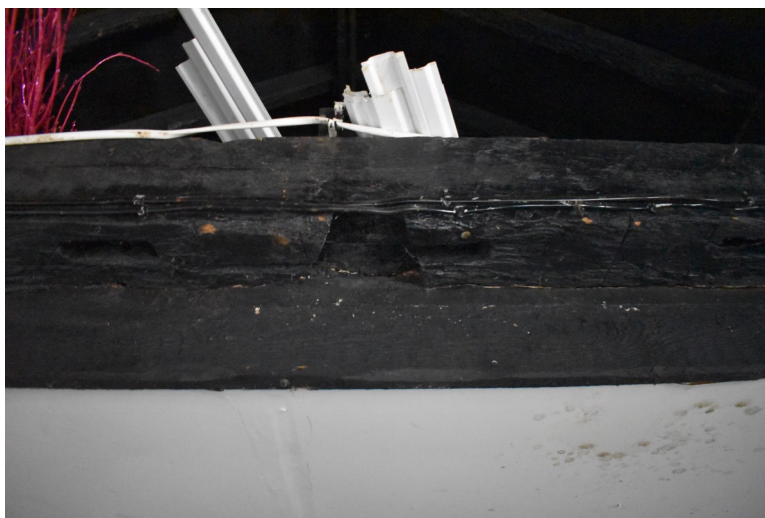
Photograph 11 Underside of tie-beam between bays 3 and 4, showing inverted lap-joint and earlier mortices. Photograph taken facing north-east.

The vast majority of the visible timber is hand-sawn, and several structural timbers have evidence of re-use in the form of empty mortices. This is particularly notable on the tie-beams, several of which have varied mortices on their upper and lower face, indicating they have been re-used at least once before (Photograph 11).

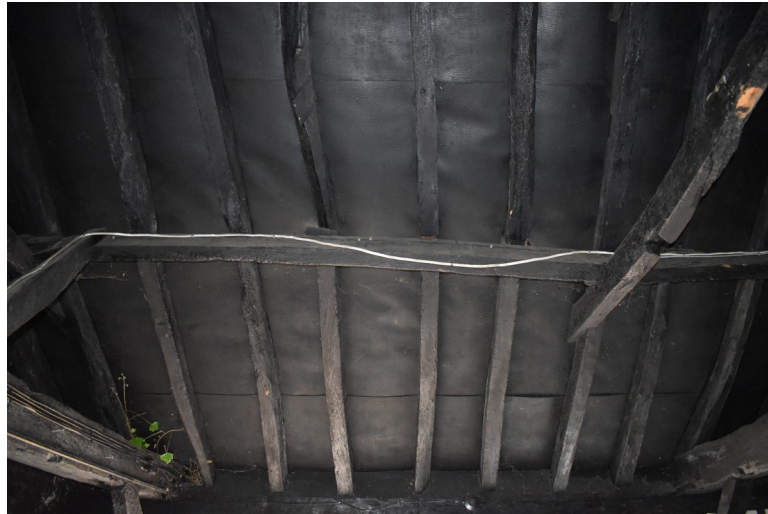
Additionally, almost all the rafters are hand-sawn, and many also have evidence of re-use (Photograph 12).

Photograph 12 Detail of hand-sawn rafters on south-eastern pitch of roof above bay 2. Photograph taken facing south-east.

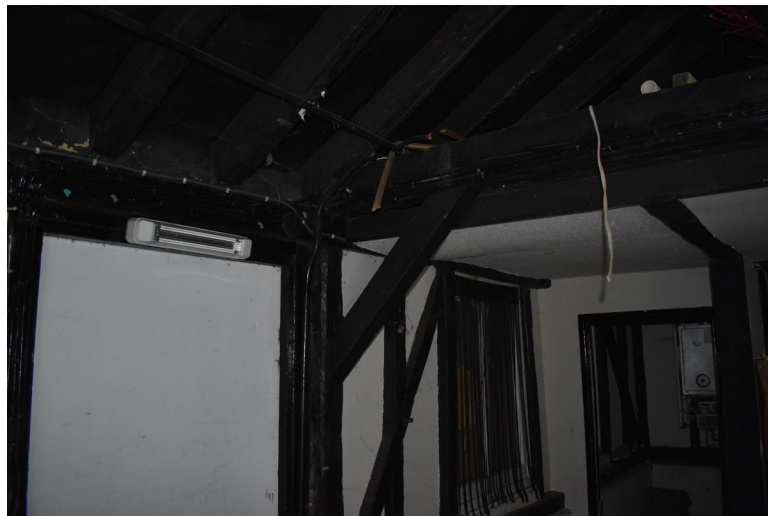
Although the majority is hand-sawn there are several examples of machine-cut timbers, including all the braces and struts projecting from each tie-beam and the through-bracing within the timber-frame (Photographs 7, 13 and 17).

Photograph 13 Detail of machine-cut brace supporting north-west end of tie-beam between bays 3 and 4. Photograph taken facing north.

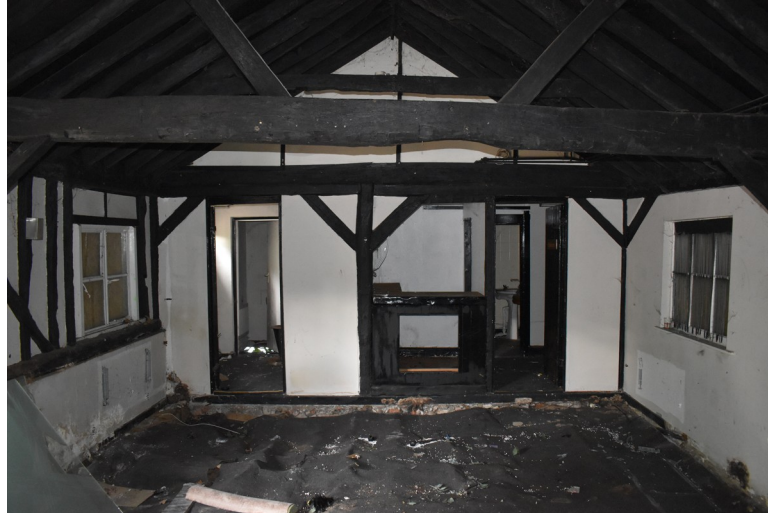
The south-west wall of bay 1 is the original gable-end of the building but has been significantly altered by the insertion of the brick-built extension (Photograph 14). The intermediate-post and wall-plate survive but there is no evidence of any surviving

studs. The wall-plate has had a secondary beam attached to its underside to provide additional support and, like the rest of the building, the braces going from the intermediate-post to the wall-plate are modern and machine-cut. As well as this, there is no evidence of a brick plinth and the intermediate-post is the full height of the bay, perhaps suggesting that this elevation was, like the north-west one, originally an entrance into the outbuilding.

Photograph 14 The south-west elevation of bay 1, showing the original gable-end of the building. Note lack of timber-frame, suggesting prior to modern insertions this end of the building was open. Photograph taken facing south-west.

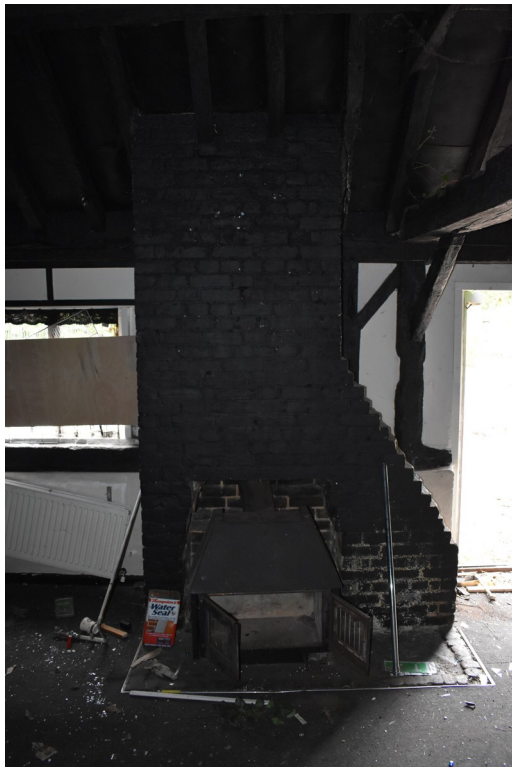
Photograph 15 Detail of inserted fireplace and chimney in south-east end of bay 3. Photograph taken facing south-east.

Bay 3 contains an inserted fireplace on its south-west wall, with regular stretcher-bond brickwork measuring 215mm x 105mm x 75mm in size (Photograph 15).

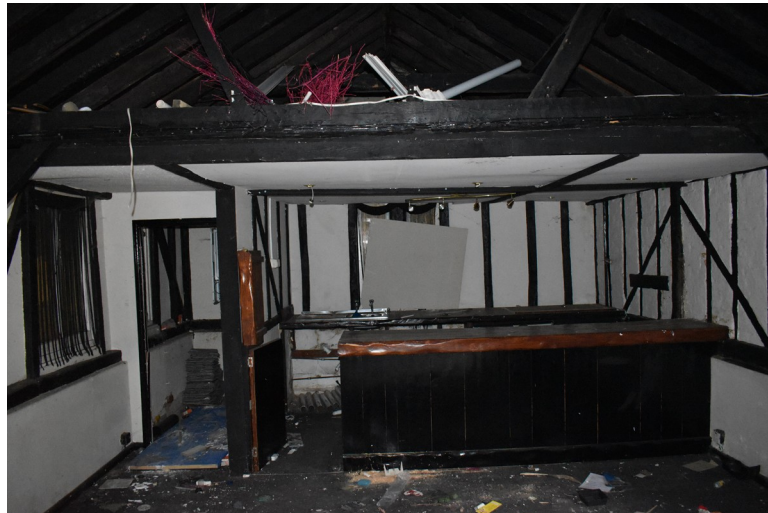
Bay 4 is the most heavily altered of the bays, and is dominated by an inserted bar and stud wall division (Fig 2). An attic storey has also been added above this bay, supported on the wall-plates (Photograph 16). The south-east wall of the bay has had brick-nogging (with bricks painted white and measuring 220mm x 110mm x 75-80mm) added into the timber-frame, presumably to further support the inserted attic storey above (Photograph 17). Additionally, unlike the other bays, bay 4 has a (rendered over) brick plinth on its north-west side, with no indication that there was ever an opening in this location (Photograph 16).

Photograph 16 Detail of bay 4, showing inserted bar, stud wall and attic space. Brick plinths beneath timber-frame rendered. Photograph taken facing north-east.

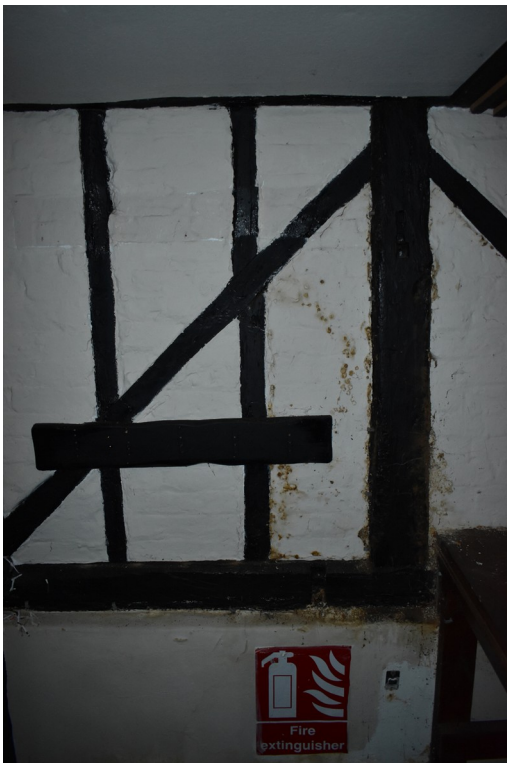
Photograph 17 Detail of inserted brick-nogging on south-east elevation of bay 4. Photograph taken facing south-east.

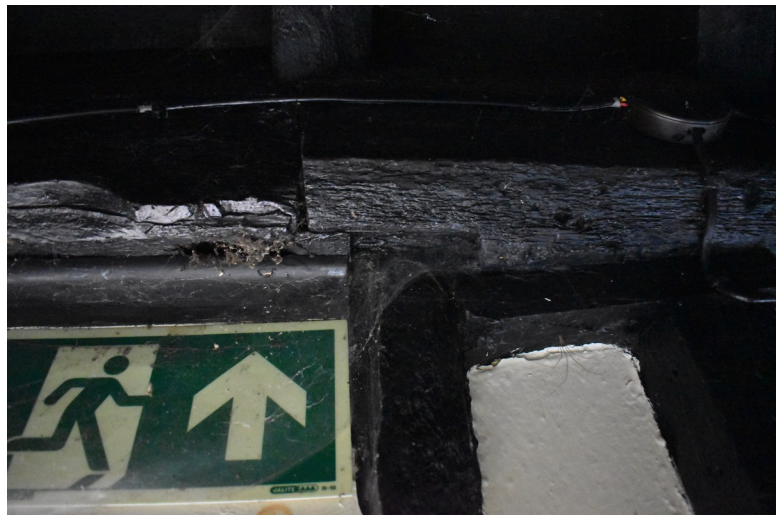
Photograph 18 Detail of partly degraded edge-halved scarf joint in south-east wall-plate of bay 2. Photograph taken facing south-east.

A number of scarf joints were observed on the wall-plates and sill-beams of the building (Fig 2). Most were partially obscured, but the identifiable forms were all rudimentary edge-halved scarfs with square abutments (Photograph 18).
