**Historic building recording at Spaynes Hall,
Cherry Lane, Great Yeldham,
Essex, CO5 4HH**

June 2021

CAT Report 1679
June 2021

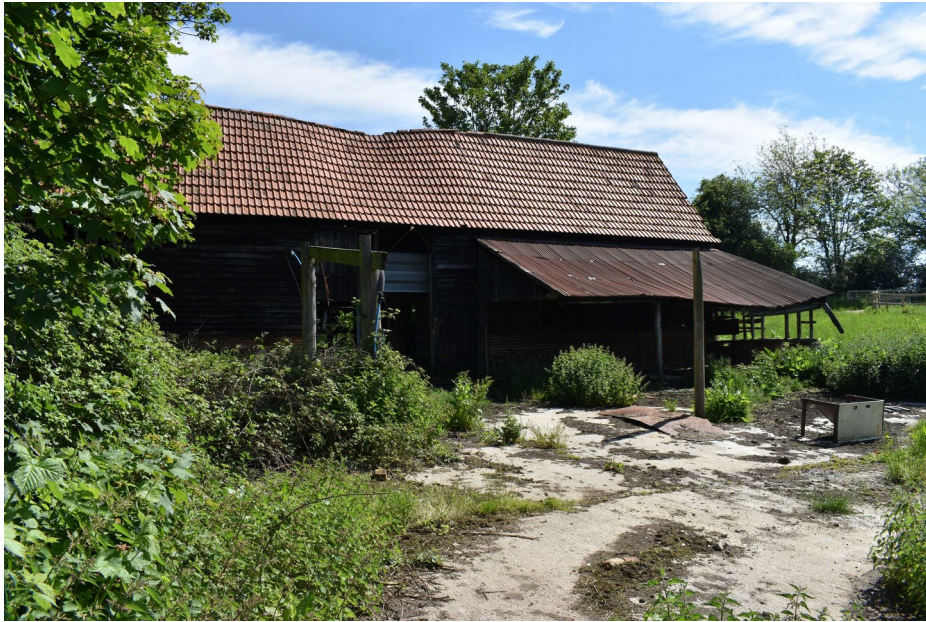
Photograph 1 South-west elevation of threshing barn. Photograph taken facing north-east.

The barn is supported on a plinth of red brick. The lower nine courses of brickwork are laid in Flemish-bond and bonded in lime mortar, with brick dimensions of 230 x 115 x 60mm. The upper five courses are also laid in Flemish-bond with lime mortar but with brick dimensions of 225 x 110 x 65mm. There is flint set in lime mortar between columns of brickwork in the lower courses.

The south-west elevation of the threshing barn has a large central opening with half of one vertical-planked door surviving. To the south-east of this entrance is a smaller single door, which is also vertically-planked and likely a later installation. Also present on this elevation is a rectangular opening in the upper register. There is a modern lean-to, roofed in corrugated metal, on the southern end of the this elevation, partially obscuring the barn. A large amount of weatherboarding has been removed in the lean-to (fig 4), revealing the timber-frame of bays 4 and 5 and a number of carpenter's marks (discussed below).

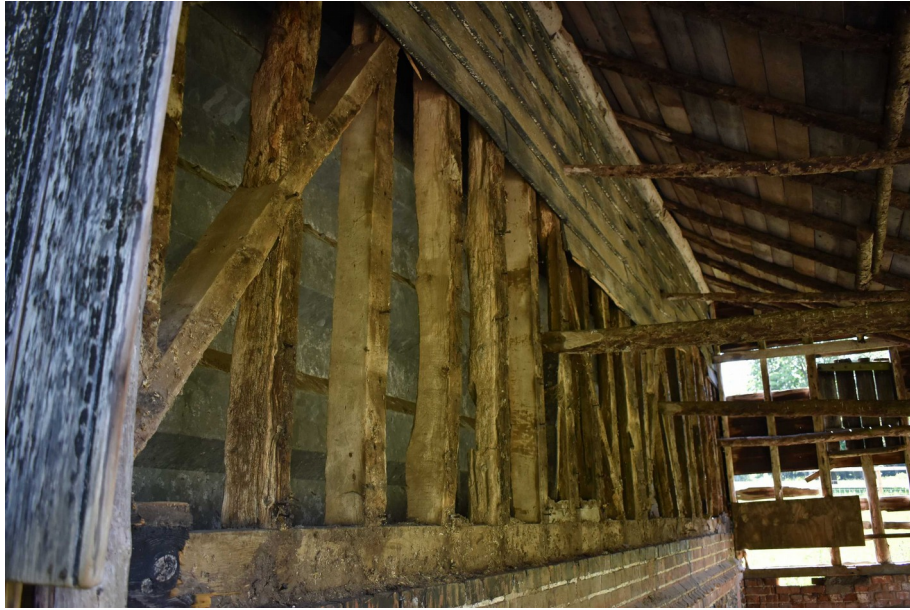
Photograph 2 Exposed timbers on south-west elevation of threshing barn. Photograph taken facing east.

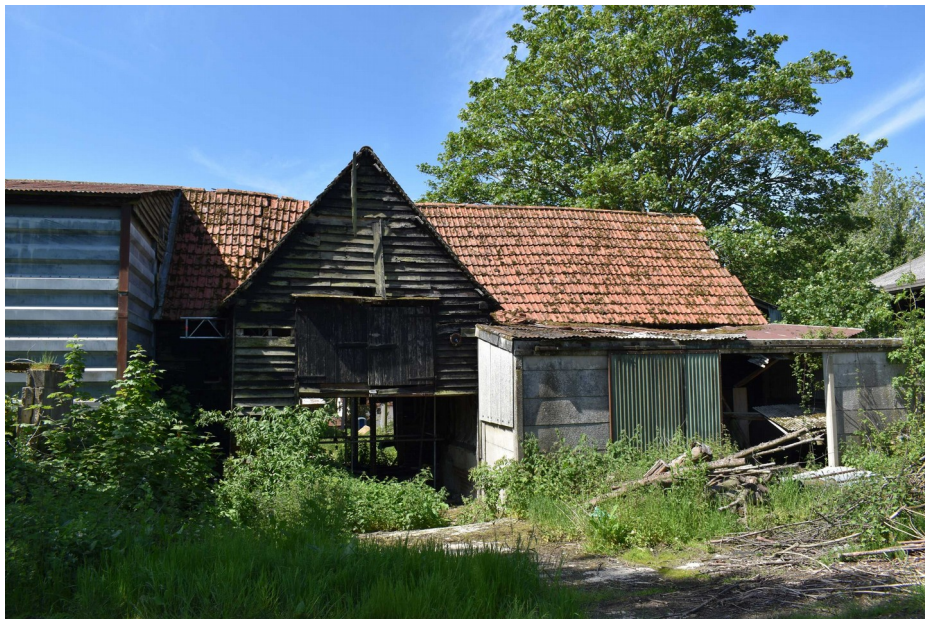
The north-east elevation of the threshing barn contains the centrally located midstrey. The midstrey has a large off-center lower opening, with no surviving doors. Also present are smaller, centrally-located vertically-planked doors above the larger opening. On both sides of the midstrey is a modern addition, to the south-east a galvanised unit and on the north-west a concrete structure. There is an inserted single-light rectangular window next to the galvanised unit on the south-east corner.

Photograph 3 North-east elevation of threshing barn. Photograph taken facing west south-west.

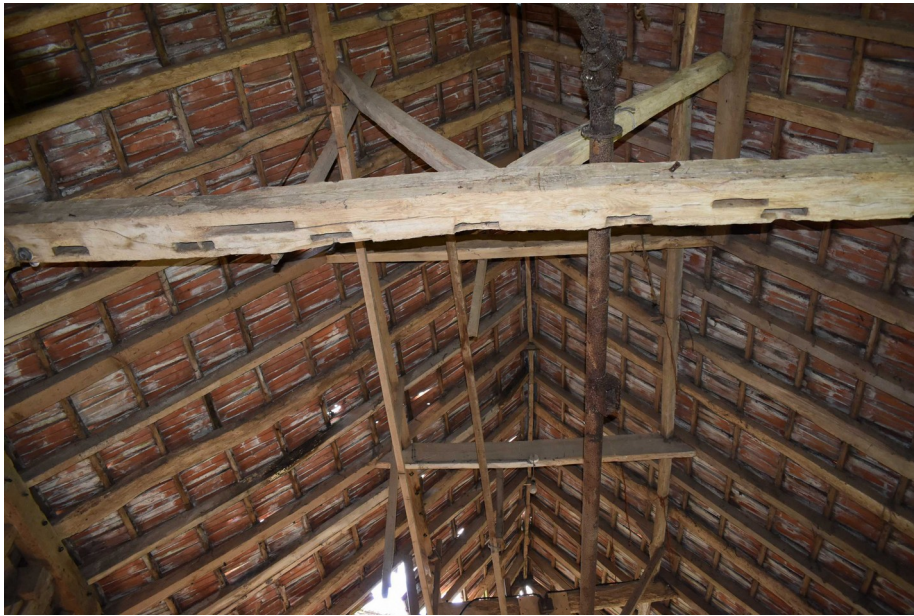
The roof of the barn is gabled. The roof consists of pairs of rafters meeting at a ridge-board, supported by two collars in the middle of each bay, which in turn support one clasped purlin on each roof pitch. Each tie beam has two inclined struts rising up to meet the purlins. The tie-beams separating the building's bays are all hand-sawn and re-used timber, which are supported at both ends by knee braces.

Photograph 4 Detail of tie-beam between bays 1 and 2. Photograph taken facing south-east.

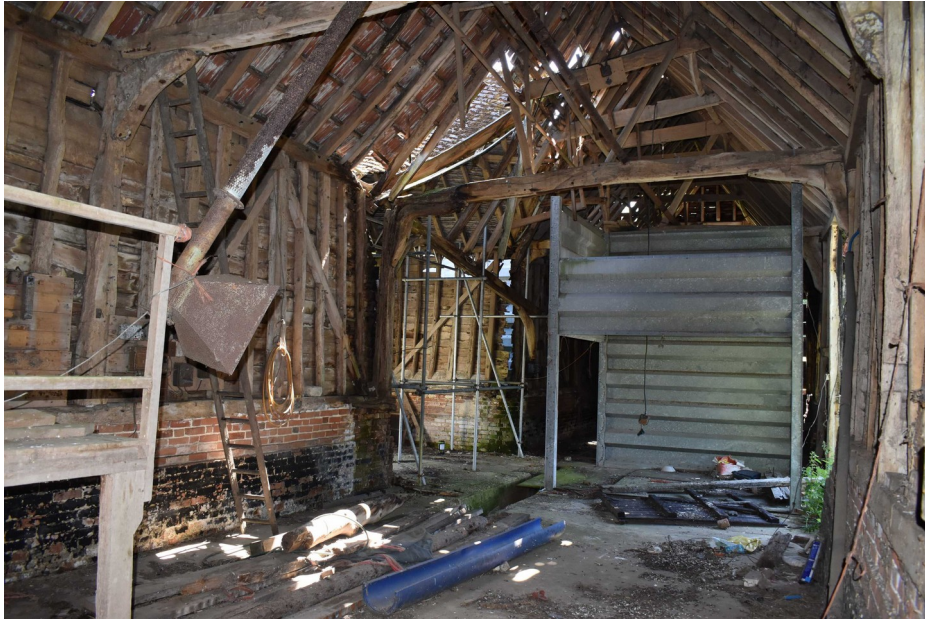
The floor of the barn is modern concrete, although the central bay (bay 3) would have at one time had a threshing floor, possibly made of brick. The lower nine courses of brickwork in the plinth have been painted black.

Photograph 5 Interior of threshing barn. Photograph taken facing east south-east.

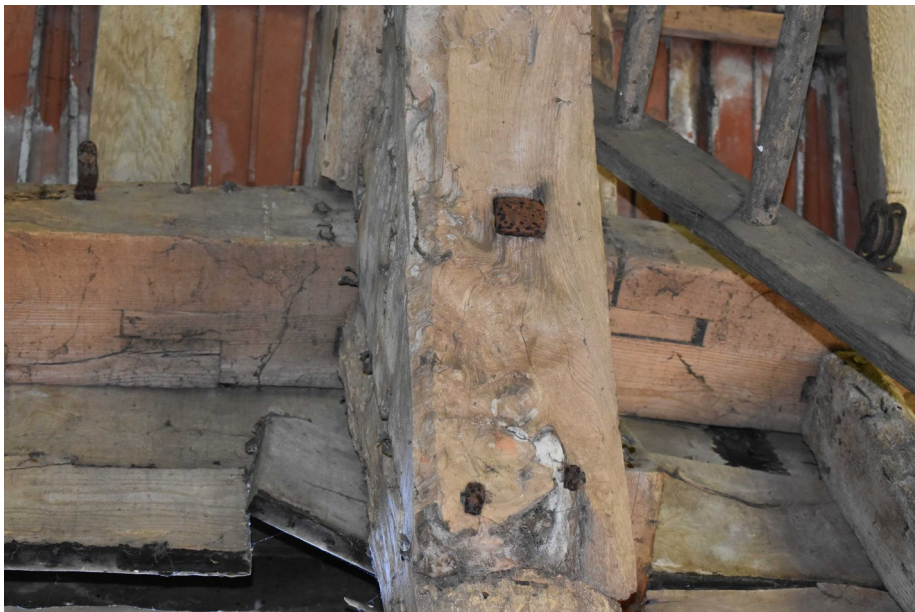
Behind each end of the tie-beam between bays 1 and 2, on the north-east and south-west wall-plates, is a face-halved and bladed scarf joint.

Photograph 6 Scarf joint on wall plate of north-east elevation between bays 1 and 2. Photograph taken facing north-east.

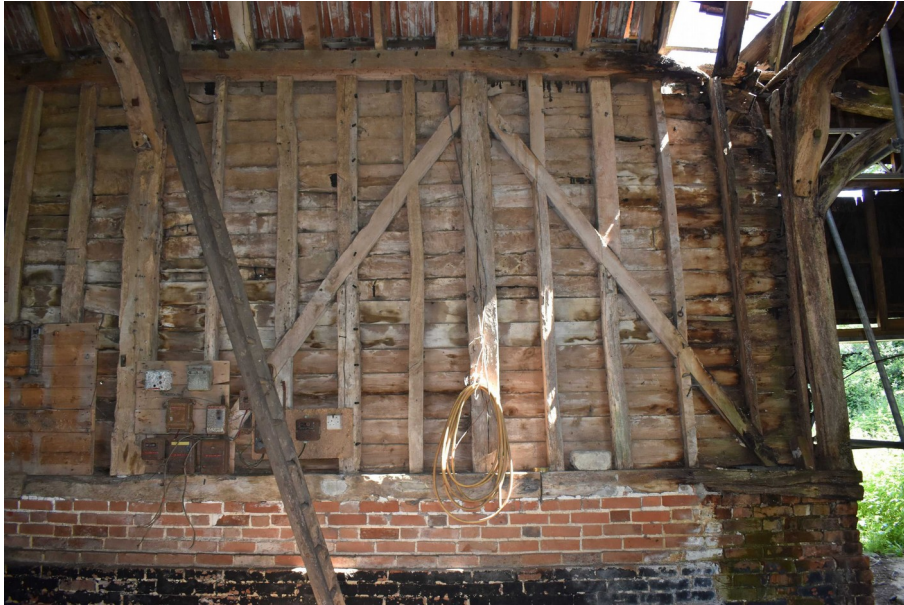
On the north-east elevation, between bays 2 and 3, serious water damage has caused the principal-post, wall-plate, knee-brace and tie-beam to start to rot. There is evidence there was once a scarf-joint behind this end of the tie-beam, most likely a face-halved and bladed joint. At the other end of the tie-beam, on the south-west elevation, there is the equivalent scarf joint on the wall-plate. Bay 2 also has two sill-beam scarf joints, one on each elevation. Both are a straight bridling with square abutments and two edge pegs.

Photograph 7 North-east elevation of bay 2 showing water damage.
Photograph taken facing south-west.

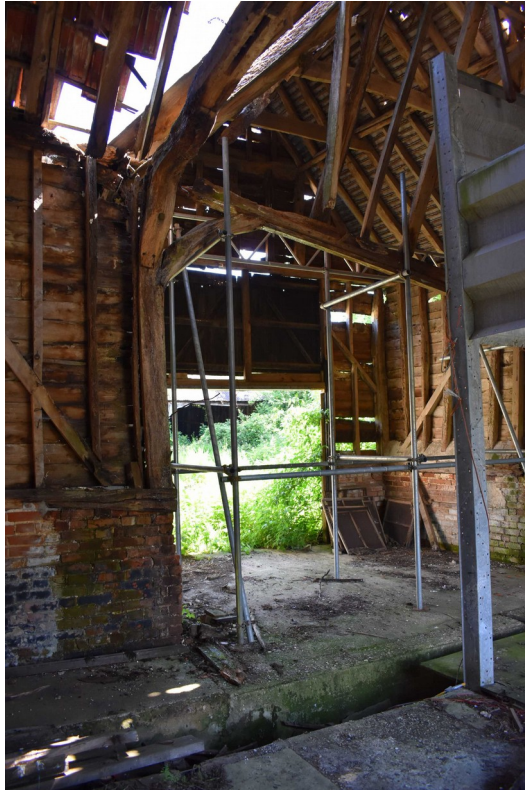
Bay 3 is the central bay of the barn and is slightly wider than the other bays. The south-west elevation is dominated by a large set of partially surviving barn doors with a smaller inserted door next to it. The principal-posts and post between the doors all have empty mortices indicative of re-use.

Photograph 8 Interior of threshing barn showing bay 3. Photograph taken facing east south-east.

On the north-east elevation, between bays 3 and 4, substantial water damage has caused the entire principal-post and part of the wall-plate in bay 4 to rot away. This in-turn has caused the wall-plate in bay 3 to collapse, it is now held in place by scaffolding.

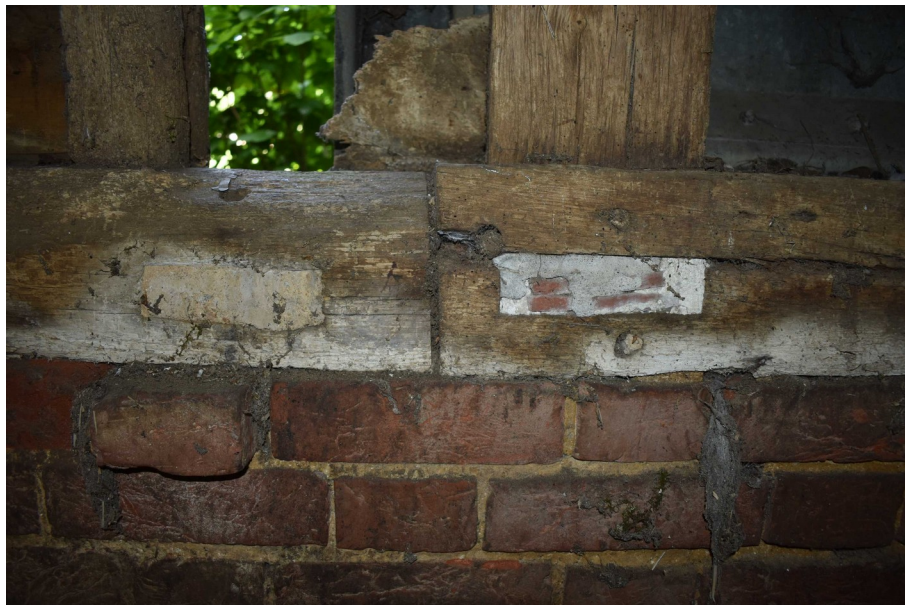
Both the sill-beam and wall-plate in bays 4 and 5 have evidence of re-use. On the sill-beam of bays 4 and 5 the old mortices have been filled with a mixture of lime mortar, concrete and peg-tile.

Photograph 9 Detail of scarf joint and filled mortices on sill-beam of north-east elevation in bay 4. Photograph taken facing north-east.

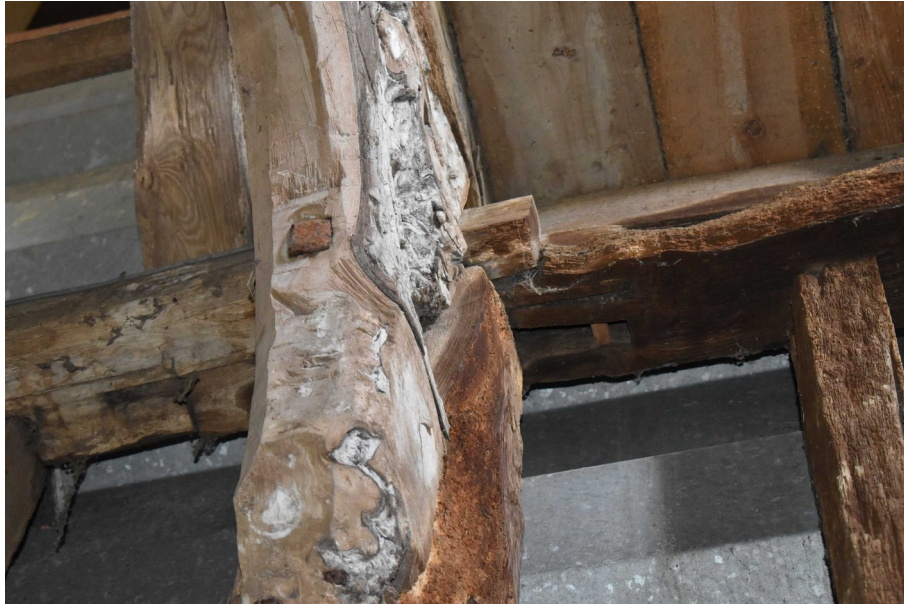
The sill-beams on both elevations of bay 4 have scarf joints, in the form of simple straight bridling with square abutments and two edge pegs. A scarf joint (face-halved and bladed) is also visible on the wall-plate of the north-east elevation, behind the tie-beam. The joints in each timber of this scarf joint do not match with each other, either due to re-use of a larger scarf joint or an empty mortice. Although the south-west elevation is mostly obstructed by a modern silo, it can be assumed that another scarf joint is present on the wall-plate at the other end of the tie-beam.

Photograph 10 Scarf joint and re-used timber in wall-plate in north-east elevation between bays 4 and 5. Photograph taken facing north-west.

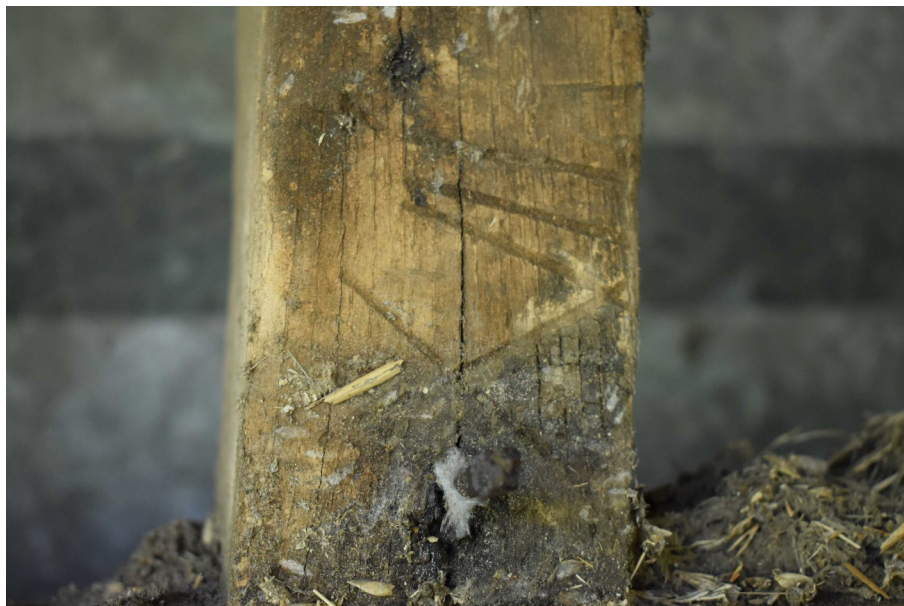
There are a number of carpenter's marks on the south-west elevation of bay 4, visible on the exterior due to the removal of the weatherboarding. Six of the studs have a 'XIII' chiselled on their south-western face. The western brace has a series of 'III' marks chiselled on the south-west face where it passes through each stud. Similarly, the eastern brace has a 'III' chiselled in the same fashion.

Photograph 11 Carpenter's marks on stud of bay 4. Photograph taken facing north-east.

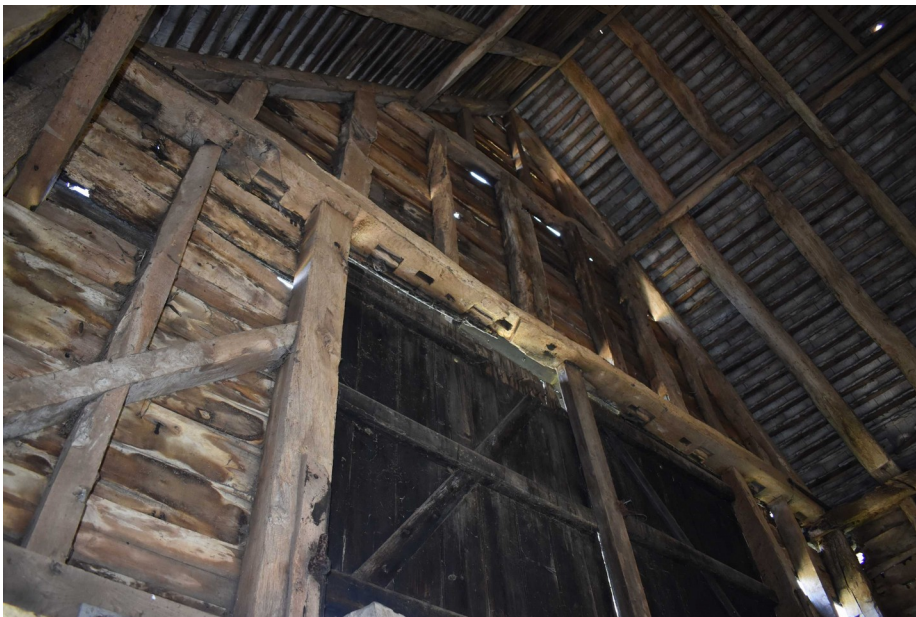
The midstrey projects from bay 3 on the north-eastern elevation. The lower half of the midstrey's north-east elevation is primarily taken up by an opening for double-doors (no longer surviving). Above this sits a set of smaller vertically-planked double doors. Both corner-posts and the wall-plate have evidence of re-use. The wall-plate appears to contain several different phases of mortices, indicating it has probably be re-used more than once.

Photograph 12 Re-used timber wall-plate in midstrey. Photograph taken facing north-east.

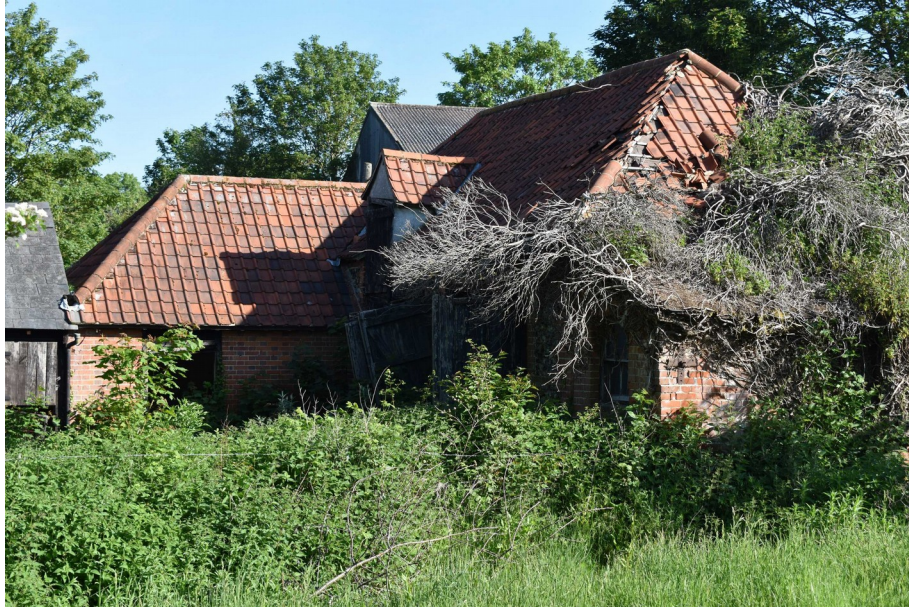
Photograph 13 Coach house exterior. Photograph taken facing north.

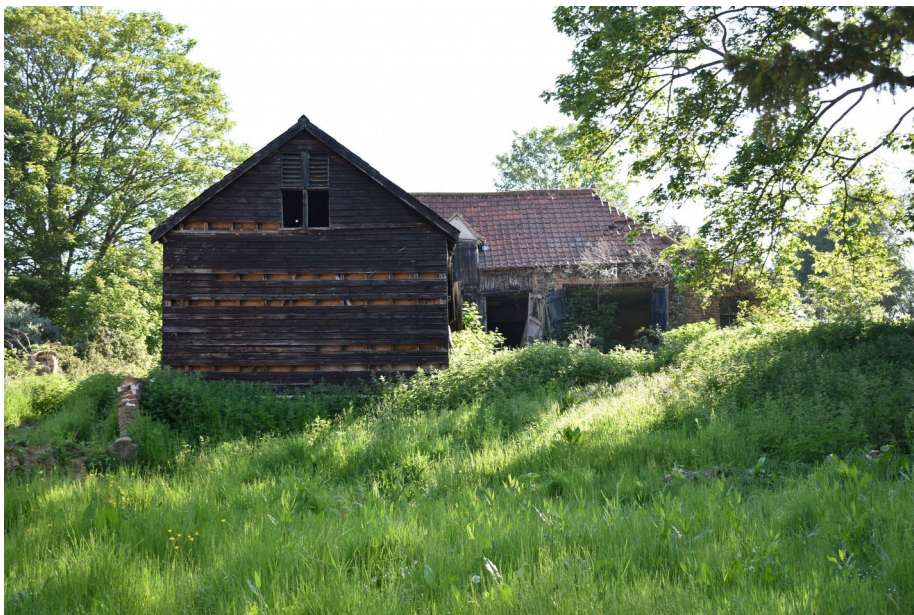
The south-west elevation has two sets of vertical-planked double-doors, separated by a column of flint set in lime mortar. There is also flint and mortar at the top and side of the south-eastern doors. Above the north-west doors is a small vertical-planked pitching door. There is a six-light horizontal sash window to the south-east of the doors. On the modern stall extension is an opening in the gable, the top half of which are louvre vents.

Photograph 14 South-west elevation of coach house. Photograph taken facing north-east.

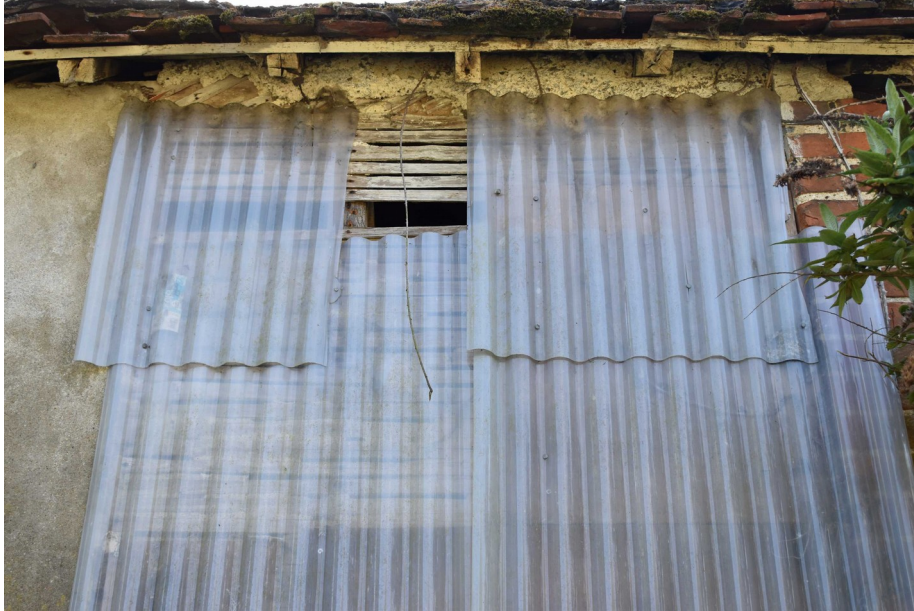
On the north-west elevation there is four-light vertical sash window. There is an area of damage to the render on this elevation showing the laths below. On the modern stalls on this elevation there are three openings and a small vertical-planked door. The plinth is visible on this elevation and consists of columns of bricks interspersed with flint set in lime mortar, the same as the threshing barn.

Photograph 15 Exposed laths on north-west elevation of coach house.
Photograph taken facing south-east.

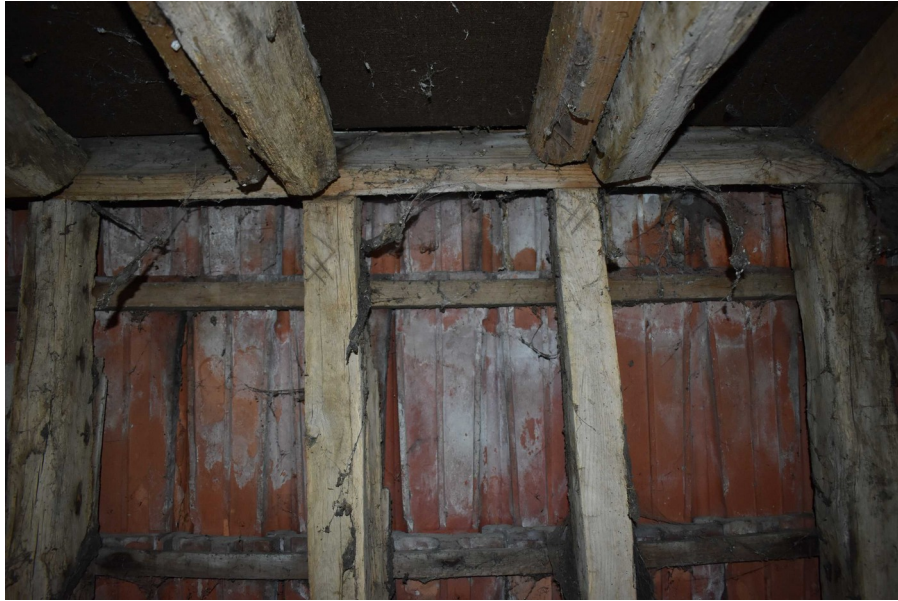
The roof of the coach house is hipped at both ends. The roof consists of pairs of rafters meeting at a ridge-board, supported by a series of collars. These collars support one clasped purlin on each roof pitch. There are three tie-beams, the most northern of which has inclined struts. Most of the timber in the roof is hand-sawn, some of which have signs of re-use. Two rafters have carpenter's marks in the apex of the roof, one reads 'XXV III' and the other 'XXV'. There are also Baltic timber marks on the northern wall-plate.

Photograph 16 carpenter's marks on rafters of coach house. Photograph taken facing north-east.

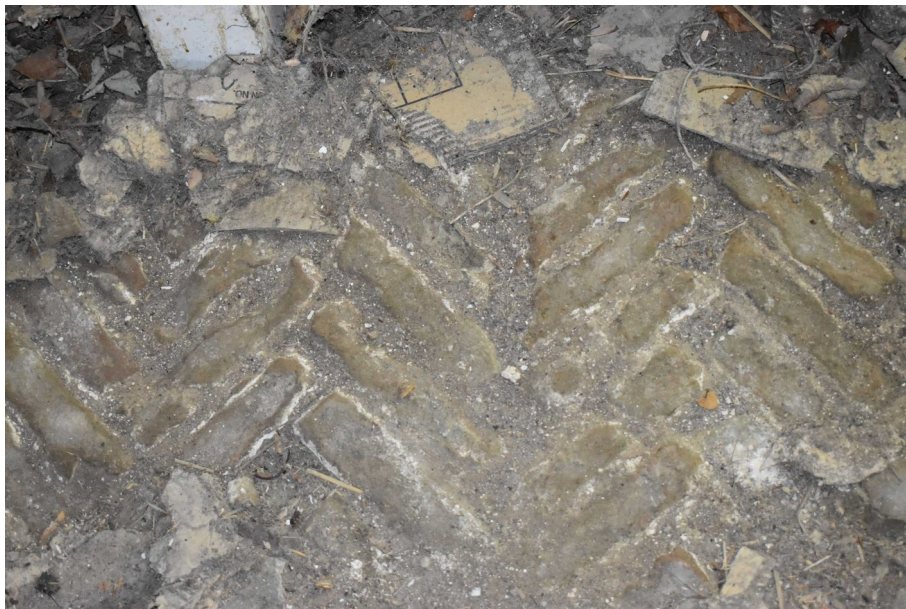
The main room of the coach house has a floor made of pavior bricks (fig 3) (195 x 105 x 50mm). The majority of which is laid flat, except one area which is in a herringbone pattern. On the north-eastern side is a strip of pavior bricks laid on edge. In the eastern corner of the room is an area floor made of red brick (230 x 100 x 50mm), this sits below the pavior bricks and could be the original coach house floor.

Photograph 17 Detail of herringbone brick floor in coach house. Photograph taken facing south-east.

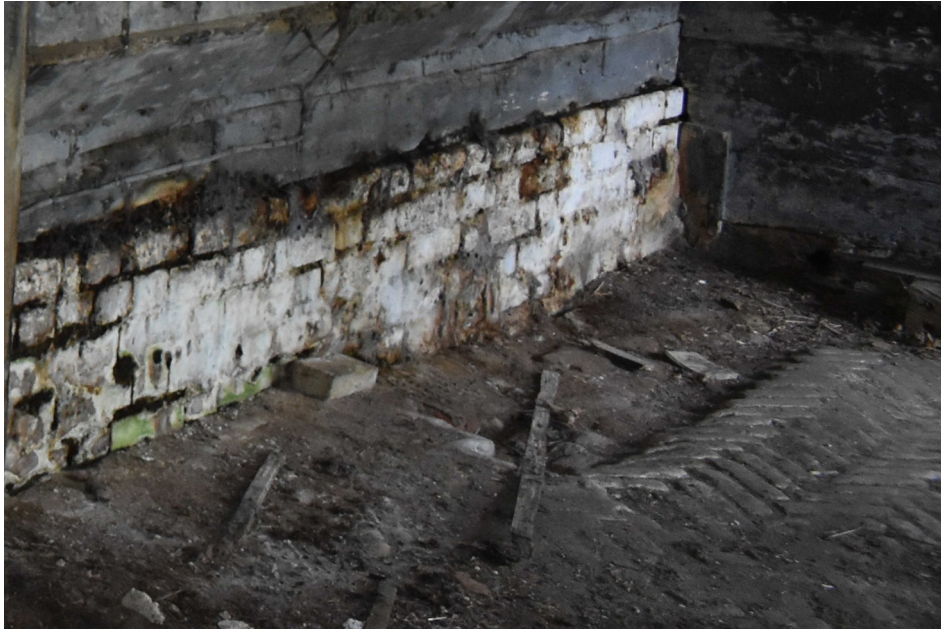
Photograph 18 Area of red brick flooring. Photograph taken facing east.

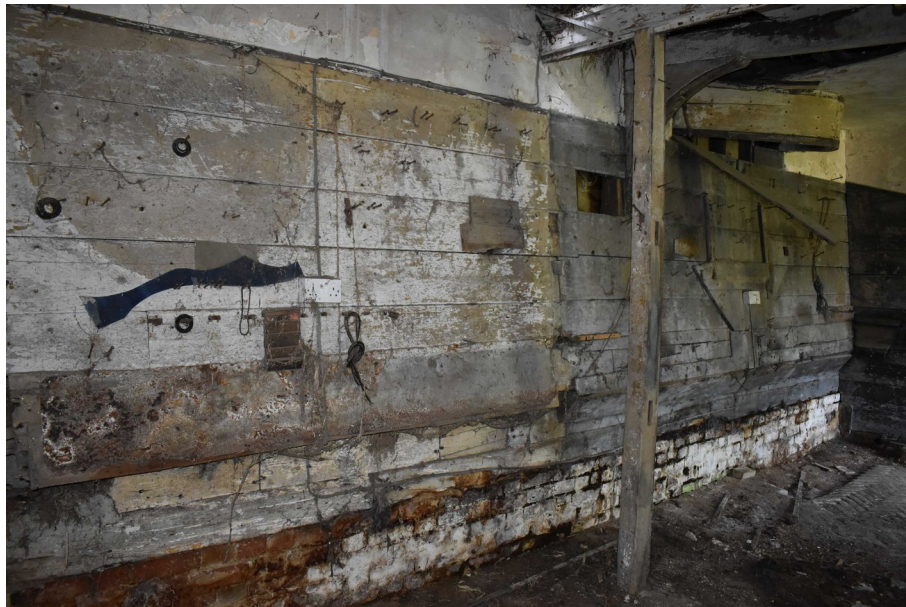
The majority of the wall of the north-east and south-east elevations are clad in timber panels, with the remaining areas and the other two walls plastered and painted. On the north-west and north-east elevations 5-6 courses of the brick-plinth are visible and a single course of bricks are visible on the south-east elevation.

Photograph 19 Wooden cladding on walls in main room of coach house. Photograph taken facing south-east.

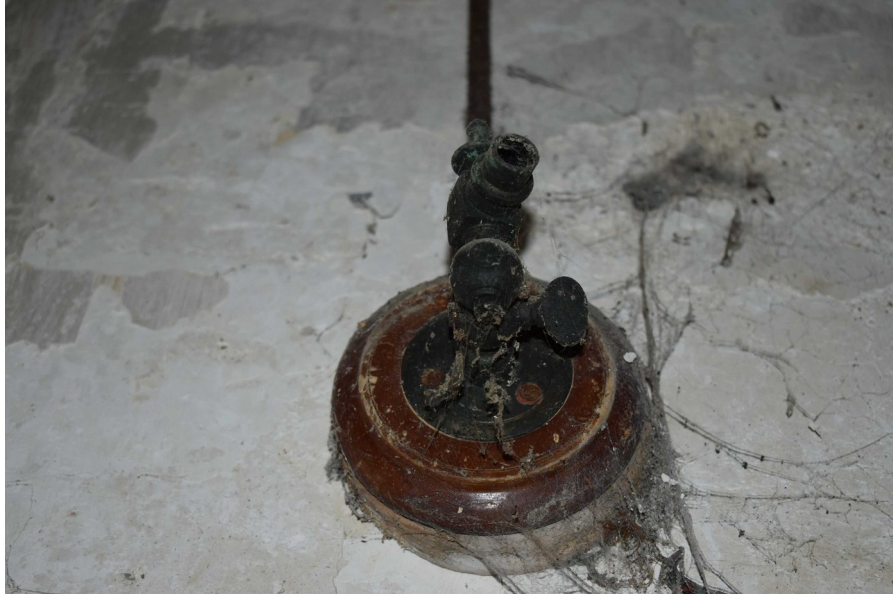
On the south-west elevation is a door which has been blocked and replaced with an eight-light fixed window. To the south of this is the mount for a gas lamp, complete with gas pipe.

Photograph 20 Gas lamp mount in main room of coach house.
Photograph taken facing south-west.

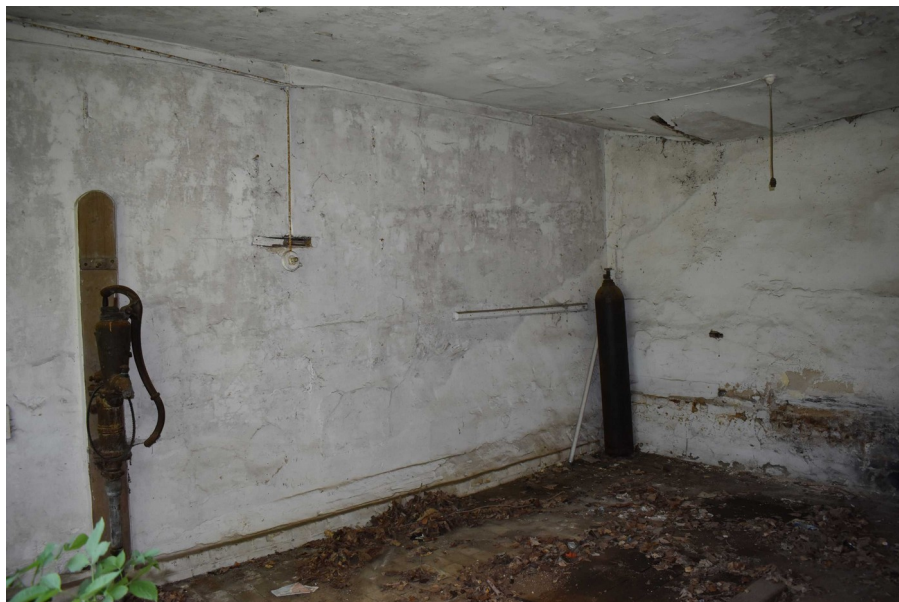
On the north-east elevation the brick plinth is visible and on the north-west elevation two courses of bricks are visible at the base of the wall. The remaining wall surfaces are plastered and painted white. On the north-west elevation is a cast-iron water-pump mounted on the wall. To the right of the pump is a remains of mount for a gas lamp.

Photograph 21 Interior of garage showing water pump and gas lamp mount. Photograph taken facing north-east.

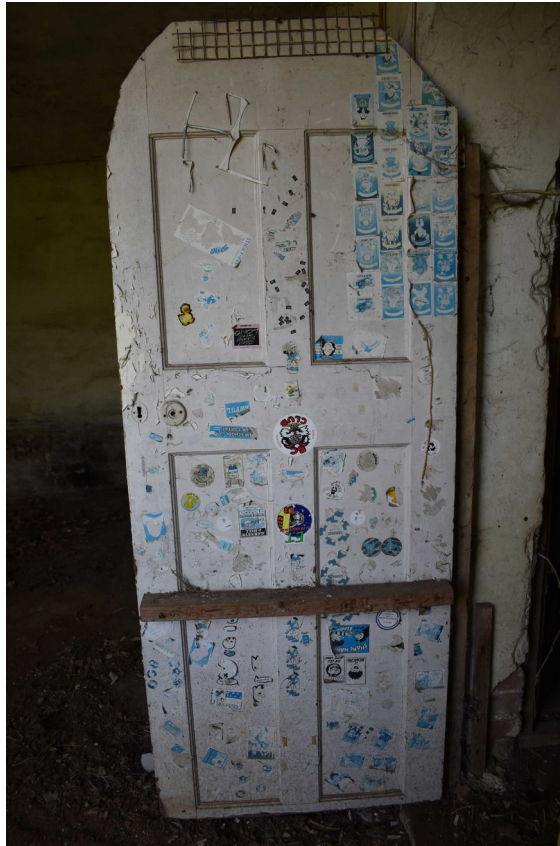
On the south-east elevation is the door leading to the brick lean-to. This is later addition to coach house. The door has been re-used, it is covered in stickers and has been turned upside down and cut to fit the existing doorway.

Photograph 22 Re-used door in garage.
Photograph taken facing north-east.

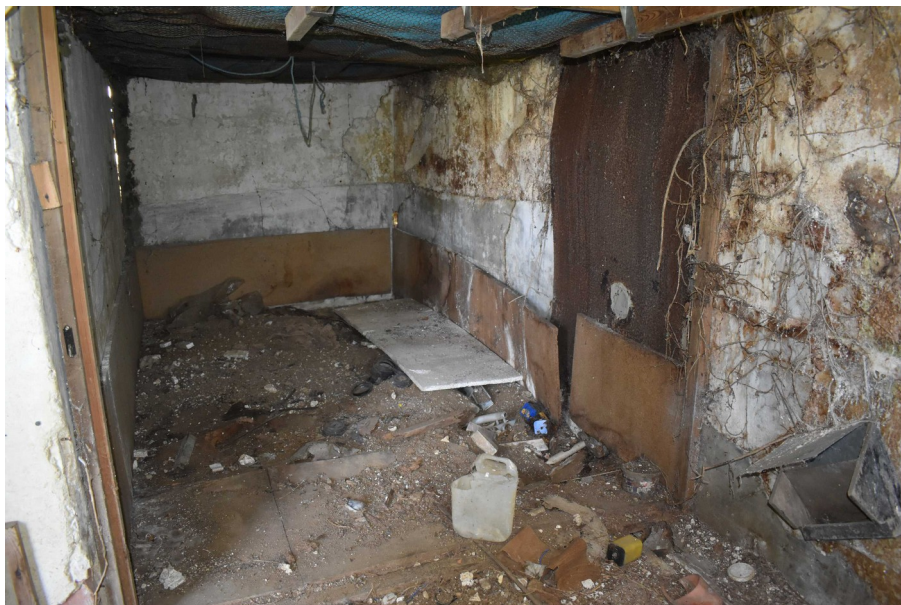
The brick lean-to has a brick floor which continues through the door from the garage and covered with fibre-board. The walls are plastered and painted white, with fibre-board fixed to lower sections. It has a low ceiling due to the incline of the roof and the north-east end is only half height.

Photograph 23 Interior of lean-to. Photograph taken facing east.

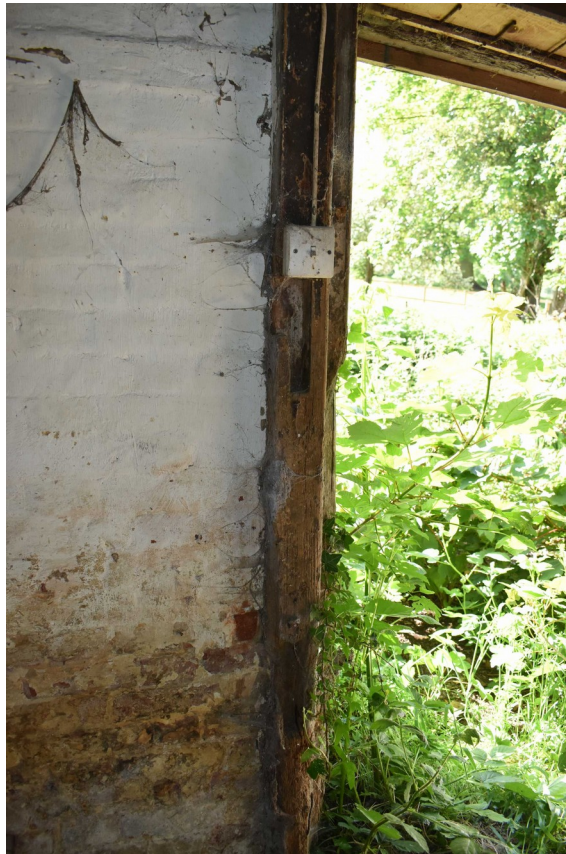
Photograph 24 Re-used timber in stable.
Photograph taken facing south-west.

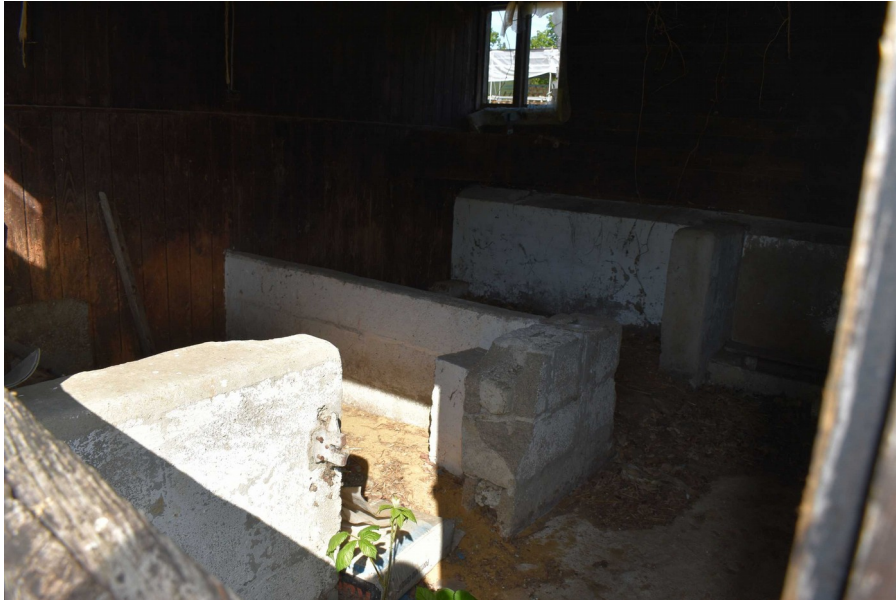
The ceiling of the stalls is made of chicken-wire overlaid with insulation. Each stall has three small binding-beams supporting the ceiling. The roof of the stalls is gabled and consists of machine-cut timber. The through purlins support pairs of rafters which meet at a ridge-board. Additional support is given by diagonal wind-braces.

Photograph 25 Interior of coach house stall. Photograph taken facing west.
