**CAT Report 1803
September 2022**

**Historic building recording of a building at Skilletts
Farm, School Road, Pentlow, CO10 7JR**

**CAT project ref.: 2022/03c
ECC code: PLSB22**

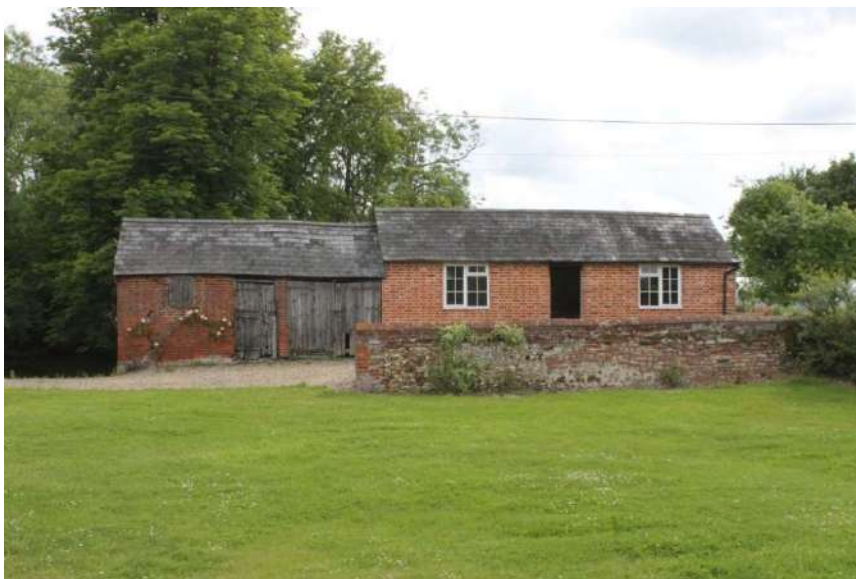
The building is approximately 15.7m by 3.7m. It is a small brick-built building with stable and cart lodge to the north, built up against the cattle shed to the south. Though the roof of the northern part of the building is built against the cattle shed, rather than integral to it, it is most likely that they were constructed at the same time. The building is approximately 15m to the north of Skilletts Farmhouse. To its rear is a modern timber lean-to measuring approximately 4.75m by 2m. The building is constructed of red brick with a slate roof and ceramic coping tiles. There is some slight variation in brick dimensions (shown on Figures 4 – 7), but they are most commonly 230 x 115 x 65mm.

Photo 1: Exterior of building

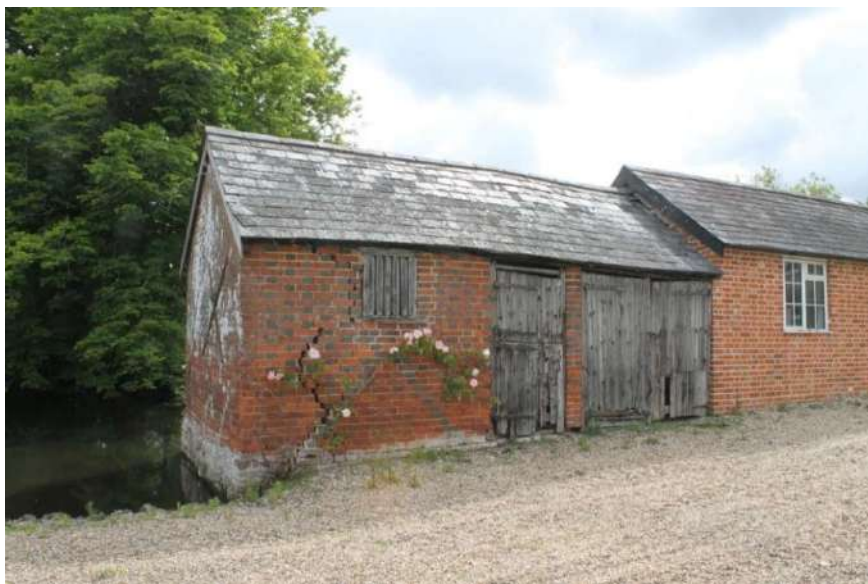
The stable and cart lodge to the north and its door and window openings are thought to be an original part of the building. They were constructed on an offset brick plinth. The bricks (235 x 110 x 65mm) are shallowly frogged, suggesting a date of c. 1850 onwards. The lower part of the wall has a burnt brick diaper pattern, and the upper part of the wall has a chequer pattern. The bricks are bonded with a lime mortar, c. 10mm thick.

Photo 2: The stable and cart lodge

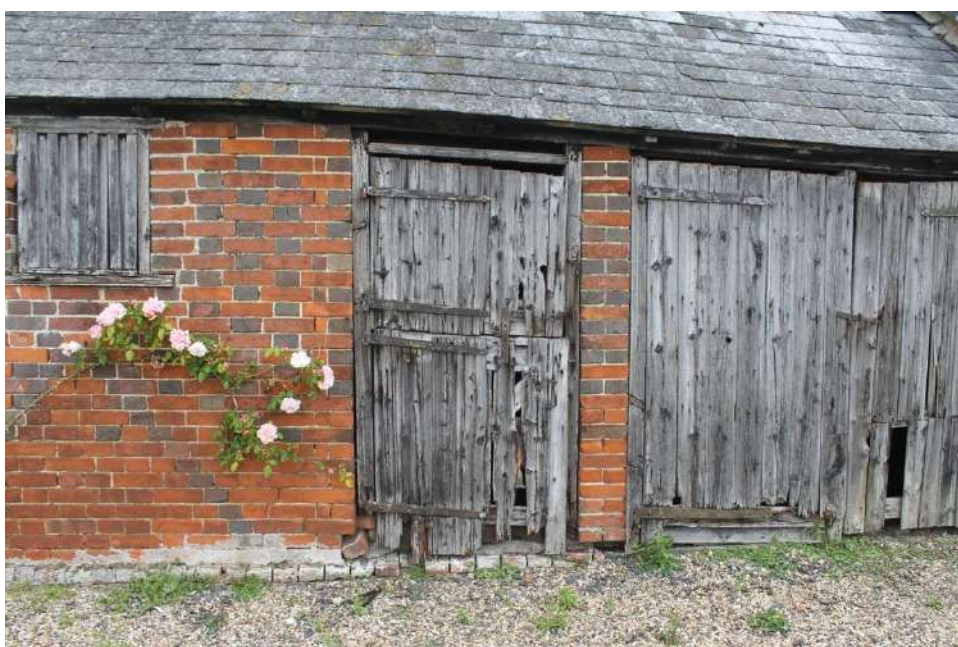
As well as the door and window openings largely being in their original positions, the furniture of both is early if not original. There is a soft-wood vertical-slatted window in the western side of the stable as well as a stable door hung on a strap hinge and pintle. The window has queen closers to the left, but none are visible to the right, and the bricks which are to the right appear to have been repointed at some stage and do not match the burnt brick chequer pattern on the rest of the upper wall, suggesting that the window opening may have been resized. The double door on the cart lodge was constructed in the same way as the stable door with almost identical hinges. At some stage, the double door appears to have been given additional support in the form of a central pillar.

Photo 3: The vertical-slatted doors and window in the western façade of the stable and cart lodge.

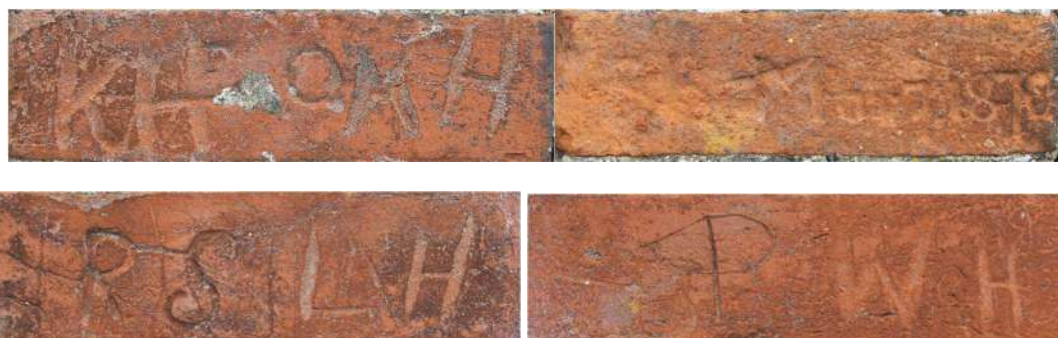
There is some graffiti on the bricks between the stable door and the double door. This gives a *terminus ante quem* of 1870 for the building.

Photos 4 – 7: Graffiti from between the stable door and double doors.

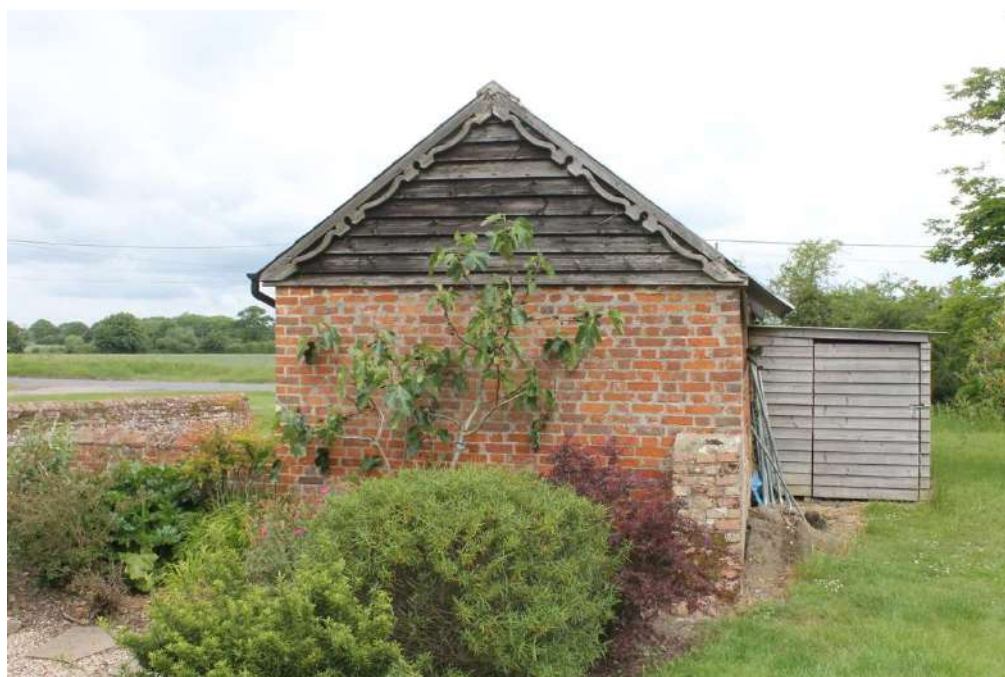
The southern side of the building has been rebuilt on a concrete plinth, but seemingly using original bricks (230x110x60mm). A fletton brick (220x103x60mm) buttress was constructed against the eastern corner of the northern wall – this is probably to support the wall as it gradually collapsed outwards. There is horizontal weatherboarding from the top of the brick wall to the apex of the roof bordered by decorative barge boards – it is unlikely that either of these elements is original.

Photo 8: The northern wall of the building

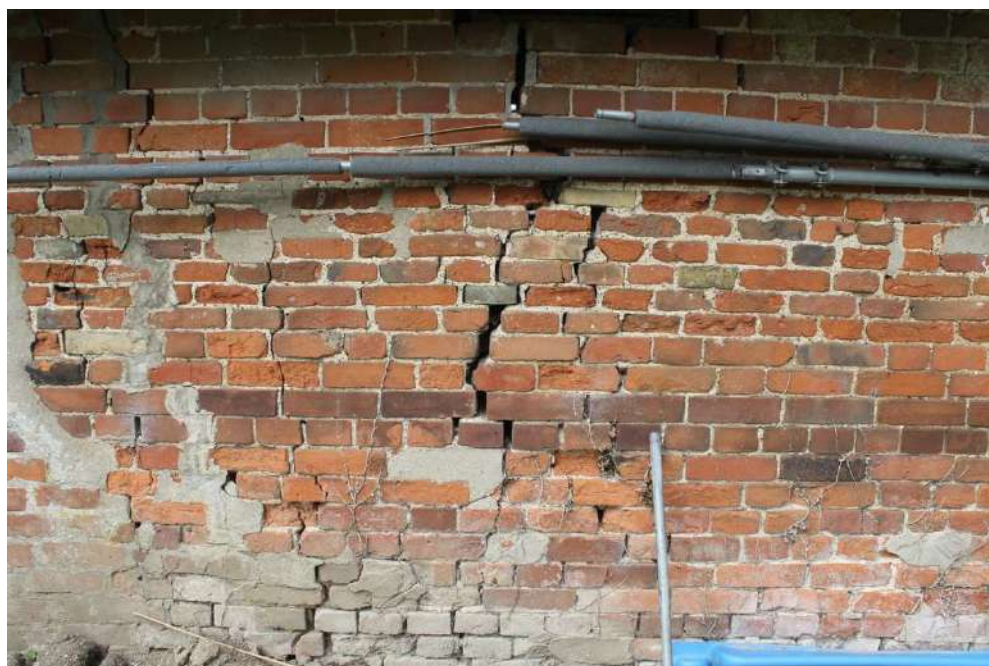
The northern corner of the eastern wall of the cattle shed appears to have been rebuilt at the same time as the northern wall. The rest of the cattle shed wall appears to be original though is unusual as far as it was not built in any coherent style, with irregular bonds and at least four distinct size bricks (see Fig. 6). The lowest courses of bricks are in a rough English bond (230x110x65mm), above these is a double line of dark brown bricks (235x110x65mm). Six courses of early brick (230x110x50mm) laid irregularly were above this and the top courses of brick (230x115x65mm) were rough English bond.

Photo 9: Detail of cattle shed wall showing irregular brickwork.

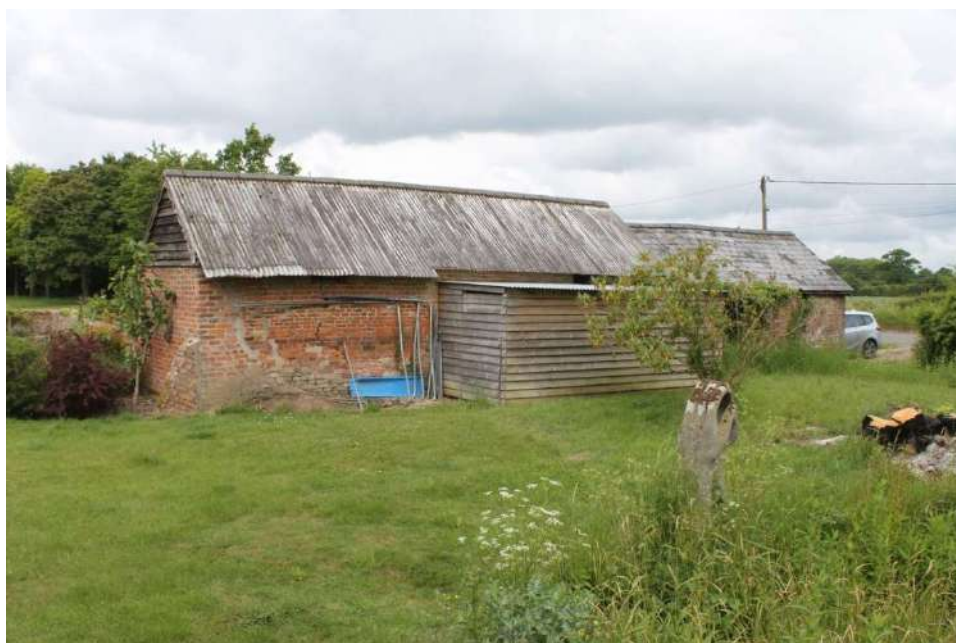
A modern timber lean-to shed covers half of the cattle shed wall. There are three small, shuttered windows along the eastern wall of the building – these are all right at the top of the wall and were probably for ventilation rather than light. The roof on the eastern side of the cattle shed is corrugated iron sheeting. This is presumably an addition after the collapse of the original slate roof in this area, though the corrugated sheeting is fixed below the ceramic coping tiles.

Photo 10: The eastern wall of the building.

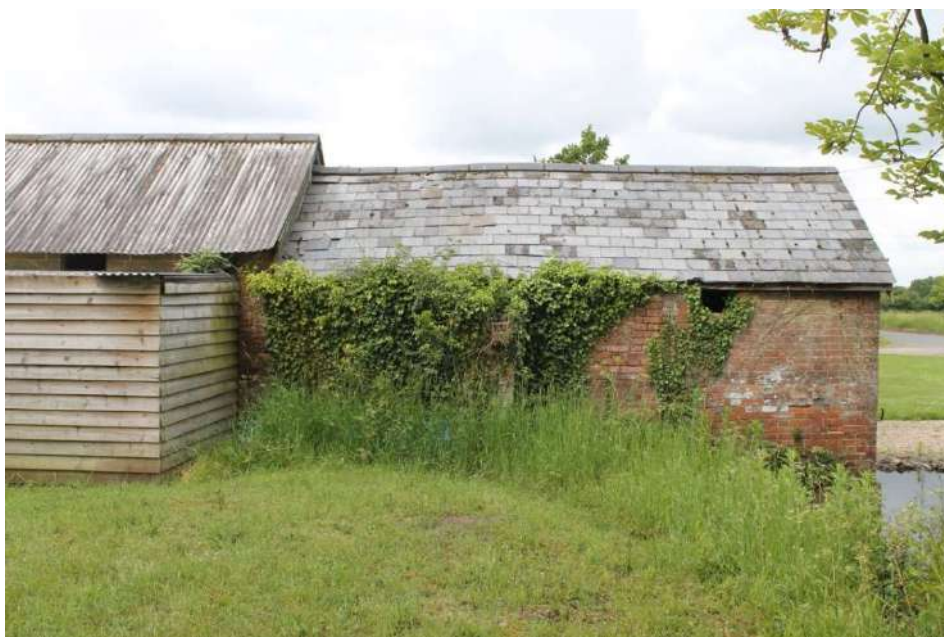
Beyond the timber shed, the eastern wall of the cart lodge and stable is heavily overgrown with ivy. The wall where the two parts of the building meet is falling away. The bricks (235 x 110 x 65mm) in this part of the building are laid in Flemish bond with the same lime mortar seen elsewhere. In the centre of this wall is another buttress. Unlike the buttress on the south wall, it was vertical rather than diagonal towards the wall. The roof on this part of the building is slate.

Photo 11: The eastern wall of the cart lodge and stable.

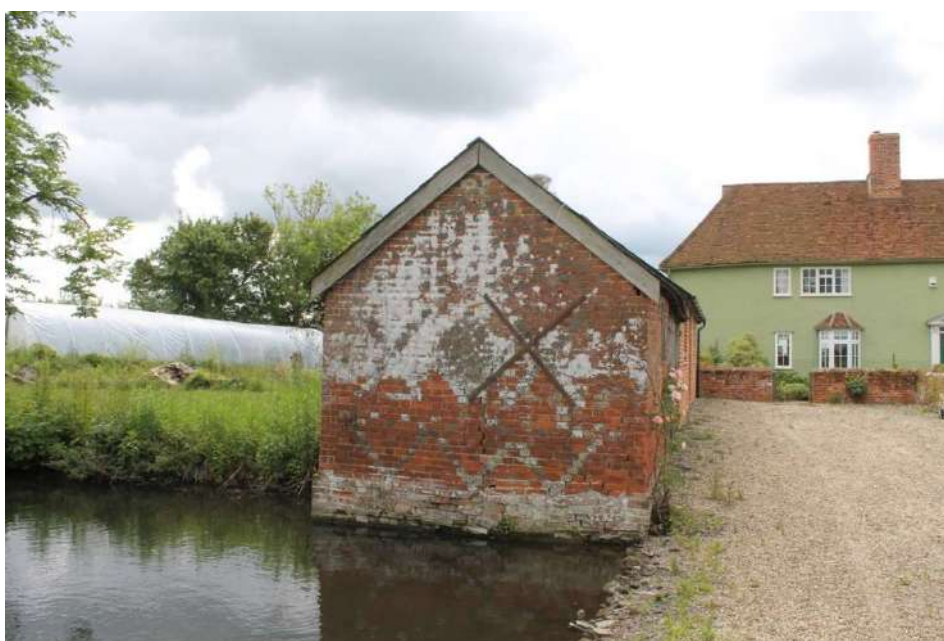
The northern wall of the building extends into the pond to the north of the building. It is brick to the apex and laid in Flemish bond with lime mortar. Like the western wall of the stable and cart lodge, the upper part of the wall has burnt-brick chequer patterning. The lower part of the wall has the symbols X ♦ X above V W laid into it in burnt bricks. A metal brace overlays the right-hand X. The barge boards on the end of the cattle shed and the end of the stable are plain.

Photo 12: The northern wall of the building.

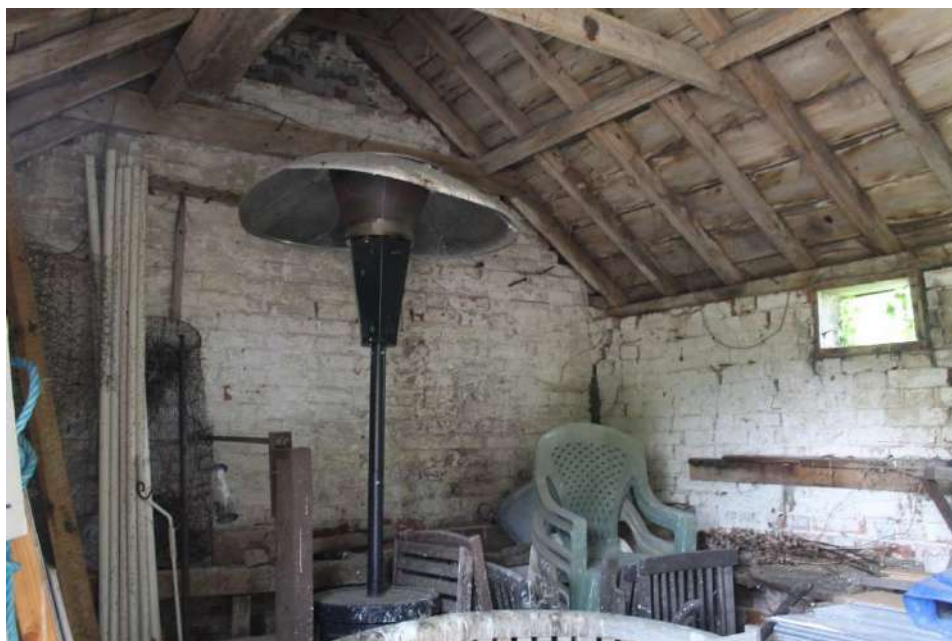
The interior of the building is coherent throughout the three different rooms. The roof is slate over sarking board throughout, with wall plates topping the brickwork and rafters rising to a ridge-board. The rafters are carried on a single purlin. All the timber within the roof is machine cut and nailed. In the stable, the roof has three collars with high collars above, in the cart lodge there are two collars and high collars.

Photo 13: Interior of stable

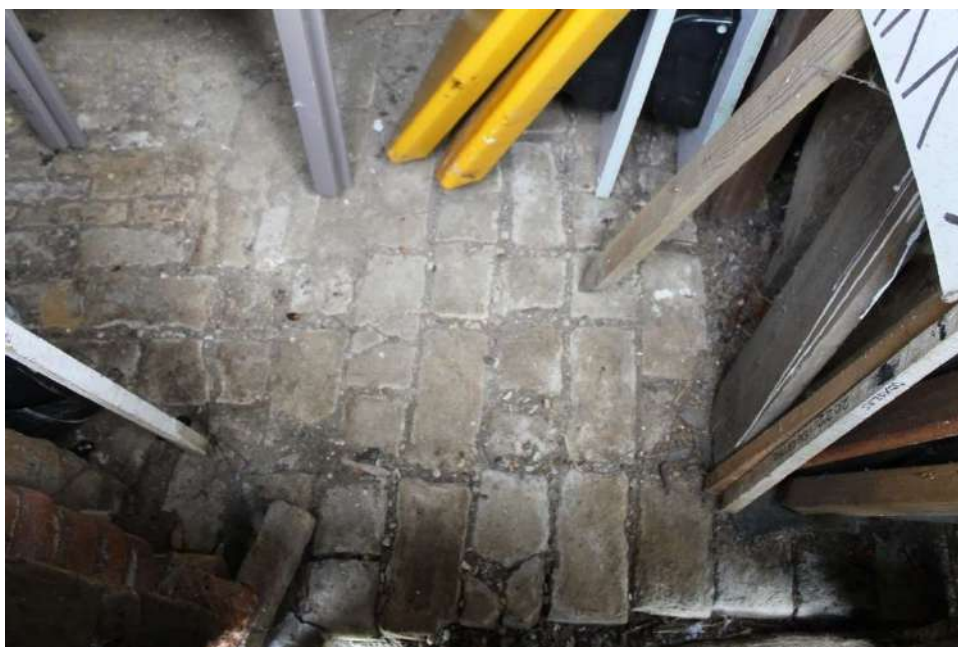
The stable has a paviour floor of unfrogged bricks (230x110x55mm). In the north-east corner of the stable are the remains of what appears to be an original manger. This is surrounded by an old wooden workbench on the north and east sides of the room. The wall between the stable and cart lodge is brick to its apex. There is a beam inset into this wall that is about the same height of the wall plate. This was for hanging things like tack on the wall. One small window was just below the wall plate in the centre of the rear wall of the stable – this was timber lined but had no other furniture.

Photo 14: Unfrogged brick paviour floor in stable.

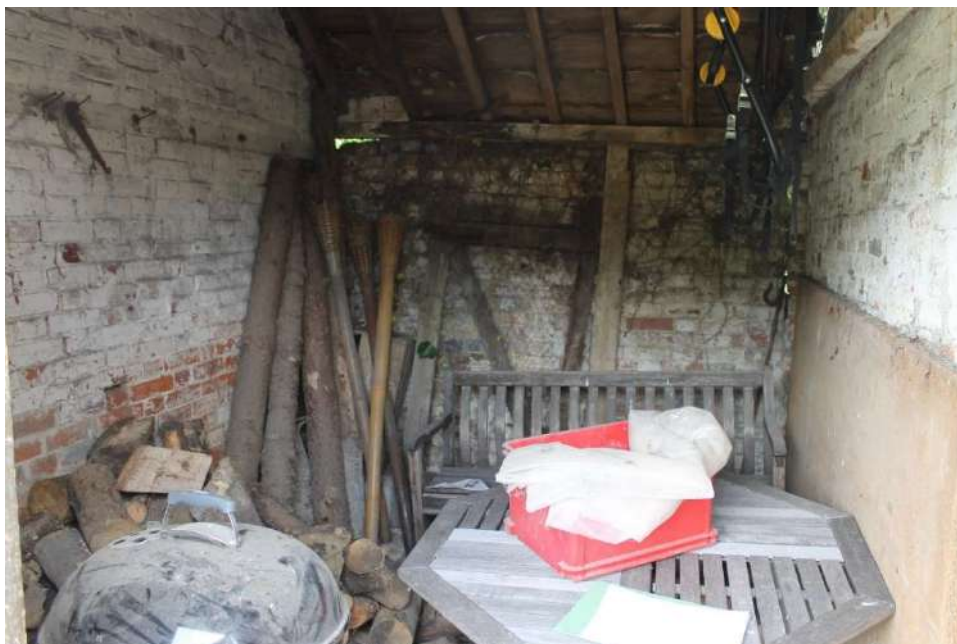
The interior of the cart lodge is almost identical to that of the stable, but slightly smaller. The floor is also unfrogged brick paviour but has been covered with poured concrete. There is no window in the cart lodge.

Photo 15: Interior of cart lodge.

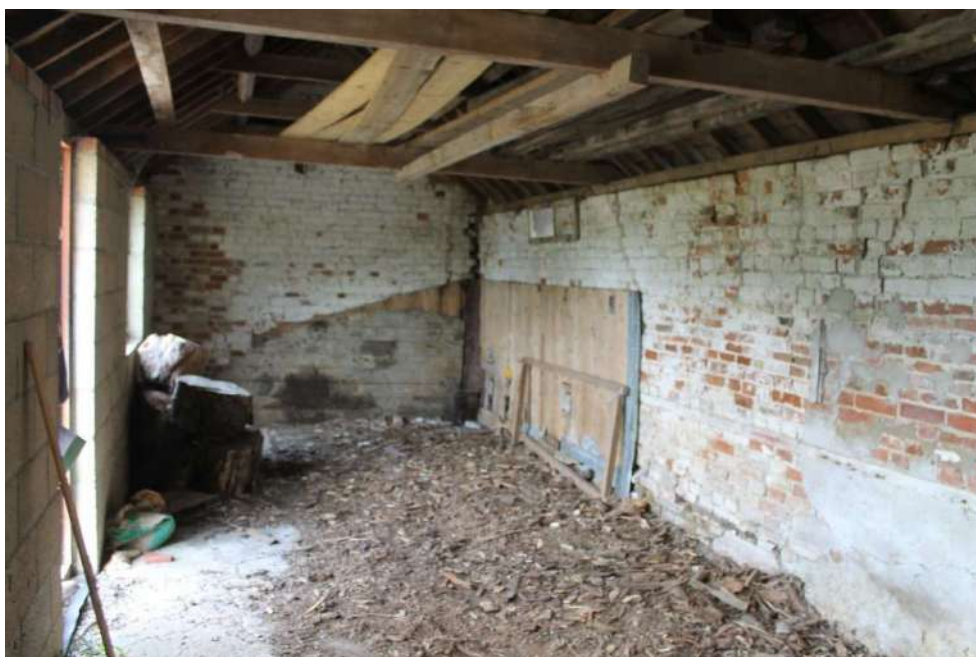
The cattle shed has three bays. Its interior is like that of the stable and cart lodge, except for where it had been rebuilt on the south and east sides. The floor is poured concrete. Timber stall remains are affixed to batons bedding into the wall in the north-east corner of the room and would have been all around the shed. Two horizontally-slatted windows are just below the wall plate on the rear wall, both have visible timber shutters to the right of the opening.

Photo 16: The interior of the cattle shed (facing north).

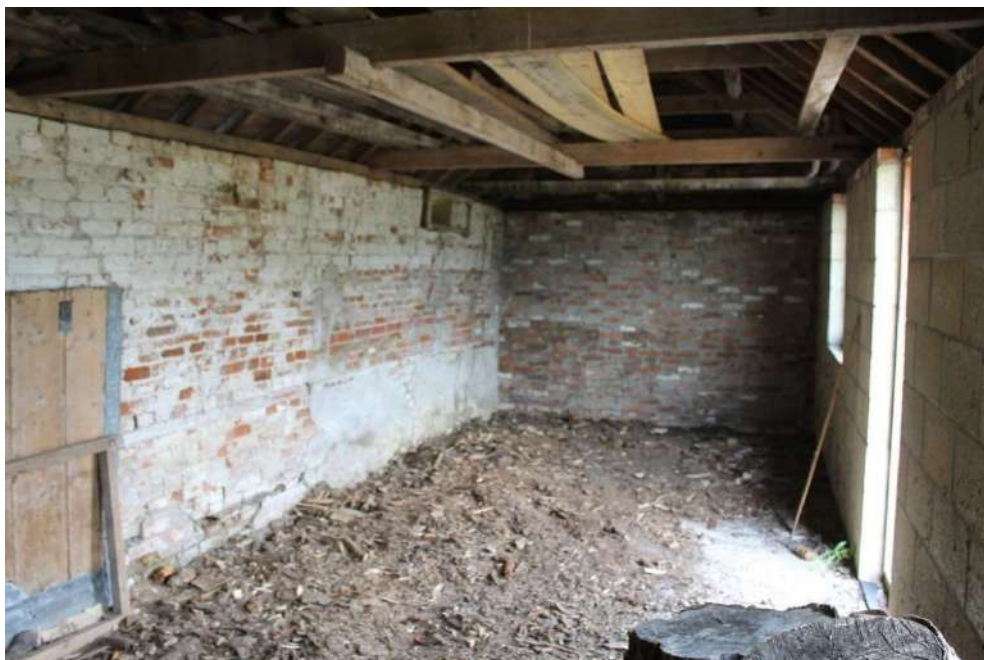
Photo 17: The interior of the cattle shed (facing south).

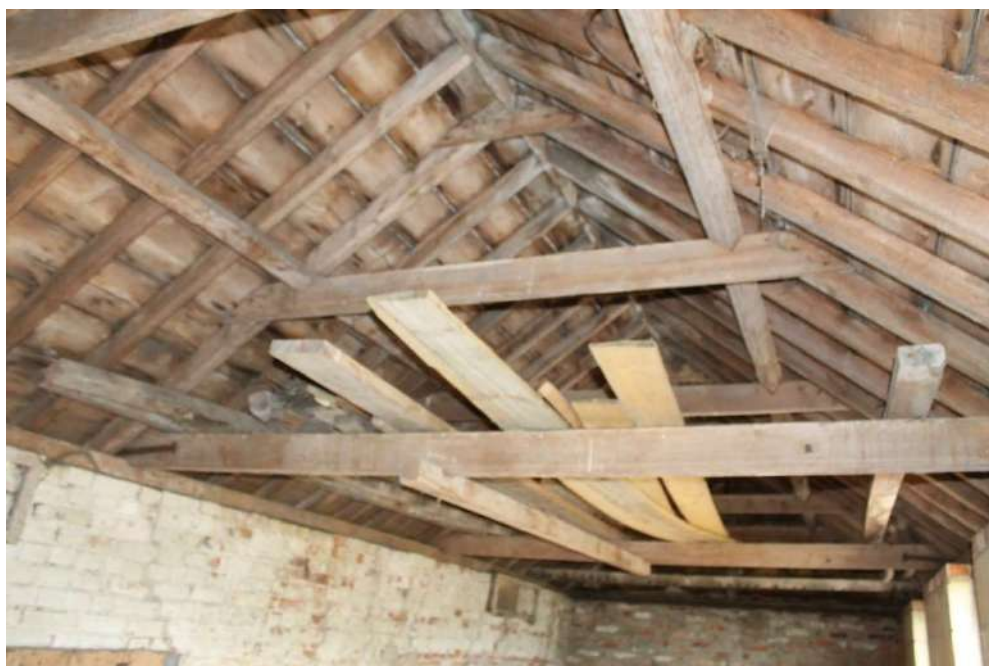
Photo 18: The roof of the cattle shed.

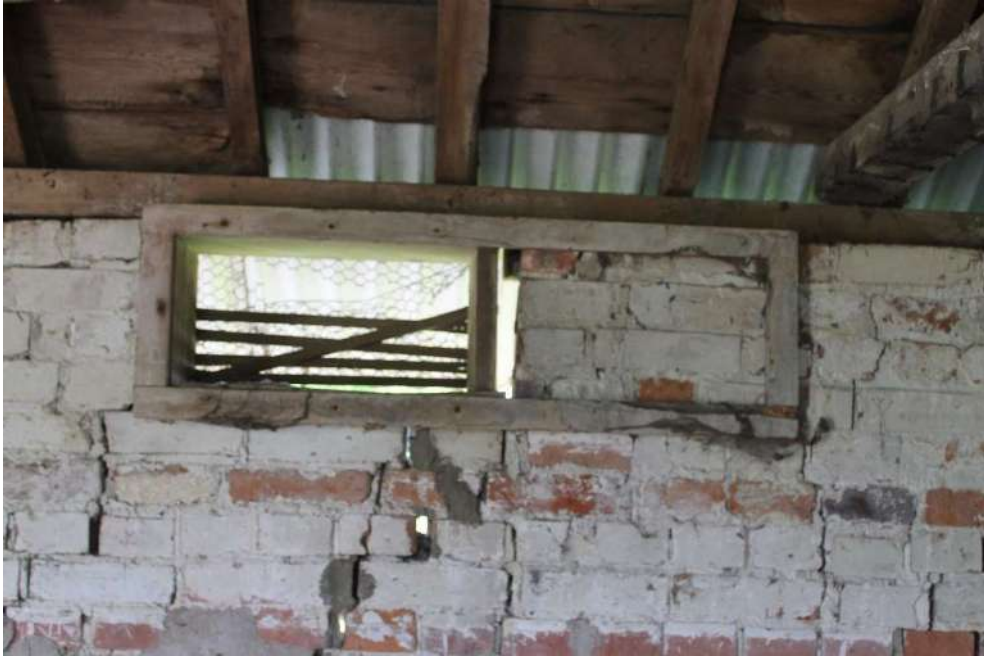
Photo 19: Window showing slatting and shutter array to the right.

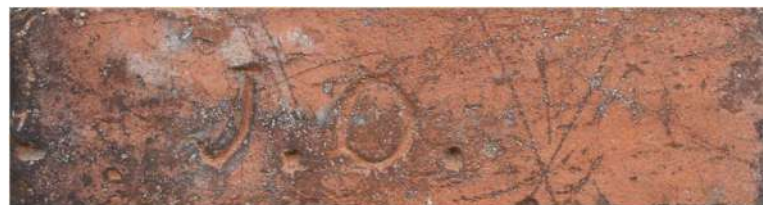
One of the pieces of graffiti on the building reads J.O. – possibly for Joseph Orbell, who is quite likely to have been the owner of the farm at the time of the building's construction. He may have marked the building for posterity shortly after its construction.

Plate 3: Graffiti showing J.O.
