**CAT Report 1901  
reissued September 2023**

**Historic building recording at 50 Moulsham Street,  
Chelmsford, Essex, CM2 0HY**

**February 2023**

**CAT project ref.: 2023/01e  
CAT Report 1901**

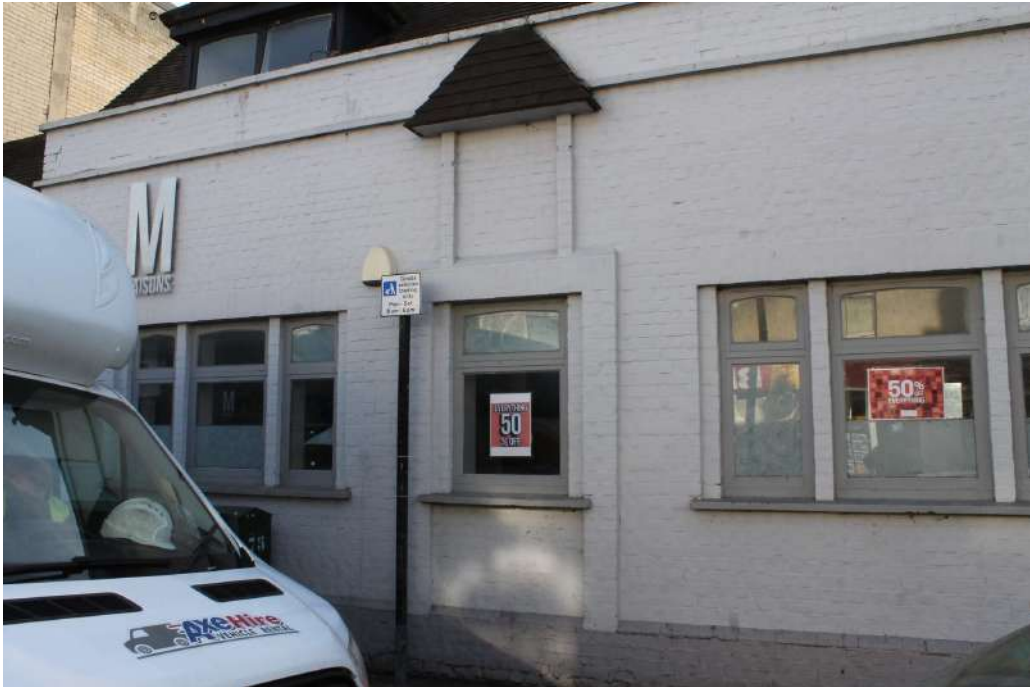
**Photograph 5** North-west elevation of range 10. Photograph taken facing south-east.

The doorway in the centre appears to have been purposely built to look as though it has been blocked and replaced with a window, denoted by protruding brickwork. The chamfered plinth remains uninterrupted, indicating there has never been a gap in the wall. Above this is a false dormer roof, clad in peg-tile, intended to imitate the dormer windows on the roof. It is possible this blind window was once used to hold a pub sign. Flanking the blocked doorway are two sets of windows, both comprising three two-light windows. All of the windows have a top awning opening and a timber-frame.

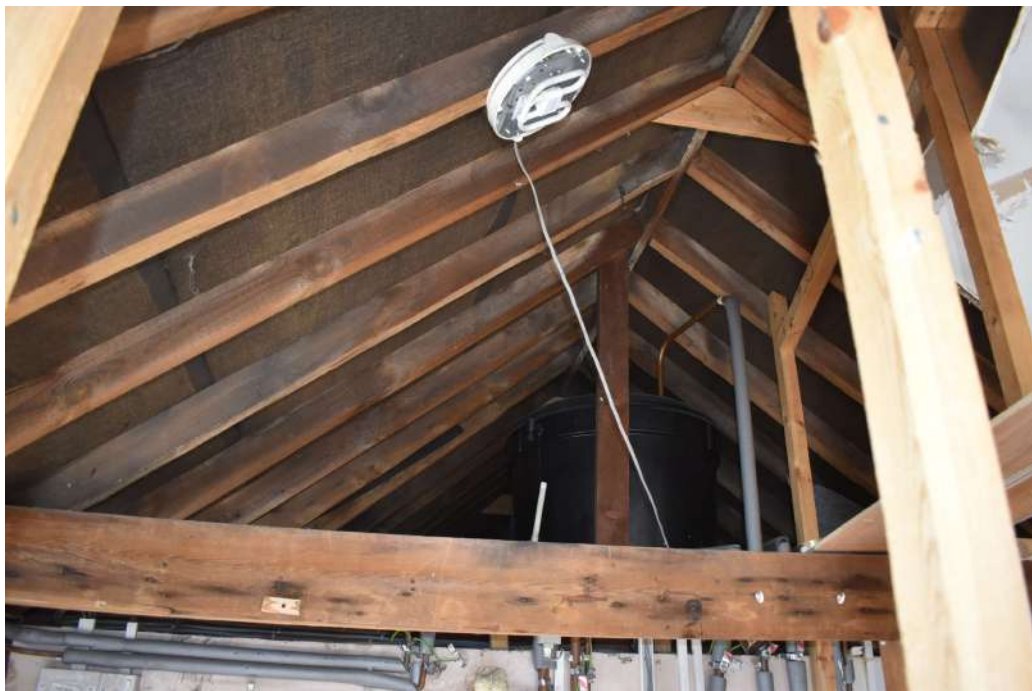
The roof of ranges 2 and 4 comprises pairs of rafters, which meet at ridge-board at the apex of the roof. The tie-beams are secured with iron straps fixed with iron staples. All of the timbers are machine cut and a Baltic timber mark is present on the south-western wall-plate.

**Photograph 12** Detail of roof construction of ranges 2 and 4. Photograph taken facing north.

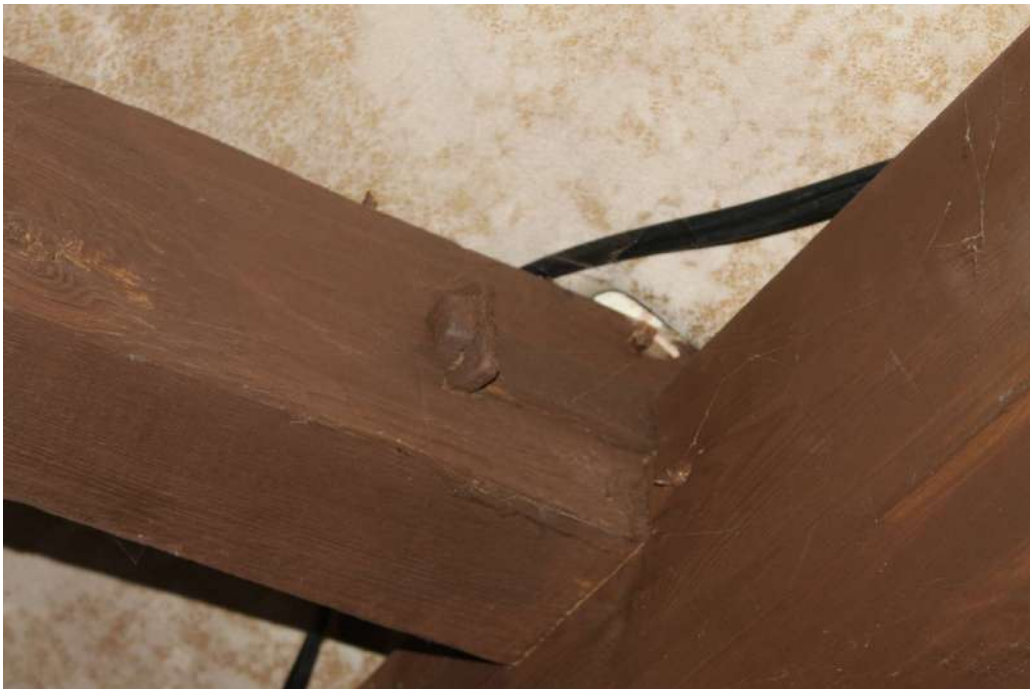
**Photograph 15** Detail of iron strap on southern tie-beam in range 3. Photograph taken facing north-east.

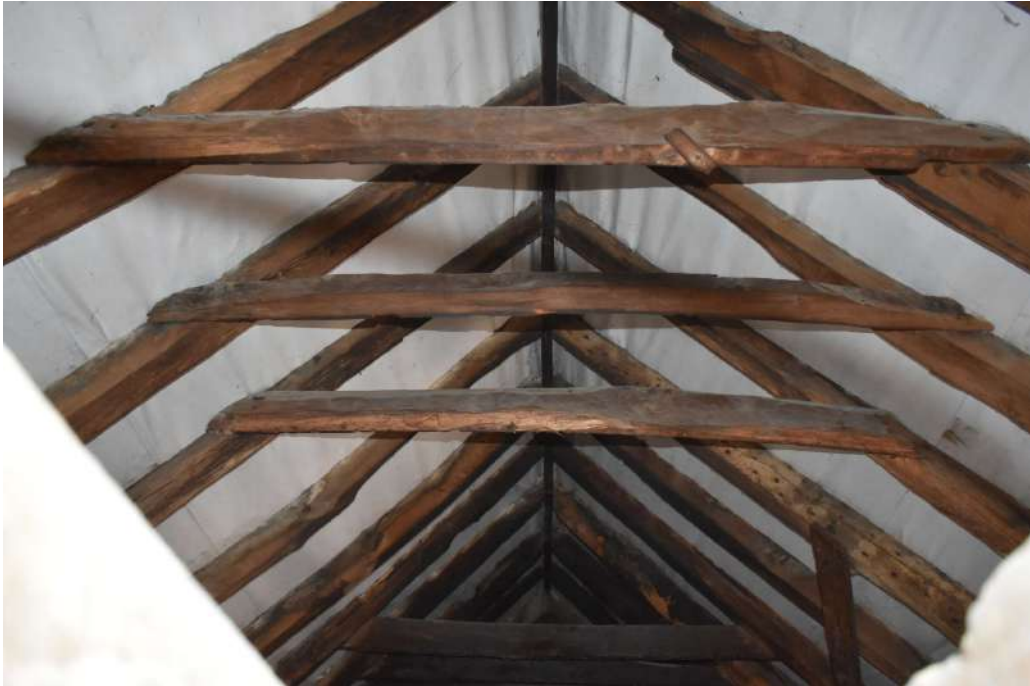
Range 6 has a roof comprising pairs of rafters, meeting at a ridge-board, with collars (some of which are missing). Diagonal bracing has been attached to the underside of the rafters at each end. All of the timbers in this roof are hand-sawn. Towards the south-eastern end of the roof, the timbers appear to have been blackened by smoke.

**Photograph 16** Detail of roof construction of range 6. Smoke blackened timbers visible towards the rear. Photograph taken facing south-east.

bracing. The roof structure of range 6 also comprises original timbers. The construction of the roof is fairly simple – the lack of purlins but use of a ridge-board indicates a probable early to mid-18th century date. Some of the timbers in the roof of range 6 appear to have signs of blackening from smoke, an indication the roof structure must have been open at some point. The empty mortices observed in an exposed tie-beam may indicate a partition for a smoke-bay when the building was originally constructed.

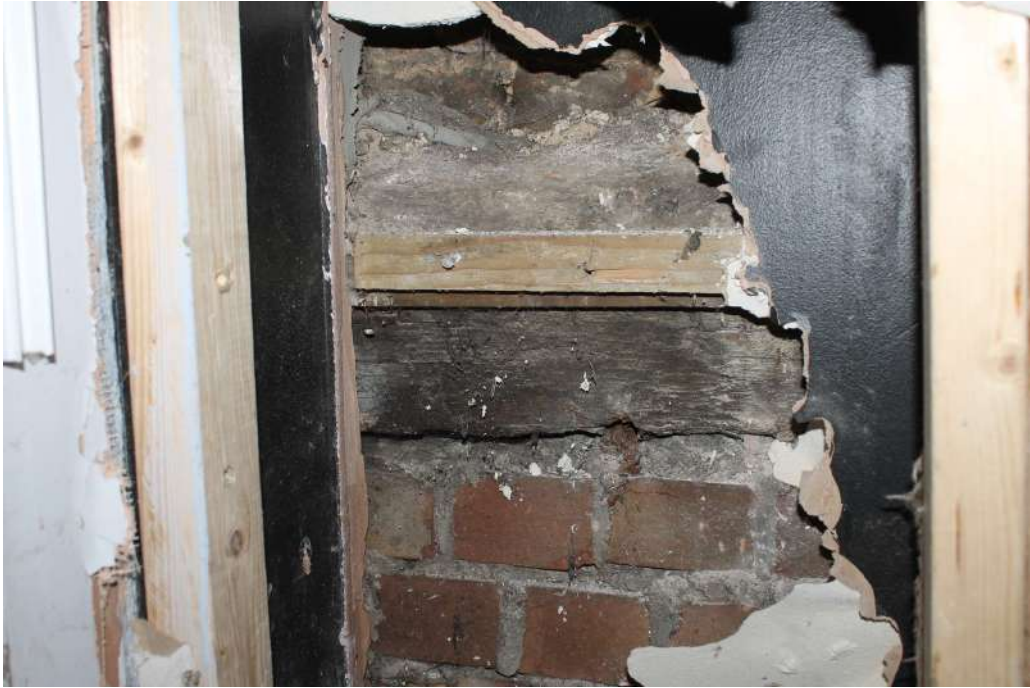
Damage to the plasterboard on the south-west wall of range 10 has revealed a small area of the timber-framing beneath. It appears to be a sill-beam supported on a red brick plinth (laid in ?Flemish bond topped with two rows of headers).

**Photograph 24** Detail of timber in south-west wall of range 10. Photograph taken facing south west.

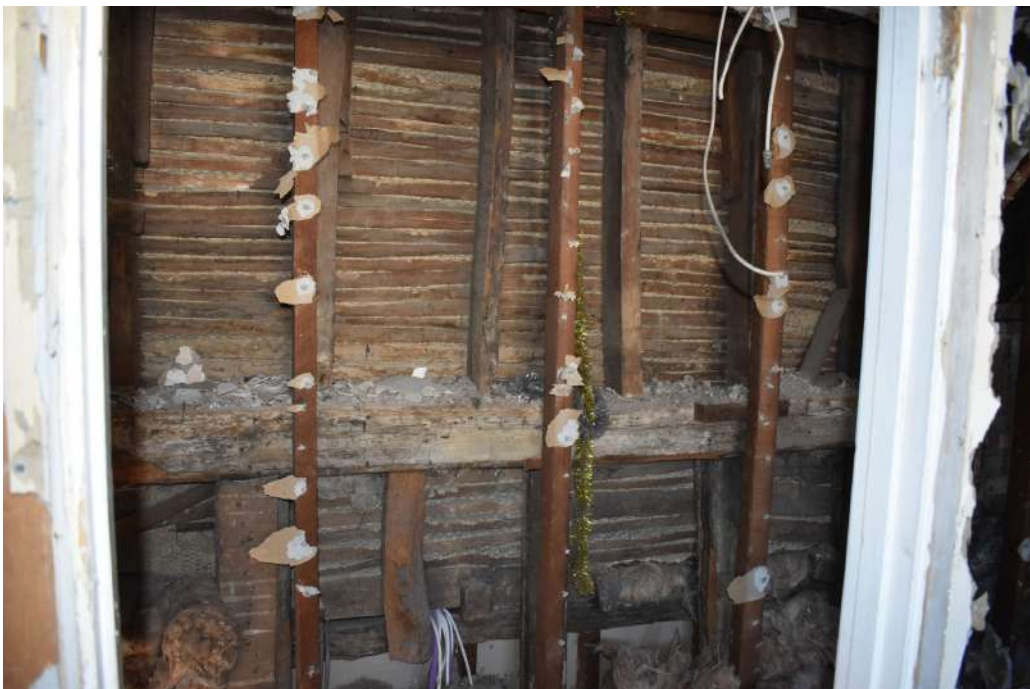
The north-east, south-east and south-west walls of range 10 have surviving timber-framing on the first floor. Whilst the timber-frame has suffered areas of repair and reinforcement from modern machine-cut timbers, what remains of the original frame is all hand-sawn.

**Photograph 31** Detail of timber-framing, including laths, in south-eastern wall of range 10. Photograph taken facing south-east.

At its core, range 10 is the oldest part of 50 Moulsham Street. Whilst much of the original frame has been rebuilt or replaced, what is left comprises hand-sawn timbers, with the occasional timber showing signs of reuse. The frame appears to comprise studs with through-bracing, a practice generally dated to the 17th century and later. Most of the timbers are relatively straight, another indication of a 17th century or later construction date. Unfortunately, the roof structure of range 10 was rebuilt sometime after 1930, so is of no help with dating the building.
