**CAT Report 1949
issued June 2023**

**Historic building recording of Wild Oaks,
East Hanningfield Road, Sandon, Essex, CM2 7TQ**

**CAT project ref.: 2023/04f
ECC code: SAWO23a**

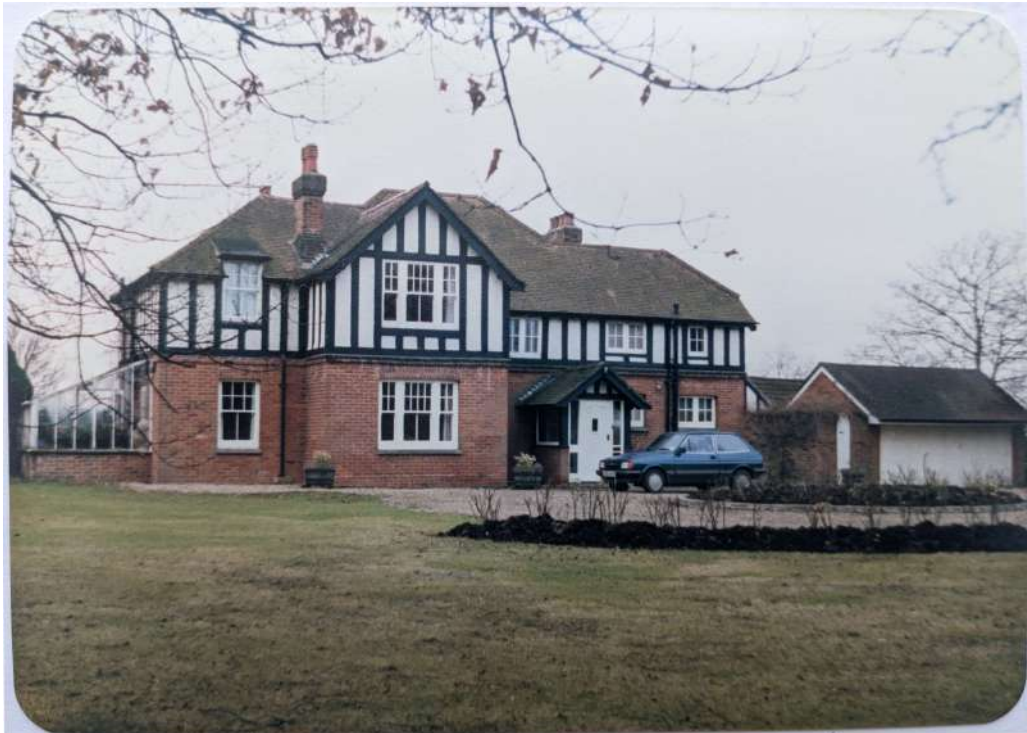
A photograph accompanying the 1986 sale catalogue (Photograph 1, ERO SALE/B7713) shows the only tangible change to the northern elevation of Wild Oaks is the replacement of the conservatories frame.

Photograph 1 Photograph accompanying the 1986 sales catalogue (ERO SALE/B7713), showing Wild Oaks has remained largely unchanged for the last 40 years.

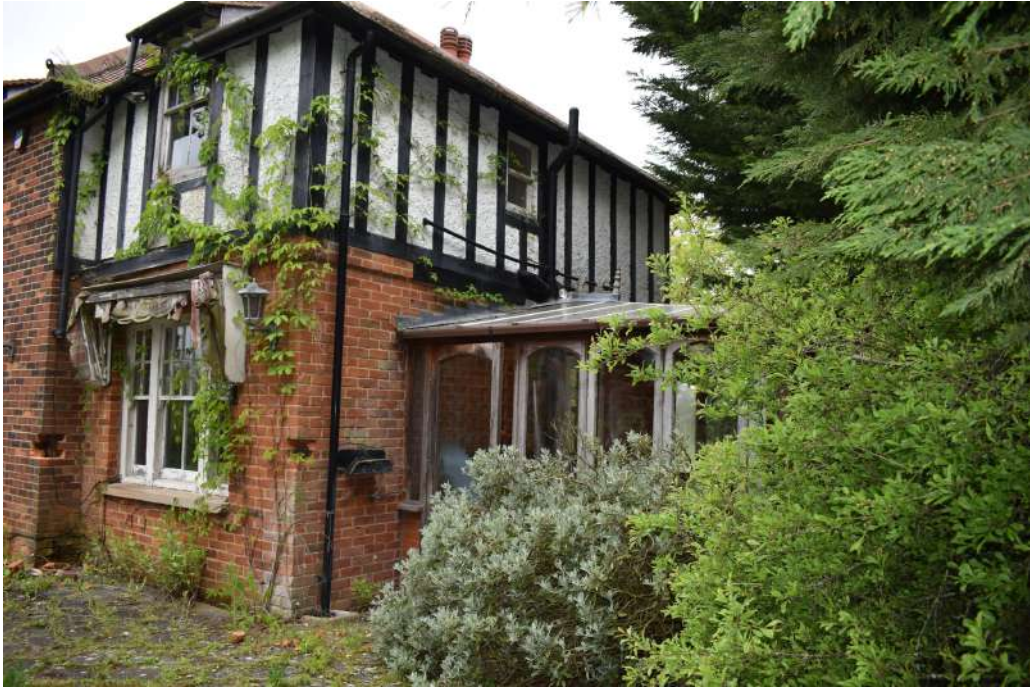
The eastern elevation of Wild Oaks is dominated by the modern extension (the eastern range). The first floor of the elevation is clad in imitation timber-framing, infilled with roughcast render. The plain oversailing brickwork is present on this elevation, although it has been partially replaced by timber-cladding as the brickwork was interrupted by the original conservatory frame. There is a single two-light sash window on the first floor.

Photograph 7 Eastern elevation. Photograph taken facing north.

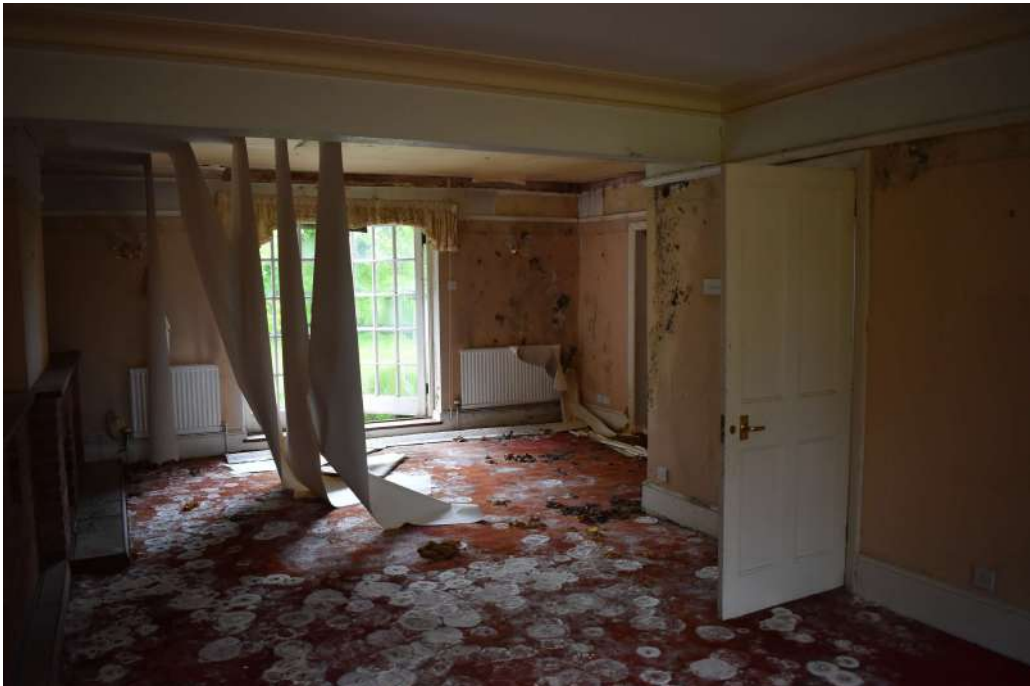
Much of the interior of Wild Oaks has become damp, causing an abundance of mould and fungi to grow on many surfaces. This made an in-depth record of the building's interior difficult to complete. The first floor was decided to be too unsafe to enter due to volume of mould growing.

Photograph 11 Interior of lounge. Photograph taken facing south-west.

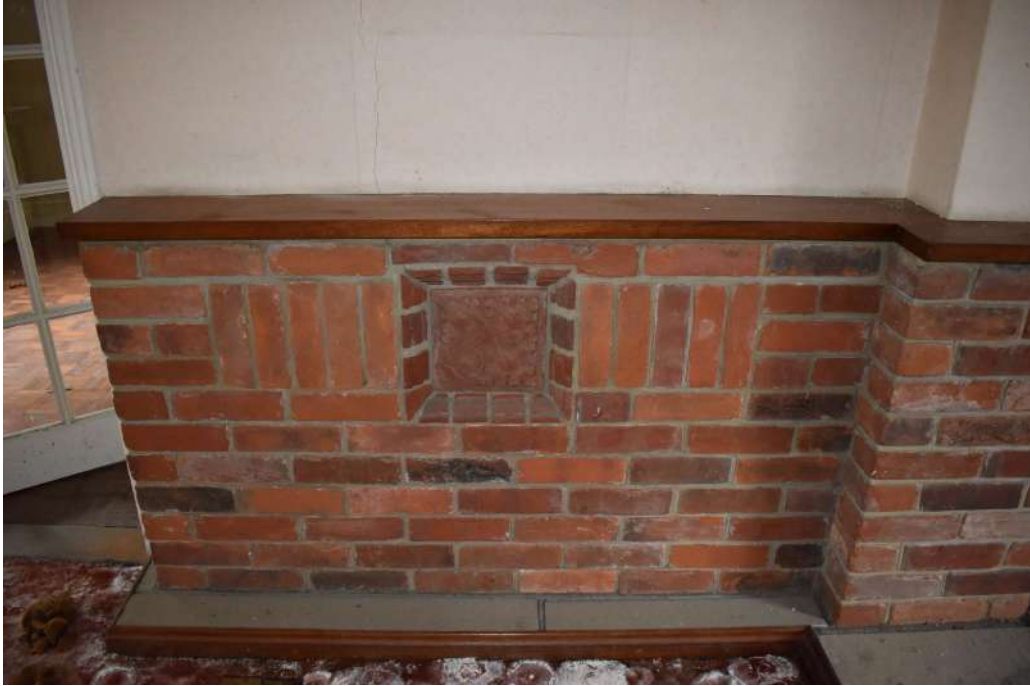
Photograph 13 Detail of decorative tile in lounge. Photograph taken facing south-east.

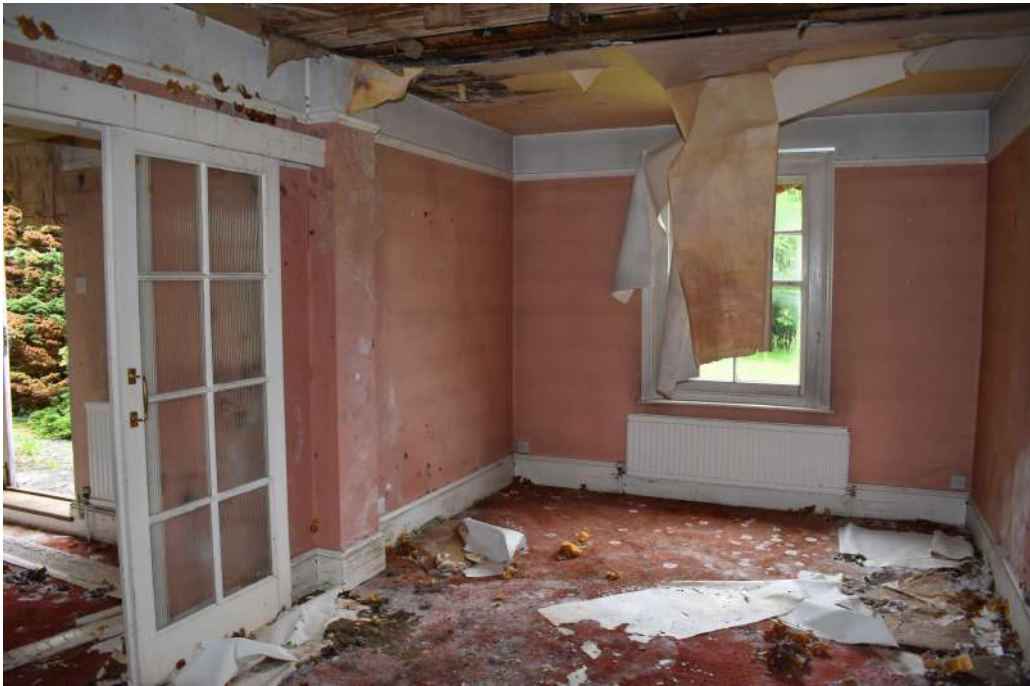
In the eastern wall of the dining room, a protruding column is an indicator of the location of the original southern wall of the building. There are double sliding-doors between the lounge and the dining room. An area of damage to the ceiling in the dining room has revealed the original ceiling laths beneath.

Photograph 14 Interior of dining room. Photograph taken facing south-east.

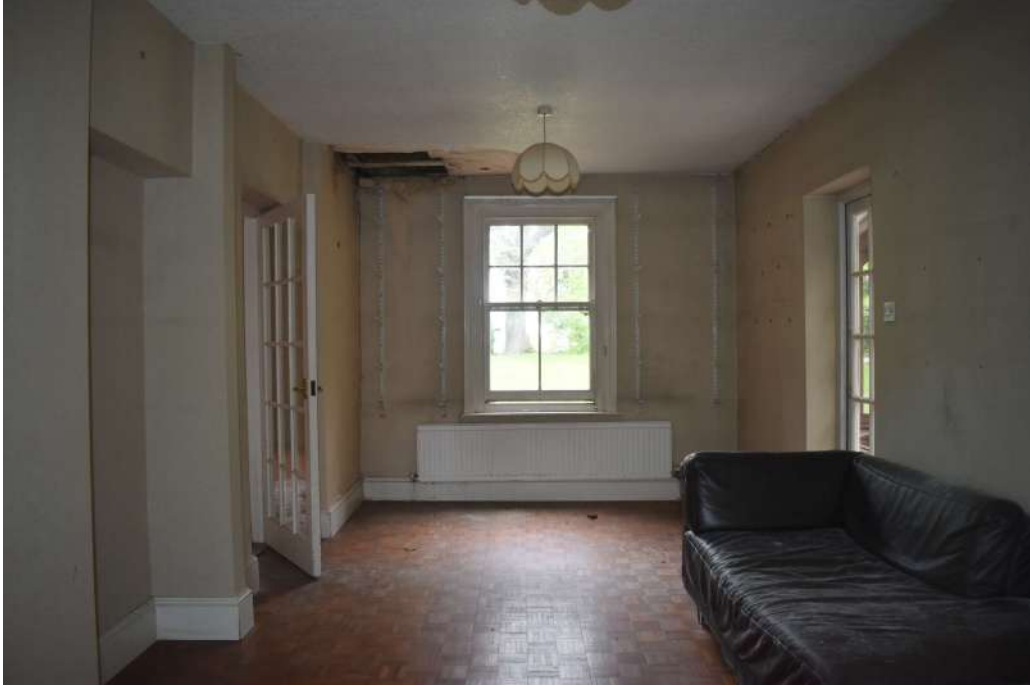
There is an alcove present on the eastern wall of the play room, a possible indication of a sealed doorway. Adjacent to the alcove is a small wall projection, likely from the removal of a wall. Plans for the extensions, submitted to Chelmsford Council in 1975, indicate the presence of a 'greenhouse' in this area. The 1975 proposed plans propose that the door to the play room has replaced a window.

Photograph 17 Interior of playroom. Photograph taken facing north north-east.

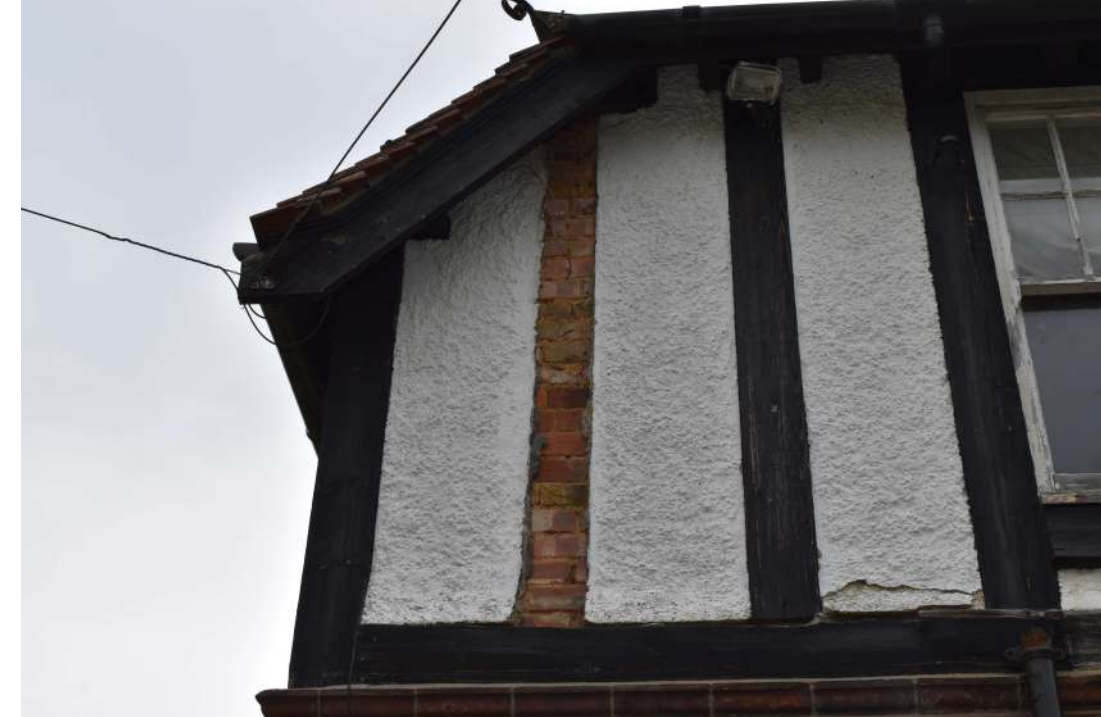
SAWO23a_PhotoGraph_023Detail of missing timber and brickwork beneath on western elevation. Ph...
