**CAT Report 2105  
Issued November 2024**

**Historic building recording of a coach house at  
Mauds Court, Long Lane, Tendring, Essex,  
CO16 0BG**

**October 2024**

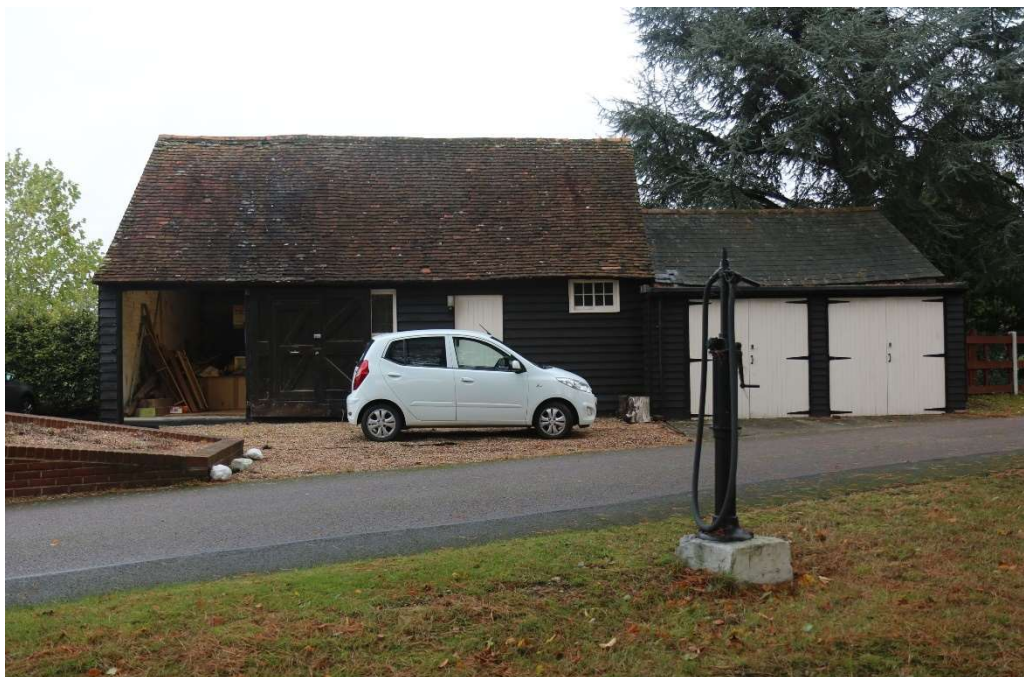
**Photograph 1** South-western elevation. Photograph taken facing north north-east.

Two doors are present on the south-western elevation (Photograph 1) of the coach house, a large door with an embedded wicket door at the north-west end and a smaller door to the south-east end. In the centre of the elevation is a four-light metal framed window, with leaded lights comprising square quarries. It has both casement and

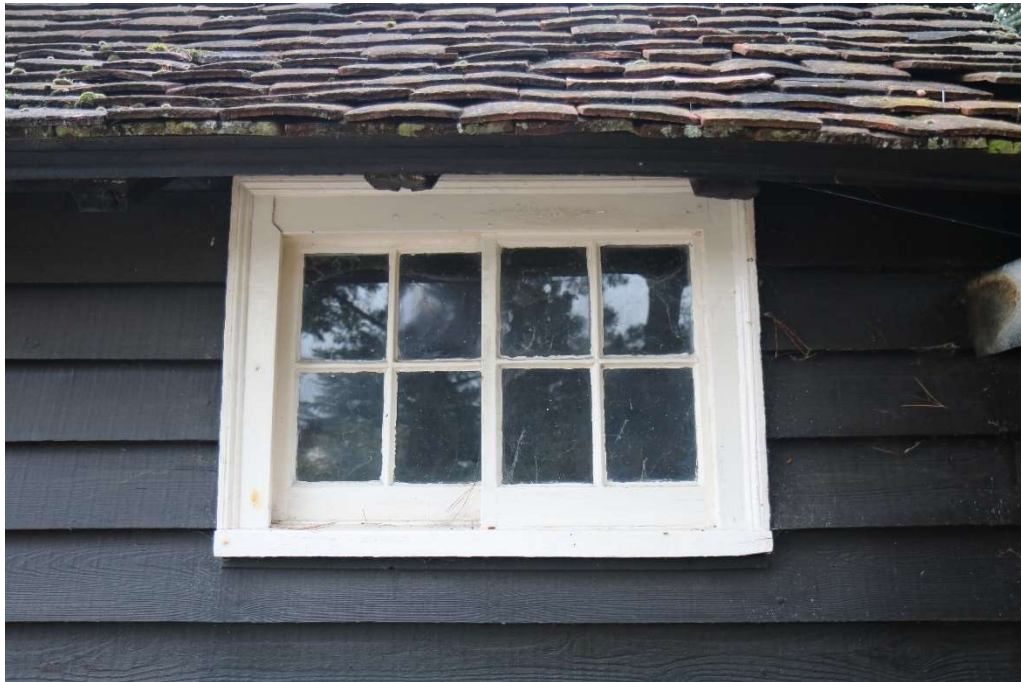
awning openings. To the south-eastern end of the elevation is a timber-framed eight-light Yorkshire sash-window (Photograph 2). The south-western elevation of the garage has two modern side-hinged garage doors

**Photograph 2** Detail of Yorkshire sash-window on south-western elevation. Photograph taken facing north-east.

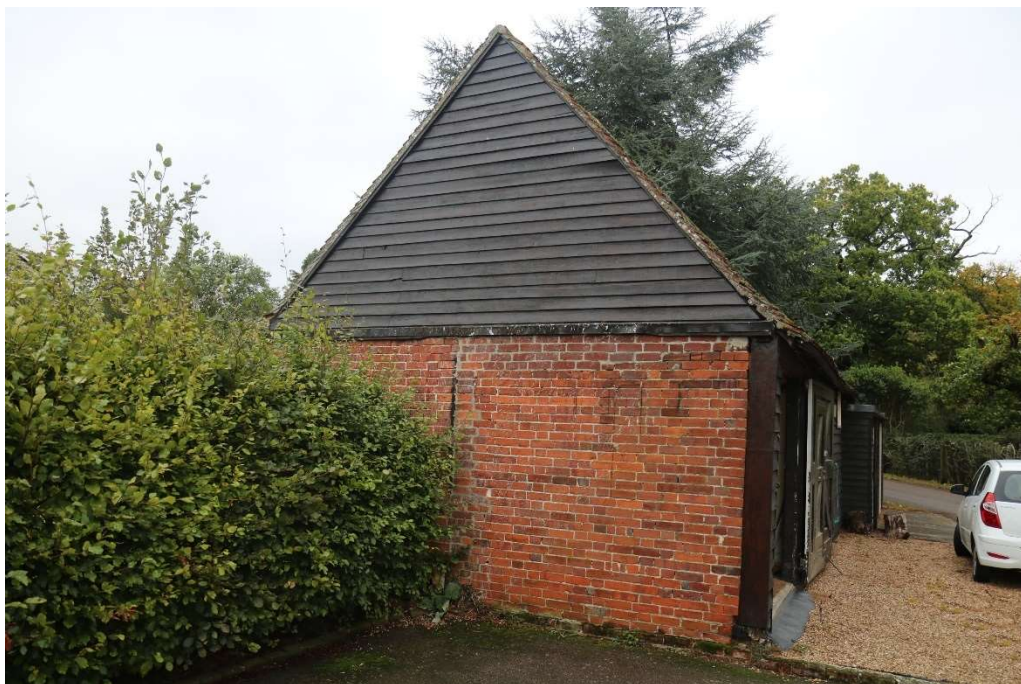
The north-western elevation (Photograph 3) of the coach house comprises red brick (brick dimensions: 230 x 110 x 65mm) laid in Monk bond (Photograph 4). Repair to the brick work on this elevation is exhibited by an area with different brick bonding and mortar, likely from the demolition of the adjoining building depicted on early OS maps. The gable is clad in black weatherboard.

**Photograph 3** North-western elevation. Photograph taken facing east.

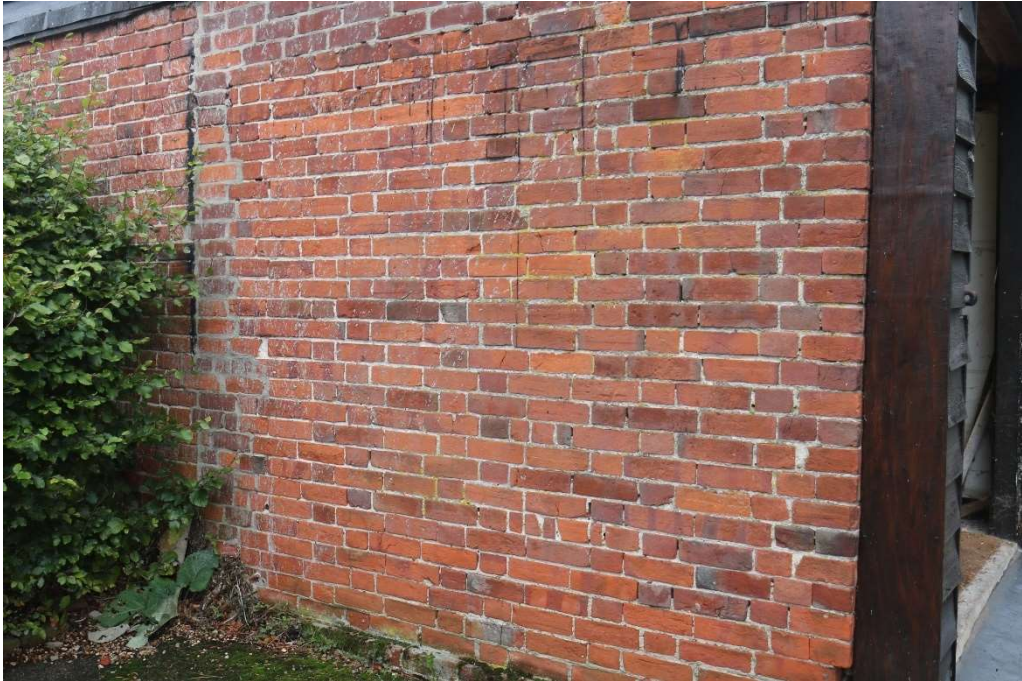
**Photograph 4** Detail of brickwork on north-western elevation. Photograph taken facing east.

The brick walls forming the north-western and north-eastern walls are laid in Monk bond, a variation of Flemish bond. Monk bond is similar to Flemish bond in that it alternates headers and stretchers on each course of brickwork but differs in that there are at least two stretchers between each pair of headers. This is a cheaper alternative that still achieves the decorative look of Flemish bond. Until the 17th century, the prevailing bonding used for bricks in Britain was English bond, after which it was succeeded by Flemish bond (Brunskill 1990). It stands to reason to suggest that Monk bond was popularised soon after Flemish bond as a money-saving exercise.

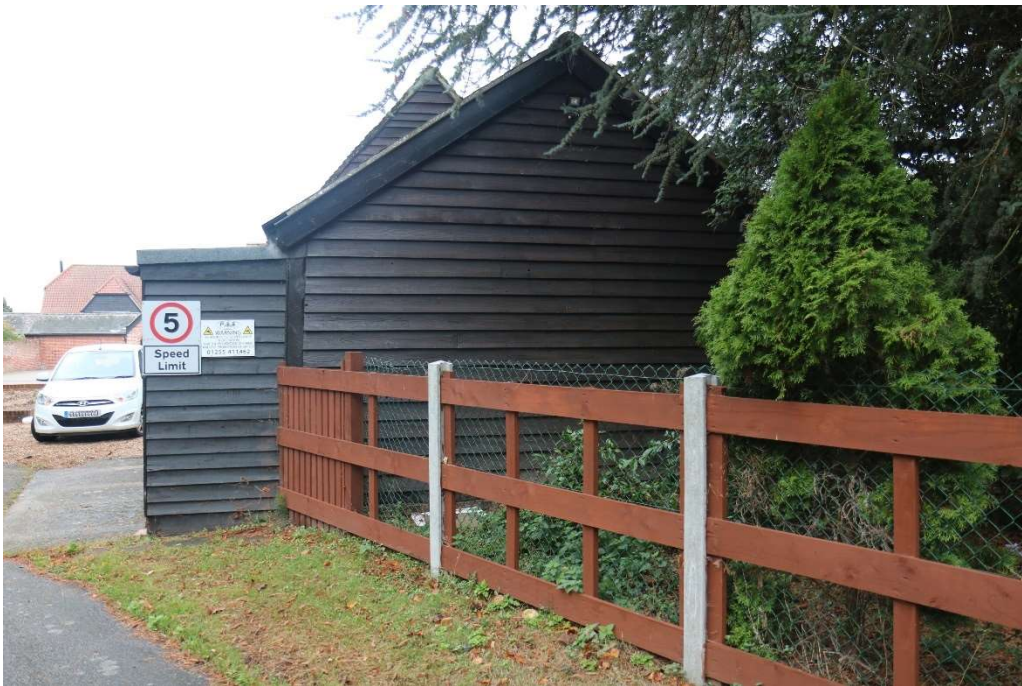
On the south-eastern elevation (Photograph 5) the garage is plain weatherboard, as is the gable of the coach house.

**Photograph 5** South-eastern elevation. Photograph taken facing north-west.

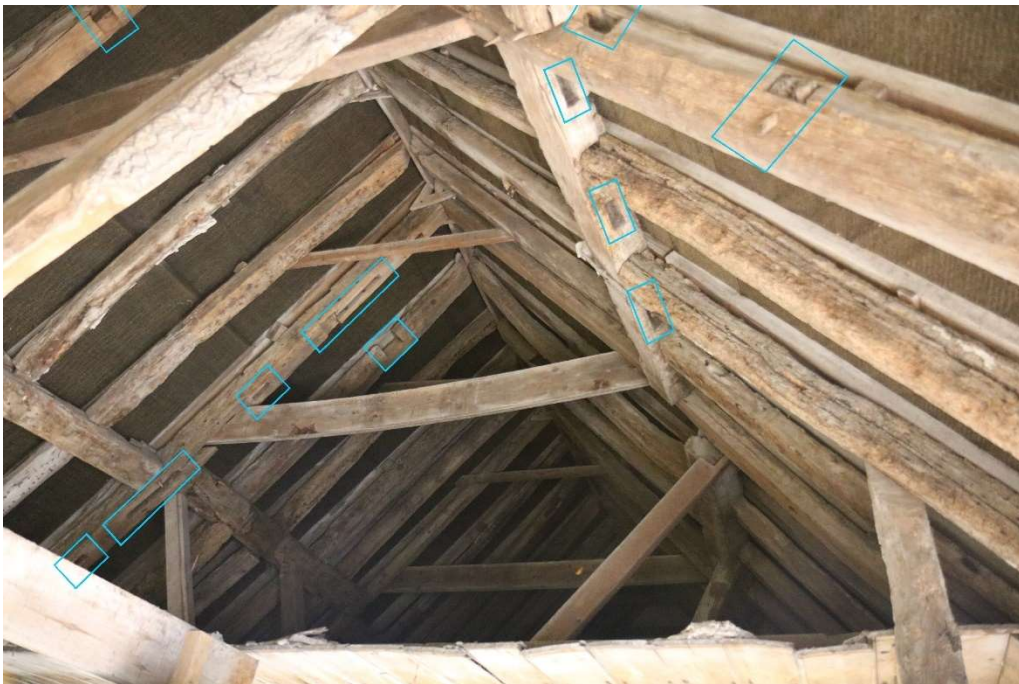
The roof of the coach house (Photograph 6) comprises pairs of principal rafters, which ascend from the wall-plates, with butt-purlins and collars. The south-western principal rafters rise to the apex of the roof and are met on their undersides by the north-eastern principal rafters. Between each pair of principal rafters are several pairs of common rafters, which also rise from the wall-plates but meet at the ridge-board. A series of staggered butt-purlins interrupt the common rafters. On both roof pitches, at the south-western end of the building, are short diagonal wind-braces which intersect the common rafters. The south-western gable also has two diagonal wind-braces, which sit on top of the studs and are a later addition. This wind-bracing is presumably mirrored at the other end of the roof structure. Above each original tie-beam is a corresponding collar, secured to the principal rafters with half-dovetail joints. V-shaped carpenter's marks are present on the most north-western collar and adjacent principal rafter.

The structure of the roof comprises mostly hand-sawn timbers held secured by timber pegs. A number of the timbers in the roof framing display evidence of reuse (Photograph 6 and 7), mostly in the form of unused mortices, including common rafters, principal rafters and tie-beams. The tie-beams are joined to the wall-plates using lap-dovetail joints as well as later inserted iron-straps. At the north-eastern end of the central tie-beam is a H-shaped carpenter's mark (Photograph 8). A number of modern timbers laid on top of the common and principal rafters suggest that the roof has been recovered at some point.

**Photograph 6** Detail of roof construction of coach house. Area's evidencing reuse highlighted in blue. Photograph taken facing east.

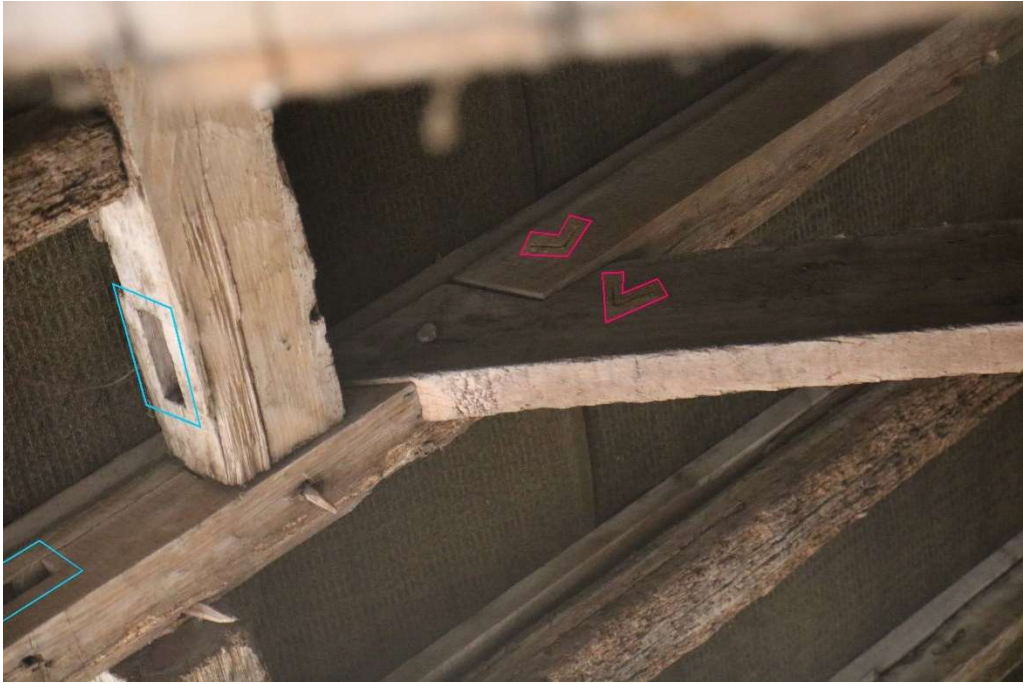
**Photograph 7** Detail of half-dovetail joint and carpenter's marks (in pink) in the collars and rafters of the coach house. Area's evidencing reuse highlighted in blue. Photograph taken facing south-west.

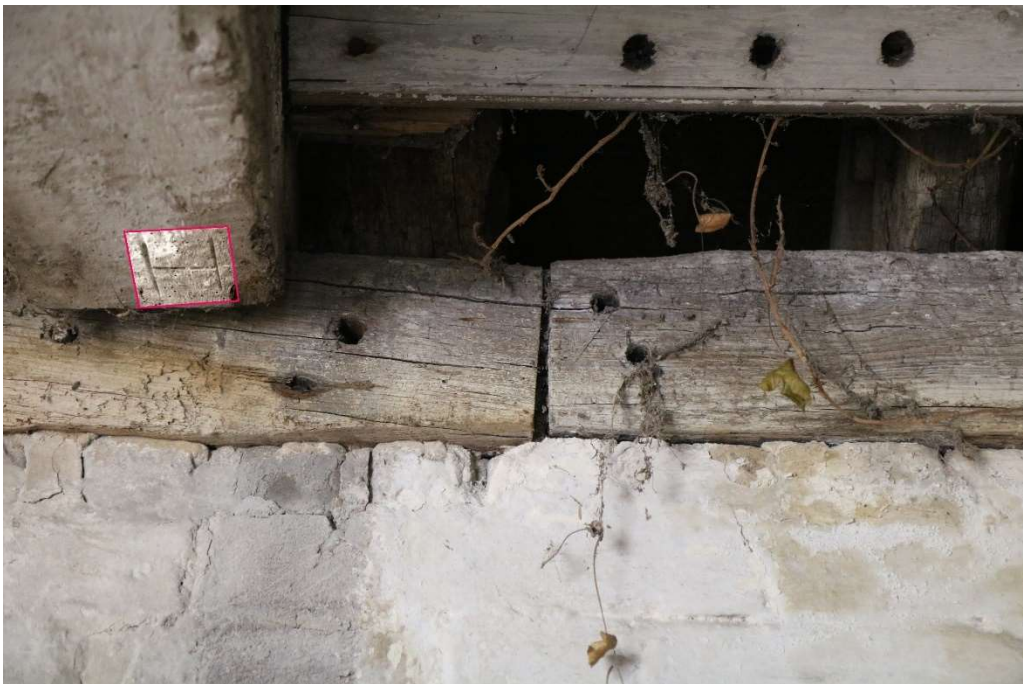
**Photograph 8** Detail of north-eastern wall-plate scarf-joint and tie-beam carpenter's mark (in pink). Photograph taken facing north north-east.

Both the north-eastern and south-western wall-plates are reused, evidenced by a number of empty mortices. They both also have a single face-halved scarf-joint, of an undetermined type (Photograph 8 and 10). The south-western scarf-joint appears to be a variation of fished scarf-joint.

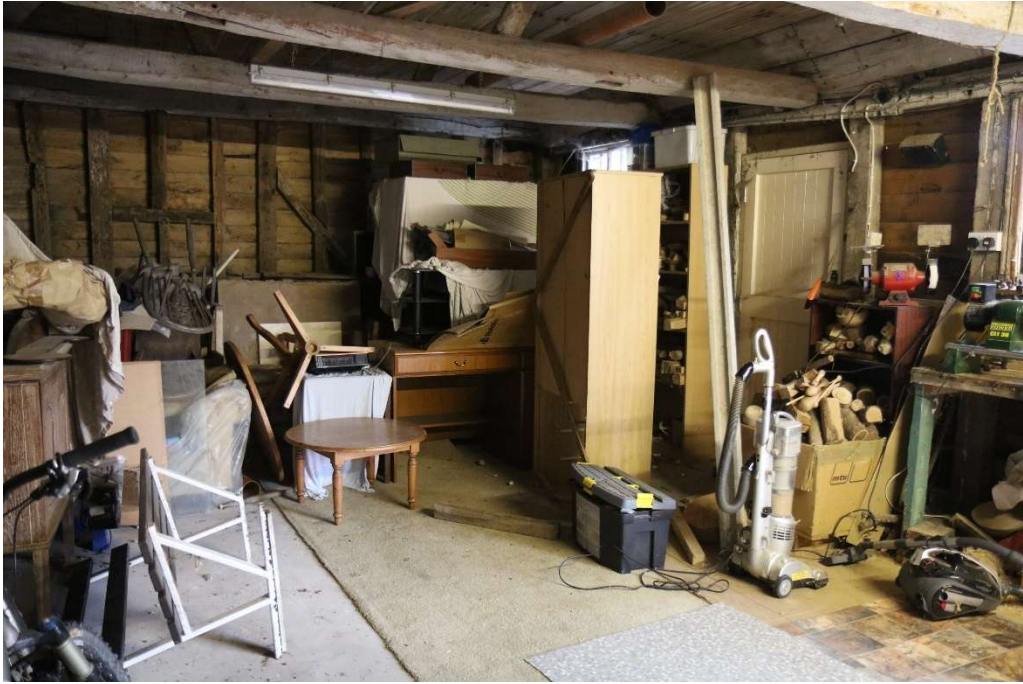
The north-eastern and north-western walls of the coach house are exposed brick painted white while the remaining walls are exposed timber-framing. The floor is poured concrete.

**Photograph 9** Interior of coach house. Photograph taken facing south-east.

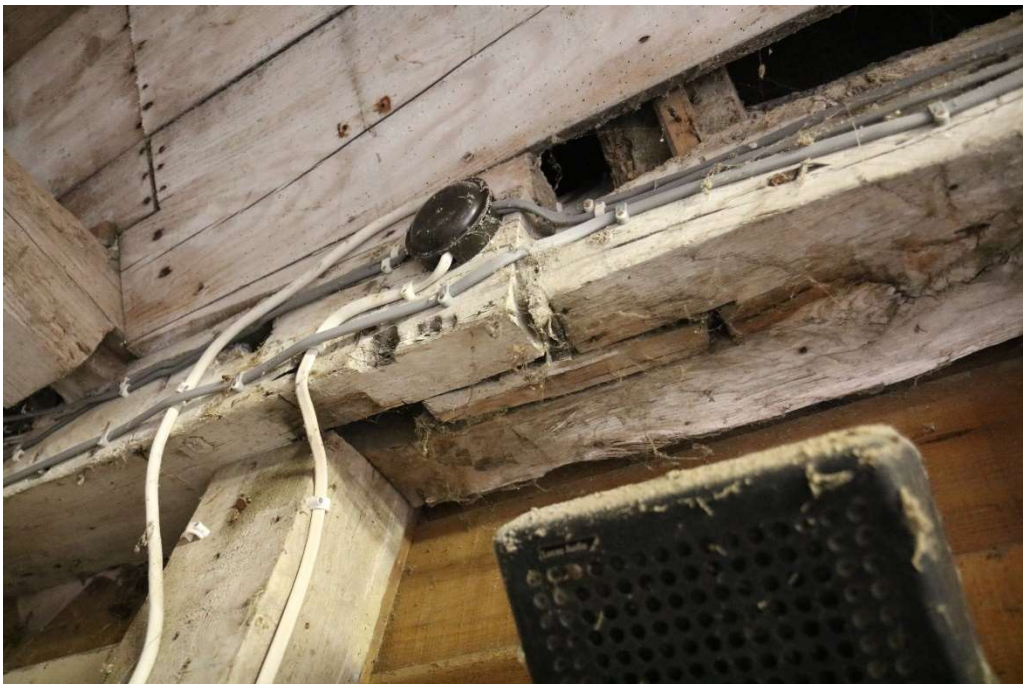
**Photograph 10** Detail of south-western wall-plate scarf-joint. Photograph taken facing south.

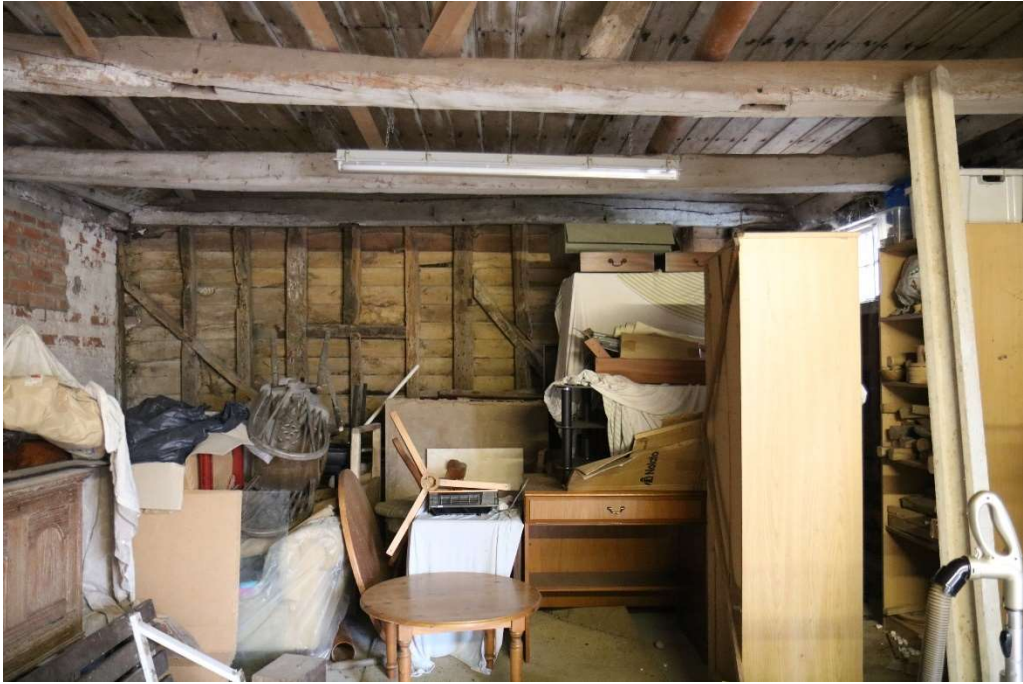
The timber wall-framing (Photograph 11) utilises a number of bracing techniques; diagonal through-bracing, Y-shaped bracing and a number of short girts. The frame comprises mostly hand-sawn timbers with iron nails. There are two windows and two doors in the south-western wall of the coach house.

**Photograph 11** Detail of wall-framing of south-eastern wall. Photograph taken facing east south-east.

The use of diagonal through-bracing in the wall-framing, albeit in a haphazard fashion, is a technique used from the 17th century (Stenning 2013). Another 17th century and later practice is the number of studs pegged to the frame. Up until the 17th century, every stud would have a timber peg at the top and bottom to secure it. During the 17th century, it became common place to peg them less frequently (*ibid*). The studs in the coach house have minimal pegs.

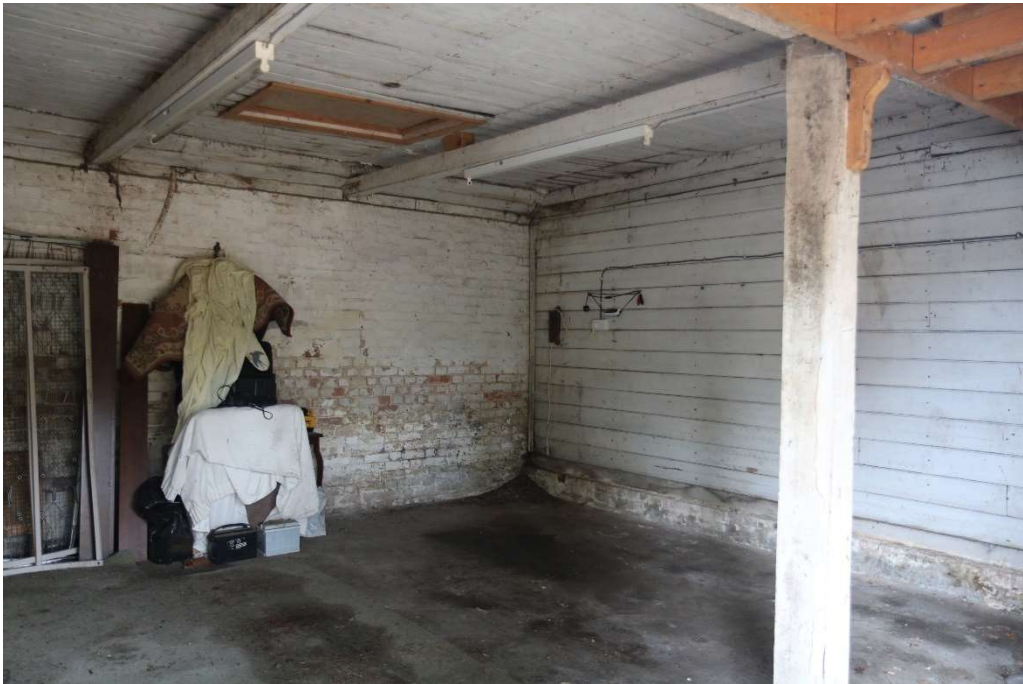
The roof of the garage was not accessible at the time of recording, but it is presumably constructed from modern machine-cut timbers. Two tie-beams cross the garage, which are secured at both ends by iron straps. The floor is concrete.

**Photograph 12** Interior of garage. Photograph taken facing north-east.

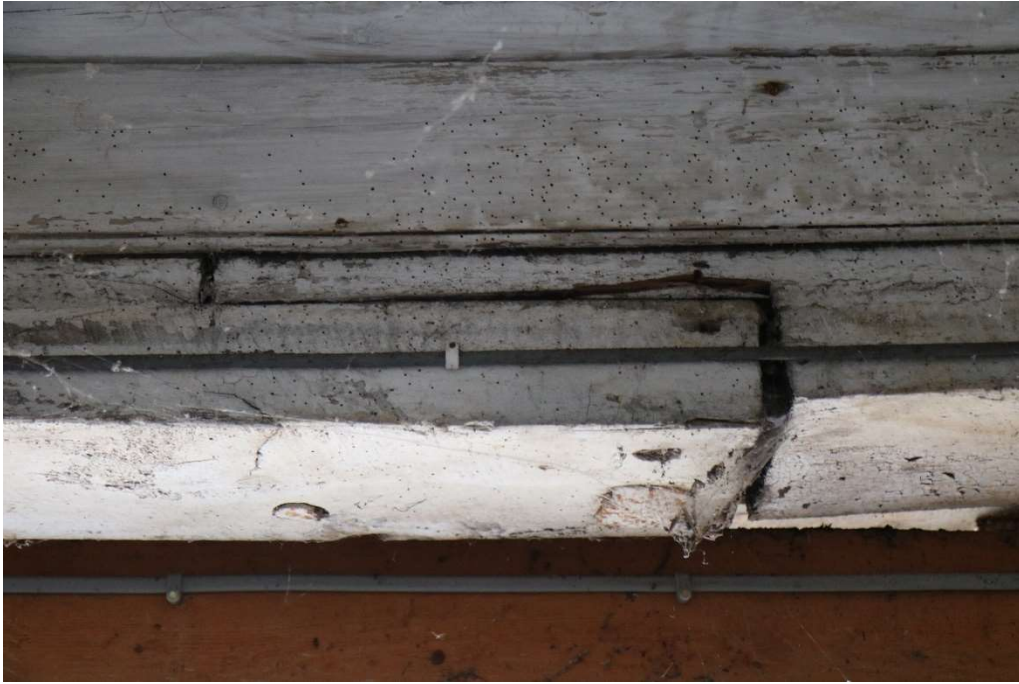
**Photograph 13** Detail of south-western wall-plate scarf-joint. Photograph taken facing south south-west.

The north-western and south-eastern walls are clad with timber planks while the north-eastern wall is exposed brickwork. The south-western wall has been extended to the south-west and is dominated by two garage doors. There is a flat roof above this extension, comprising machine-cut joists. The addition of the extension has left the original wall-plate exposed, which is supported on a central post. A lack of mortices on the underside of the wall-plate suggests the garage was originally open-fronted. A side-halved scarf-joint (Photograph 13) is present in both the south-eastern and north-western wall-plates.

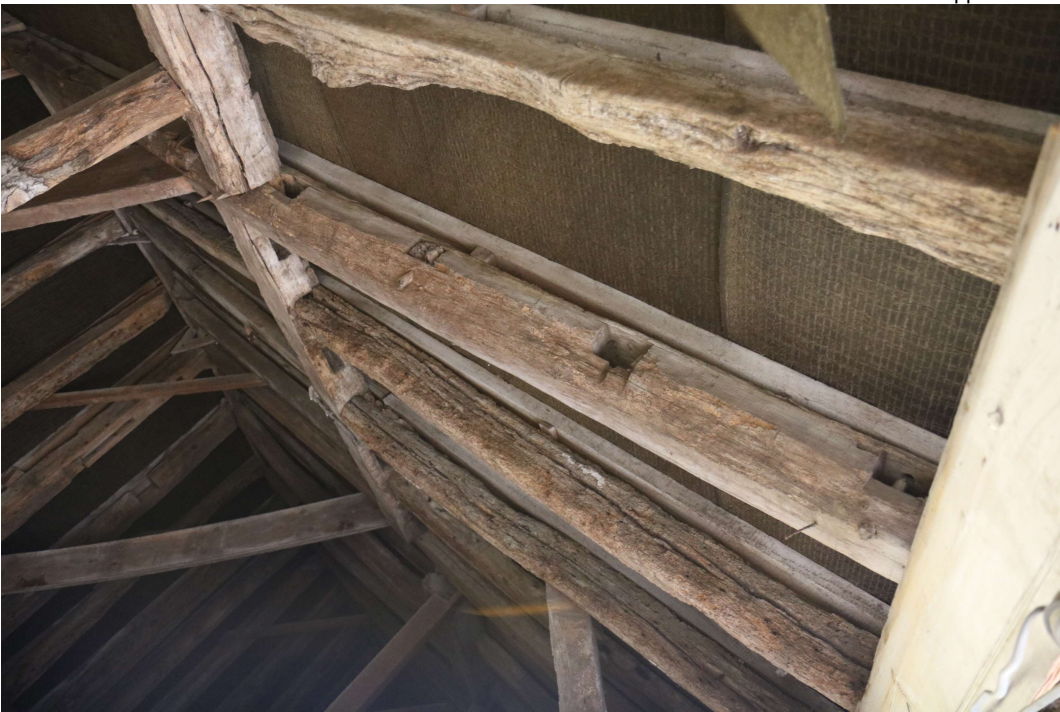
EEX60095\_PhotoGraph\_021

Example of reused principal rafter in roof of coach house. Photograph taken facing south-east.

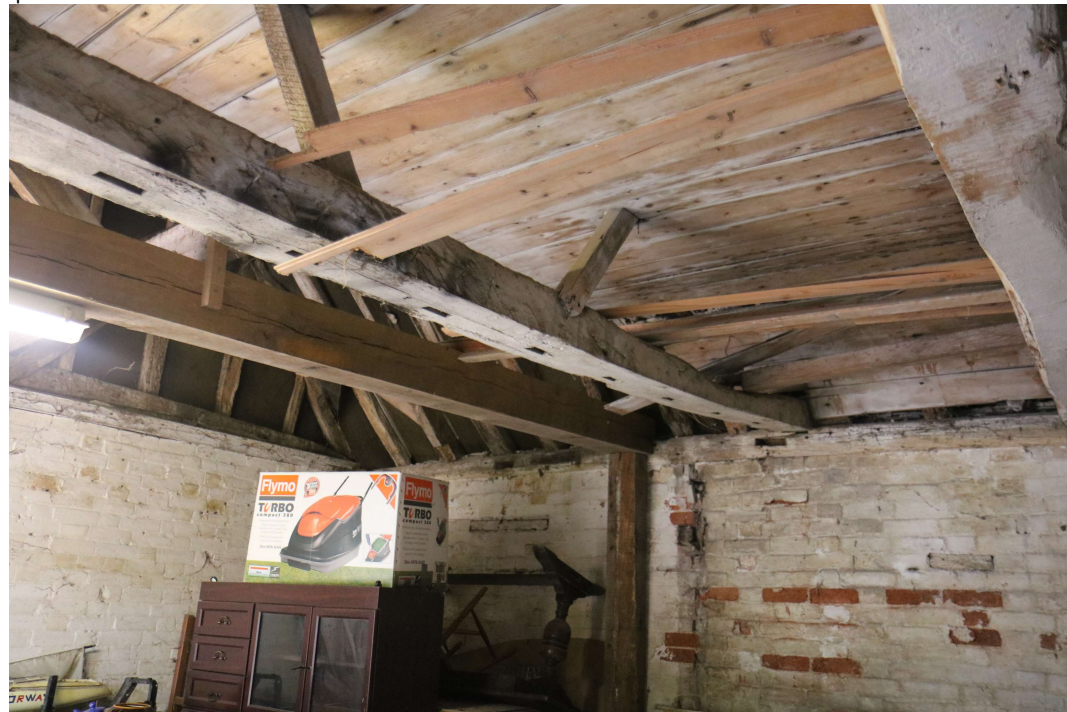
EEX60095\_PhotoGraph\_022

Detail of reused tie-beam and wall-plate in coach house. Photograph taken facing north-west.

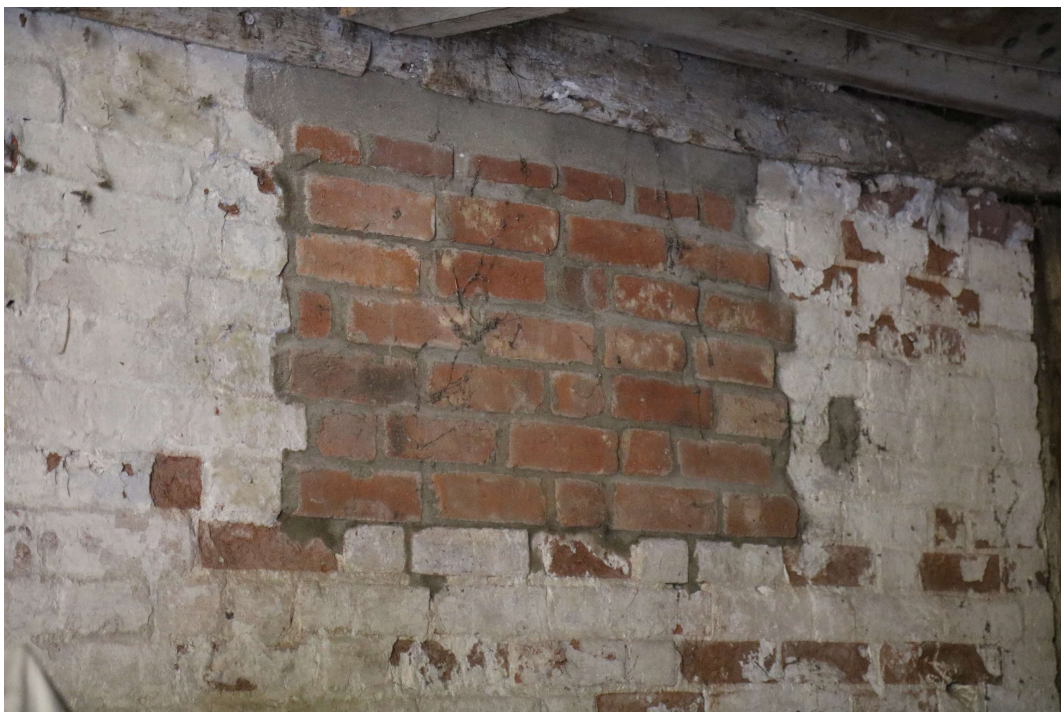
EEX60095\_PhotoGraph\_031

Detail of area of repair to brickwork of north-eastern wall of coach house. Photograph taken facing north-east.

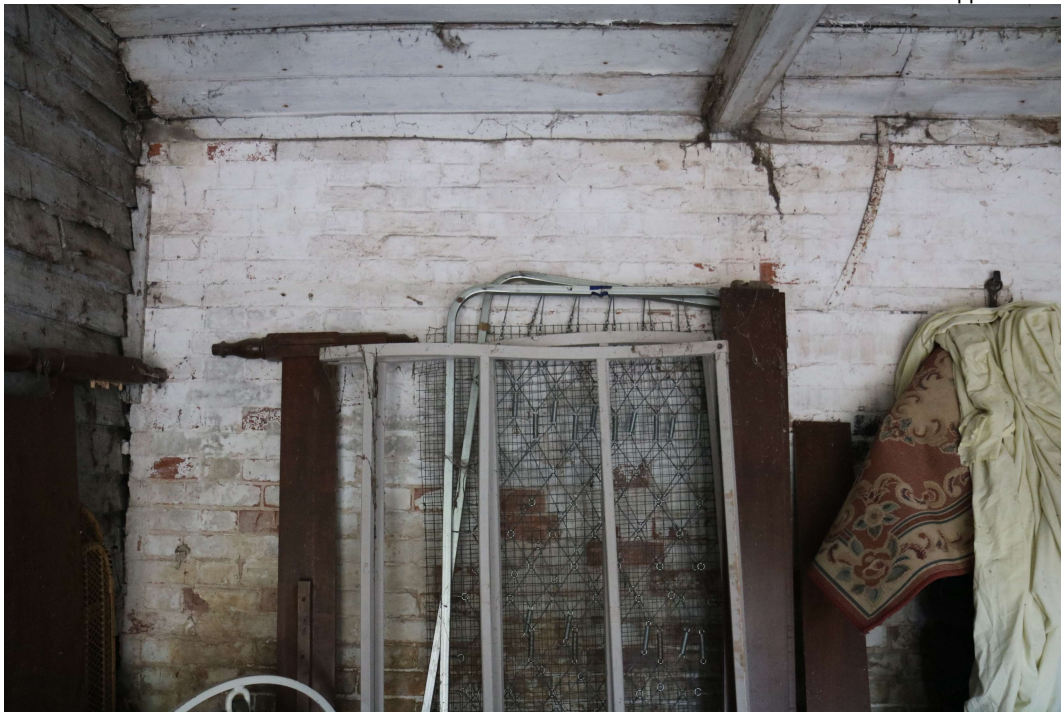
EEX60095\_PhotoGraph\_037

Within the north-eastern wall is short length of timber. It is unclear if this is acting as a bond timber to strengthen the structure of the wall or has been incorporated for ease of attaching hardware to the wall.

Detail of timber in north-eastern wall of garage. Photograph taken facing north north-west.
