**An archaeological trial-trenching evaluation  
at the Hope Inn,  
16 High Street, Tollesbury, Essex**

**July 2011**

**CAT Report 614**  
September 2011

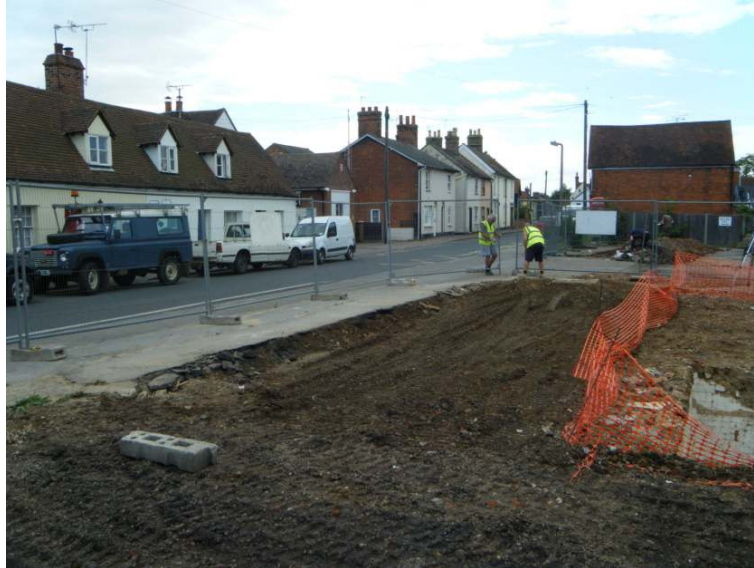
Cover View SE across site to Tollesbury High Street  
Plate 1 T1 view W.  
Plate 2 T1 view East  
Plate 3 T2 view east  
Plate 4 Plate 4: T2 view west. Modern brick foundation F5 centre  
Plate 5 view north showing representative section of T2  
Plate 6 sondage showing thickness of clay floor L6  
Plate 7 T3 view north.  
Plate 8 T3 representative section  
Plate 9 finds from L5: glazed floor tile; sherds of fabric 21a Colchester-type ware

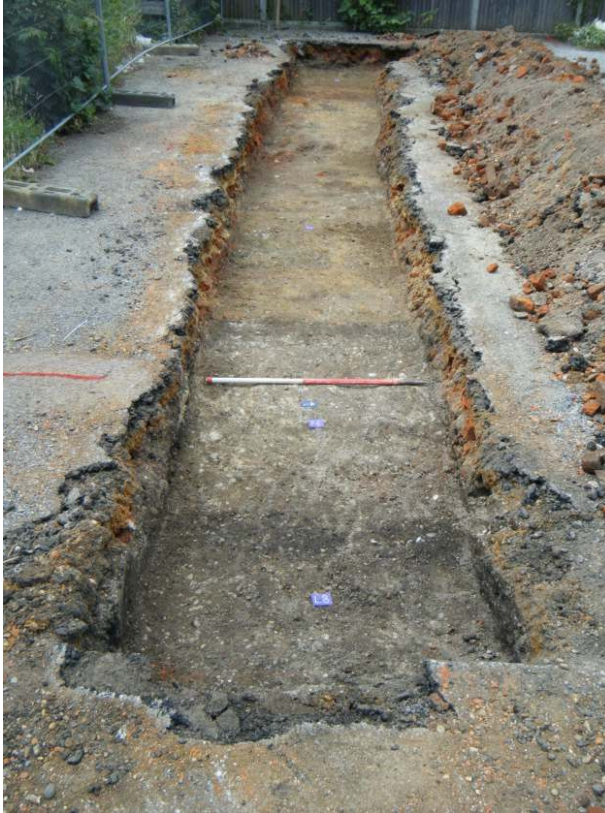
**Plate 1: T1 view W. L8 (soily layer or yard surface) foreground, F6 (gravel or foundation), and L6 (clay floor) beyond. Bricky L2 visible in sides of trench under L1 tarmac.**

The following layers were removed by machine: L1 modern tarmac (60mm thick), and L2 post-medieval make-up (310mm thick). This exposed three archaeological horizons and a cut feature, as follows. At the west end of T1 was L9 a soily layer, possibly a garden soil, which was cut by medieval or post-medieval pit F7. A compacted clay layer/clay floor (L7) occupied approximately 8.8m of the centre of the trench. Finds from L7 were 16th-18th century in date. This may indicate the date of the clay floor (and the building of which it formed a part). Its east end was cut by F6, which may be a gravel path, or possibly the top fill of a cut feature (foundation trench?). Beyond F6 at the east end of the trench was L8, a band of gravelly soil (very likely to be a yard surface). Compacted clay L7 was heavily cut by (unnumbered) modern features.

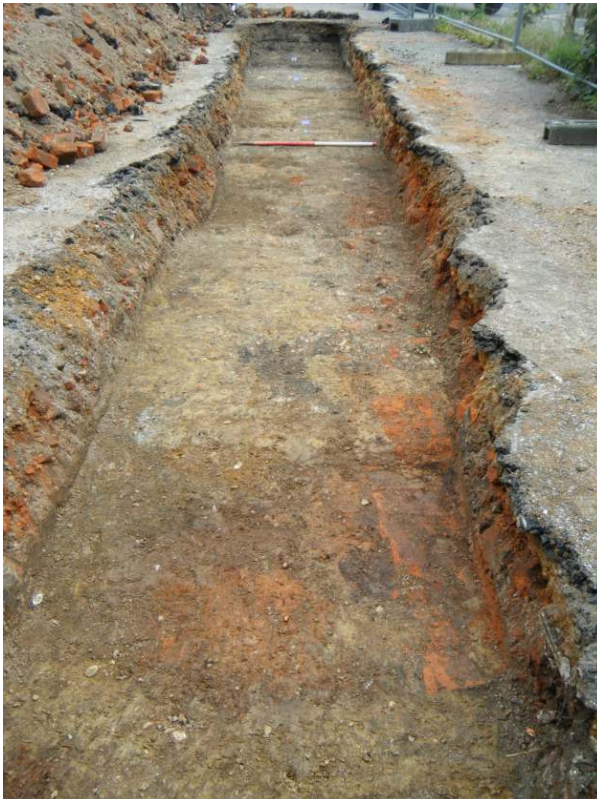
**Plate 2: T1 view East. Clay floor L6 with area of burning (hearth?) foreground**

The clay layers are very likely to be the remains of clay floors of a building or buildings which once stood on the southern edge of the Hope Inn plot (essentially on the High Street frontage, and in line with surviving properties either side of the Hope Inn). A burnt patch on the clay floor in T1 may be a hearth.

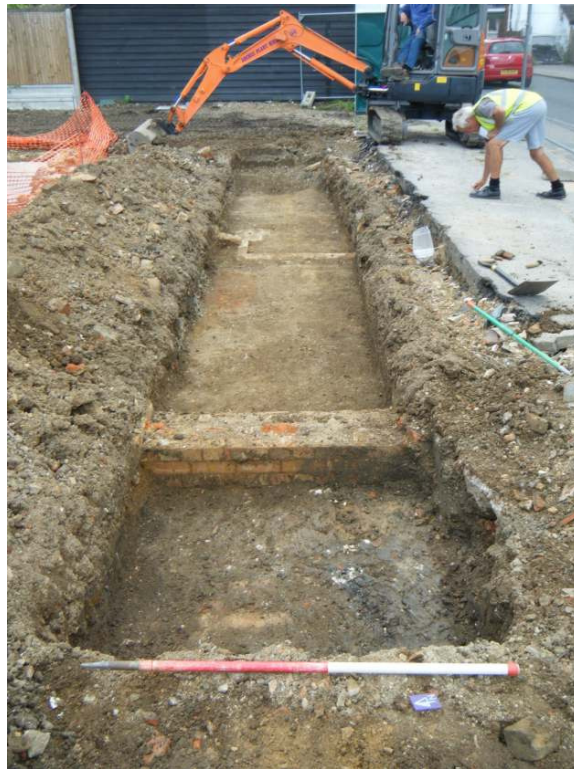
**Plate 3: T2 view east. Modern brick foundation F5 foreground and centre**

L5 and L6 were cut and damaged by modern brick foundations F5 (a group number for two separate walls). A test pit was dug alongside the easterly F5. This produced post-medieval and medieval pottery. On reflection, it seems that this test pit coincided with a post-medieval linear cut running E-W along the south edge of T2.

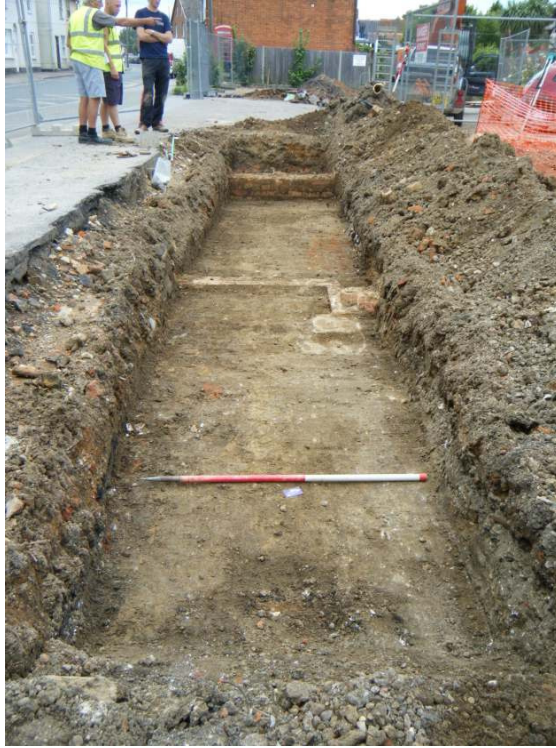
**Plate 4: T2 view west. Modern brick foundation F5 centre**

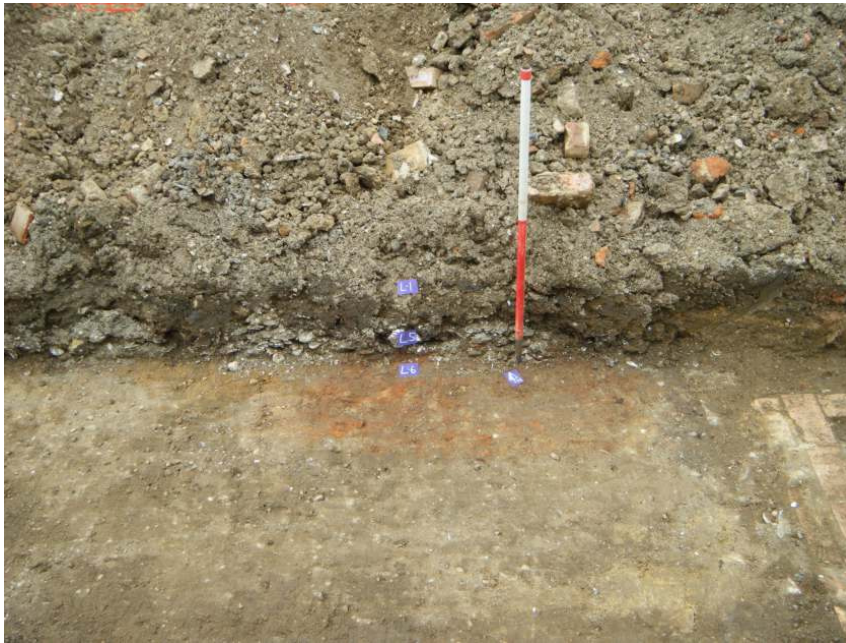
**Plate 5: view north showing representative section of T2 (L1 topsoil over L5 oysters over L6 clay floor)**

The following layer was removed by machine: L1 topsoil / tarmac mix (180mm thick). This revealed L5 soil accumulation with oyster shells, overlying clay floor L6 (whose surface was at 330mm below modern ground level).

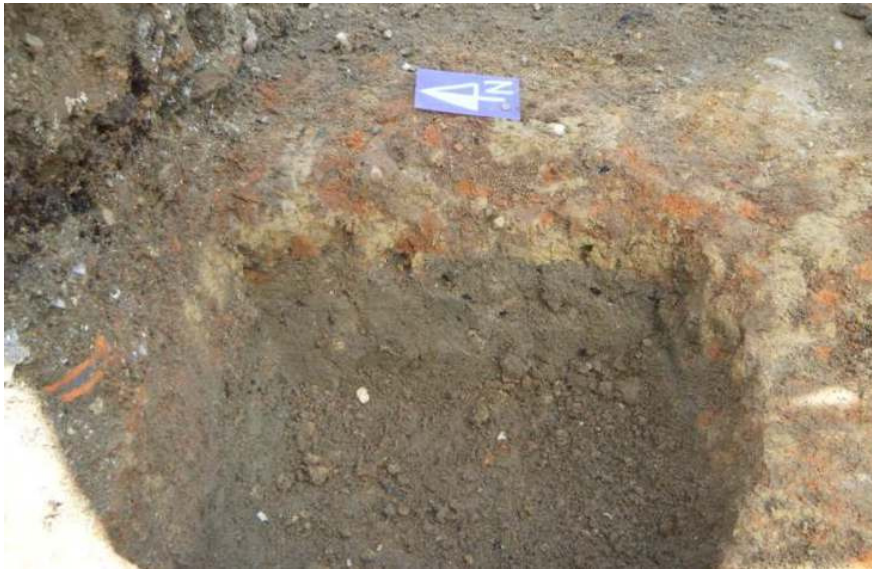
Plate 6: sondage showing thickness of clay floor L6 (65mm)

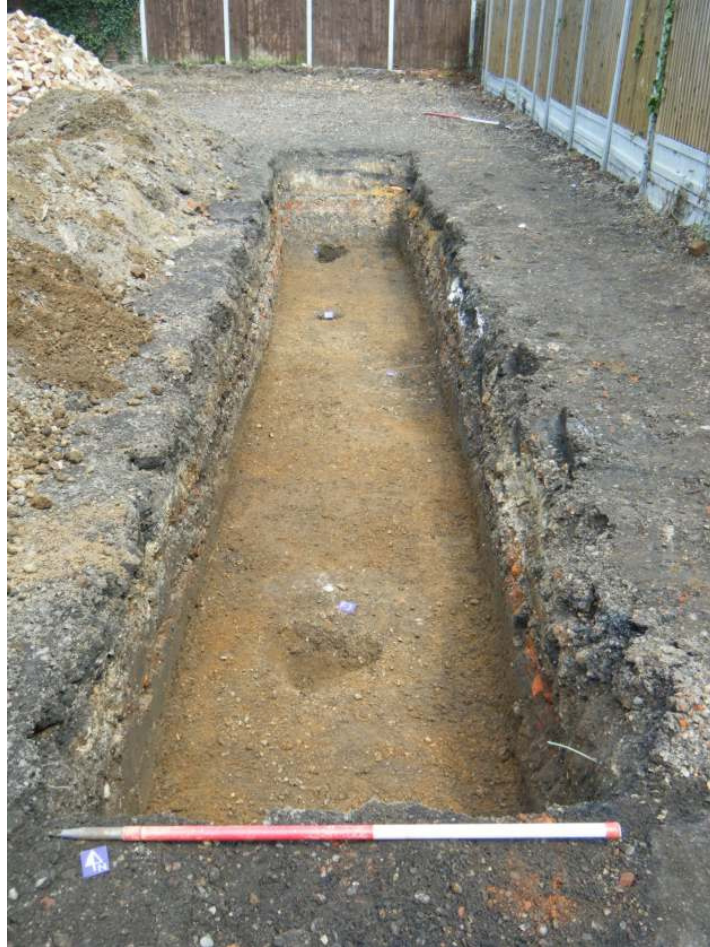
**Plate 7: T3 view north. Post-medieval pit F3 in foreground, post-hole F1 and pits F2, F4 beyond.**

The following layers were removed by machine: L1 topsoil (160mm thick), L2 rubblely make up with clay and bricks (360mm thick). This revealed a soil layer L3 (presumably garden soil, 240mm thick). Under L3 was natural L4, into which the archaeological features were cut. These were small pit or post-hole F1, and pits F2-F4. As a group, these were dated by peg-tile and clay tobacco pipe.

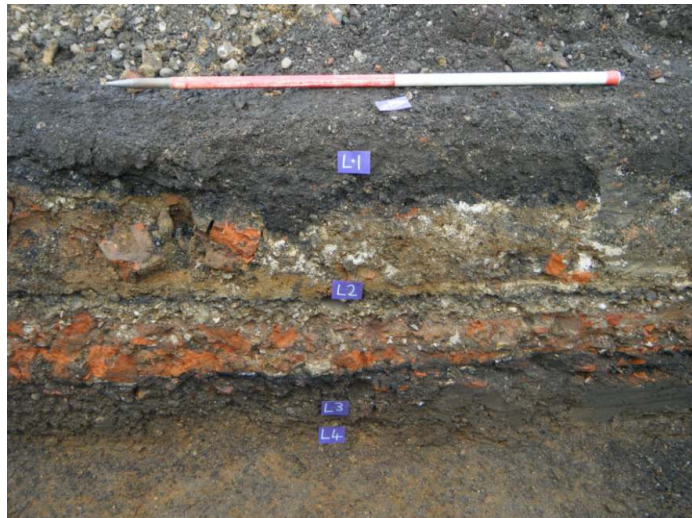
**Plate 8: T3 representative section (topsoil/tarmac L1, over rubblely make-up L2, over L3 post-medieval topsoil, over L4 natural).**

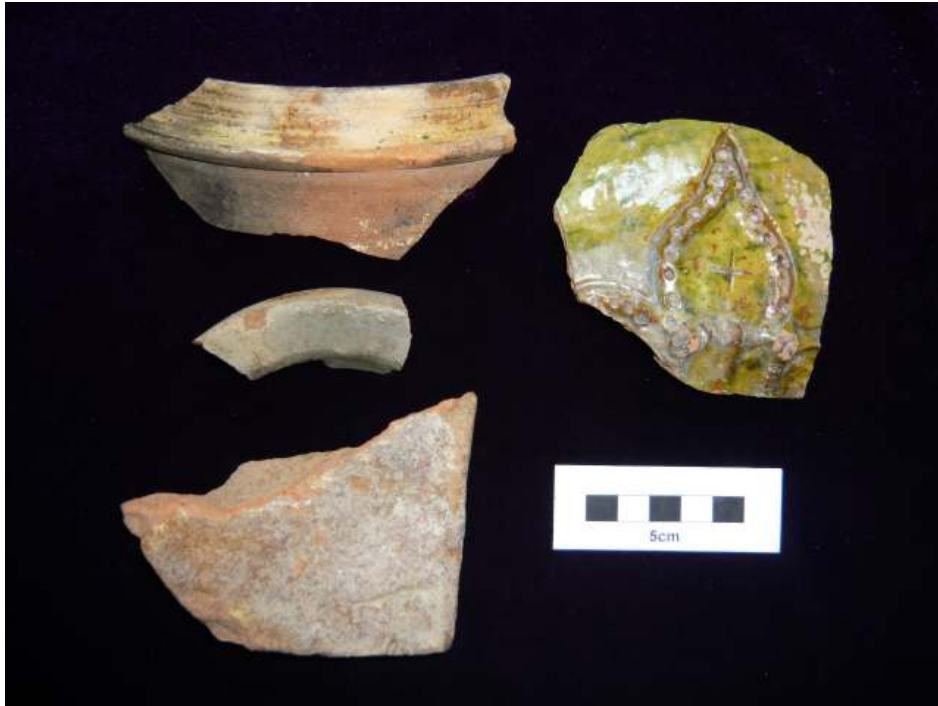
Plate 9: finds from L5 (overlying clay floor L6). Bottom left: glazed floor tile; top, 3 sherds of fabric 21a Colchester-type ware

A small quantity of bulk finds of medieval and post-medieval date, consisting of pottery, ceramic building material (CBM), vessel glass, clay pipe, animal bone and shell, was recovered from nine contexts divided between three evaluation trenches. There was also one metal small find (SF1). These finds are listed and described in Table 4. The medieval and post-medieval pottery fabric types recorded refer to the Essex post-Roman fabric series (Cunningham & Drury 1985; CAR 7 2000) and are listed in Table 5. Some of the sherds from L5 are shown in plate 9 below.
