**Historic building recording
at Highfields Farm,
Highfields Lane,
Kelvedon, Essex
July 2013**

**report prepared by
Chris Lister
on behalf of
Mr and Mrs Bunting**

CAT Report 727
October 2013

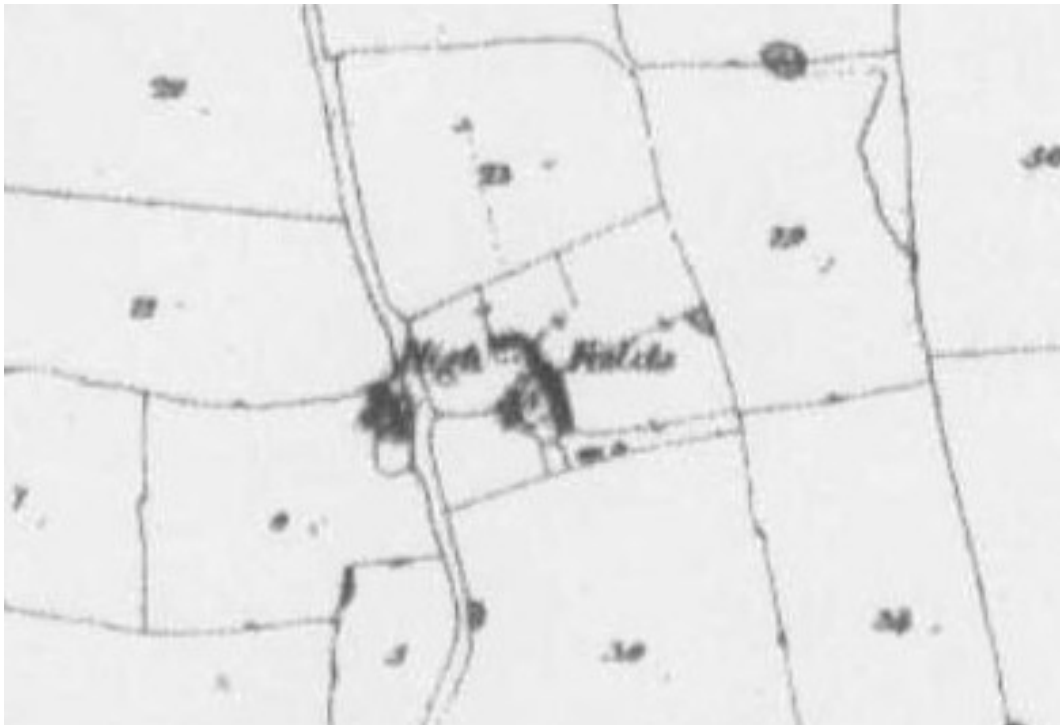
Fig 3 1841 tithe map (ERO D/CT 196).

The tithe map for 1841 (Fig 3, ERO D/CT 196) shows a long rectangular building parallel to Highfields Lane, in much the same location as the one depicted on the 1777 map. The structure perpendicular to this on the 1777 map has been removed and replaced with a smaller, free-standing building. South-east of the barn, on the edge of parcel 30 are two smaller structures. The tithe award names parcel 30 as 'Cart Lodge' field, so it is likely that these buildings are the farm's cart lodges.

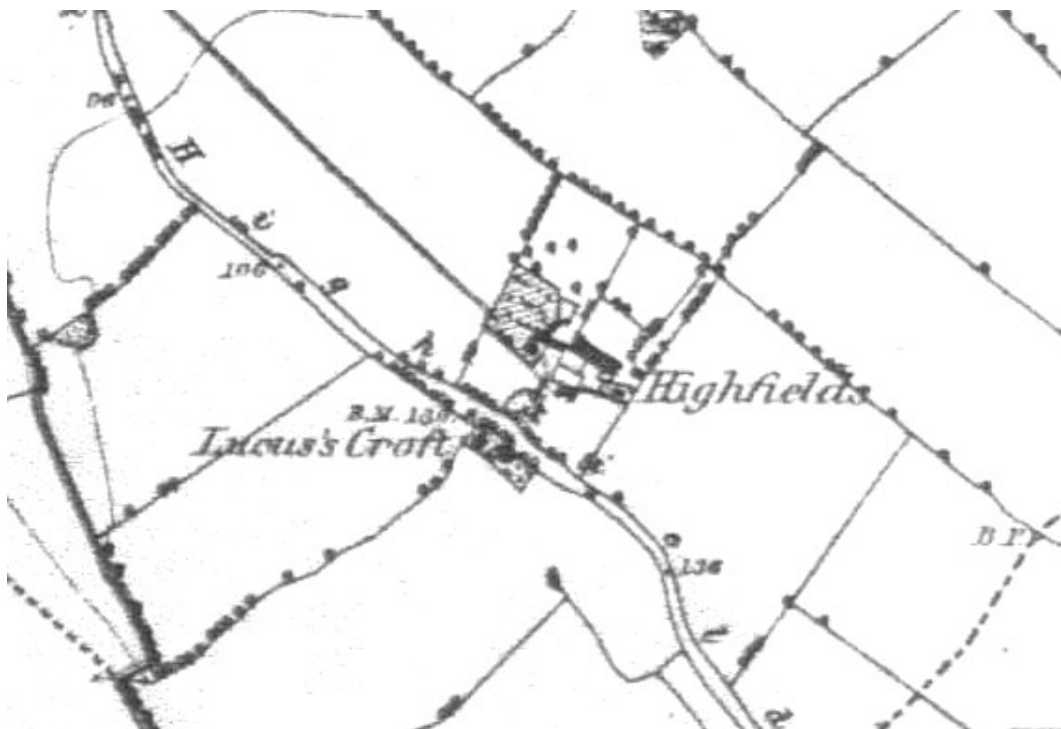
Fig 4 1st edition 6" OS map, 1874 (sheet 35).

The 1st edition 6" Ordnance Survey of 1874 (Fig 4) shows little variation to the tithe map of 1841. The barn is shown parallel to Highfields Lane and there appear to be three enclosed yards on the south-west side. The 2nd edition 6" Ordnance Survey of 1897 (Fig 5) shows the same plan form, although there appears to be a small extension on the south-west corner of the barn.

Adjacent to the north midstrey is a lean-to with a mono-pitch slate roof. The south-west wall of this structure sits on a brick plinth but the timber frame of the south-east wall is carried on a brick wall that forms the dividing wall between stable blocks 2 and 3. This wall appears to be one of the farmyard walls shown on the 1st edition Ordnance Survey map (Fig 4).

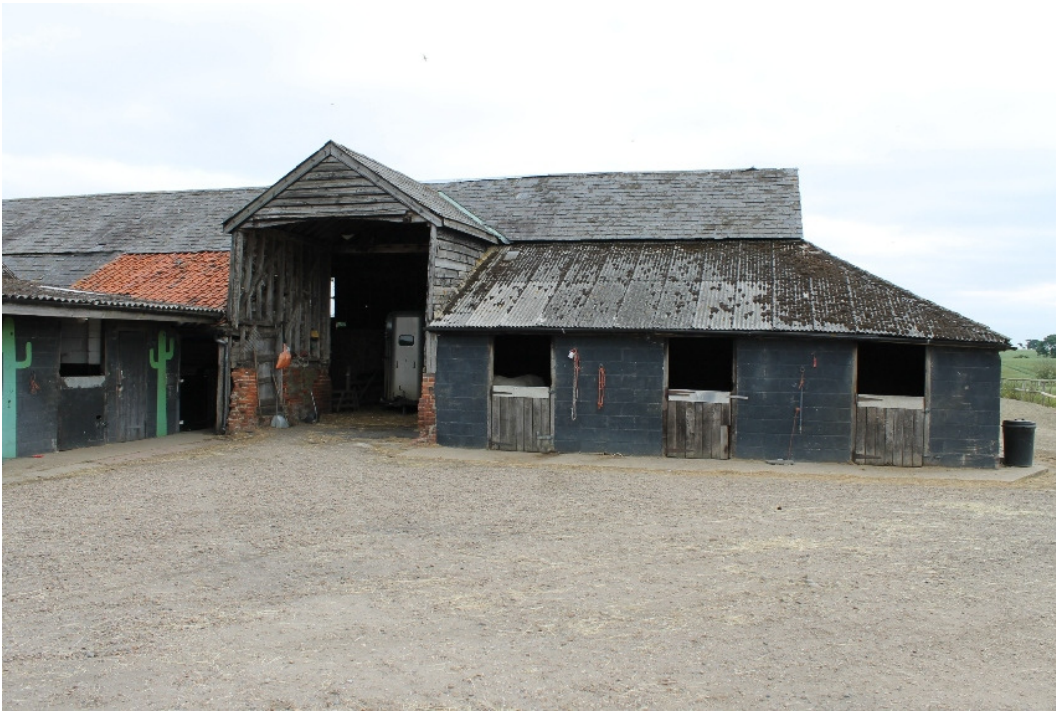
Plate 1 Highfields barn, south midstrey with modern stable block 4 obscuring the south-east end - view north-east

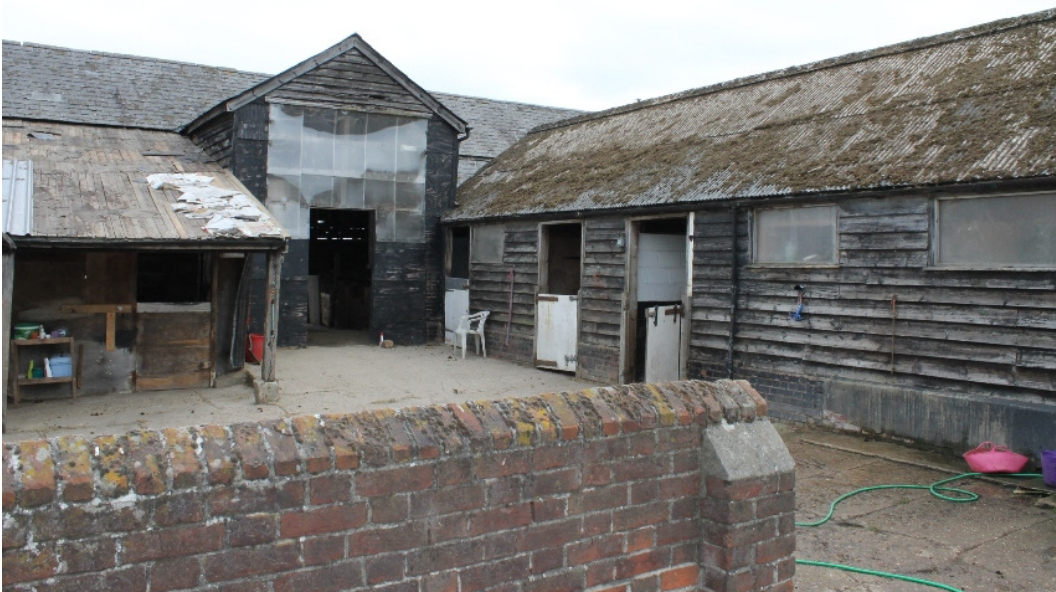
Plate 2 North midstrey with boarded over opening and modern stable blocks to left and right – view south-east

over to reduce the size of the doorway (Plate 2), but the south midstrey is intact and indicates there were originally full height doors. There is an inscribed brick on the plinth of the north midstrey, bearing the legend 'WD 1837' (Plate 3). These initials refer to William Docwra, who inherited the farm in 1834, with the date most likely referring to the year the barn was erected.

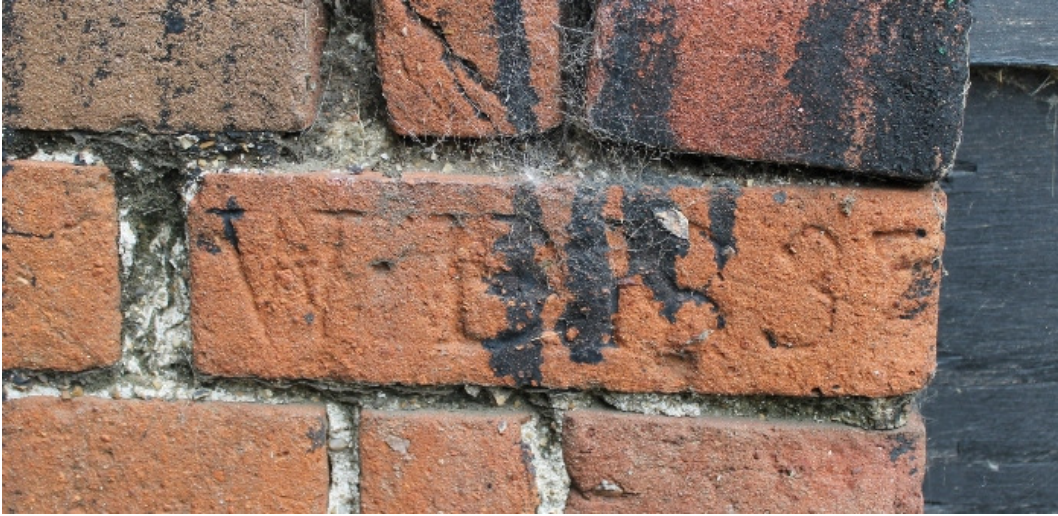
Plate 3 Date brick on the plinth of the north midstrey, inscribed 'WD 1837', with the initials standing for William Docwra – view north-east

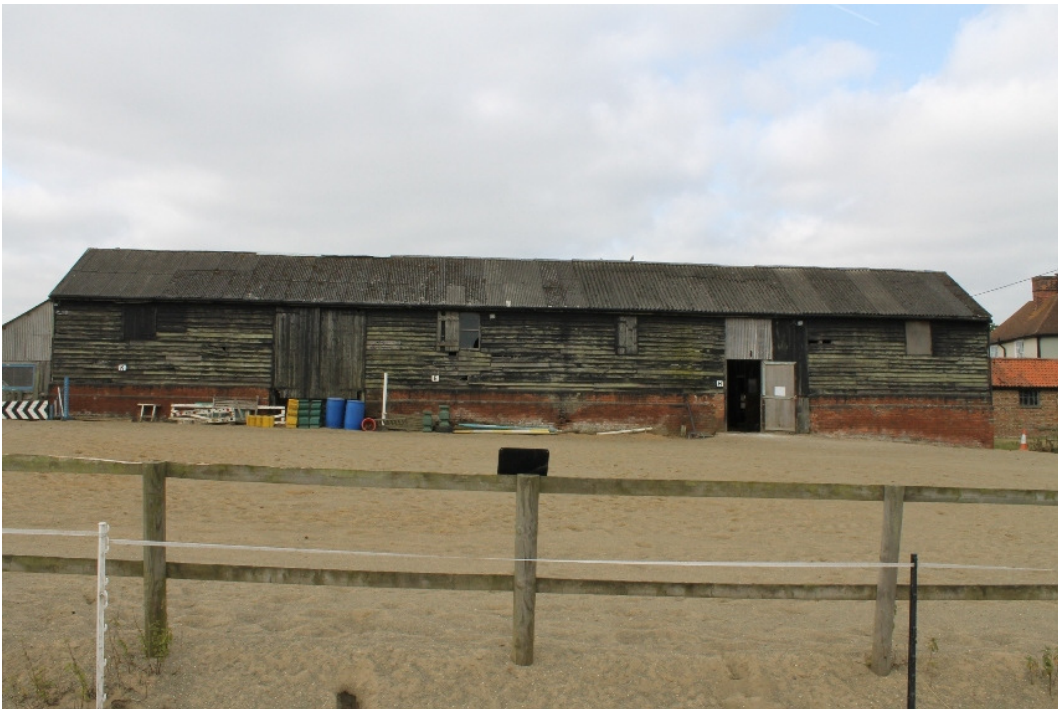
Plate 4 North-east elevation of the barn – view south-west

The north-east elevation has two full height doorways (Plate 4). The one to the south has plank doors held on what appear to be the original strap hinges (Plate 5). The doors themselves are later replacements, probably installed when the building was re-clad. The door posts have slots for a threshold leap (Plate 5). There are four pitching doors arranged along the elevation, located below the eaves. The outermost of these (bays 2 and 11) are slightly larger than those in the middle of the barn. The openings for these doors (bays 6 and 7) have been glazed as has the one in bay 11.

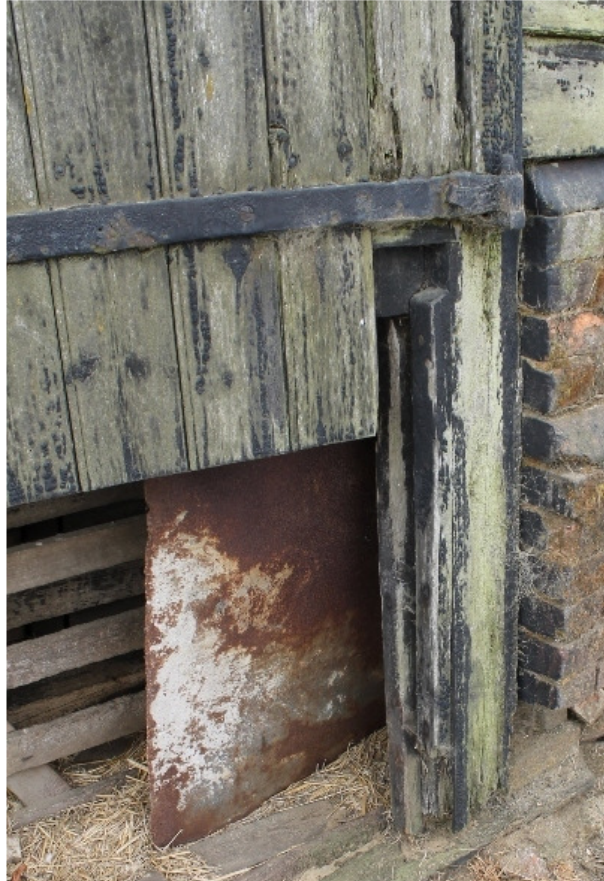
Plate 5 Detail of strap hinge on barn door to bay 9 and threshold leap – view north-west

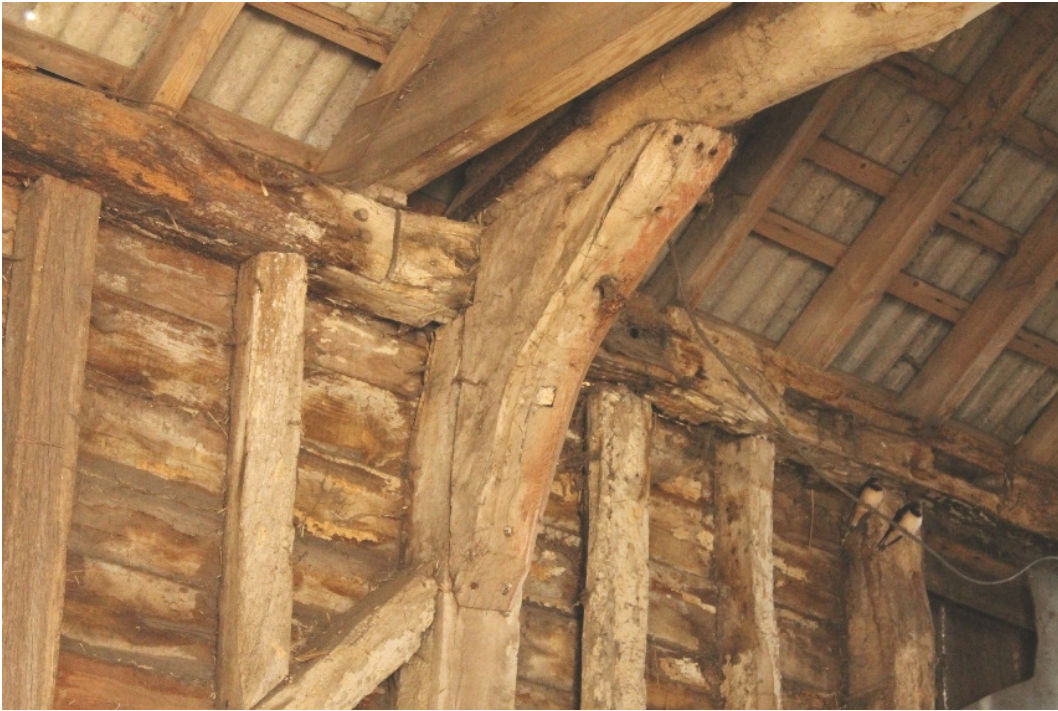
Plate 7 Bolted knee brace to truss J and face-halved scarf joint on wall plate of bay 10 – view north-east

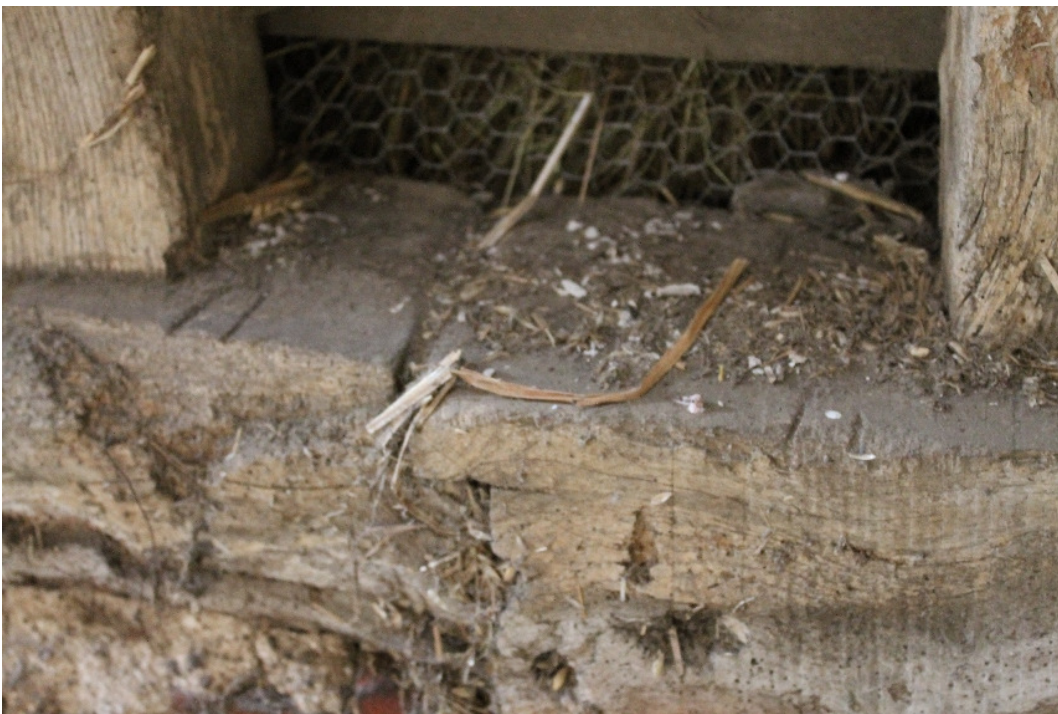
Plate 8 Carpenter's marks (II) on either side of edge-halved scarf joint in the sill beam of the south wall - view south-east.

Despite the high proportion of re-used timbers in the barn, very few carpenters' marks were observed. The sill beam of the south-east wall has a chiselled 'II' on either side of the scarf joint (Plate 8), and there is a chiselled 'VI' next to an empty mortice on the post at the south-west side of truss K (Plate 14). The south midstrey has a chiselled 'II' on either side of the scarf joint where the wall plate of bay 10 meets the bridging beam of the south midstrey (Plate 15) and a chiselled 'III' on the wall plate of bay 8 at the other end of that bridging beam.

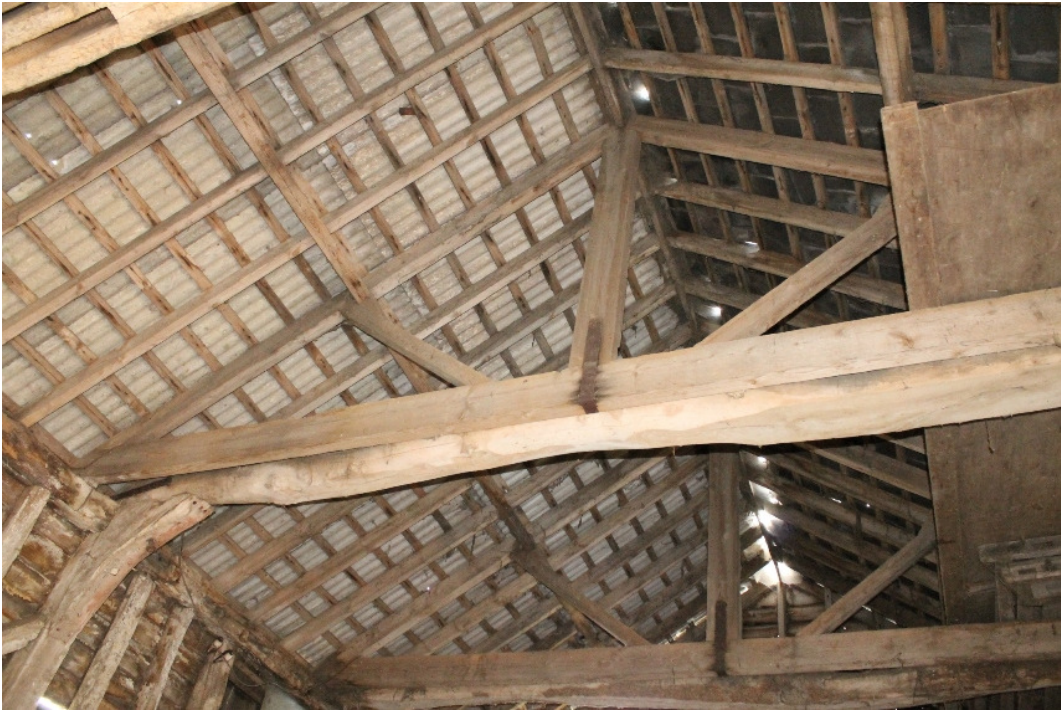
Plate 9 Truss J, original cambered tie beam and bolted knee brace with machine-cut secondary tie beam, king post, inclined struts and principal rafters – view south-east

There are 11 roof trusses (A-K), of which the outer trusses (A-C and I-K) have the original tie beams, cambered timbers with dimensions of approximately 200mm x 200mm (Plate 9). The tie beams of trusses B, C, I and J are carried on bolted knees braces (Plate 7). These tie beams are strengthened by a secondary timber which forms a king post roof truss, with inclined struts supporting the principal rafters. The common rafters are carried on a single through purlin to each pitch, with the roof covering supported on battens.

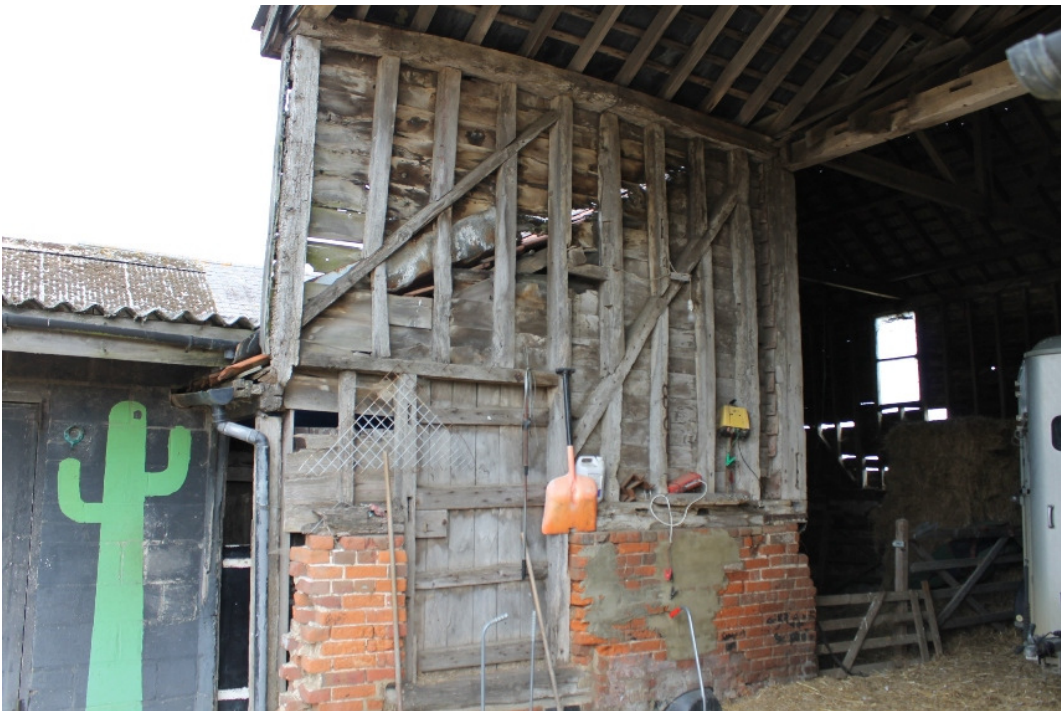
Plate 10 South midstrey with original doorway through brick plinth – view north

The south midstrey has an original doorway in the plinth of the north-west side wall (Plate 10). The plank door appears to be original. The north midstrey has an identically located doorway, although the door has been removed to provide open an opening to stable block 1 (Plate 11). These doors would have provided points of egress when the leap gates were in place during threshing. The north midstrey has an additional doorway in its south-east wall (Plate 12). This provides access to the lean-to and is an original opening in the brickwork of the plinth. This strongly suggests that the lean-to is contemporary to the barn, perhaps intended as an implement store. The south wall of the midstrey plinth has a recess at the base of the brickwork (Plate 12). There is no indication as to the function of this feature, but it could possibly be the location of a boot scraper.

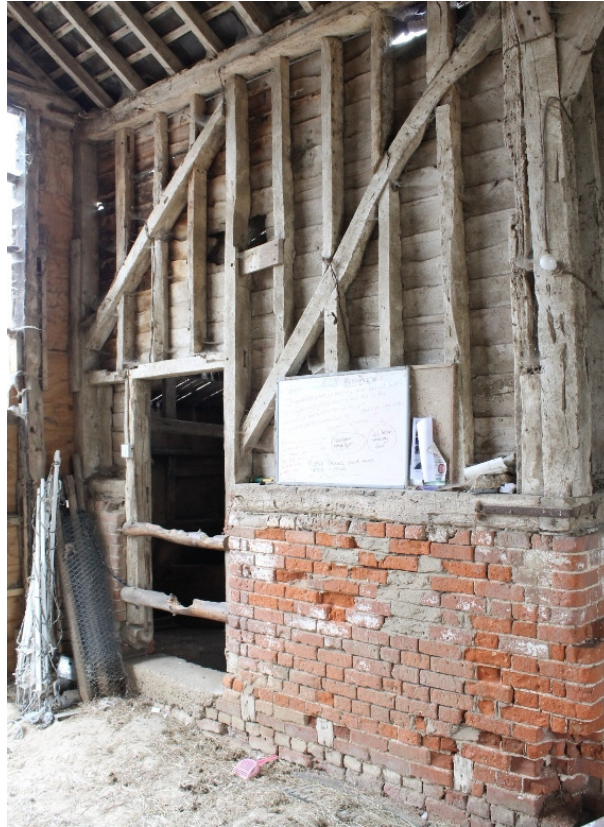
Plate 11 North midstrey with original doorway – view north-west

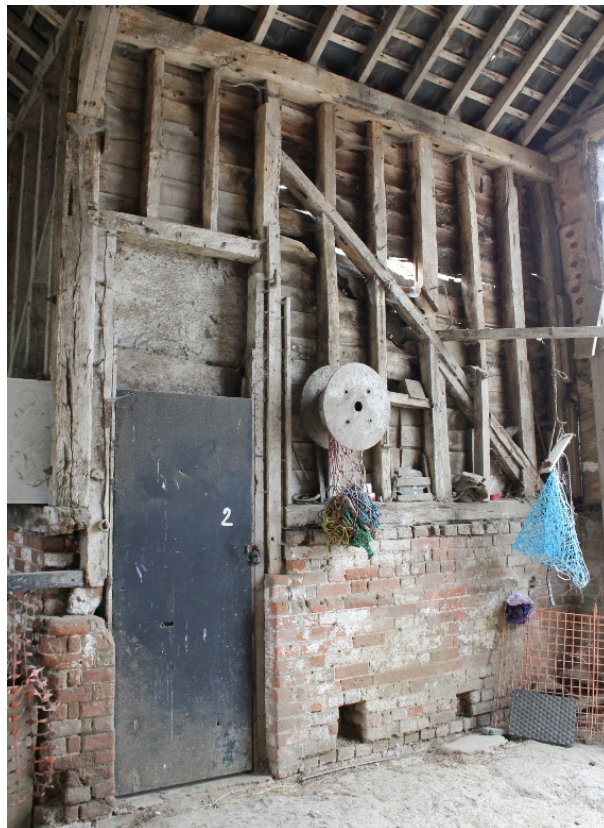
Plate 12 North midstrey, original doorway to lean-to and recess in brickwork, possibly for a boot scraper - view south

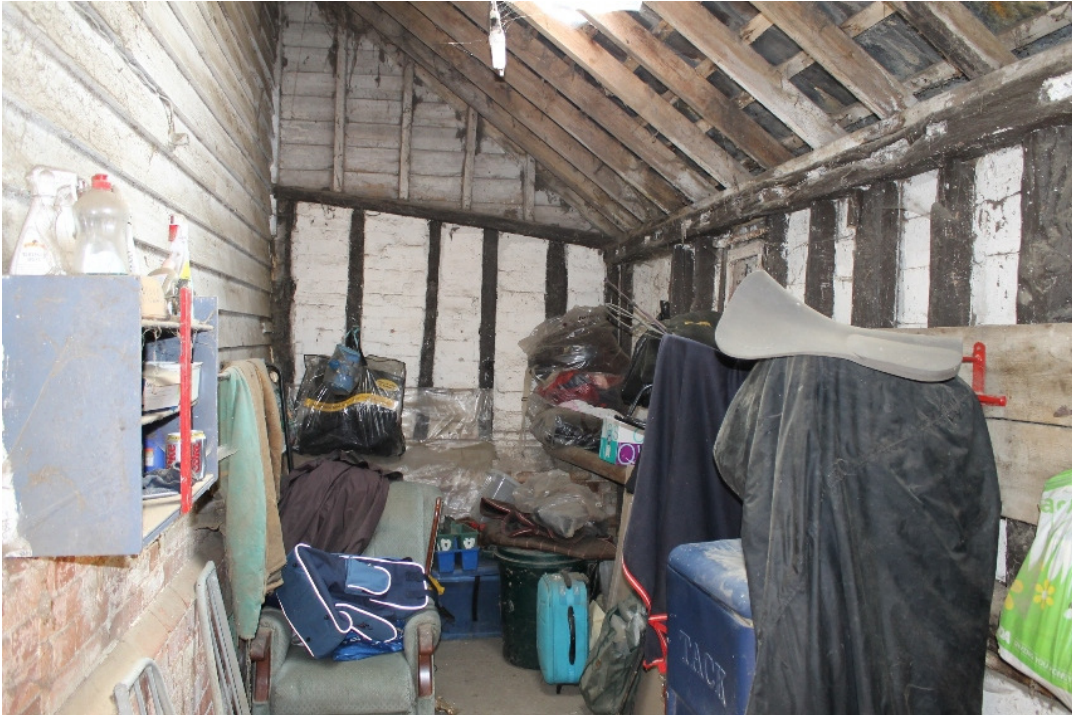
Plate 13 Original lean-to with brick-nogging between studs of end wall – view south-east

The interior of the lean-to shows how the farmyard wall was utilised as a plinth for the south-east wall (Plate 13). Above this, the gaps between the studs of the timber frame are infilled with brick-nogging.

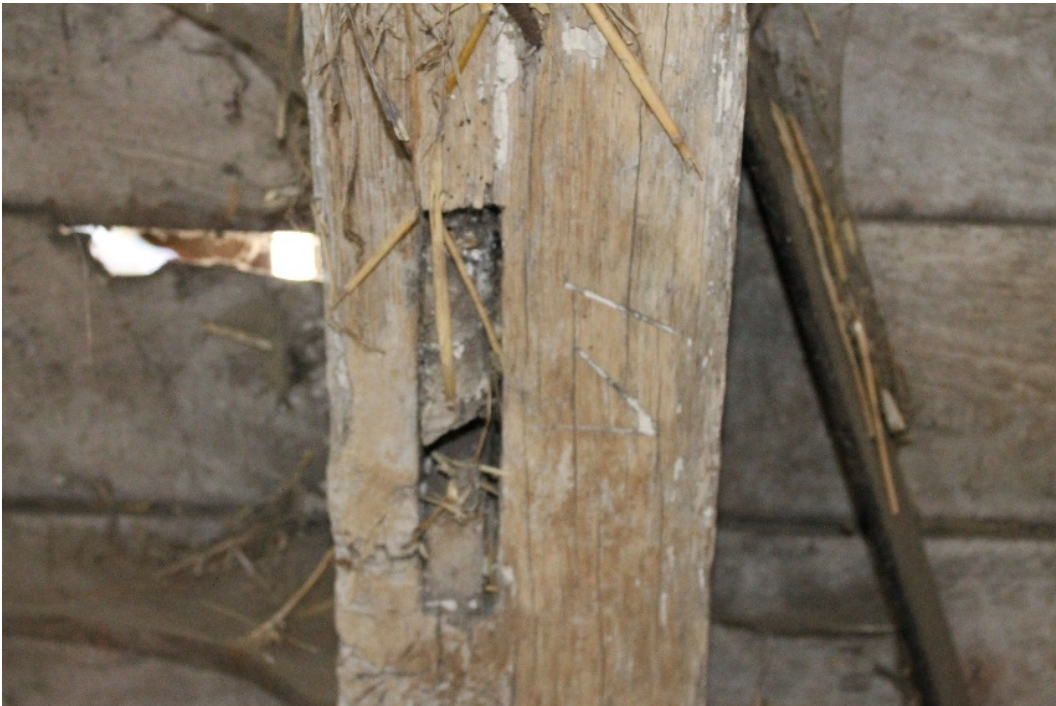
Plate 14 Chiselled carpenter's mark 'VI' on re-used post of truss K - view south-west

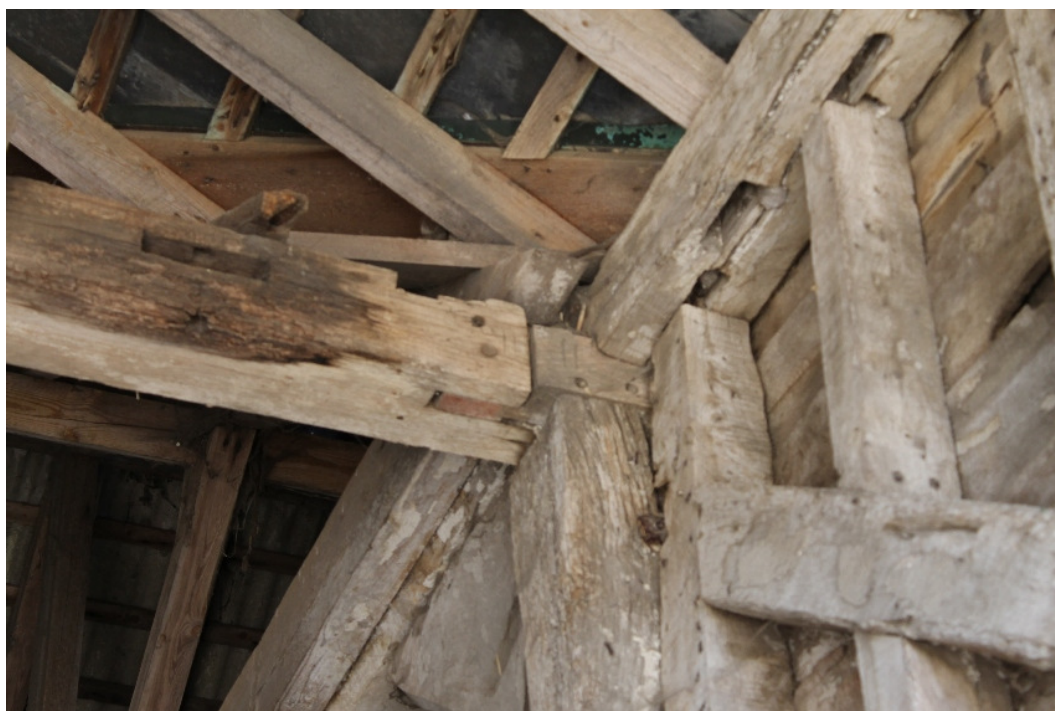
Plate 15 Chiselled carpenter's marks 'll' on post of truss J and bridging beam of south midstrey - view east
