# Archaeological monitoring during the installation of floodlights at the Colchester Garrison Officers' Club, St John's Green, Colchester, Essex.

report prepared by  
Adam Wightman

**CAT Report 737**  
November 2013

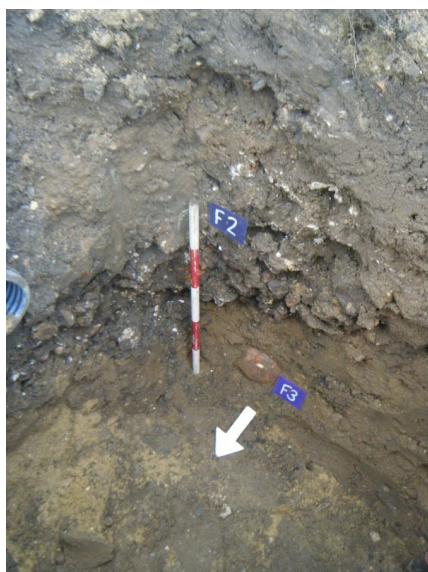
a depth of 1m below modern ground level (Plate 2) and was not located within a discernable grave cut (Fig 6). It is probable that the skull is medieval in date due to the high level of bone preservation and its proximity to the abbey church.

**Plate 2** The human skull (F3) in FP3, facing south-east.

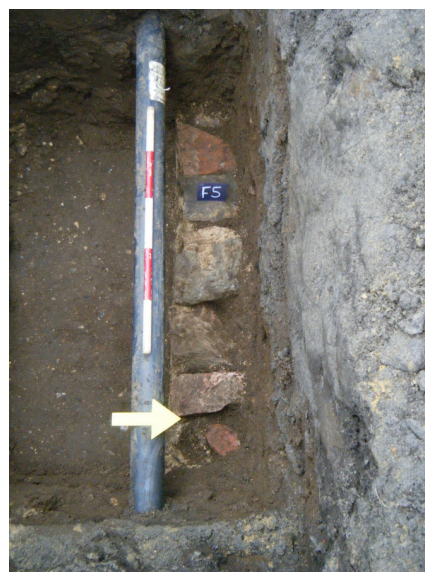
A rubble-wall constructed from septaria, greensand and Roman brick/tile bonded in a pale yellow mortar (F5) was encountered at a depth of 1m below modern ground level in FP7 (Figs 3 and 6). Some of the stone and brick/tile pieces had mortar on their upper surfaces (Fig 4). However, the top of the rubble-wall was flat and it is unlikely that there had been any further courses above this point. This would indicate that the building materials were re-used and probably originated from a nearby Roman building. The rubble-wall continued beyond the limit of excavation to the north, east and west (Fig 4). It was overlain by a thick layer of dark sandy-silt (L8) which, in turn, was overlaid by the post-medieval/modern topsoil L2 (Fig 6).

To the south of F5, the foundation-pit was hand-excavated down to the required depth of 1.1m below modern ground level (Fig 6). This exposed the southern face of the rubble-wall which was relatively smooth and even. Two sherds of Roman greyware (Fabric GX, 31g) and one fragment of Roman tile (85g) were recovered during the reduction of the southern half of the pit. A small sondage was hand-excavated against the southern face of the rubble-wall to try to ascertain its depth (Fig 4). However, excavation of the sondage ceased when the distal end of a human femur and part of a pelvis were encountered c 75mm below the base of the pit. The human bone was covered over with soil and the rubble-wall was protected with plastic sheeting and a layer of soil before the pit was infilled with concrete.

**Plate 3** The rubble-wall F5 in FP7, facing west.

The rubble-wall identified in FP7 is most likely to be the northern edge of an early medieval rubble-lined grave. Fifteen lined graves were uncovered during excavations in 1972 on the site of the Anglo-Saxon or early Norman church of St John to the north of FP7 (Fig 5) (CAR 1, 44). As with the wall identified in FP7, the materials used to line the graves were obtained from Roman buildings and some were set in mortar so that the inner faces were smooth and even (CAR 9, 215).

Further evidence for the association of the wall with a grave comes from its significant depth (0.7m-1m below the top of the abbey church foundation trenches to the south) and the presence of human remains directly to the south. The southern side of the grave is presumably just outside the southern limit of excavation. This would make this rubble-lined grave comparable with the larger graves excavated in 1972 (CAR 9, 216).

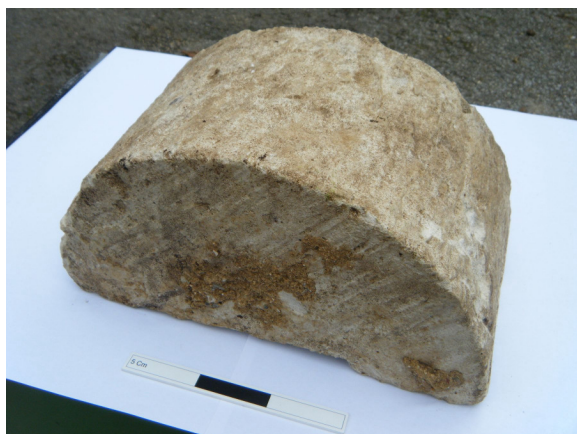
White limestone. Complete semi-circular piece presumed to be from a column or attached column. Stone saw marks across back, upper and lower faces. Even curvature to front face which has slightly coarse tooled finish. There is a 20mm un-tooled vertical strip at one end of the face which is slightly raised in relation to the tooled surface. Areas of white lime mortar adhering to upper and lower surfaces. Height 170mm, radius (maximum depth of stone) 160mm, width at back 310mm.

**Plate 4 Architectural worked stone (no 4).**

The two large pieces of architectural worked stone can be assumed to have come from the abbey church.

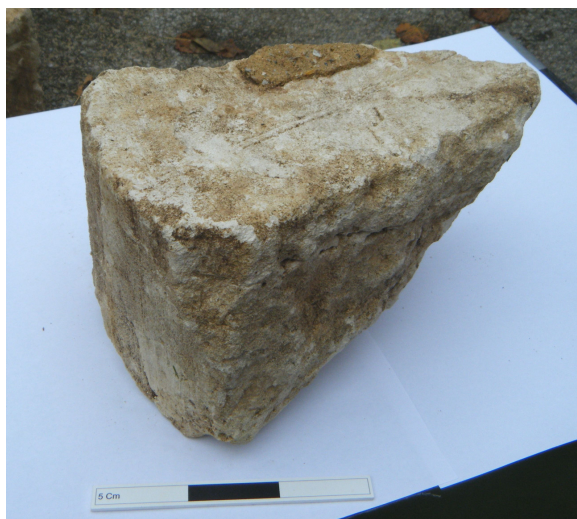
White limestone. Roughly triangular stone piece with saw cut upper and lower surfaces and curved face. The sides and back of the stone are rough and although there is some recent damage these were clearly broken away in antiquity. This could suggest that the stone has been reused. The face is of similar, although possibly slightly broader curvature to that of the other stone (5). However, the stone itself is of greater depth and the height slightly less. It appears that the face had originally been cut, as one half is relatively smooth with vertical saw marks and is slightly raised in relation to the other half which appears to have been finished with slightly coarse tooling similar to the other stone (5). There are two parallel, thin, shallow tooled grooves 5mm apart running from the area of the sawn part of the face to the surviving back end of the stone on one (upper/lower) surface. The same surface has

a surviving patch of sandy, yellow-brown lime mortar. Height 160mm, maximum depth of stone 270mm, maximum width (behind face) 210mm.

**Plate 5 Architectural worked stone (no 5).**
