**Historic building recording  
at the Sergeants' Mess,  
formerly the Officers' Quarters,  
Le Cateau Barracks,  
Colchester, Essex  
November 2013**

**report prepared by  
Chris Lister**

**CAT Report 739**  
March 2014

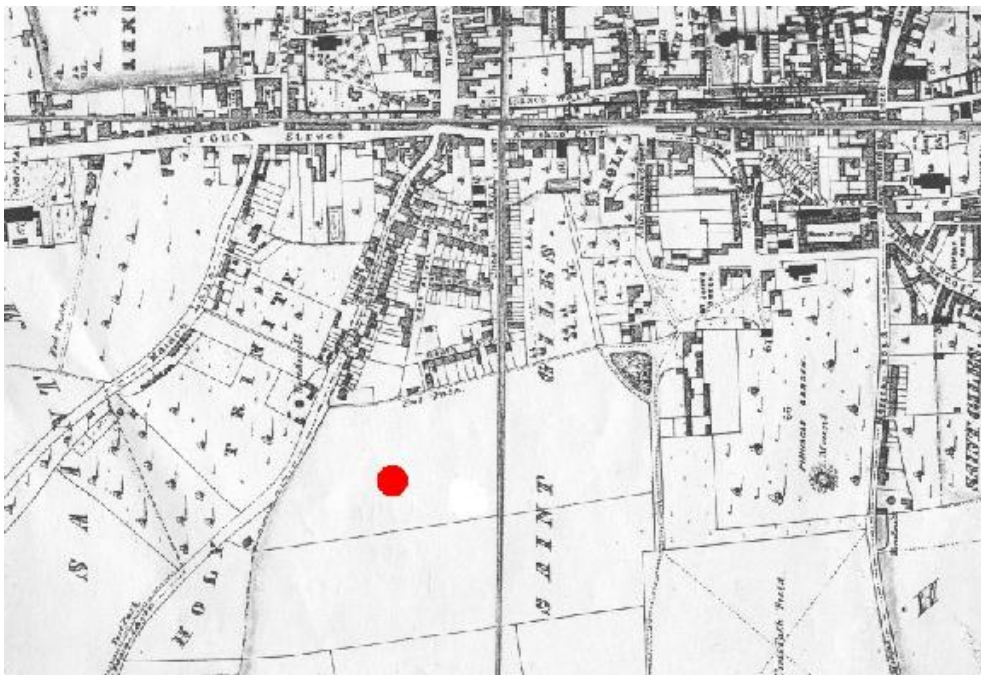
Map 2 Monson's map of Colchester, 1848 with the location of the Officers' Quarters marked as a red dot.

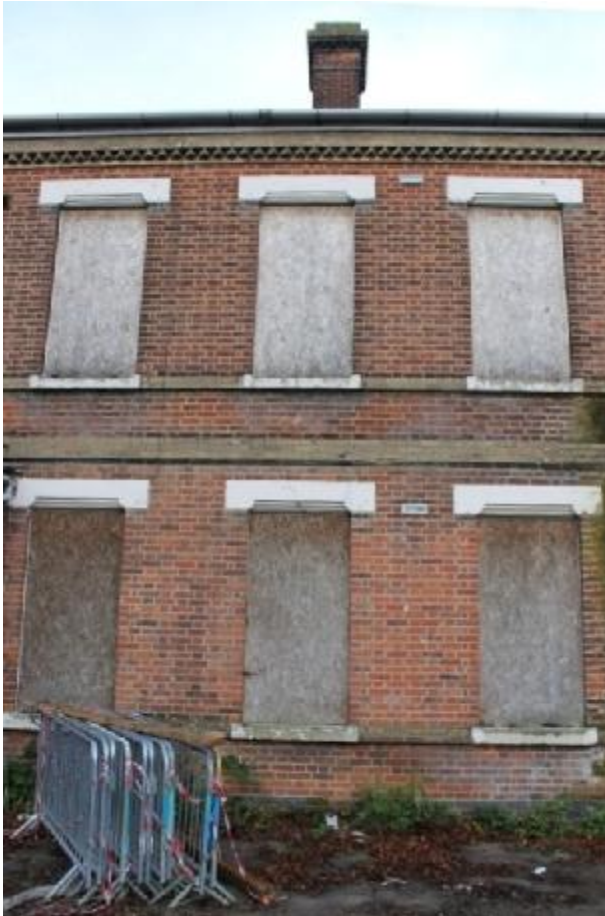
**Plate 1** Section of the south-east elevation, showing the windows with their cast lintels and sills and the decorative cornice and string lines of yellow stock brick - view north-west

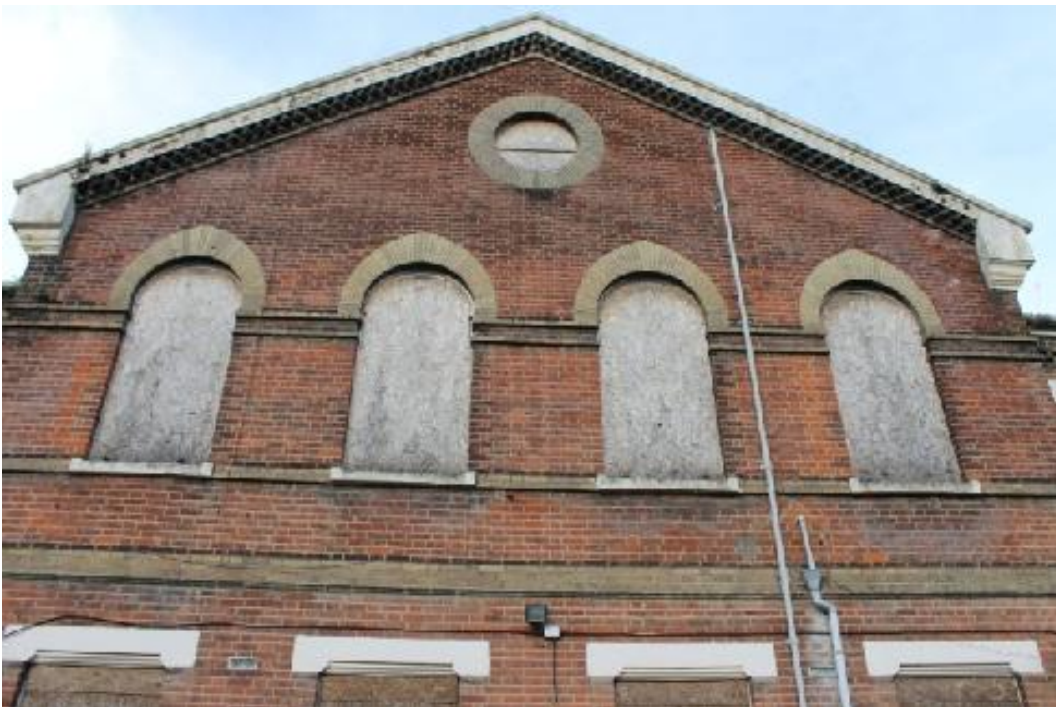
**Plate 2** Central projecting gabled section of south-east elevation, showing the pointed arches of the first floor windows and the oculus above – view north-west

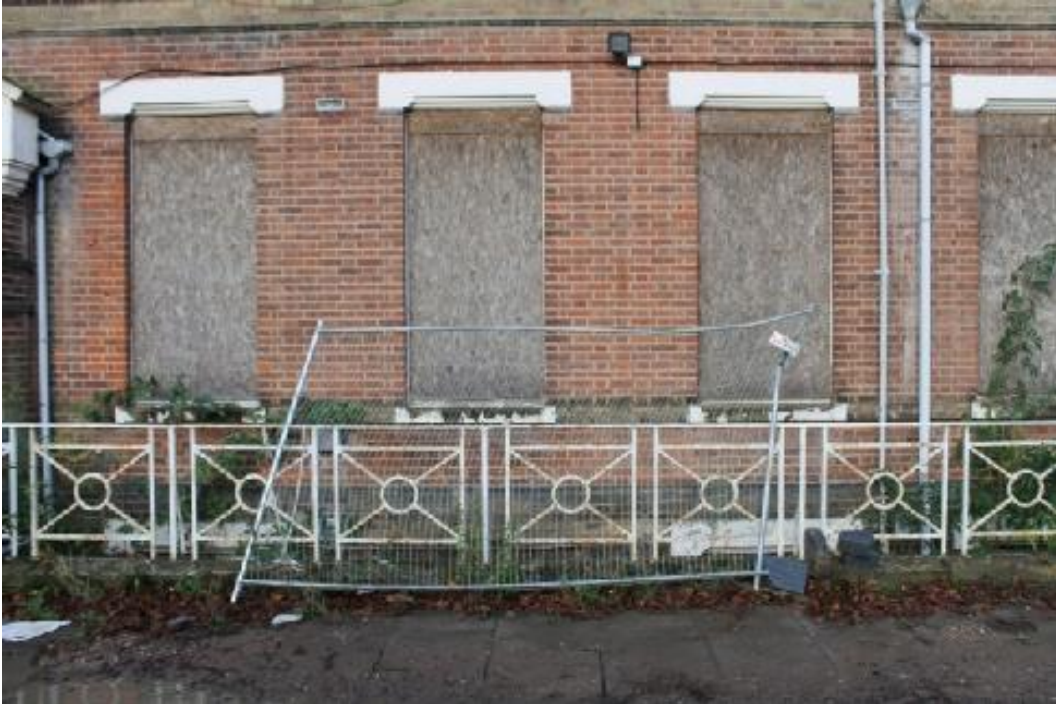
**Plate 3** Original railings to the light-well on the south-east elevation - view north-west

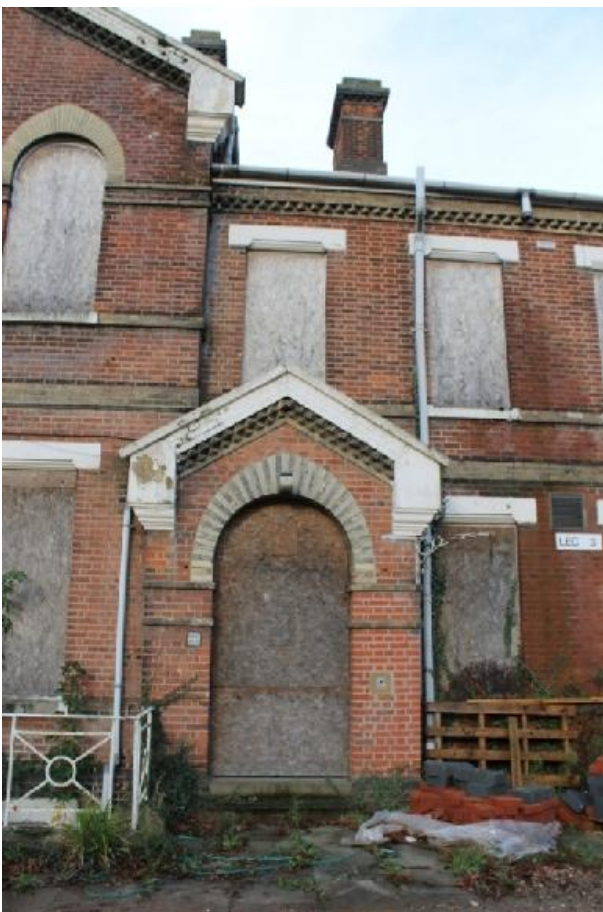
**Plate 4** Entrance way *iii*, showing the projecting gabled porch with the yellow stock brick embellishments, sandstone bell pull and iron bracket for gas lamp – view north-west

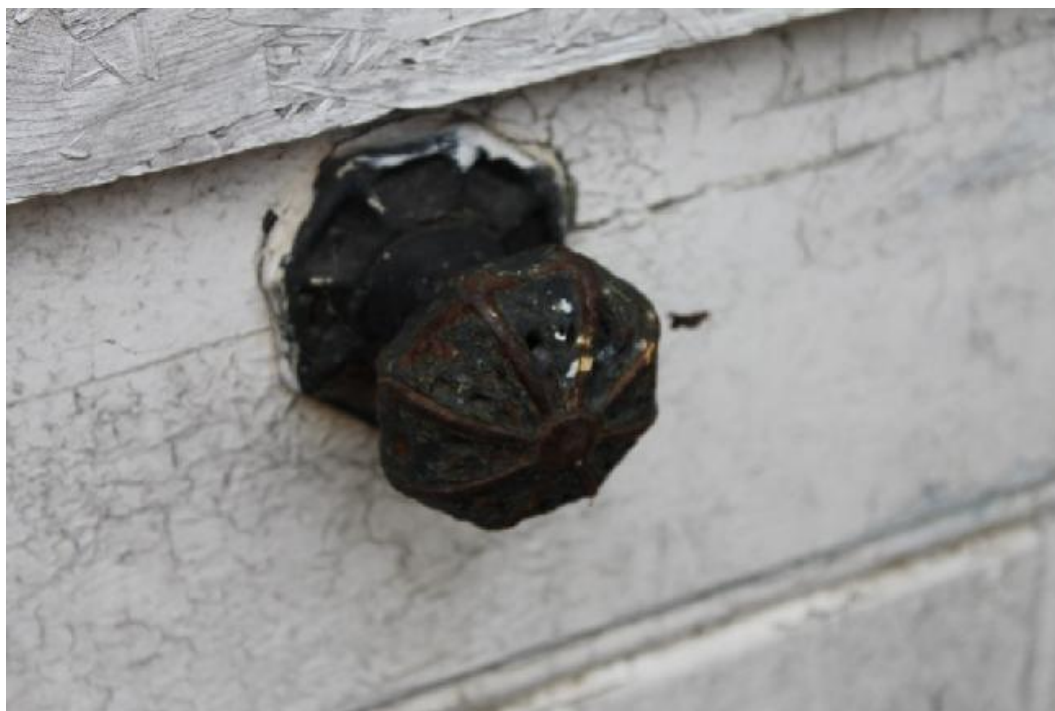
**Plate 5** Detail of the original door knob on the entrance way doors

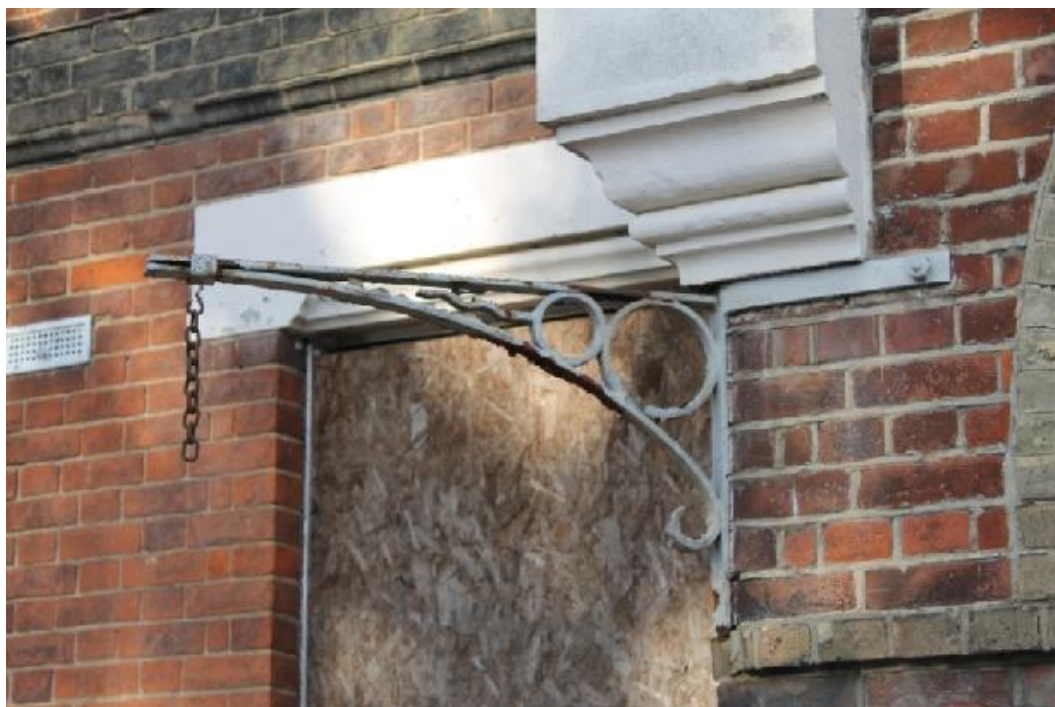
**Plate 6** Detail of the iron bracket and chain for the original gas lamp on the corner of entrance way *i*

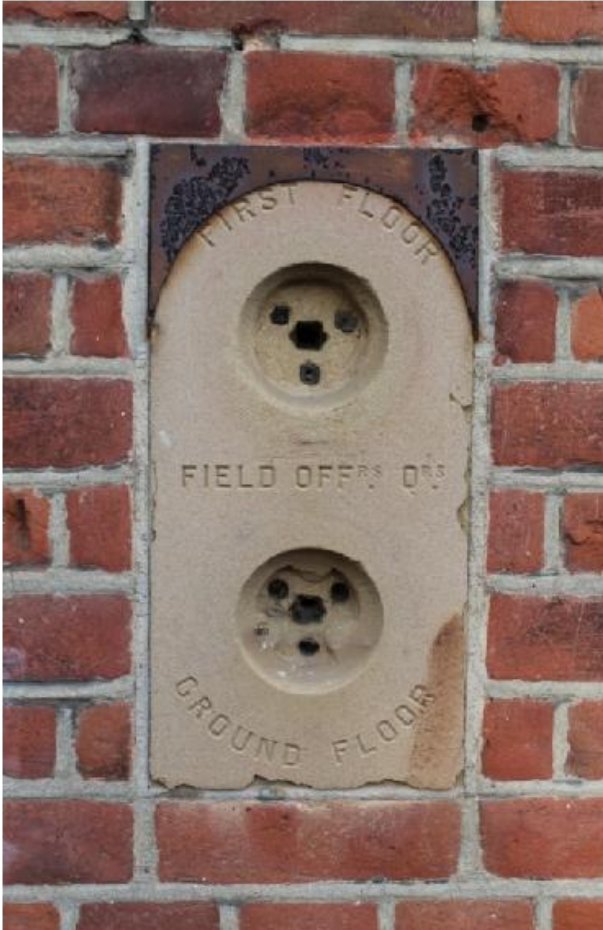
**Plate 7** Detail of the sandstone block housing the bell pulls to the Field Officers' Quarters on entrance way *i*

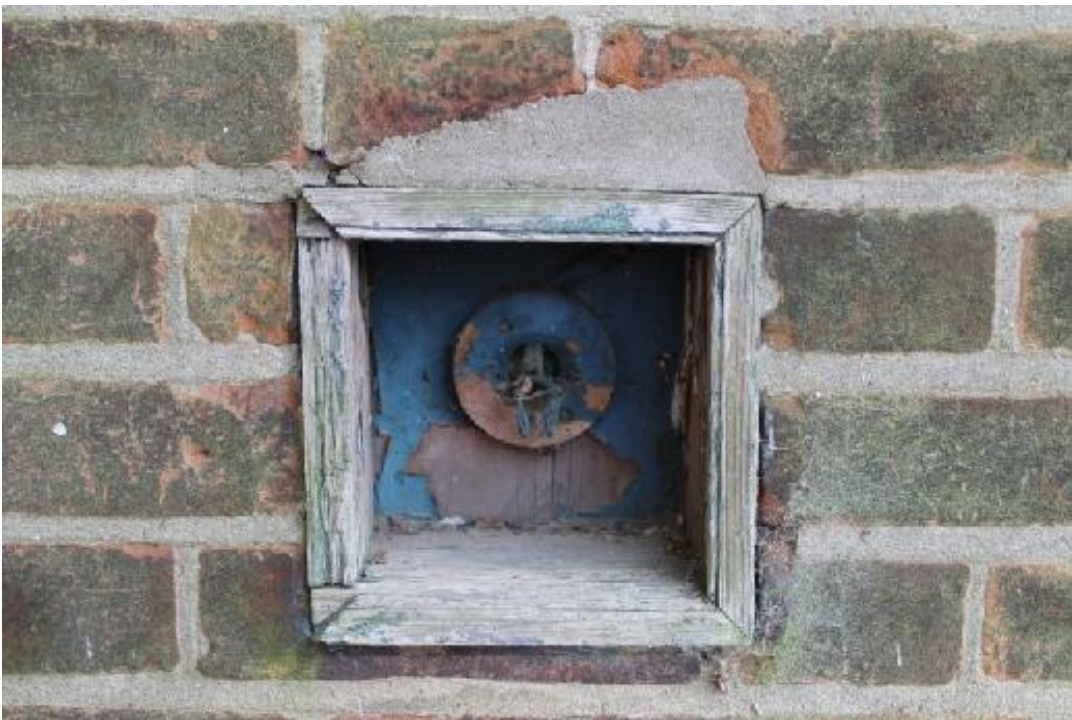
**Plate 8** Detail of the wooden housing for electric door bell to the 1904 extension, inserted into the side wall of entrance way *i*

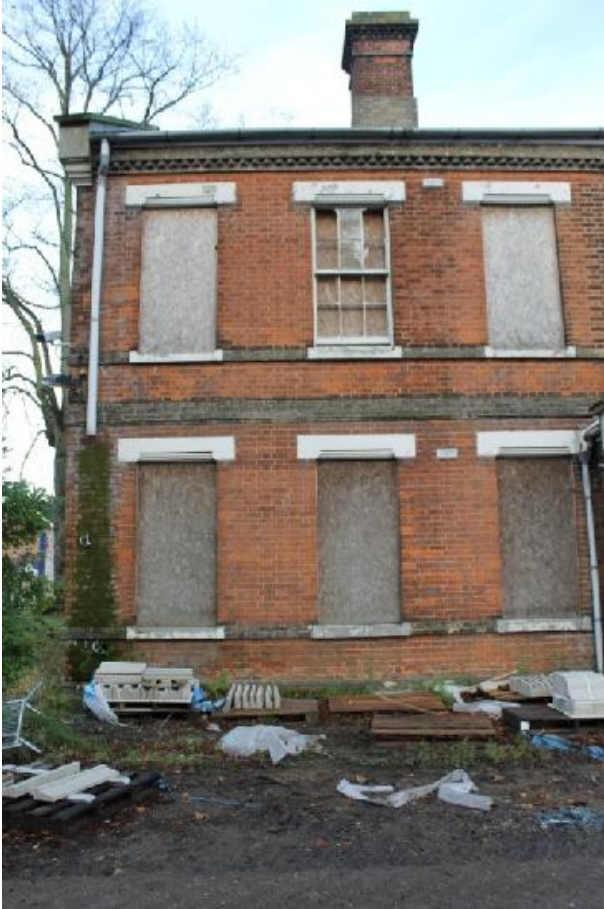
**Plate 9** South-east elevation of the 1904 extension to the Officers' Quarters, showing the continuation of the architectural embellishments; the change in the brickwork is visible in the top right of the photograph - view north-west

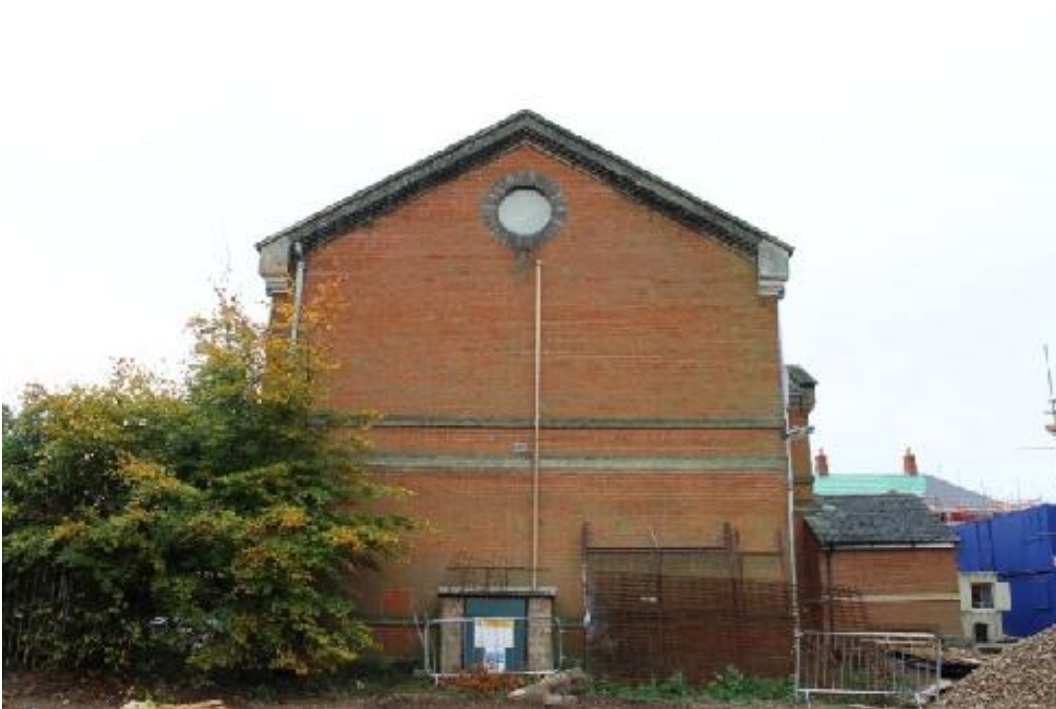
**Plate 10** North-east elevation of the 1904 extension, with the 1980s toilet block to the right - view south-west

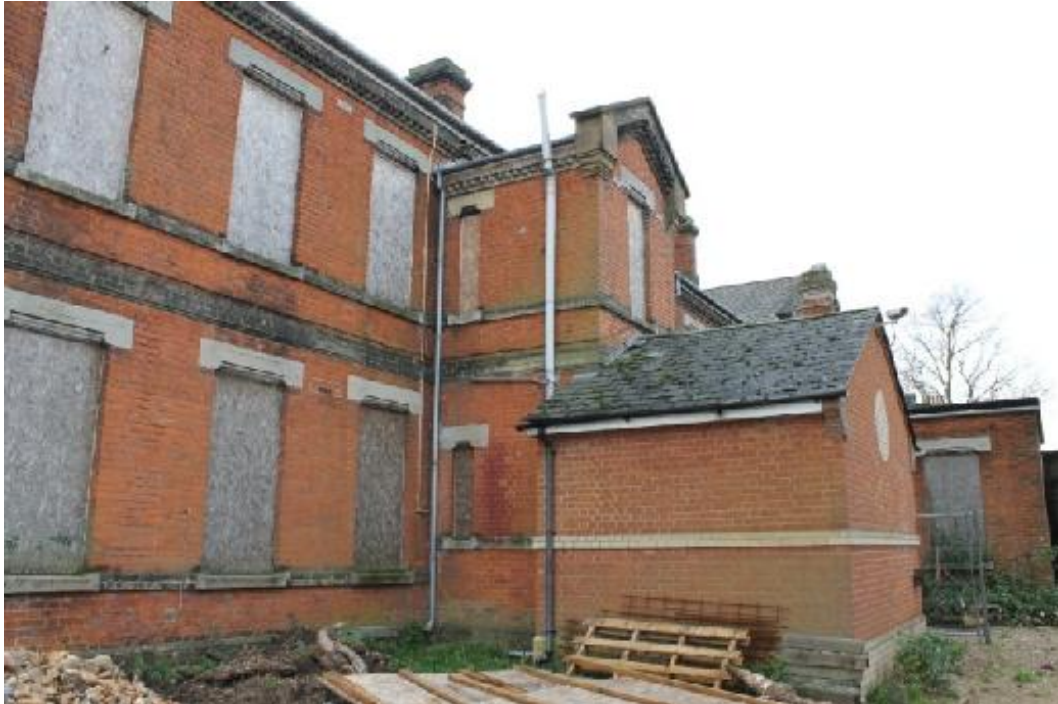
**Plate 11** The north-west elevation showing the 1904 extensions, with the additional officers' accommodation to the left, the projecting ablution block and the 1980s toilet block – view south

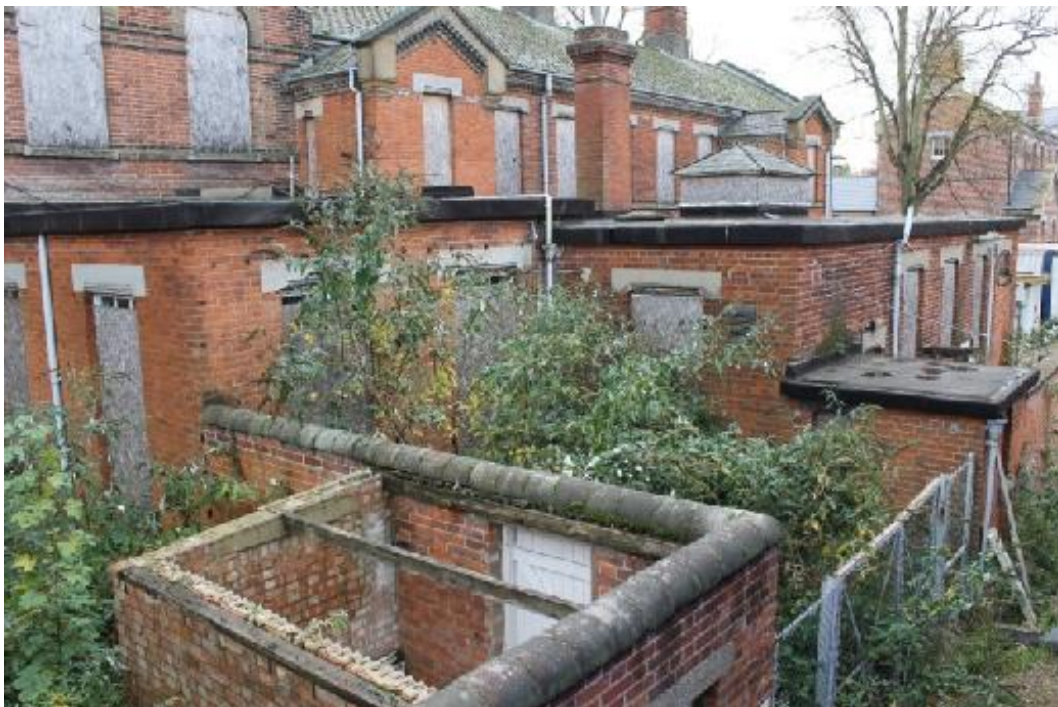
**Plate 12** The north-west elevation with the 1922-62 single-storey extensions in the foreground - view south

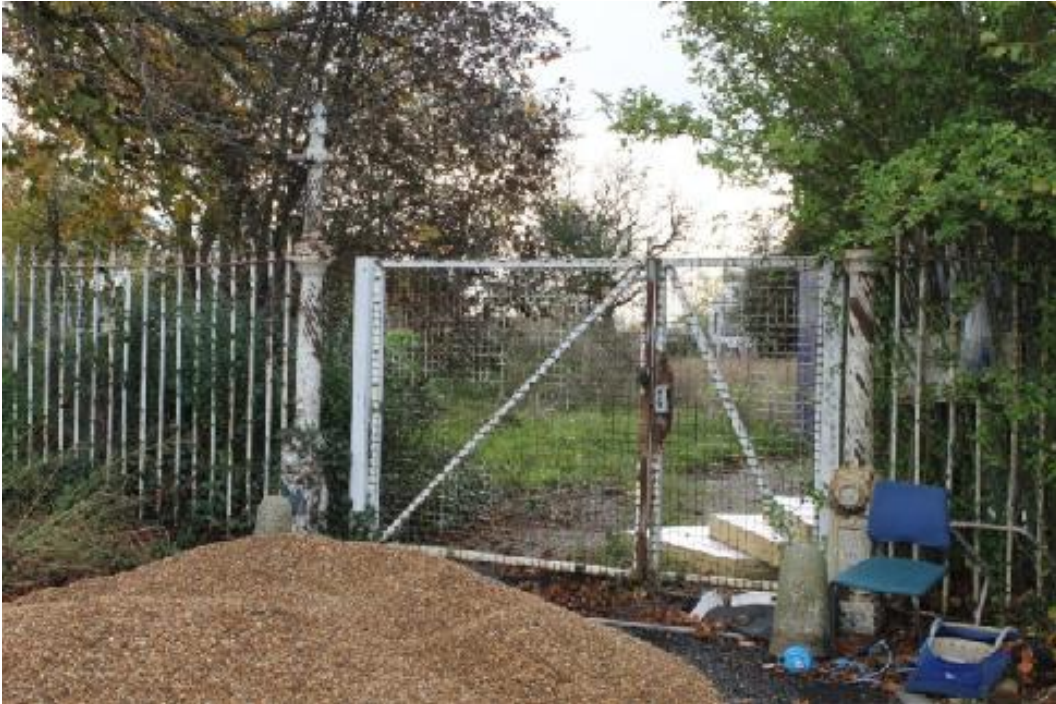
**Plate 13** The 1904 railings and barley twist gate posts with integrated gas lamps  
– view east

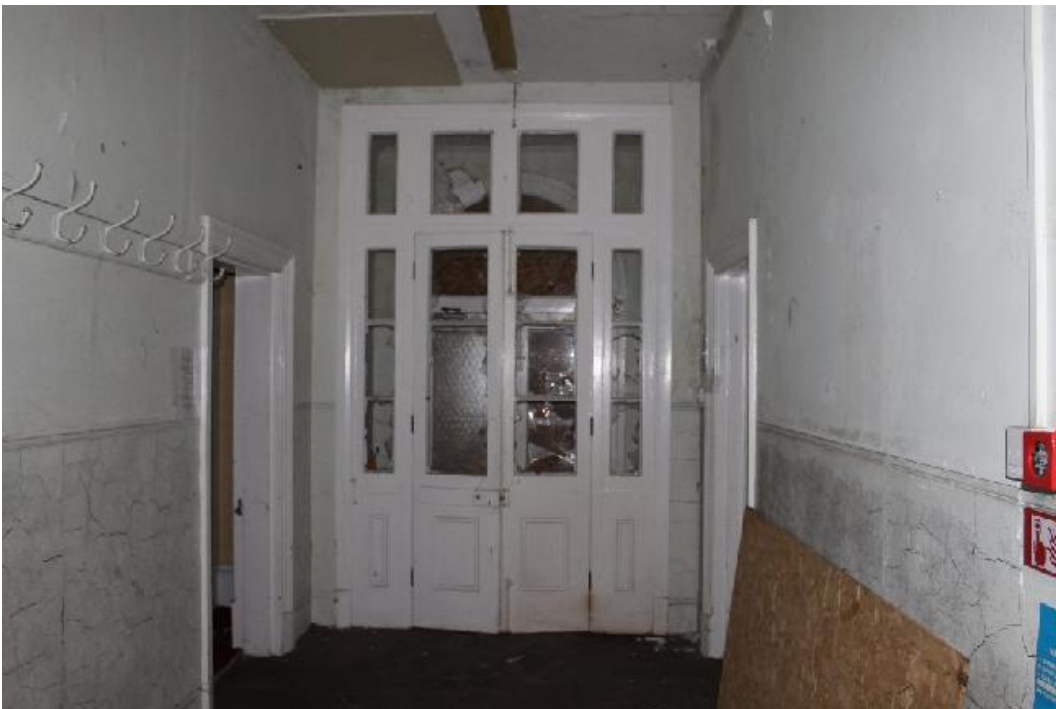
**Plate 14** Entrance way ii, showing the original inner and outer doors of the porch and original coat hooks on the left wall - view south-east

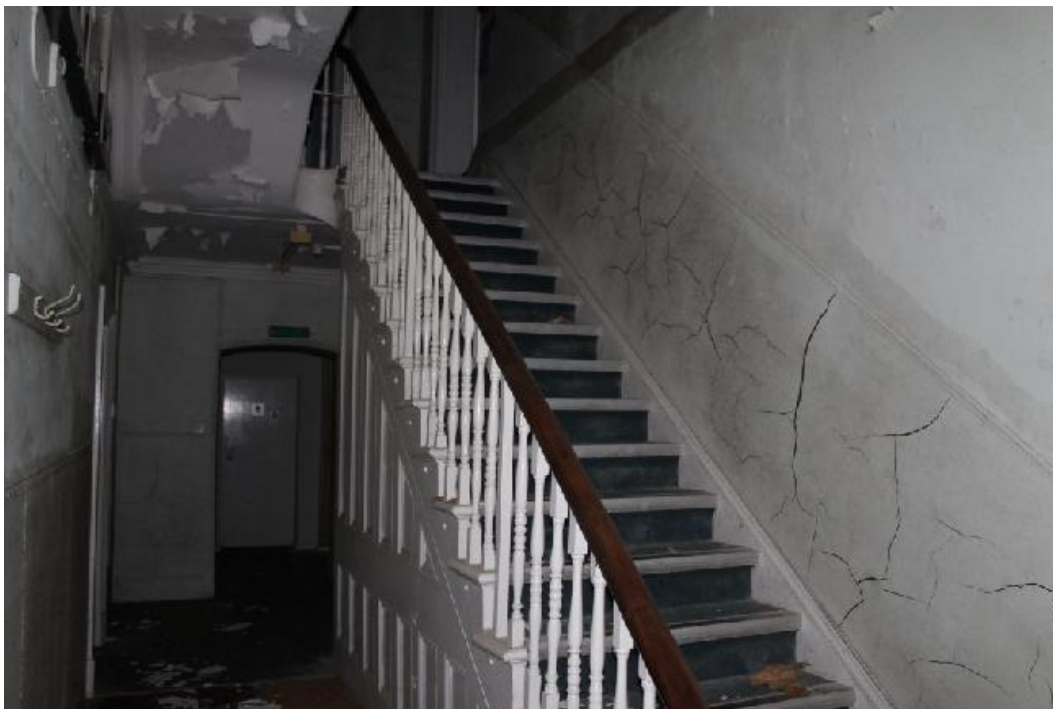
**Plate 15** Stairwell *iv*, showing the original staircase, coat hooks and the entrance to the 1904 lavatory – view north-west

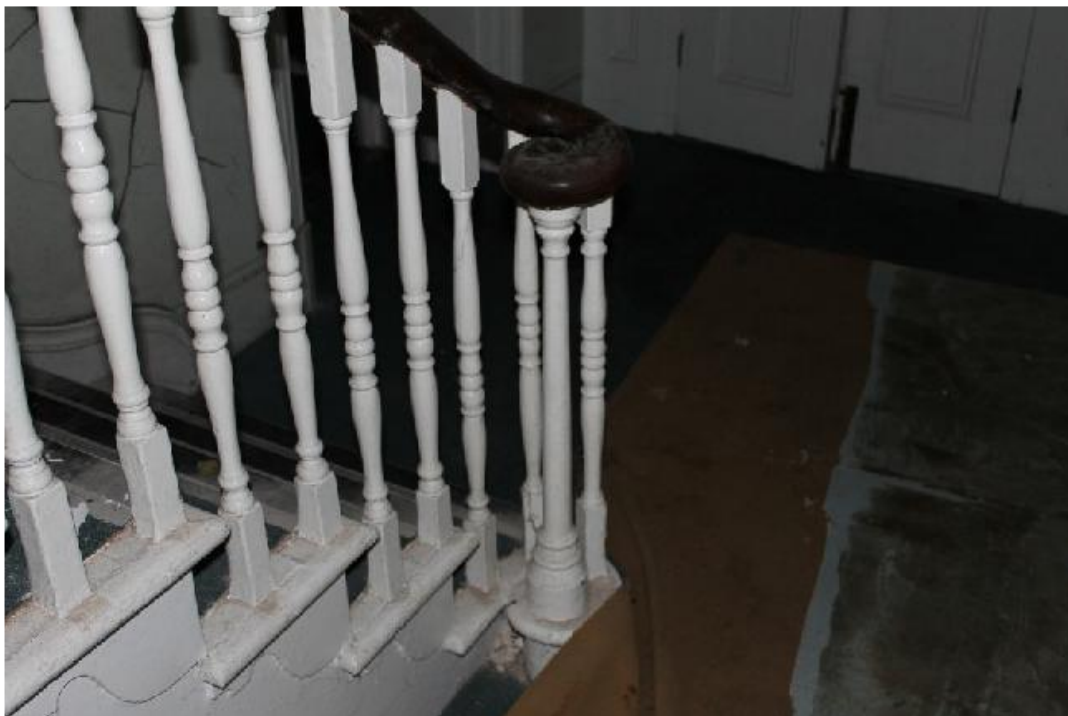
**Plate 16** Stairwell *iv*, detail of the mahogany banister with spiral end and the turned balusters of the open string staircase

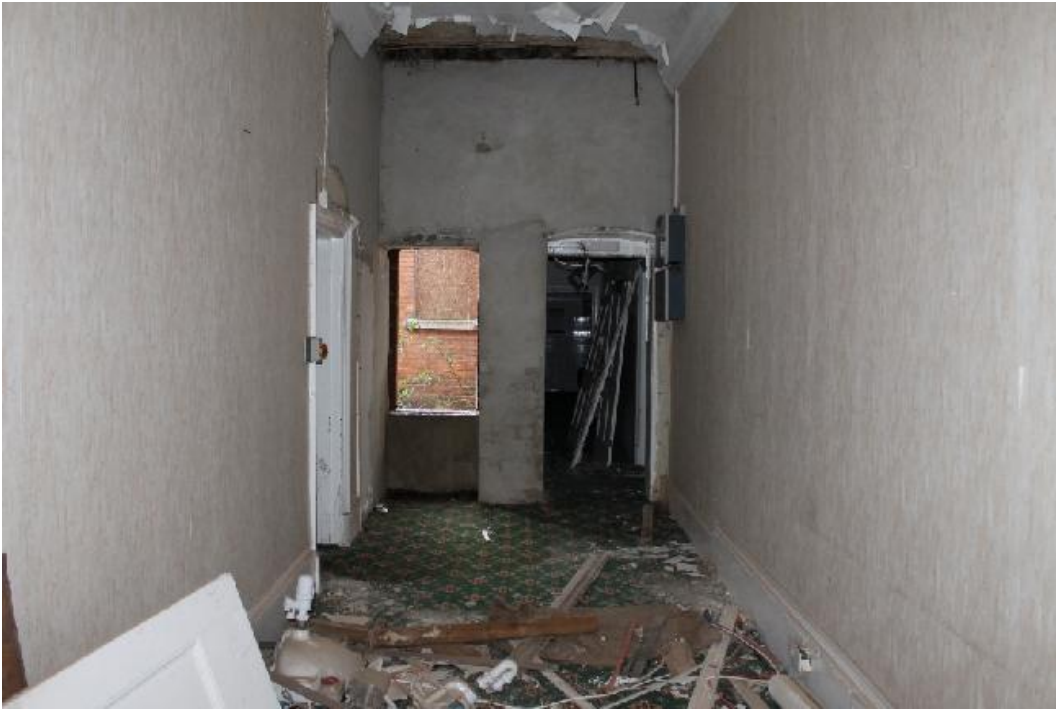
**Plate 17** Entrance way *iii* with the removed staircase and the 1904 toilet block to the rear - view north-west

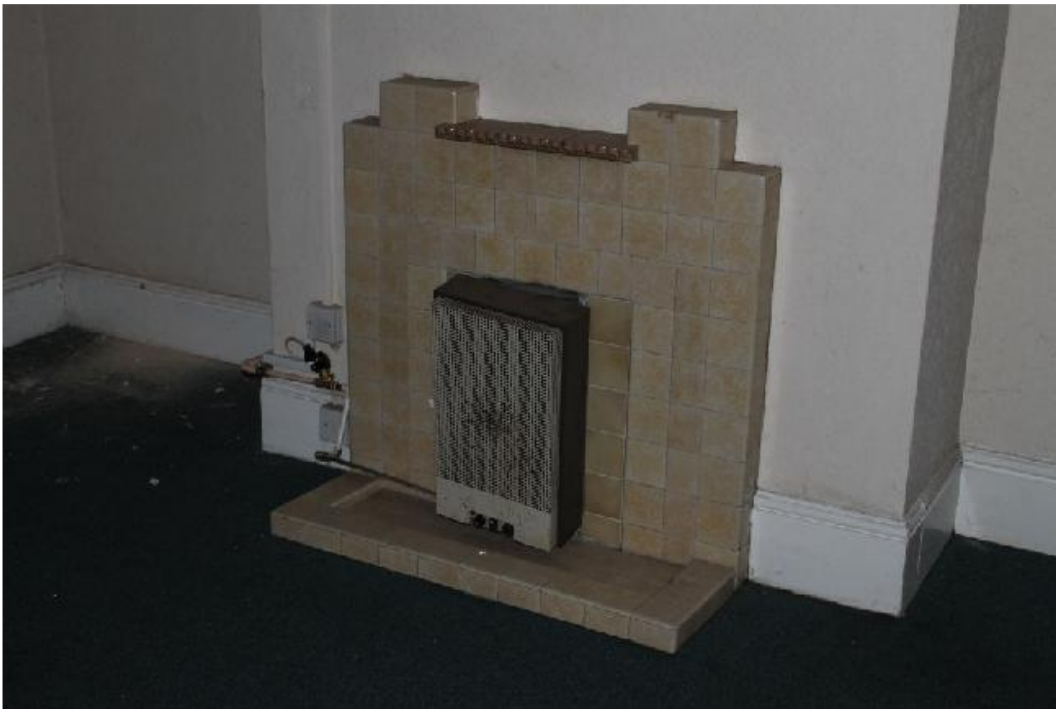
**Plate 18** Example of the replacement 1930s Art Deco fireplace with the later gas fire, found in each of the accommodation rooms

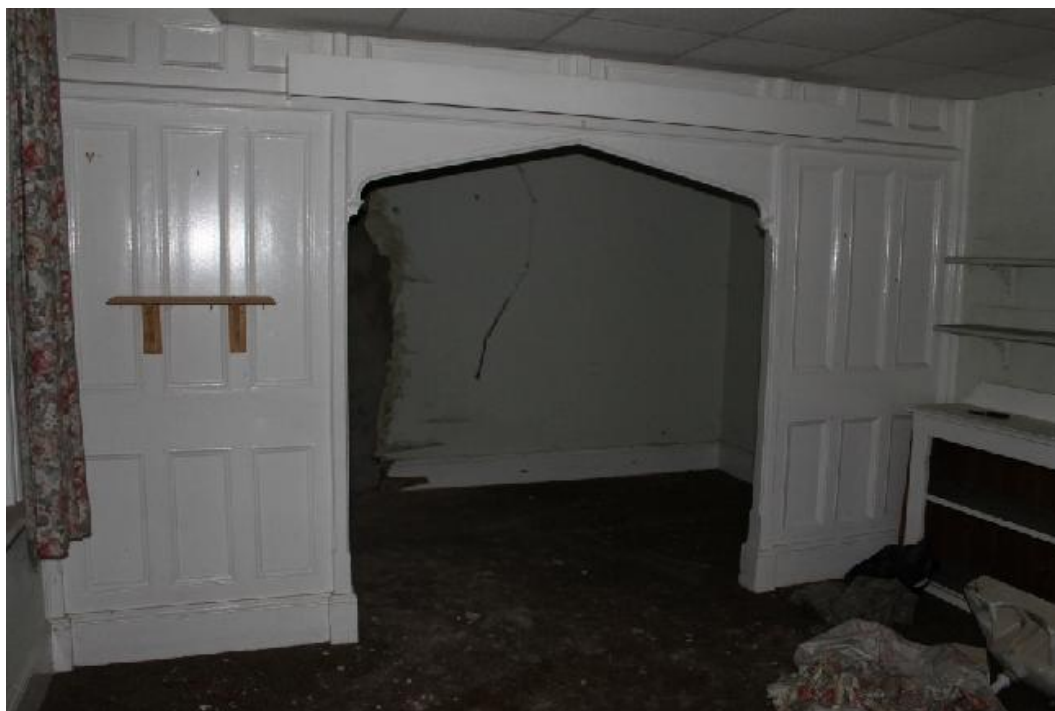
**Plate 19** Original wooden partition in room 2 separating the sleeping area from the sitting room – view south-west

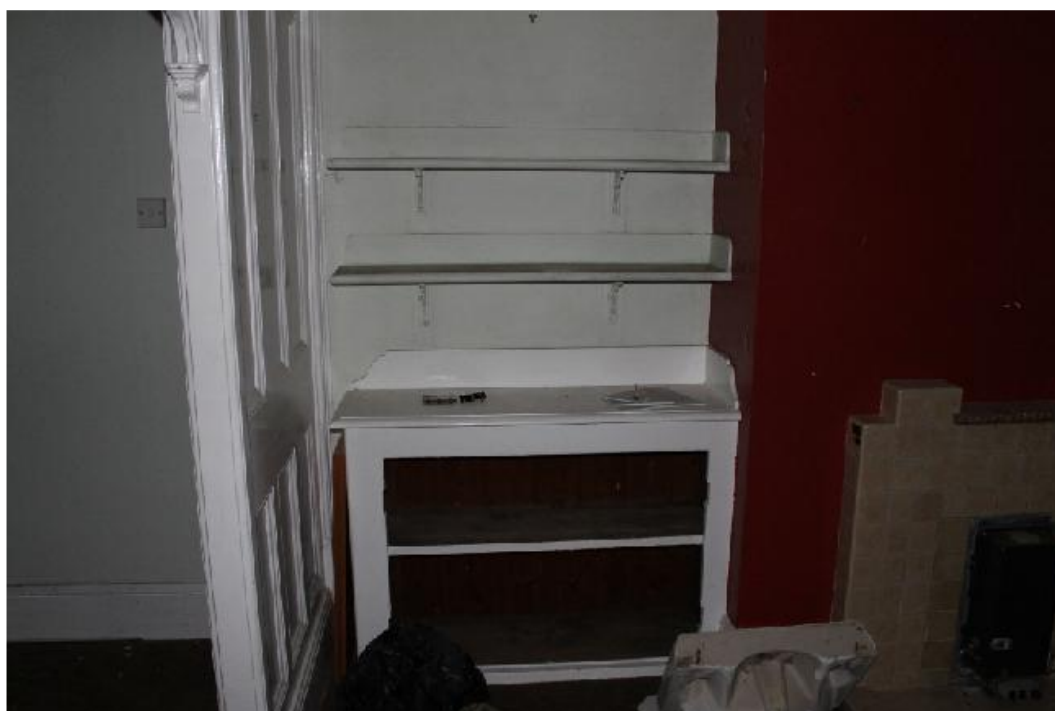
**Plate 20** Dresser and shelving in room 2, either relocated from the 1876 rooms or faithfully reproduced – view north-west

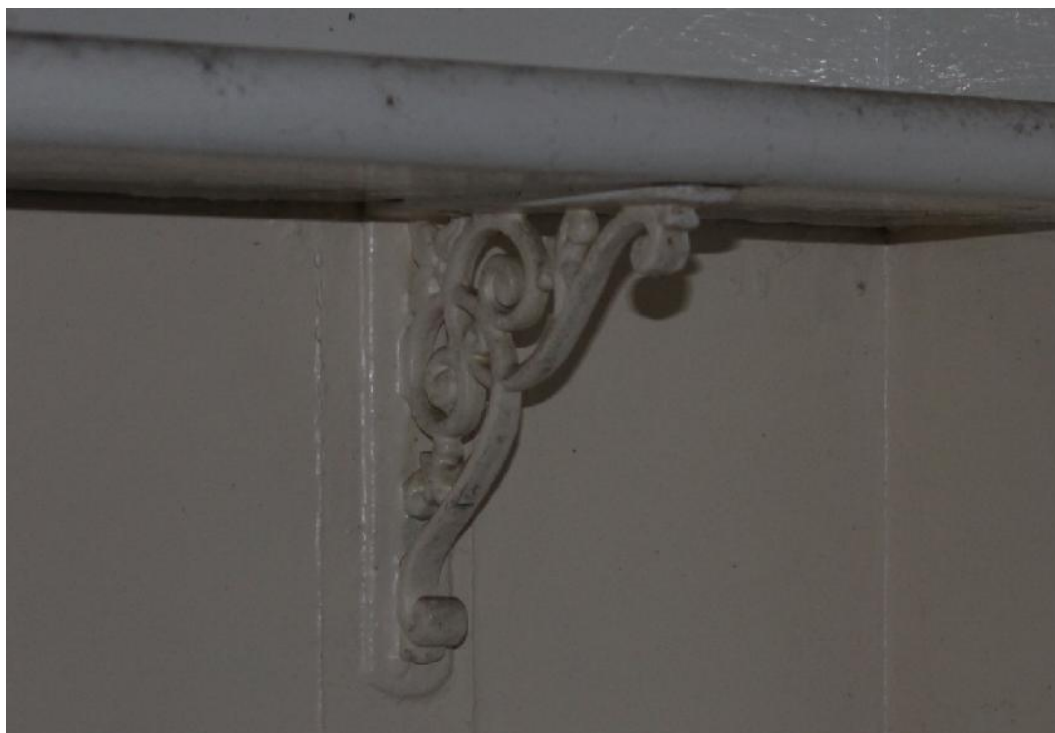
**Plate 21** Detail of the ornate shelf brackets common to both the 1876 rooms and the 1904 extensions

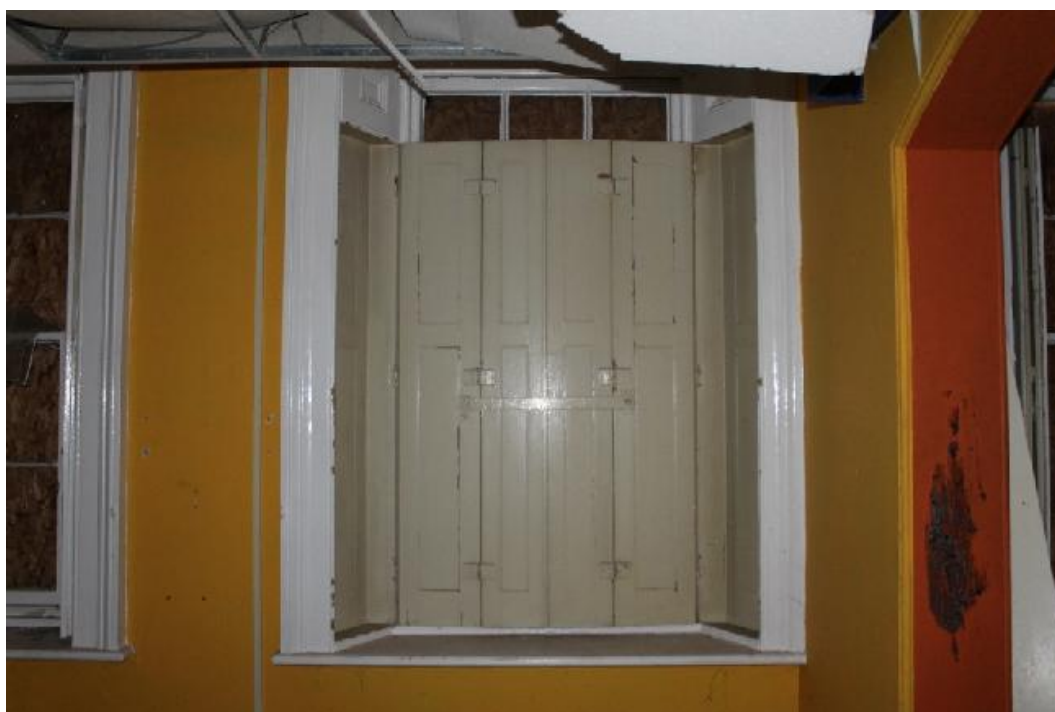
**Plate 22** Example of the sash windows with recessed wooden shutters in the ground floor rooms of the 1874-5 building - view south-east

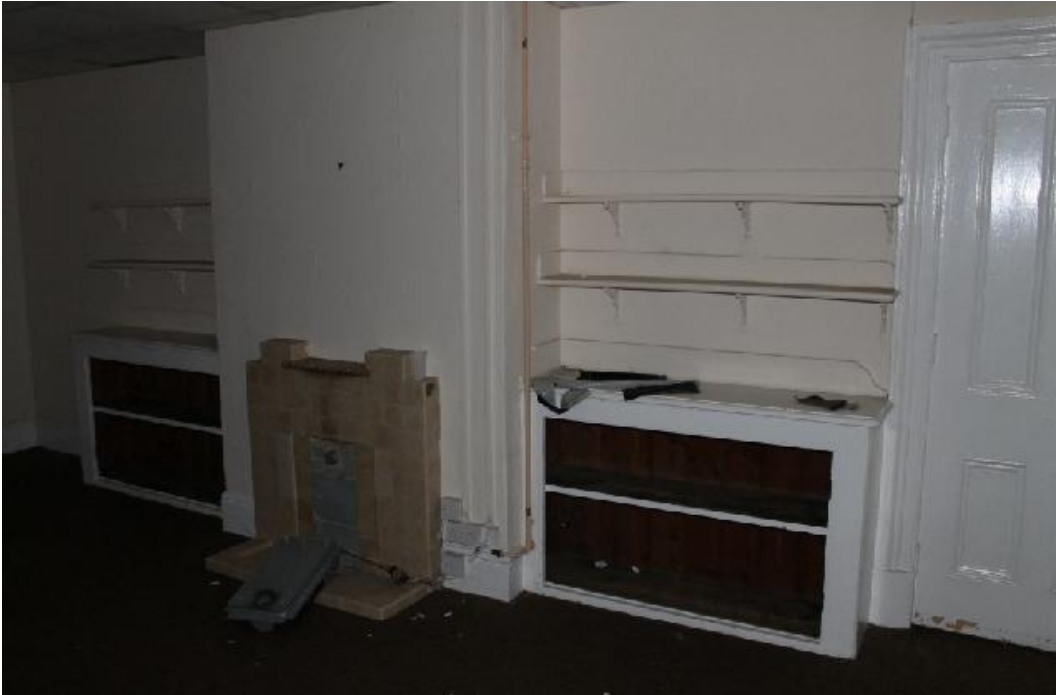
**Plate 23** Room 4, formerly the sitting room of the second Field Officer, with the original four-panel door leading to the bedroom of said officer – view west

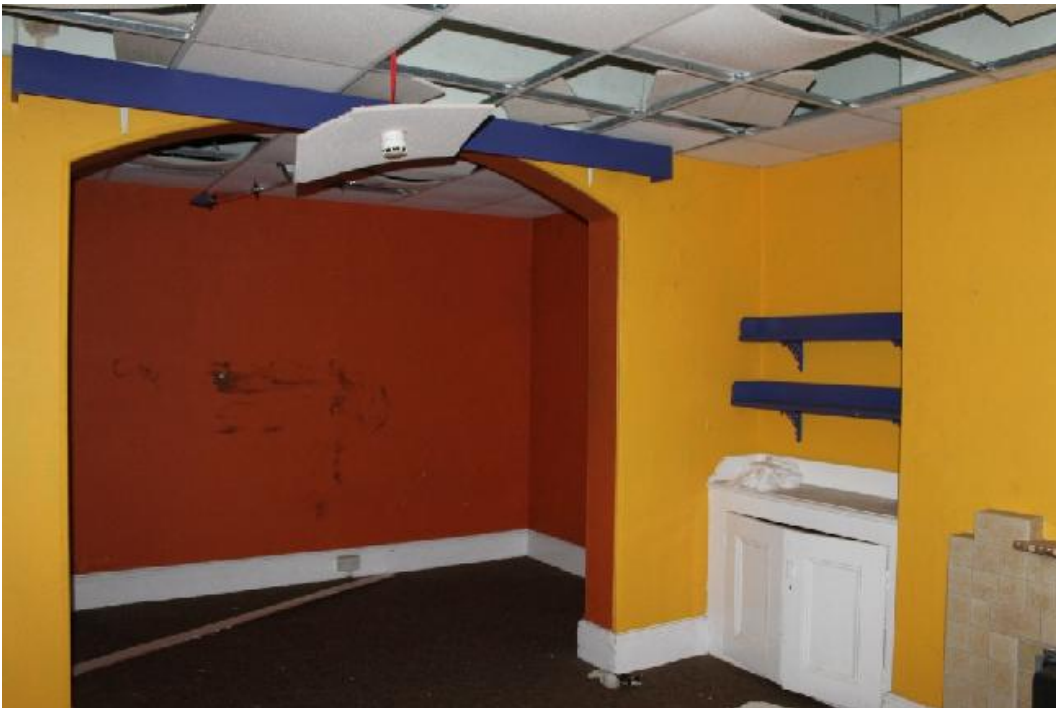
**Plate 24** Room 7, formerly the quarters for Officer No.1, showing the brick arch separating the sleeping area from the sitting room, with the original dresser and shelving to the left of the chimney breast – view south

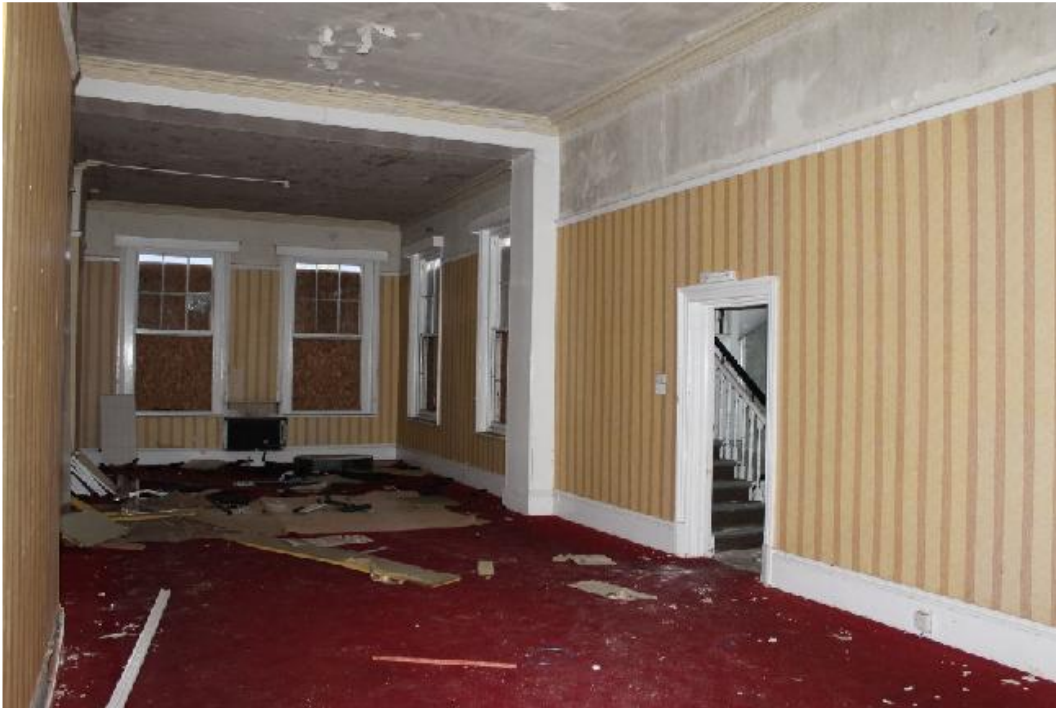
**Plate 25** The mess room with the 1922-62 extension to the rear and the original doorway to the servant's stairs in the right-hand wall – view north

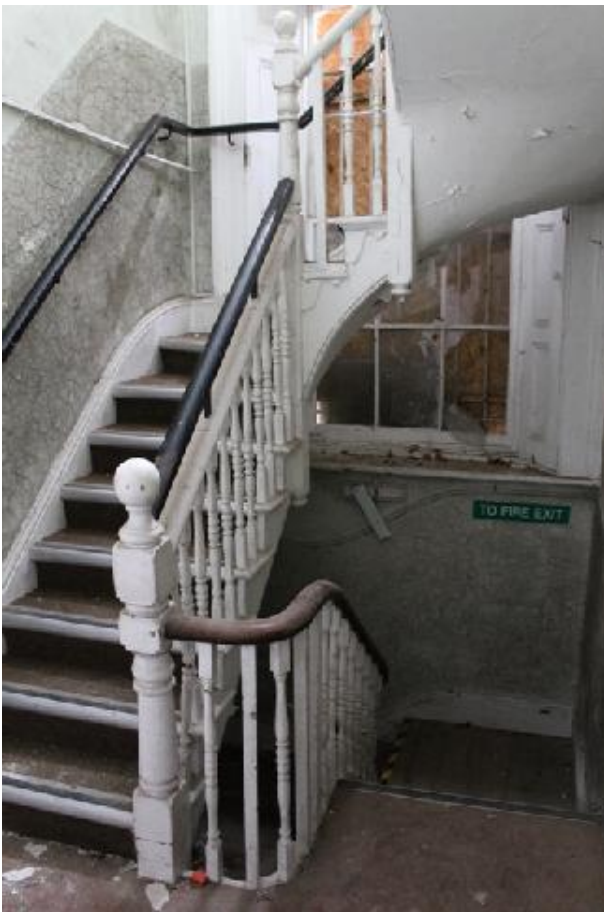
**Plate 26** Servants' stairwell v, with the original access to the basement and the inserted staircase to the first floor - view west

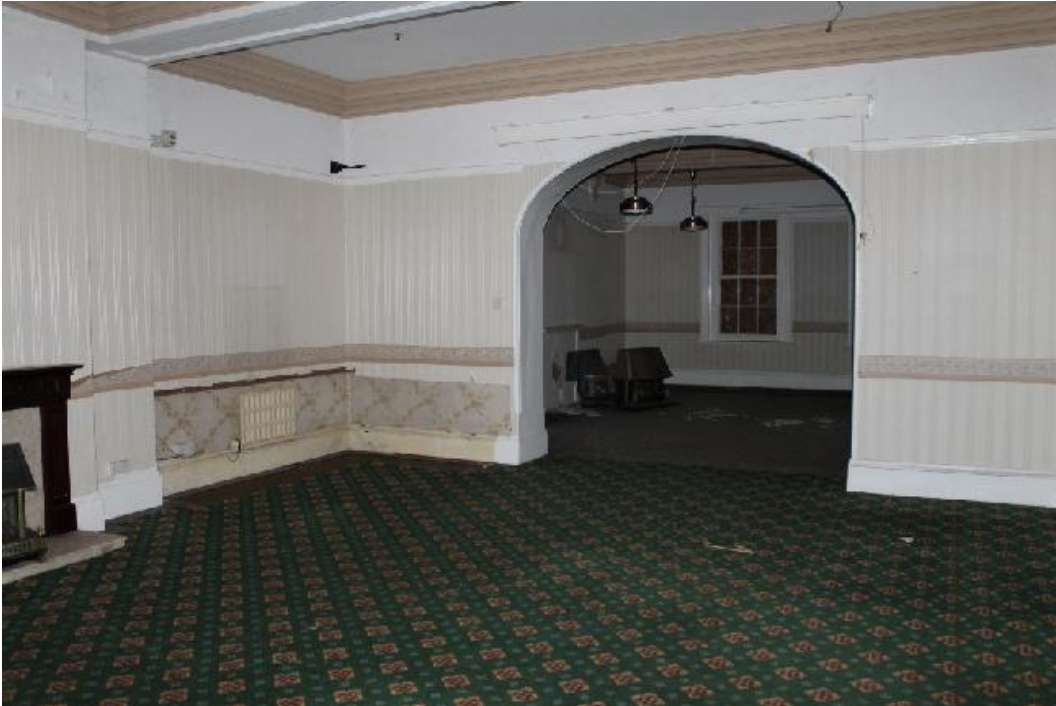
**Plate 27** The 1904 bar converted from the quarters for Officers Nos.2 and 3, with the extension through the archway and the inserted fireplaces on the left-hand walls – view west

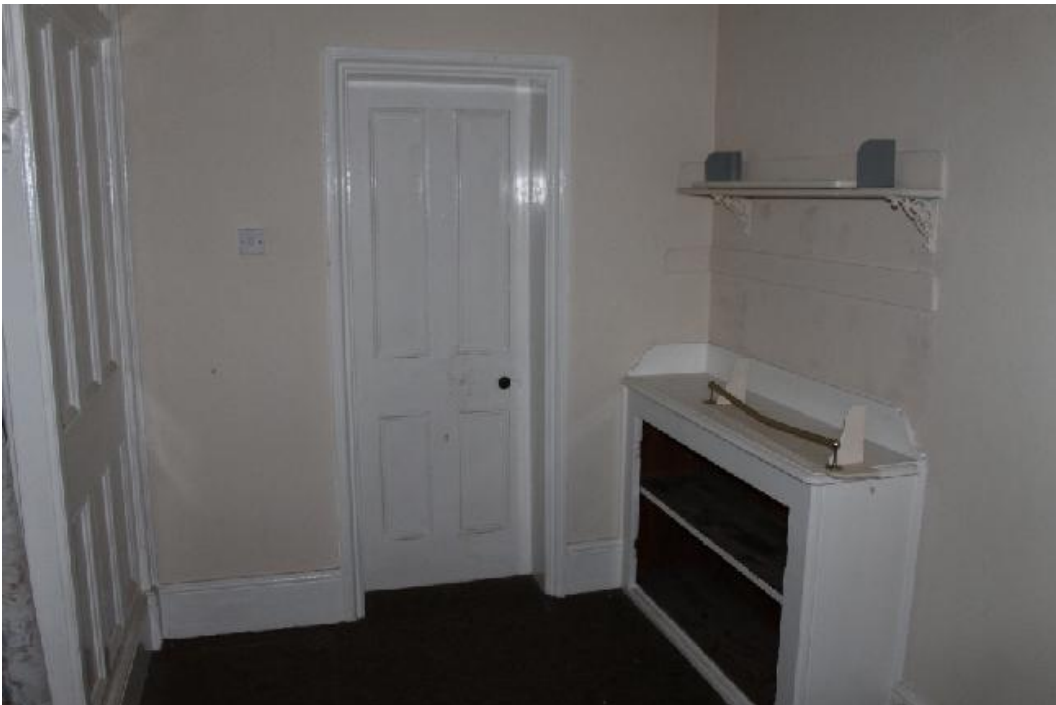
**Plate 28** Room 11, showing the additional dresser and shelving in the sleeping area and the connecting doorway with the sleeping area of Room 12 – the panelled wooden partition separating the sleeping area from the sitting room can be seen on the left – view south-east

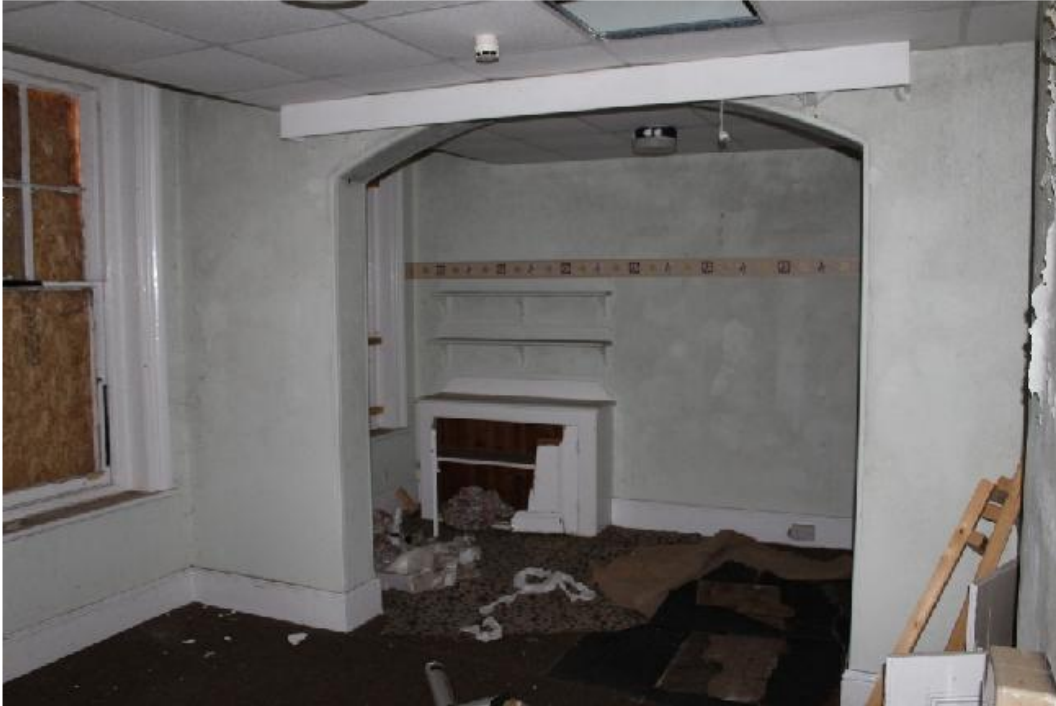
**Plate 29** Room 17, the former quarters for Field Officer No.6, showing the repositioned dresser in the sleeping area and the windows without the recessed wooden shutters – view south

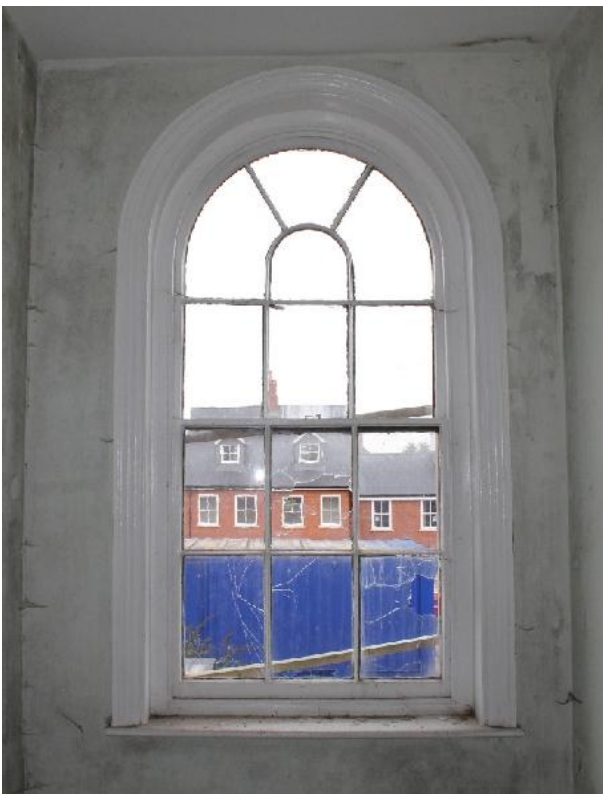
**Plate 30** Example of the Italianate sash windows found in rooms 18-21
