**Historic building recording  
at the Sergeants' Mess,  
formerly the Officers' Quarters,  
Le Cateau Barracks,  
Colchester, Essex  
November 2013**

**report prepared by  
Chris Lister**

**CAT Report 739**  
March 2014

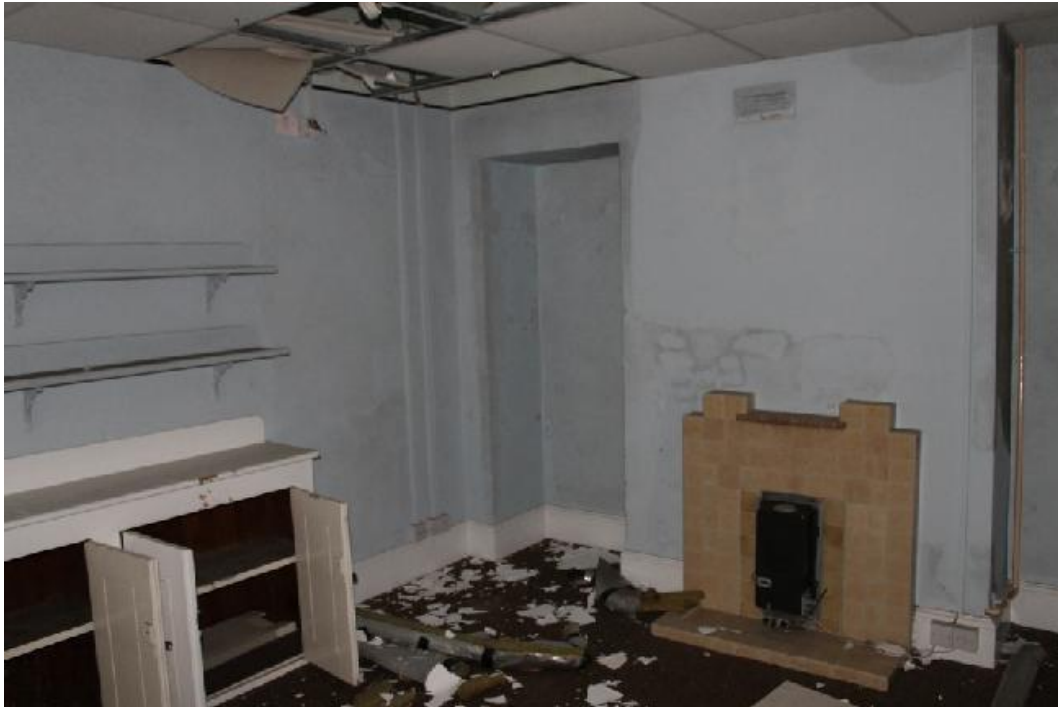
**Plate 31** Room 18, formerly quarters for the servants of Officers Nos.1, 6 and 7, showing the bricked-in original doorway to the left of the chimney breast and the double-width dresser on the dividing wall – view south

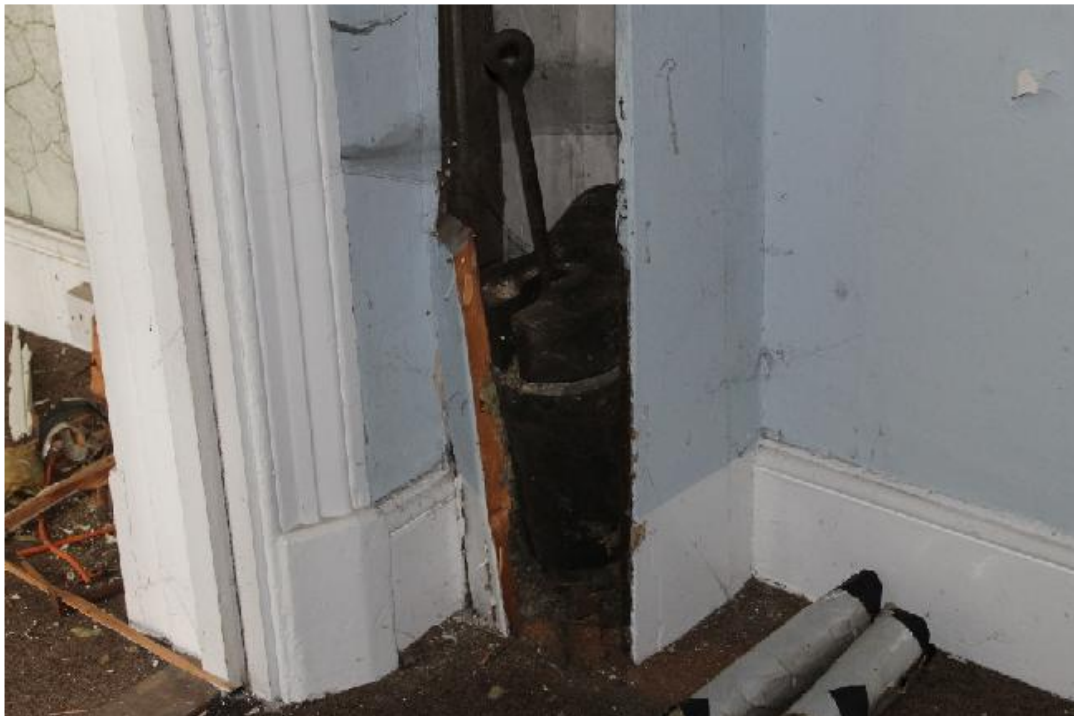
**Plate 32** One of the original counter-balances for the food lift, located in the corner of room 18 – view north-east

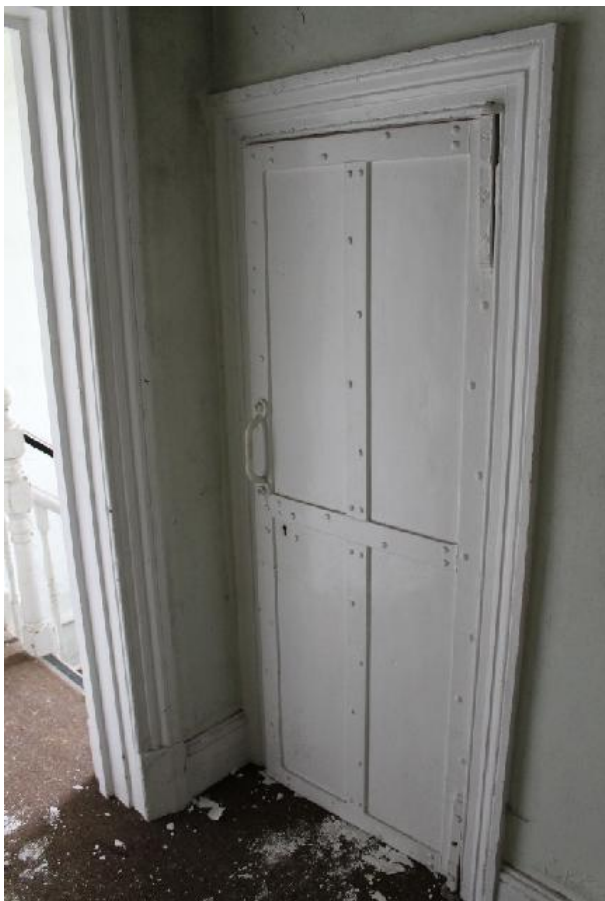
**Plate 33** Iron door to strongroom 20, converted from the former servants' quarters for Officers Nos.2 and 3 - view west

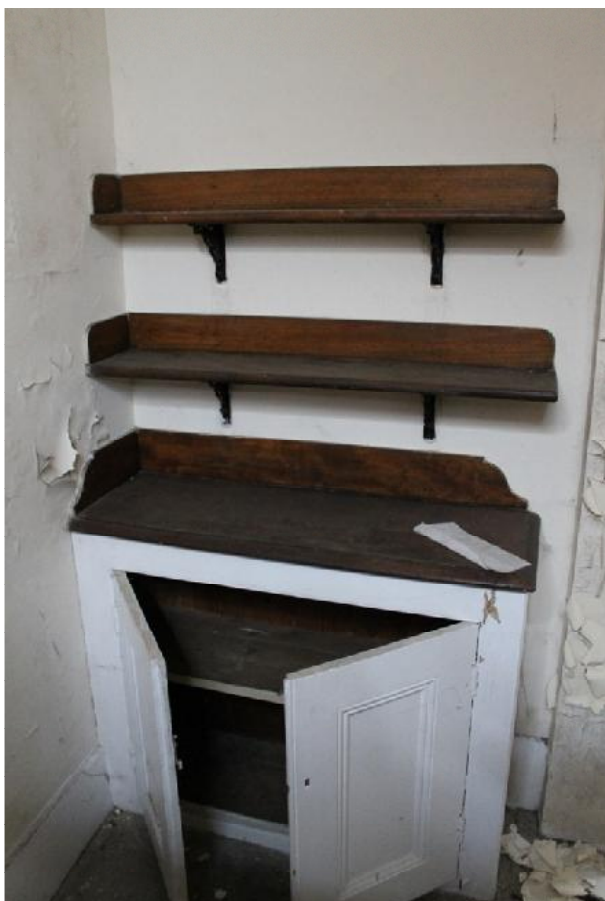
**Plate 34** Detail of relocated dresser in room 20, showing the unpainted finish – view north-east

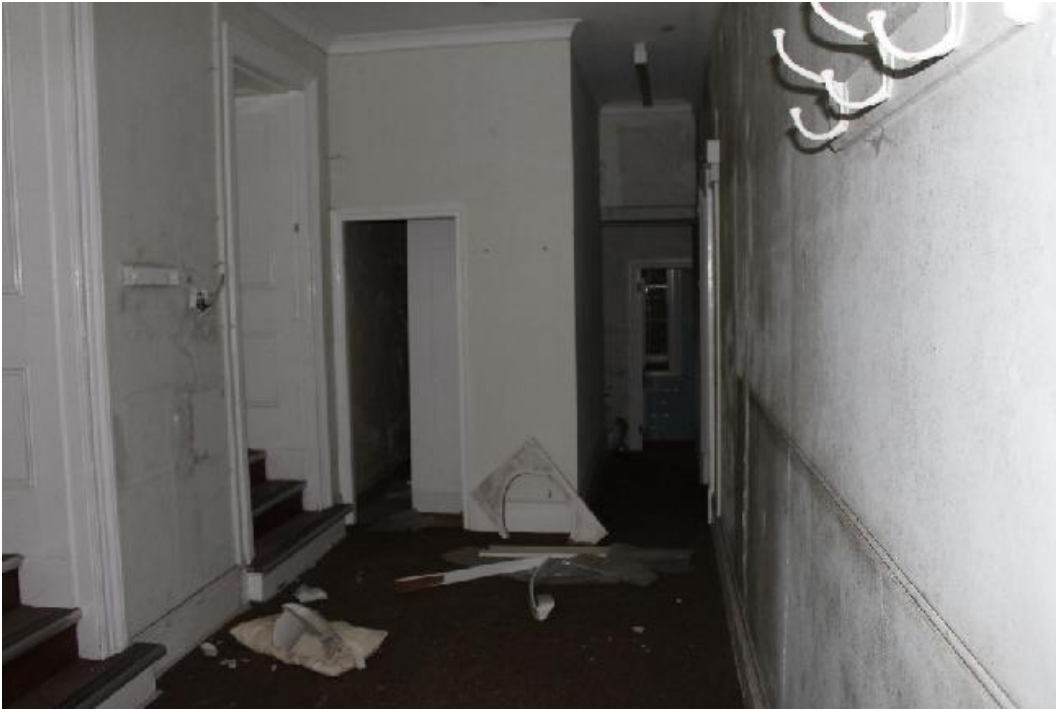
**Plate 35** The converted landing of the former stairwell *iii*, with the inserted shower room, the 1904 ablution block to the rear and the original doorways to the servants' quarters in the left-hand wall – view north-west

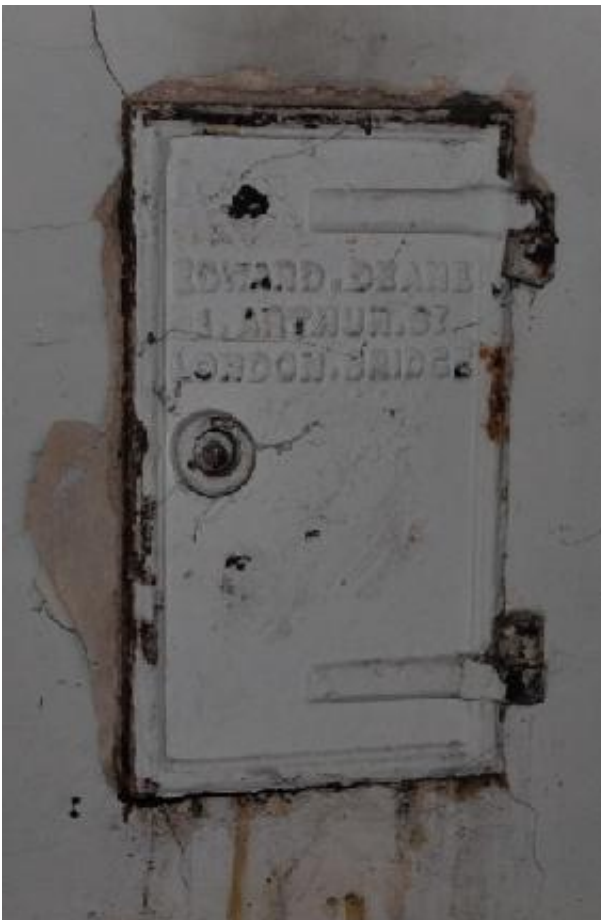
**Plate 36** Detail of the original soot door in the first floor wall of stairwell *iii*

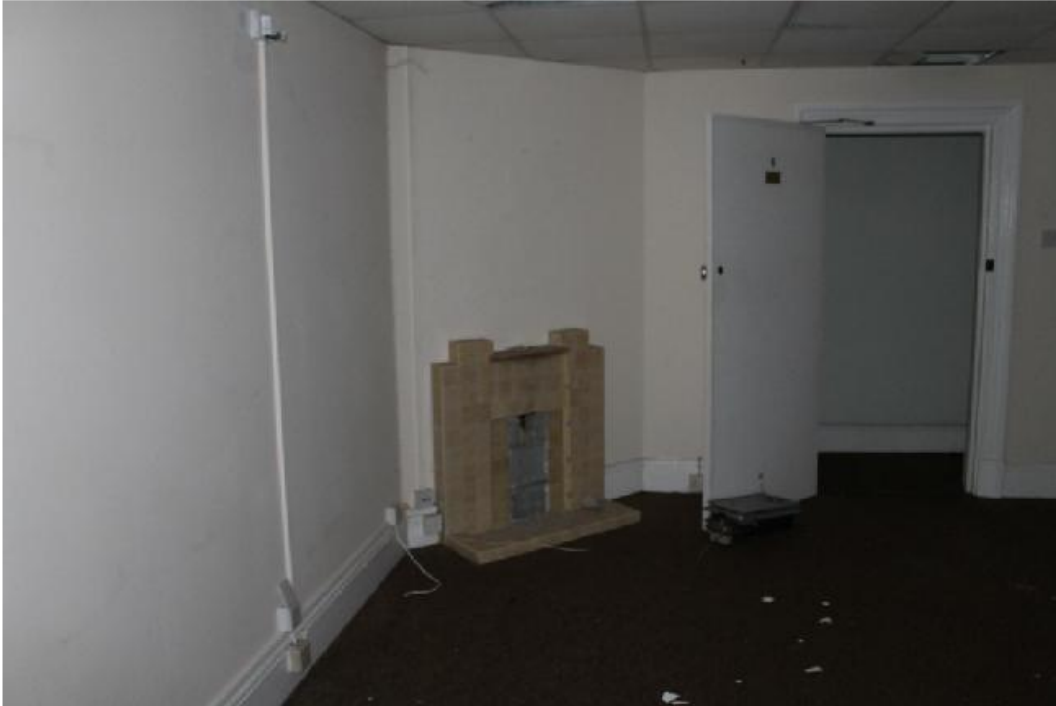
**Plate 37** Room 22, formerly the quarters for Officer No.9, showing the relocated doorway and fireplace – view south-west

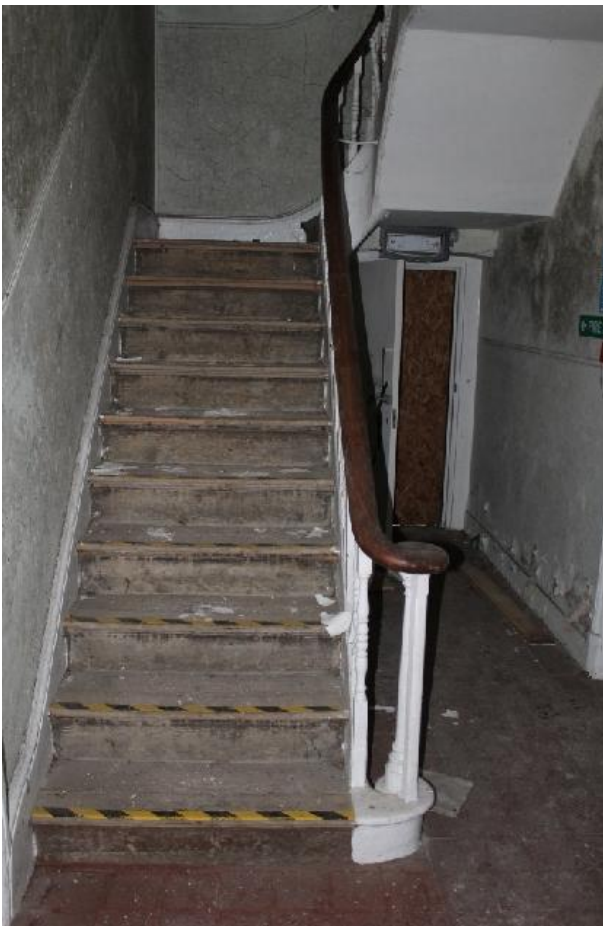
**Plate 38** Stairwell v, the basement stairs with the same mahogany banister with spiral end and turned balusters as the staircases of the entrance ways – view north-west

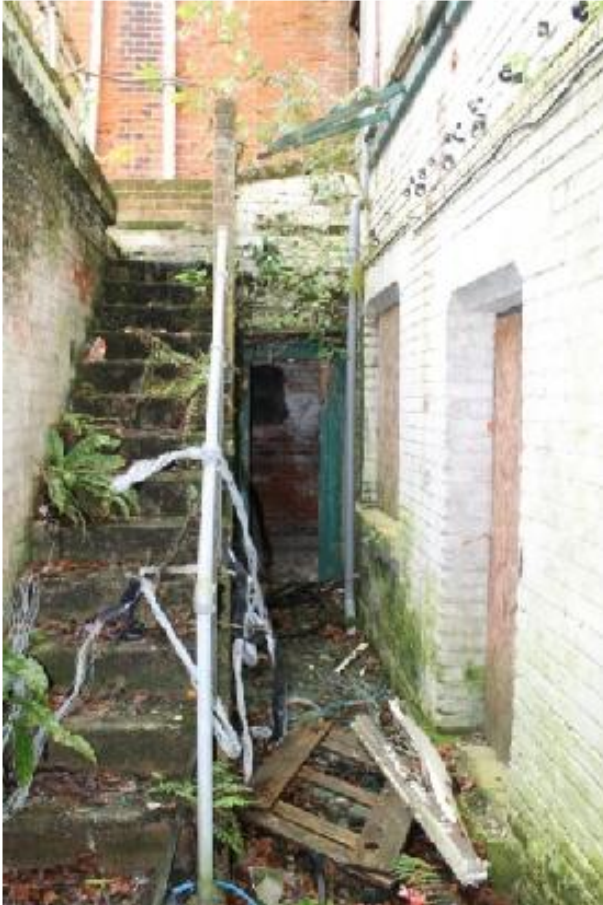
**Plate 39** Stairwell vi, leading from the basement kitchen and underground storage area to the yards at the rear of the building: the original coal store is visible at the end of the passage – view north-east

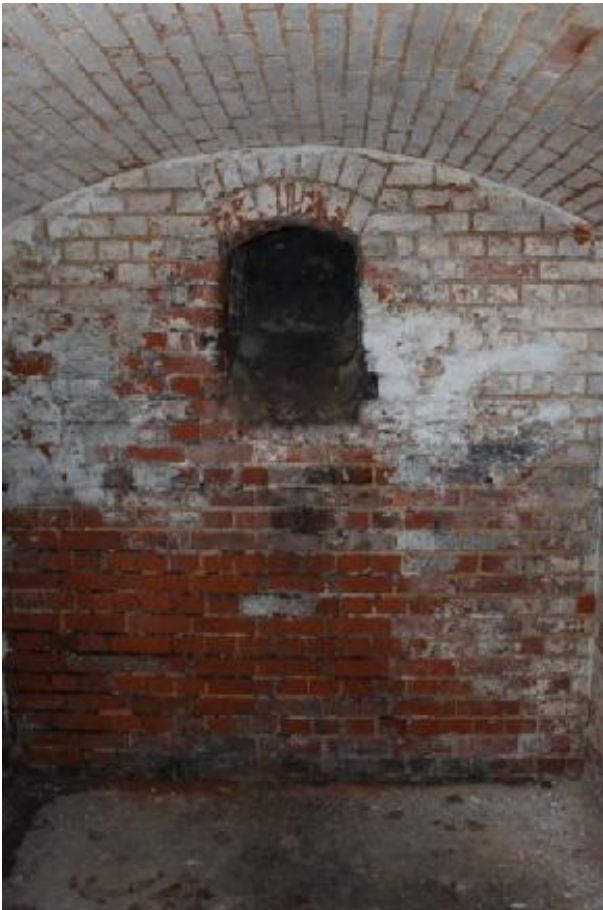
**Plate 40** Room 34, the brick vaulted coal store with the original coal chute – view north-east

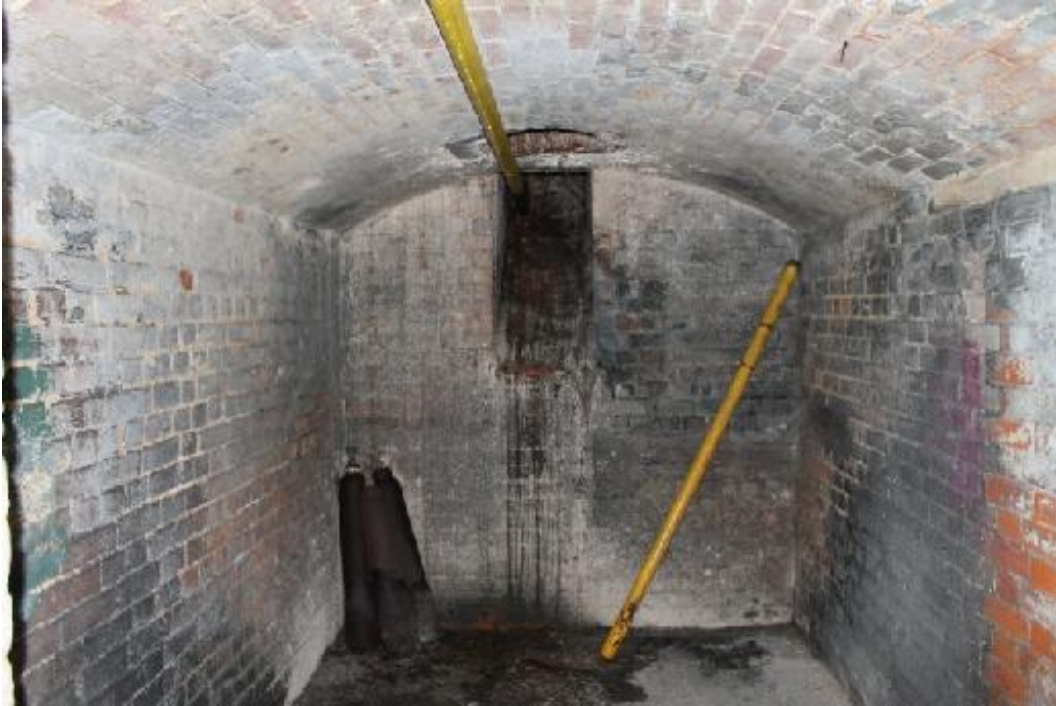
**Plate 41** Room 29, the former beer cellar converted to an additional coal store, with a coal chute inserted through the rear wall and the connecting doorway to the wine cellar (in the foreground on the right) bricked in – view north-east

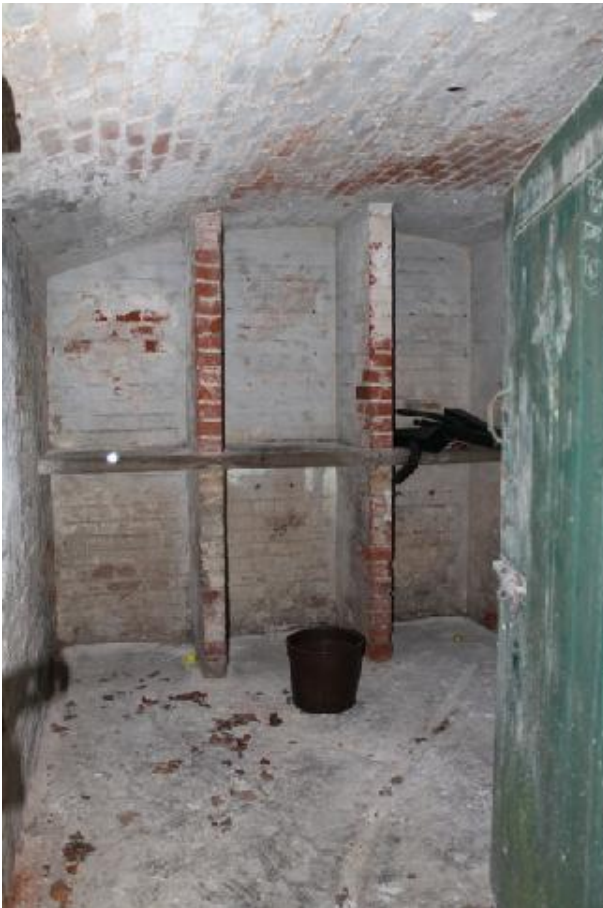
**Plate 42** Room 30, the wine cellar viewed through the inserted doorway, with the original sandstone shelves and drainage channel cut into the concrete floor – view north-east

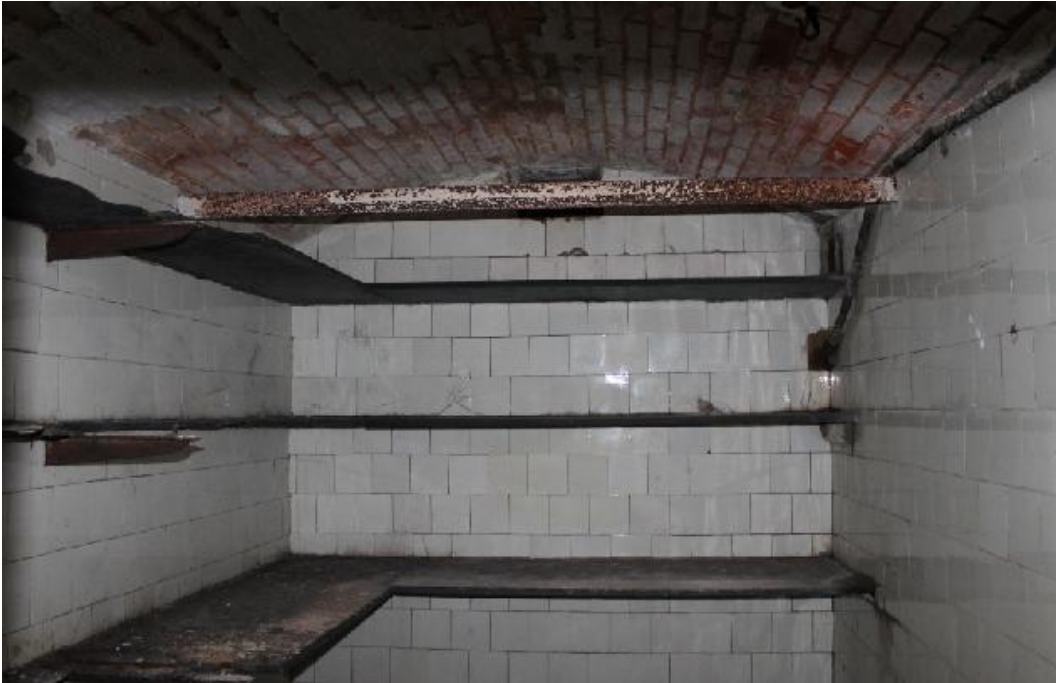
**Plate 43** Room 31, the larder with the original glazed wall tiles and slate shelving – view north

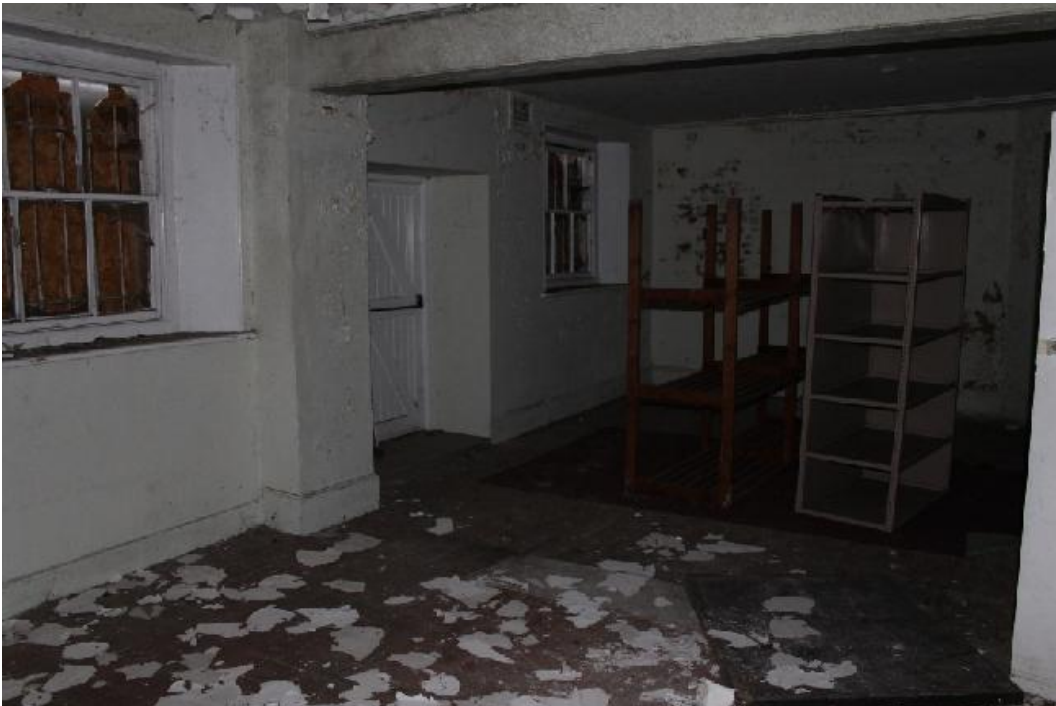
**Plate 44** Rooms 39 and 38, the former kitchen and mess manager's room, with the dividing wall removed and a doorway inserted through one of the windows of the mess manager's room – view south

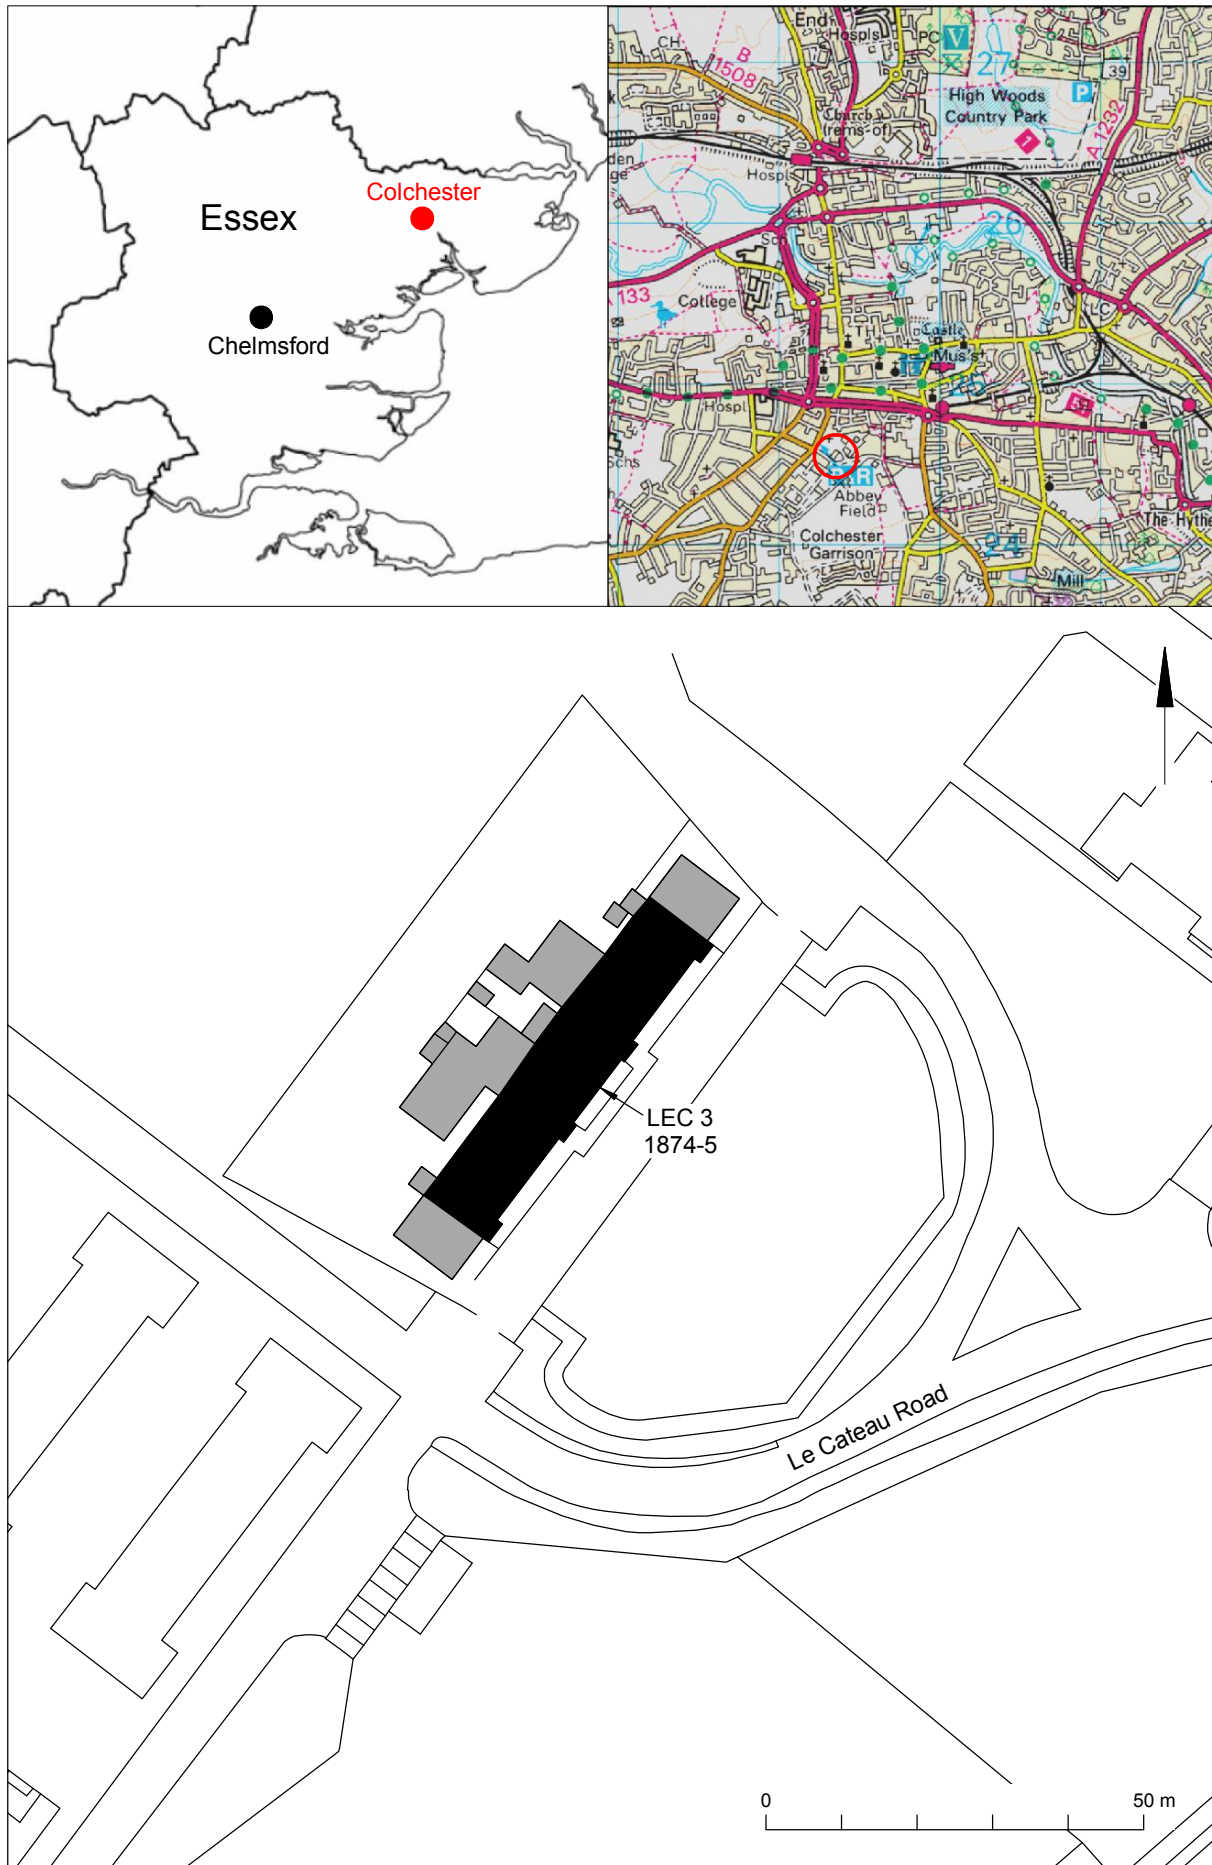
Fig 1 Site location and block plan with the original Officers' Quarters shown black and subsequent alterations shaded grey.

The Royal Artillery Barracks is located on the north-west edge of Abbey Field, to the south of the historic town of Colchester (Fig 1). George Gilbert's 1846 plan of Colchester (Map 1) shows that the Cavalry and Royal Artillery Barracks were constructed on open fields, alongside what would later become Butt Road, in the parishes of St Botolph and Holy Trinity. The title award for 1838 lists part of this area as Harp Field, owned by the Right Honourable Lord Ashburton and rented to Samuel Green Croke.

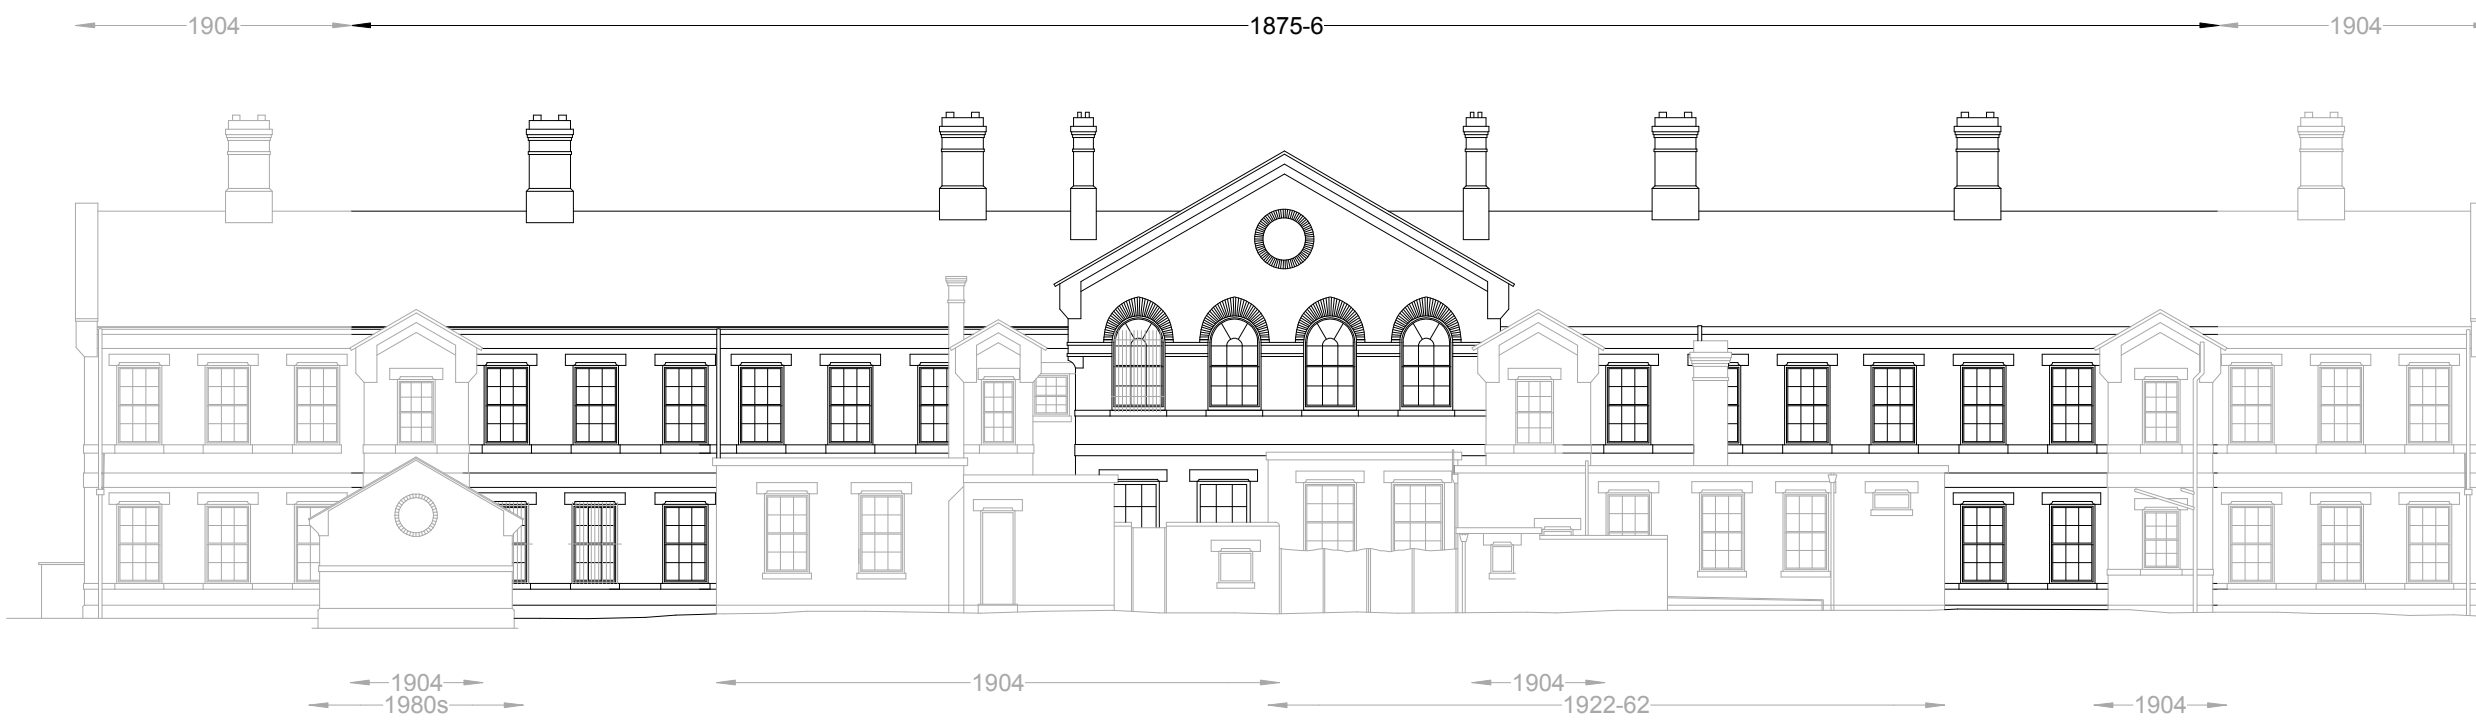
Fig 10 North-west elevation of the former Officers' Quarters, with alterations shown grey.
