## Archaeological watching brief at Roman House (former bus station), Queen Street, Colchester, Essex

November-December 2013, May-July 2014

Final report: CAT Report 780

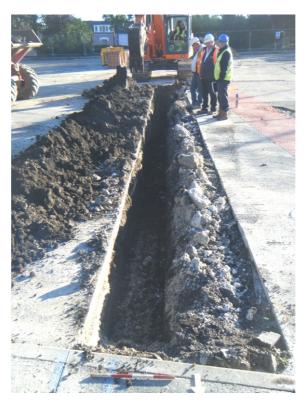
Pictures: <u>cover</u> - watching service trench. <u>Left</u> -made ground south of VAF. <u>Above</u>: the eastern boundary wall, looking south into Vineyard St car park over the top of the Roman wall (here capped with post-medieval brickwork).

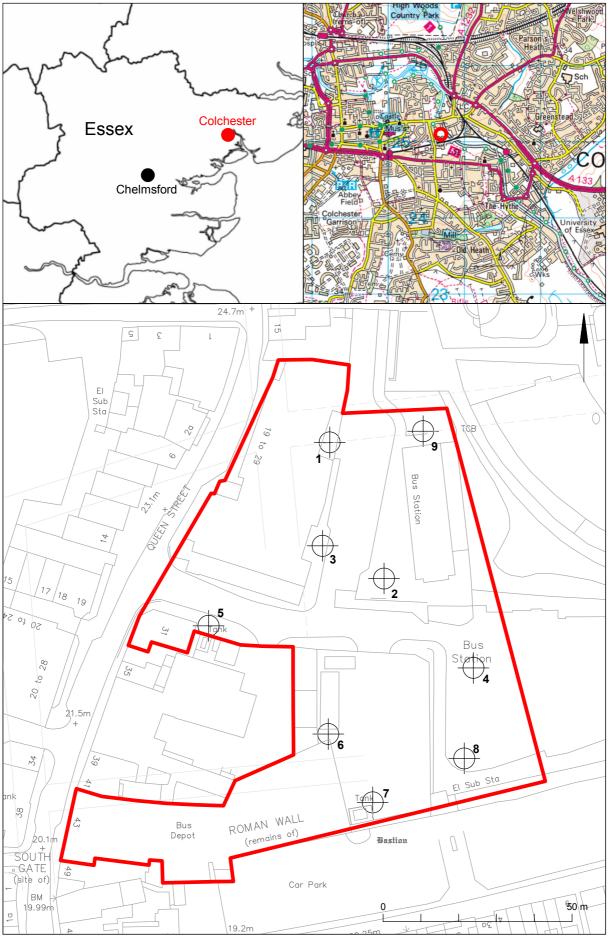
Fig 1 Site location (red outline), with location of Boreholes 1-8.

On the southern site edge, fence post-holes revealed but did not damage the top of the Roman town wall. In other places, topsoil was not penetrated (in some parts of the site, services/fence posts were cut through made ground dumped during the construction of Firstsite - see picture below). No archaeological finds or features were revealed. The boreholes were the deepest intrusions - although direct observation was impossible, some finds were observed in the cores. In Borehole 8, sealed by 1.3 - 1.5m of post-medieval topsoil was a layer containing fragments of Roman tile and oysters (a layer consisting of the demolished remains of Roman structures, and possibly overlying more solid structures such as floors), and a possible mortar floor. BH2 and BH5 revealed the same sequence. BH1 revealed at 1.2m a possible *opus signinum* (pink mortar) floor, and BH3 the remains of an *opus signinum* floor at 1.2m. BH2, 4 and 9 revealed clay with *op sig* fragments, suggesting demolished Roman buildings and floors.

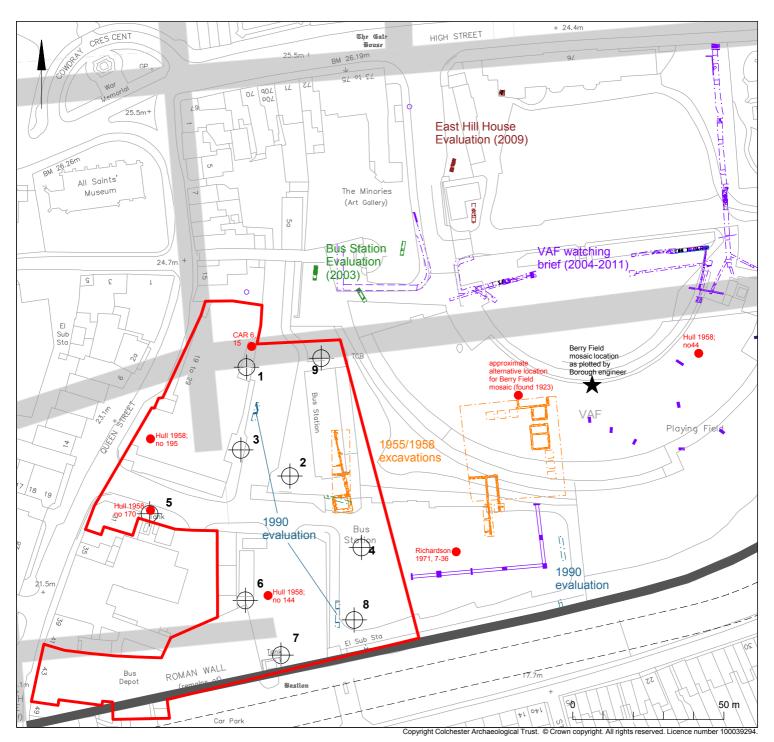
Fig 2 Site (red outline), showing previous excavation, evaluation and monitoring.

town wall Roman street
