**Historic building recording
at the Arena, Circular Road East, Colchester,
Essex, CO2 7SZ**

October 2015

CAT Report 883
February 2016

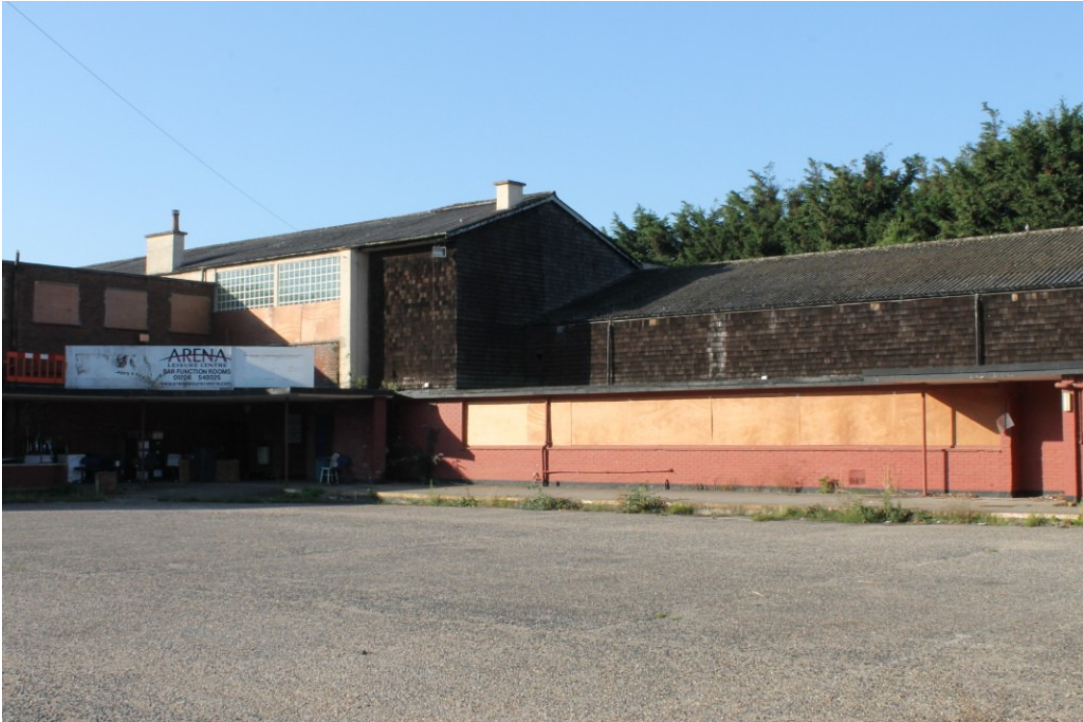
The NAAFI postcard also shows that where the modern entrance is located was originally the site of a three-storey, flat-roofed structure. Photograph 3 shows that this has been replaced and the gabled roof of the main range extended to incorporate the replacement two-storey structure.

Photograph 3 Northern end of the main range with shingle-clad sides and the reduced central section (formerly three storeys) – view south

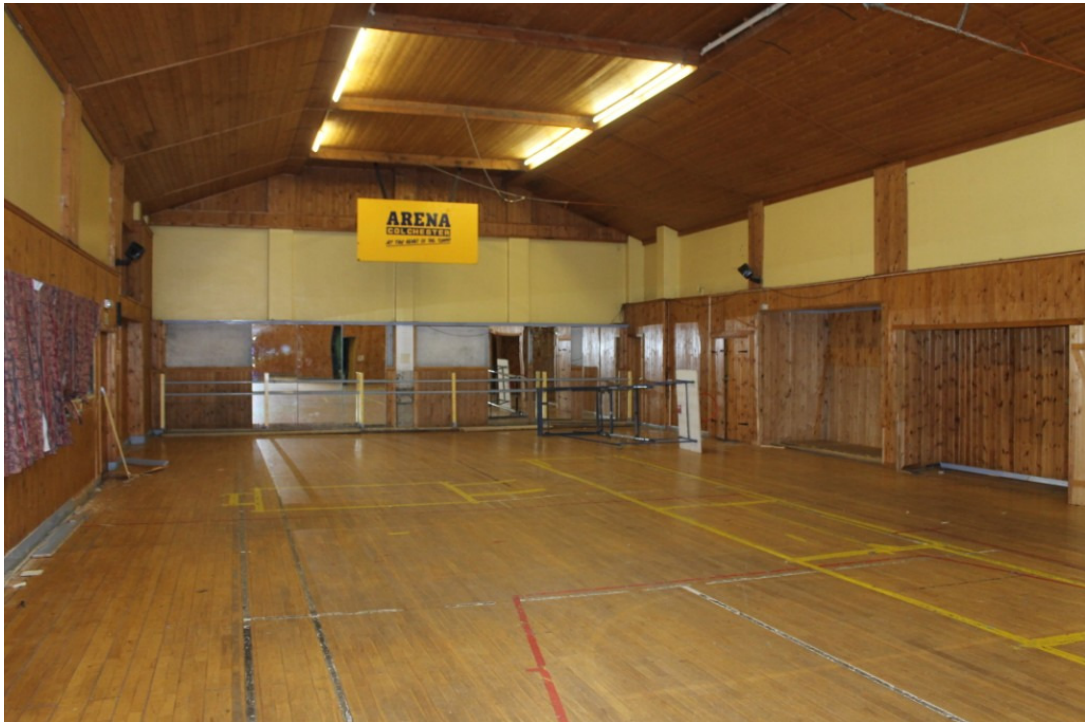
GF1, located at the north end of the complex is probably the most altered component of the original NAAFI building. This has been converted to a sports hall/dance studio, complete with a sprung cedar floor (Photograph 9).

Photograph 9 GF1 converted to a sports hall – view north

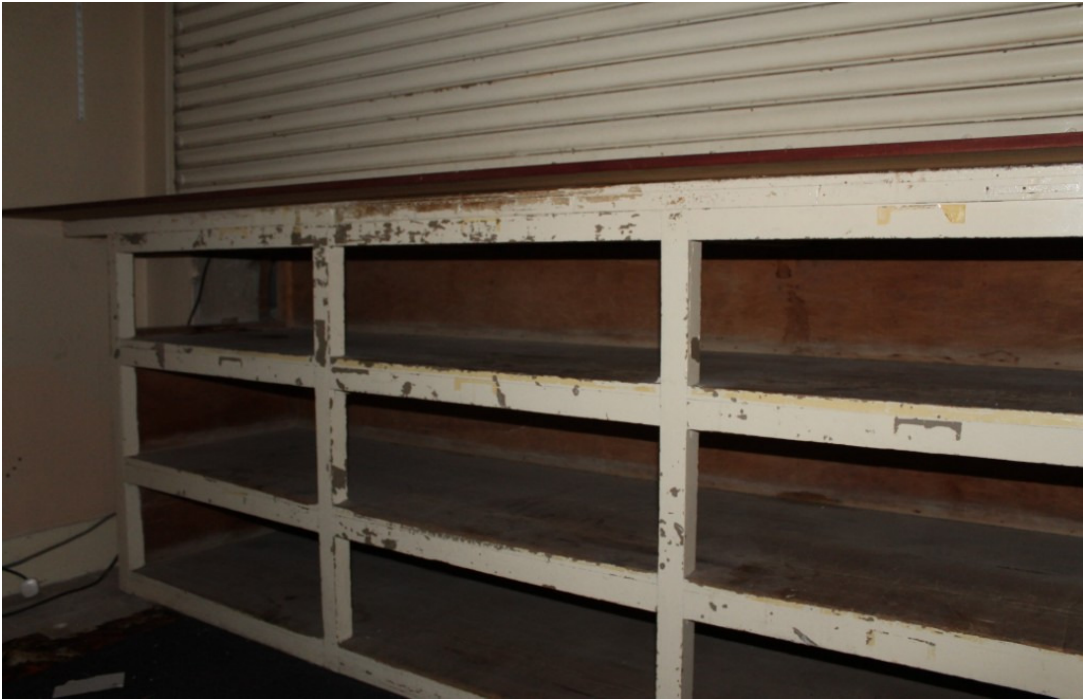
Photograph 10 An original NAAFI serving hatch and counter in the south-east corner of GF1 – view south-east

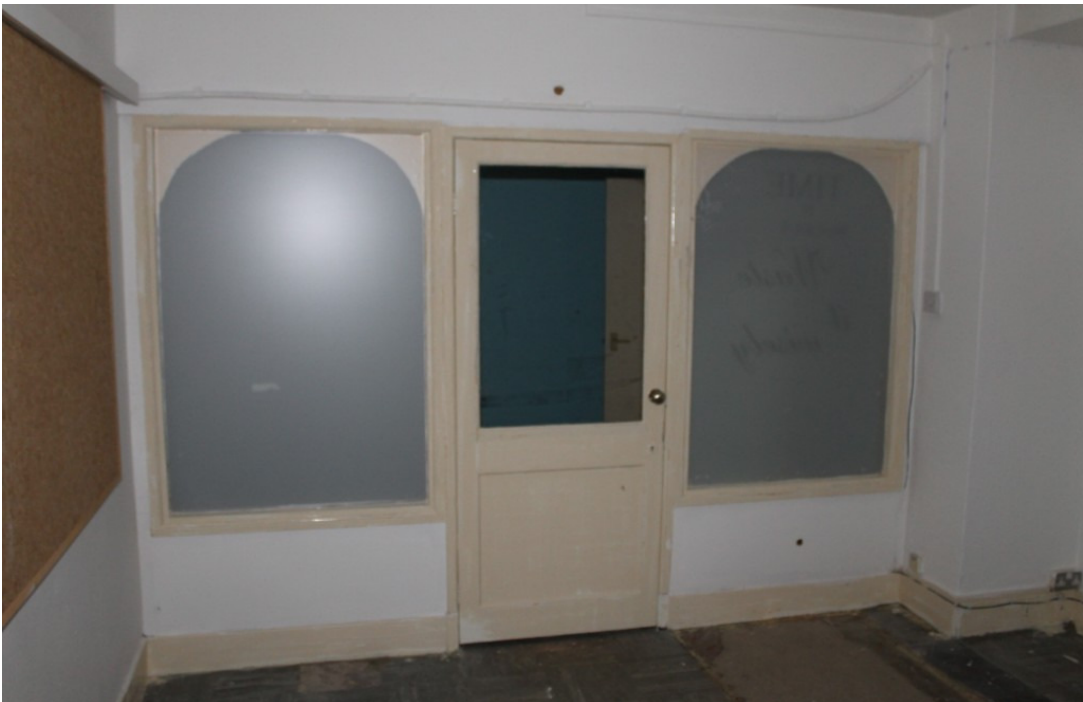
Photograph 11 Interior view of a plate glass shop front, located at the south end of GF1 – view east

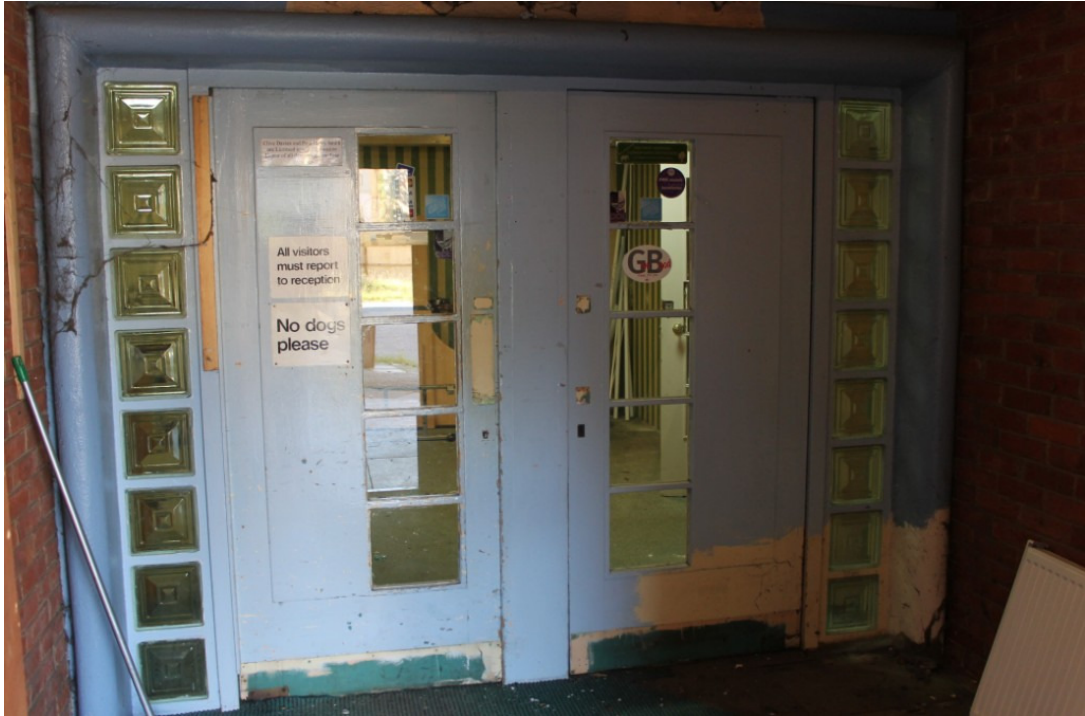
Photograph 12 The modern entrance to the Arena (GF2), one of the original entrances to the NAAFI with probable replacement doors – view north-west

Photograph 12 shows one of the original entrances to the NAAFI, with a distinctive moulded concrete door surround and glass block margin lights. The doors may be original but are probably later replacements as the same style doors are found throughout the Arena, some in locations that are definitely post NAAFI. A second original NAAFI entrance is located to the south of this one (Photograph 13, labelled 'f' on Fig 2). This has the same distinctive moulded concrete surround and margin lights formed from glass blocks, although it is a single-width doorway instead of a double-width entrance.

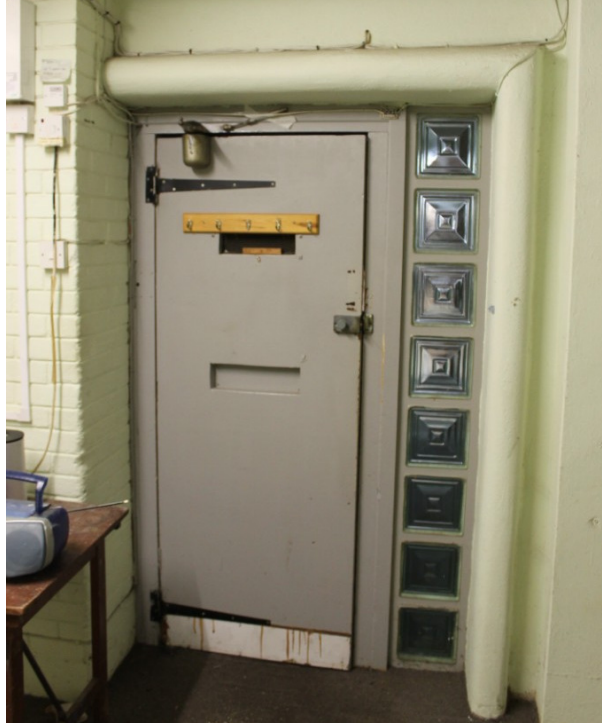
Photograph 13 A second original entrance to the NAAFI located in GF2 – view south

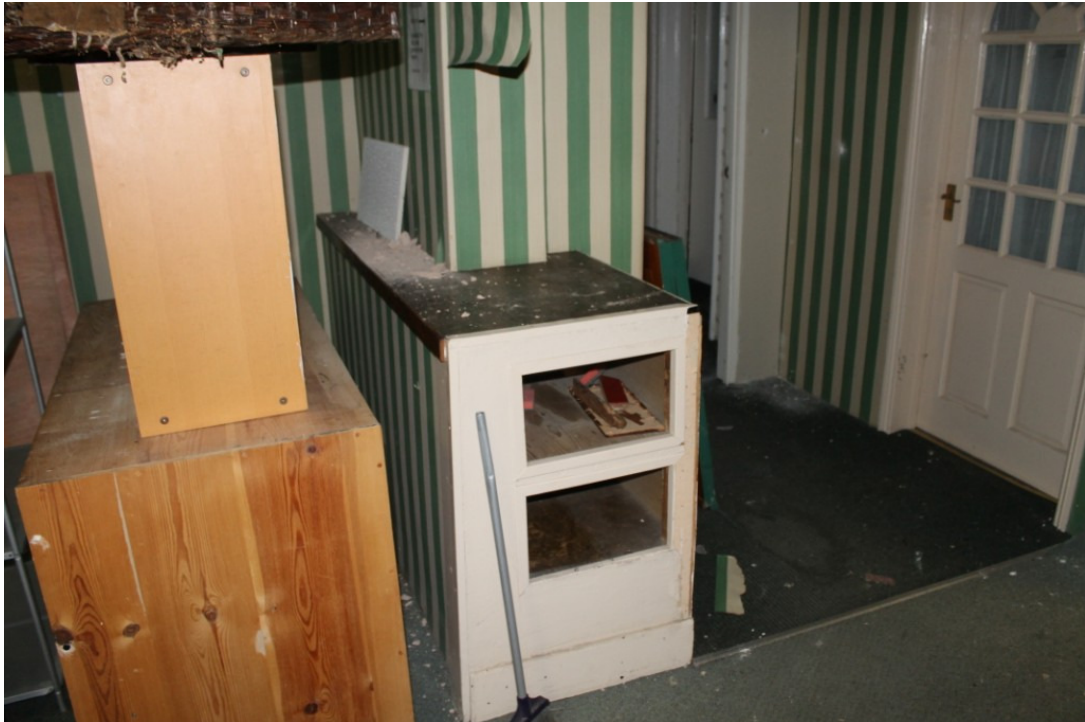
The modern foyer of the Arena has two original NAAFI serving hatches which have been blocked and a third where the counter has been cut to provide access to the rooms behind the servery (Photograph 14).

Photograph 14 Part of the original NAAFI servery in GF2, cut to provide access to the rooms behind – view south

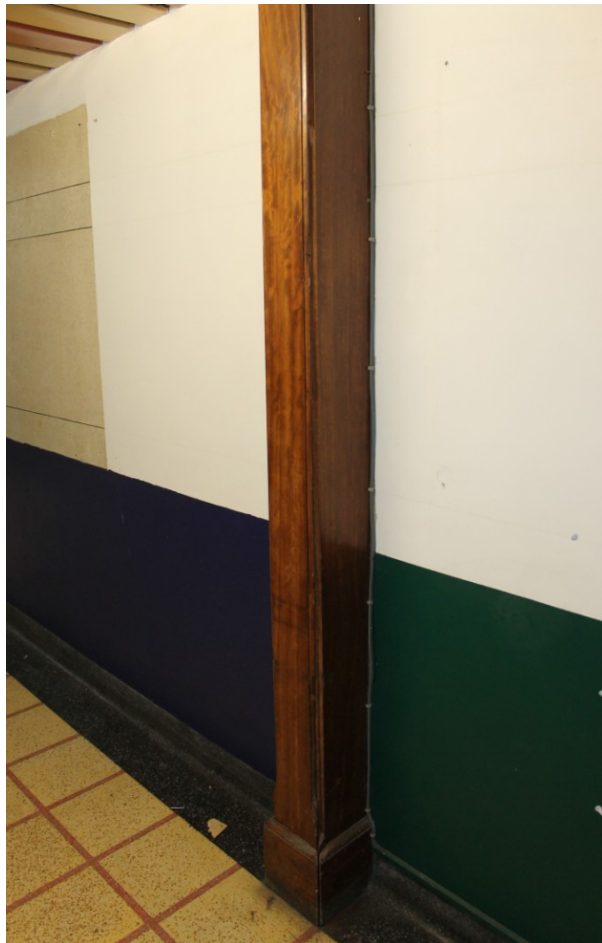
GF2 also has the original flooring and wall covering in the corridor that extends the length of the building (Photographs 15 and 16). In particular Photograph 15 shows that the steel frame of the building's superstructure was encased in timber veneers to soften the appearance.

Photograph 15 One of the steel supporting posts of the building's superstructure encased in timber veneers, located in GF2. The original flooring and wall covering can also be seen – view south

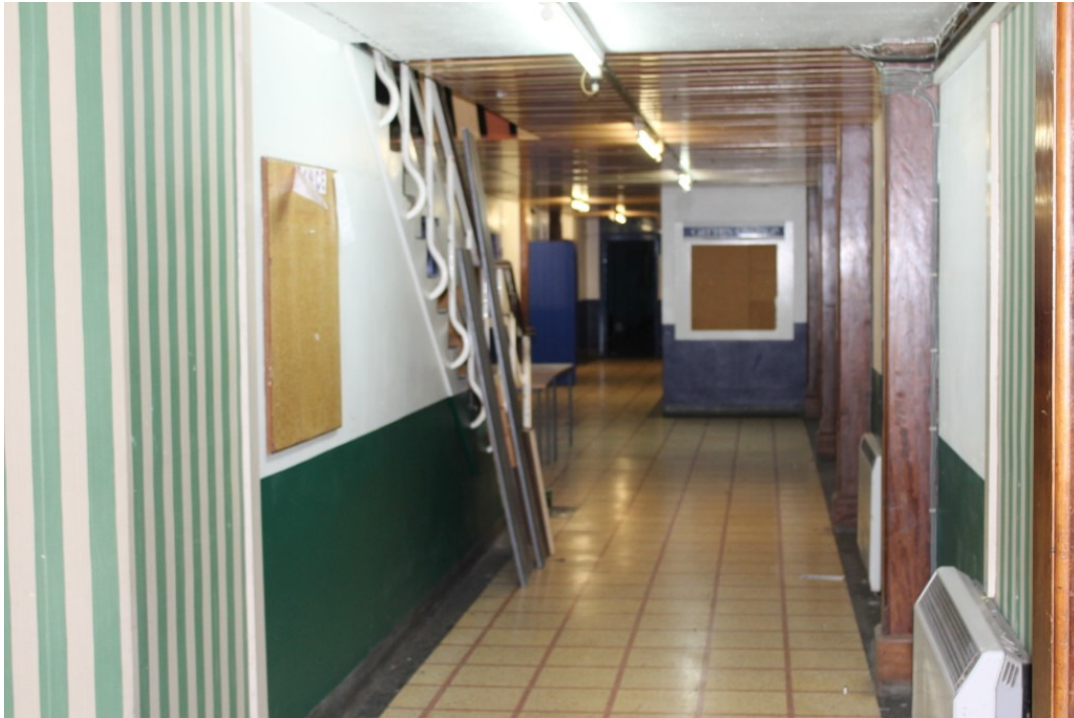
Photograph 16 The corridor extending the length of GF2 with the original flooring and the stairs to the first floor – view south-east

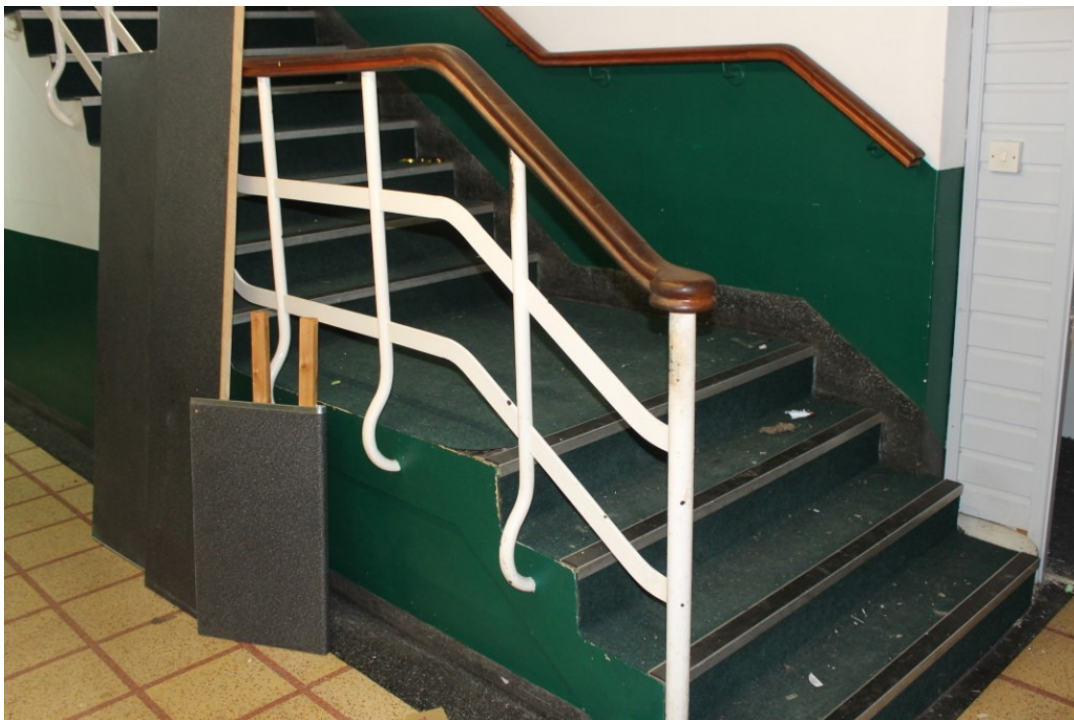
The open staircase to the first floor is original to the NAAFI building and has straight steel balusters with curves at the bases and a hardwood bannister (Photograph 17). The NAAFI postcard shows that a second staircase was originally located somewhere in the building,

Photograph 17 The staircase located in GF2 providing access to the first floor – view north

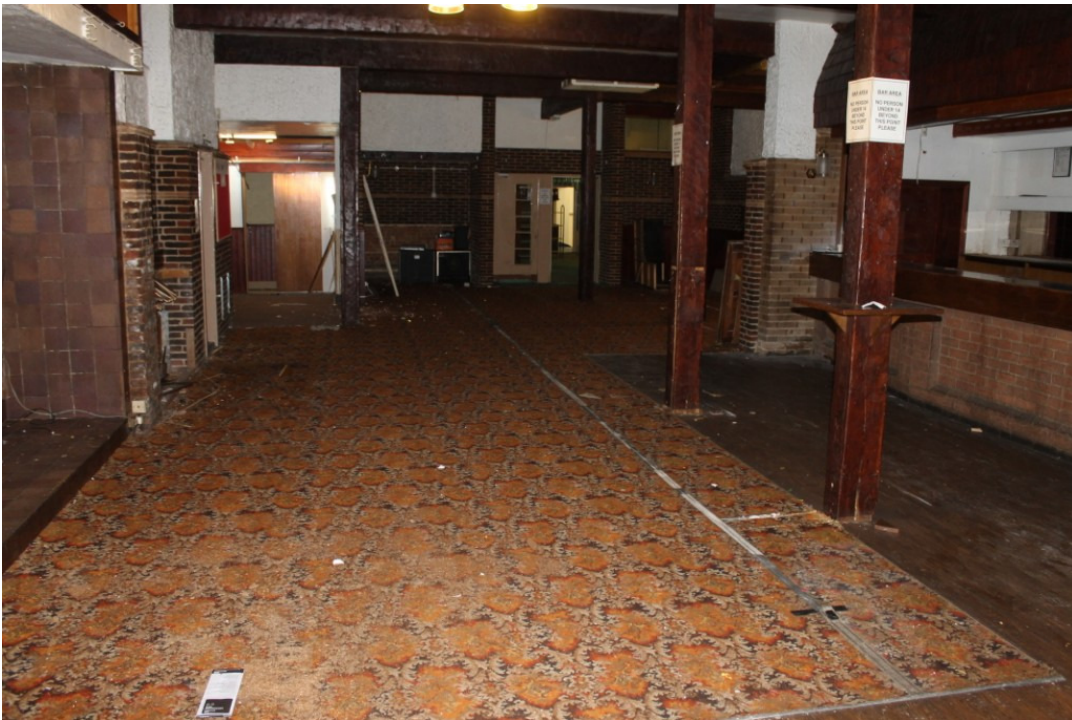
Photograph 18 The bar located in GF3 - view west

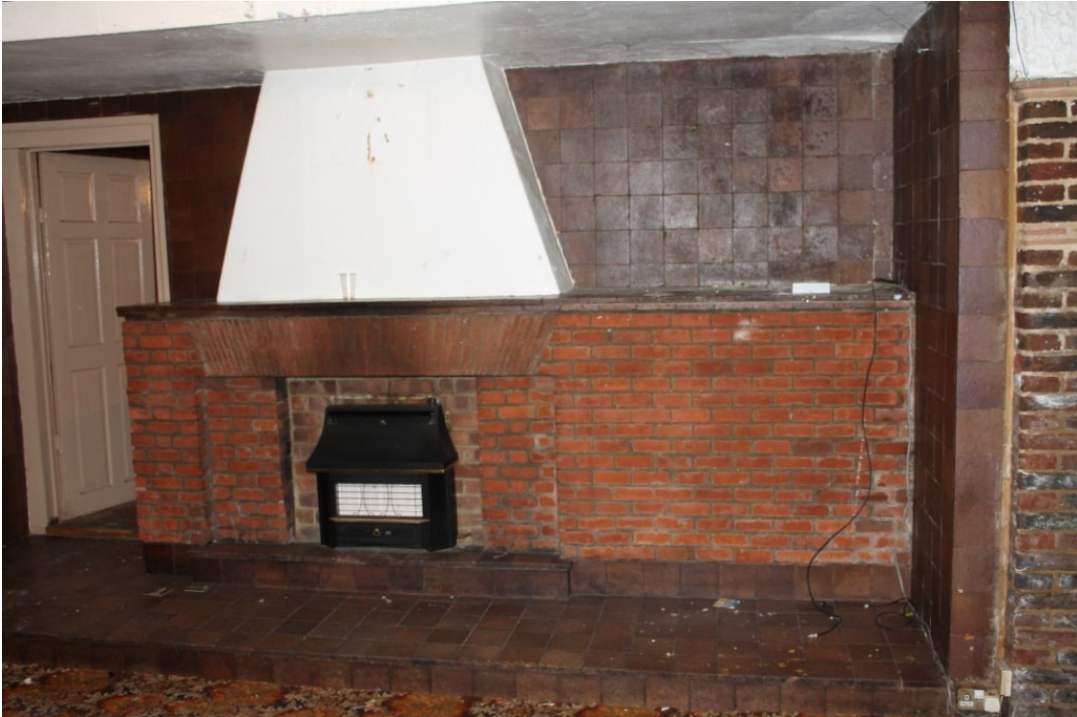
The NAAFI postcard provides firm evidence for the original function of the bar in GF3. The photograph of the Lounge shows a fireplace with a large, distinctive smoke hood. This feature (Photograph 19) survives in the bar and is labelled 'l' on Fig 2.

Photograph 19 Original NAAFI Lounge smoke hood located in GF3 - view south-east

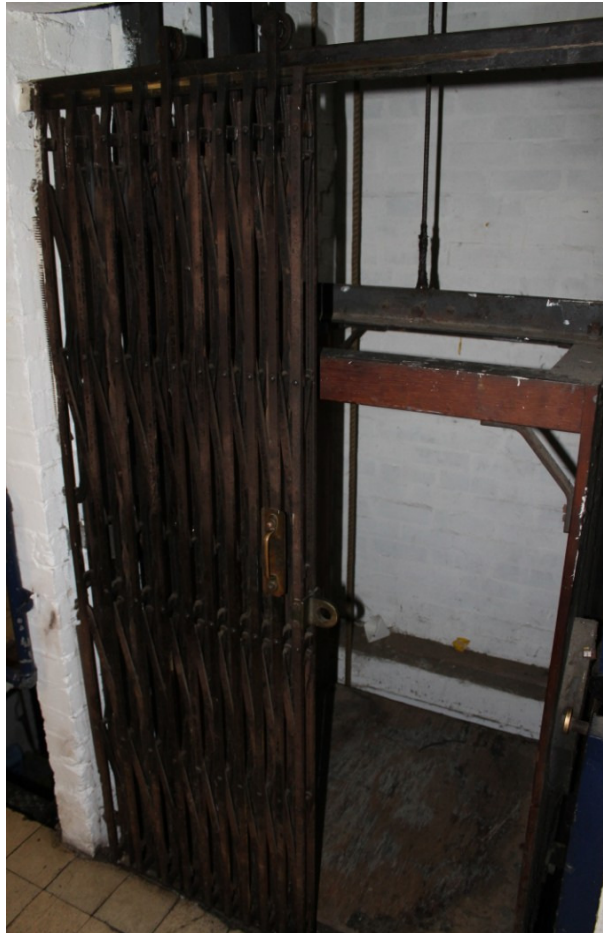
A cellar is located beneath the kitchen and the access for this is between the kitchen and the storage area. This has both a steep ladder access and a motorized barrel lift (Photograph 20). The cellar itself is open with barrel racks on the west wall and a drayman's hatch to the south. This latter feature has been covered over by auxiliary bar 'j'.

Photograph 20 Mechanized barrel hoist to the cellar below GF3 – view west

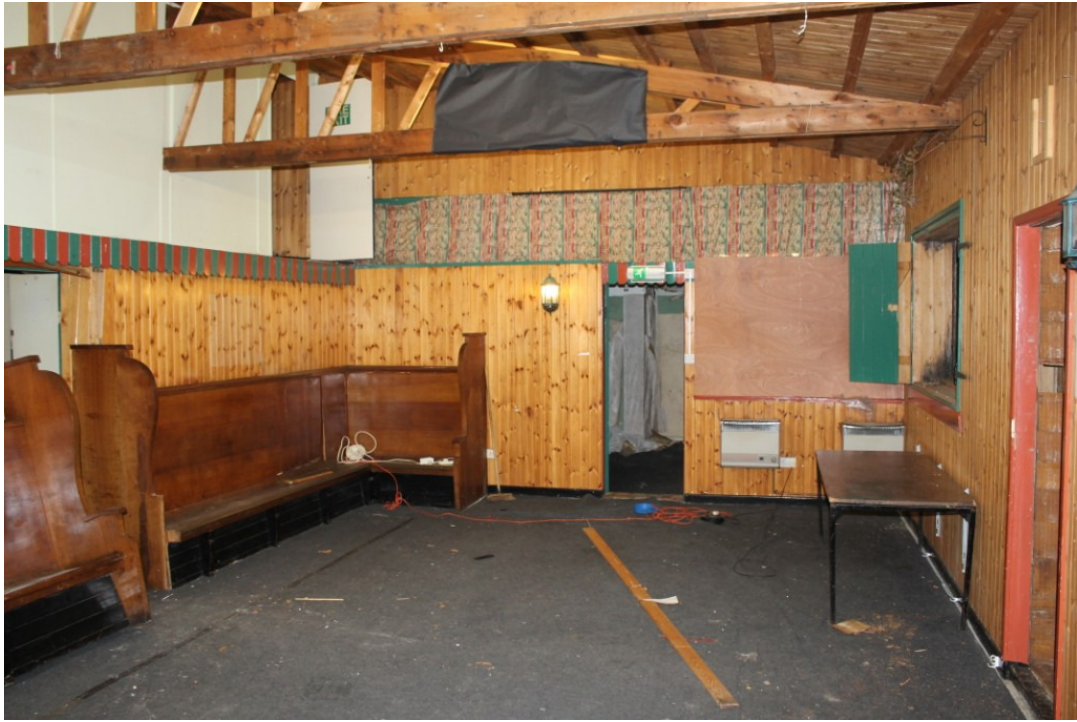
Photograph 21 Auxiliary bar/games room 'j' located in GF3 - view south-east

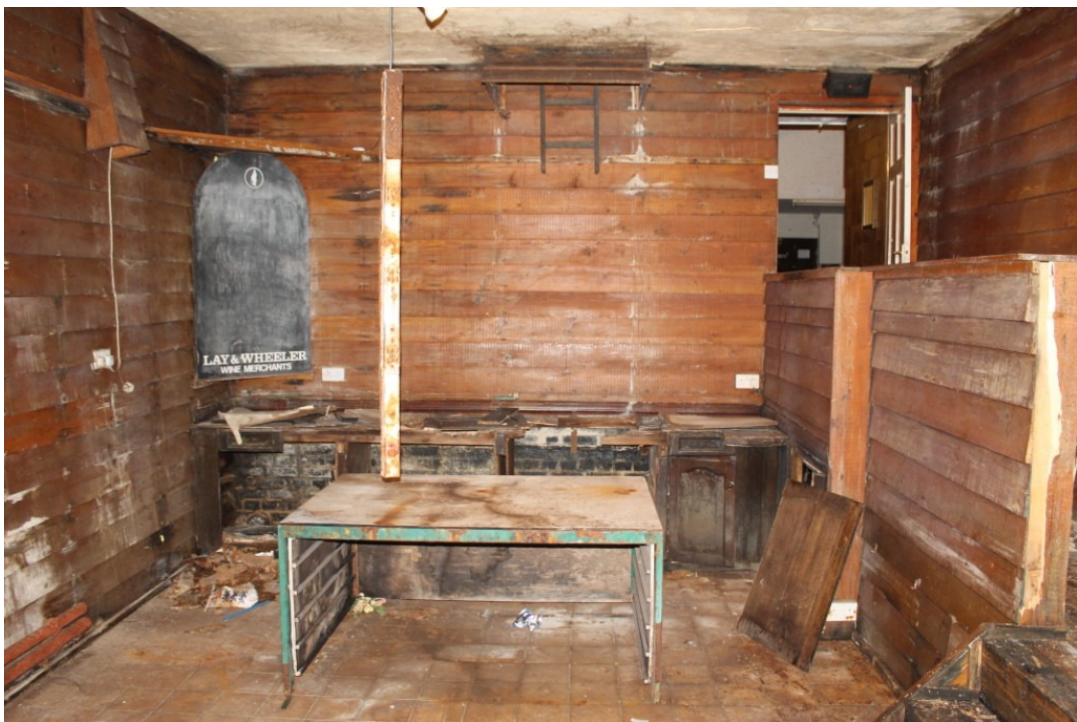
Photograph 22 Auxiliary bar/games room 'k' located in GF3 - view north

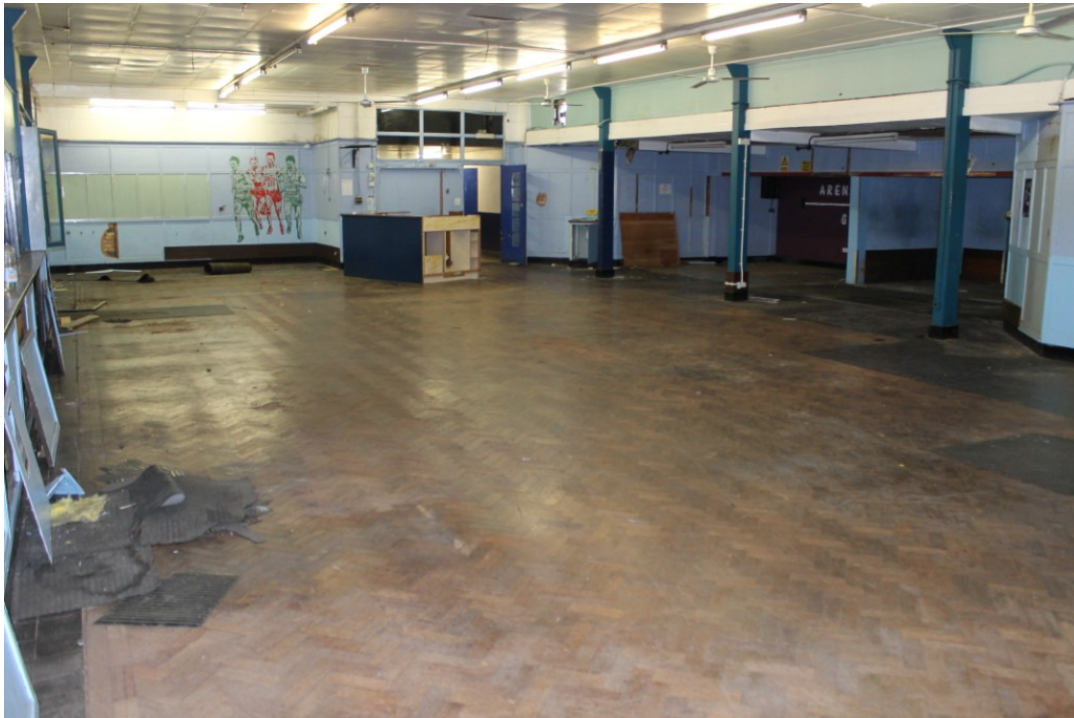
Photograph 23 The Arena Gym, located in GF4, with the original parquet flooring and tiled border - view north

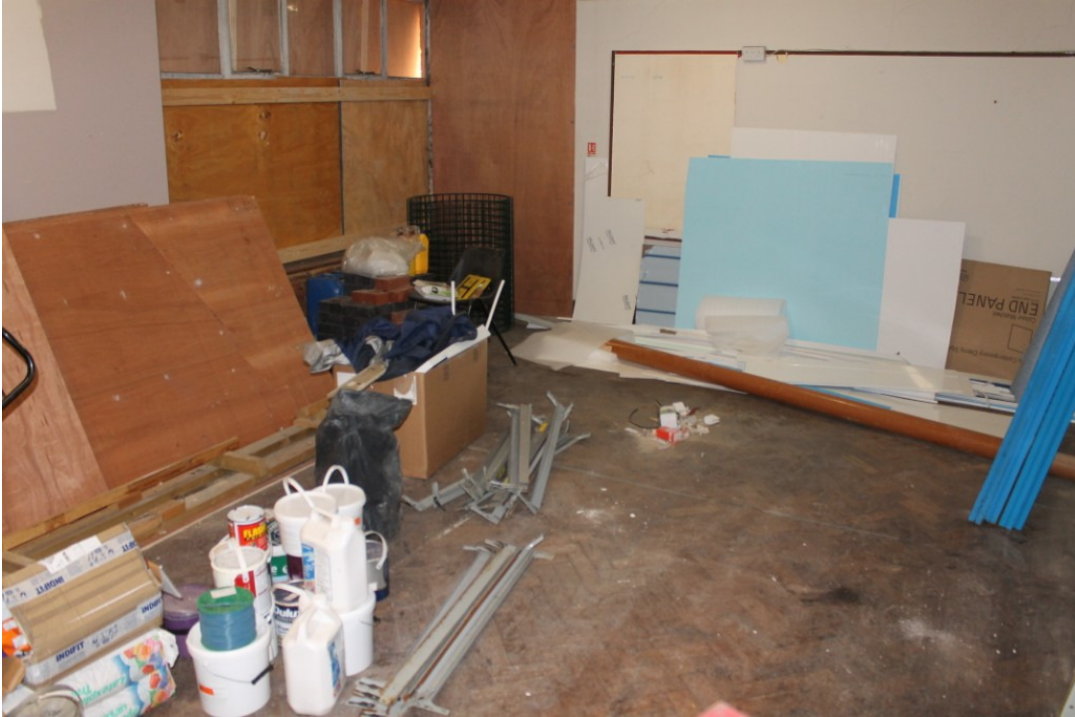
Photograph 24 Example of the difficulties faced in recording GF5, the original parquet flooring can be seen in the foreground - view south-west

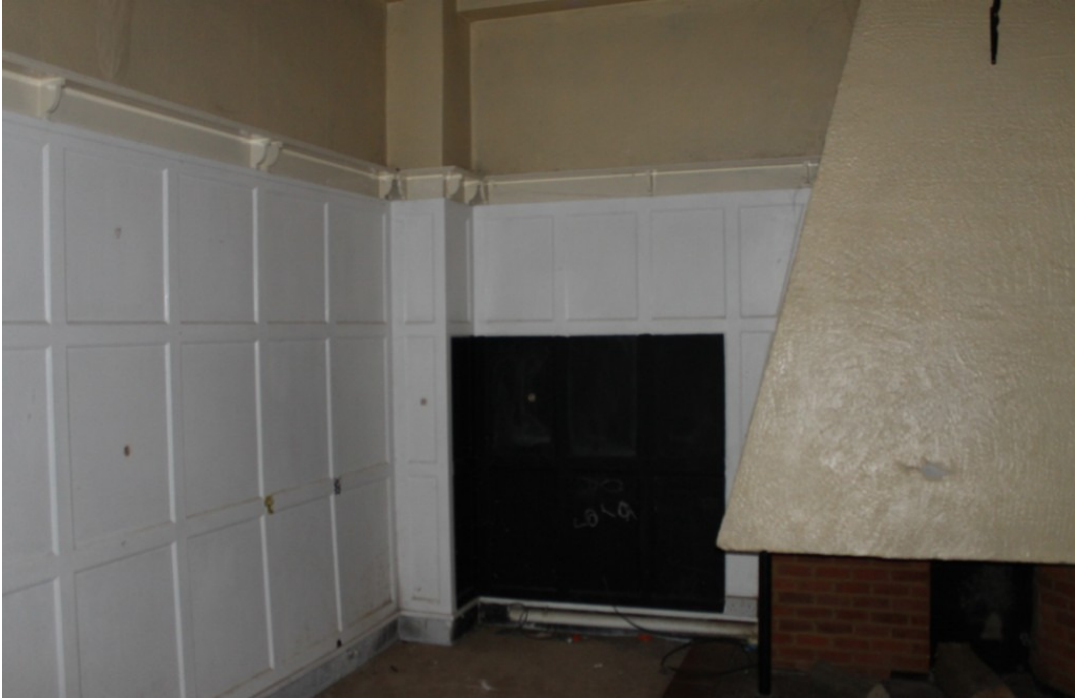
Photograph 25 A probable dining room located in GF6, with original parquet flooring, wood panelling and hearth with large smoke hood, identical to the one in GF3 - view north-west

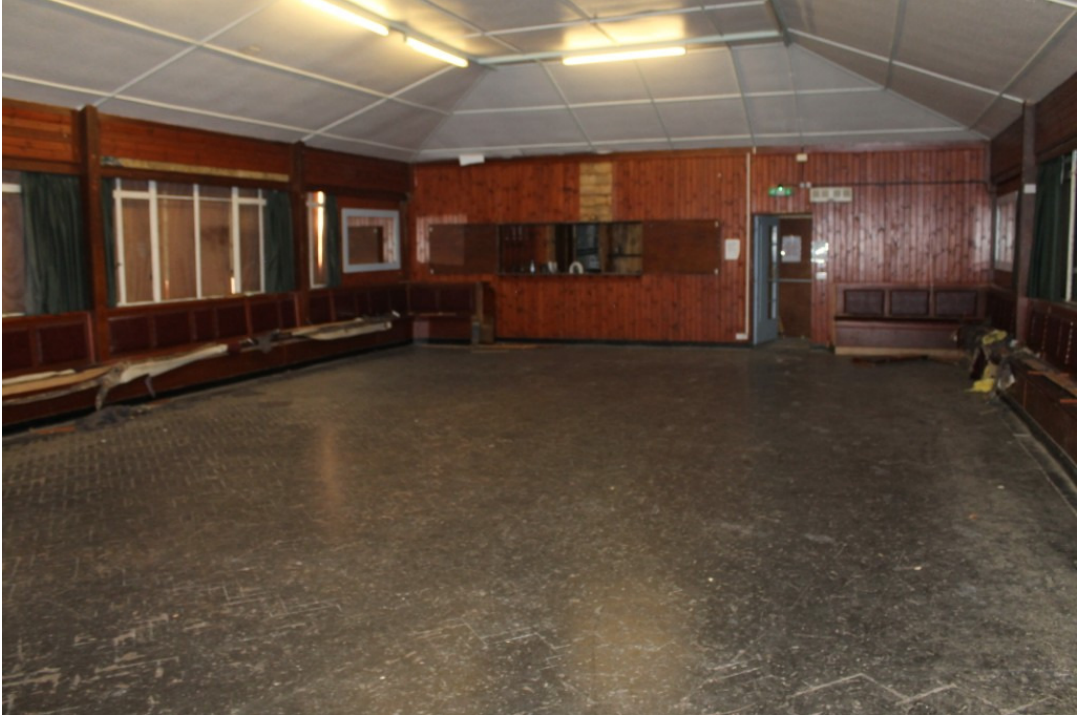
Photograph 26 The interior of GF7, with original parquet flooring, vertical tongue and groove cladding and bar in the far wall; the benches around the walls are probably later additions - view south-west

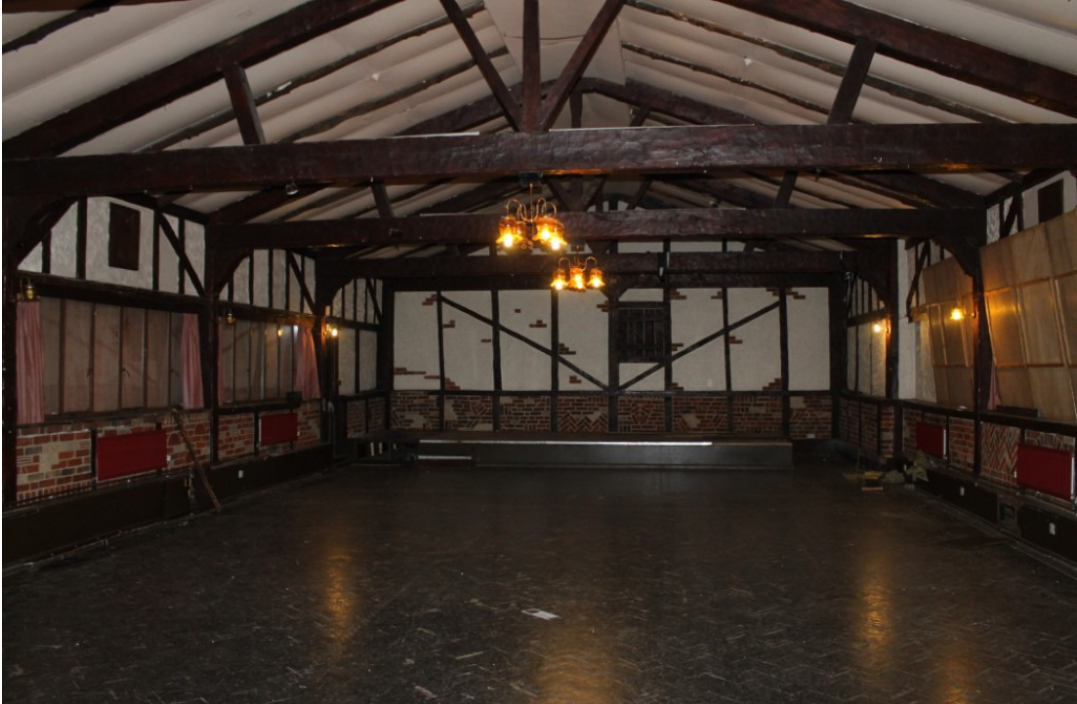
Photograph 27 The interior of FF1, with original parquet flooring and later faux rustic decoration - view south-east

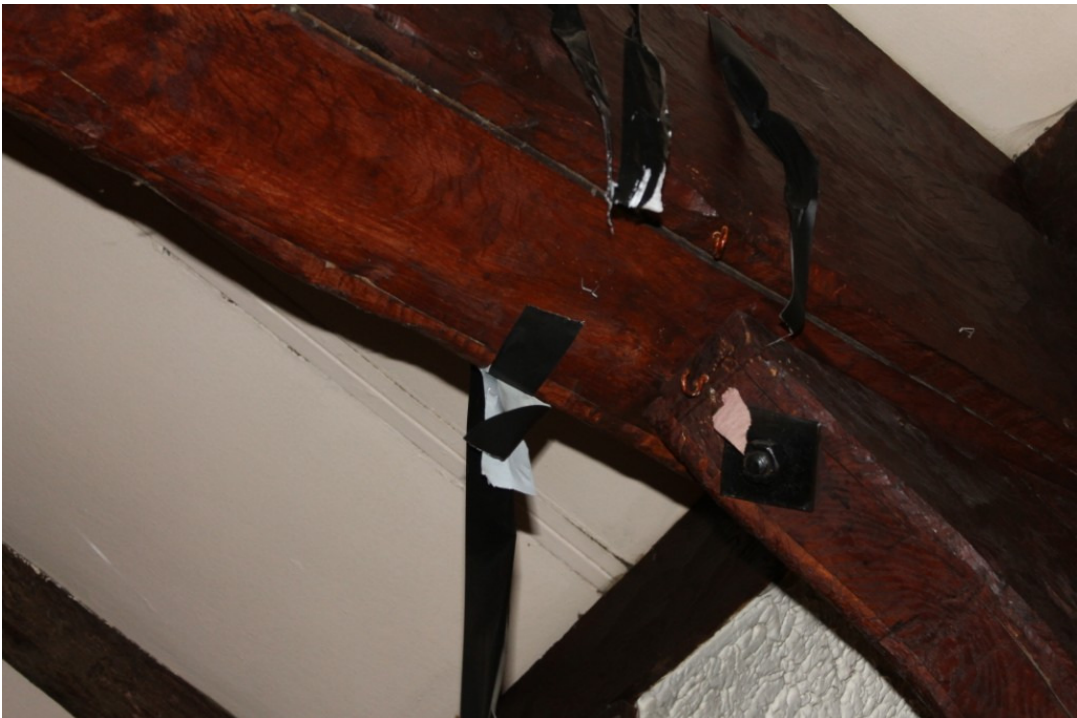
Photograph 28 Tie beam and brace of truss in FF1, showing timber veneers attached to steel superstructure

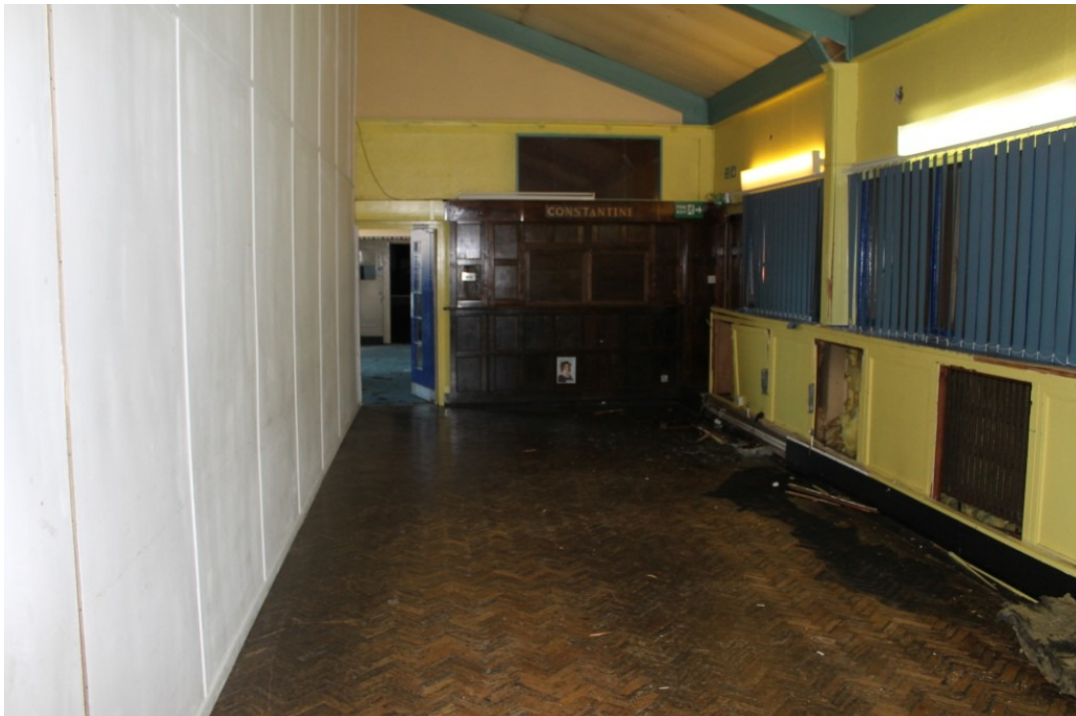
Photograph 29 Western half of FF2 showing the original bar, parquet flooring and inserted stud wall to the left – view south-east

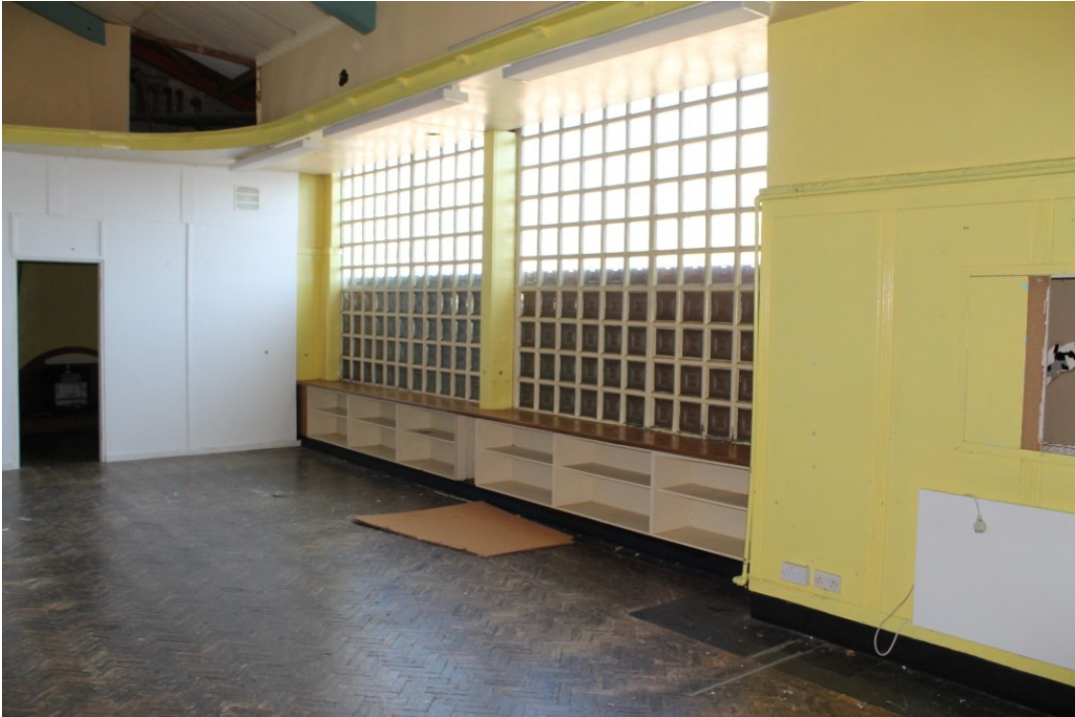
Photograph 30 Eastern half of FF2 showing the original parquet flooring, wood panelling and glass block wall. The white painted stud wall to the right conceals the original curved wall and brick hearth at the end of the room. The serving hatch connecting FF2 and FF3 is just visible on the right of the photograph – view north

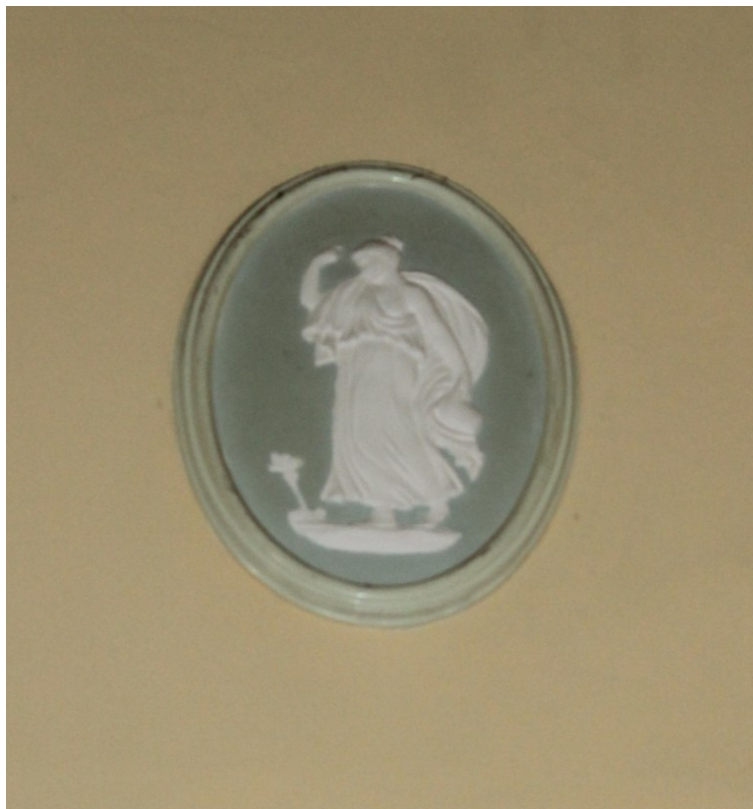
Photograph 31 Detail of one of the two cartouches located at either end of FF2

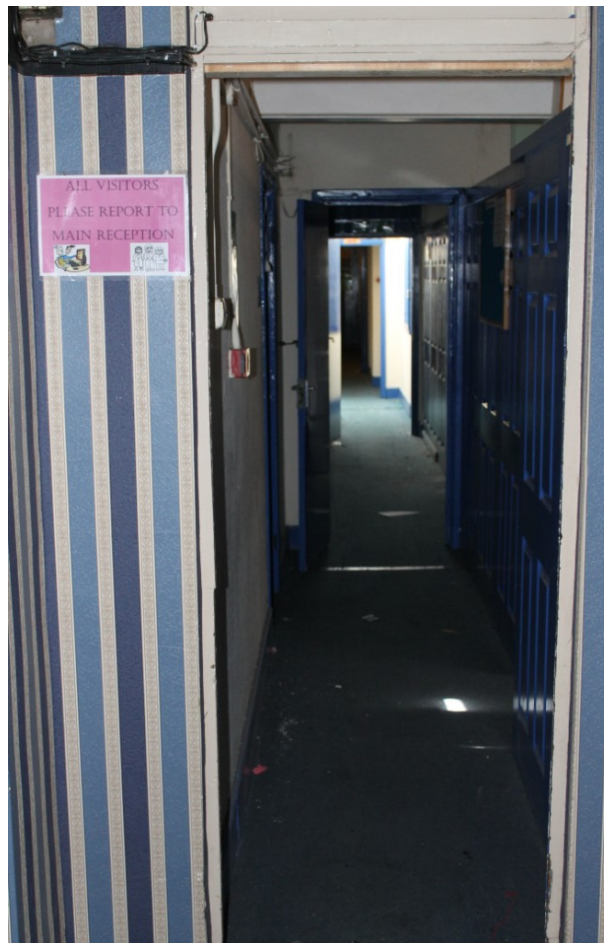
Photograph 32 Doorway providing access to FF3 – view north-east
