**Historic building recording at
St John's Abbey Wall, Flagstaff, Napier Road,
Colchester, Essex, CO2 7GA**

July 2016

CAT Report 995
September 2016

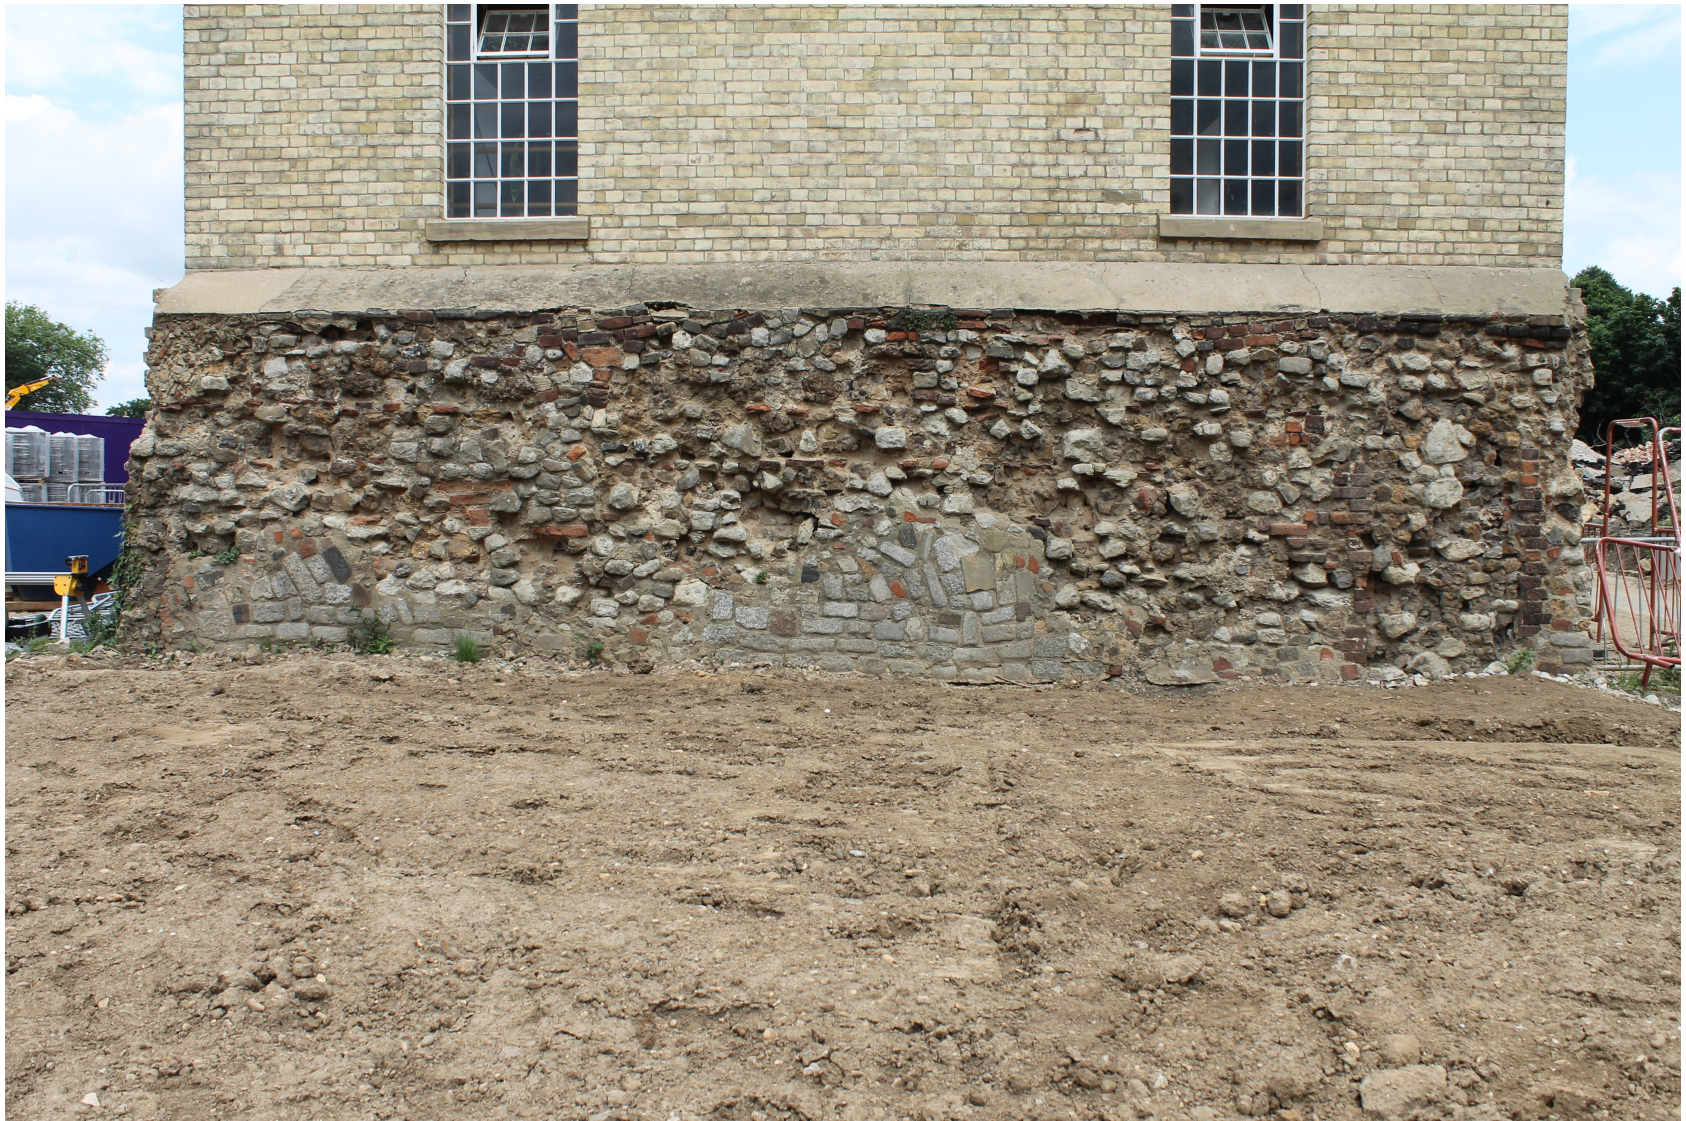
Photograph 1 St John's Abbey Wall before conservation

The most obvious repairs to this piece of wall are of granite which is unusual and suggests a very modern date. The top of this wall is also missing. It is hard to judge how much has been removed but it could easily have been twice as high as it is now. Before the recent conservation of the wall took place it was obscured by a row of closely spaced conifers. When they were removed the remains of what appears to be a blocked doorway were exposed at the east end of the wall (Photograph 1-2, Fig 1). Both jams of the doorway are made visible by vertical lines of bricks although there is no sign of the head of the door which we can only assume was removed when the door was filled in. The blocking material in the lost doorway is similar to the material used to build the wall itself. The apparent absence of any peg-tile in the doorway (as in the main wall itself) suggests that it was blocked by the 13th century at the very latest.

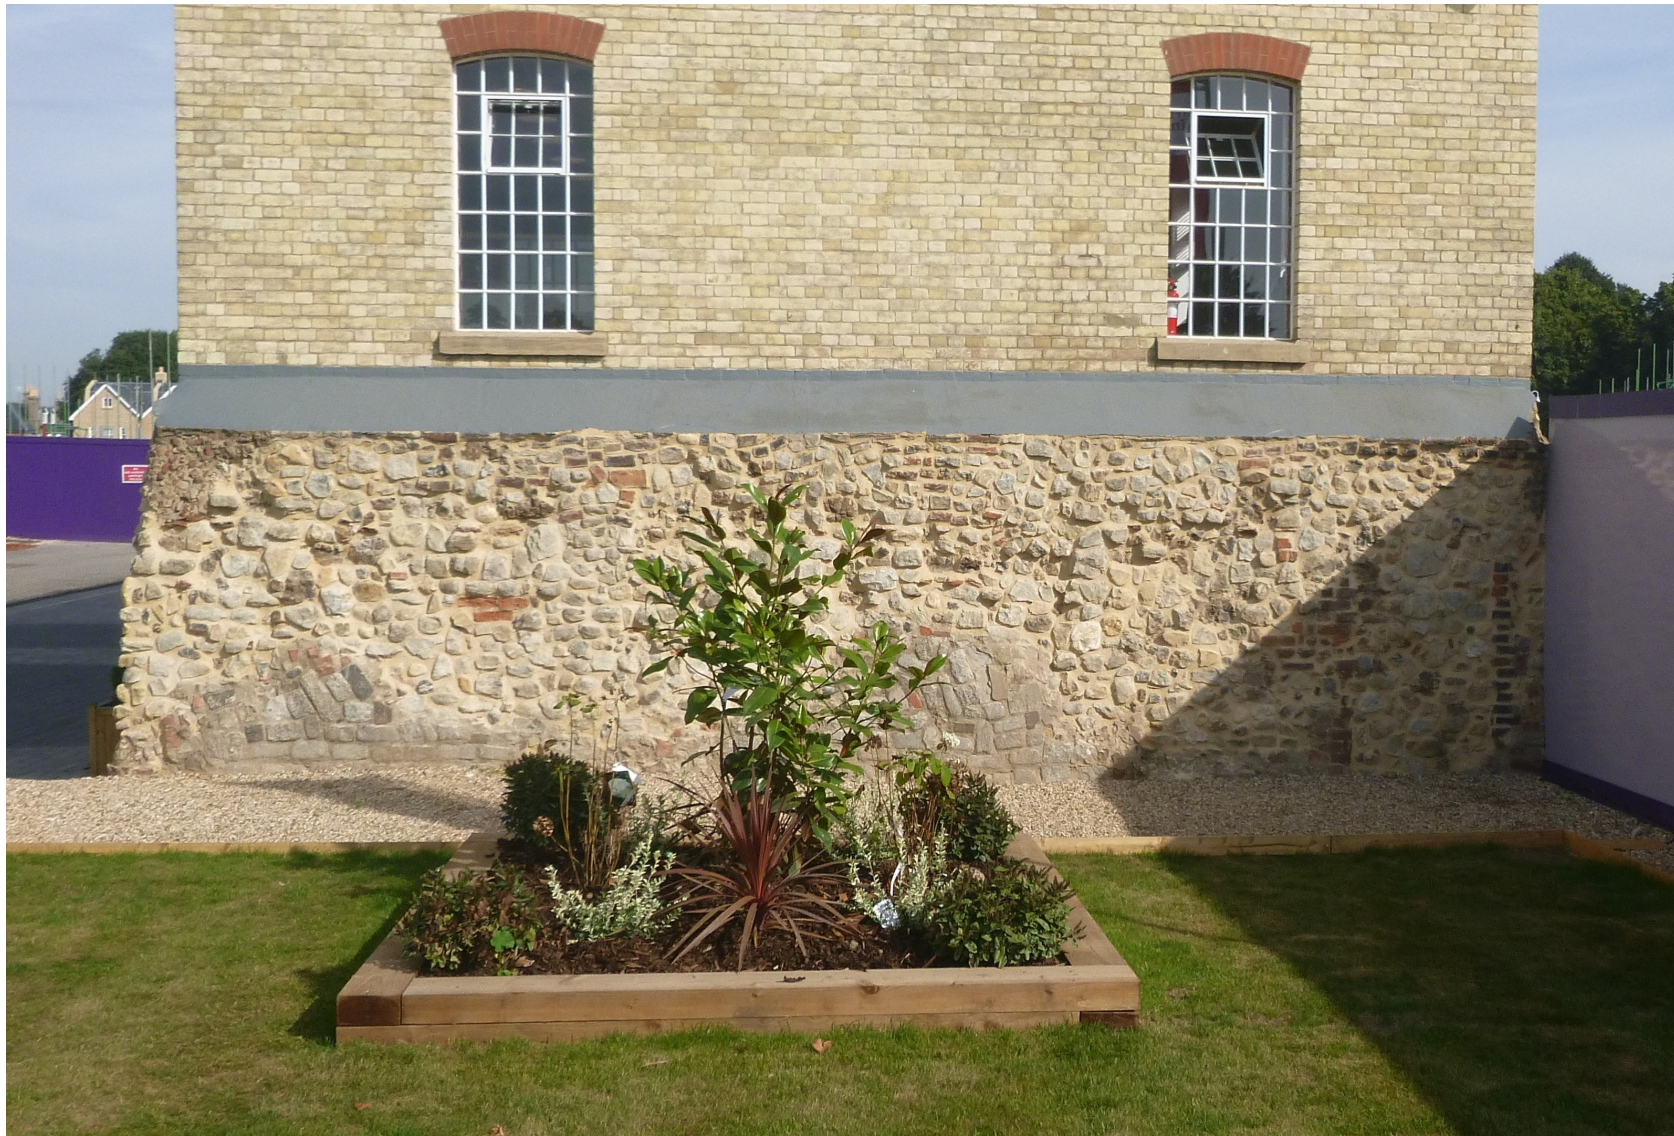
Photograph 2 St John's Abbey Wall after conservation
