**Historic building recording at
Mission Hall, Bannister Green, Felsted,
Essex, CM6 3NF**

May 2017

CAT Report 1093
May 2017

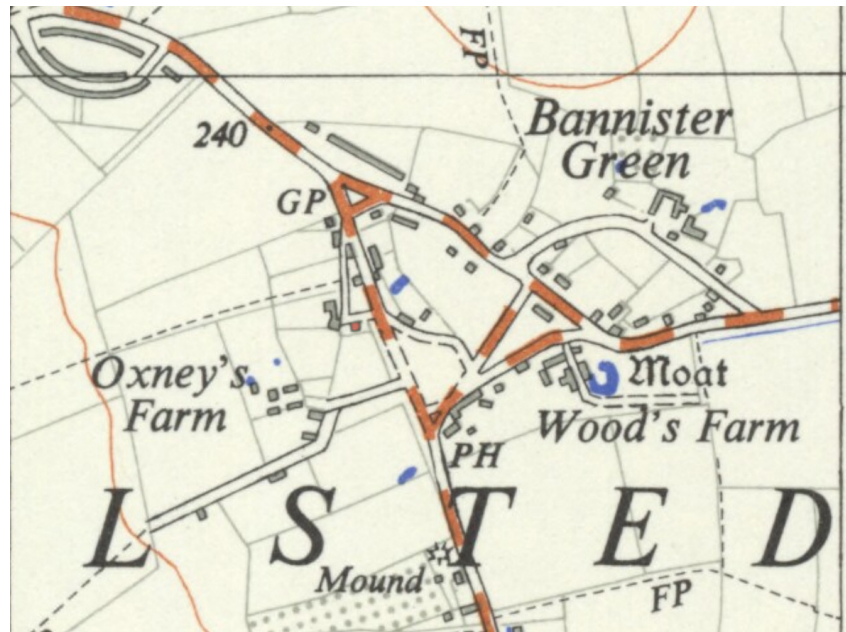
A brief analysis of the cartographic data shows that the Mission Hall is not present on OS maps up to 1947 (Map I), and first appears on the 1953 OS map (Map I).

Map II 1953 OS Map of Bannister Green. Mission Hall highlighted in red.

The cartographic evidence, however, is an issue. Showing as it does that the Mission Hall was erected at its current location between 1948 and 1953 (some 30-35 years after the end of the First World War) it becomes problematic to suggest it is a re-purposed army accommodation hut.

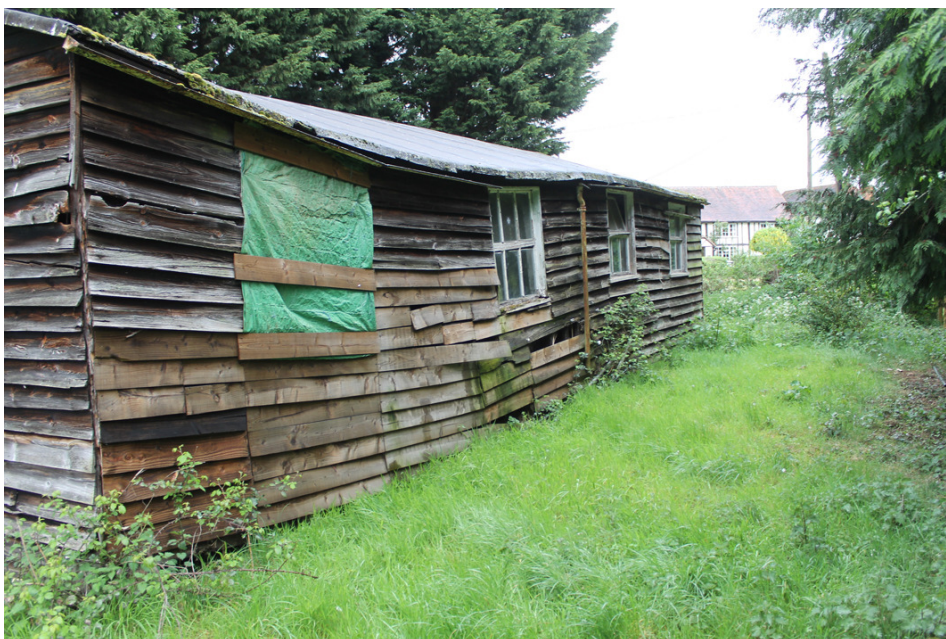
Photograph 2 South elevation of Mission Hall. Photograph taken facing north-east.

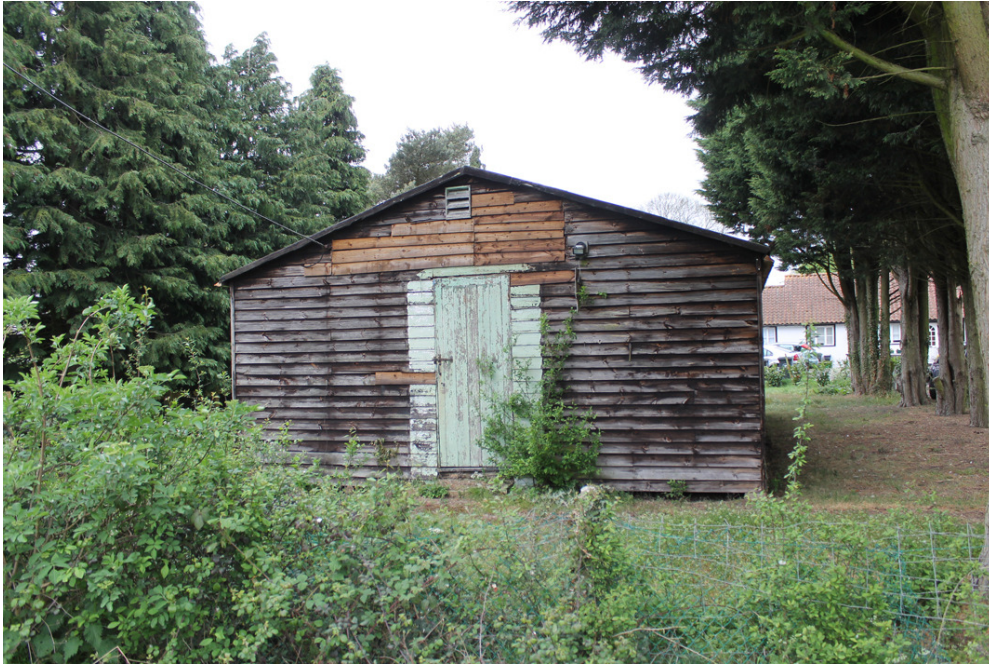
Photograph 3 East elevation of Mission Hall. Photograph taken facing west.

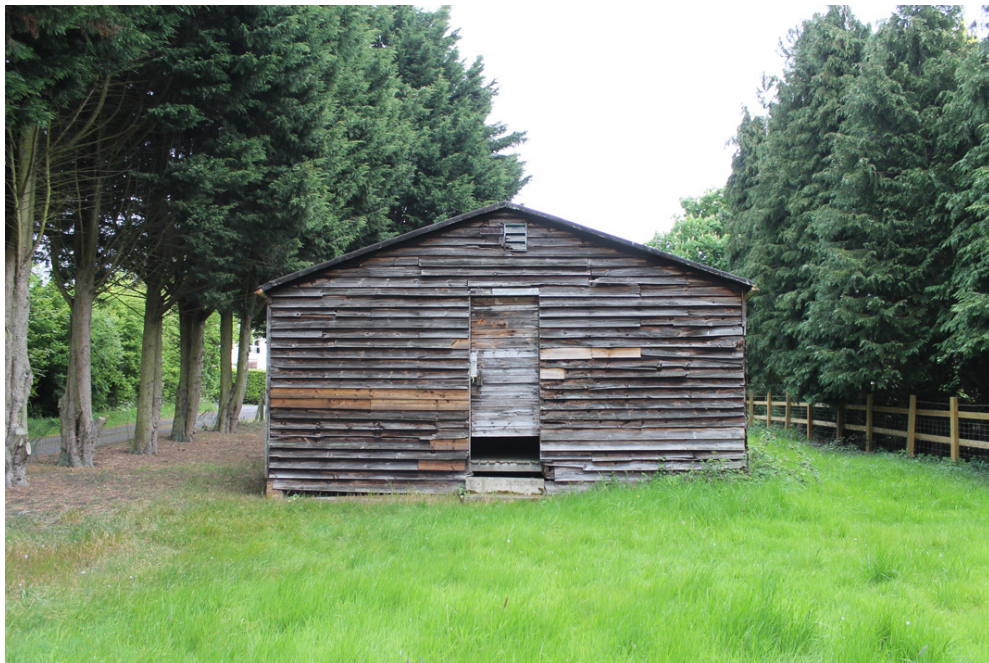
Photograph 4 West elevation of Mission Hall. Photograph taken facing east.

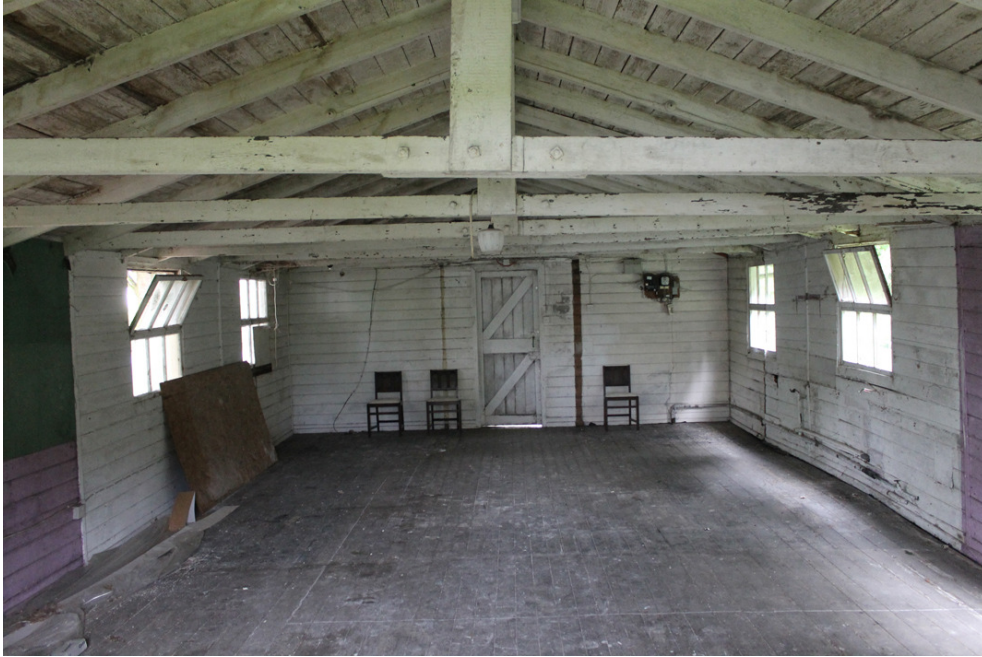
The interior of the building has a wooden plank floor and roof. The posts, sill-beams and wall-plates are all covered with wooden boards. None of the timber-frame of the building is visible except for the king-post roof trusses, which are constructed of machine-cut timber and held together with metal bolts.

Photograph 5 Interior shot of Mission Hall. Photograph taken facing east.

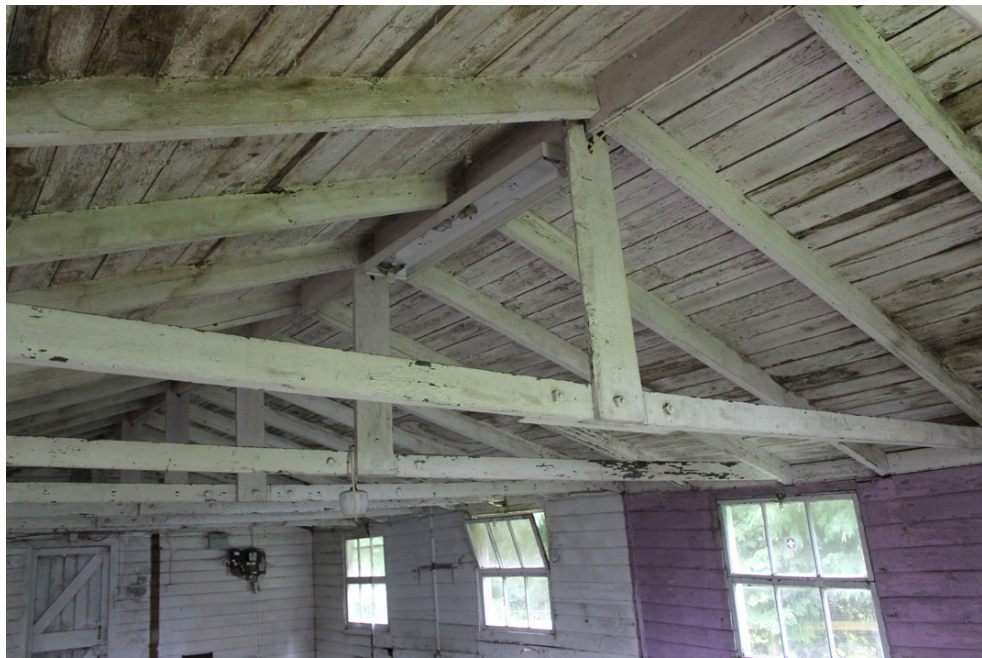
Photograph 6 King-post roof trusses. Photograph taken facing south-east.

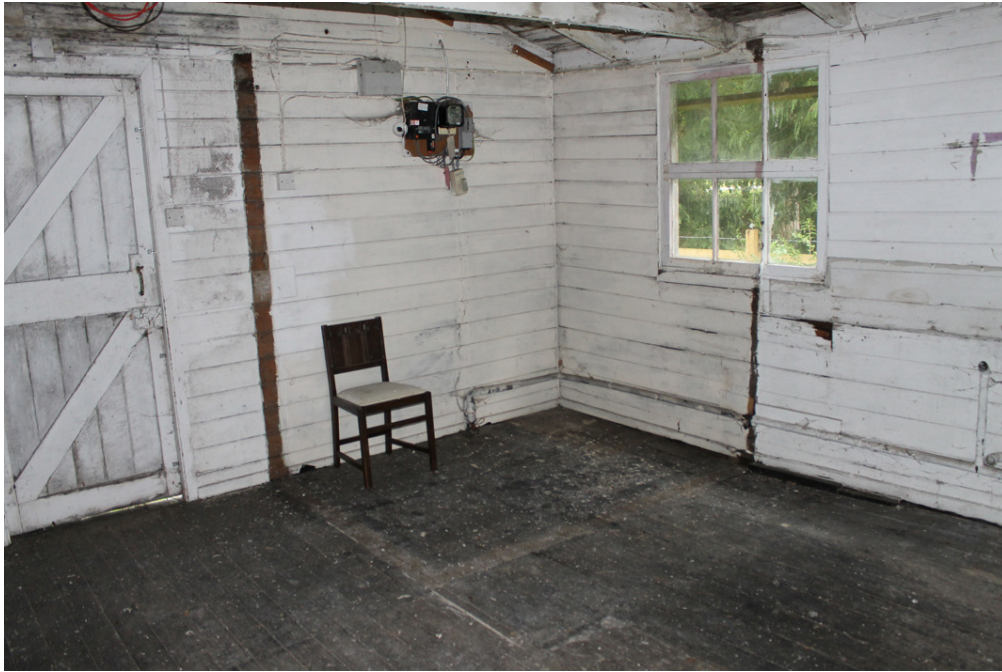
At the eastern end of the Hall there is evidence for two recently removed subdivisions within the building, forming two separate rooms, one on each side of the eastern entrance.

Photograph 7 Recently removed division in the south-east corner of Mission Hall. Shot taken facing south-east.

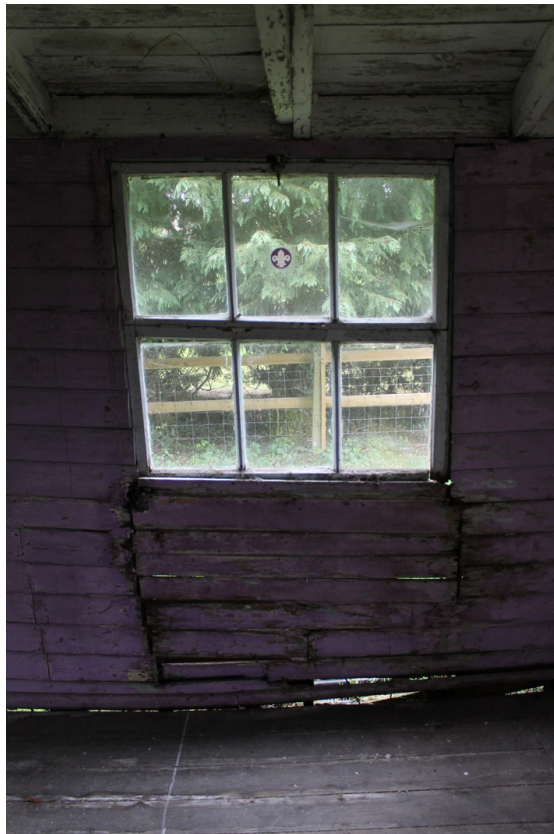
Photograph 8 Detail of one of the six-light windows on the southern elevation. Photograph taken facing south.

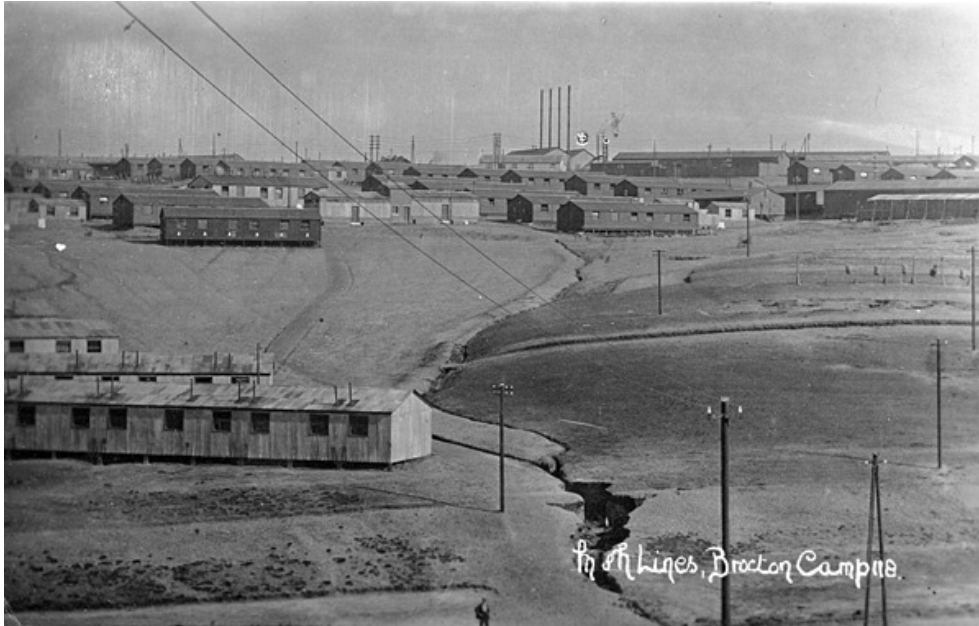
Photograph 8 First World War hutted camp at Brocton. Taken from <http://www.staffspastrack.org.uk/exhibit/chasecamps/hut.htm>.

Although Mission Hall is slightly smaller than the standard size of these huts, which was 60ft (18.2m) x 20ft (6.1m), it could be a surviving example. It shares many stylistic traits with First World War huts, including shape and method of construction.

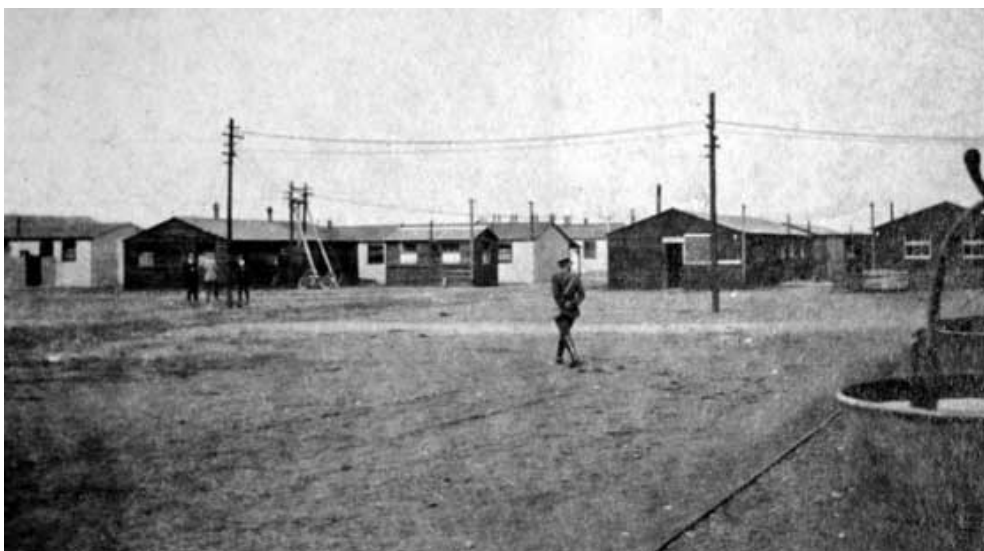
Photograph 9 First World War hutted camp at Wareham. Taken from <http://www.kingsownmuseum.com/ko1769pagethree.htm>.
