Continuous archaeological monitoring and recording and a test-pit evaluation at St James' House and The Waiting Room, Queen Street, Colchester, Essex, CO1 2PQ

December 2017-January 2018

CAT Report 1230

March 2018

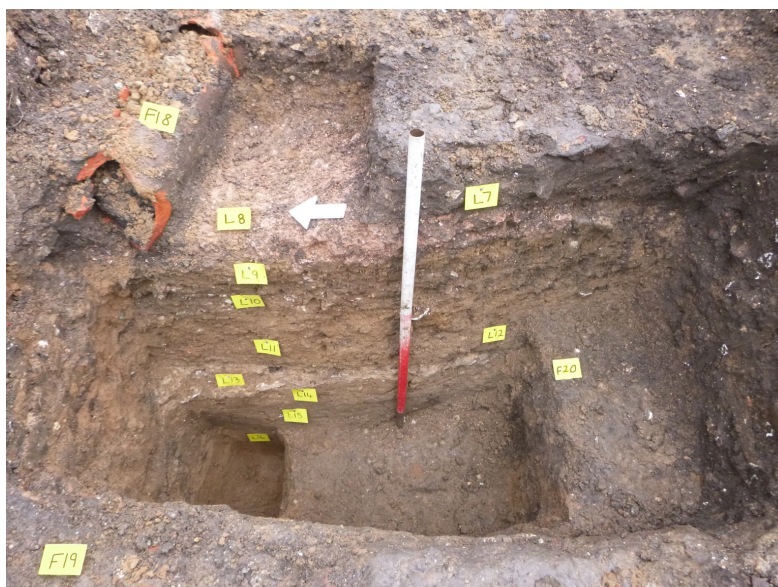
Photograph 1 TP1: The archaeological sequence (L7-L16), looking east.

TP1 was located adjacent to a concrete stanchion on the Queen Street frontage (Fig 2). In the western half of the test-pit, a large, straight-sided pit (F19) with 20th-century material in the backfill was sealed beneath L1. Based on the findings in TP3 (see below), pit F19 is likely to have contained the large concrete pad on which the stanchion to the north-west was constructed (for safety reasons the concrete pad was not uncovered in this test-pit). A 0.5m wide section of F19 was hand-excavated (Fig 4) so that any potential archaeological deposits to the south-east could be recorded in section (Photograph 1).

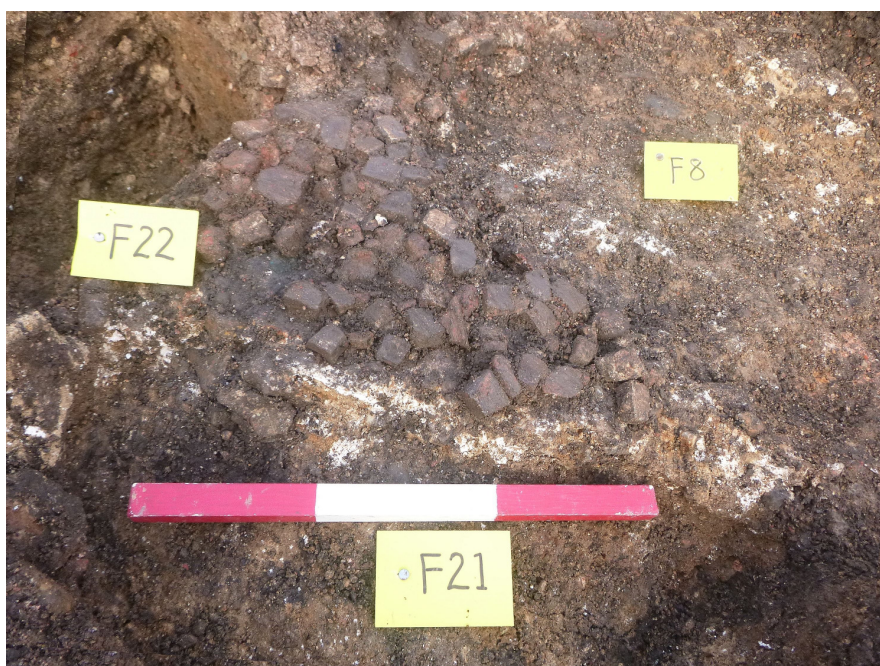
Photograph 2 TP2: Close-up of the remains of mosaic floor F21, looking north.

A smaller trial-pit c 1.8m x 1.7m in size was excavated in the centre of TP2 (Fig 5) to ascertain the depth of Roman deposits in this area. The trial-pit was excavated through a layer of post-Roman dark soil (L3) which overlaid a layer of Roman building materials (L4) from the demolition of a Roman building (Fig 9 TP2a). Late 4th- to early 5th-century pottery was recovered from the Roman demolition layer (L4). Late Roman pottery was also recovered from the overlying soil (L3), as well as peg-tile fragments and three sherds of 15th- to 16th-century German stoneware. Two post-Roman pits (F7 and F8) were partially excavated so that the deposits below the Roman demolition layer could be examined. The remains of a mosaic floor (F22) lying directly beneath the demolition debris (L4) was observed in the edges of the two pits (Fig 9 TP2a and Fig 10 TP2b). A small area of L4 was excavated to examine the mosaic (Fig 5). A triangular area (less than 0.1m²) of the floor was uncovered. It had been cut to the south by a pit (F21) (Photograph 2), into which the demolition debris (L4) was slumping. The black, white and red tesserae of the mosaic had all been detached from the mortar surface in which they had presumably been set (see Photograph 2). Many of the tesserae had become incorporated in the fills of pits F8 and F21 (see section 6 below). A coin dating to c 275-285 was recovered from the loose soil amongst the displaced tesserae cubes. This indicates that the floor was destroyed at sometime after this date. The remains of the floor could be seen continuing to the north where there is likely to be more truncation by the post-Roman pits recorded in this area.

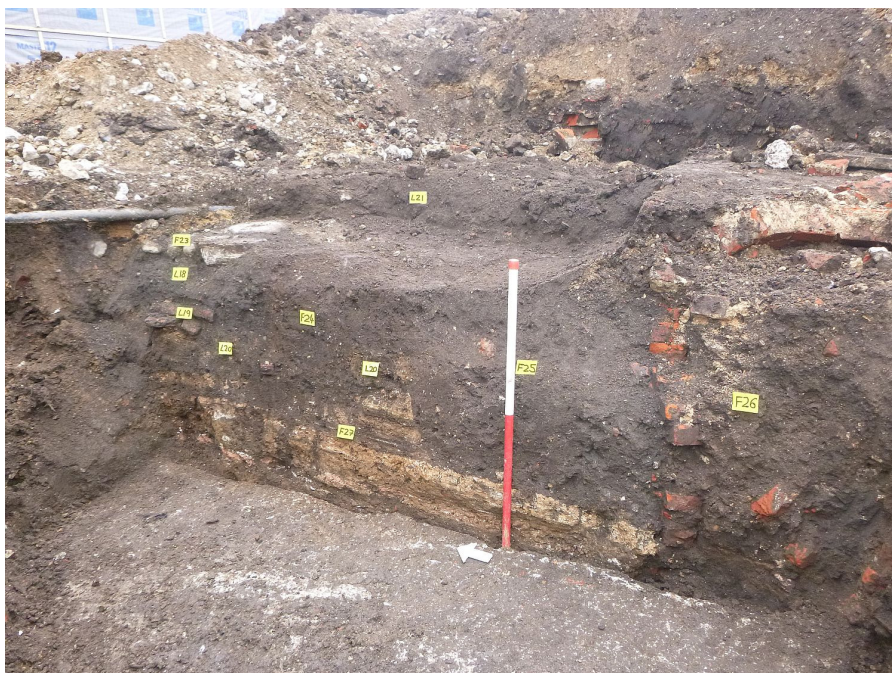
Photograph 3 TP3: the eastern edge of F32, looking north-east.

The remains of a Roman building were observed in the edge of the pit for the concrete pad (F32) (Photographs 3 & 4). To allow these deposits to be cleaned and recorded safely, it was necessary to reduce the top edge of the test-pit using the mechanical excavator. A step c 1.3m wide and 0.95m deep was excavated through the crushed concrete (L1) and a thick layer of homogeneous modern/post-medieval dark soil (L21). L21 overlaid the remains of a cobbled surface (F23) and a brick-lined soakaway (F26) (Fig 6), both of which are likely to date to the post-medieval period.

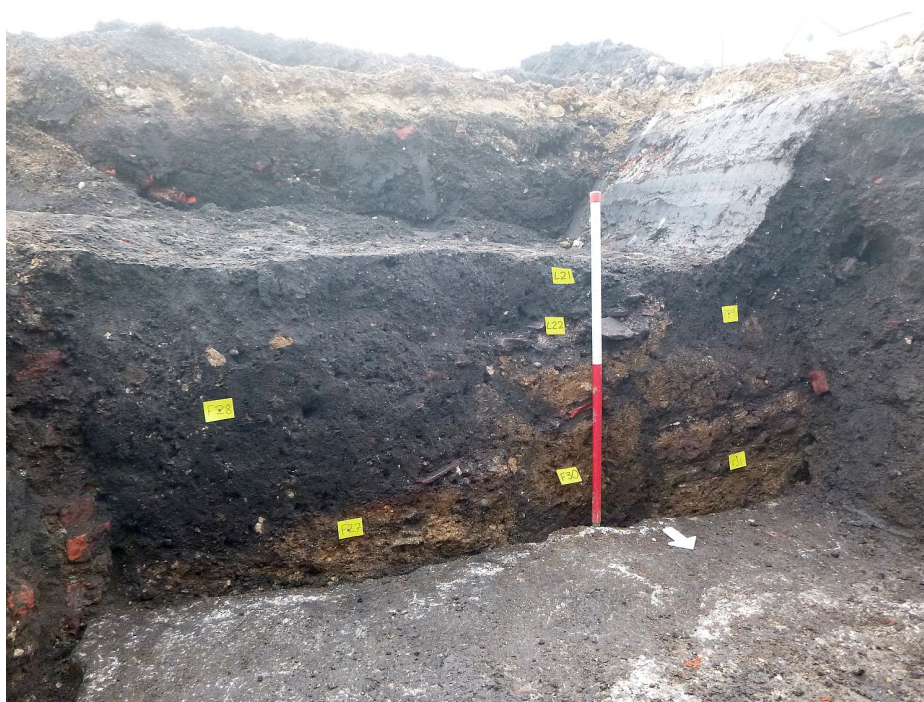
Photograph 4 TP3: the southern edge of F32, looking south-west.

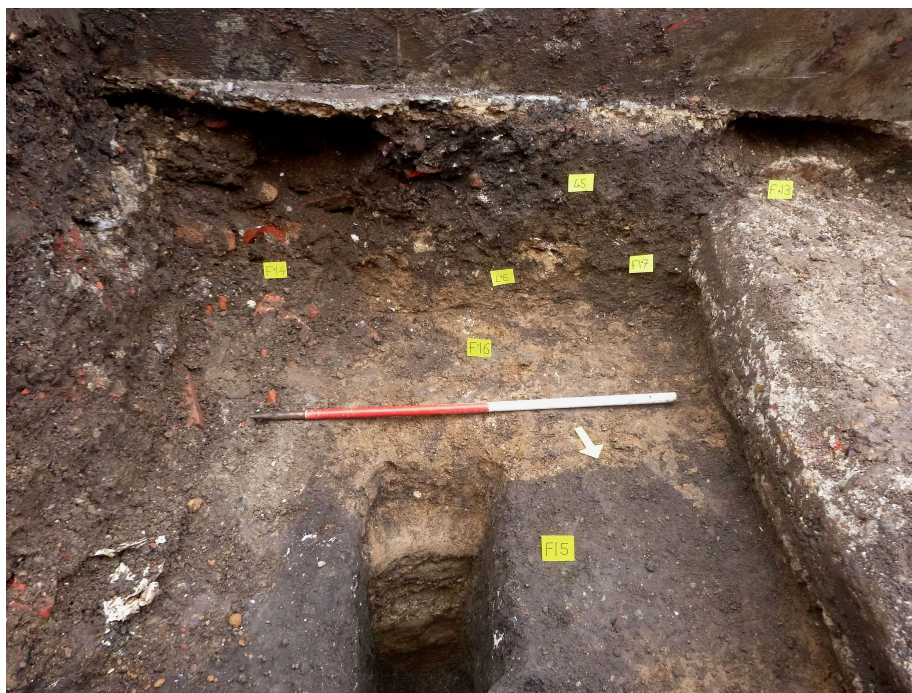
Photograph 5 TP5: a medieval/post-medieval pit (F15) cutting Roman floor deposits (F16), looking south.

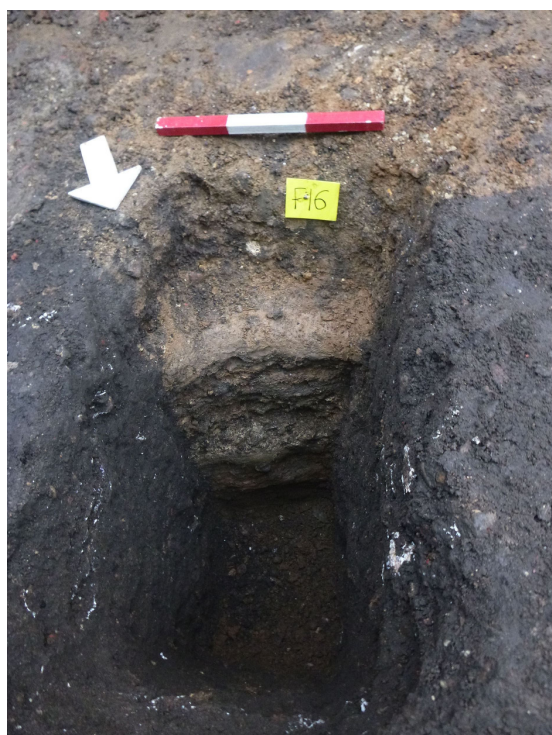
Photograph 6 TP5: Roman floor deposits in the edge of F16, looking south.

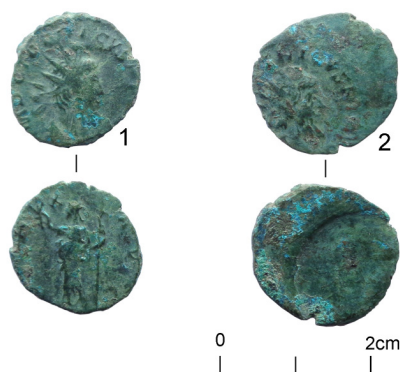
Photograph 7(1) SF1 F7 (7) A copper-alloy radiate of Tetricus I, AD 271-273. Obverse: bust right, radiate, cuirassed, [I]MP C TE[TR]ICVS [P F AVG]. Reverse: Pax, standing left, holding olive branch and vertical sceptre, [P]AX [A]VG. Die axis: 1 o'clock. Weight: 2.9g. Diameter: 18mm.

Photograph 7(2) SF2 F22 (11) A copper-alloy barbarous radiate, c AD 275-285. Coin has been mis-struck by approximately half the diameter. Obverse: bust right, radiate, [...]ANICVS M[...], possibly meant to be GERMANICVS MAX V, and usually found on reverse inscriptions. Reverse: illegible. Weight: 1.9g. Diameter: 19mm.

Photograph 7 Roman coins.

Two 3rd century coins were recovered from F7 (a post-medieval ?pit) and F22 (a disturbed/damaged Roman floor). The first from F7 (SF1) was a copper-alloy radiate of Tetricus I, AD 271-273, and the second from F22 (SF2) a copper-alloy barbarous radiate. Barbarous radiates were contemporary copies of coins of Gallienus through to the Tetrici, and it is thought that most of them were struck c 275-285 when there was a shortage of small change in Britain (Moorhead 2015). Both coins are described below.

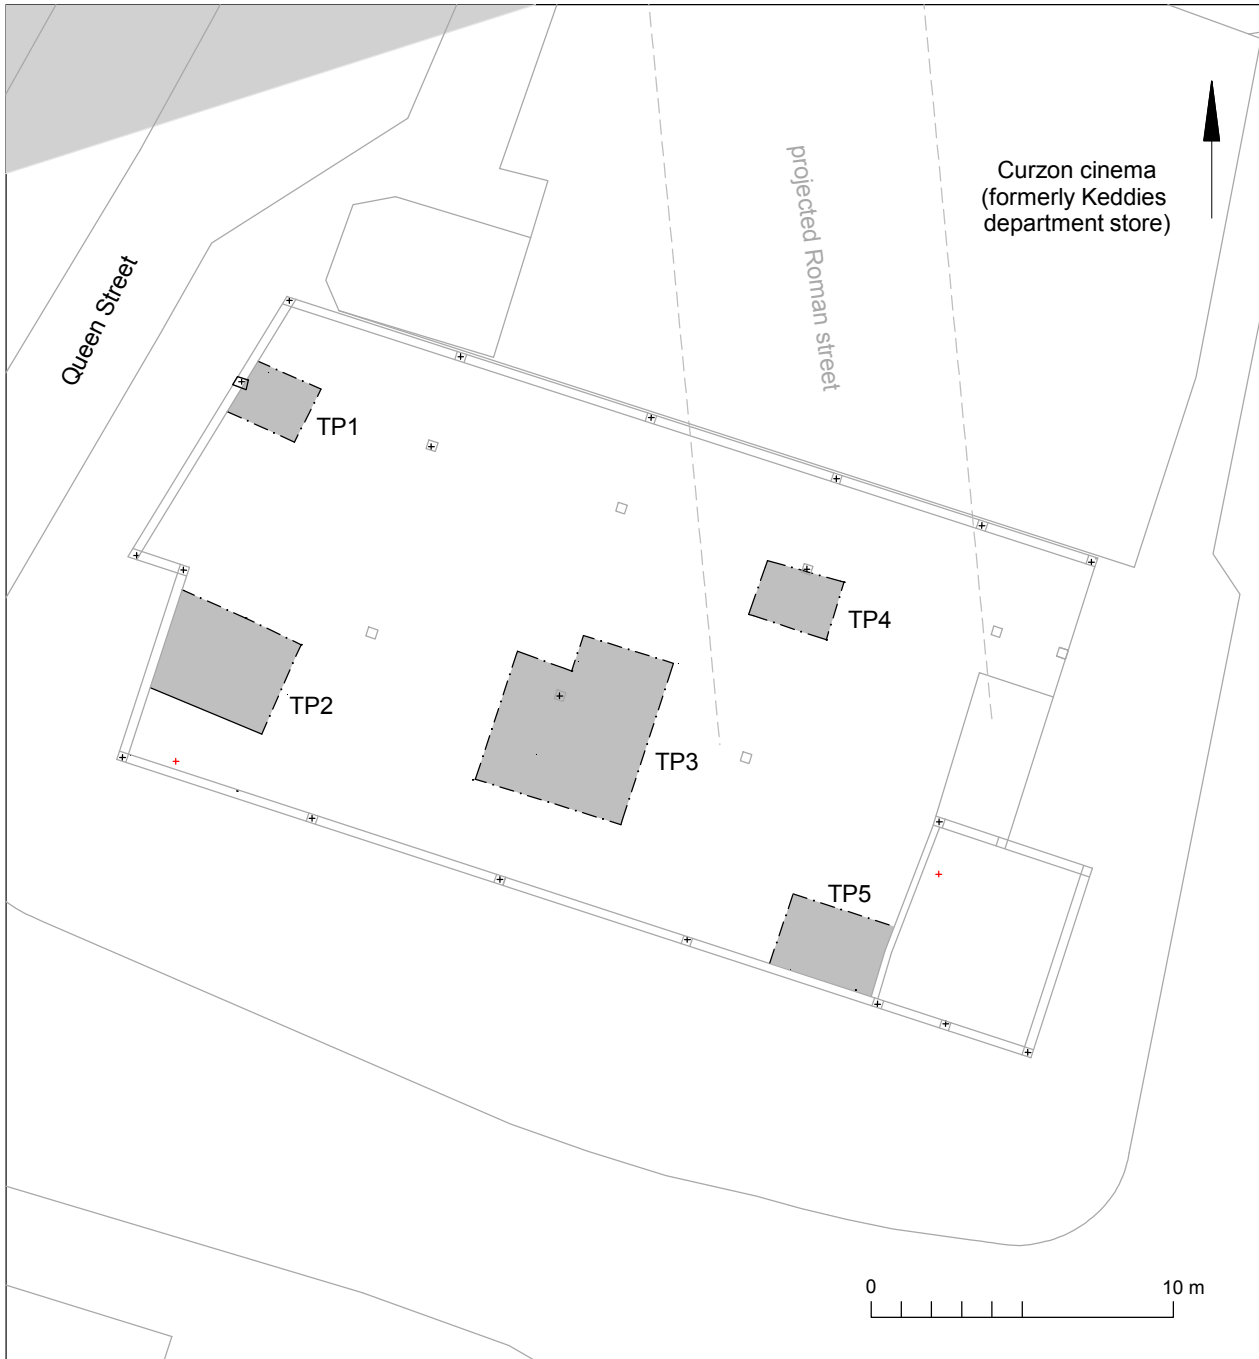
Fig 2 Site plan showing the locations of the five test-pits in the former St James' House (Phase 2).

Five test-pits were positioned next to a sample of the concrete stanchions across the building footprint (Fig 2). Demonstrably modern deposits (ie L1) were removed from the areas of the test-pits using a mechanical excavator under the supervision of a CAT archaeologist. It was necessary to step-in four of the test-pits to allow safe access for archaeological recording (TP1-TP3 and TP5).

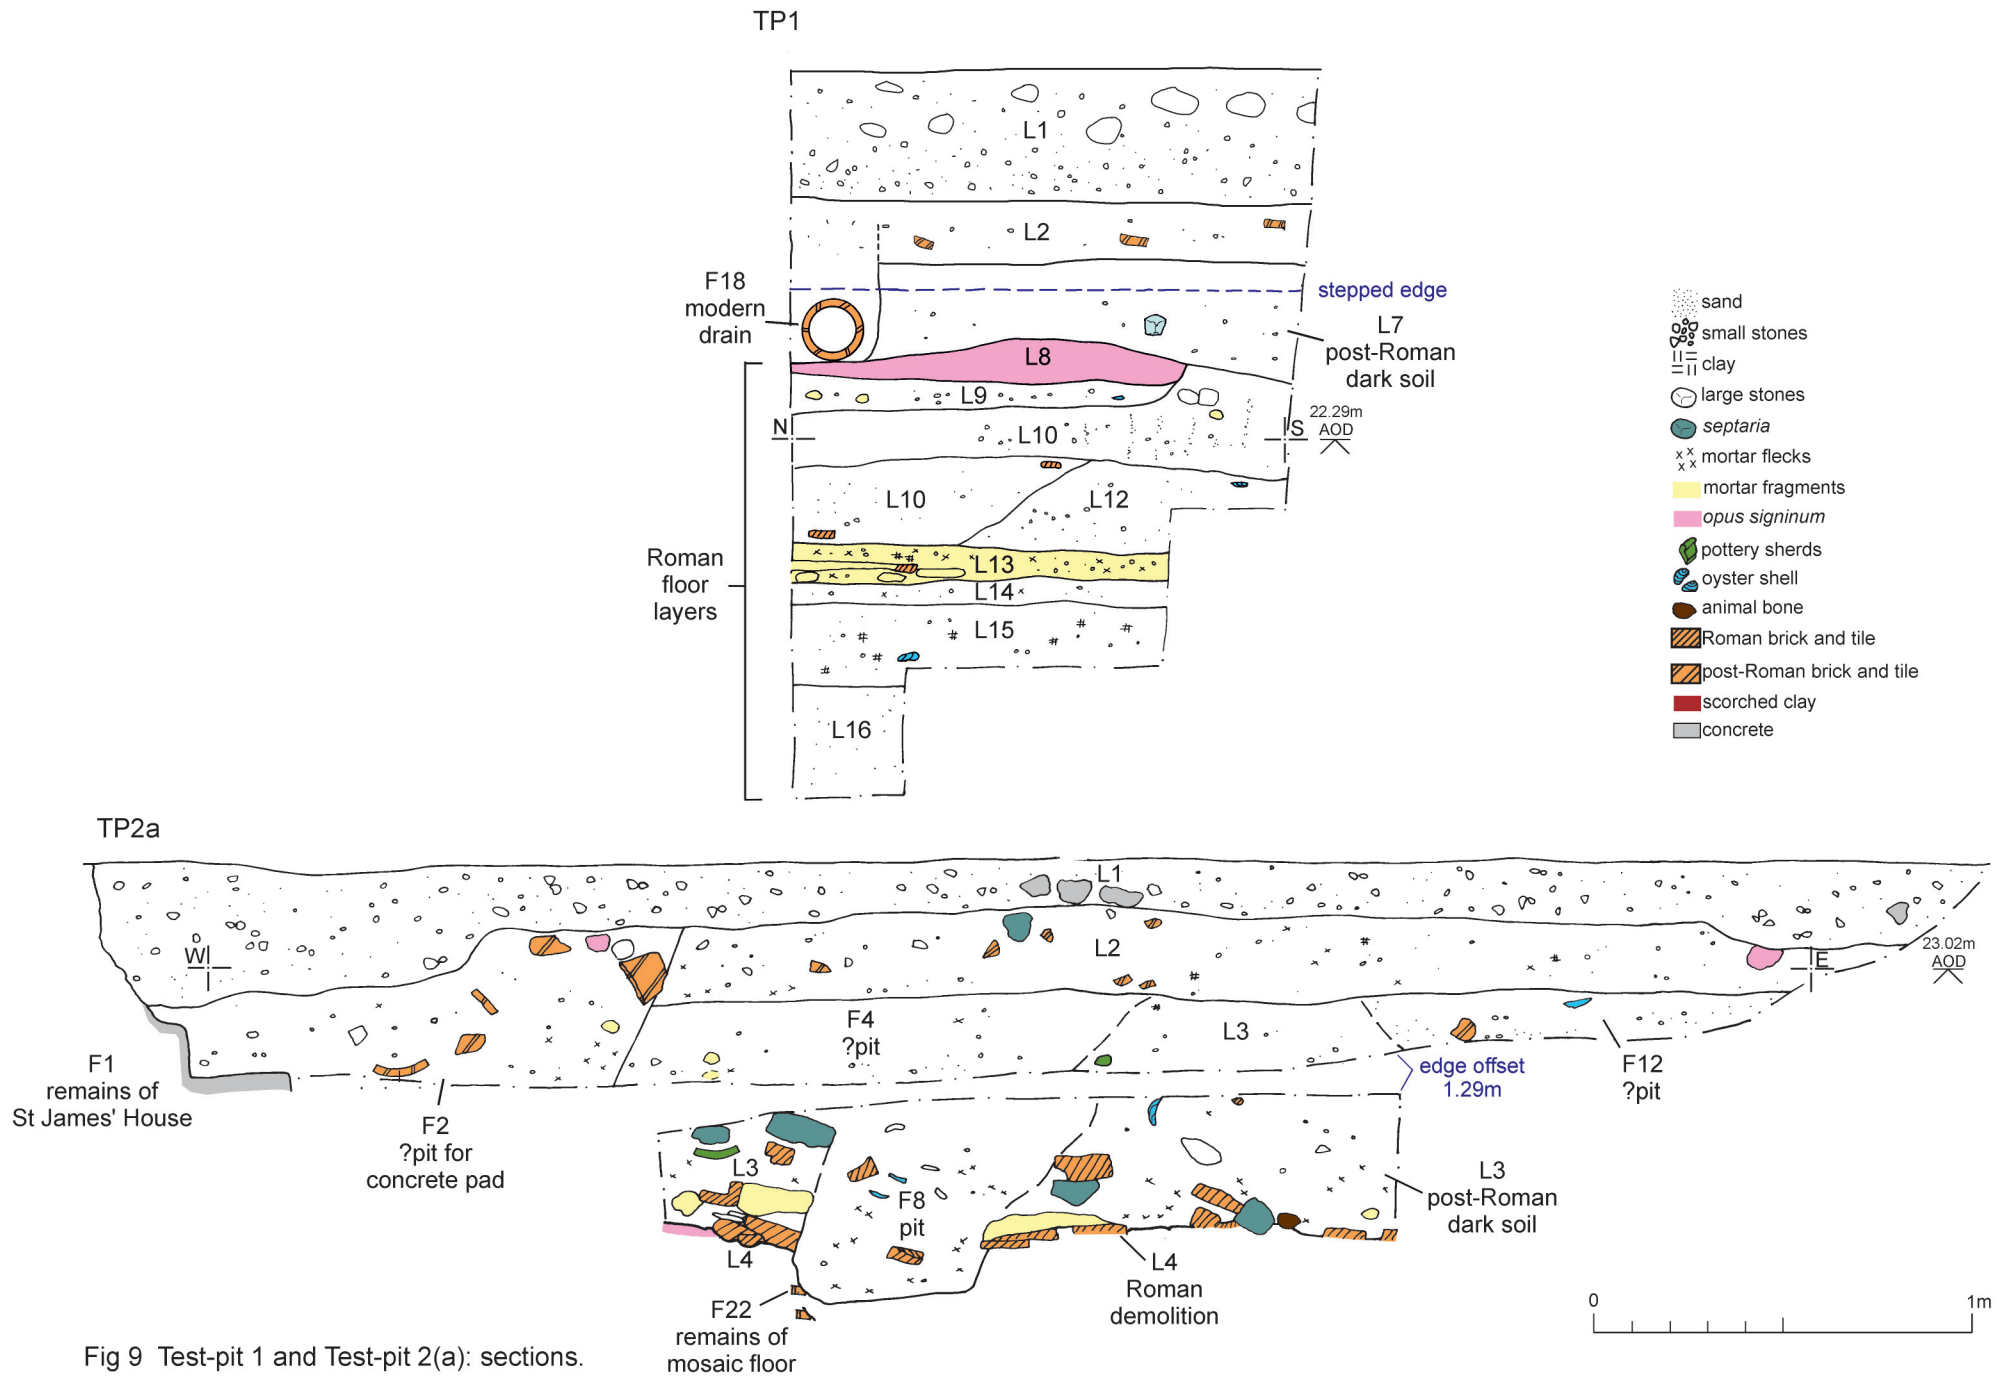
Fig 9 Test-pit 1 and Test-pit 2(a): sections.

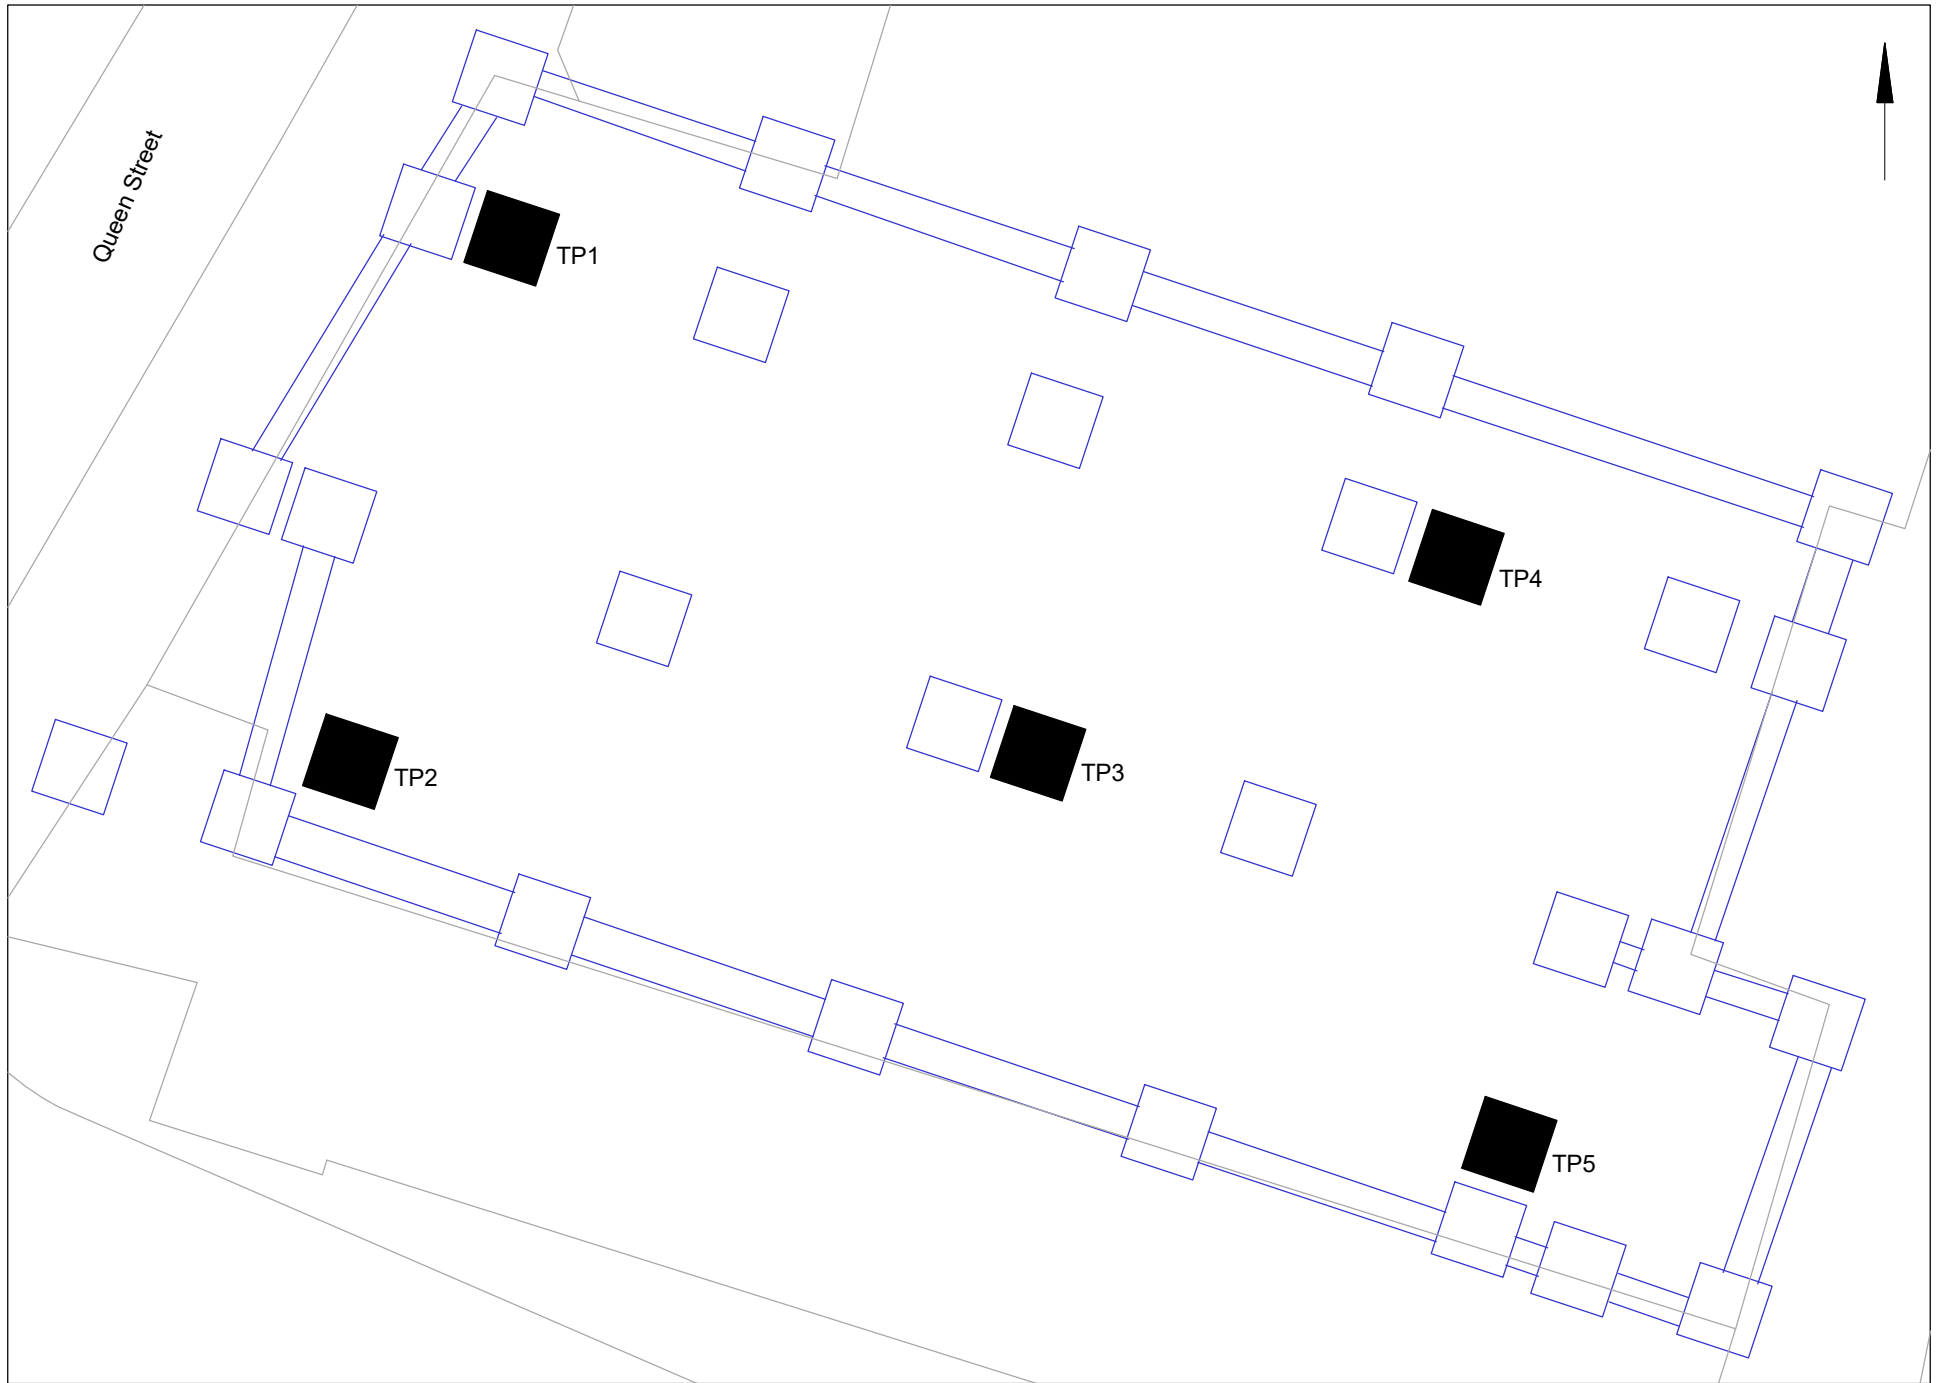
Fig 2 Plan of anticipated piling cap and ground-beam positions in St James' House (blue) and proposed test-pit locations.
