# Archaeological monitoring on land west of Granta Cottages, Market Road, Great Chesterford, Essex, CB10 1NS

July - November 2017

**CAT Report 1292**

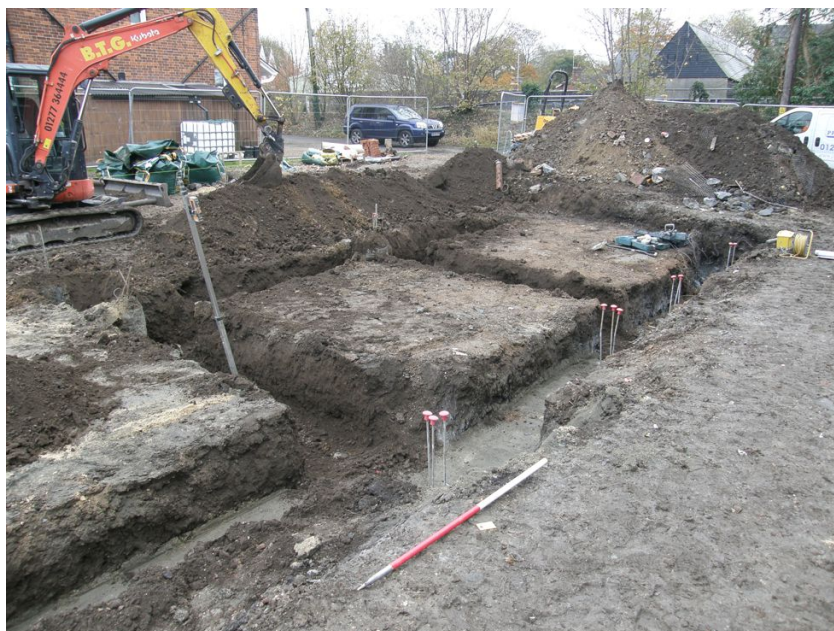
**Photograph 1** South-west corner of foundation trench during excavation. Photograph taken facing east.

During the monitoring, a CAT archaeologist observed the excavation of approximately 70m of foundation trenches, connecting a series of rammed piles. The foundation trenches (on average) measured 0.9m in width and 1m in depth.

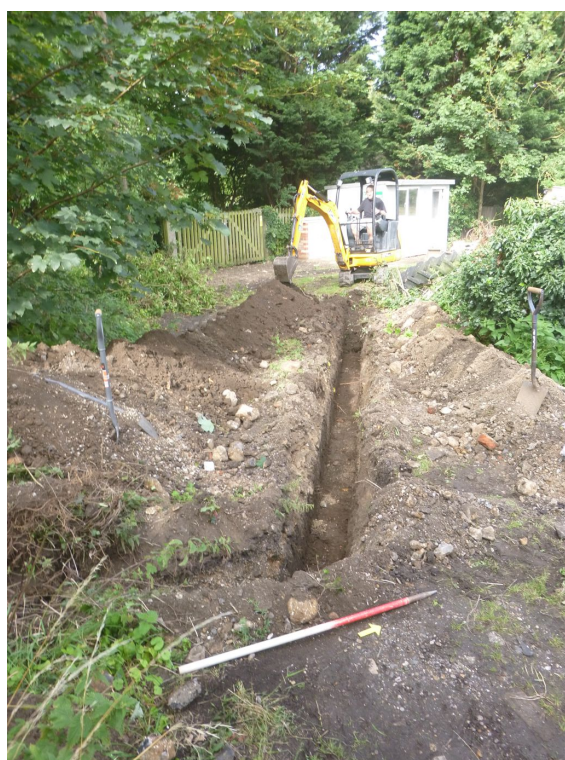
**Photograph 2** Trench for water pipe under excavation. Photograph taken facing north-west.

The excavation of two service trenches was also observed (Fig 2). One was for a water pipe and consisted of c 21m of trenching aligned east-west, between Newmarket Road and the temporary builders compound. This trench measured 400mm wide and 750mm deep.

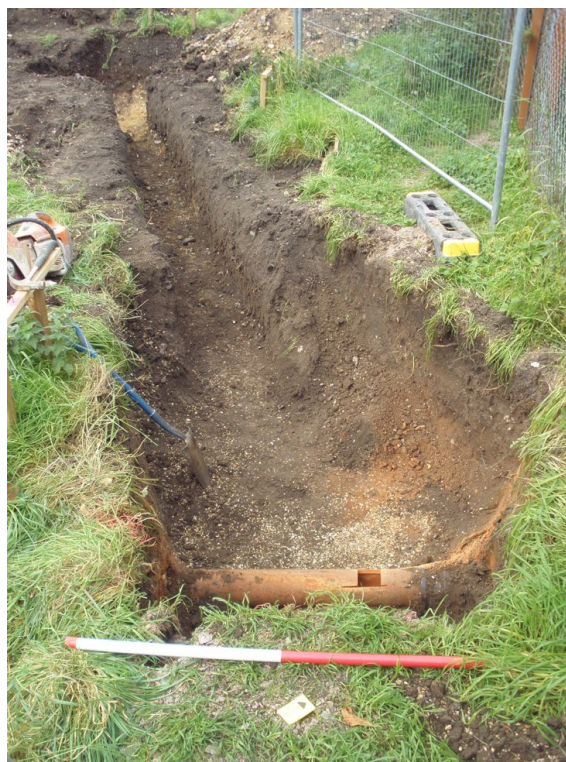
**Photograph 3** Drainage trench, showing shallower east end and original service run to be diverted. Photograph taken facing north-west.

The second trench was for much more substantial deep drainage, connecting to an existing sewer and surrounding the new building on the north, east and west (Fig 2). This trench was c 37m long, measured 0.6m wide (although was larger in the location of manholes) and varied between 2.7m deep (to the west) and 0.65m deep (to the east).

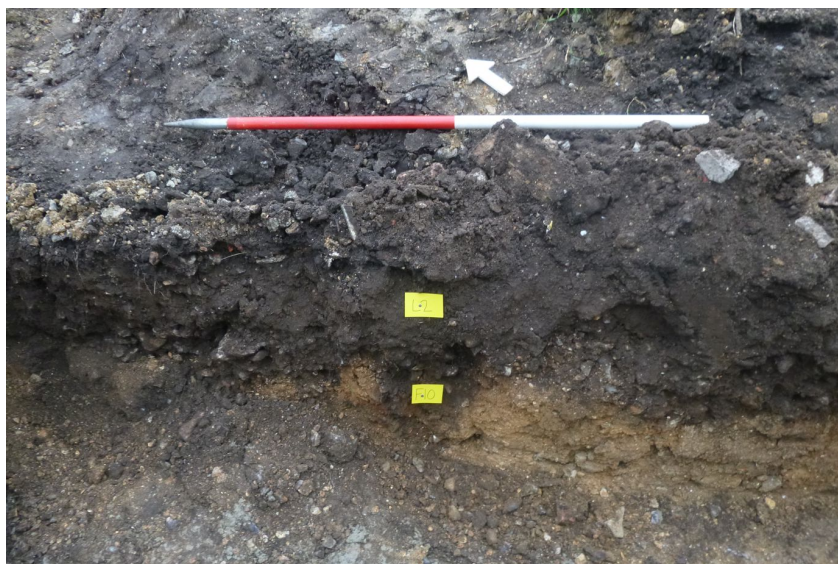
**Photograph 4** Section in eastern foundation trench, showing F10 and L2. Photograph taken facing north-east.

Only one feature was encountered during the monitoring, a small posthole observed in the section of the easternmost foundation trench (F10). No finds were recovered from this feature, but it was sealed by L2 (Photograph 4).
