# Essex Historic Environment Record/ Essex Archaeology and History

## Summary sheet

<b>Address: St Nicholas Church, Tolleshunt D'Arcy, Maldon, CM9 8TS</b>	
<b>Parish:</b> Tolleshunt D'Arcy	<b>District:</b> Maldon
<b>NGR:</b> TL 92822 11698 (centre)	<b>Site code:</b> CAT project ref.: 18/04a
<b>Type of work:</b> Archaeological monitoring	<b>Site director/group:</b> Colchester Archaeological Trust
<b>Date of work:</b> July 2018	<b>Size of area investigated:</b> 19m <sup>2</sup>
<b>Location of curating museum:</b> Colchester museum	<b>Funding source:</b> St Nicholas Church
<b>Further seasons anticipated?</b> No	<b>Related EHER number(s):</b> NHLE: 1328214 EHER: 11417, 11418
<b>Final report:</b> CAT Report 1302	
<b>Periods represented:</b> Medieval, Modern	
<p><b>Summary of fieldwork results:</b> Archaeological monitoring was carried out by Colchester Archaeological Trust at St Nicholas Church, Tolleshunt D'Arcy, Maldon in July 2018. The monitoring was undertaken during the lowering of the floor of the chapel projecting from the north of the church (Fig 1).</p> <p>The church is a Grade I listed building (NHLE. 1328214) and the list entry describes it as being constructed in the late

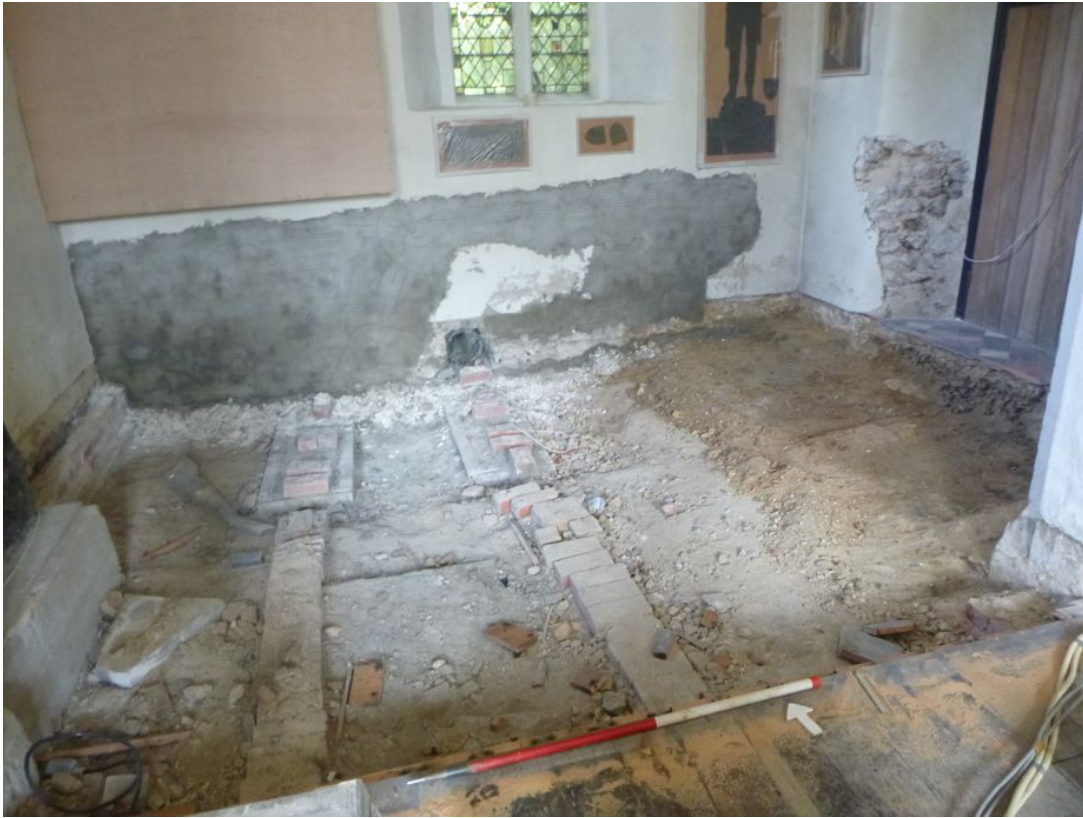
**Photograph 1** Interior of Chapel after floor removed. Brick and concrete supports (F1) visible to left. Photograph taken facing north-east.

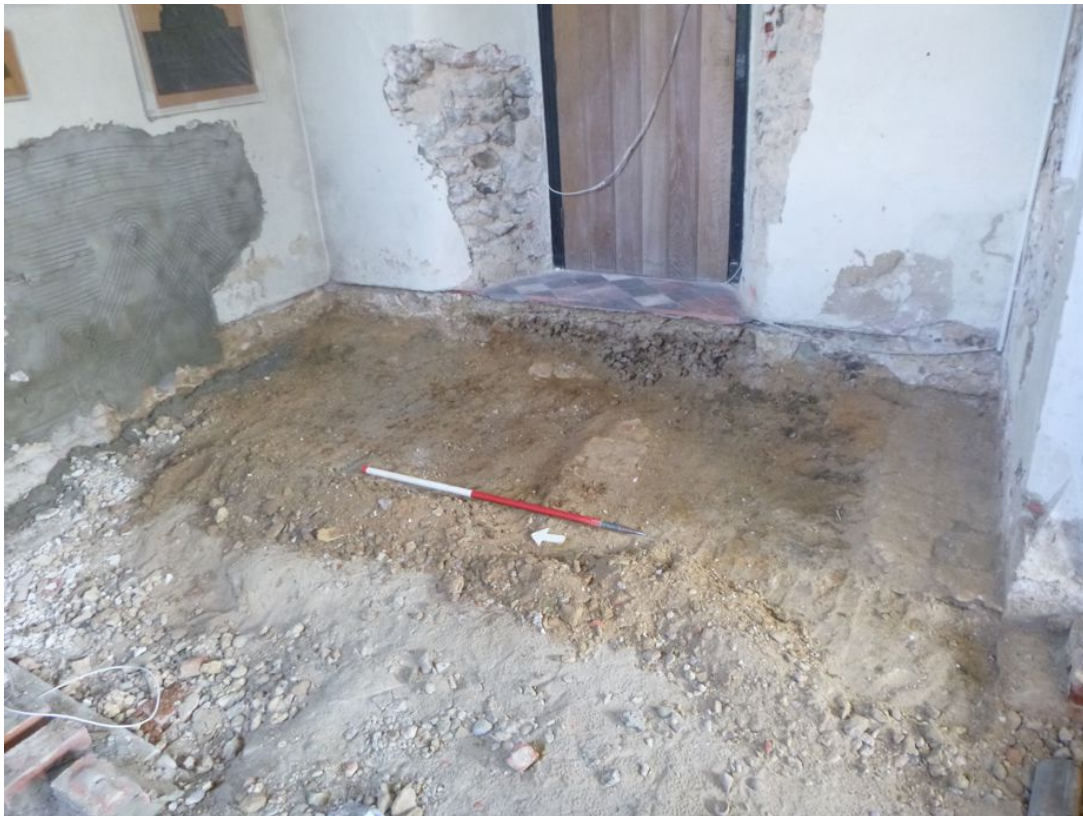
**Photograph 2** Detail of east of Chapel floor after cleaning. Original lime mortar floor (F2) visible in corners. Brick pads (F1) visible in centre. Photograph taken facing east.

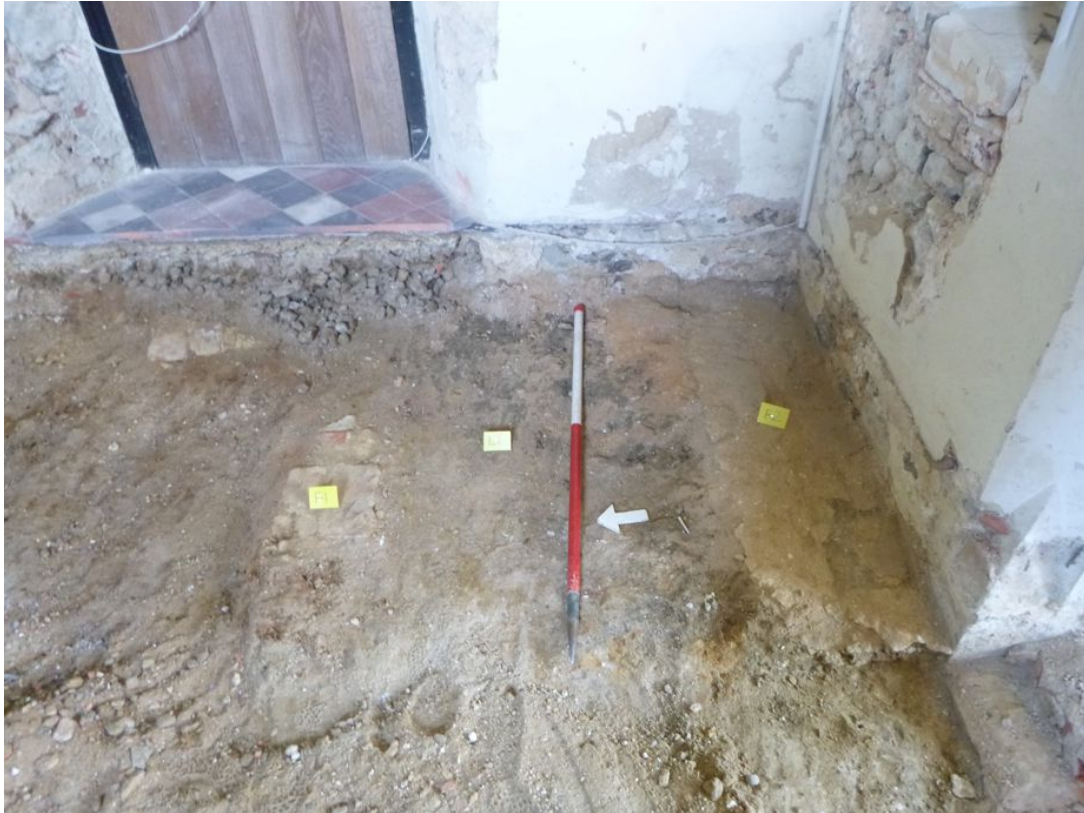
**Photograph 3** Detailed shot of lime mortar (F2) and brick pads (F1) in south-east corner of Chapel. Photograph taken facing east.

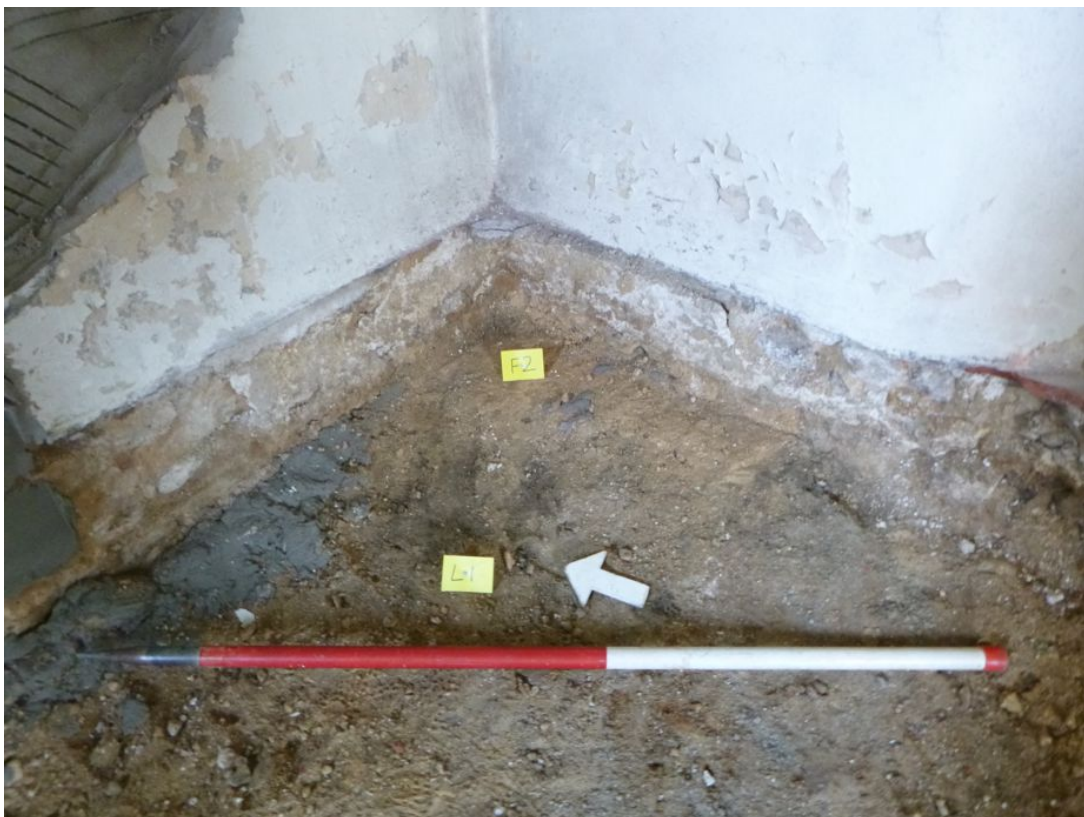
mortar is probably original to the chapel (i.e late 15th century) and would have supported the first, probably tiled, floor.

**Photograph 4** Detailed shot of lime mortar (F2) in north-east corner of Chapel. Photograph taken facing north-east.

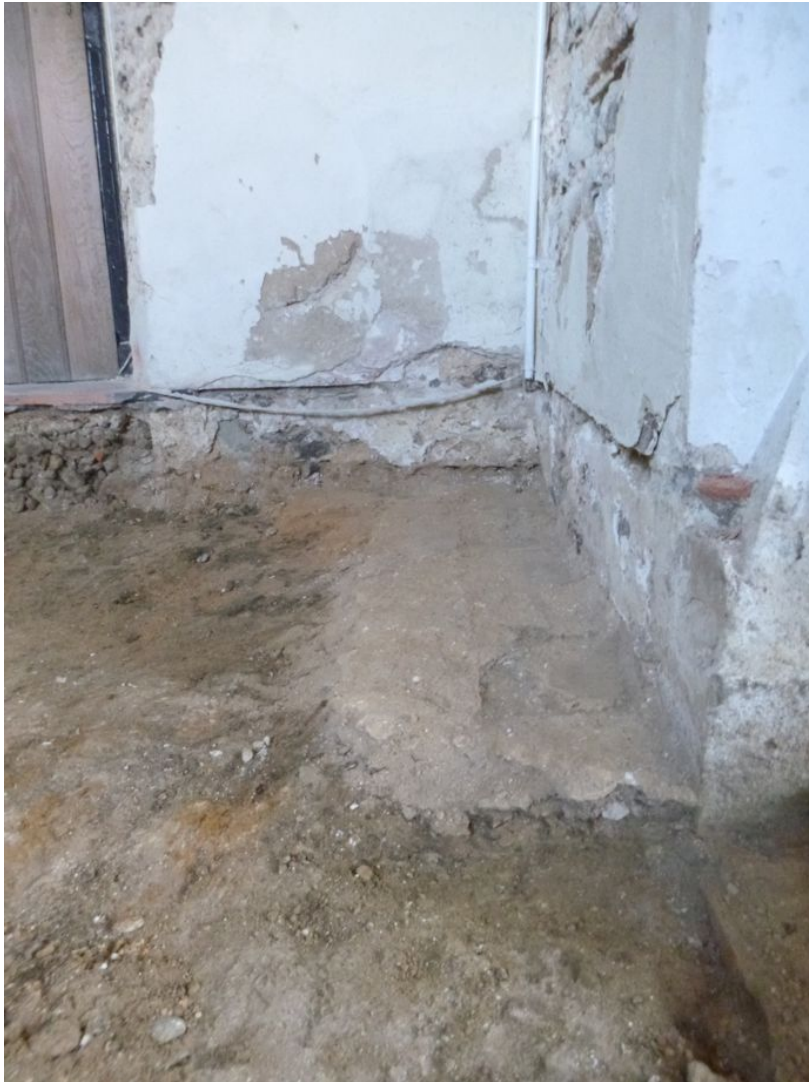
**Photograph 5** Section of lime mortar (F2) in south-east corner of Chapel, showing thickness. Photograph taken facing east.

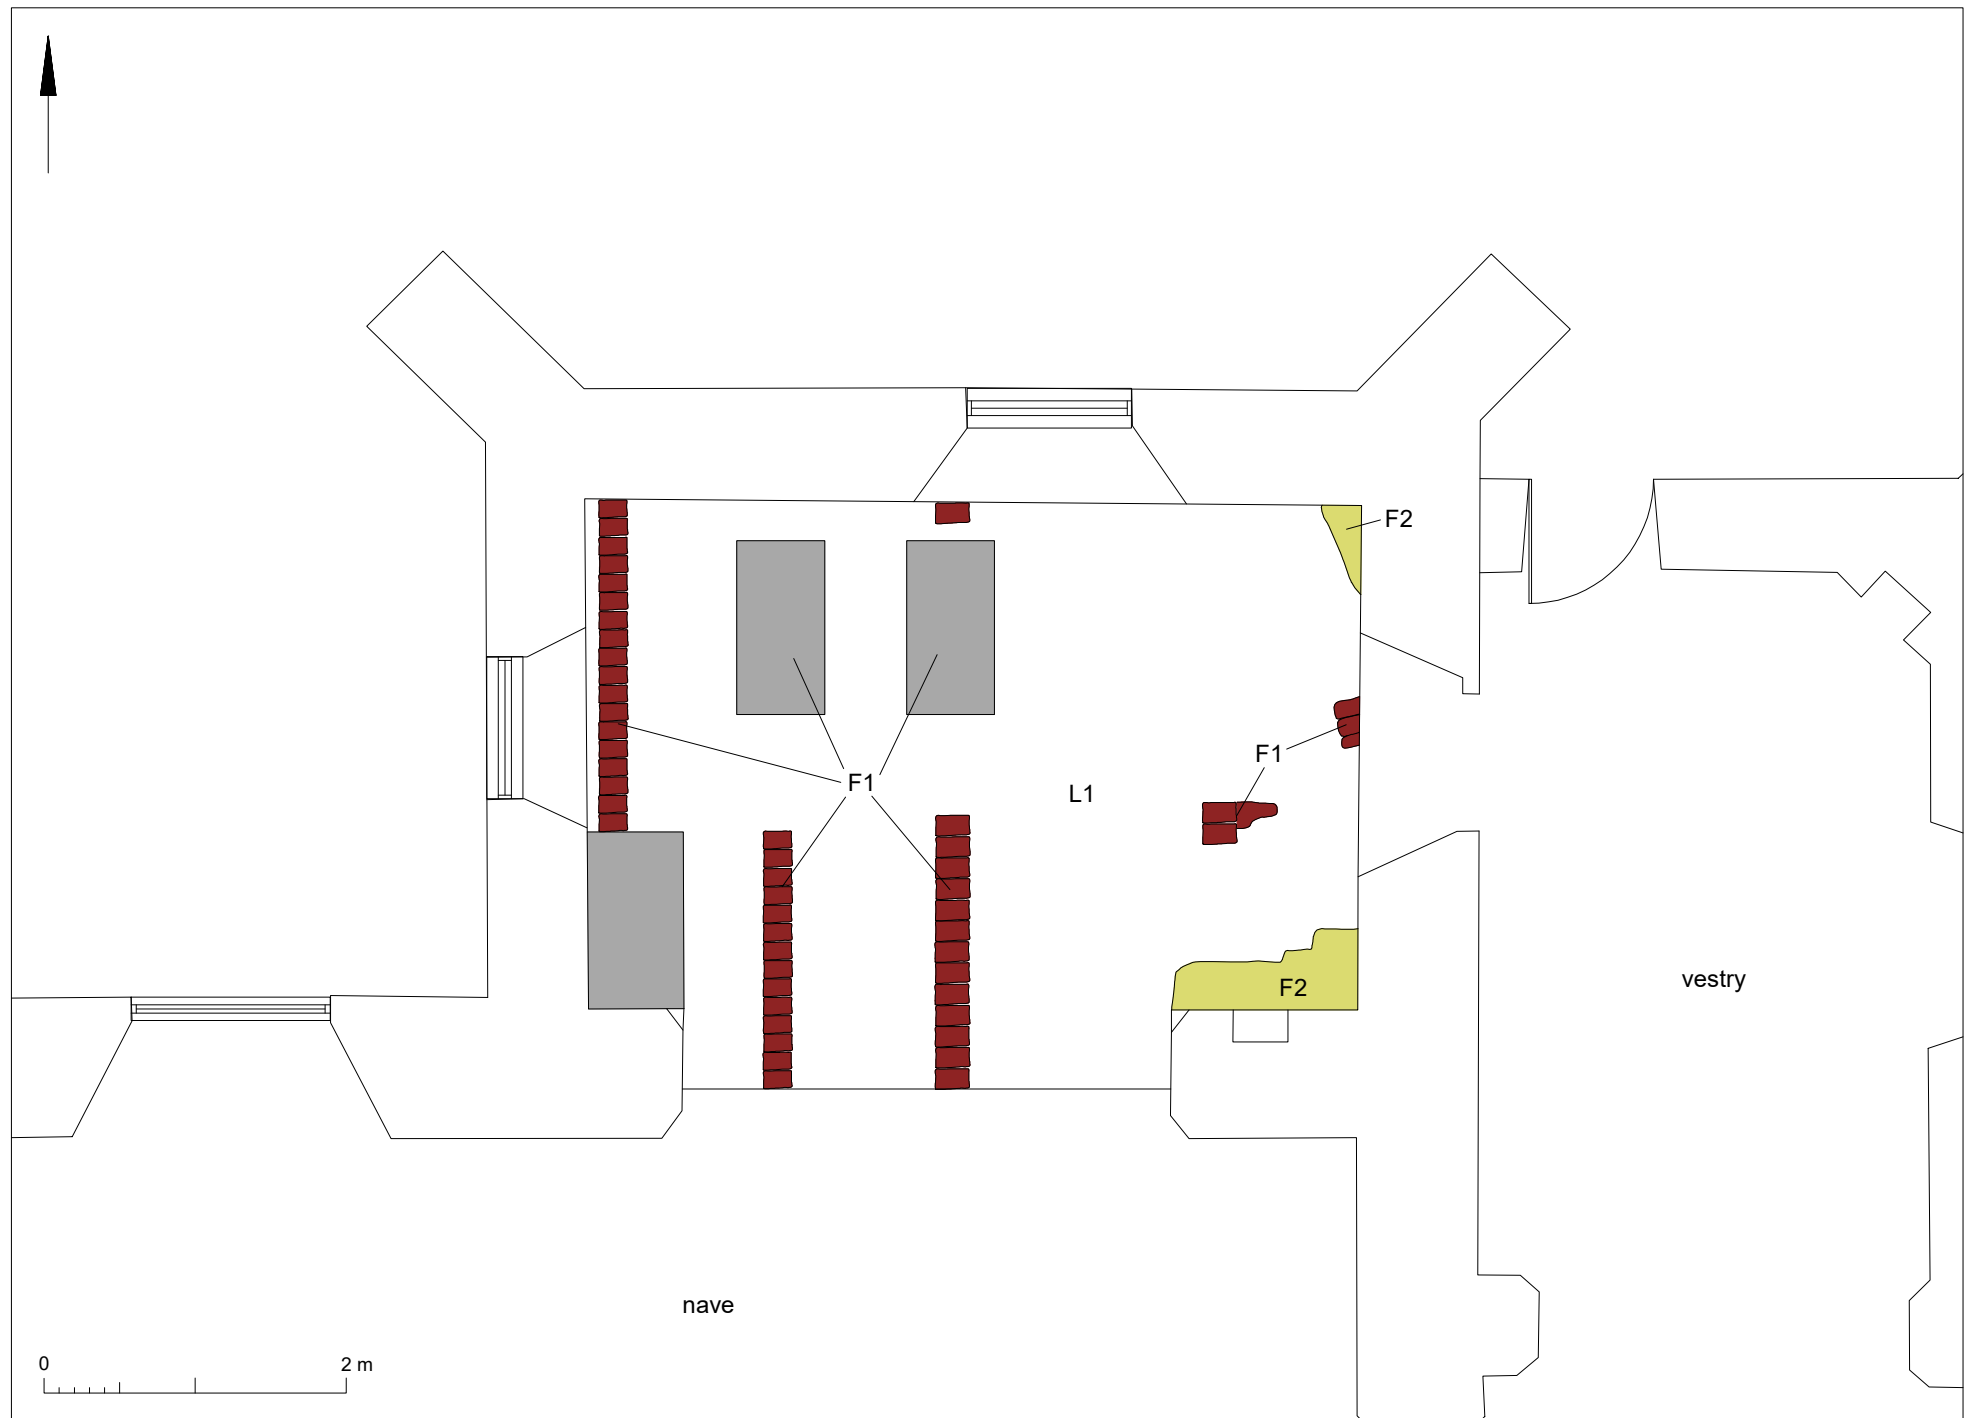
Fig 1 Plan showing monitoring results in chapel of St Nicholas Church, Tolleshunt D'Arcy.
