Archaeological excavation at East of England Co-op, High Street, Dedham, Essex, CO7 6DE

June-September 2018

Colchester Archaeological Trust

CAT Report 1394
March 2020

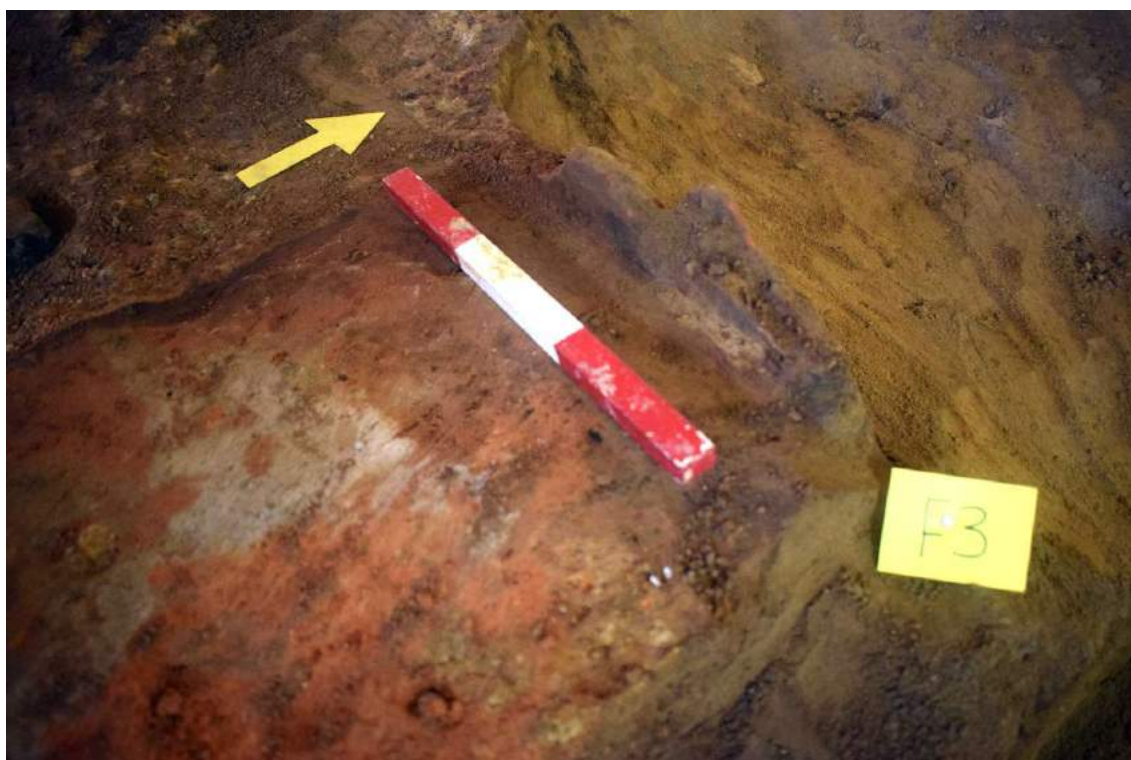
Photograph 1 Edge of hearth F3 with *in situ* peg-tile surround, looking northwest

Environmental remains from hearth F3 included fragments of charcoal identified as *Prunus sp.* (cherry/plum) (see Section 7). A sample of this material was sent to SUERC Scottish Universities Environmental Research Centre for radiocarbon dating. The analysis produced a 2-sigma calibrated date (at 95.4% confidence) of 1272 to 1389 cal AD (SUERC-91972 (GU54952)) (see Appendix 5).

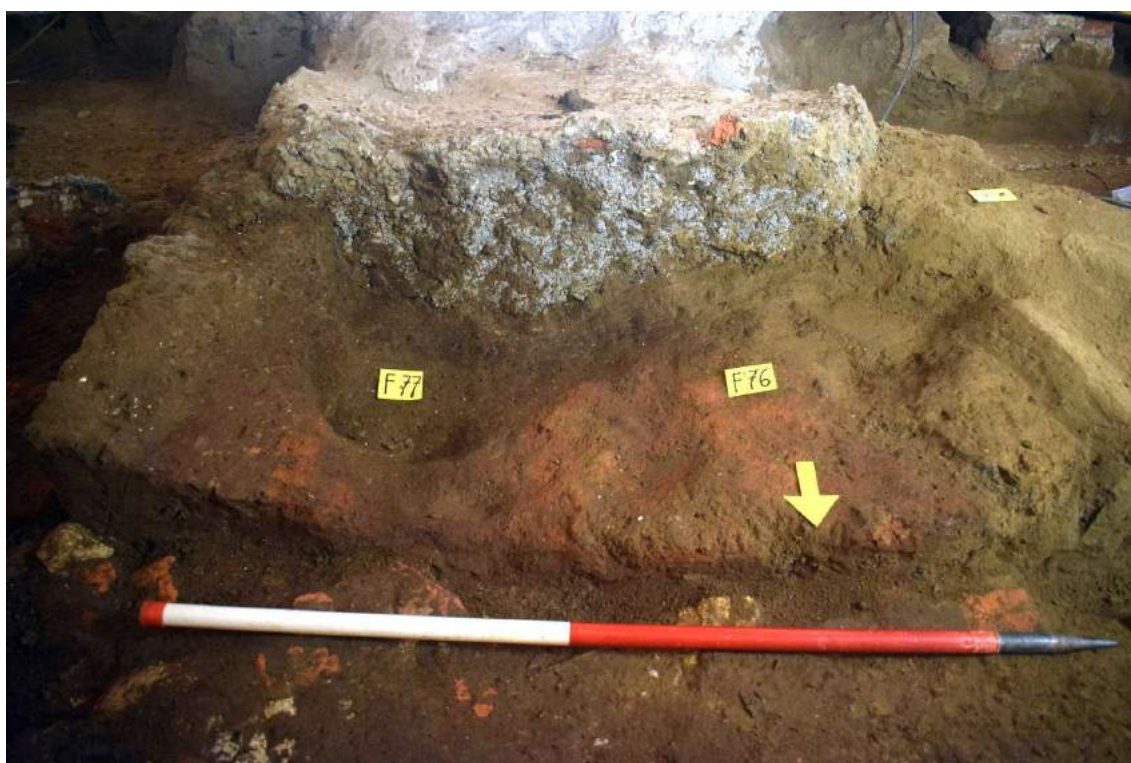
Photograph 2 Oven or hearth F76 with post-hole F77, looking south.

Oven or hearth F76 (Photograph 2) was located immediately to the rear of the hall and was sealed beneath the Phase 2 metalled yard surface (L17/L18/L23/L30/L45/L48/L49/L50). Most of the feature had been truncated by later activity. The surviving section was 1.25m wide by 0.21m deep and was defined by layers of scorching/burning around the sides and base. It is therefore possible that the open hall had a rear courtyard containing a bakehouse or workshop to which this oven/hearth belonged, but no associated structure was identified. Possible post-pad F81 was probably associated with the oven/hearth and post-hole F77 had been cut into it.

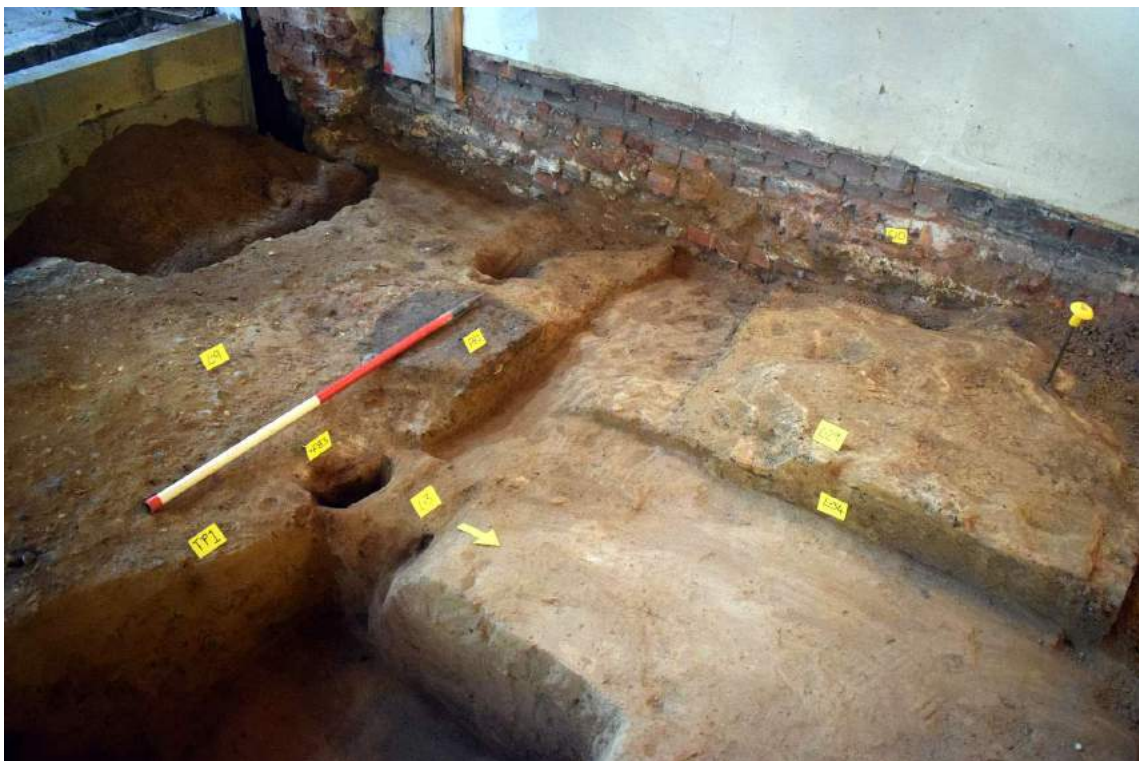
Photograph 3 Area underneath the 'chimney-trap', includes clay floor L34 (overlaid by later clay floor L29) with pit F82 and posthole F83, looking southwest.

Archaeological evidence for a chimney or hearth immediately underneath the trap was however limited (Photograph 3). Part of clay floor L20/L31/L32/L34/L35 is missing underneath the trap, and there is an area of heavily scorched clay floor, F78, on its northeast corner. Scorched floor F78 could be evidence of a severely truncated hearth but its position is difficult to explain. The missing clay floor and truncated scorching could suggest that all evidence of the chimney structure itself has also been removed. However, it is also possible that the chimney consisted solely of a hood in the ceiling and not a full chimney stack. The presence of pit F82 and posthole F83 against the chimney and cross-passage cannot be satisfactorily explained, although F82 did produce fragments of burnt brick.

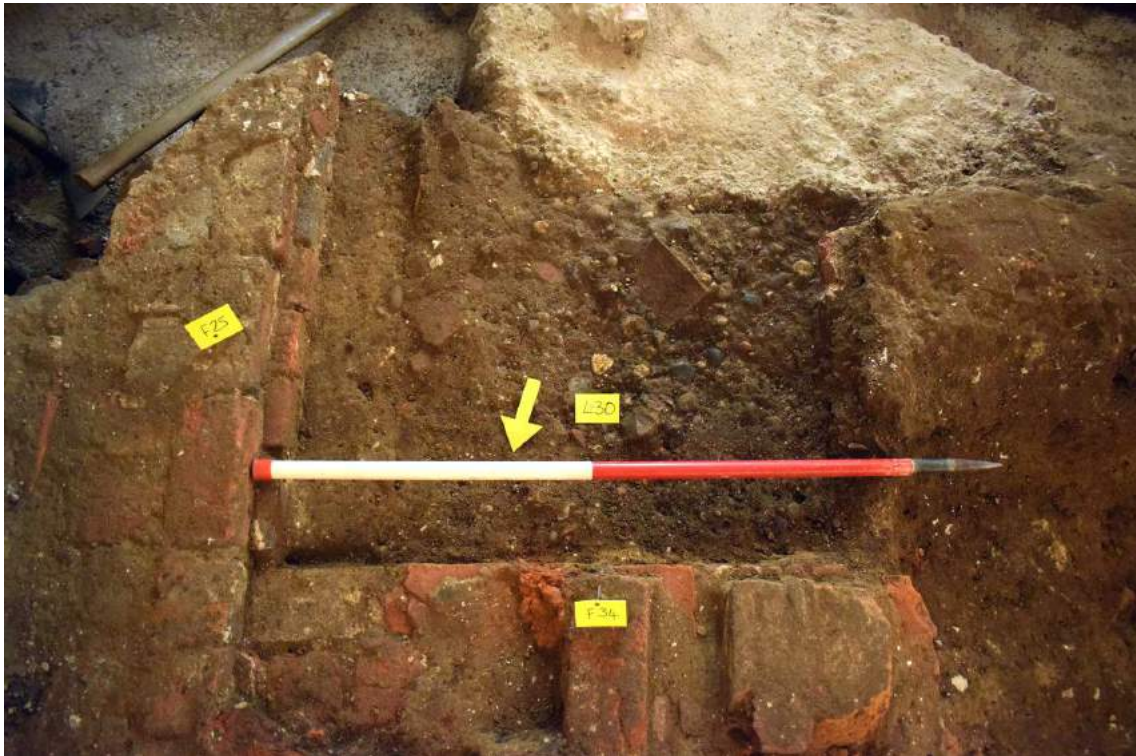
Photograph 4 Metalled yard surface L30 cut by later brick wall foundations F25 and F34, looking south.

To the rear of the hall was metalled surface L17/L18/L23/L30/L45/L48/L49/L50 which had been, at least partially, set in a clay bedding layer (L51/L52) (Photographs 4 & 10). Pit/depression F128 cut the gravel and contained 15th/16th century material. Linear F84 may have been formed by water run-off from the roof or was perhaps a beam slot for the rear (northern) wall. A small layer of peg-tiles (L53), in the northwestern corner of the excavation area, possibly came off of a roof.

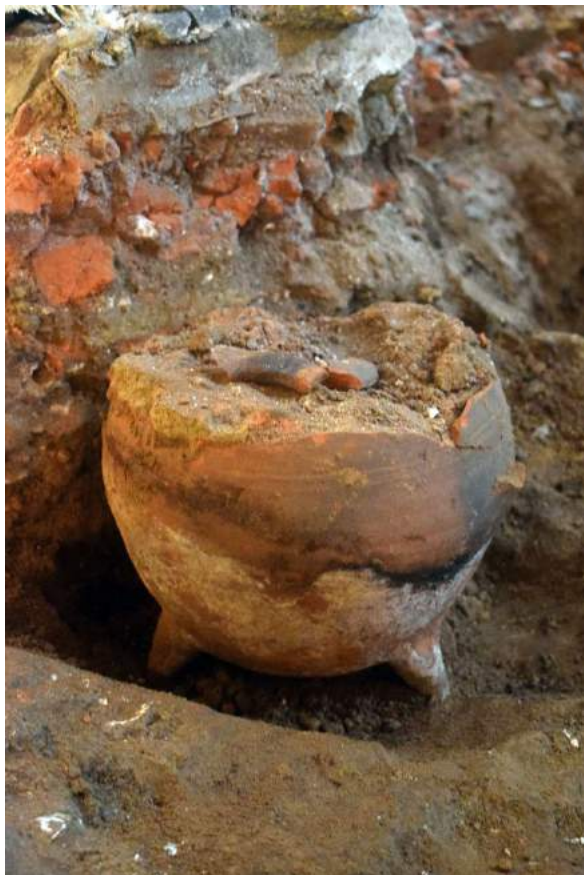
Photograph 5 Tripod pipkin from as excavated from pit F102, looking south

Specific alterations to the hall during this phase appear to have included the construction of a new wall on the street front associated with brick wall foundation F12/F30 (construction cut F91). The burial of an almost complete tripod pot in pit F102 immediately behind the new wall may well have been a deliberate act (Photographs 5 and 21). The pot mainly contained later backfilled building rubble but included a small quantity of copper-alloy dress pins and iron nails, commonly found within witches bottles, suggesting that this was a deliberately buried apotropaic (protective) deposit.

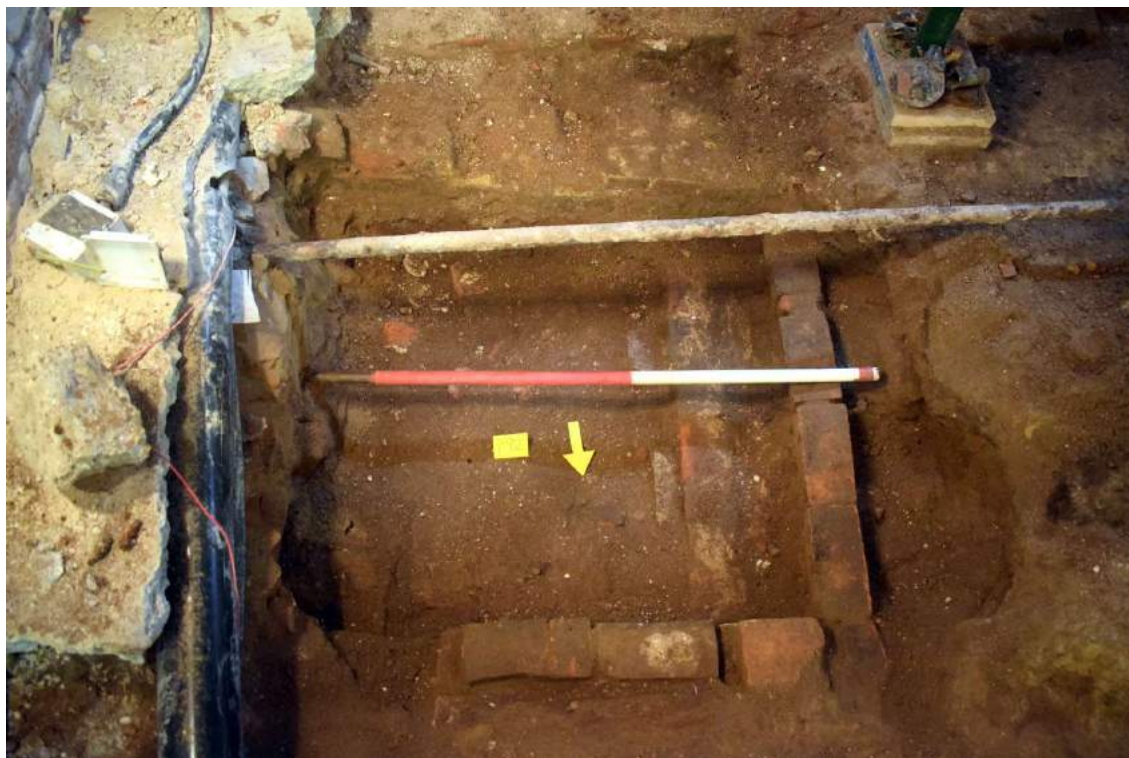
Photograph 6 Brick-lined pit F92, looking south.

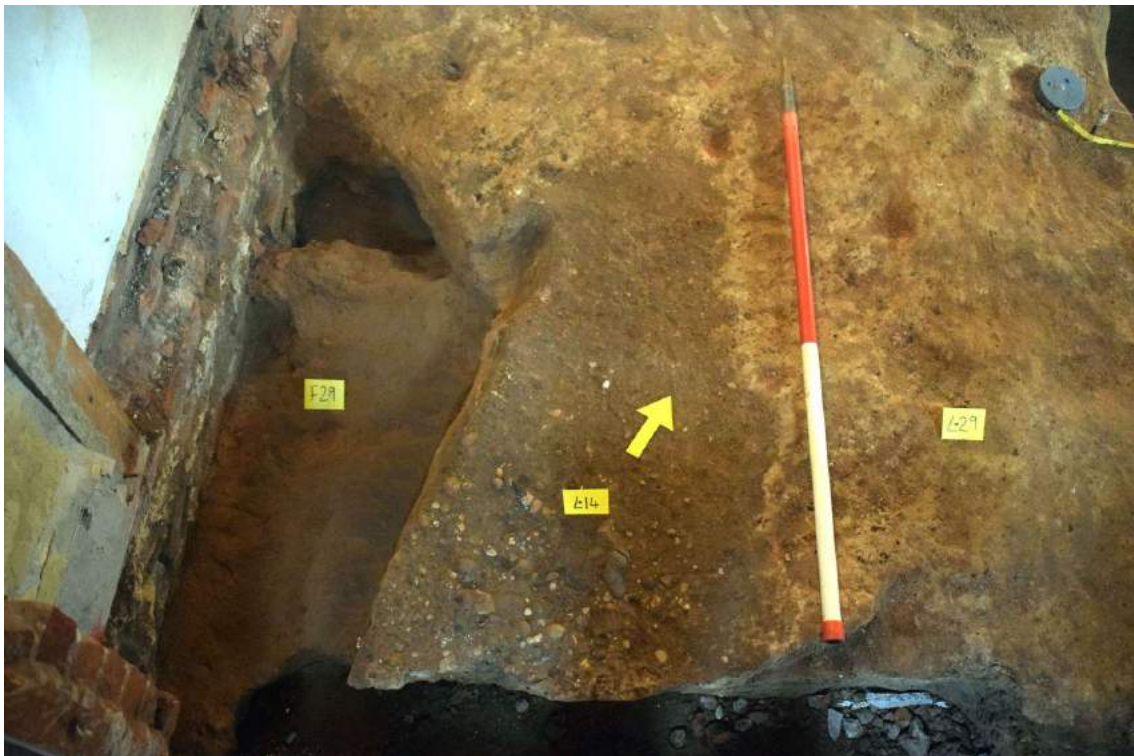
Photograph 7 Metalled threshold L14 and clay floor L29, looking north-northwest.

New layers of beaten clay floor were laid over the western third of the hall (L13/L29, in the area of the former cross-passage) and in the eastern half (L2). Gravel L14, laid over the top of beaten clay floor L13/L29 in the southwest corner, created a new threshold into the building from the street (Photograph 7).

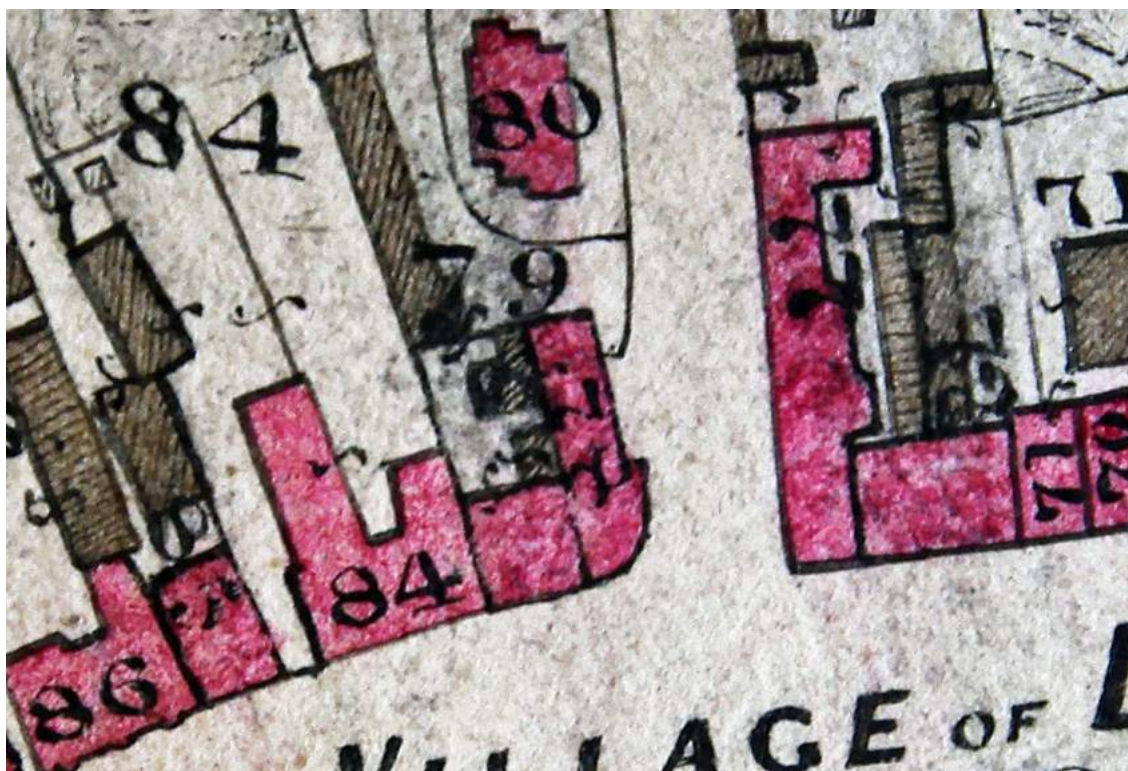
Map 1 1838 Tithe map. The Essex Rose Tea Room is plot no. 78, occupied by William Booth (grocer and draper). The Co-op, plot 79, belongs to Sarah Salmons and is occupied by baker Charles Fitch (Alston 2018).

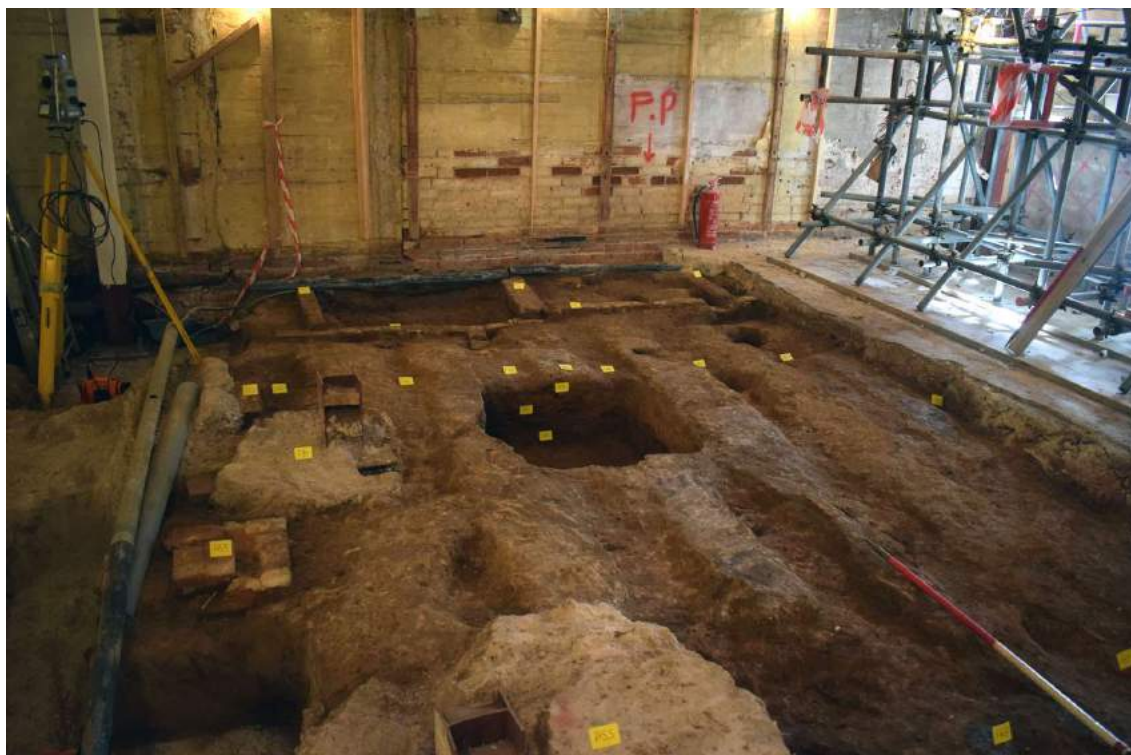
Photograph 8 Eastern room/eastern tenement and corridor showing brick plinths, floor joists and beam slots, looking east-southeast.

To the east (the eastern room/eastern tenement) were two rooms separated by a timber-framed wall on brick plinth F80 (construction cut F90) (Photograph 8). The small room at the front is likely to have been a shop. Both rooms had beam slots (F45, F46, F47, F48, F49, F50, F51, F70, F87, F88, F89 and F94, with joists surviving as F71 and F103) excavated into the earlier clay floor to allow floor joists, for a wooden boarded floor, to be suspended above the damp earth beneath. A thin layer of dust (L27/L38) covering the earlier clay floor between the (now rotted) floor joists is likely to have settled here through the floor boards. Brick pads F52 (construction cut F69) and F53 (construction cut F68) were also constructed at this time perhaps supporting the base of a hearth or baker's oven with a possible external chimney occupying a rectangular space immediately behind this room (defined by brick foundations F20/F25/F34/F37).

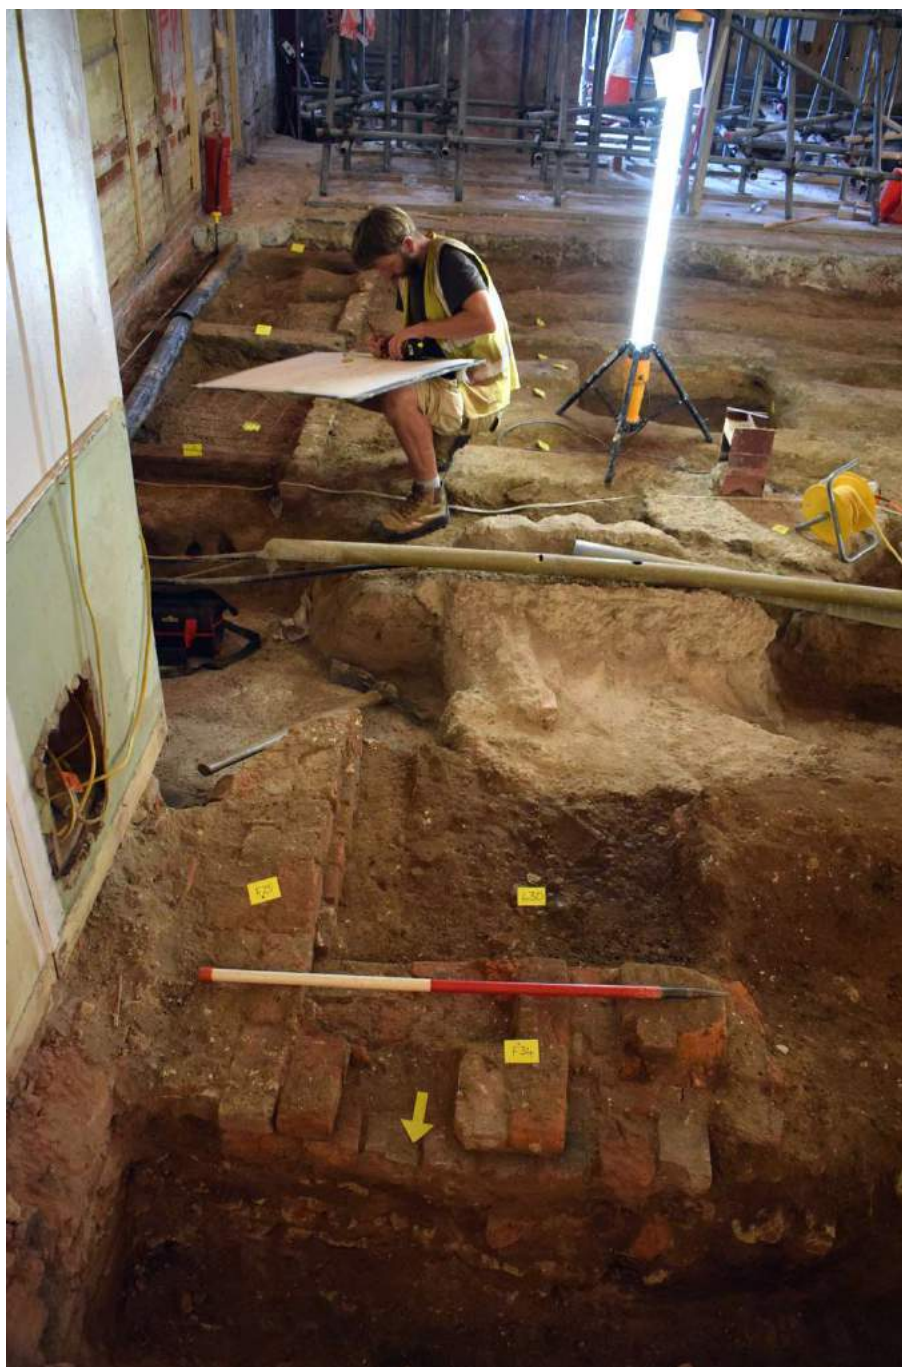
Photograph 9 Brick wall foundations F25 and F34 of the rear extension, looking south.

The extension to the rear of the hall is represented by wall foundations F20/F25/F26/F34/F37 (Photograph 9) which were constructed on top of rubble-filled foundation trenches F16/F18/F23/F33. At least two types of brick were used in the construction of these foundations. Tudor place bricks, dating from the 15th to early 17th century, were used alongside late 17th to early 18th century red bricks with diagonal crease marks. Together they show that earlier Tudor bricks were being reused in the construction of this extension. Hearth/oven F19 was built into the eastern wall of this building. Clay layer L12/L16/L19/L24/L25/L44 covers the floor of the extension but also extends out beyond F20 to the west, perhaps indicating the existence of a partially covered yard or another outbuilding.

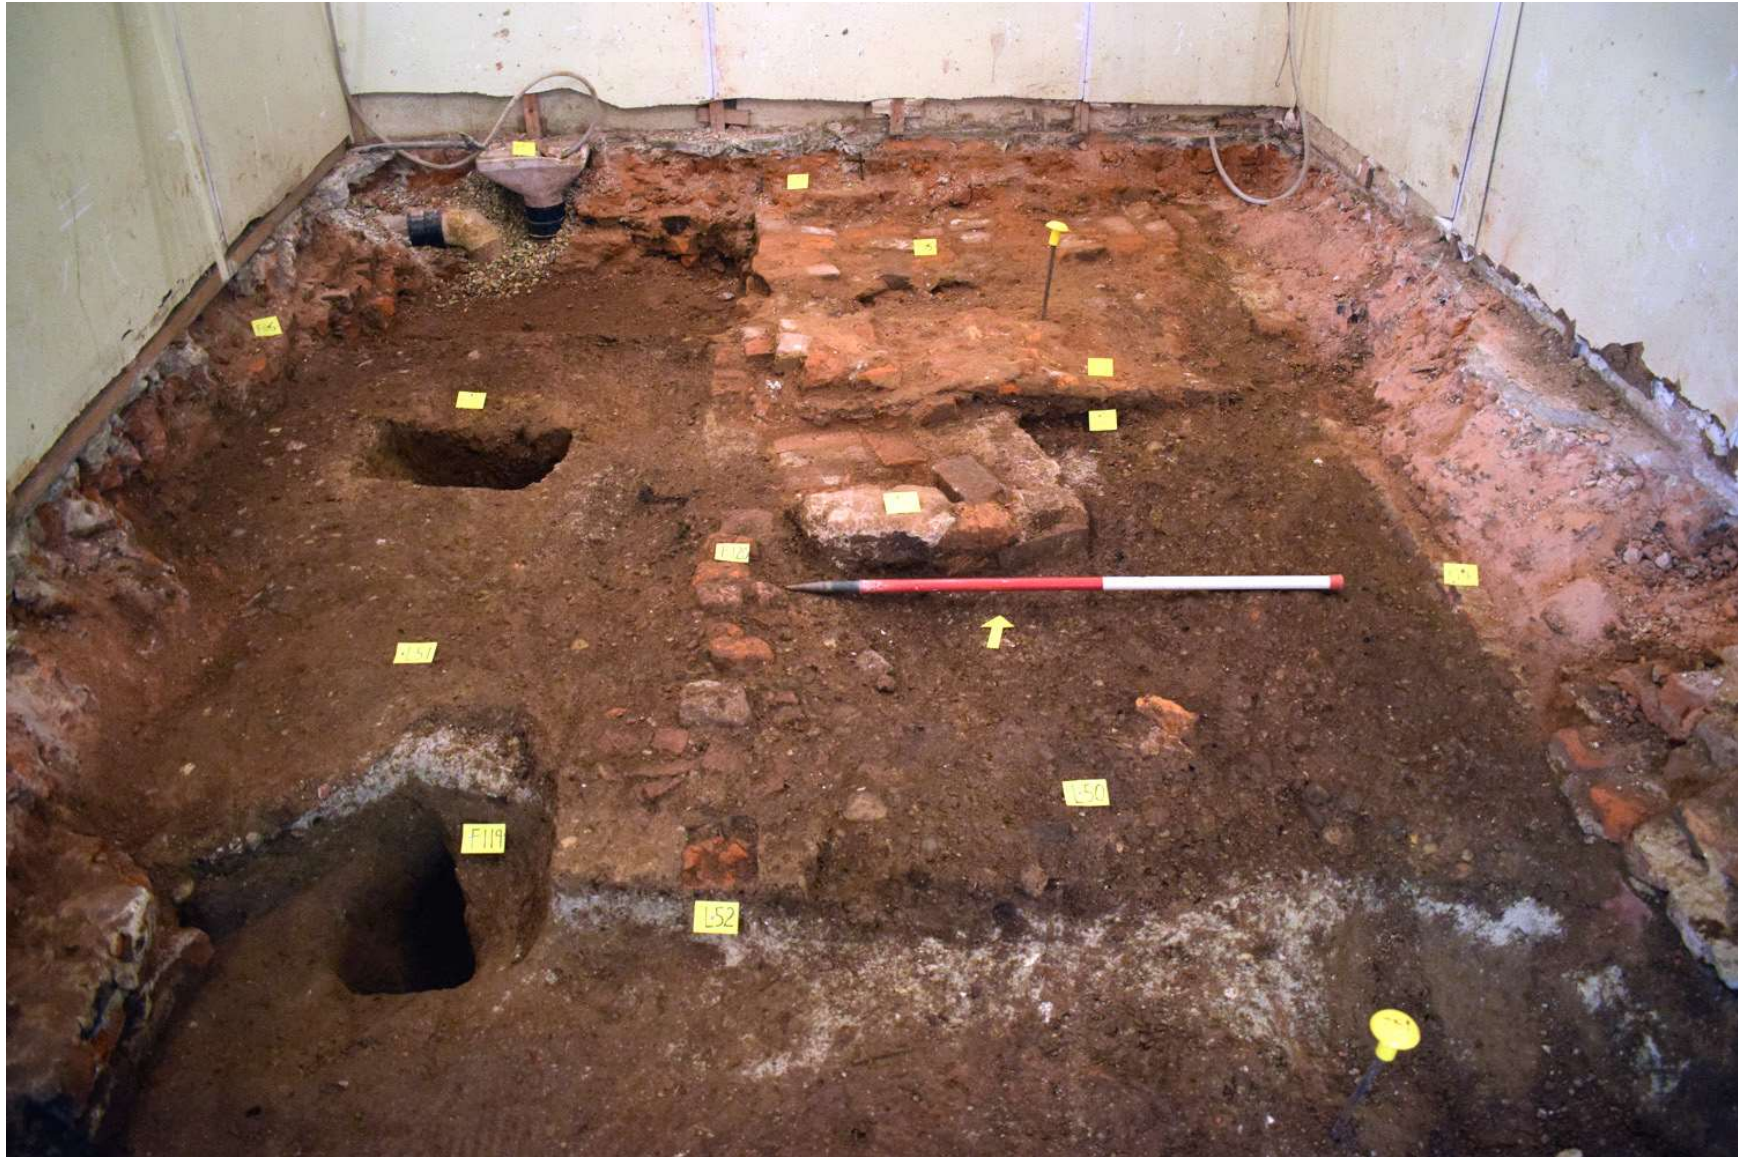
Photograph 10 Phase 2-3 contexts L50 & L51/L52; Phase 3 contexts F118 & F119; Phase 4 contexts F114, F115, F120 & L47; and Phase 5 contexts F111, F112, F116 & L46, looking north.

Brick wall foundations F114 and F115, to the north of the extension, are probably part of the southern edge of the outbuildings in the rear yard (Photograph 10). Both foundations were laid on top of similar rubble-filled foundation trenches (F122 and F126) as seen in the extension. Wall foundation F115 was slightly haphazardly constructed out of a variety of different-type broken bricks bound in clay, with F114 probably representing the remains of a pad/plinth for a timber post. This structure appears to have been built over brick wall foundation F120, represented by a single line of bricks sat on a layer of clay.

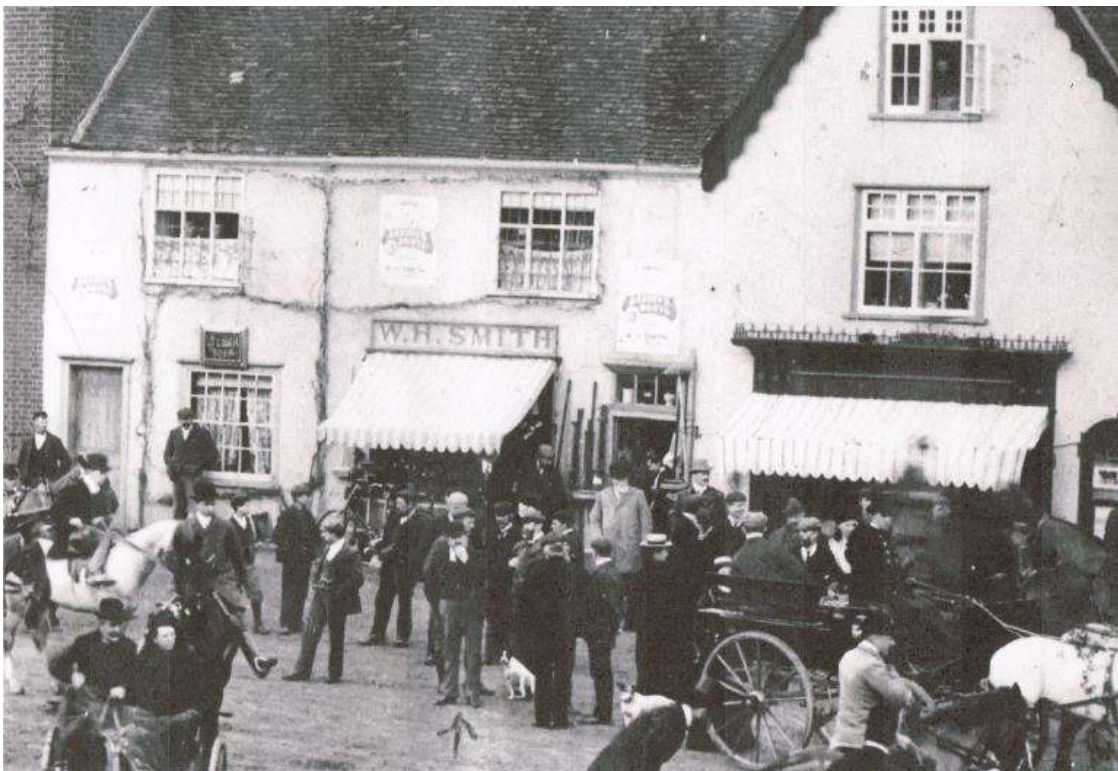
Photograph 11 The building as occupied by house furnisher W.H. Smith c 1902 (image supplied by Phil Chatfield)

Brick plinth F44 (construction cut F66) marks the wall between the eastern rooms/tenement and the corridor. Like these rooms, the corridor also had a suspended wooden floor, with floor joists F41, F42, F43, F73 and F86 partially surviving. A photograph from 1902 (Photograph 11) shows a door leading from the street into this corridor, and it is likely the corridor would have provided access to both rooms (and by the mid 19th-century access to a new brick cellar sunk beneath the neighbouring property).

Evidence for the internal layout of the original hall in this phase is unclear. The 1902 photograph would suggest that the north/south dividing wall is still in place, but it is perhaps more likely that the rooms and corridor to the east were opened out to house the shop.

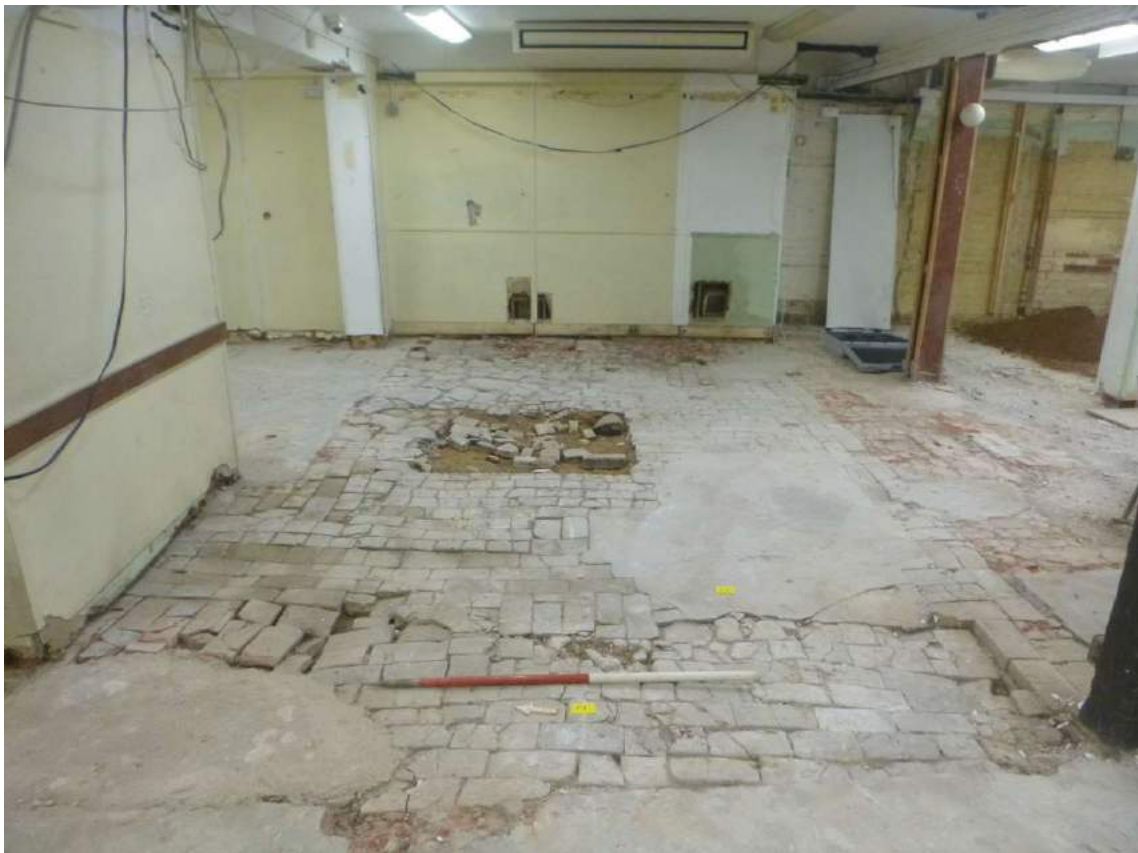
Photograph 12 Floor F1, looking east.

The brick and stone floor (F1) of this extension was recorded during the evaluation (CAT Report 1265) (Photograph 12). A modern service trench had removed the far western edge of the floor (c 1.15m wide) which had been replaced with modern concrete. Adjacent to this, also at c 1.15m wide, was an area of crushed red brick (that at the time of recording was still mostly overlaid by a thin layer of later concrete). It is interesting to note that this section of floor leads to the stairs of the rear cellar of extension 2 (see below), perhaps accounting for the difference in flooring used here. Interestingly, bricks walls/plinths F98 and F100 (construction cut F99) and brick pad F101 are also located in this area and may be associated with internal supporting structures.

The surviving brick and stone floor was in a poor condition, with many of the bricks cracked or broken and some reduced to fragments. This is usually a sign of heavy wear but may be the result of the paviors being bedded directly onto soil rather than a sub-base. The majority of the surface comprised unfroged cream bricks laid flat in a north/south alignment with areas of similar cream brick aligned east/west and areas of unfroged red brick. These changes in orientation and colour probably represent later repairs. The main surface was divided by a section of cream brickwork aligned north/south, four bricks wide. These bricks had a shallow frog and were laid bottom side up and slightly angled, creating a shallow gully that was probably to aid in drainage.

At the south edge of the pavior surface were two rows of heavily degraded square terracotta tiles, each approximately 30cm (12") to a side. These abutted a row of east/west bricks along

the far southern edge of the room. At the eastern extent of the pavior surface was an area of red brick, very heavily degraded, most probably later repair. Within this were the remains of six fire bricks suggesting a hearth or a stove may have been present at one time.

A particularly intriguing feature of this surface was a large area of repair formed from pieces of smoothed granite of different sizes. The temptation is to refer to these as granite cobbles but that would imply a uniformity of size that did not exist. About half of the stone conformed to an approximate rectangular shape with the remainder being irregular. There were no clear lines of bedding and the whole is more reminiscent of “crazy paving” rather than a cobbled surface. The smooth nature of the surface formed by the granite would suggest that it was sourced from worked stone, either part of a building/surface or perhaps from a stonemason’s waste pile. Four pieces in particular appear to form a ring, clearly shaped by hand rather than by geology. Even more intriguing is the presence of several pieces of Purbeck marble within the surface. The provenance of the granite and the marble is unknown.

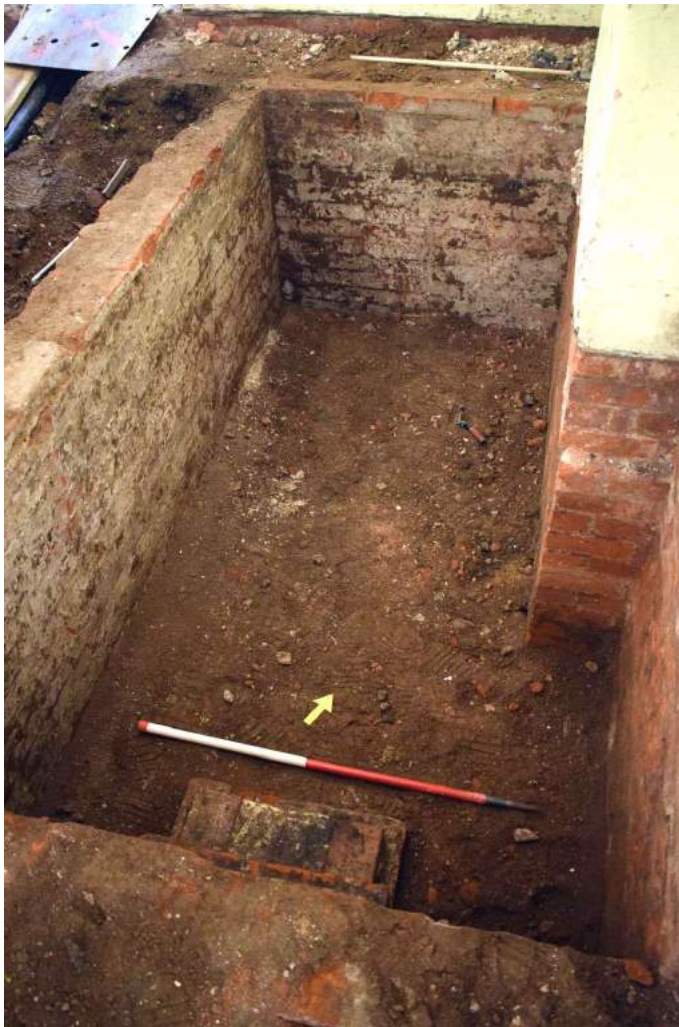
Photograph 13 Cellar F6 during excavation of backfill, looking north-northeast

In the northwestern corner of the plot a narrow two-storey red brick structure with slate-roof was also added, and the extension had been built with a cellar. The cellar walls (F6, with construction cut F96/F117) had been constructed of unfrosted red bricks which had been painted white on the inside with paved brick steps F97/F109 providing access (Photograph 13). Brick-built chute F15 led into the cellar, it was probably a coal-chute or similar structure. It is interesting to note that the structures associated with the cellar do extend into extension 1 (see

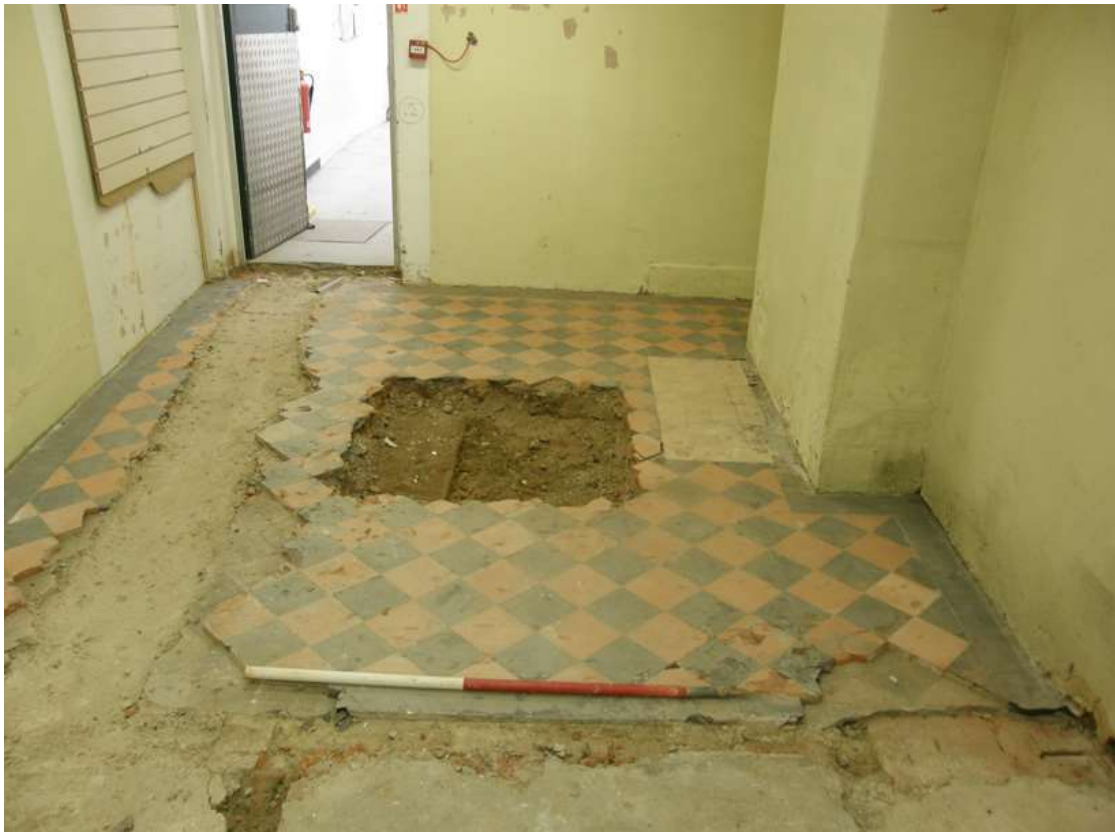
Photograph 14 Floor F5, looking north.

The chimney on the east wall had been bricked-up and partially dismantled (probably during the construction of the 20th-century staircase) but the floor of the room had survived. The floor (F5) was composed of red/terracotta and black ceramic tiles set in a diamond pattern with a border of black tiles with the hearth defined by 40 stone-coloured ceramic tiles in four columns (Photograph 14). Victorian tiled floors became fashionable in the 1860s, becoming an essential feature of ordinary Victorian houses by the 1890s (<http://www.buildingconservation.com/articles/tiles/tiles.htm>).

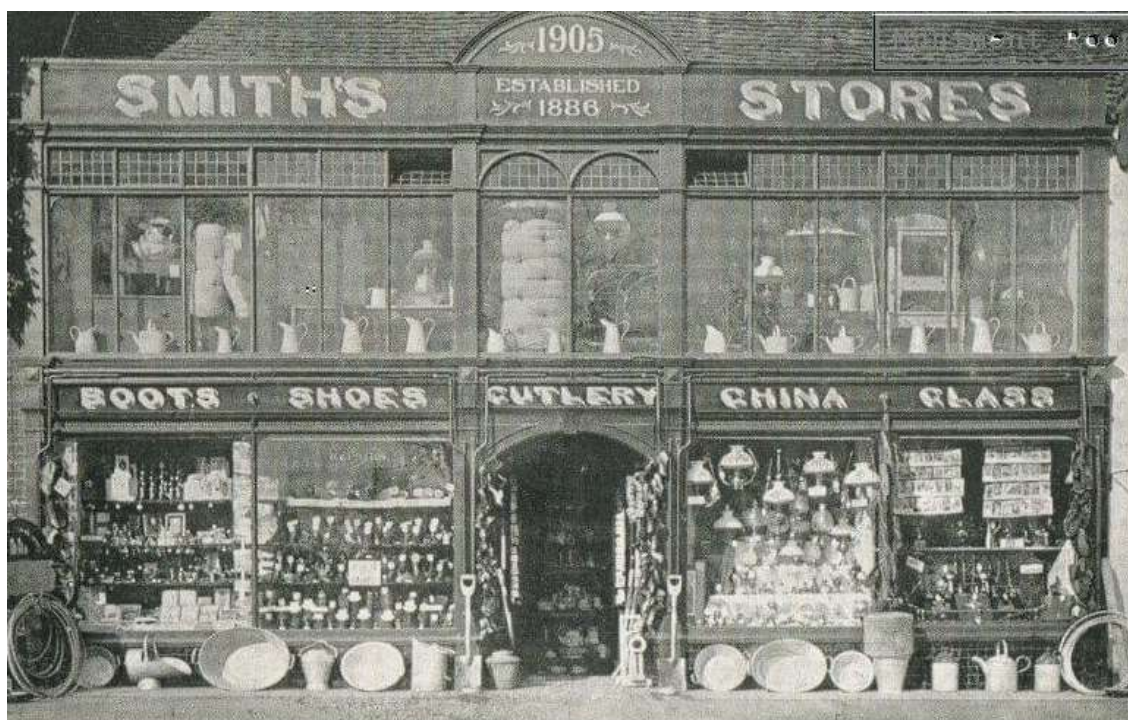
Photograph 15 New shop front for house furnisher W.H.Smith constructed in 1905.

In 1905 the entire front wall of the building was replaced by a two-storied glazed shop façade belonging to house furnisher W.H.Smith (Photographs 15-16). This effectively destroyed the surviving timber-frame front of the merchant's hall and moved the front of the building 0.4-0.6m further south. It is likely that the four rooms as seen in Phase 5 survived into Phase 6, but the cellar underneath Phase 5 extension 2 was probably backfilled at this time.

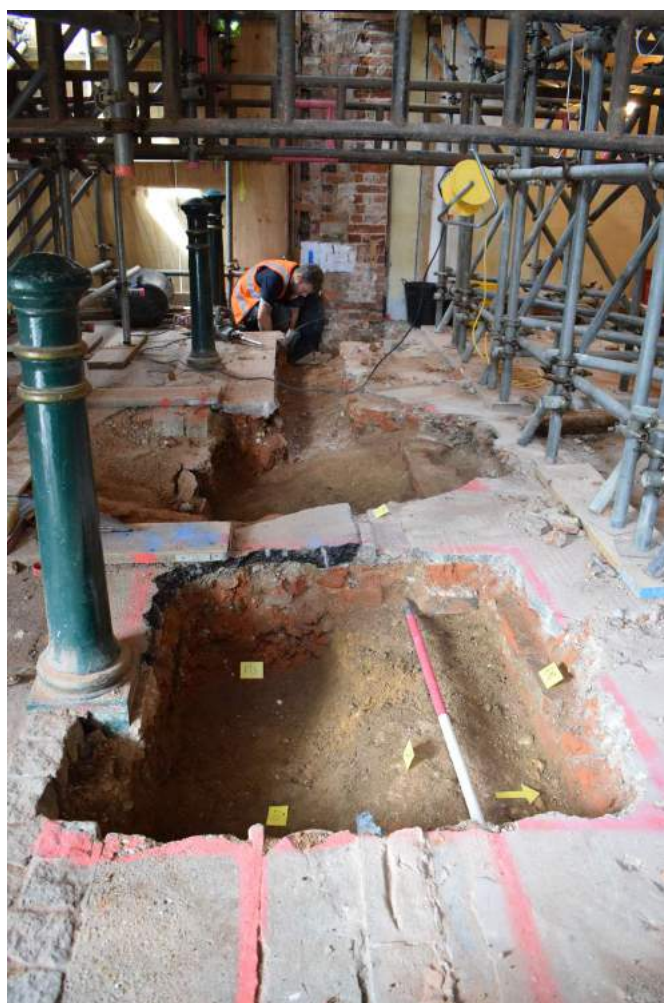
Photograph 16 Pad F showing brick wall foundation F12 (Phase 3) to the north and trench F13 for the demolished 1905 shop façade to the south, looking west.

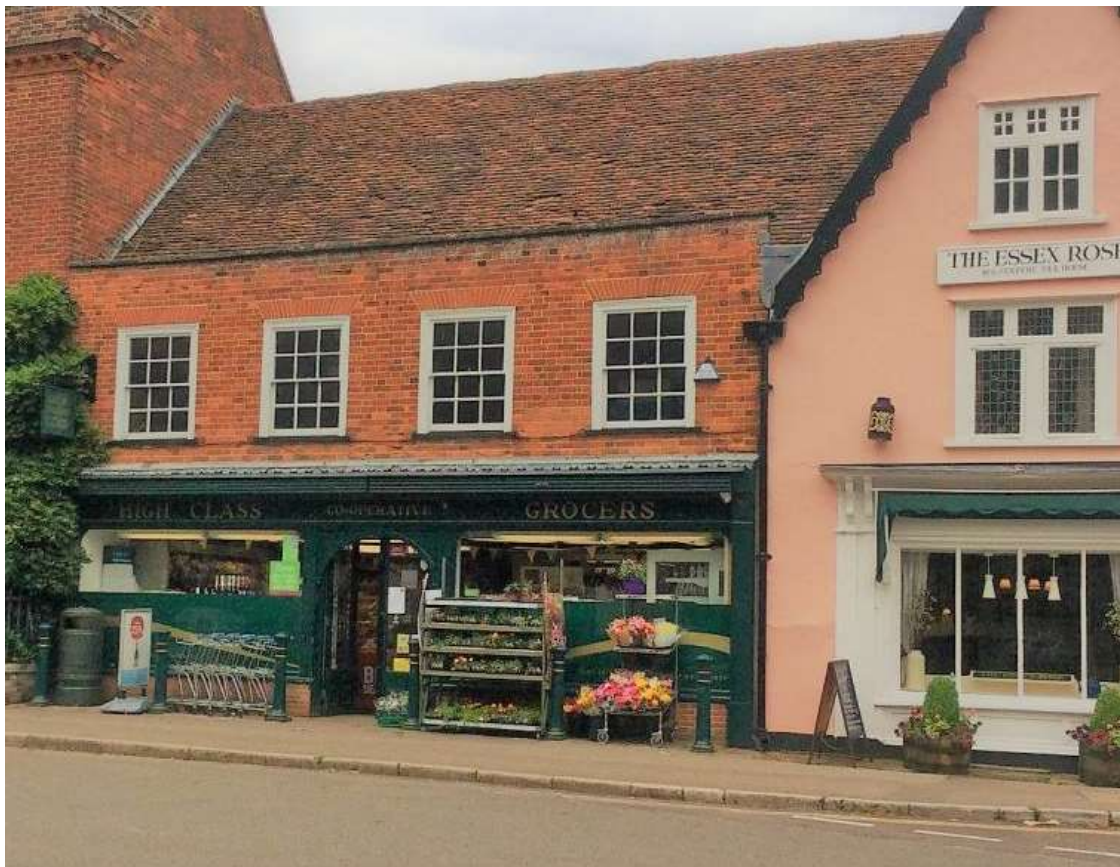
Photograph 17 The Co-op shop before the 2017 ram-raid, the street frontage was built in the 1950's.

The Co-operative society took over the premises in 1945 and rebuilt the street frontage in the 1950s. The new frontage (F11) was constructed directly behind the backfilled trench (F13) of the dismantled 1905 façade, and was built in a more traditional style with imitation Georgian brickwork and sash windows to its upper storey (Alston 2018). To increase the floor space, many of the internal walls were removed with concrete pads (F14, F54, F55 and F67) and steels added to support the first floor. Post-pad F105, brick infill F106 and brick floor or pad F107 are all probably associated with the entrance. A service trench in the northwest corner of the building, concrete floor L1 (which covered the entire building), a staircase inserted between to the two northern extensions, and drain F113 are all likely to be of a similar 1950s date.

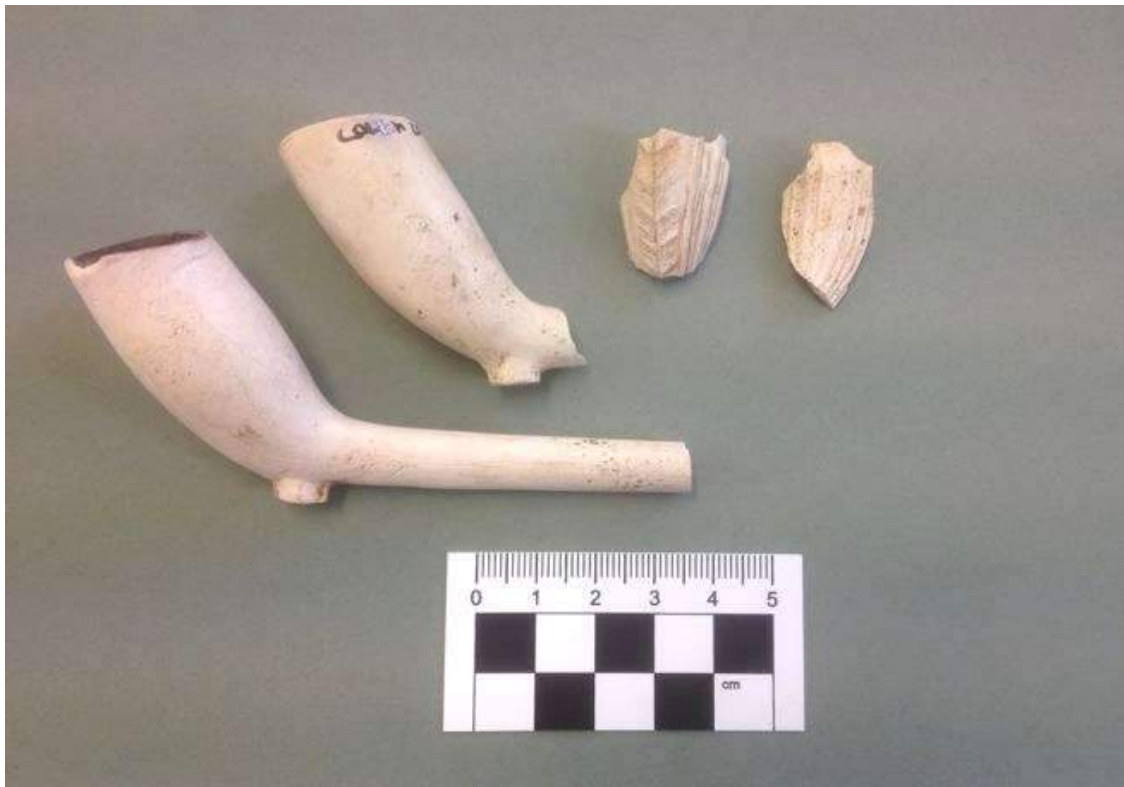
Photograph 18 Plain clay pipe bowls from L15 and decorated bowl fragments from F18 (left) and L10 (right).

The fluted bowl fragments are in keeping with examples illustrated by Crummy (CAR 2 1988, 57) and dated c 1820-60, and in Simpson (1982), Groups 6 and 7, dated 1760-1830.

Bore size is more contentious with recent Historic England guidelines (Higgins 2017) stating they should only be used to help date large well-stratified assemblages, but it cannot harm to discuss it. Bore size has been calculated on a spreadsheet created by the late Nobby Clarke (using Maldon examples). Bore sizes range from 3mm to 1.25mm, giving a date range of between the 1660s and 1880s. The most common bore sizes are between 1.5mm and 2mm, which calculate as between 1788 and 1850 on the Clarke spreadsheet. Bore sizes do not individually match the bowl dates. However, the average bore size of the group (1.5-2mm) accords quite well with the later end of the bowl date range.

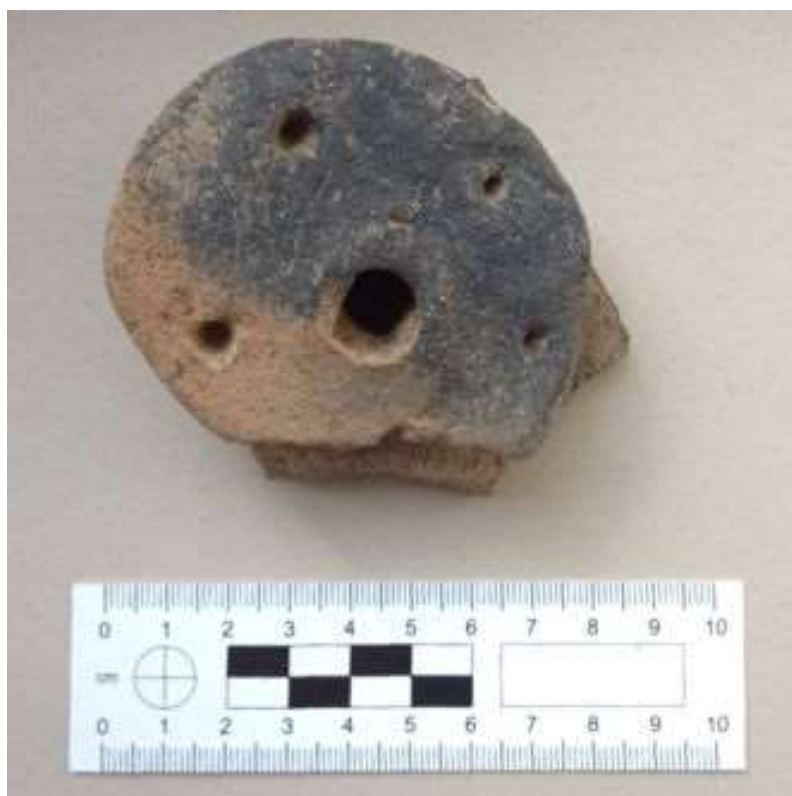
Photograph 19 Bung hole from cistern in Fabric 20 (L45, finds no. 137).

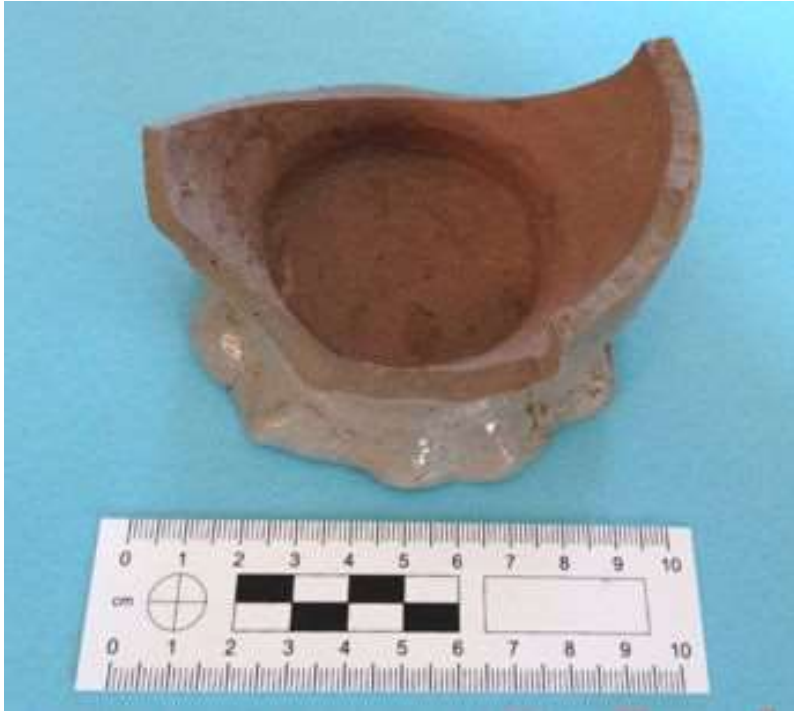
Photograph 20 Frilled base of Raeren stoneware jug (F123, finds no. 149).

Fabrics of this period (Fabrics 21a/40, 45c, 45) account for 7% of this group. Suffolk and Norfolk archaeologists use the LMT classification to cover those sherds in between the medieval sandy orange ware (Fabric 21) and the proper post-medieval earthenware (Fabric 40, or East Anglian Redware). In Essex, unhelpfully, there is no such category. This is probably because the Essex type series originated in Chelmsford, where there is less exposure to the Colchester fabrics. In this group, some sherds share the characteristics of LMT ware, and are here described as transitional Fabric 21a/40. Their date range is probably 15th-16th century. One good piece from this period is the frilled base of a Raeren stoneware jug (Photograph 20).
