Archaeological excavation at East of England Co-op, High Street, Dedham, Essex, CO7 6DE

June-September 2018

Colchester Archaeological Trust

CAT Report 1394
March 2020

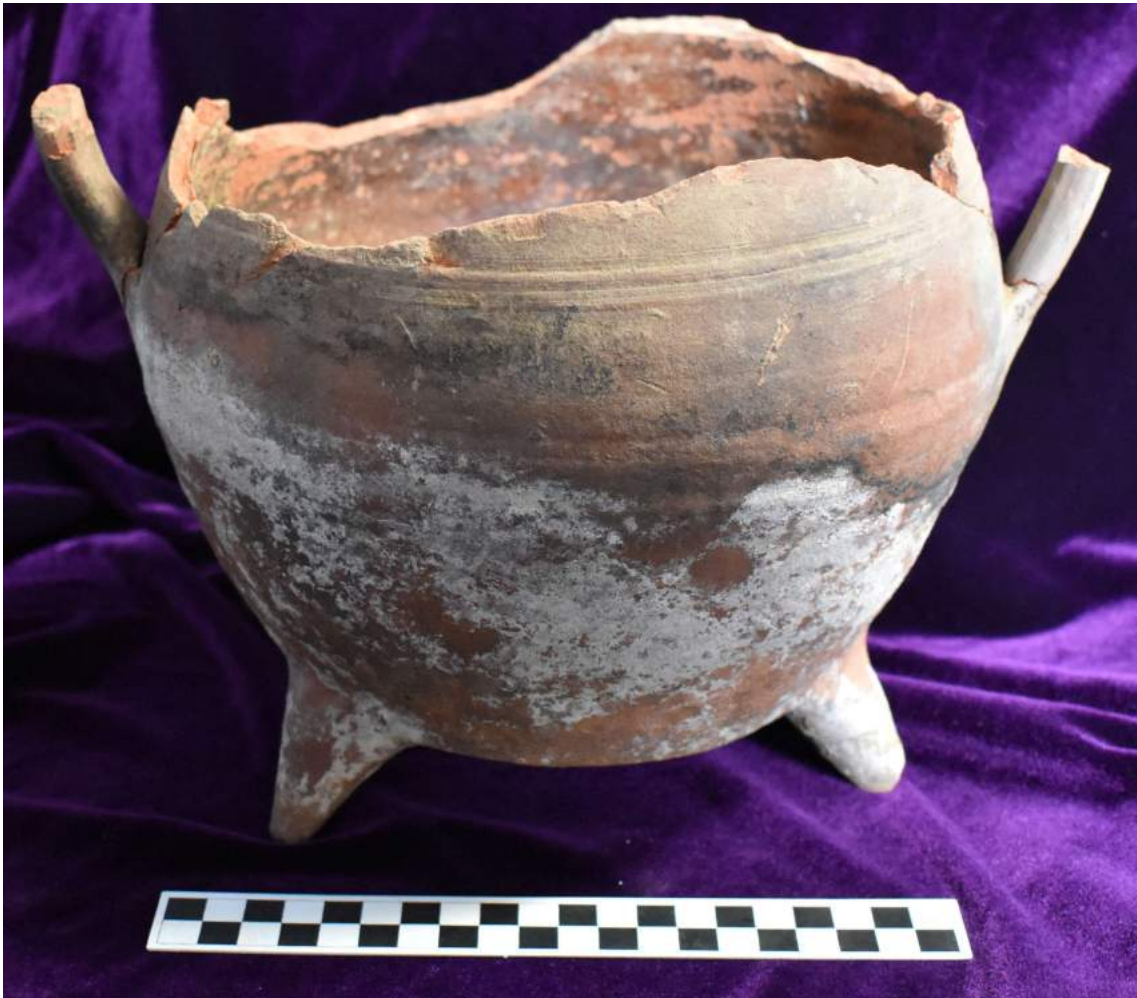
Photograph 21 Tripod pipkin from F102 (finds no. 130), later used as a guard against witches.

Witches were widely believed to enter a house via chimneys and doors, so it may be possible that the burying of this pot coincided with changes to the structure of the building.

The soil from the tripod pipkin found placed in pit F102 (finds no. 130) was carefully removed during post-excavation. The soil was similar to that from the surrounding backfill containing a small amount of demolition debris. Recovered from the bottom of the cauldron were three of the

dress pins (SF7, SF10, SF11), iron nails (SF8 & SF12) and an unidentified copper-alloy bar (SF9). Nails and pins are commonly found within witches bottles, but it is uncertain if these items had been deliberately placed within the vessel or became incorporated into it as part of the general backfill.

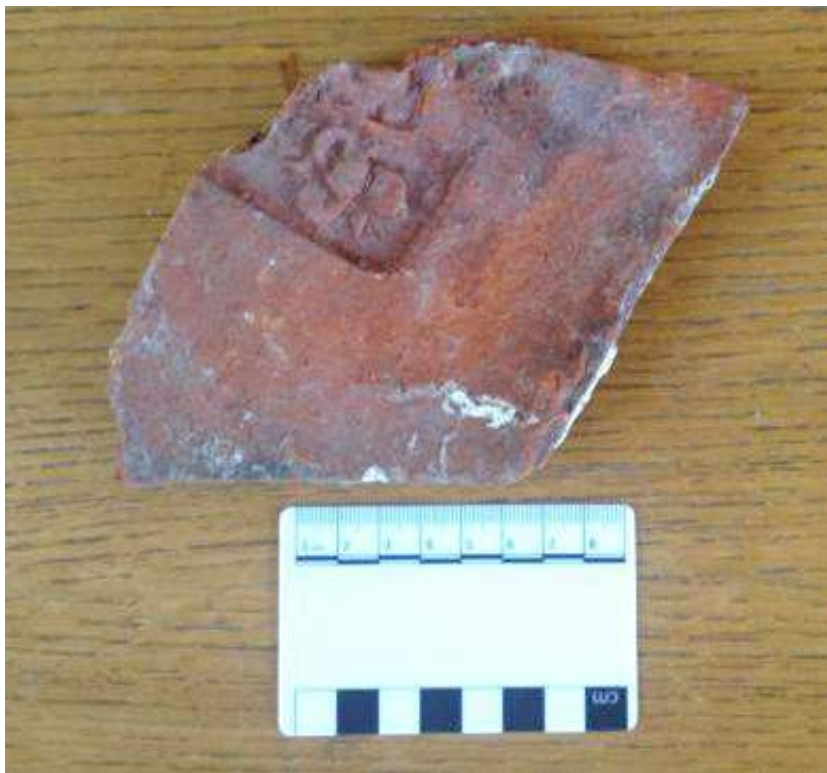
Photograph 22 Stamped peg-tile (L10, finds no. 85).

For quantities and descriptions see Appendix 2. These peg-tiles are all the normal flat tiles – there are no ‘nibs’ which might indicate an early medieval date, nor are there any pan-tiles. The group (185 pieces, weighing 13.84kg) is not generally of interest apart from one stamped piece (Photograph 22). The partial stamp appears to be about a third of a large stamp with a flower in each corner and possibly in the middle. Stamped peg-tiles are very uncommon. It came from a 19th to 20th century demolition debris, so may not be of any antiquity.

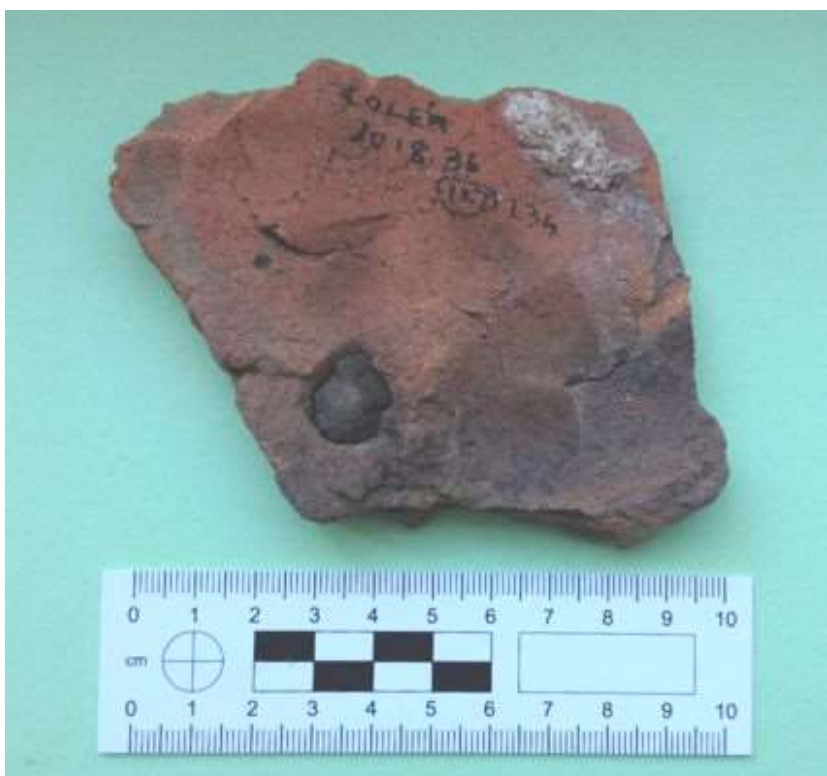
Photograph 23 Peg-tile with surviving wooden peg (L34, finds no 127).

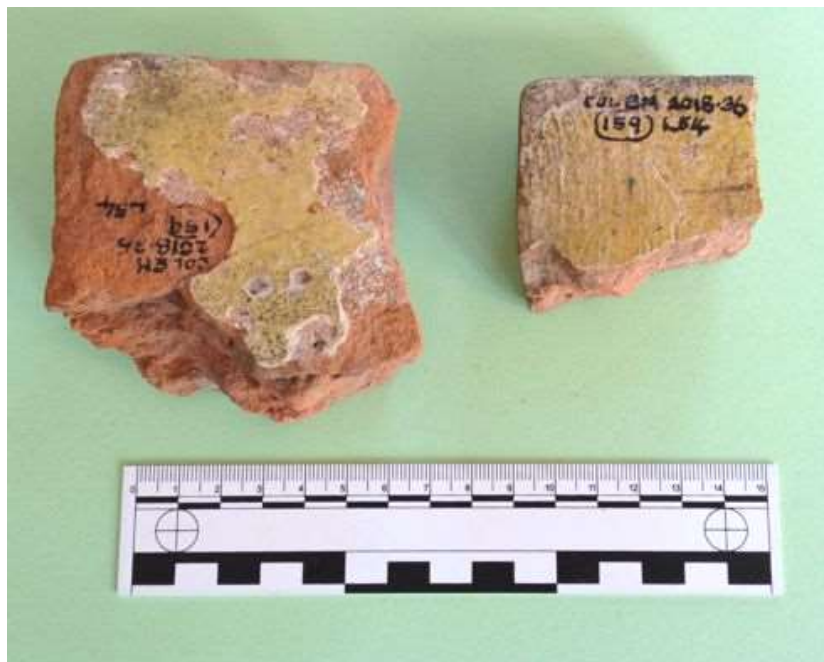
Photograph 24 Glazed floor tiles (L54, finds no. 159).

Undecorated tiles are difficult to date, but the overall cream slip covered in glaze is reminiscent of early Colchester-type ware of the 13th-14th centuries. We may tentatively say the first three are Colchester products of that date. The fourth piece has more of a post-medieval feel, and a different glaze. It may be from a more local source than Colchester.

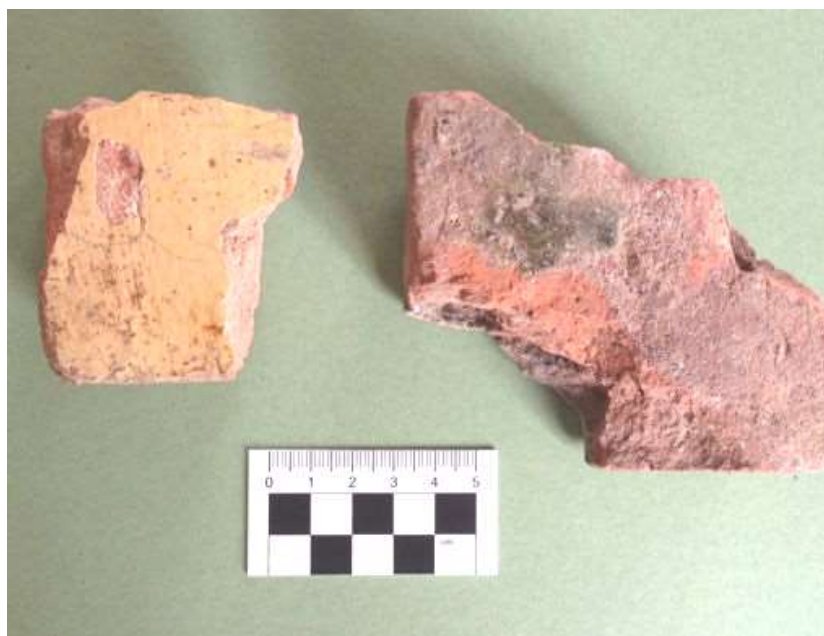
Photograph 25 Glazed floor tiles (F128, finds no. 155 and F18, finds no. 14).

A third piece is from F128, a Phase 2 15th-16th-century depression. It weighs 130g, is 30mm thick, and in fabric and glaze is identical to the L54 examples. The fourth is from Phase 4 foundation trench F18. It weighs 232g, has a green glaze, and its fabric is coarser and more brick-like than the other three examples.

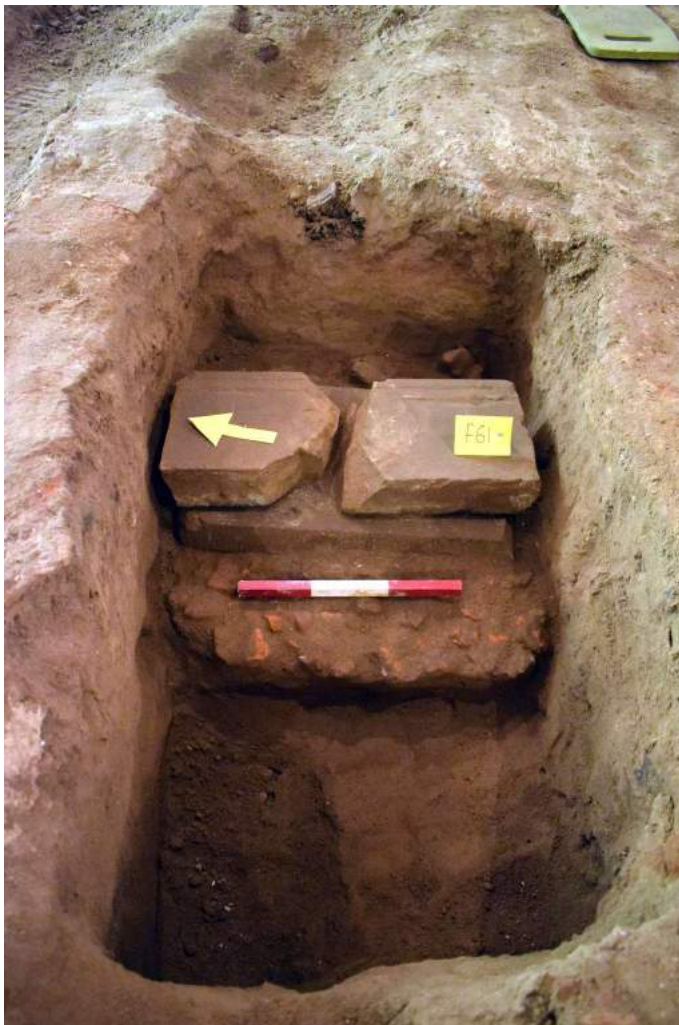
Photograph 26 Limestone block SF33 *in situ*, looking east.

A large block of limestone (SF33) from posthole F61 was probably used to support a pillar as it was located underneath one of the crossbeams (Photograph 26 and Fig 12.8). The rectangular block had a small shallow square notch, 30mm by 35mm by 2.5mm thick, cut into the surface of it, probably to hold the base of the pillar. The block is broken into two across this notch, suggesting it had been subjected to a significant weight which had cracked the block in half. A single groove runs lengthways along one edge of the block with a second slightly more irregular (?damaged) groove located behind the first. Most of the base of the block is burnt black, indicating intense heat on the surface. As the block was found on a mortar pad this burning would suggest that the block had been reused in posthole F61.

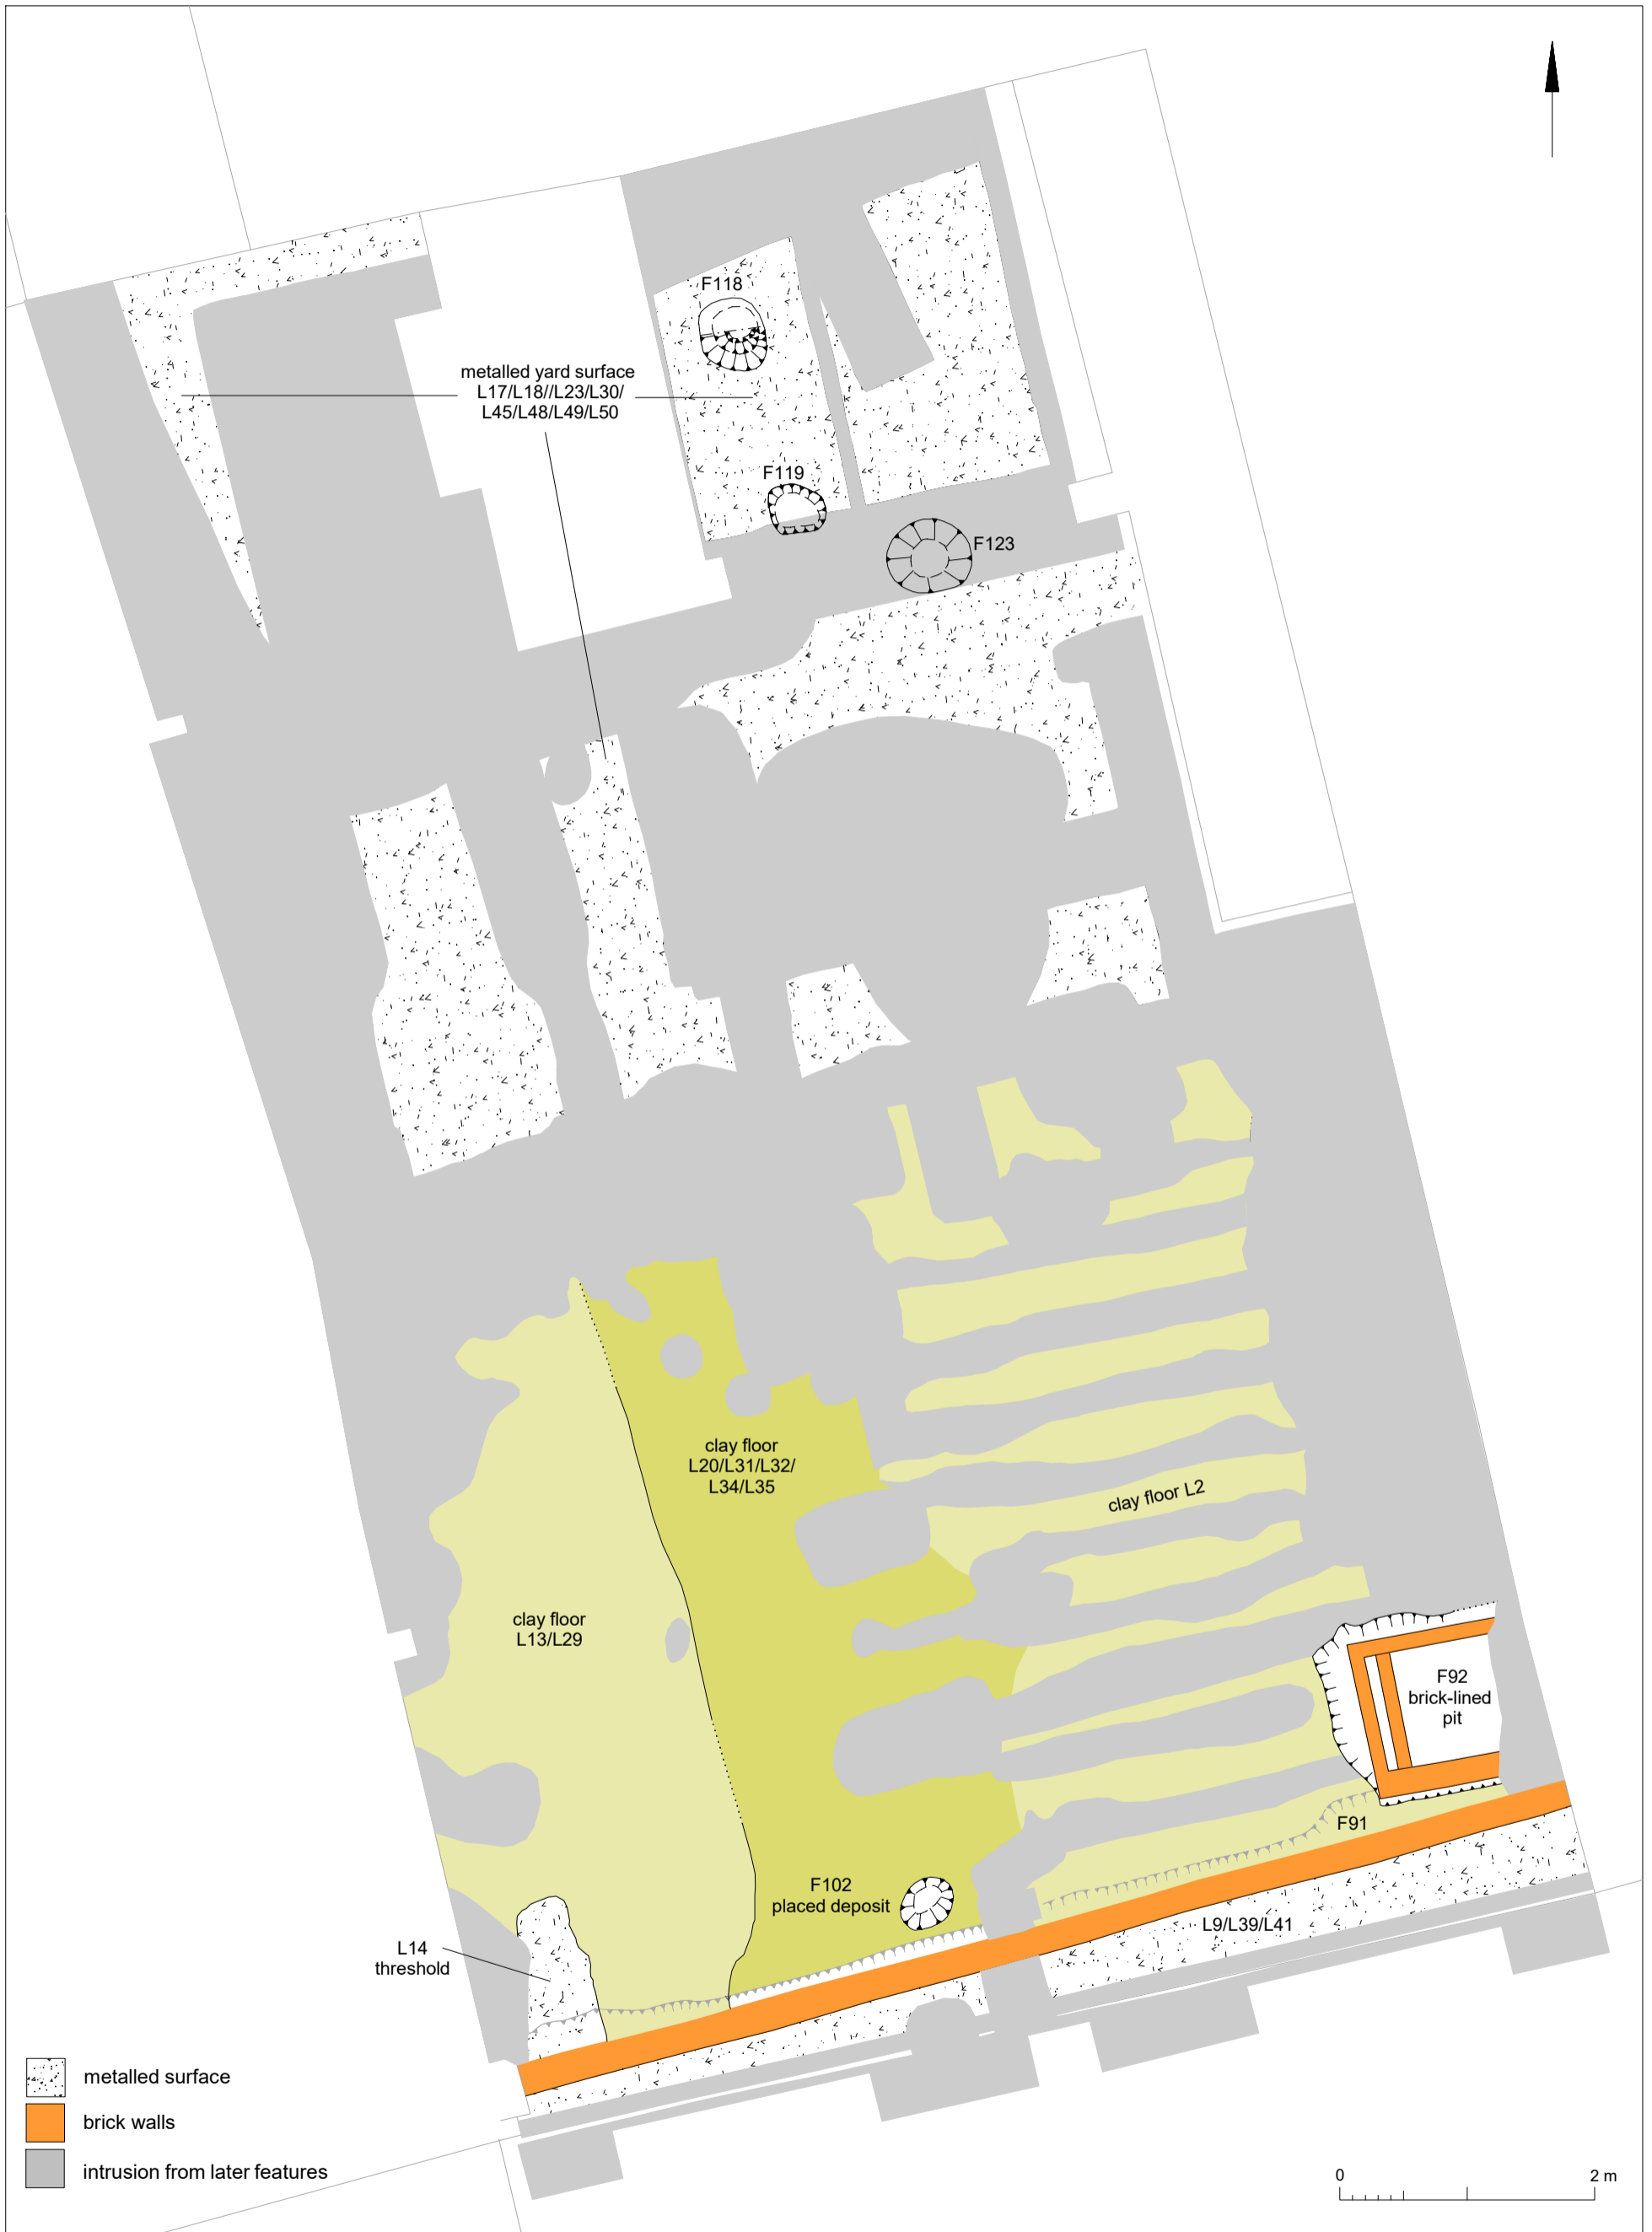
Fig 5 Phase 3: 17th-century alterations
