**Historic building recording of
an air-raid shelter at the former
Brentwood Police Station,
London Road, Brentwood,
Essex, CM14 4QJ**

March 2019

CAT Report 1400
April 2019

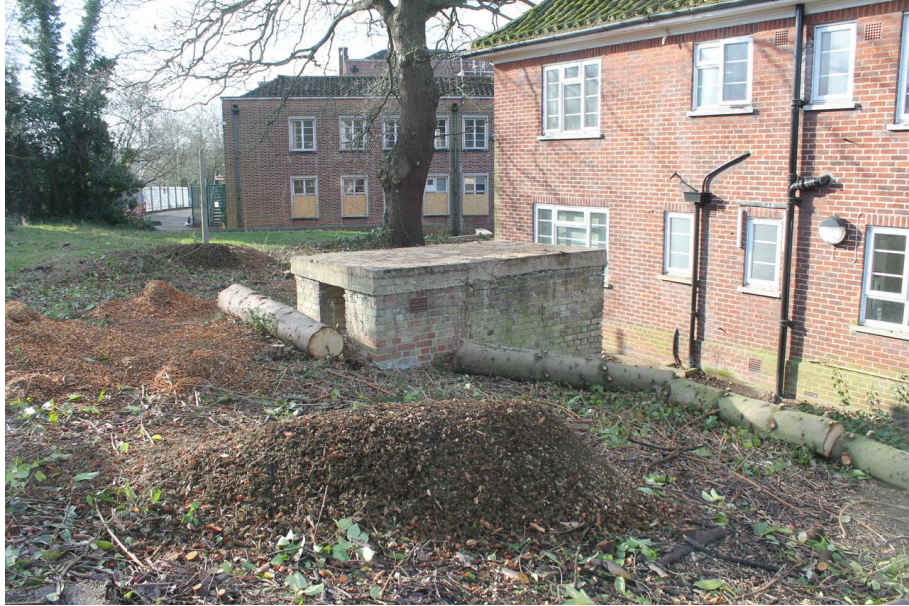
It is a brick-built building constructed on a concrete slab and with a flat concrete roof. It is built partially into an earth bank that rises to the north-east (Photograph 1).

Photograph 1 North-west and north-east elevation of air-raid shelter. Police Station building visible in background. Photograph taken facing south.

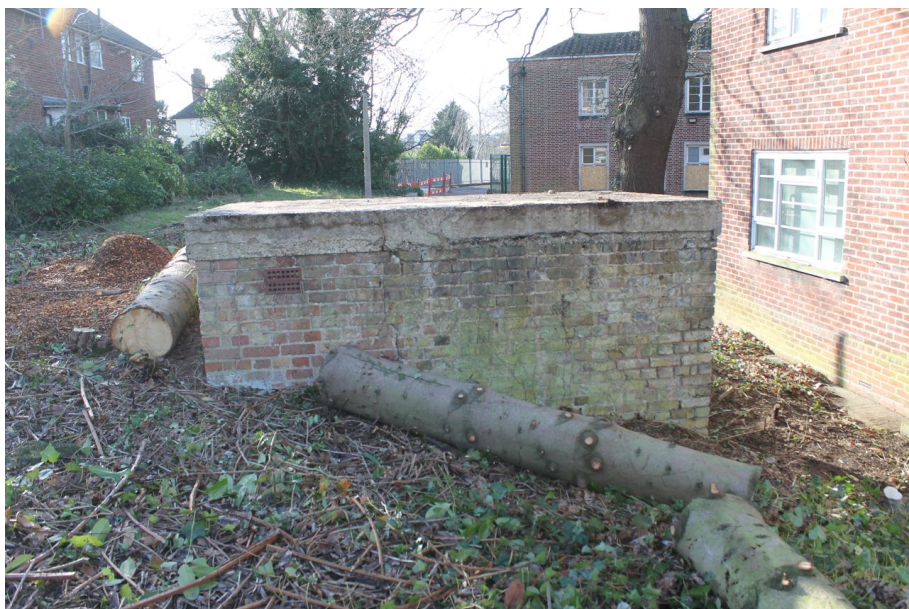
The brickwork of the structure is divided into two distinct types. Most of the building is constructed of yellow London stock bricks laid in English-bond with queen-closers and bonded with mortar, with brick dimensions of 230 x 110 x 60mm. The north-east metre of the building is constructed of red bricks laid in English-bond with queen-closers, bonded with mortar and with brick dimensions of 220 x 110 x 60mm. The join between these two types of brickwork is clear on the exterior of the building (Photographs 2-3). The walls around the building are 350mm thick and consist of three courses of bricks.

Photograph 2 North-west elevation of air-raid shelter, showing differing types of brickwork. Photograph taken facing south-east.

The relatively large opening in the north-east elevation is somewhat contradictory to the buildings use as an air-raid shelter: certainly such an opening would have reduced the protective merits of the building. This is probably explained by the two clear types of brickwork visible in the structure, which suggest that the north-east end of the building has been rebuilt. Presumably this rebuilding occurred at a date when the structure was no longer in use as an air-raid shelter, and so the addition of an opening on the north-east elevation to provide light would have desirable. Given the lack of features and fittings within the structure, determining any later use is difficult, but an outside store seems like a reasonable assumption.

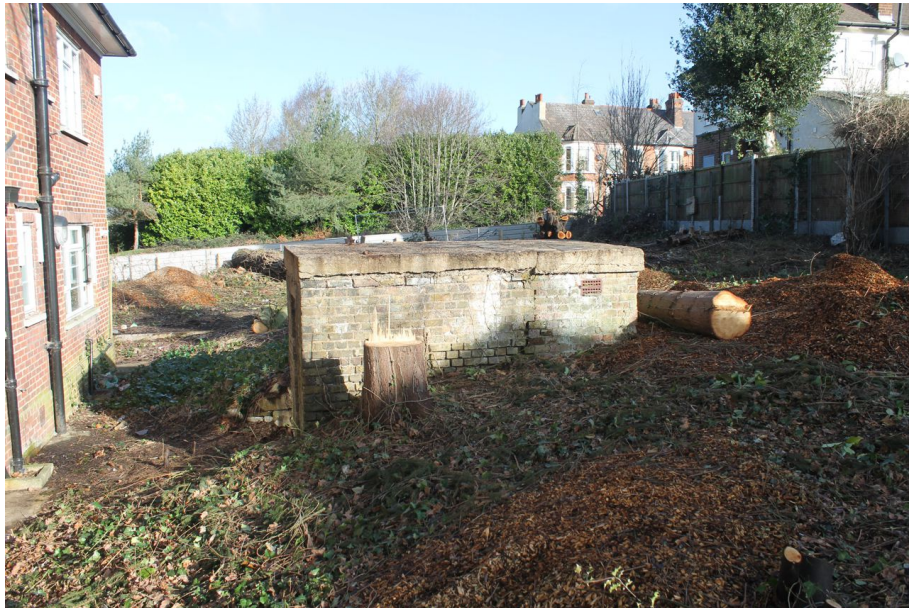
Photograph 3 South-east elevation of air-raid shelter. Photograph taken facing north-west.

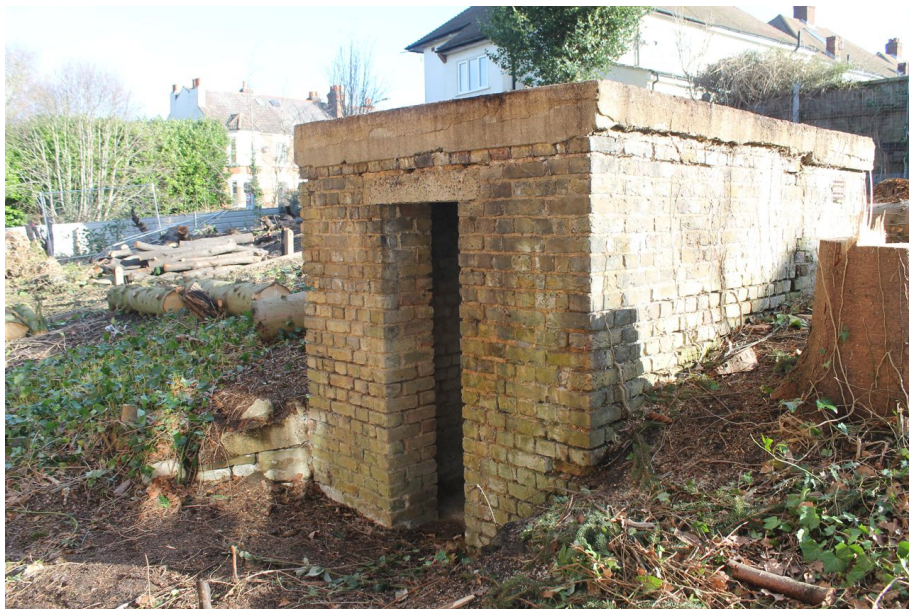
The entrance into the shelter is on the south-west elevation and has a concrete lintel (Photograph 4). The north-west and south-east elevations are featureless apart from air-bricks (Photographs 2-3). The north-east elevation of the shelter, although largely obscured by the earth bank, has an opening at the top of the wall (Photograph 5). There is no evidence for any hinges or other fittings that would suggest a door in the entranceway or any sort of shutter in the north-east opening.

Photograph 4 South-west elevation of air-raid shelter, showing entrance. Photograph taken facing north.

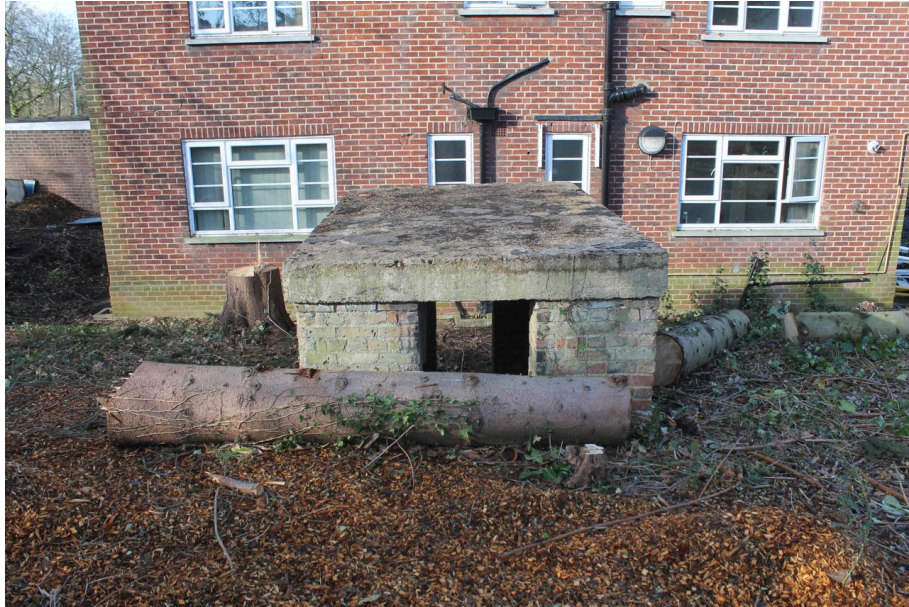
Photograph 5 North-east elevation of air-raid shelter, showing opening. Photograph taken facing south-west.

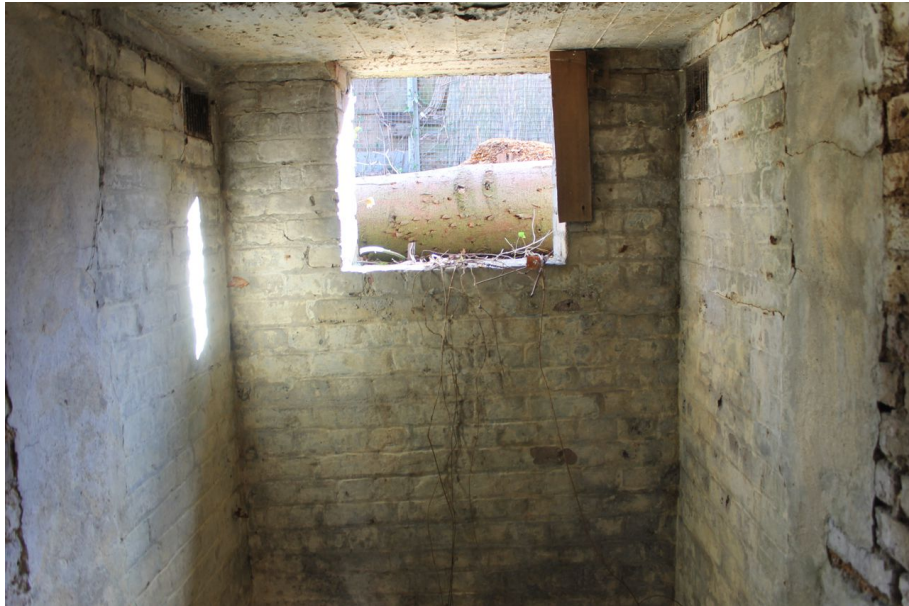
The interior of the shelter is a single room with a concrete floor. The ceiling is plastered. The north-east metre of the building (constructed of red brick) has painted walls on the interior, partially obscuring the brickwork (Photograph 6).

Photograph 6 Interior of air-raid shelter showing painted bricks. Photograph taken facing north-east.

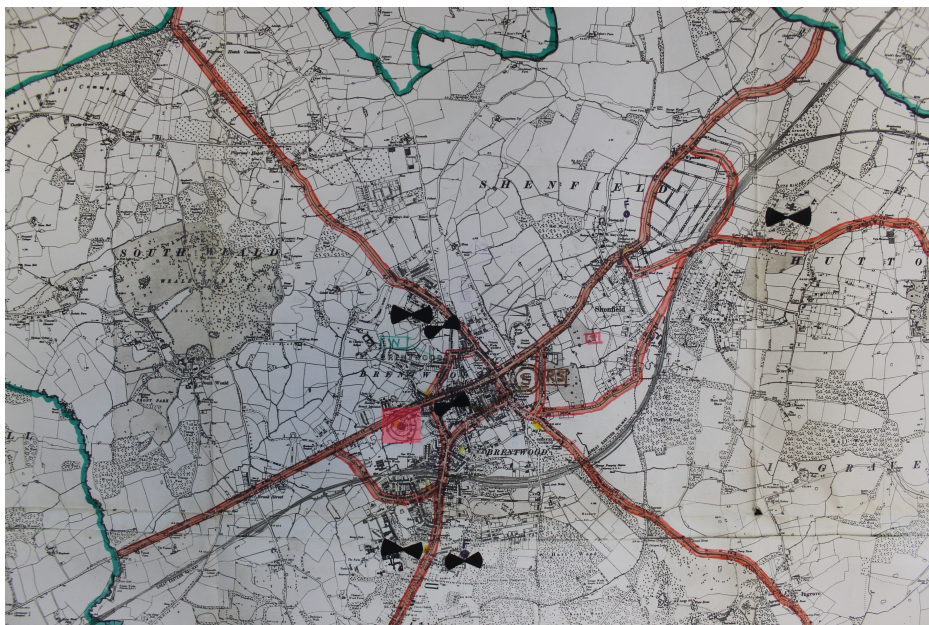
Map 2 1938-39 map of Brentwood showing air-raid precautions. No key. Symbol on Police Station site highlighted in red. ERO C/W 4/11/1.

A map in the Essex Record Office detailing air-raid precautions carried out in Brentwood during World War II has the police station highlighted with a symbol (Map 2). Unfortunately this map does not have a surviving key. The symbol may represent the location of a siren, which were often placed on police stations (Brown et al 1996, 75). Regardless, it implies that the shelters on this site were an important aspect of the town's air-raid defences.

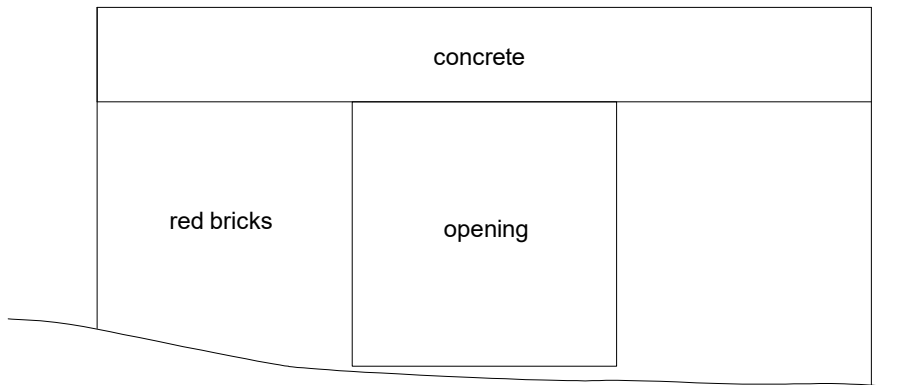
Fig 3 South-west and north-east elevations of the air-raid shelter.
