**Historic building recording of  
a semi-sunken air-raid shelter  
at the former Brentwood Police Station,  
London Road, Brentwood,  
Essex, CM14 4QJ**

**May 2019**

**CAT Report 1414**  
May 2019

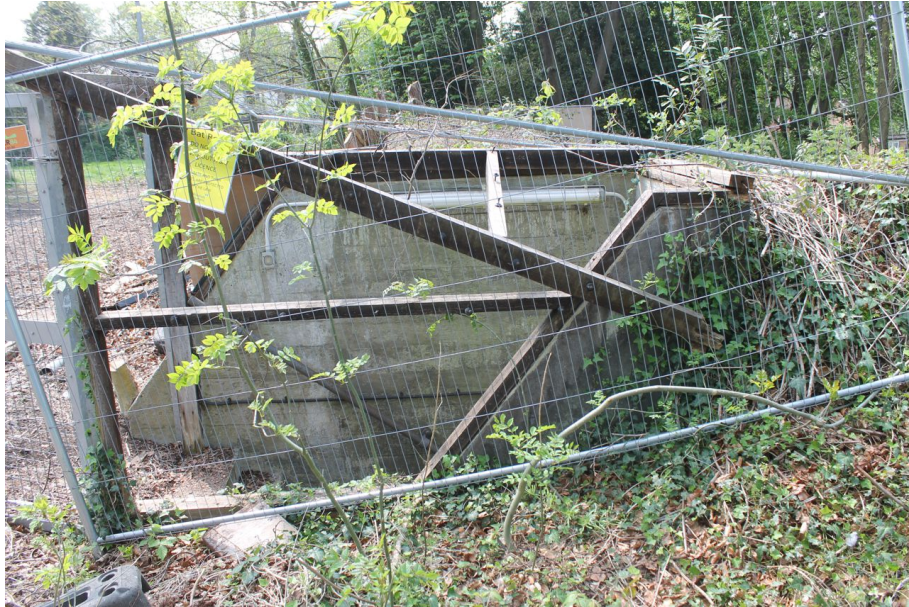
The shelter is entirely constructed of cast concrete with a flat concrete slab roof. It is covered by an earth bank, which rises 1.5m above current ground-level, with two projecting entrances/exits into the structure; one at the northern end and one at the southern (Photographs 1 and 2; and Fig 2). Until recently the shelter had several large trees growing on top and around it.

**Photograph 1** Northern entrance of air-raid shelter. Photograph taken facing south-west.

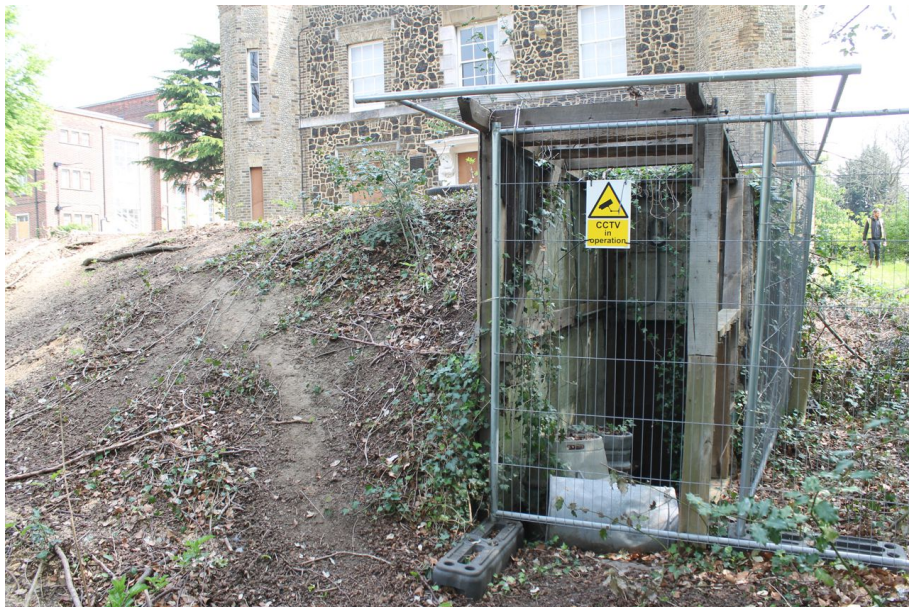
**Photograph 2** Southern (blocked) entrance into air-raid shelter. Photograph taken facing north-east.

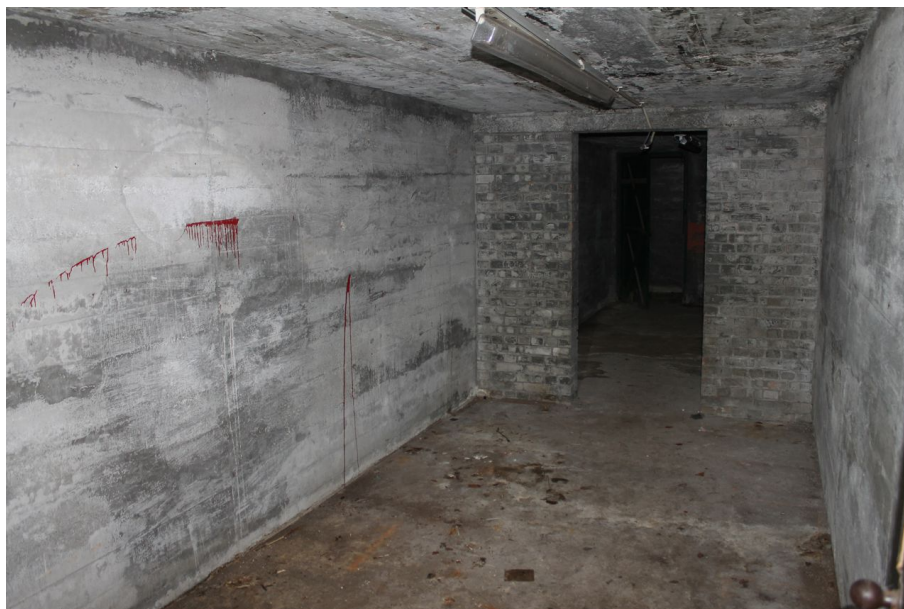
The shelter is accessed via the entranceway to the north, down a flight of stairs. The interior of the shelter is divided by a brick wall which serves to separate the main area of the shelter into two rooms (Photograph 3). The brickwork of this dividing wall is laid in English-bond with the bricks measuring 210 x 100 x 70mm, and there is an entrance through the wall, supported by a concrete lintel, allowing access between the two sides of the shelter. In the north-east corner of the shelter, backing onto the entrance stairway, is a small room that would have originally been the W.C. (Photograph 4).

**Photograph 3** Interior of air-raid shelter, showing dividing brick wall. Photograph taken facing south-east.

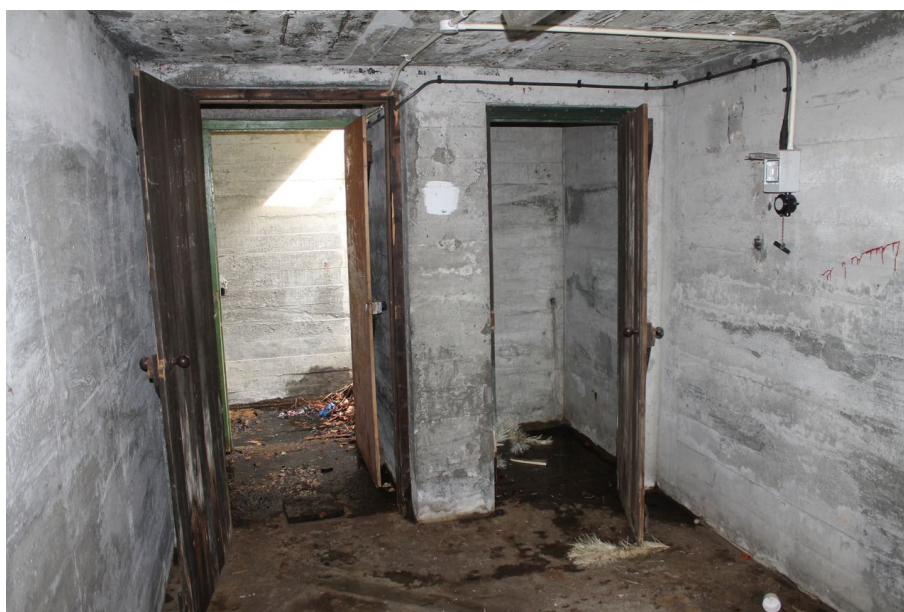
**Photograph 4** Interior of air-raid shelter, showing separate room next to northern entrance. Photograph taken facing north-east.

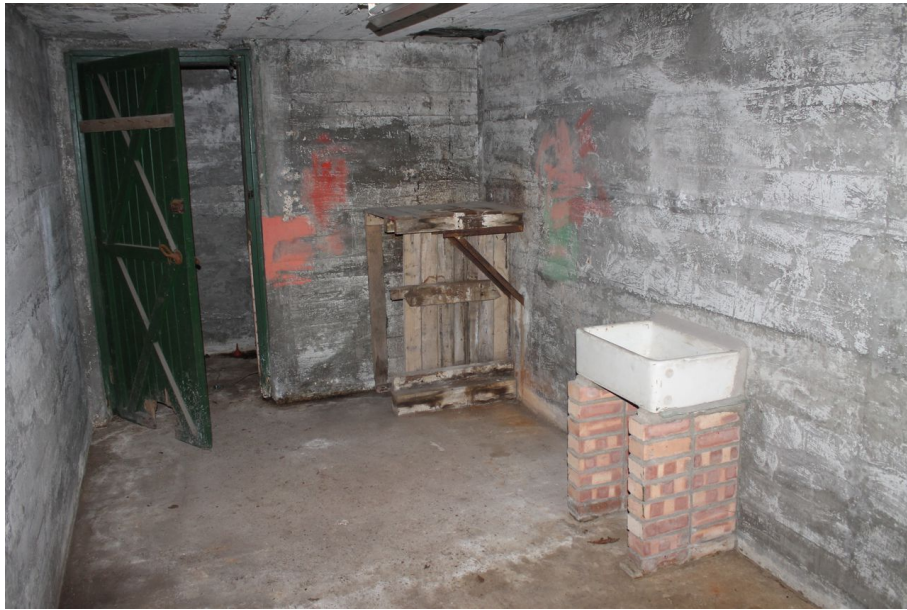
The interior of the shelter is featureless except for an inserted Belfast sink (that is not plumbed in) and a rudimentary desk constructed out of the remains of a wooden pallet (Photograph 5).

**Photograph 5** Interior of air-raid shelter, showing inserted sink and desk in south of structure. Photograph taken facing south-west.

The surviving features within the shelter; the Belfast sink, the rudimentary desk and the metal ventilating pipe, are all the result of later insertions into the structure. Presumably these features were all added at a date when the structure was no longer in use as an air-raid shelter. The current owner of the site attests that the shelter continued to be used by the police until relatively recently (*pers comm*), and that it even served as an office for a period of time. The presence of the sink and ventilation system could perhaps suggest that the shelter was at some point used as a dark room for the development of photos, although this is largely speculative.

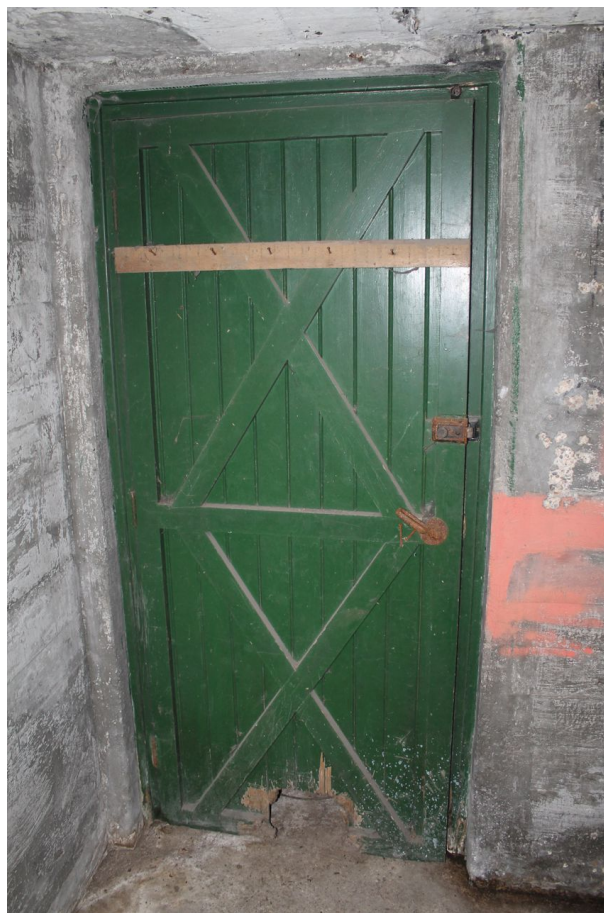
All the doors within the shelter are vertically-planked, supported with battens and cross-battens on their rear (Photograph 6). There are two distinct types of door in the shelter; the ones to the north of the structure are constructed of larger planks than the ones to the south (Photographs 7). An inserted metal pipe provides ventilation to the structure via the northern entrance (Photograph 8 and Fig 2).

**Photograph 6** Detail of southern door on interior of air-raid shelter, showing cross-battens on rear. Photograph taken facing south.

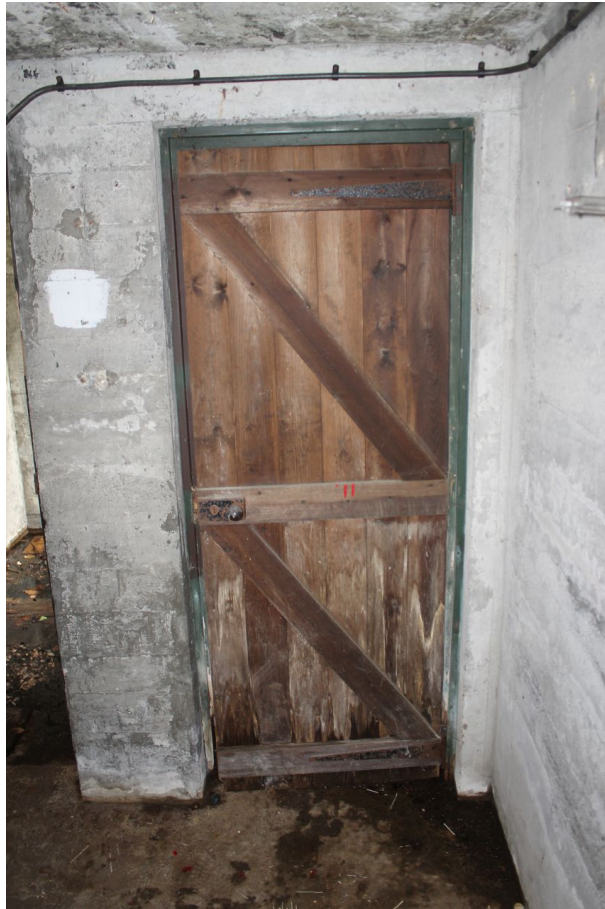
**Photograph 7** Detail of northern door on interior of air-raid shelter, showing cross-battens on rear. Photograph taken facing north.

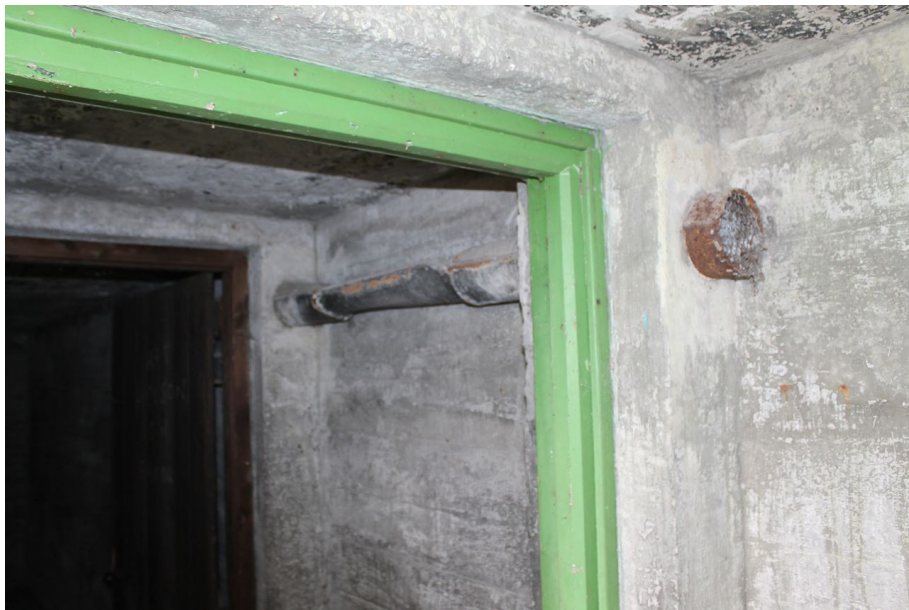
**Photograph 8** Detail of inserted metal vent and pipe in north of air-raid shelter, adjacent to entrance. Photograph taken facing south-west.

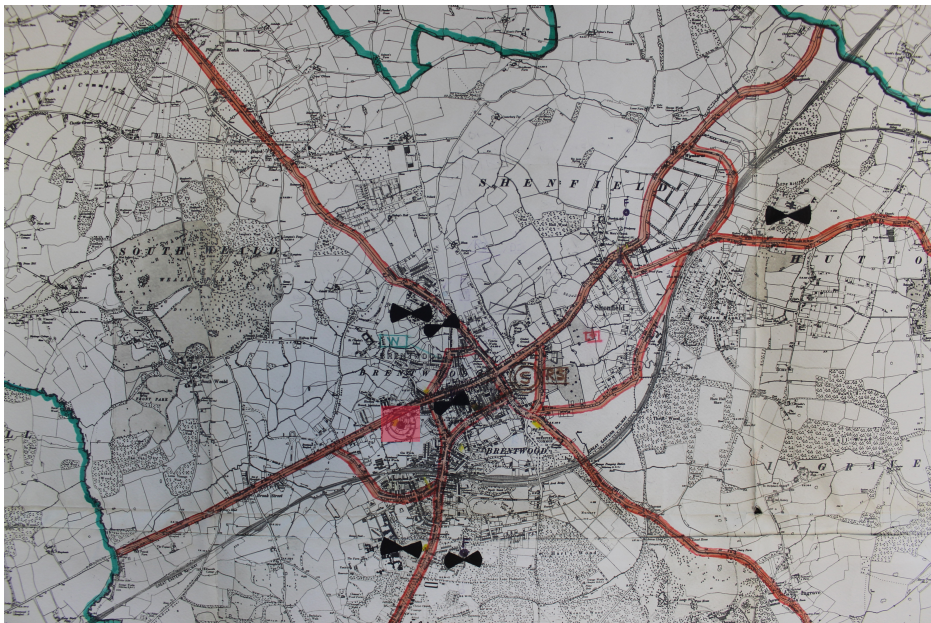
A map in the Essex Record Office detailing air-raid precautions carried out in Brentwood during World War II has the police station highlighted with a symbol (Map 1). Unfortunately this map does not have a surviving key. The symbol may represent the location of a siren, which were often placed on police stations (Brown et al 1996, 75). Regardless, it implies that the shelters on this site were an important aspect of the town's air-raid defences.

**Map 1** 1938-39 map of Brentwood showing air-raid precautions. No key. Symbol on Police Station site highlighted in red. ERO C/W 4/11/1.
