Archaeological evaluation at Rebow House, 58-62 Head Street, Colchester, Essex, CO1 1PB

April 2019

CAT Report 1425

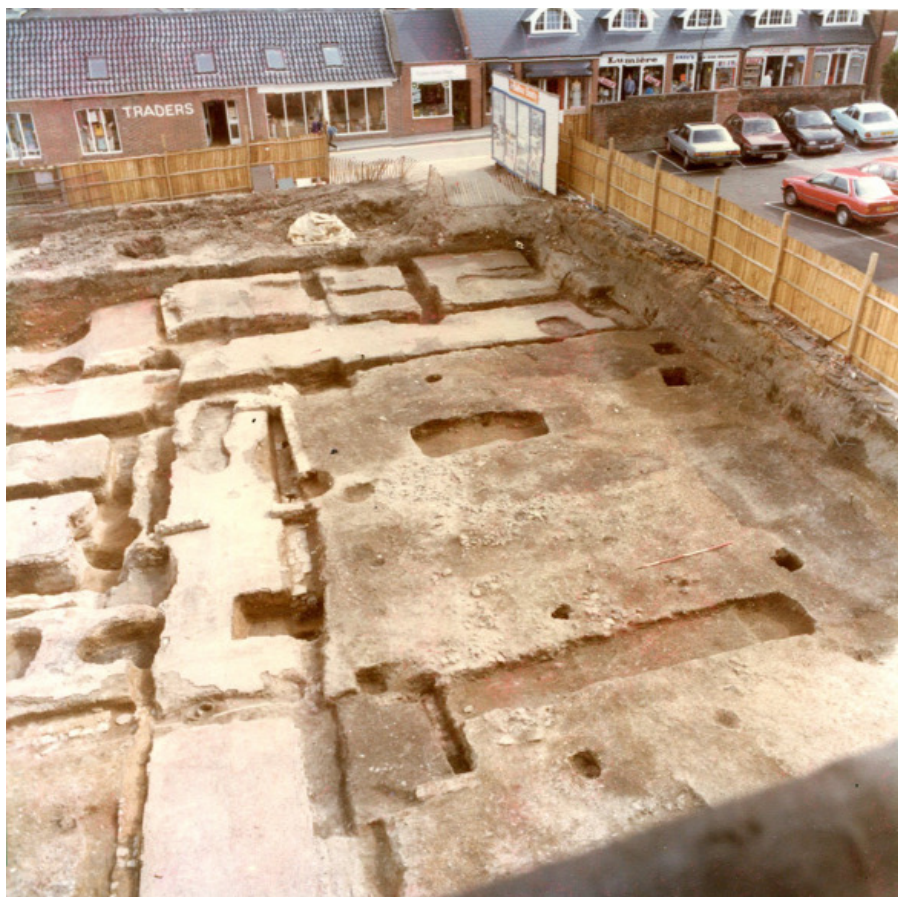
Photograph 1 The Rebow House site (right, with parked cars) in relation to the excavation at Culver Street Area H, looking south towards Sir Isaac's Walk.

Post-Roman remains on Area H mostly comprised of pits and linear features thought to relate to a large planned garden of Rebow House (see Map 1). To the north of a medieval cellar were the fragmented foundations of a small rectangular building (CAR 6, Building 129). The building measured 4.7m by at least 3.4m. The foundations were shallow, coursed septaria and peg-tile, probably supporting a timber-frame. This was probably an outbuilding of 15th- to 16th-century date belonging to one of the houses fronting onto Head Street.

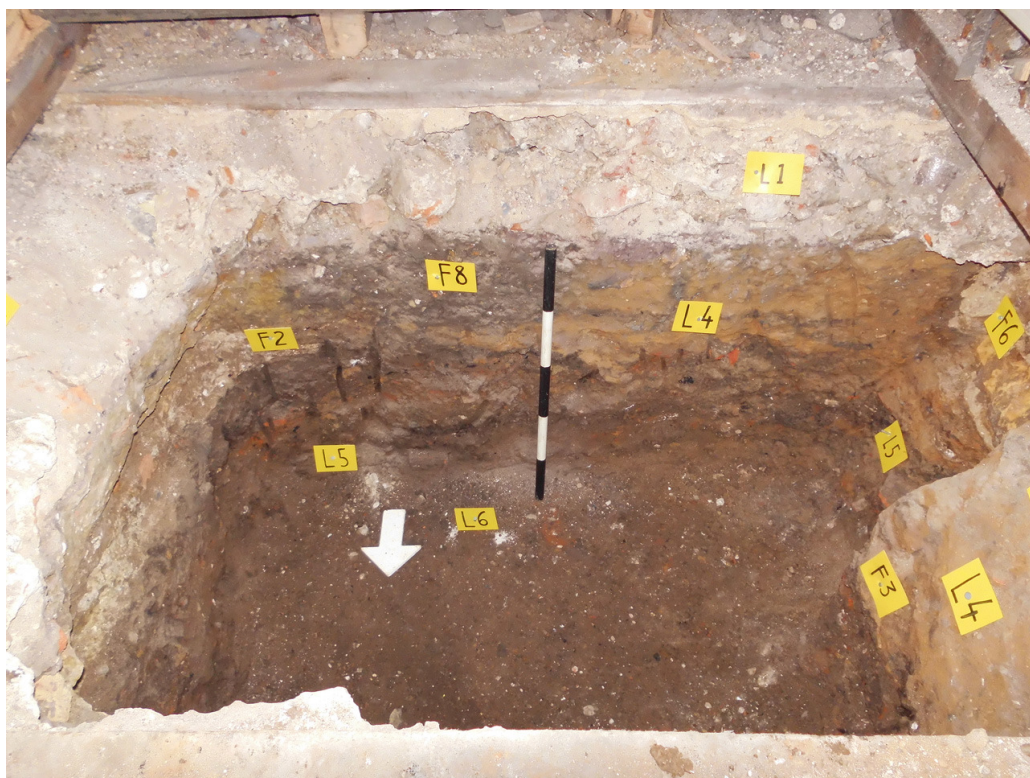
Photograph 2 Test-pit 1, looking south

- The wooden floor (F1) of the existing mid-19th to late-20th century extension which was set on a layer of concrete (L1).
- The original back wall (now an internal wall) (F7) of Rebow House set on a foundation of septaria and sandstone blocks in mortar (F6). This wall has been dated to c 1700 or before (Alston 2016).

- Layer L4 probably pre-dates Rebow House as it is cut by F6.
- Layers L2, L3, L11 and features F2 and F8 are therefore either associated with the construction of Rebow House, activity to the rear of the house, or the construction of the later extension.

- Beneath L4 were six layers (L5, L6, L9, L10, L12 and L13) of make-up/levelling. Three of the layers contained peg-tile (L5, L9 and L13) as well as earlier residual finds. Peg-tile is dated in Essex from the 14th century onwards (Ryan 1996). Rebow House is recorded as having a medieval cellar and an exposed fragment of 15th-century timber-frame has been recorded internally (Alston 2016). These six layers may actually be layers of accumulation associated with activity to the rear of the medieval building.

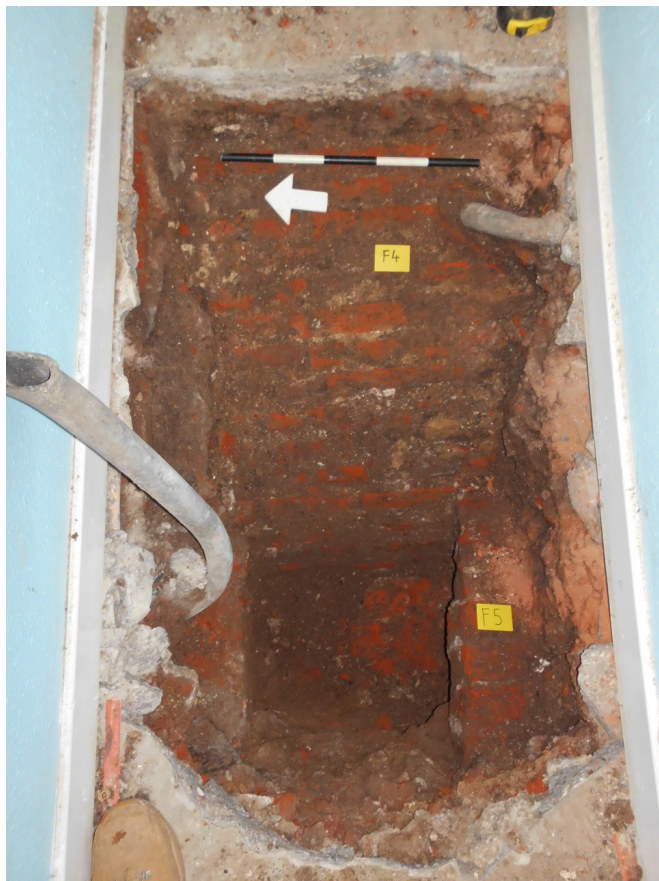
Photograph 3 Test-pit 2, looking east

- The concrete base (L9) for the existing mid-19th to late-20th century extension which sealed a layer of backfill (L7).
- The backfill (L7) had been laid over a brick culvert (F4) which was orientated north to south. Bricks sampled from the culvert have been dated from the late 17th to early 18th century, suggesting that the culvert was probably constructed at around the same time as Rebow House.
- A later brick arch (F5) had been added to the western side of the culvert. A void in this arch shows it had been backfilled (L8).

Test-pit 2: A late 17th- to early 18th-century brick culvert was aligned north to south along the rear of the property. It was probably constructed at the same time as Rebow House for drainage. The raft foundation would demolish the top of the culvert and the later brick arch butted against it.

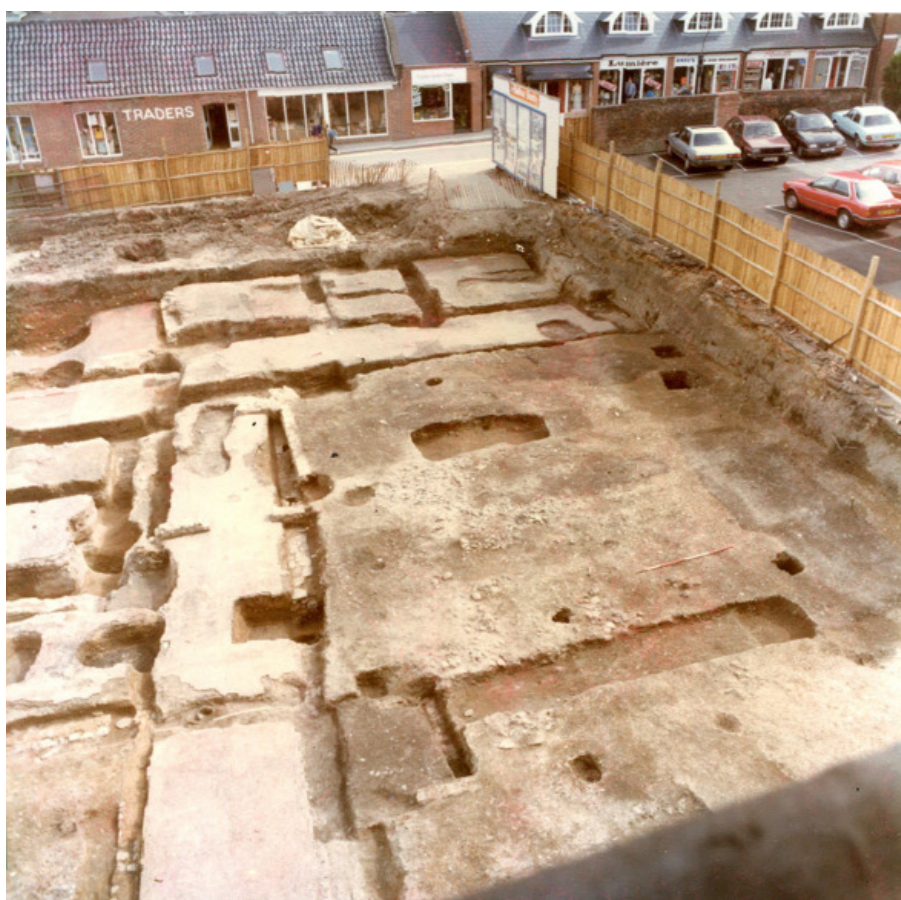
Photo 1: The Rebow House site (right, with parked cars) in relation to the excavation at Culver Street Site H, looking south towards Sir Isaac's Walk.
