**Historic building recording at the
Red Lion Public House,
42 South Street, Manningtree,
Essex, CO11 1BG**

September 2019

CAT Report 1520
February 2020

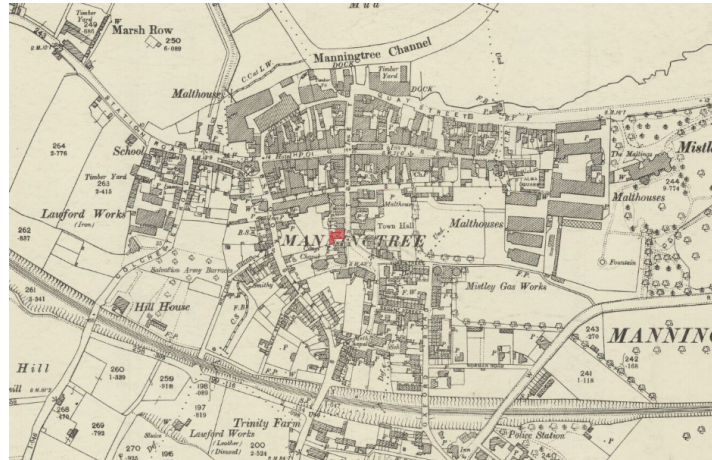
The second edition 25-inch OS map of 1896 shows that the Red Lion has been further extended to the west and is now connected to, and forms one contiguous building with, the north/south aligned outbuilding (Map 4).

Map 4 1895 25-inch OS map. The Red Lion and (now connected) outbuilding to rear highlighted in red.

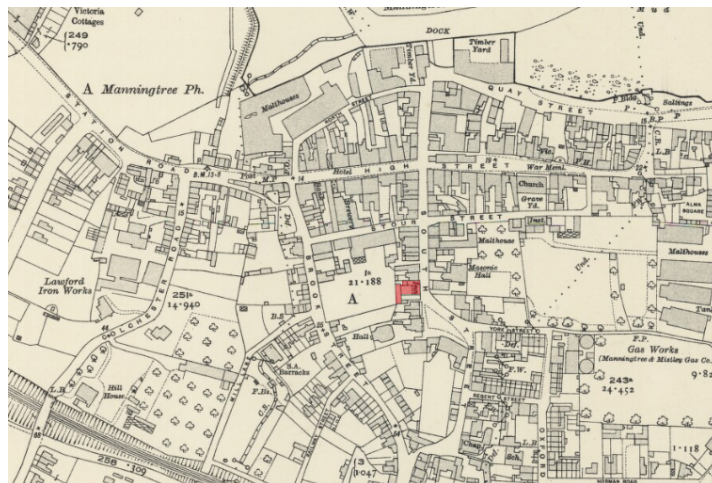
The 1921 25-inch OS map shows the site in more detail, including divisions between the buildings (Map 5).

Map 5 1921 25-inch OS map. The Red Lion and (now connected) outbuilding to rear highlighted in red.

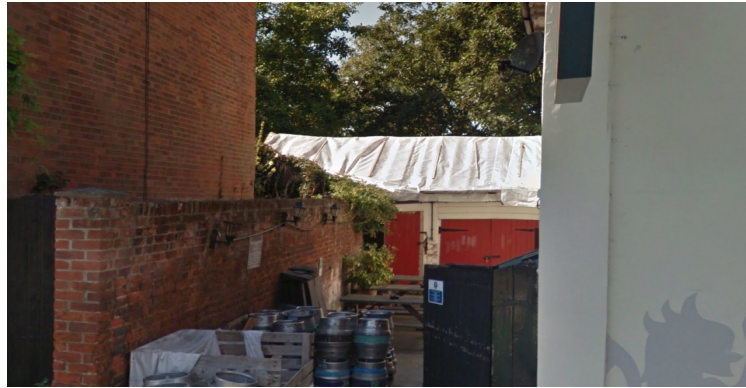
A photograph of the building taken from Google Maps in 2016 (Photograph 1) shows the two pairs of vertically-planked double doors on the eastern elevation, and with the roof covering removed and replaced with sheeting.

Photograph 1 East elevation of demolished building, viewed from the road. Photograph taken facing west. Copyright Google 2020, image captured September 2016.

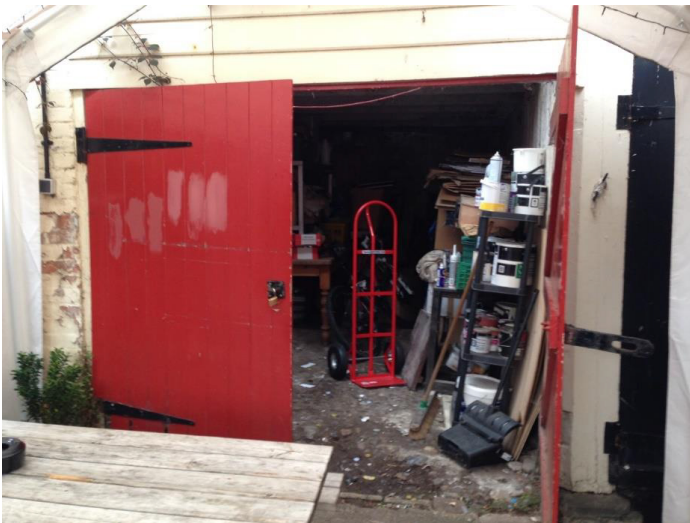
Photograph 2 Detail of double-door on eastern elevation of building. Photograph taken facing west, reproduced from Wright 2019.

Two photographs (Photographs 2 and 3) taken for the heritage impact assessment (Wright 2019) show the demolished section of the building in more detail, including one set of its double doors (Photograph 2) and the southern gable from the interior, showing the machine-cut roof timbers and the Flemish-bond red brickwork (Photograph 3).

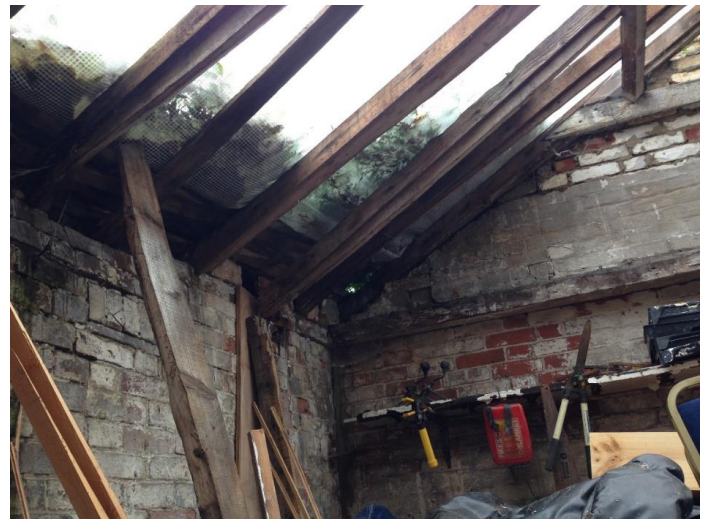
Photograph 3 Detail of interior of building, showing roof timbers and part of southern gable end. Photograph taken facing south-east, reproduced from Wright 2019.

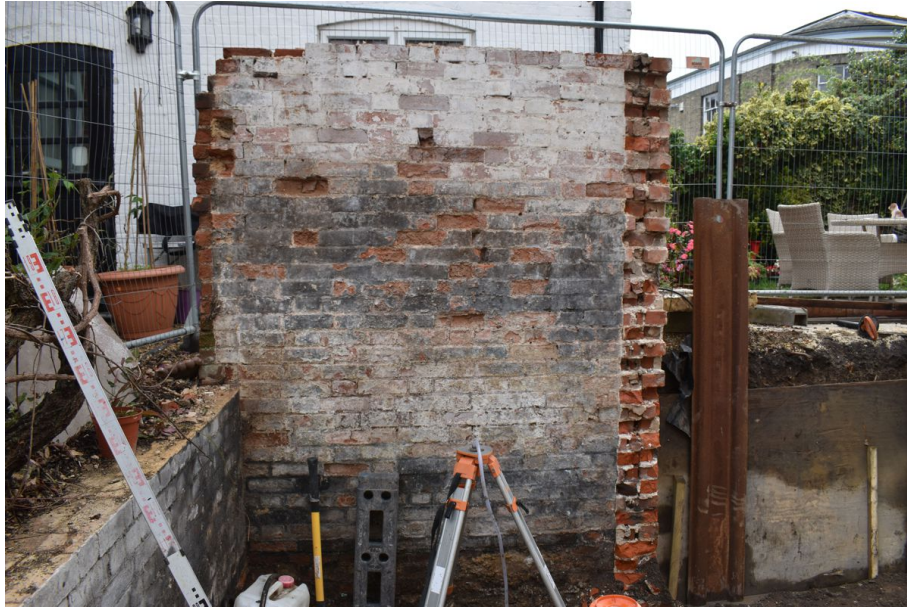
A red brick wall, that appears to have been keyed in to the demolished section, survives as part of the property boundary on the southern side of the site. It is laid in Flemish-bond with bricks bonded in lime mortar, with dimensions of 220 x 110 x 65mm (Photograph 4).

Photograph 4 Detail of red brick wall that was keyed into south end of demolished structure (joints visible on right side of wall). Photograph taken facing south.

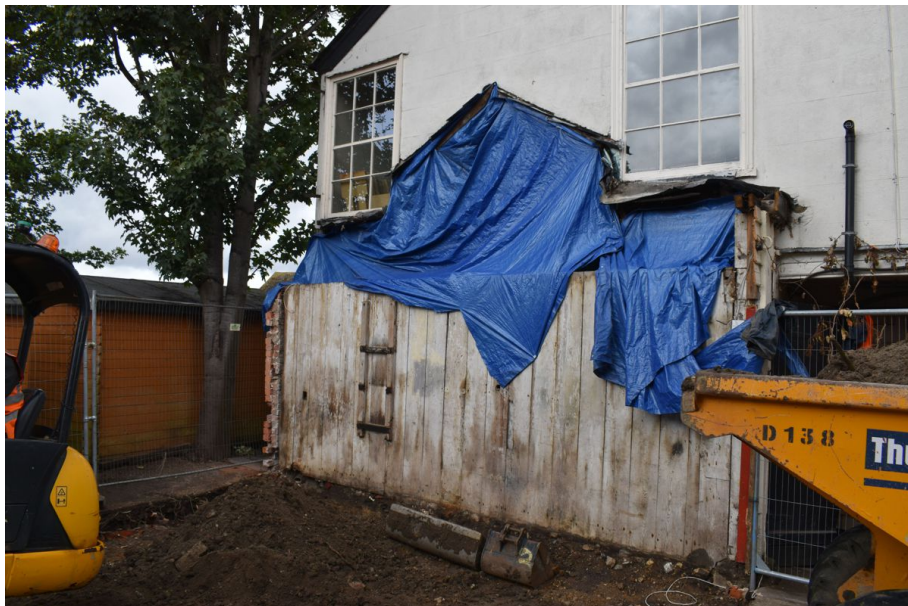
The location where the southern half of the building projected from the Red Lion is clear; a wooden-panel division survives and the scars showing the pitches of the roof are evident at the first-floor level (Photograph 5). Also in this location, on the west side of the panelling, is another red brick wall that was jointed to the demolished section, with similar dimensions of bricks as the brick wall to the south (see above).

Photograph 5 Detail of northern half of building surviving underneath 1970s first-floor extension. Scar on first-floor shows roof pitches of demolished half. Wooden panel division visible with projecting brick wall visible to left. Photograph taken facing north-west.

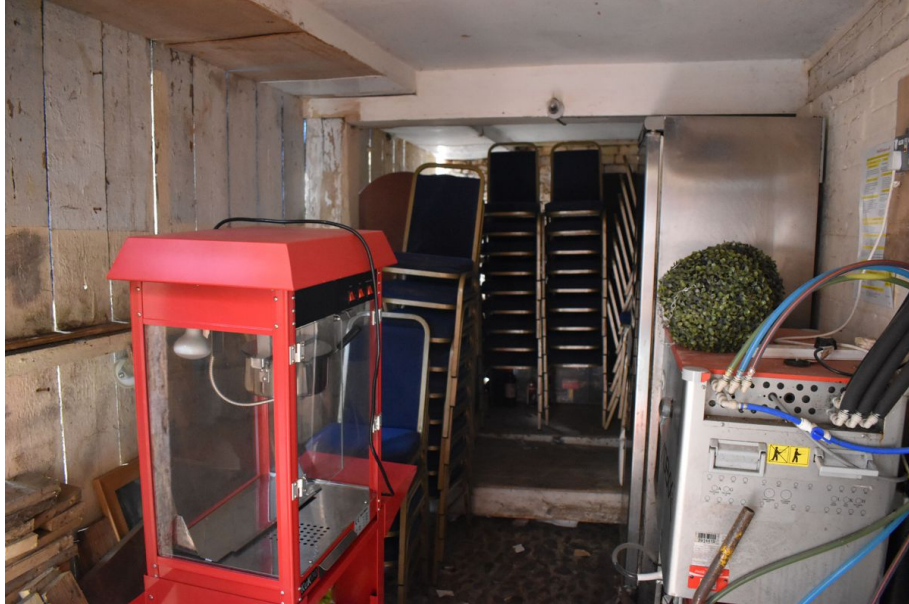
The interior of the northern half of the building shows that it has a modern cobbled floor laid in concrete and a raised wooden platform to the west. Currently the building is used for storage. An inserted brick wall to the north supports the modern first-floor above and is constructed of bricks measuring 240 x 100 x 80mm, laid in stretcher-bond (Photograph 6).

Photograph 6 Interior of surviving northern half of building, showing brick wall to right and cobbled surface. Photograph taken facing west.

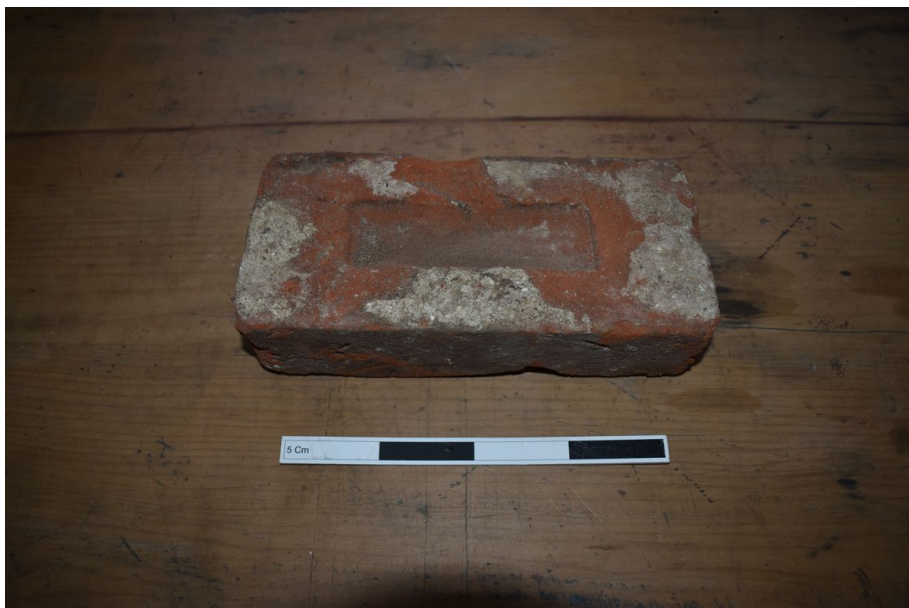
A red brick from the wall of the demolished section (Photograph 7), measures 235 x 108 x 65mm in size and is of a regular shape with no visible inclusions in its make-up. It has slightly rounded arrises and a mildly striated upper surface, with the remaining faces and base lightly creased. It has a shallow, central, frog measuring 125mm in length, 40mm in breadth and 15mm in depth. Patches of lime mortar remain on its surfaces.

Photograph 7 Red brick recovered from wall of demolished building.

However, while the roof and the brick flooring could both have been redone or subsequently added to the building, the brick from the wall of the structure is presumably part of the original fabric (unless, of course, it was reused from an earlier structure). The narrow frog on its upper surface dates it to the late 18th century or after, frogs not appearing in moulded bricks before that date (Brunskill 1990, 24).

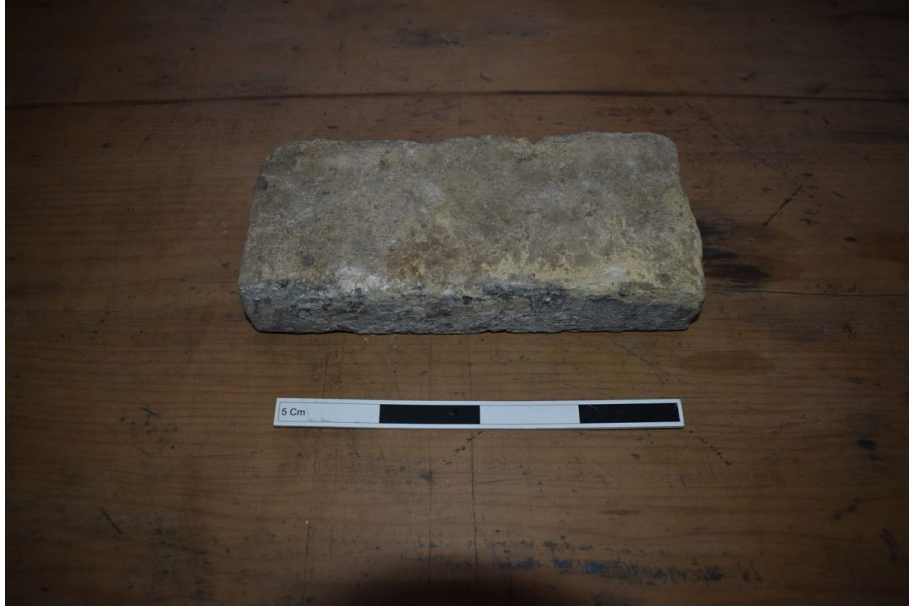
A floor (pavior) brick from the demolished section was also recovered (Photograph 8). It is yellow/white in colour and slightly misshapen, tapering inwards at one end. It measures 235 x 105 x 42mm in size and has no visible inclusions in its fabric. It has sharp, only slightly rounded, arrises and a smooth upper surface and faces. Its base has some mild striations and small patches of lime mortar remaining.

Photograph 8 Pavior brick recovered from demolished building, showing slight tapering from right to left.

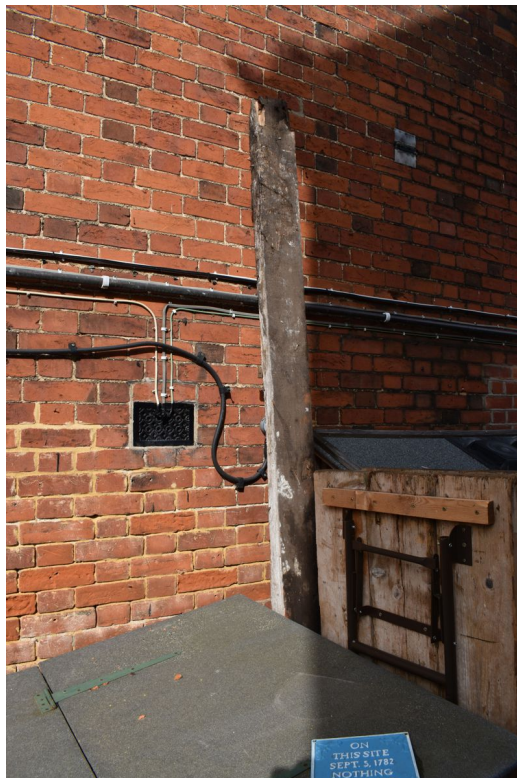
Finally, a timber from the demolished section was observed on site (Photograph 9). It was straight, approximately 4m long, machine-cut and measured 100mm x 150mm in profile.

Photograph 9 Timber from demolished building, observed on site.

As for the structural evidence, the machine-cut timbers of the roof (assuming they were original to the building) must broadly date to after the Industrial Revolution and the introduction of industrial processes for sawing timber. The white pavior brick from the floor, meanwhile, is typical of the 19th century (Ryan 1996, 96).
