Archaeological monitoring and a historic building record of the medieval cellar at Rebow House, 58-62 Head Street, Colchester, Essex, CO1 1PB

October 2019 – February 2020

CAT Report 1530

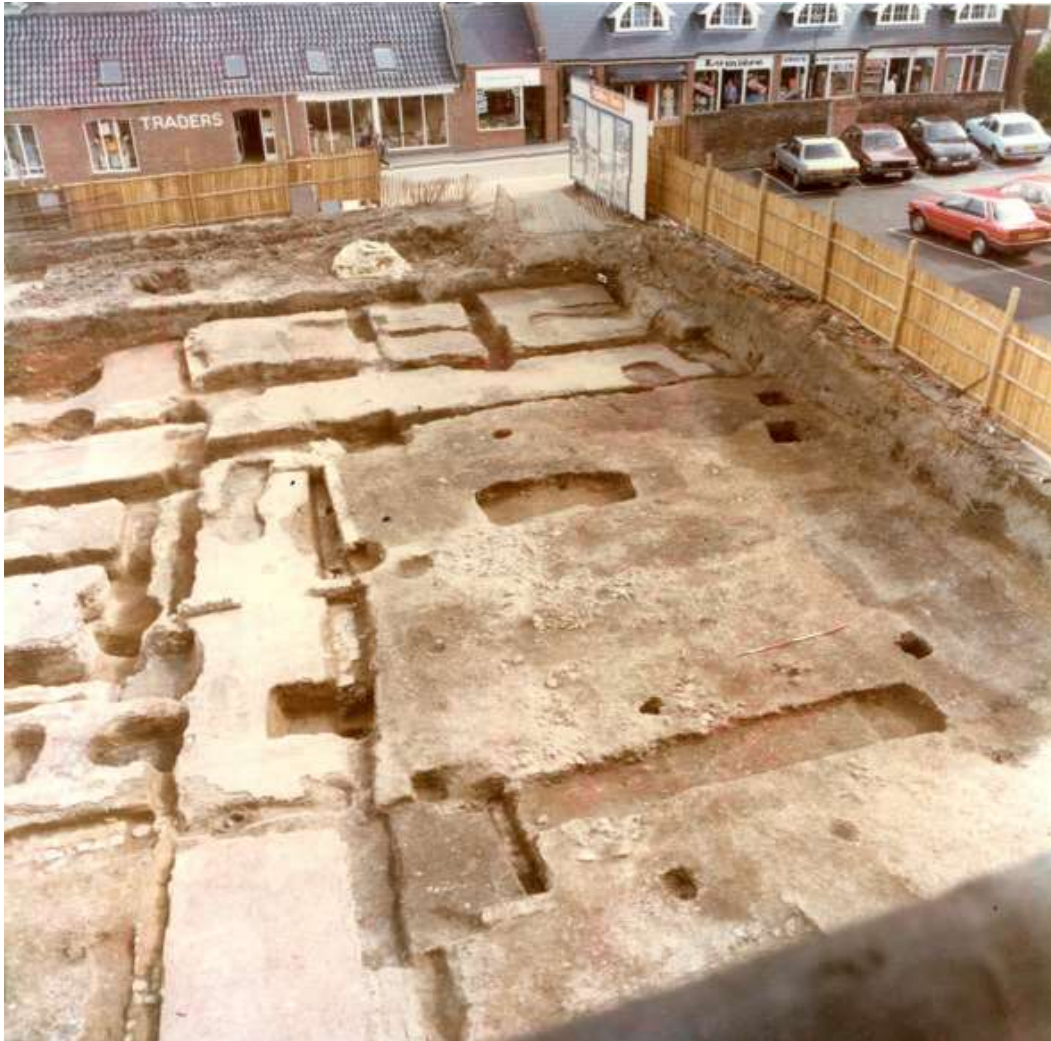
Photograph 1 The Rebow House site (right, with parked cars) in relation to the excavation at Culver Street Area H, looking south towards Sir Isaac's Walk.

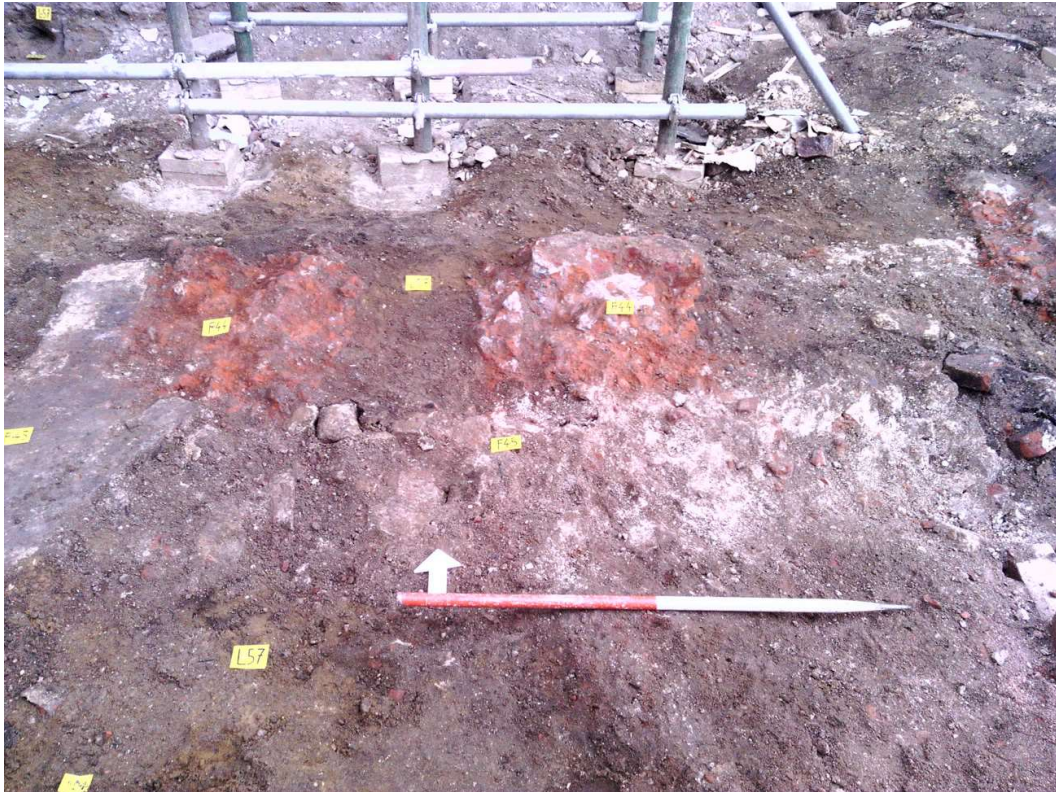
Photograph 2 Wall foundation F45 with brick chimney foundations F44, looking north.

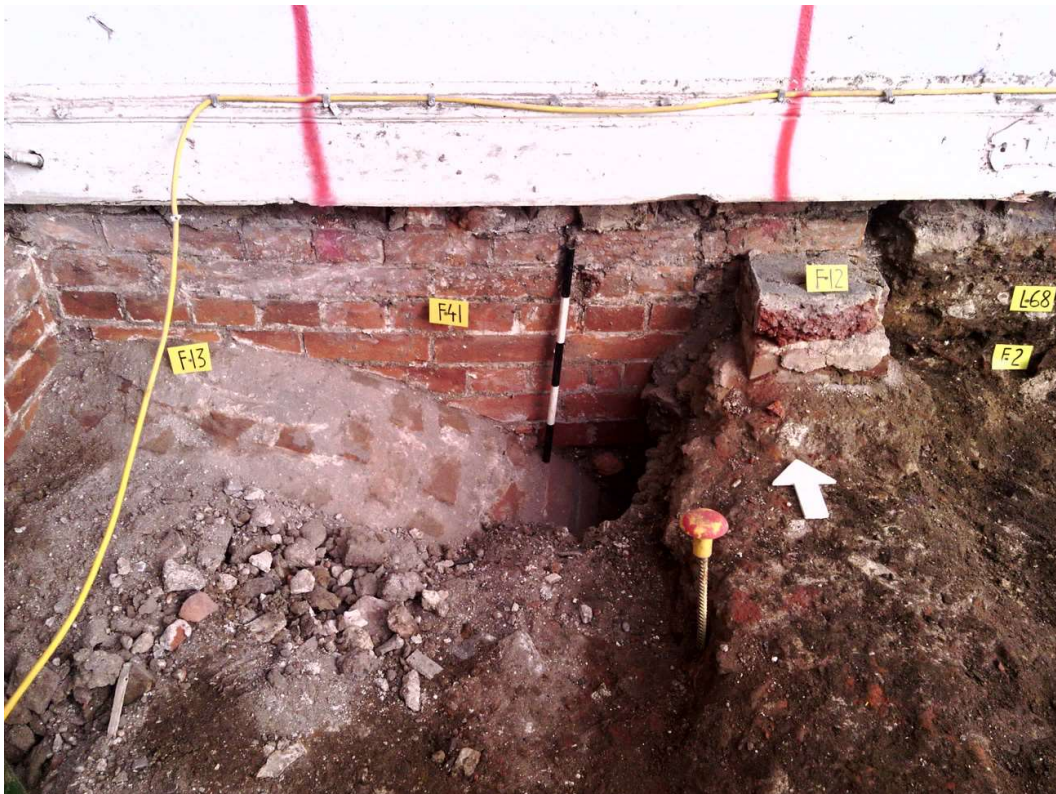
Photograph 3 Well cap F13 with brick underpinning F41 beneath standing wall F42 and plinth F12, looking north.

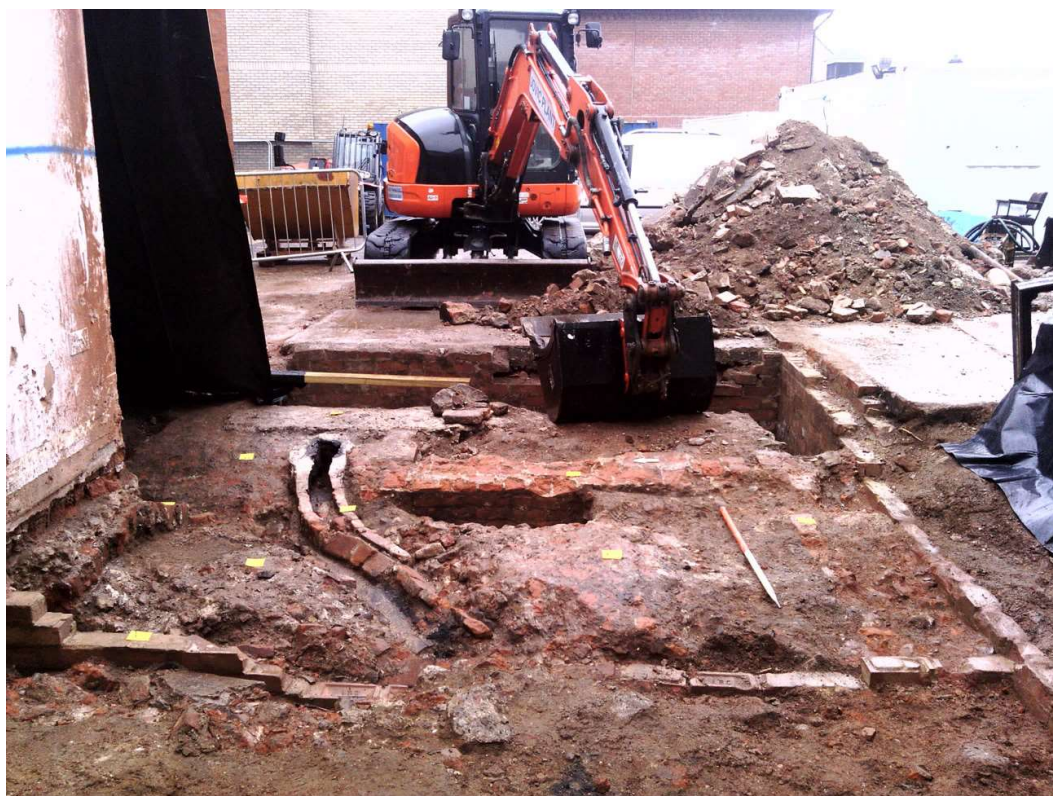
Photograph 4 Brick soakaway F4, drain F16 and wall foundation F17 (Phase 2) surrounded by 20th-century wall foundations F19 in LBC bricks (Phase 3), looking east.

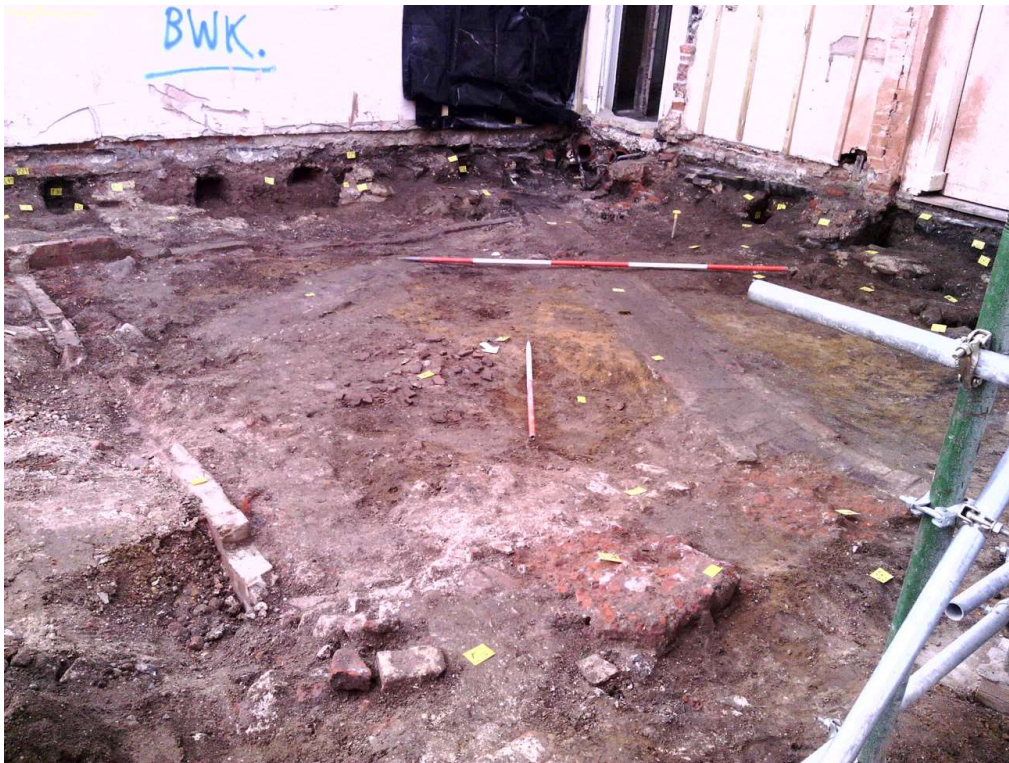
Photograph 5 Remains of brick drains F16 and F34/F37/F43 both leading towards the southwest corner of the raft reduction area, looking southwest.

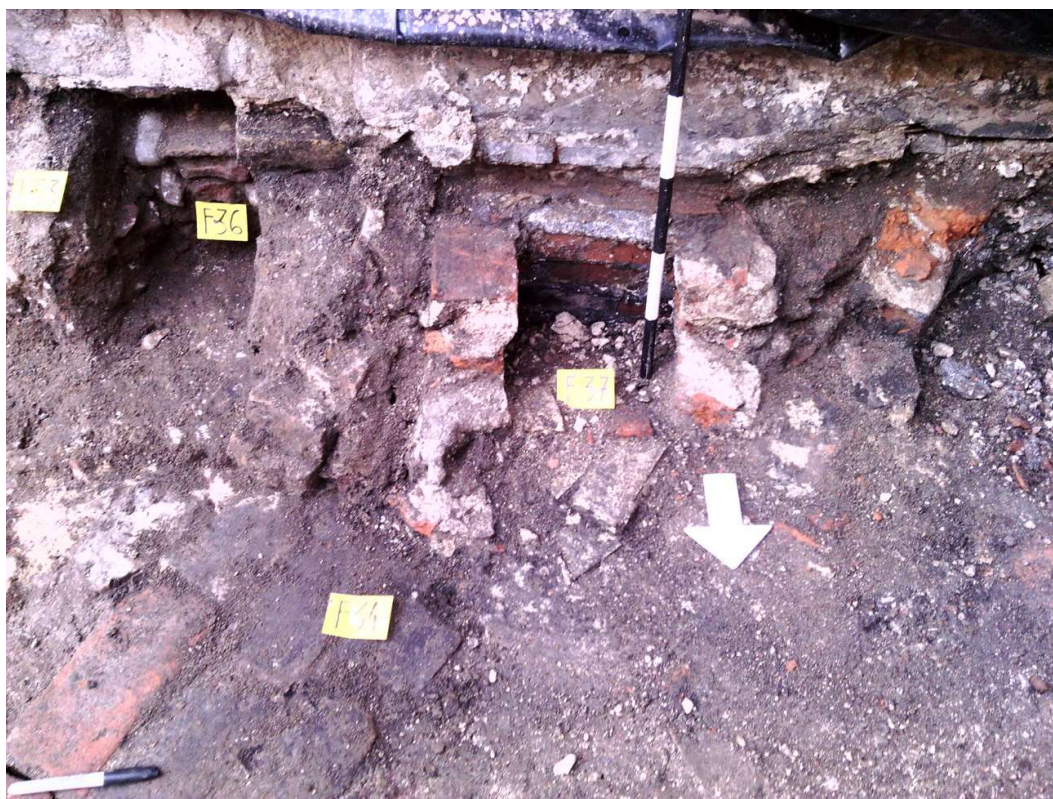
Brick drain F34/F37/F43 was built underneath the foundation of standing wall F29 in the southwestern corner of the raft reduction area. In section it had survived to its full height and, constructed on a base layer four bricks wide, it was three bricks high and had been capped by stone tiles (Photograph 6). At a depth of c 30.82m AOD, the stone tiles likely represent contemporary ground level. Beyond the section, only the base layer of bricks survived and the drain continued in a north-easterly direction towards the centre of the site where it was truncated by the mid 19th- to late 20th-century extensions (Photograph 5). However, at this point both the alignment of the drain and the pattern of the brickwork changes, suggesting a junction may have originally existed here, but no further signs of the drain had survived. The drain was plotted over a distance of c 2.7m, was 0.25m wide and, when complete, would have been c 0.3m high.

Photograph 6 Full height of brick drain F34/F37/F43, looking south.

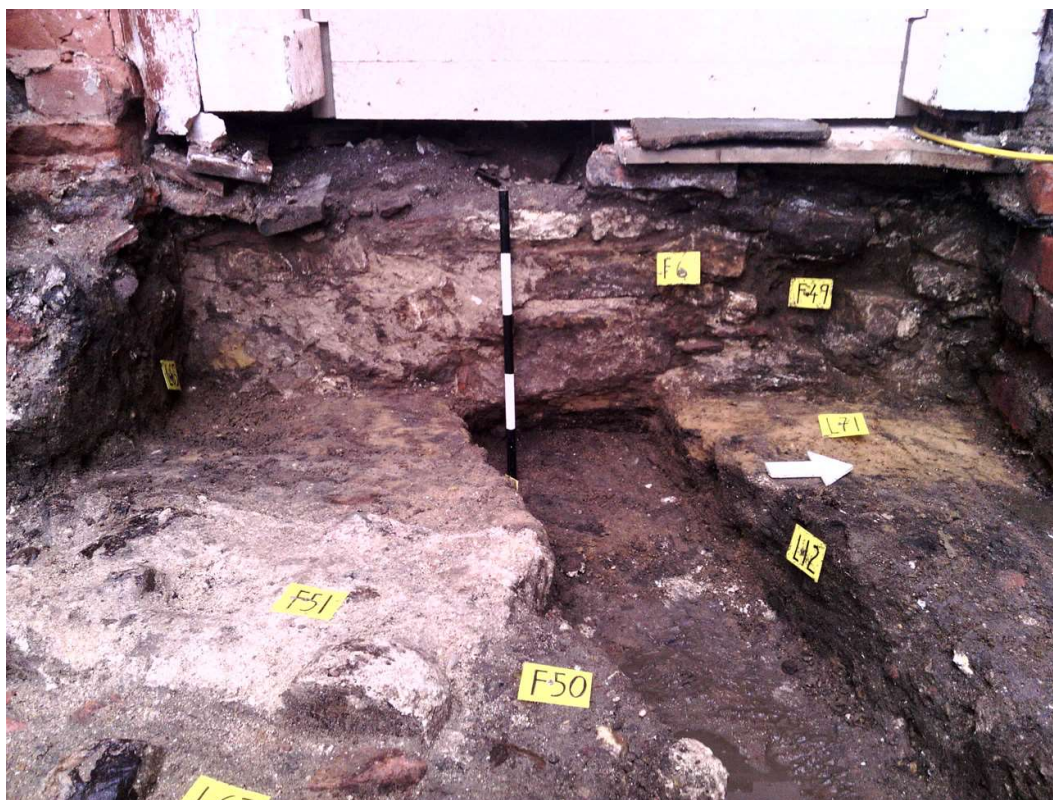
Photograph 7 Standing wall foundation F6 (F6/F7) with brick drain F49, in the foreground structural feature F51, looking west.

Along the western side of the raft reduction area were three unidentified structural features (F2, F51 & F56) truncated by later activity (Photograph 7). All three features were on the same NNW/SSE alignment and were recorded at the same depth cutting into make-up/ levelling L57 (see Phase 1 below). Consisting of yellow bricks and blocks of septaria/stone set in mortar, they are likely to be part of the same structural feature, but it is uncertain if this was a drainage feature, a wall foundation or something different. However, they do broadly align with unidentified arched structure F40.

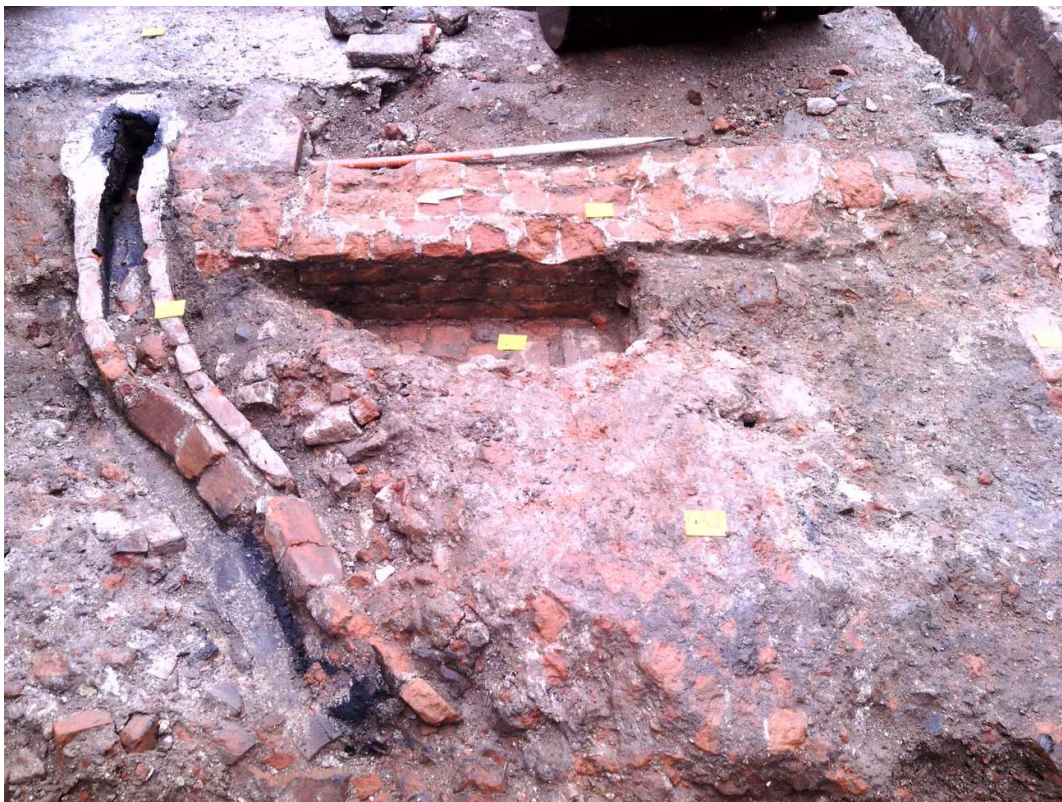
To the west of wall foundation F17, a small investigative hole revealed brick floor F18, which was sealed by layer of compacted rubble L32 (Photograph 8). Brick drain F16 had been built on top of L32, which had presumably been laid to raise ground level to accommodate the drain. Therefore, if wall foundations F17 and F20/F28 are contemporary with soakaway F4, and if brick floor F18 is associated with these features, then brick drain F16 must be a later addition.

Photograph 8 Wall foundation F17 with brick floor F18, compacted rubble L32 and drain F16, looking east.

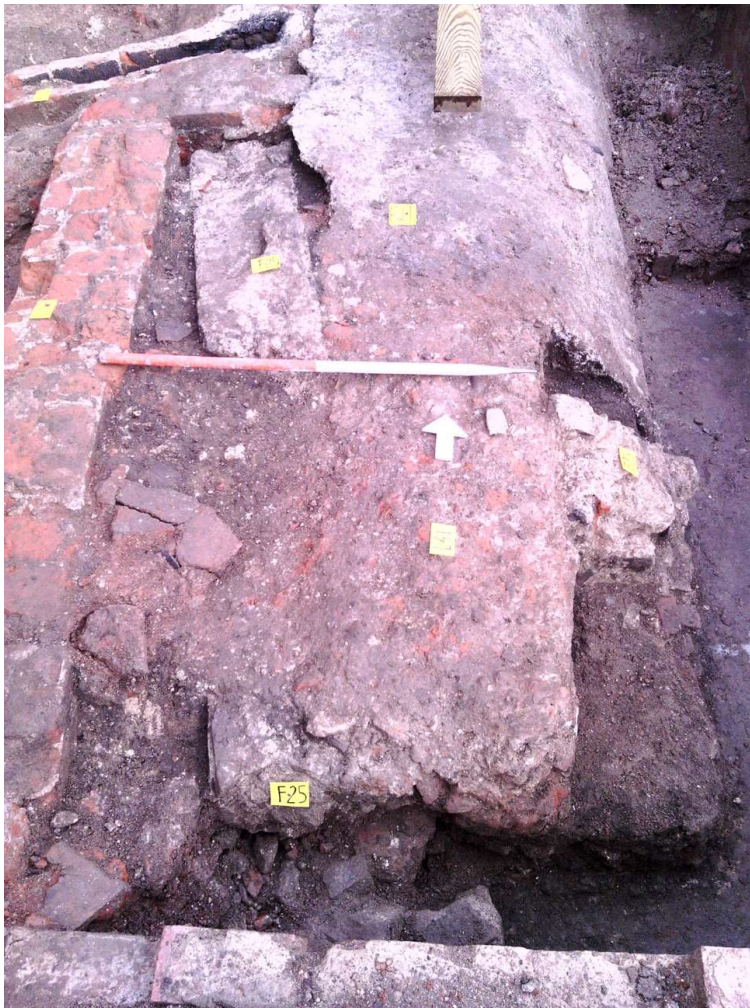
In the far southeastern corner of the raft reduction area, sealed beneath L41 and cut by wall foundations F17 and F19, was a stone wall foundation. This foundation, F25, was c 0.3m wide and made of septaria fragments in an off-white/pale grey mortar with horizontal peg-tile fragments visible in the upper surfaces (Photograph 9). Either side of the east/west section of foundation were possible accumulation layers L42 and L43, with a horizon of peg-tile just visible below L43.

Photograph 9 Wall foundation F25 sealed by L41, with wall foundations F17 to the west and F19 to the south and east, and concrete infill F21 to the north, looking north.

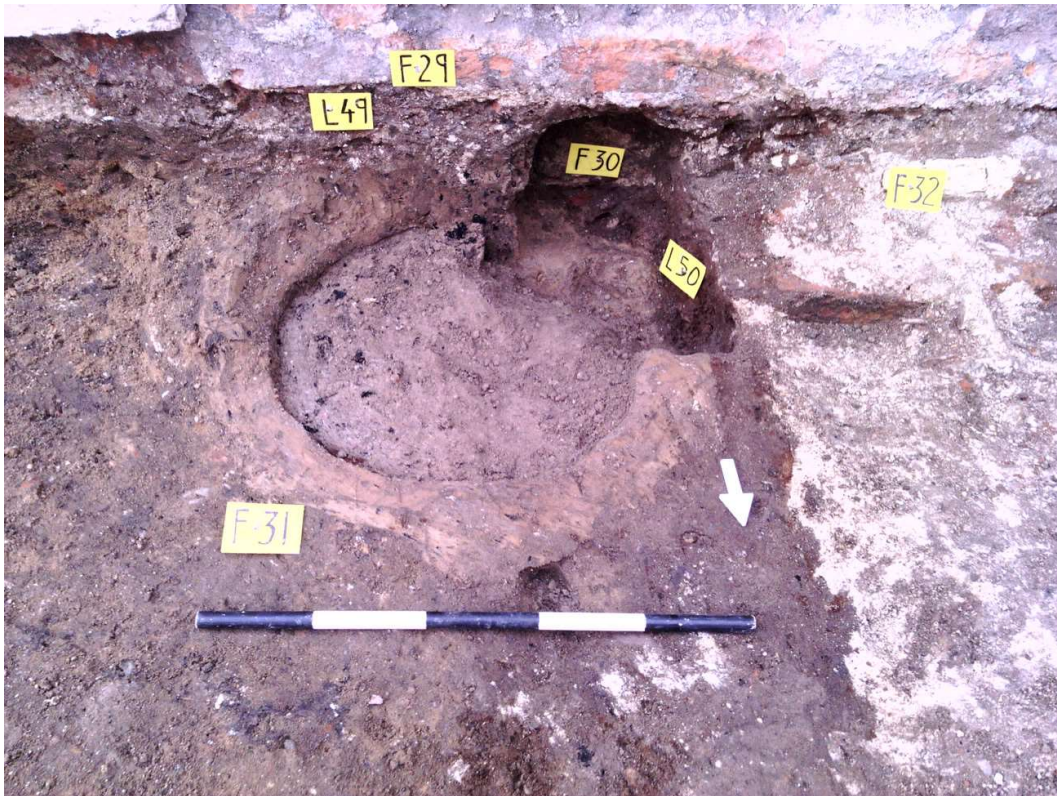
A brick sample taken from foundation F32 dated from the late 17th to the early 18th century, indicating that it may actually be contemporary with Rebow House, but the stratigraphy would suggest that it was earlier. Perhaps it was rebuilt or repaired in this later period. A piece of medieval pottery was also recovered from the surface of clay-lined pit F31, but as this feature was not excavated the precise date of this feature cannot be determined.

Photograph 10 Clay-lined pit F31 and wall foundation F32, looking south.

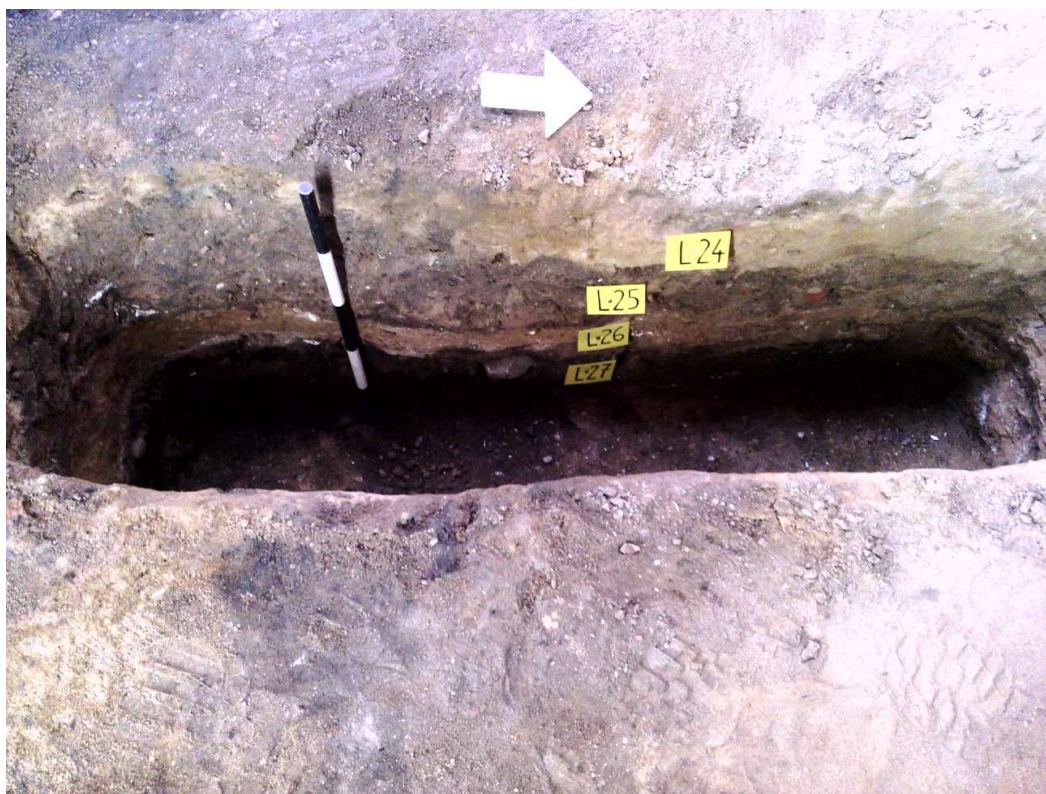
Photograph 11 Concrete sleeper pit 4 showing make-up/levelling layers L24-L27, looking west.

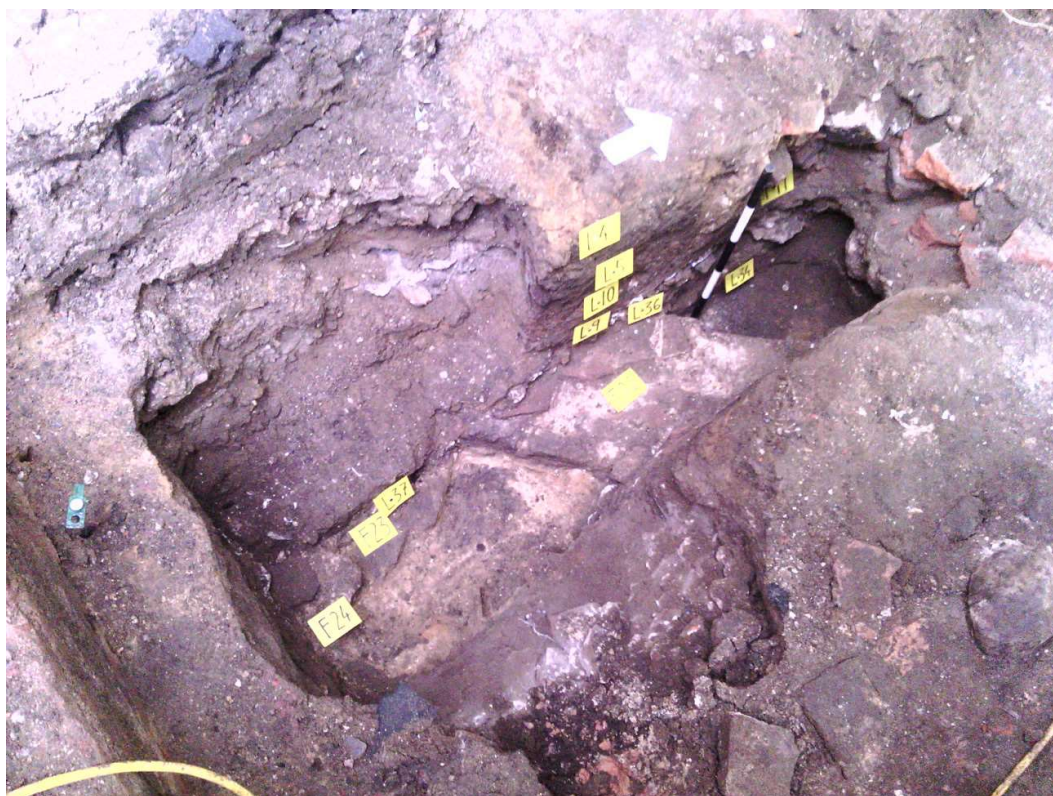
Photograph 12 Concrete sleeper pit 5 with wall foundation F22 and structural features F23 and F24, looking northwest.

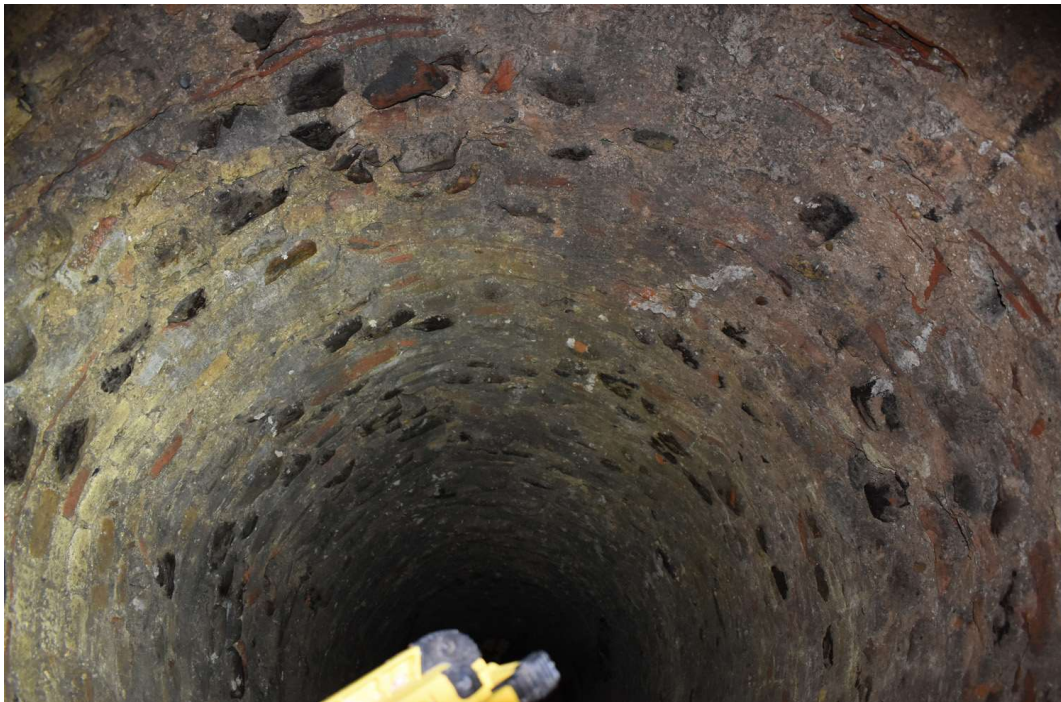
By the 17th century, the well had been sealed by a domed structure/cap (F13) made of brick/tile and concrete (set within construction cut F11). Rebow House, specifically walls F6/F7 and F42, were then constructed over the top of the well. This means that the well itself predates Rebow House. The well is located outside of the footprint of the medieval cellar but it is uncertain if the well is contemporary with the medieval building and unfortunately, due to the constraints of the groundworks, the relationship between the well and cellar wall (F85) could not be examined. Peg-tile in Essex was common from the 14th century onwards, and the inclusion of peg-tile within the structure of the well suggests that it could be contemporary with the medieval cellar, but could also conceivably be of 15th- or 16th-century construction.

Photograph 13 Inside the well.

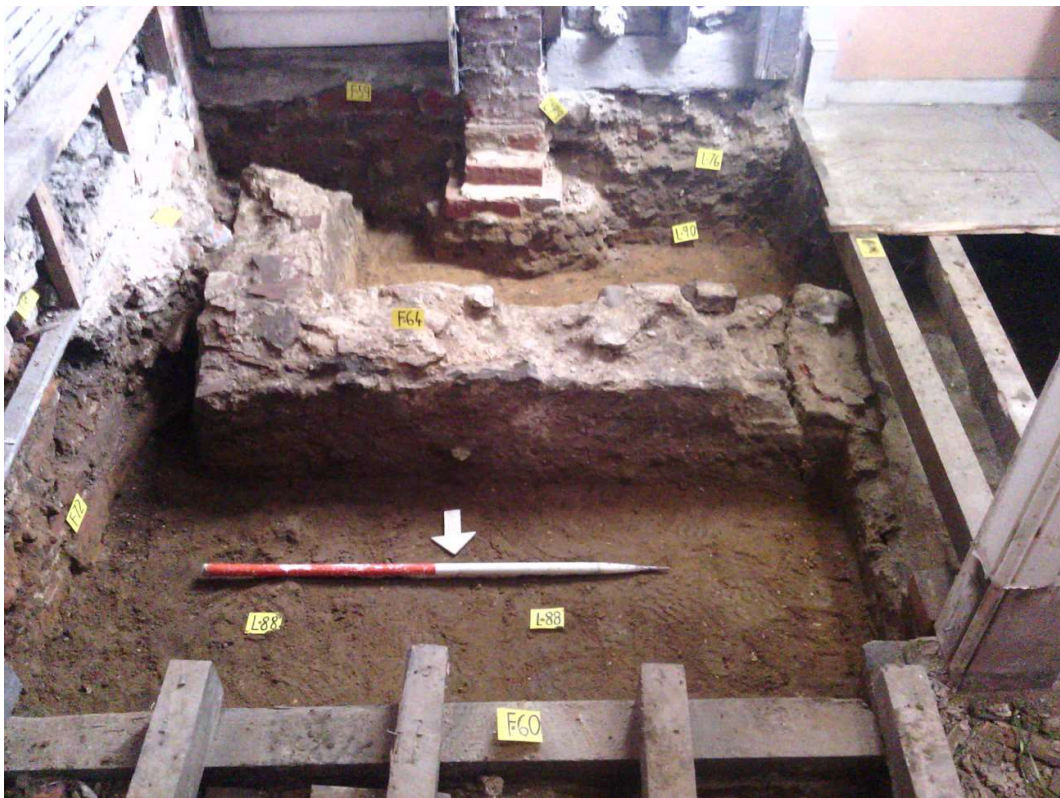
Beneath the modern floor layers, the lift pit was effectively divided into two by wall F64 (Photograph 14). This wall appears to be on the same alignment as a small cellar shown on modern architectural plans of the building (measuring 2.8m by 2.3m). The cellar is located underneath Rebow House and the 1897-1909 brick office range (see Fig 7) suggesting that it is earlier than both these buildings. Unfortunately it was not possible to access the cellar to investigate it properly. The cellar could be contemporary with the medieval cellar underneath the main part of Rebow House, but a similar cellar located to the east in the 1980s was dated from the 15th to 16th centuries (see discussion). There is, however, a possibility that wall F64 and the cellar shown on architectural plans are two separate features.

Photograph 14 The base of the lift pit showing cellar wall F64 and layers L88 and L90, looking south.

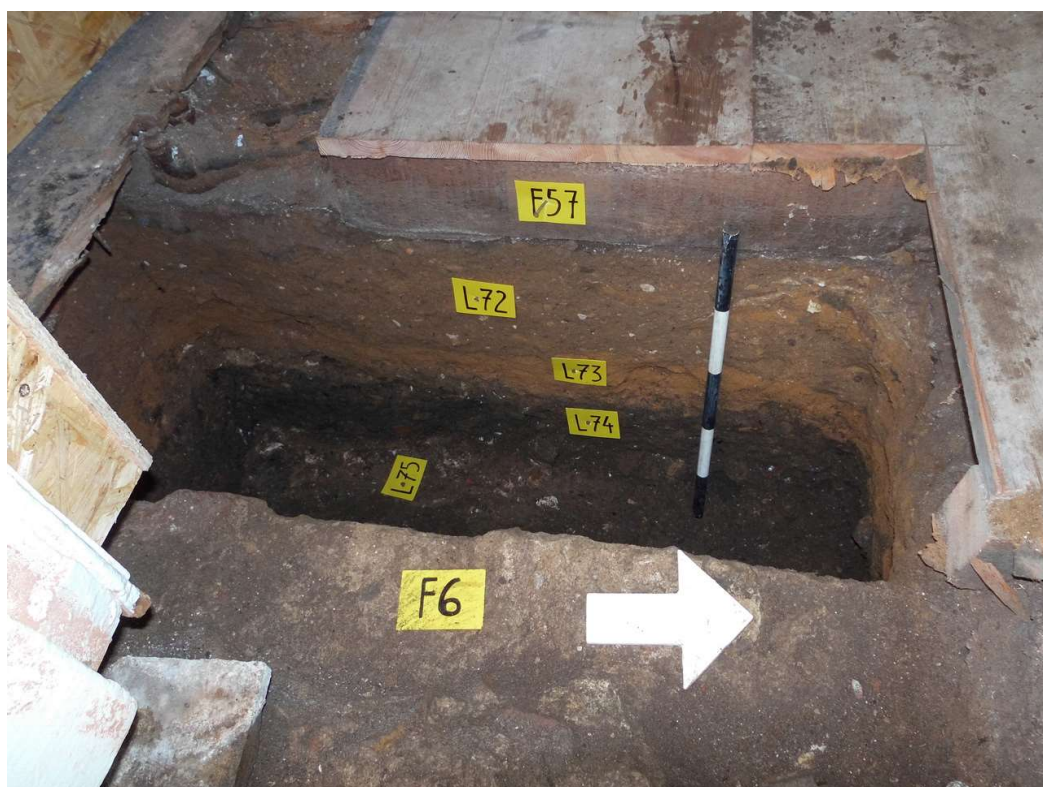
Service pit 1 was dug just inside Rebow House halfway along standing wall F6/F7. The pit was 0.9m long, 0.3m wide and dug to depth of 0.6m through the modern floorboards/joists (F57) into successive layers of probable make-up/accumulation/levelling (L72, L73, L74 & L75).

Photograph 15 Service pit 1 with layers L72-L75, looking west.

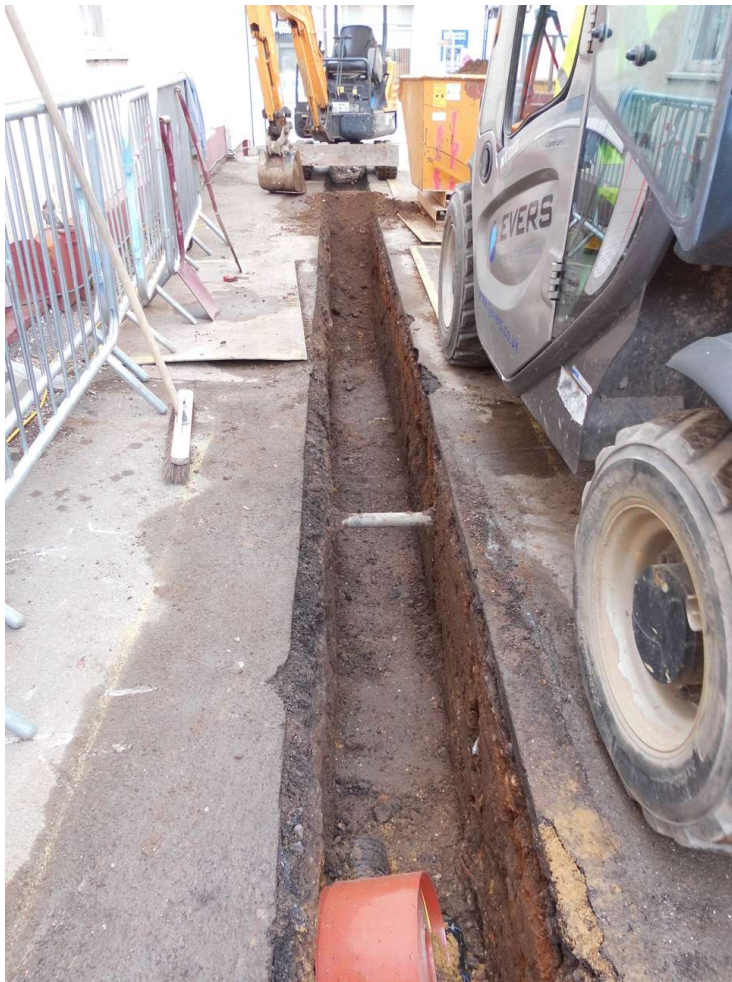
Photograph 16 The service trench in the access road, looking west.

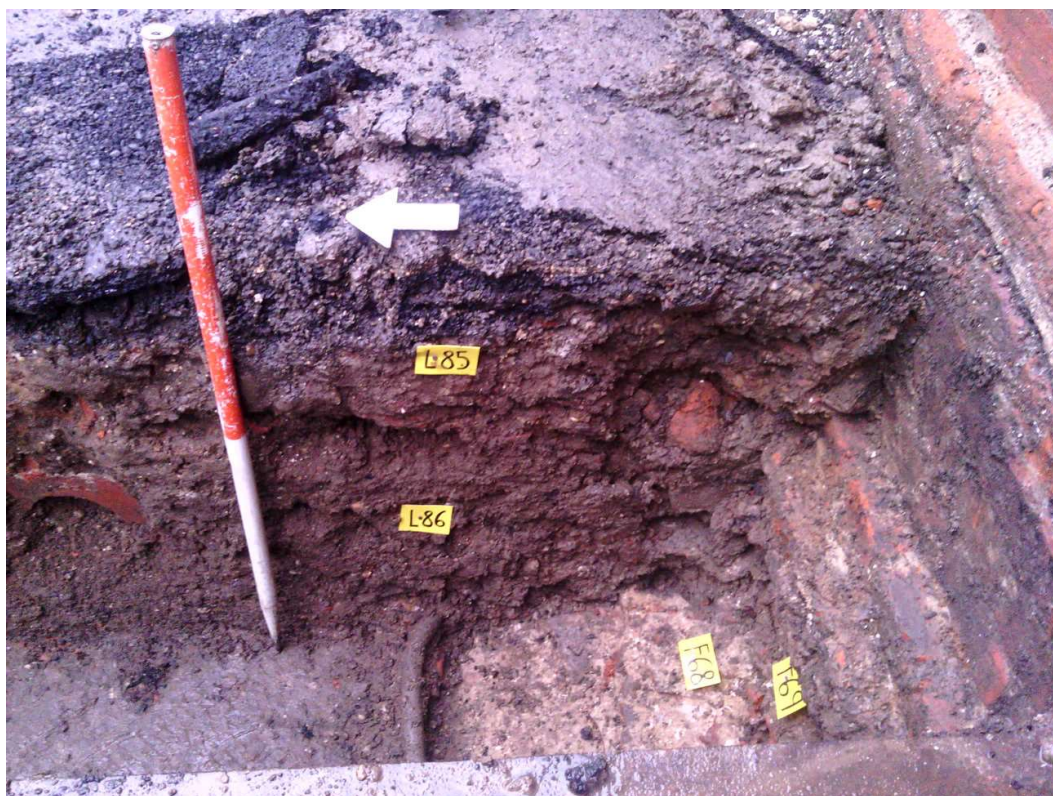
At the eastern end of the trench was a short section of wall foundation (F68) aligned north/south and made of peg-tile fragments and septaria pieces set in soft yellow/cream/brown mortar (Photograph 17). The wall foundation had been cut by the north wall of Rebow House (F69) so predates this building. A modern service trench (F81/L87) also cut F78/L86.

Photograph 17 Wall foundation F68 in the base of the service trench, looking east.

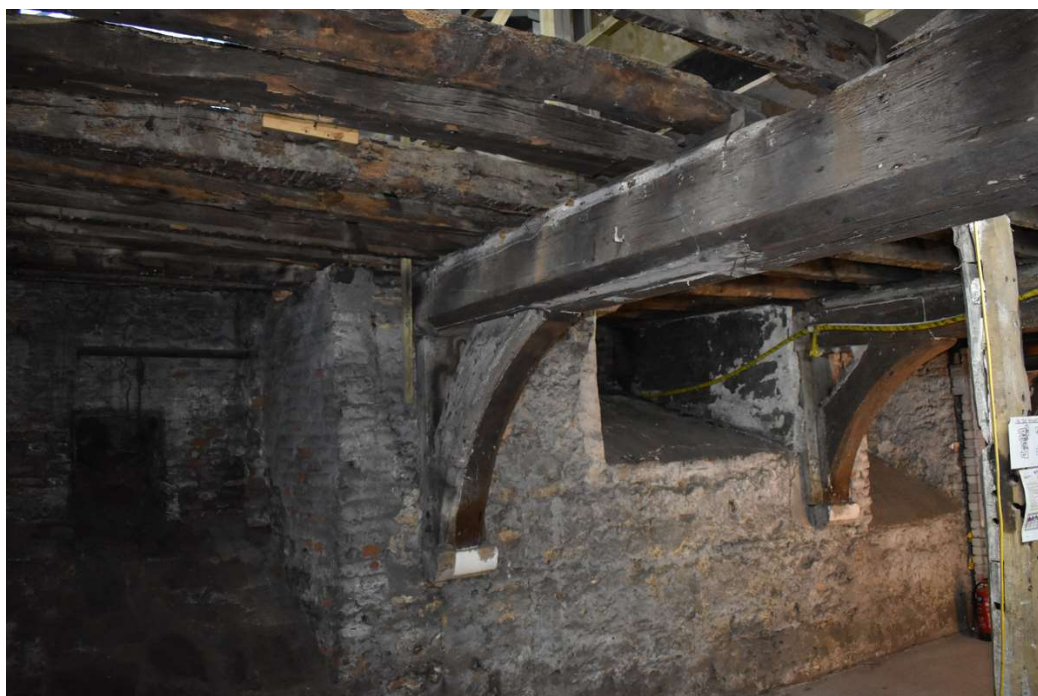
Photograph 18 Bay 1 of cellar, showing access chutes in western wall and arched-brace supporting binding-beam, looking northwest.

The cellar is 2.76m deep and its main section comprises five bays, each 2.8m wide (numbered 1-5 from south-to-north; Fig 12). The truss between each of these bays originally comprised a substantial binding-beam supported on equally substantial arched-braces, themselves sitting on corbels built into the wall of the cellar (Photograph 18).

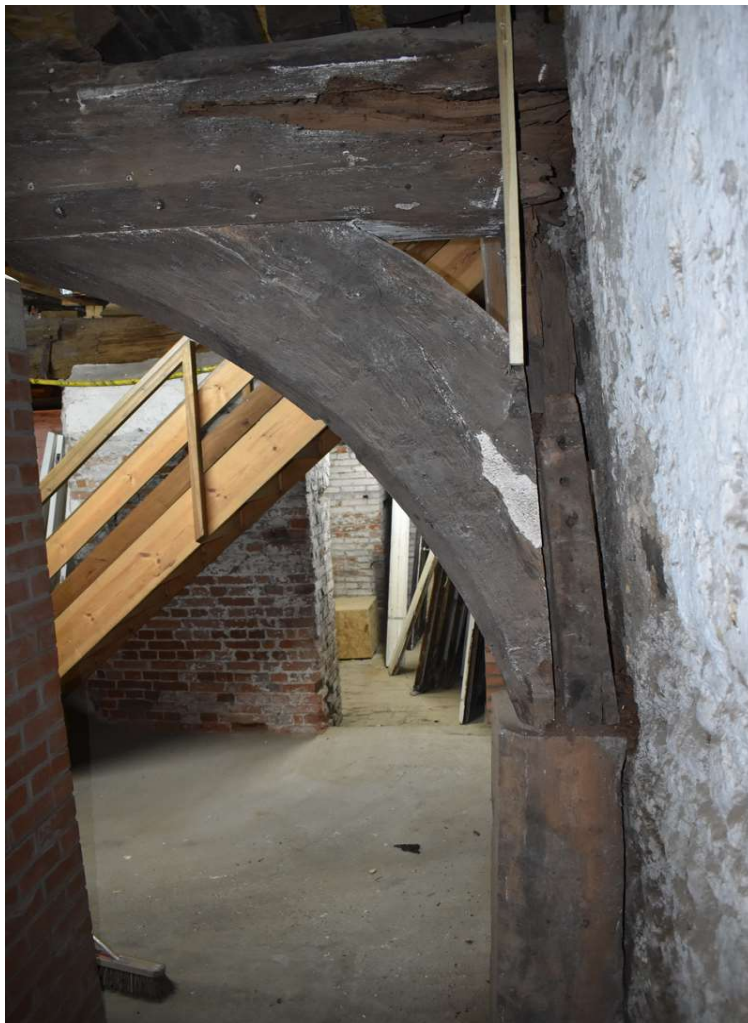
Photograph 19 Detail of eastern brace supporting binding-beam between bays 1 and 2, showing modern post support, looking north.

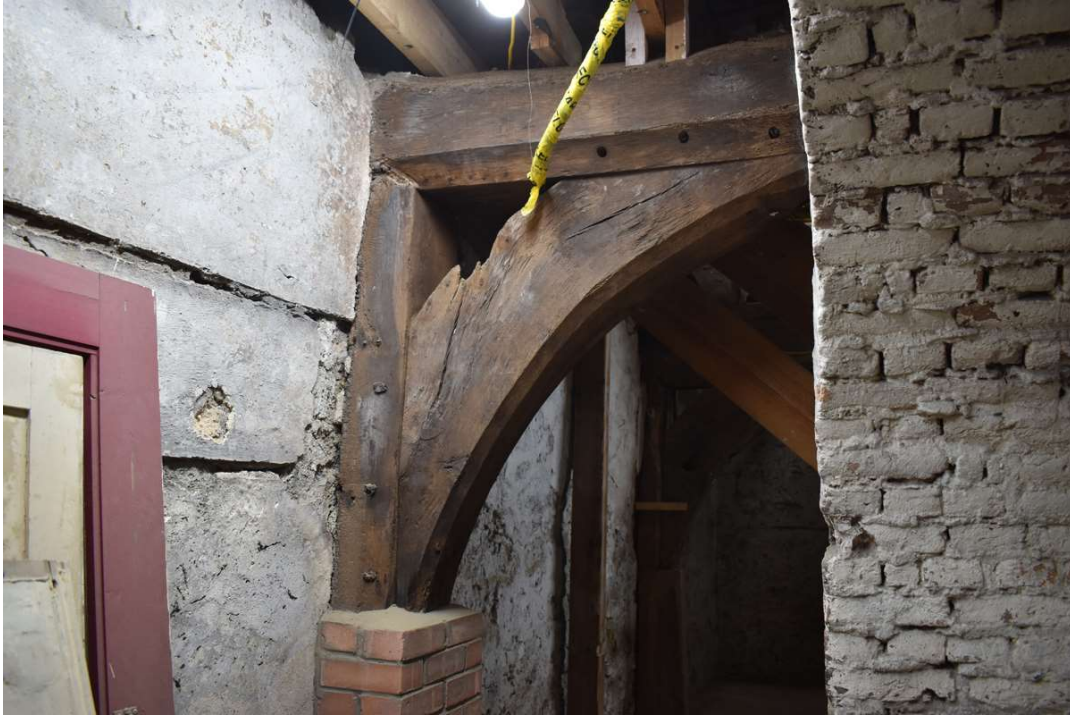
Photograph 20 Detail of arched-brace supporting eastern end of binding-beam between bays 2 and 3. Brick pillar visible below. Looking southeast.

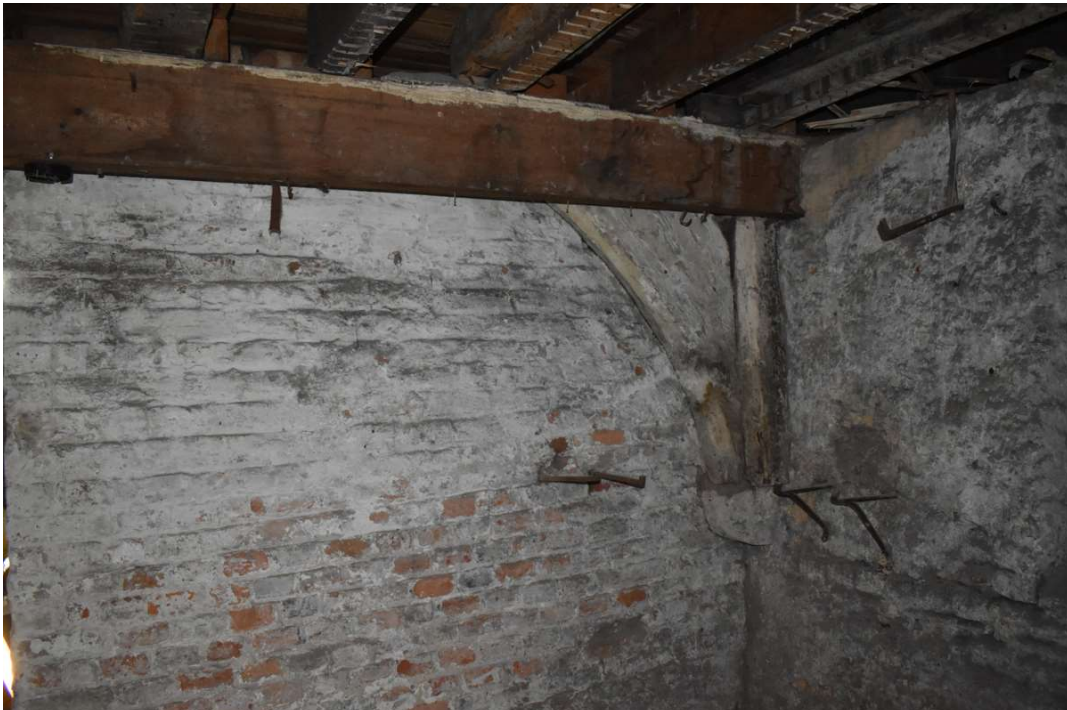
Photograph 21 Detail of western arched-brace between bays 3 and 4, showing original corbel, modern replacement binding-beam and 19th-century brick wall subdividing bays, looking southwest.

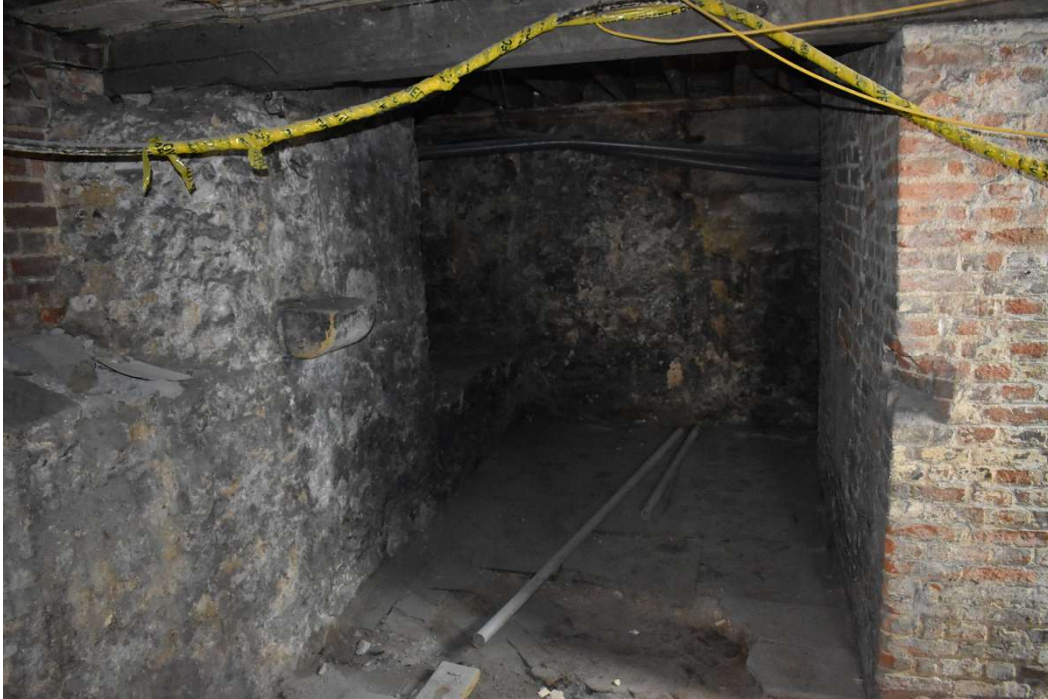
The northernmost truss, between bays 4 and 5, is completely absent, although the corbel that would have supported its western brace is still *in situ* (Photograph 22). The surviving original binding-beams are all identical; 400mm x 400mm in size and with concave chamfers, and the arched-braces are all 230mm thick.

Photograph 22 Bay 5, showing the corbel that would have supported the original truss. Inserted 17th-century brick arch to right, looking north.

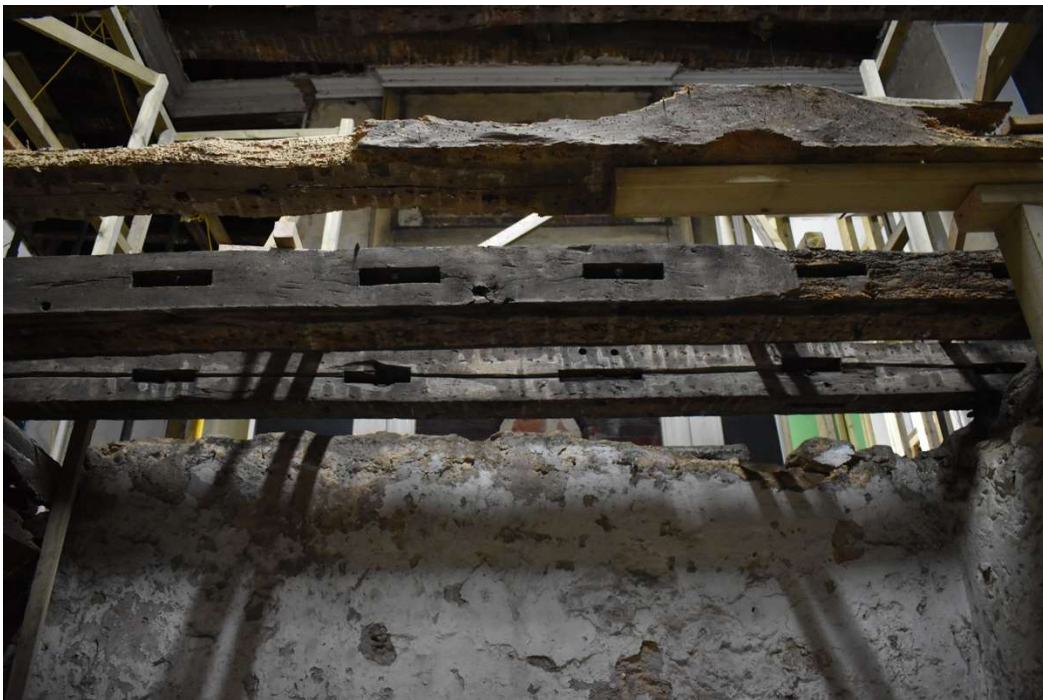
Sitting on the surviving binding-beams are joists supporting the floorboards of the rooms above (Photograph 23). In many areas (particularly above bays 4 and 5) these joists have been replaced with modern machine-cut timbers, but where they survive the earlier joists are all hand-sawn and have varying dimensions, although most appear roughly square. In addition, many of the earlier joists have evidence of re-use, in the form of empty mortices (Photograph 23).

Photograph 23 Example of re-used joists above bay 1, looking east.

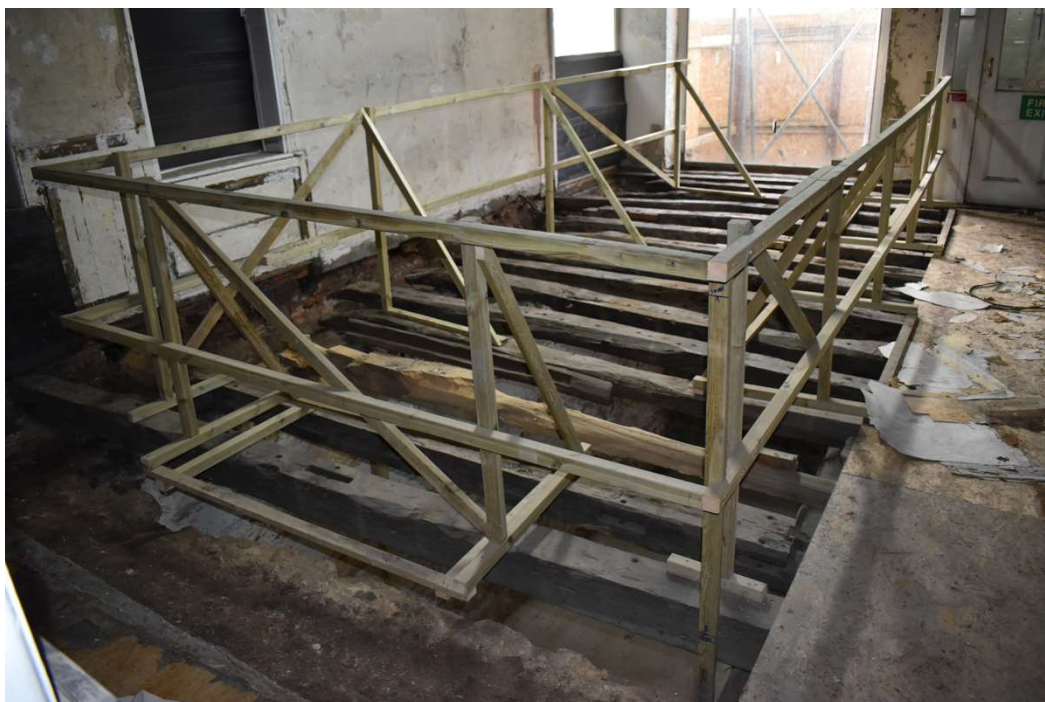
Photograph 24 Section of exposed joists above bay 1 after removal of floorboards, looking southwest.

The removal of the floor above bay 1 allowed for the detailed examination of the joists suspended above the cellar in this location (Photograph 24). All the joists were hand-sawn and, like the joists elsewhere in the cellar, varied substantially in their dimensions, with their width measuring between 150-250mm and their depth between 80-185mm. Some of the joists were remarkably sinuous (Photograph 25) and a number of them contained significant evidence of re-use in the form of empty mortices, peg-holes and tenons. As has been previously noted (Alston 2016), these joists sit on top of the cellar's binding-beams, and are not jointed into them. In fact, close examination, made possible after the removal of the floorboards, showed several of the joists to be suspended above the southernmost binding-beam by smaller 'cut-off' pieces of timber, presumably put in place order to ensure the joists, with their varying dimensions, were all at the same level (Photograph 27). Also visible upon close examination were a series of shallow indentations on the upper face of the binding-beam, within which the original joists would have presumably sat (Photograph 27). None of the observed joists projected into bay 2; they were all cut short at their northern end and abutted against bay 2's joists (Photograph 27). At their southern end the joists sat on a hand-sawn and partially degraded beam that was embedded into the fabric of the cellar's southern wall (Photograph 26). Additionally, several of the joists projected beyond the southern wall of the cellar, abutting against the southern wall of the current building (Photograph 26).

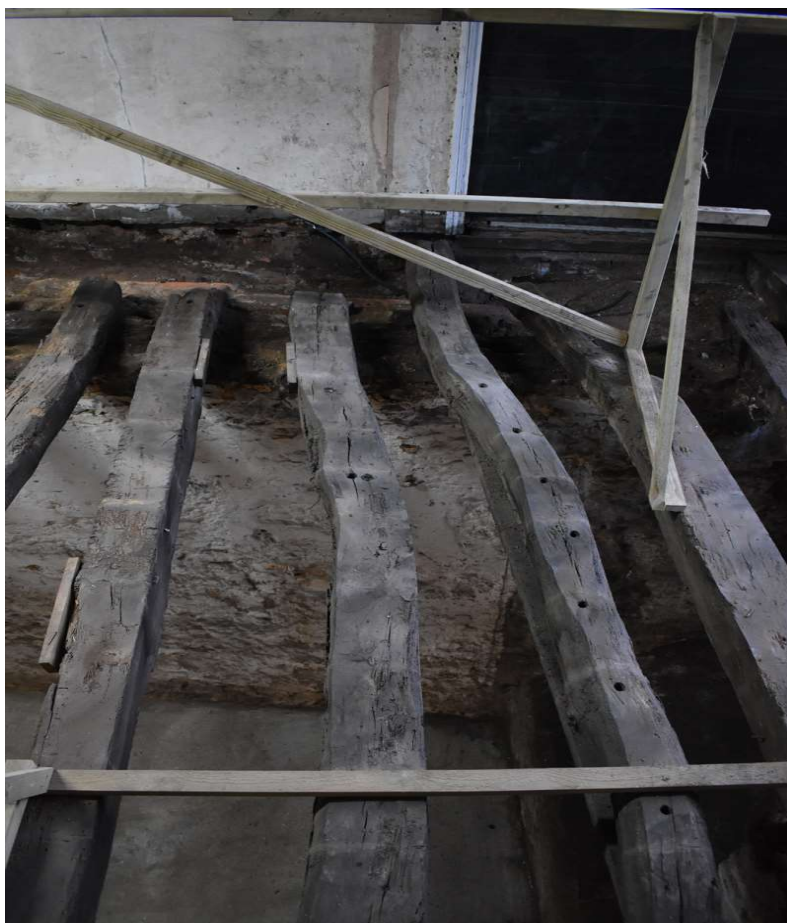
Photograph 25 Detail of sinuous joists above bay 1, looking south.
