Archaeological monitoring and a historic building record of the medieval cellar at Rebow House, 58-62 Head Street, Colchester, Essex, CO1 1PB

October 2019 – February 2020

CAT Report 1530

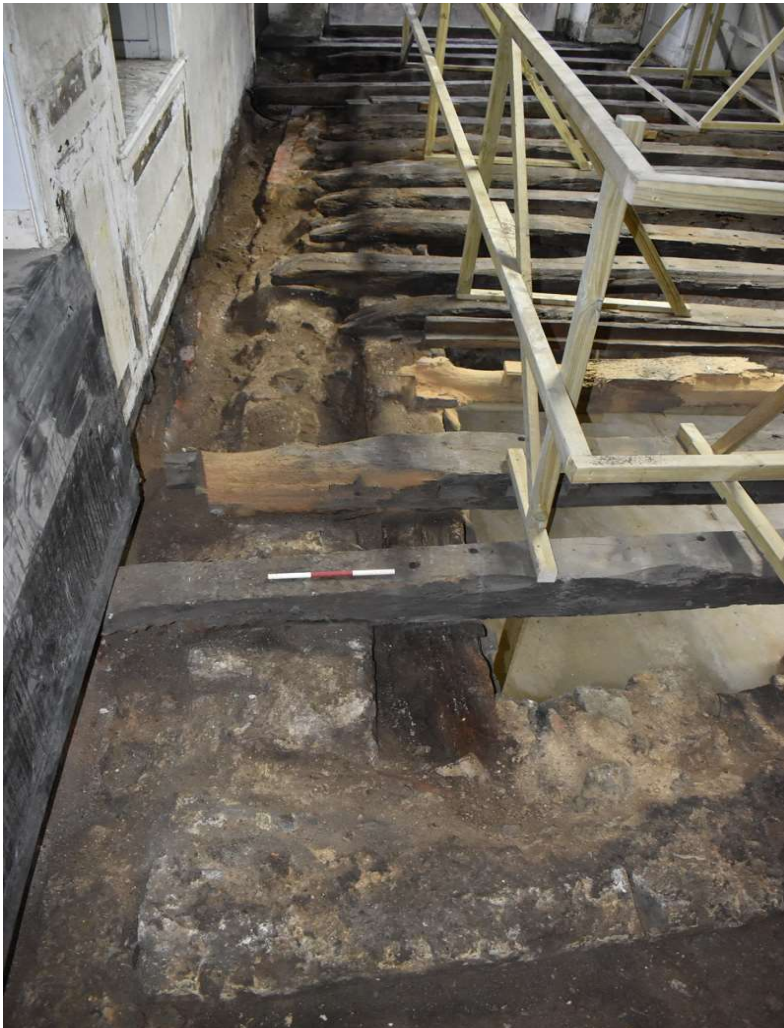
Photograph 26 Beam inserted into cellar wall supporting joists above bay 1, looking west.

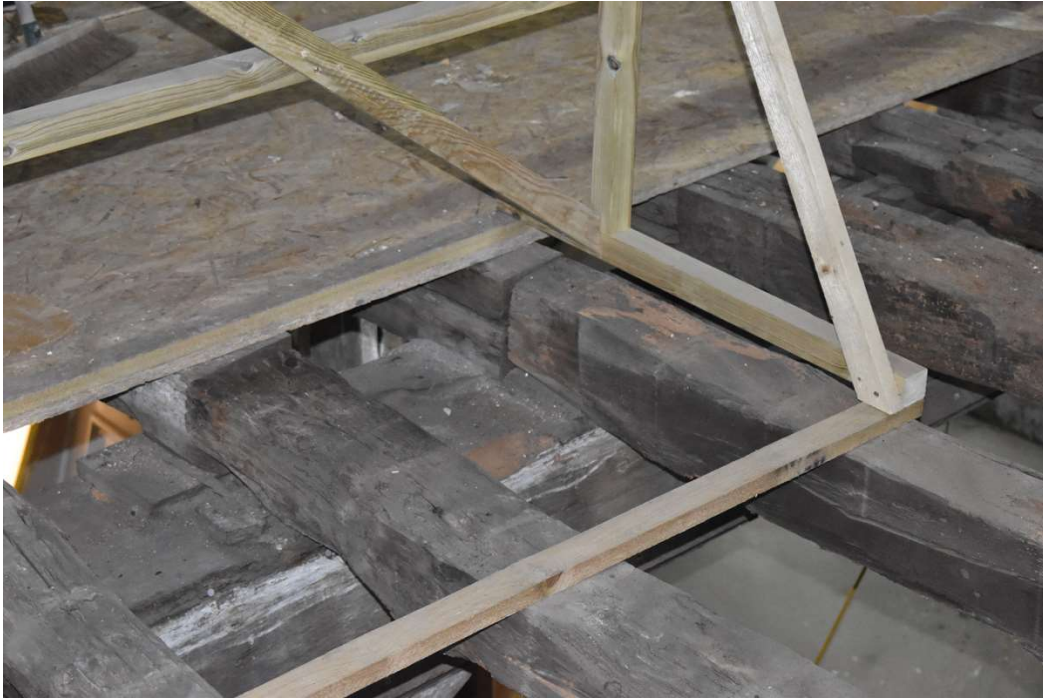
Photograph 27 Detail of abutting joists sitting on the binding-beam between bays 1 and 2. Slight depressions in binding-beam for original joists visible, looking northeast.

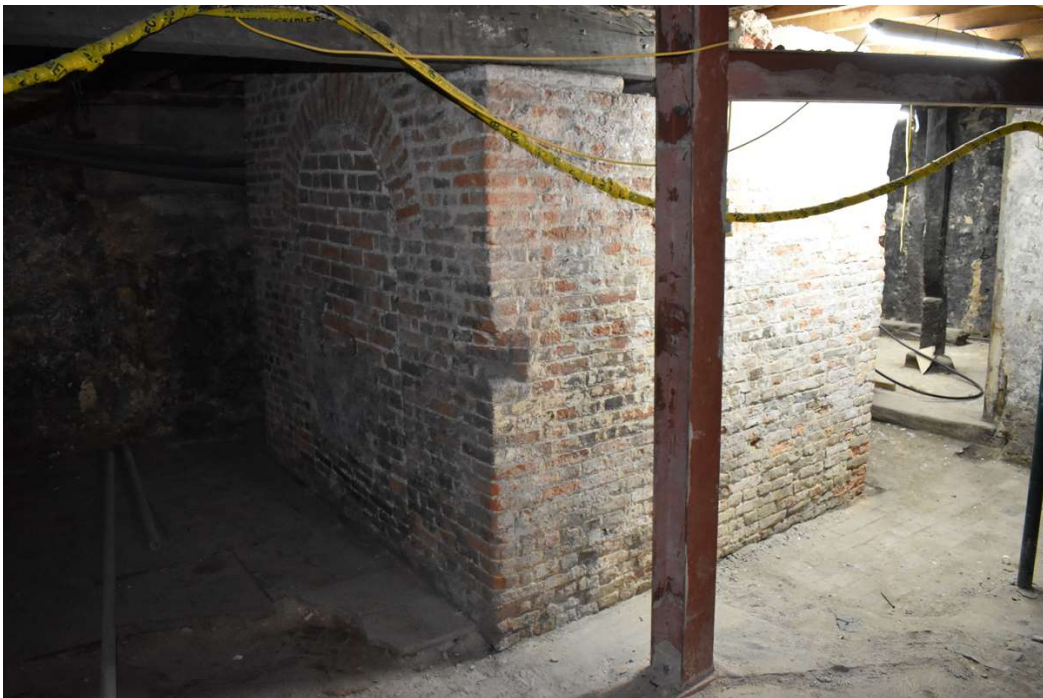
Photograph 28 Brick arch in bay 5. Blocked northern archway visible. Looking northeast.

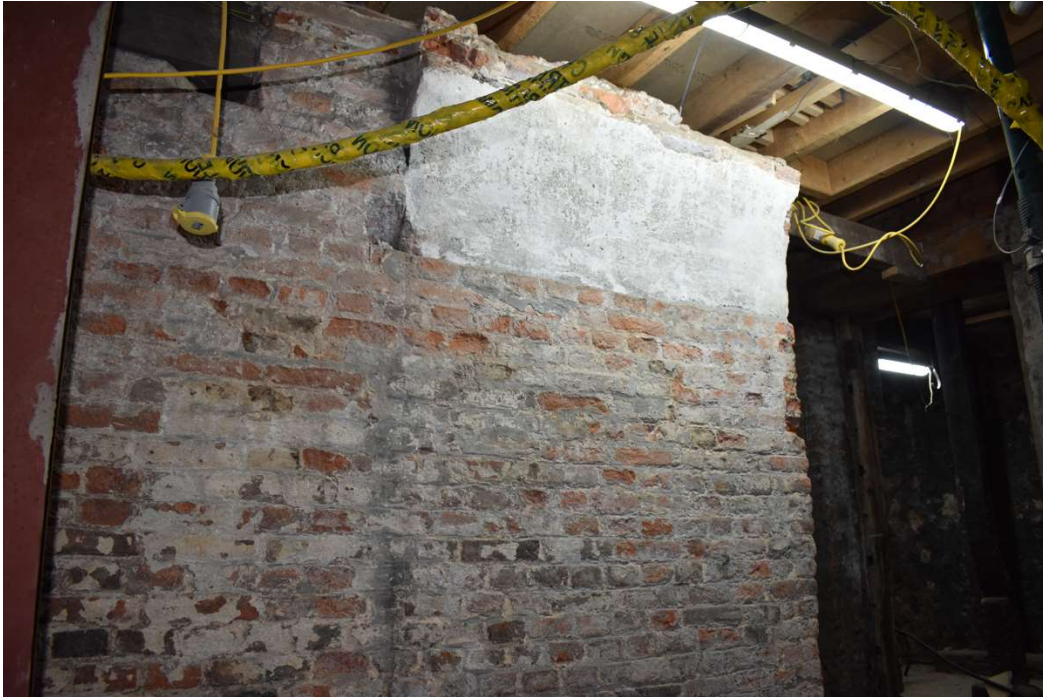
Of note is that it appears the curve of other, since removed, arches are visible projecting from the sides of the surviving brickwork in both bays, suggesting that at some point the arches were connected and the cellar had several more brick arches supporting the floor above (Photographs 29 and 30).

Photograph 29 Partial brick arch projecting off south of brick arch in bay 5, looking northeast.

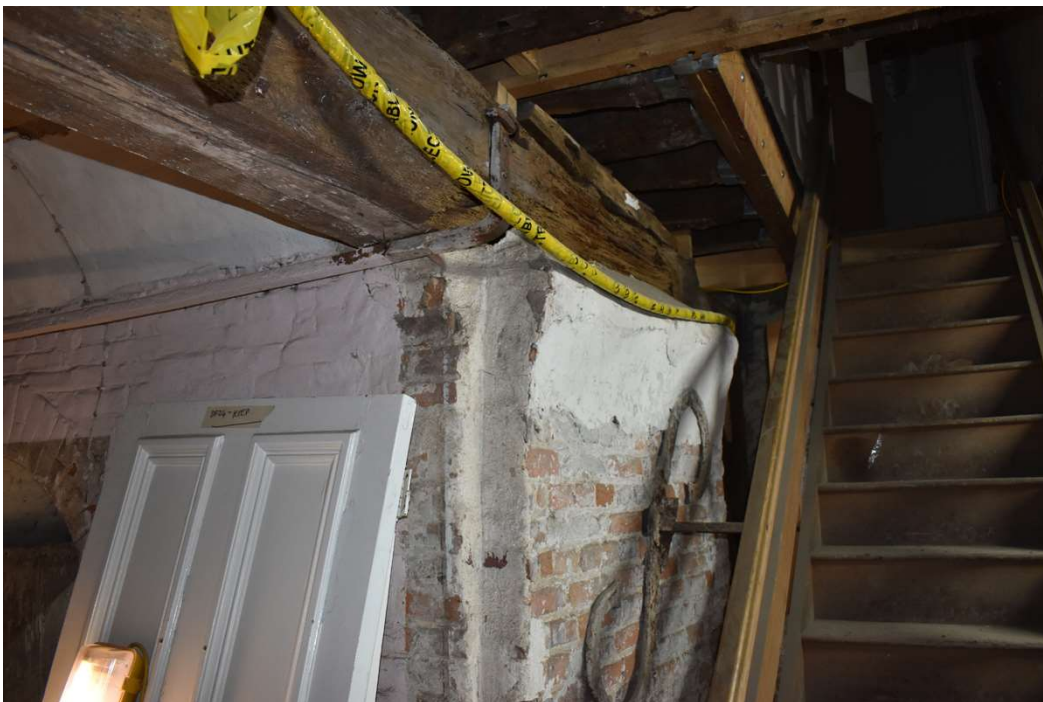
Photograph 30 Start of brick arch projecting off south of brick arch in bay 3, looking northeast.

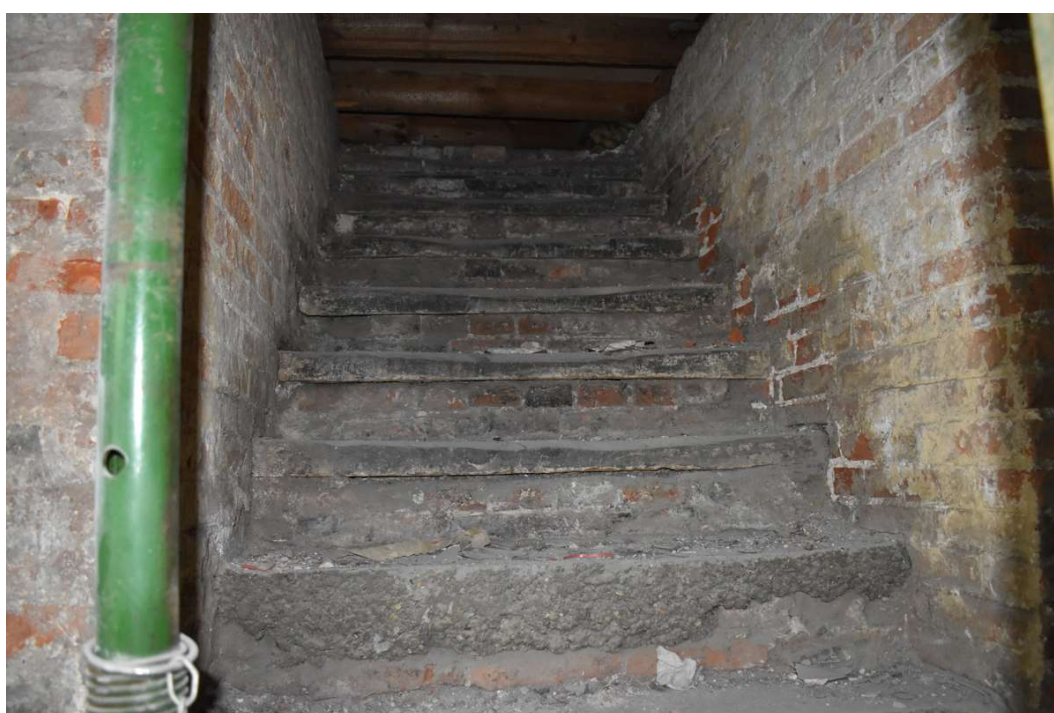
The current access into the cellar is via two modern staircases (Fig 12). Bay 4 contains a brick-built staircase on its eastern wall that is suspended 1.2m above the floor of the cellar (Photograph 31). Presumably when this staircase was in use the lower half of it would have been constructed of timber. These stairs have surviving wooden treads that show significant wear, although one step has had its tread replaced with concrete (Photograph 31). The brickwork of the staircase is laid in English-bond with brick measurements of 220mm x 100mm x 55mm, very similar to the 17th-century brick arches in bays 3 and 5 (see above). Like the arches, the staircase appears to have been inserted into the cellar when the 17th-century house was constructed above. Prior to the installation of this staircase the cellar would have presumably been accessed via a trapdoor and ladder, of which no trace survives.

Photograph 31 Inserted brick staircase in eastern wall of bay 4, looking east.

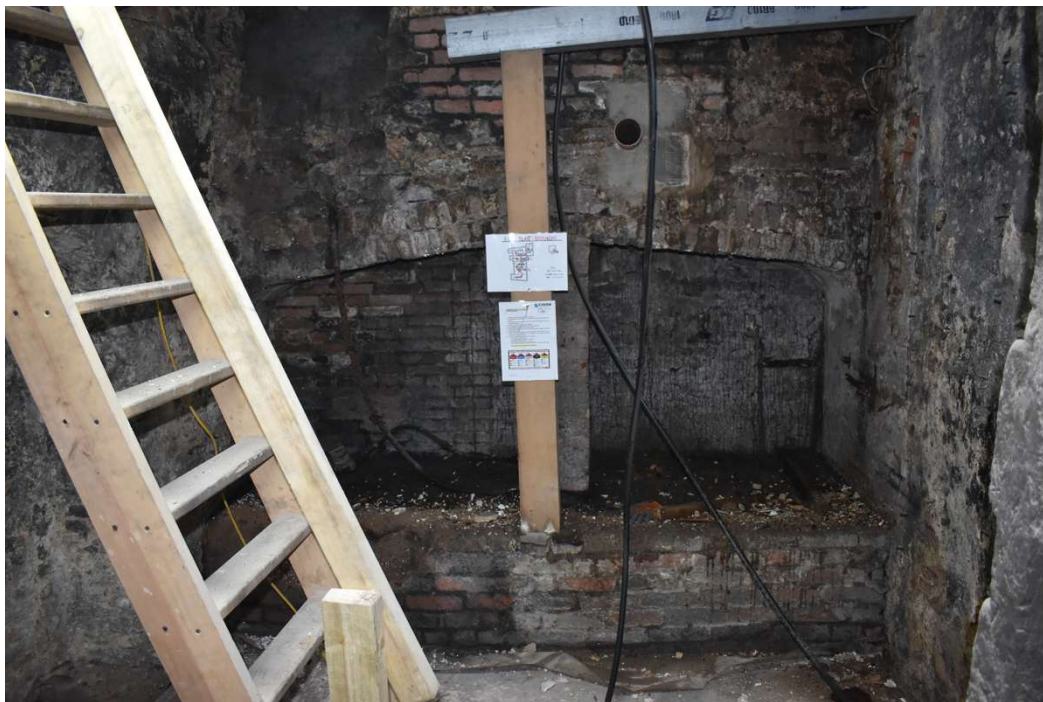
More than any other section of the cellar, this bay has been altered significantly since its initial construction. Most recently, the northern wall has been entirely infilled by an arched alcove constructed of modern brick (Photograph 32). The west wall of this bay contains a large amount of 17th-century brickwork within another alcove, with little remaining of the original fabric of mortar and flint-rubble. The brickwork within this alcove has evidence of burning, and probably is the location of an oven, cooking-range or similar feature (Photograph 33).

Photograph 32 Modern brickwork alcove in northern wall of bay 6, looking north.

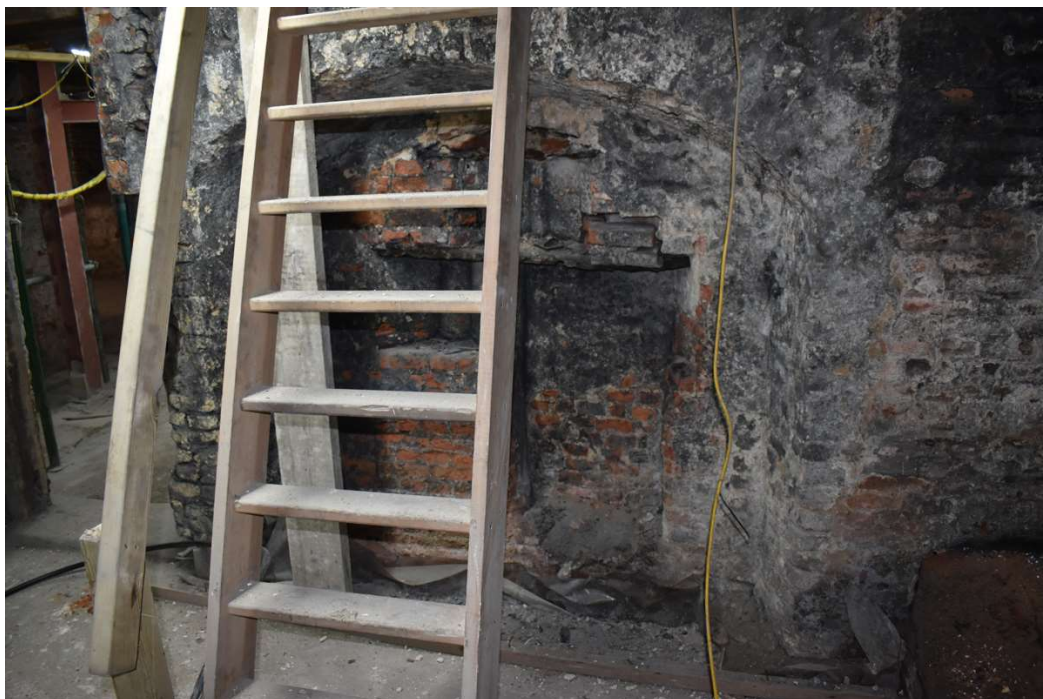
Photograph 33 Inserted 17th-century brick ?cooking-range in western wall of bay 6, looking southwest

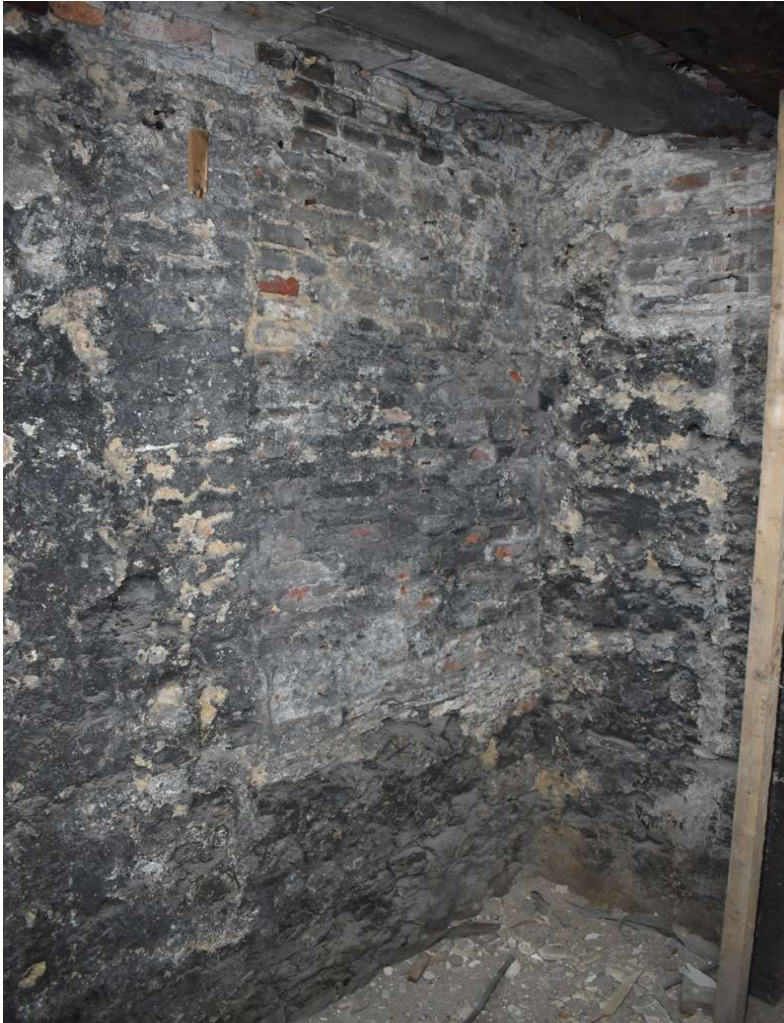
The eastern and southern walls of bay 6 both have areas of 17th-century brickwork, and on the eastern wall specifically the section of brickwork seems to indicate the presence of a blocked entranceway (Photograph 34), perhaps indicating that originally the cellar extended even further to the east (Fig 12).

Photograph 34 Detail of brickwork in eastern wall of bay 6, possibly indicating the location of a blocked entranceway into another part of the cellar, looking southeast.

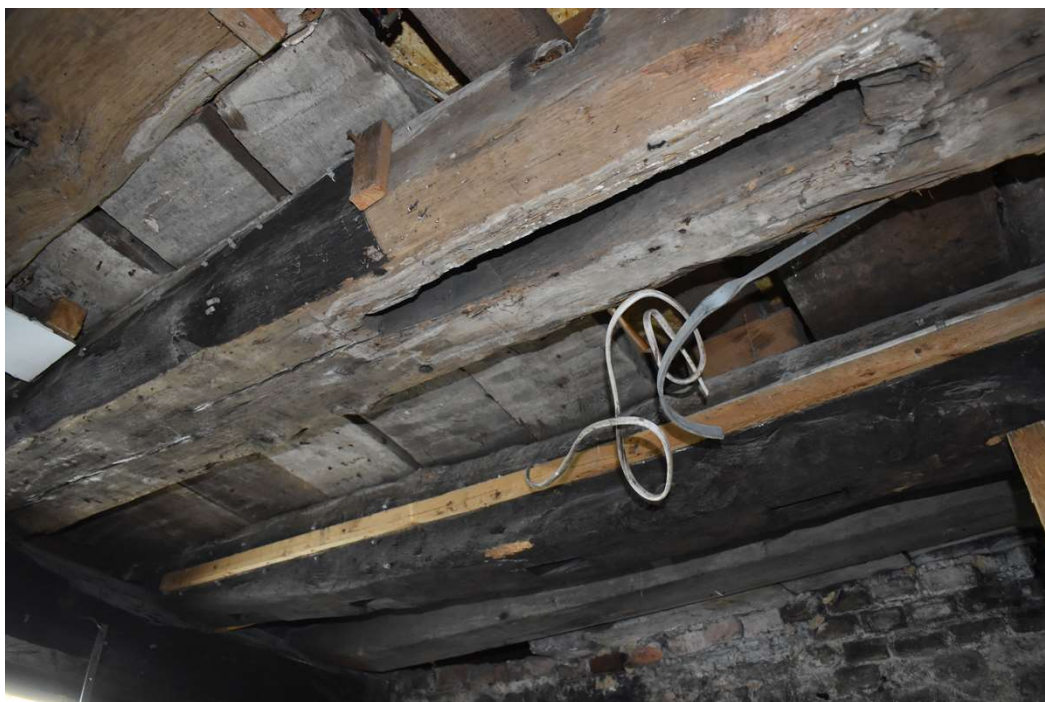
The binding-beam in this bay is probably a later insertion, but several of the joists for the floor above have mortices on their underside, indicating, like several other joists in the cellar, that they are re-used from an earlier structure. Also visible above the joists are several substantial floorboards that may be original to the 17th-century building above (Photograph 35).

Photograph 35 Detail of re-used joists above bay 6, with wide floorboards visible, looking northeast.

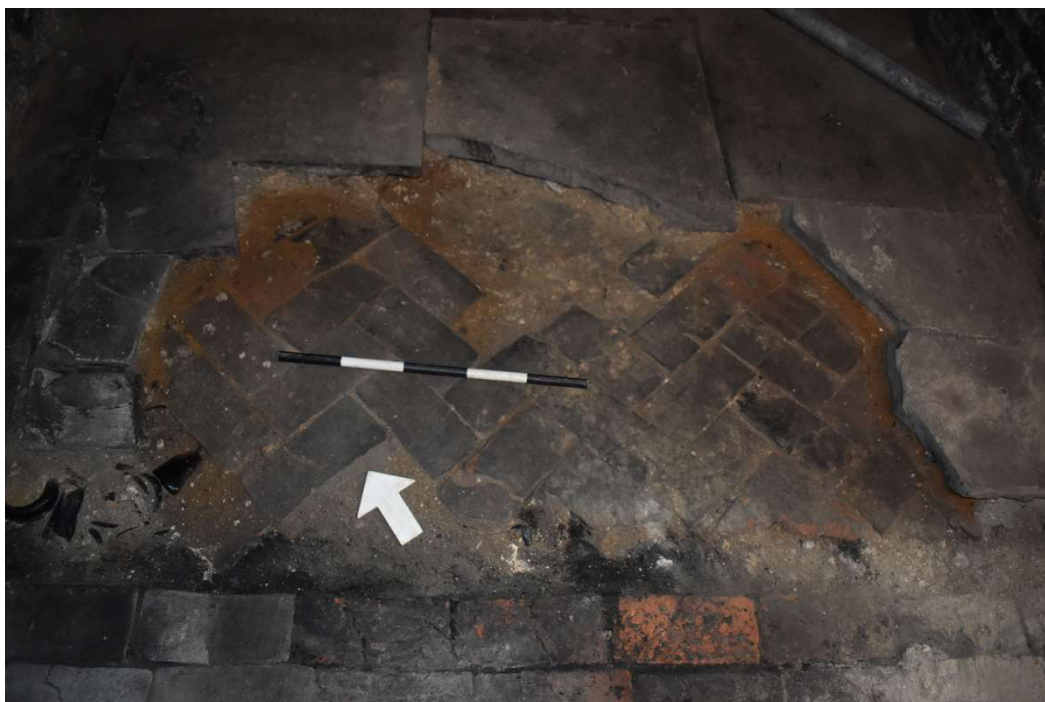
Most of the floor of the cellar is covered in concrete screed, but in some areas earlier flooring materials have survived (Fig 12). Bay 5 has an area of pavior bricks laid in a herringbone pattern, themselves beneath flagstones (Photograph 36). Beneath the brick arch in bay 3 another section of pavior brick floor survives, which also contains some re-used medieval floor tiles (Photograph 37).

Photograph 36 Herringbone pavior brickwork beneath flagstones in bay 5, looking north.

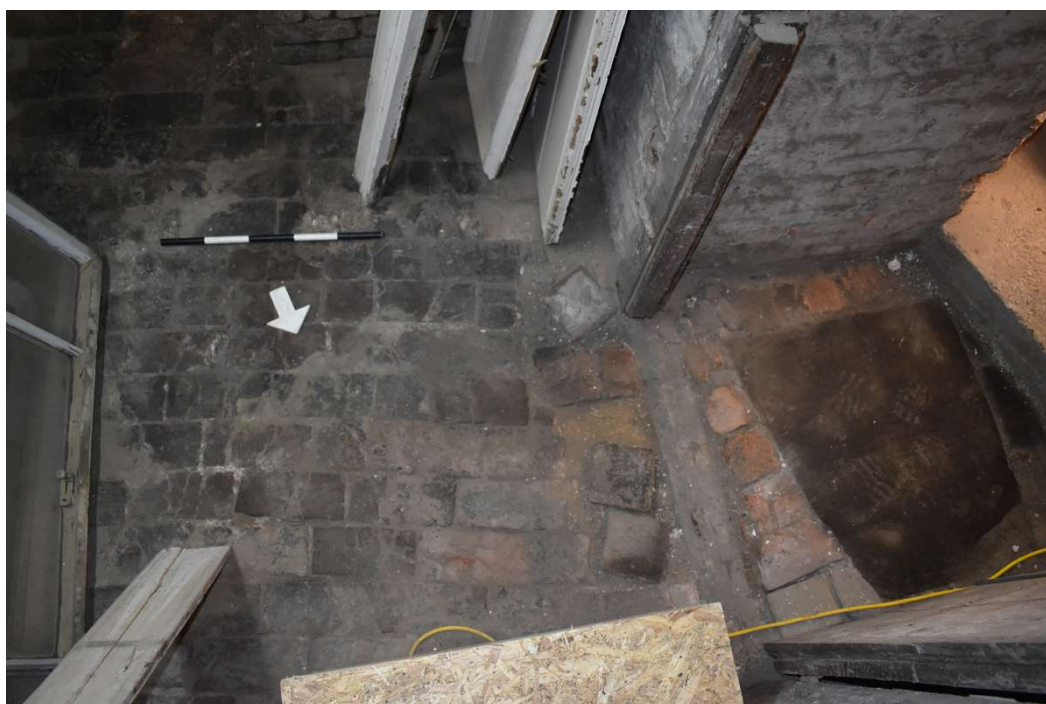
Photograph 37 Pavior brickwork in bay 3, including some medieval floor tiles, looking south.

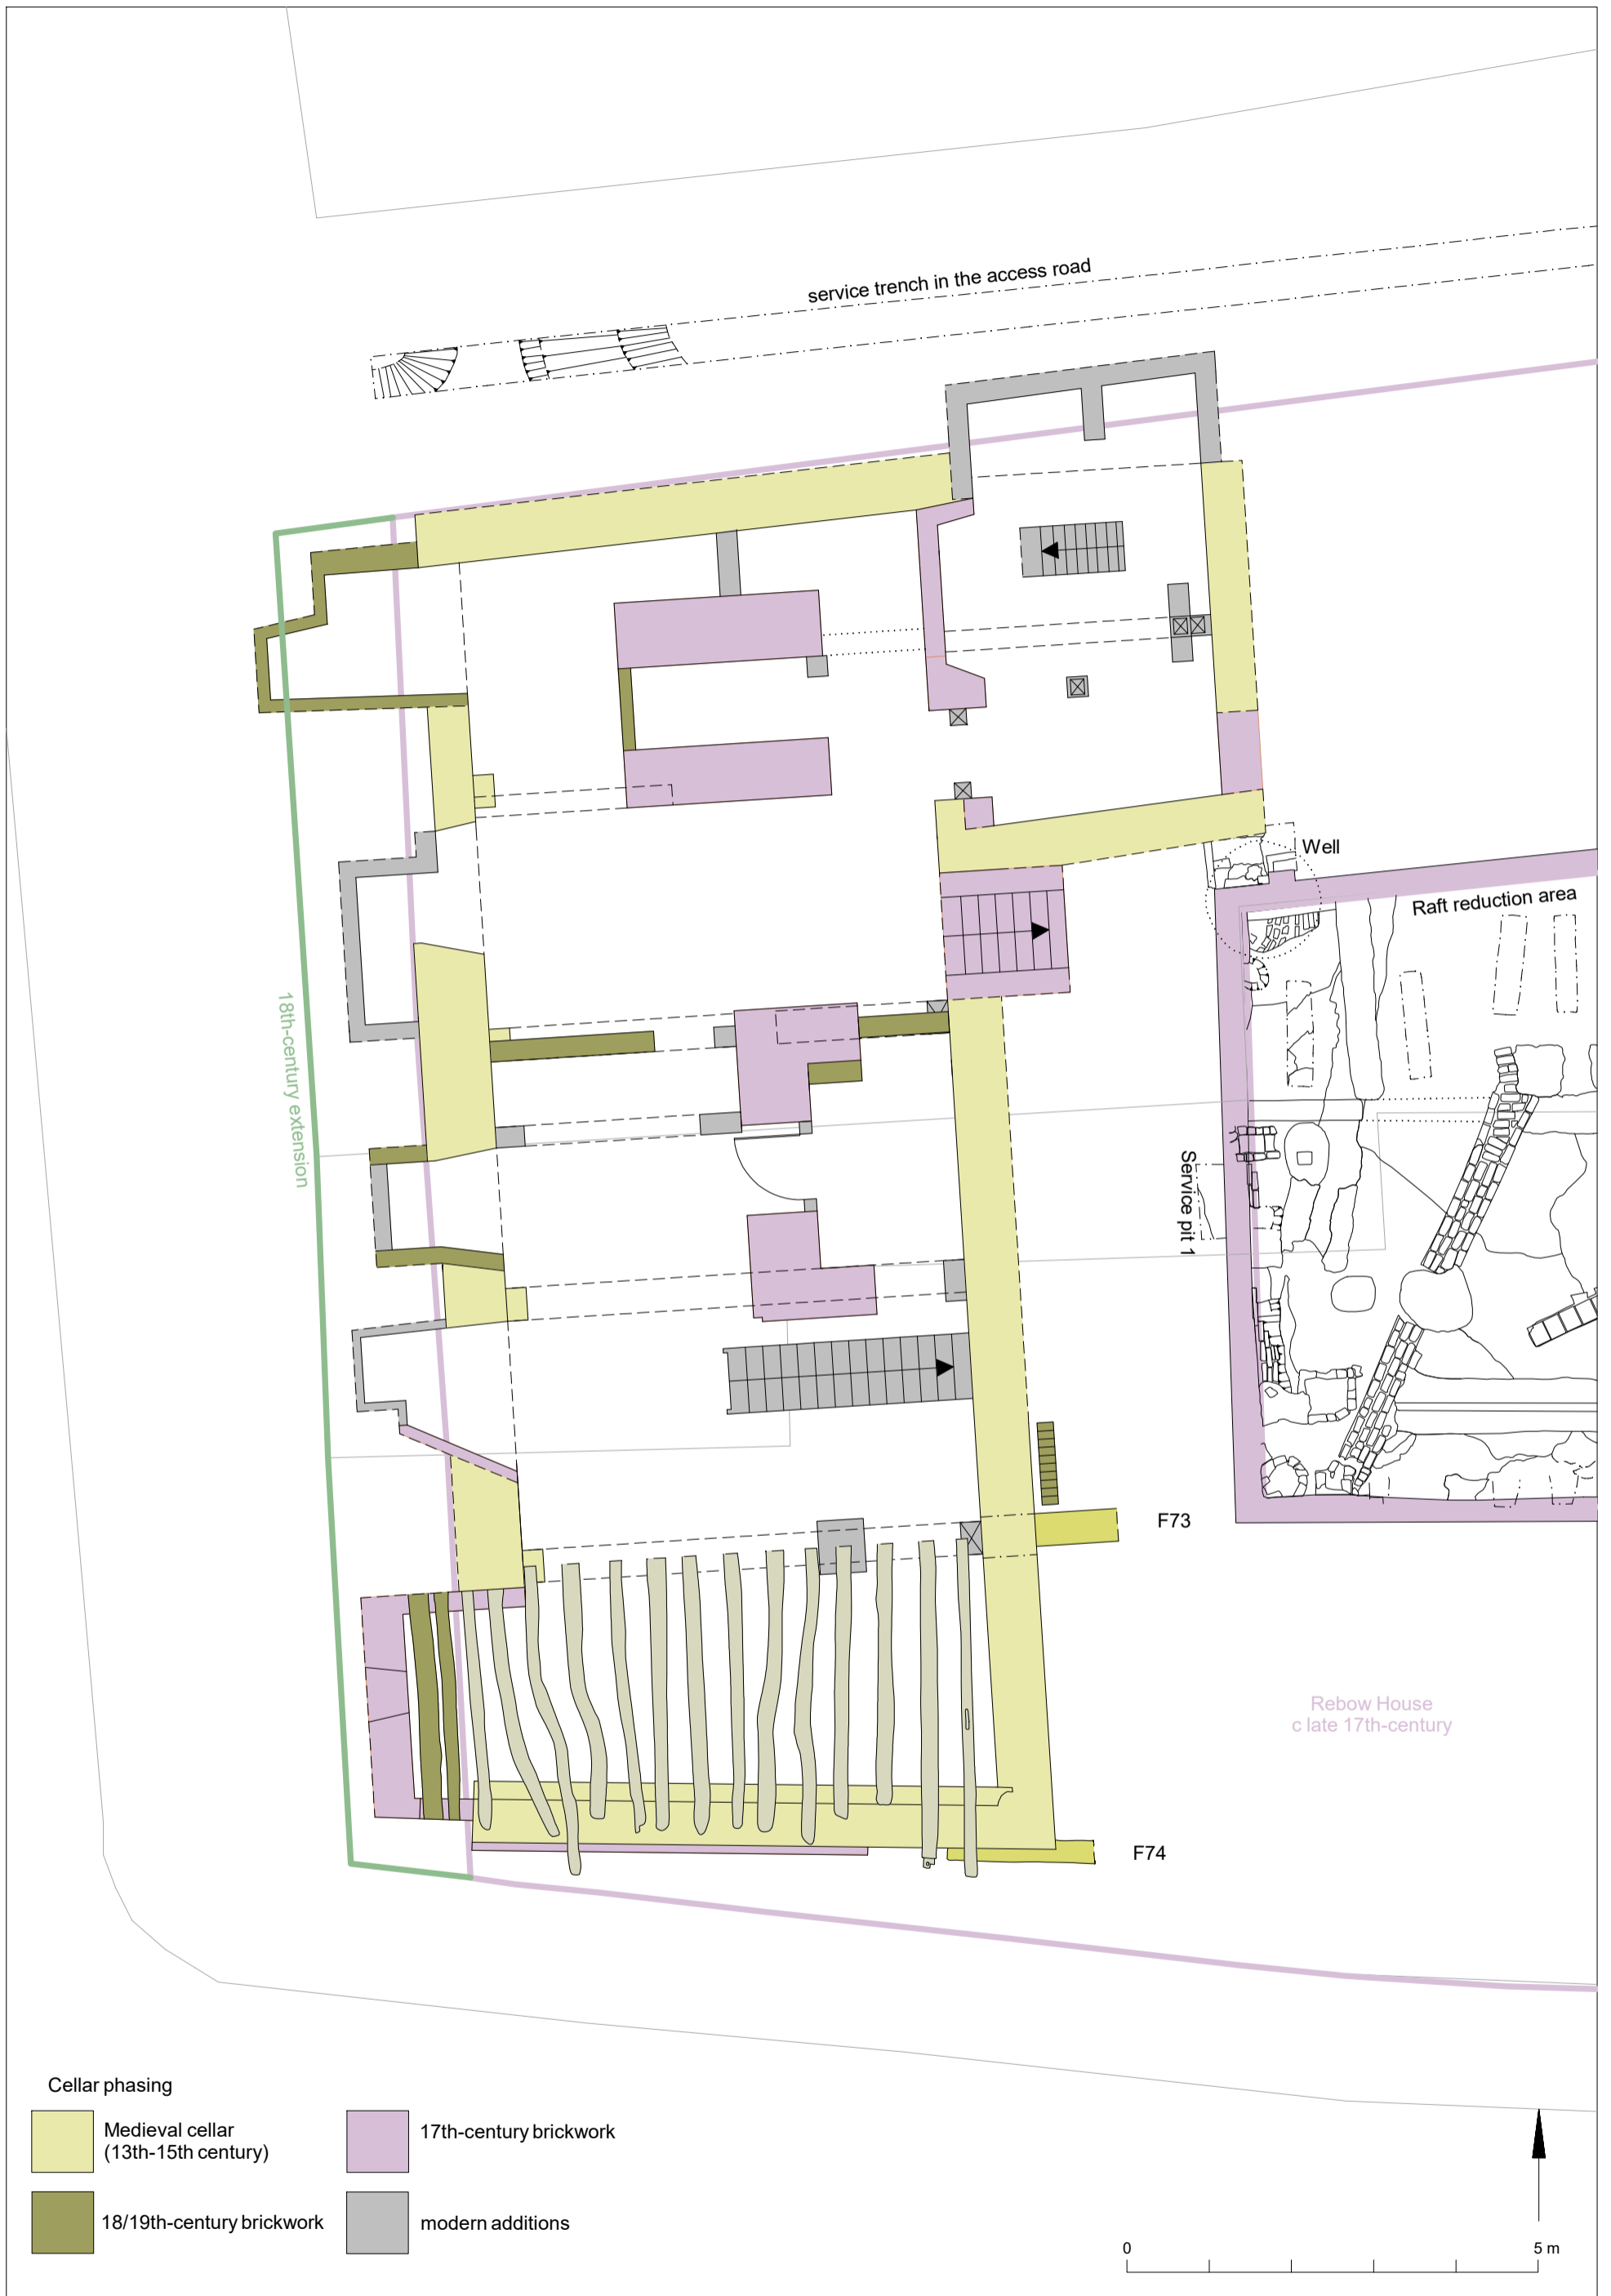
Fig 11 Plan of the medieval cellar plus wall foundations F73 & F74 (see Fig 12 for further details)

Wall foundation F73 was constructed of septaria and very occasional peg-tile fragments in a hard beige/brownish-grey mortar. It was approximately 1m long, 0.3m wide and, orientated east/west, was in line with the cellar roof beam. Wall foundation F74 was recorded butting against the southeastern corner of the cellar. Constructed of flints and rounded pebbles with peg-tile fragments in a hard pale brown mortar, it was 1.8m long and 0.2-0.3m wide. Both foundations could be associated with the medieval cellar and its associated above ground structure. However, unlike the cellar walls, F73 included pieces of septaria in its construction and F74 was a later addition as it was possible to see where it had been joined onto the cellar wall.

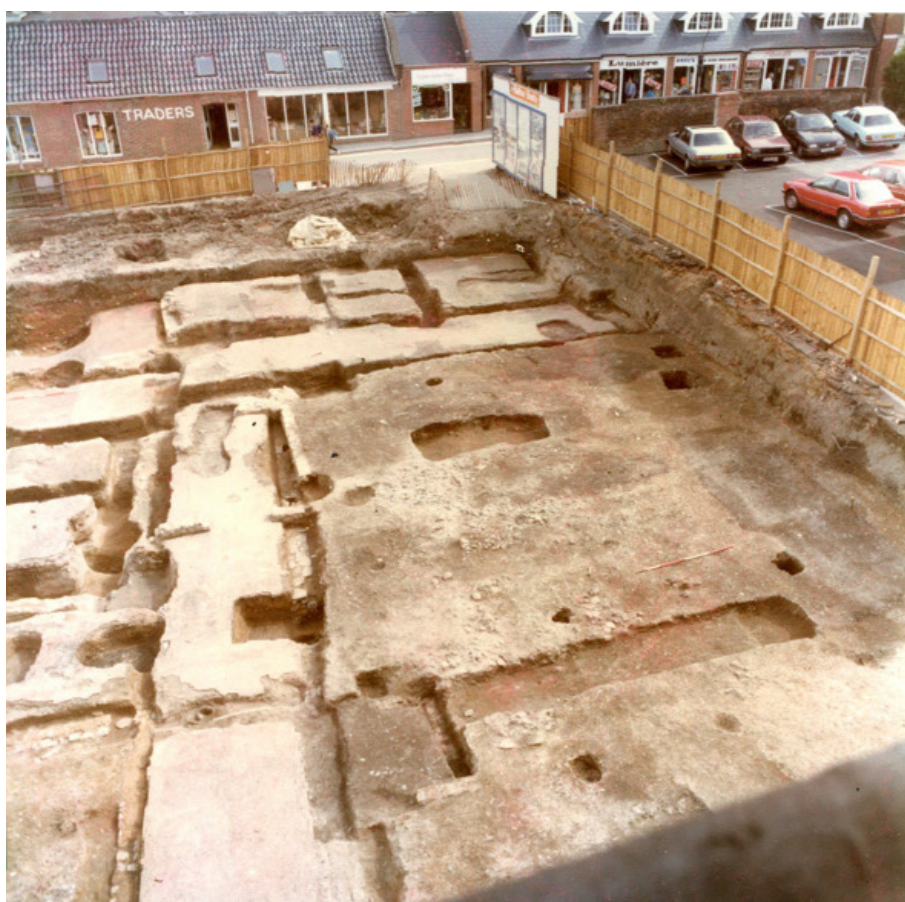
Photo 1: The Rebow House site (right, with parked cars) in relation to the excavation at Culver Street Site H, looking south towards Sir Isaac's Walk.

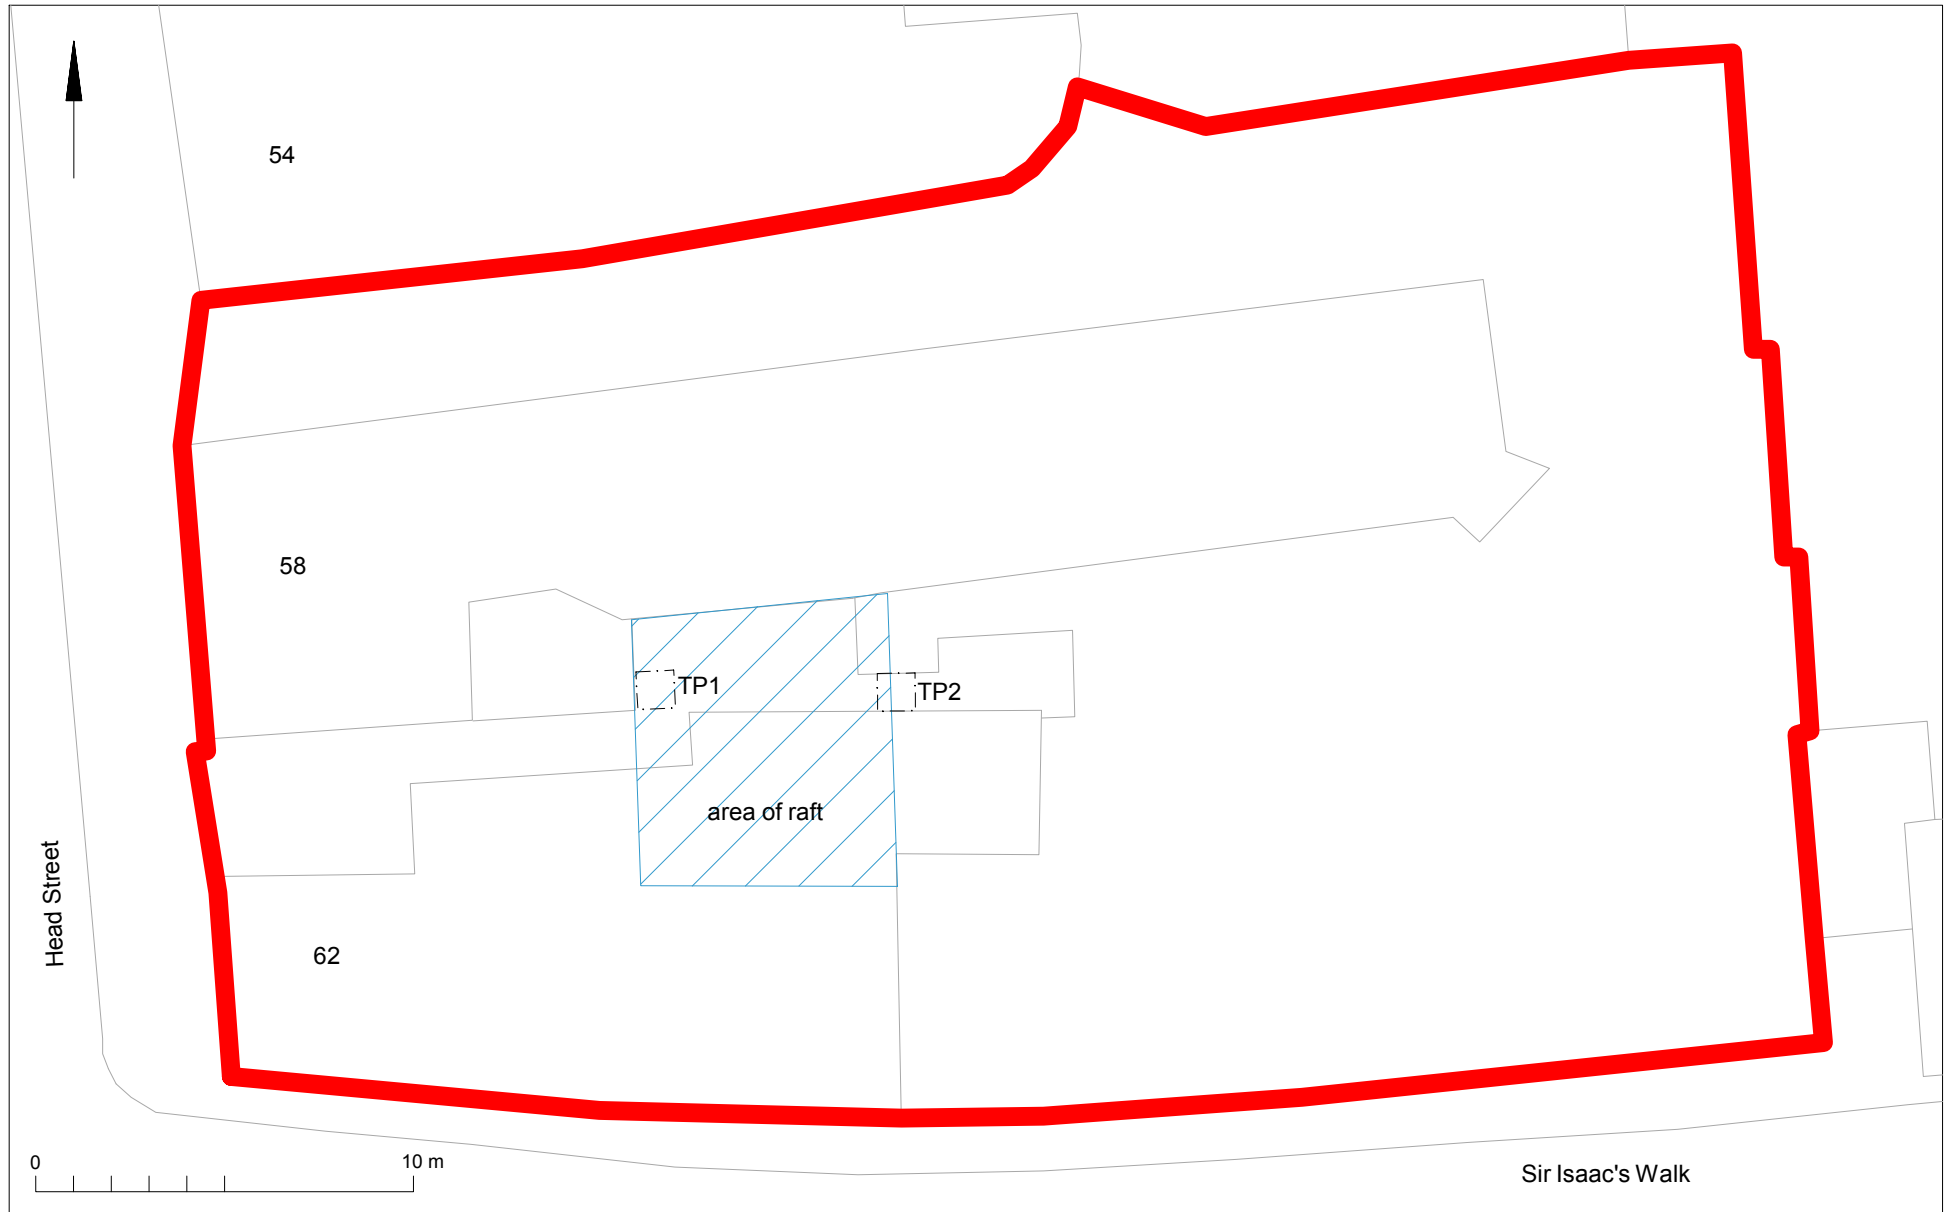
Fig 2 Test pit location plan.
