CAT Report 1998 issued November 2023

Archaeological evaluation on land between Back Lane and Old Church Road, East Hanningfield, Chelmsford, Essex, CM3 8BL:
October 2023

CAT project ref.: 2023/08I ECC code: EHBL23

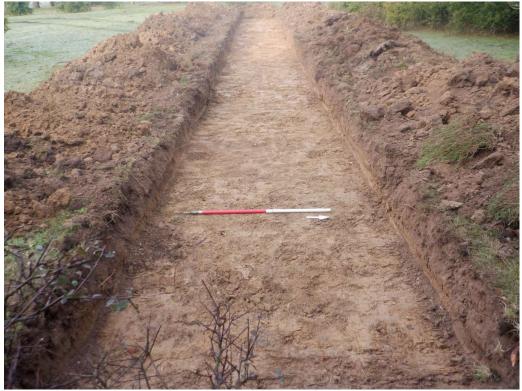
Photograph 1 T1, view west.

Trench 1 was orientated east-west and excavated to a depth of 0.42-0.44m. The corner of a geotechnical test-pit was seen mid-trench.

Natural (L3) was noted from c 0.42m bcgl. No archaeological features were encountered.

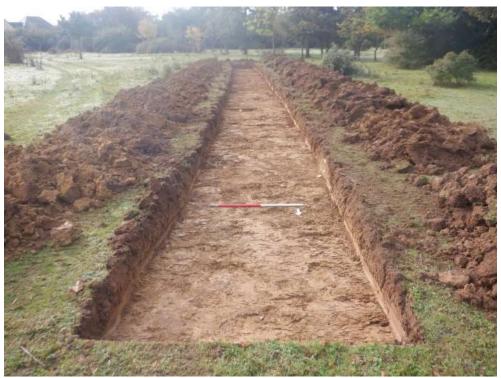
Photograph 2 T2, view south.

Trench 2Trench 2 was orientated north-south and excavated to a depth of 0.33-0.44m.

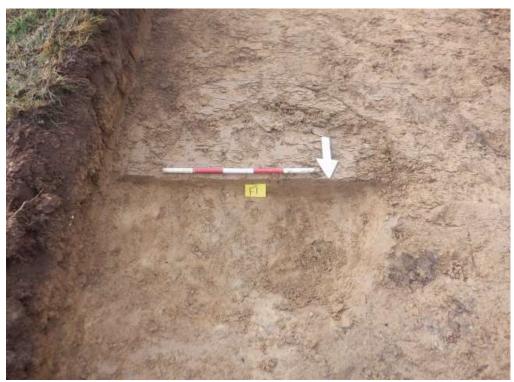
Photograph 3 F1 in plan.

Natural (L3) was encountered from 0.32m bcgl. A shallow, sub-rounded pit (F1) was noted midtrench. It was at least 0.9m wide, 1m long, and 0.1m deep. Late Iron Age and medieval pottery was recovered from this feature.

Pit F1 produced one sherd (8g) of Late Iron Age grog-tempered pottery (fabric GTW). There was also a small quantity of Roman pottery which was recorded according to the fabric groups outlined in *CAR* **10** (Symonds & Wade 1999). Ditch F6 produced one sherd (9g) of fine oxidised ware (fabric DZ) and a Cam 243-244/246 bowl (EVE:0.07, 4g), dating to AD 43-140, in fabric DJ (oxidised and related wares). Finally, two sherds (2g) of fine oxidised wares (fabric DZ) came from makeup L2.

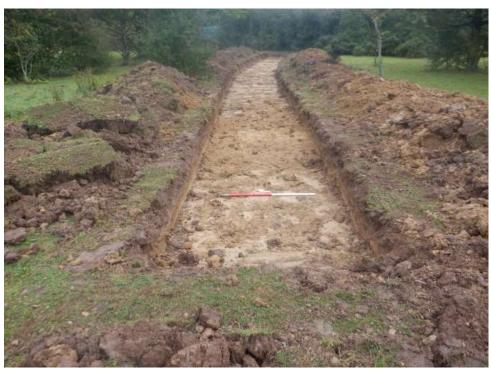
Photograph 4 T3, view north-east.

Natural occurred from 0.32m bcgl. A partial geotechnical test-pit was noted near the south-western end of the trench. At the same end of the trench, a shallow, sub-oval tree-throw (F8) was excavated. F8 was at least 1.2m long, 1.5m wide, and a maximum of 0.1m deep. A small quantity of medieval pottery was recovered from this feature.

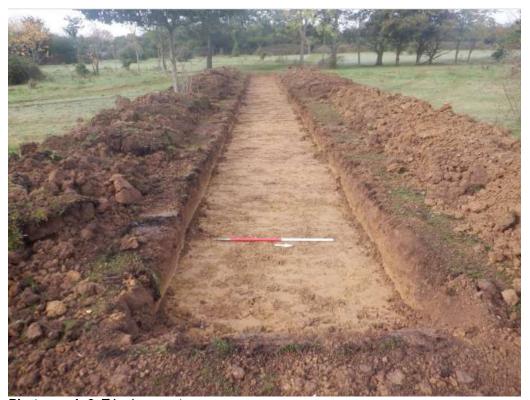
Photograph 6 T4, view west.

Trench 4Trench 4 was orientated east-west and excavated to a depth of *c* 0.43m.

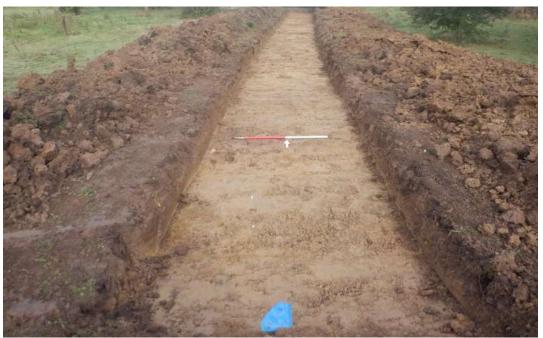
Photograph 8 T5, view north.

Trench 5Trench 5 was orientated north-south and excavated to a depth of 0.40m.

Natural was encountered from 0.4m bcgl. No archaeological features were noted in this trench.

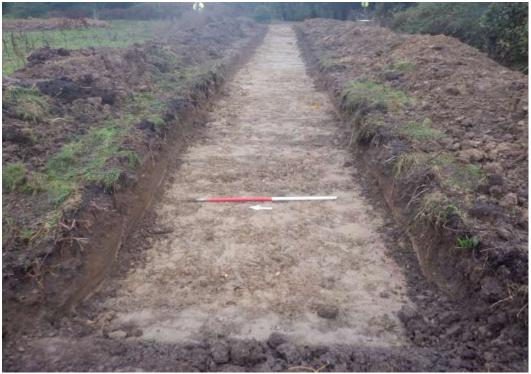
Photograph 9 T6, view east.

Trench 6Trench 6 was orientated north-east/south-west and excavated to a depth of 0.40-0.43m.

Natural (L3) was encountered from c 0.31m bcgl. Four features were excavated in this trench. F3 is a north-east/south-west orientated ditch feature, with a terminus at the south-western end. It was at least 9m long, 0.66m wide, and 0.13m deep. Post-medieval pottery was recovered from the excavated terminus.

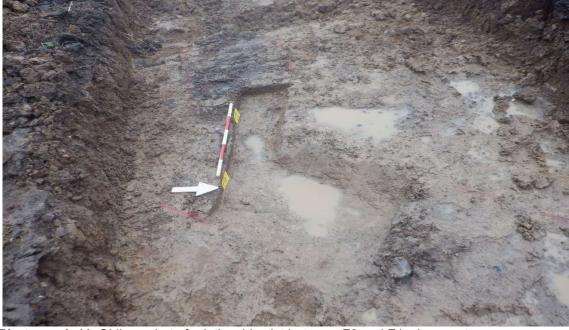
Cutting F3 is a north-south orientated ditch, F4. This feature was at least 2.7m long, 0.33m wide, and 0.08m deep. Medieval pottery was recovered from F4. It cut F3 on its western edge.

Photograph 11 Oblique shot of relationship slot between F3 and F4, view west.

Ditches F3 and F6 are the same form, orientation, date and approximate size. They are both parallel to the current road (Old Church Road) so may be a former boundary, with an entrance in the gap. Although the pottery recovered from F4 implies it is earlier than F3, F4 clearly cuts into F3, so may be contemporary, or later than, F3. F4 may be another field boundary.

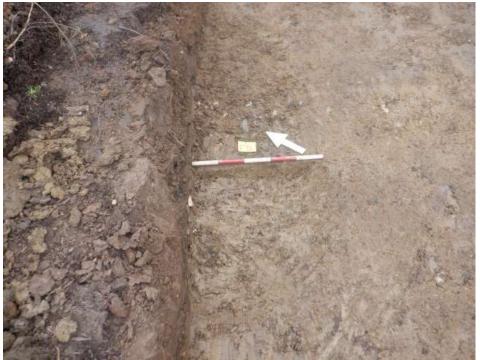
Around the middle of the trench is an undated sub-oval tree-throw, F5. Only half of it was seen, the other half extending beyond the limit of excavation (LOE). F5 is at least 1.3m long, 0.5m wide, and 0.10m deep.

Photograph 11 F5 in plan.

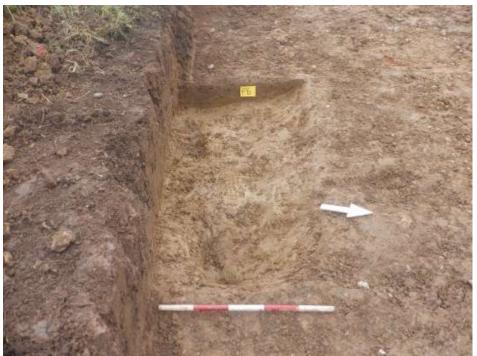
Photograph 12 F6 section, view west.

Seen at the south-west end of the trench, a north-east/south-west orientated ditch, F6 was encountered, with a terminus at the north-eastern end. It was at least 6.6m long, 0.6m wide, and 0.17m deep. No finds were recovered.
