CAT Report 2049
issued May 2024

Archaeological monitoring and recording at
16 Albert Place, Coggeshall, Essex, CO6 1TZ:
April-May 2024

NGR: TL 85259 22739 (centre)

**Planning district.: Braintree
Planning ref.: 24/00082/FUL**

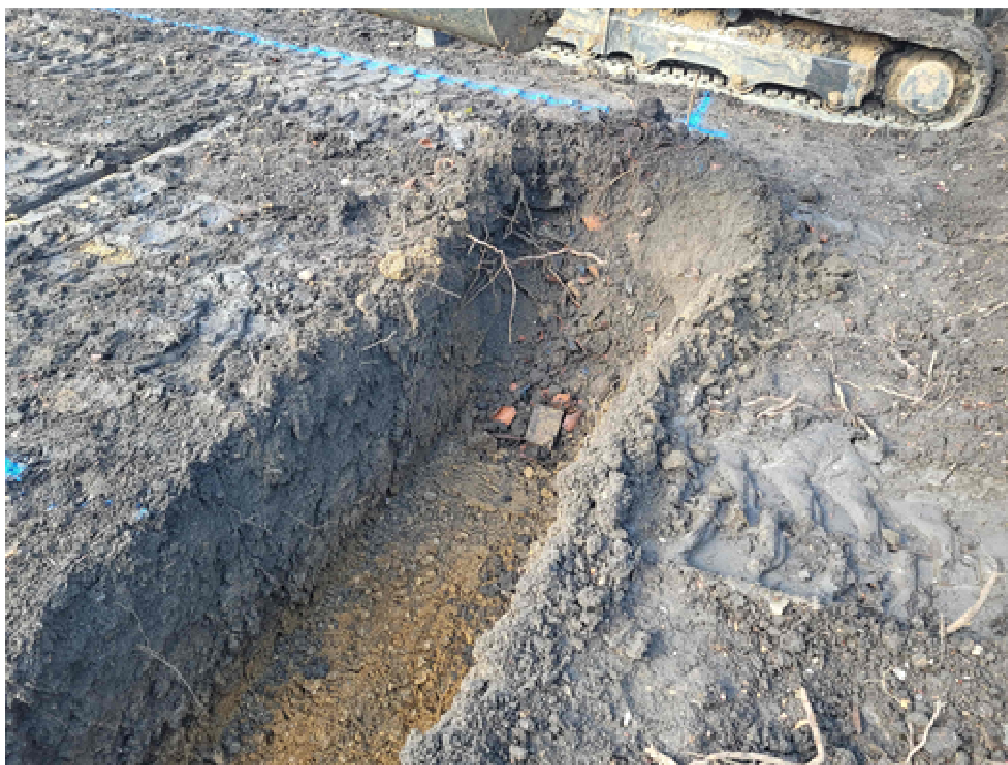
A modern ?soakaway (F1) was identified in the north-western extent of the foundation trenches. F1 had been backfilled with modern terracotta flowerpots and glass bottles, these were not retained for post-excavation analysis. The edges of the feature were not visible in either section of the foundation trench.

Photograph 1 Foundation trenches with F1, looking south-west

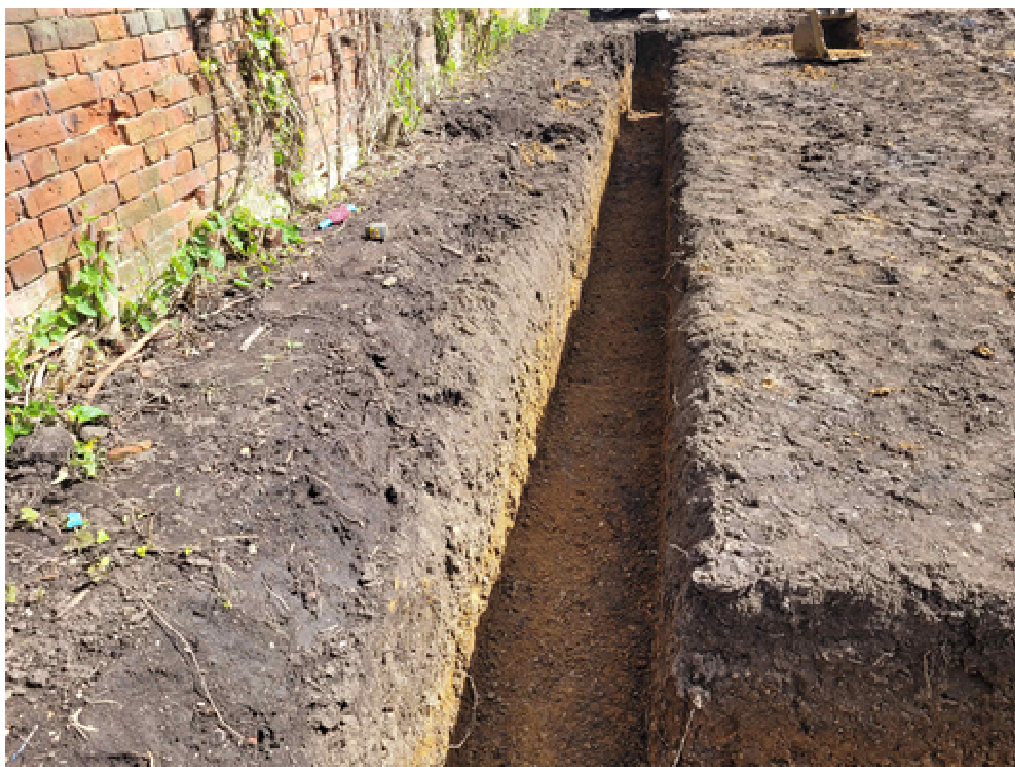
Photograph 2 Foundation trenches, looking south-east

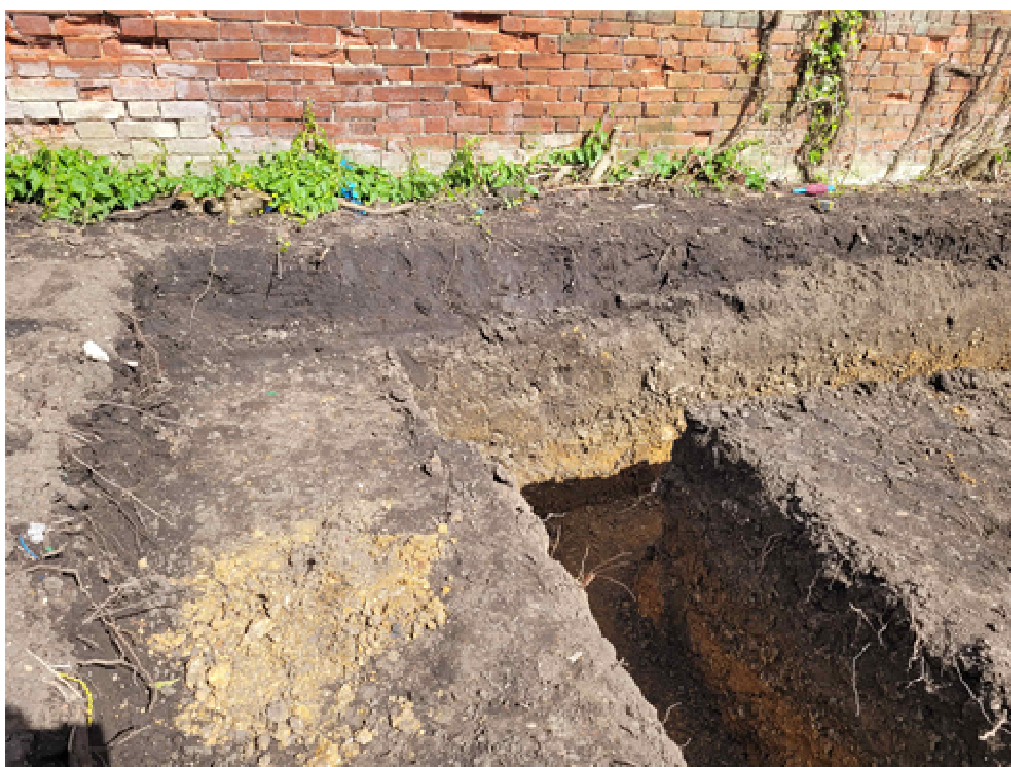
Approximately 63m of foundation trench was machine-excavated under the supervision of a CAT archaeologist. The trenches were c 0.45-0.60m wide, c 1.20-1.80m deep, and were cut through a topsoil (L1, c 0.21m thick) which sealed a subsoil layer (L2, c 0.34m thick) and into natural geology (L3). Natural was encountered at a depth of c 0.55m below current ground level. The site had been stripped down c 0.3m prior to the foundations being excavated, although only L1 and the footings of the former bungalow were removed.

Photograph 3 Foundation trenches, looking east-north-east, showing depth of topsoil stripped prior to work starting.
