CAT Report 2122 issued January 2025

Archaeological evaluation at Tillingham Hall Farm, North Steet, Tillingham, Essex, CM0 7ST:

CAT project ref.: 2024/12d ECC code: EEX61131

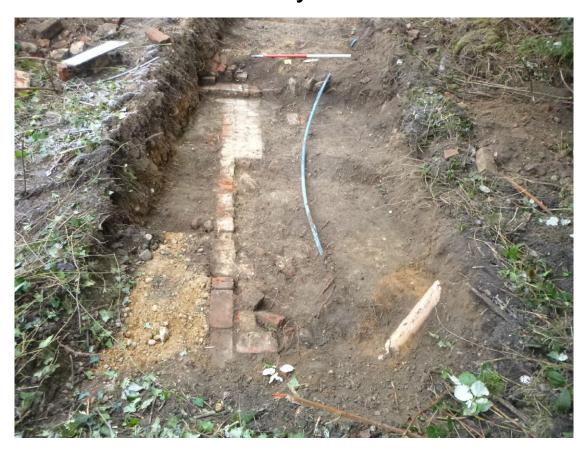
Cover: Trench 5A, wall foundation F7, looking east.

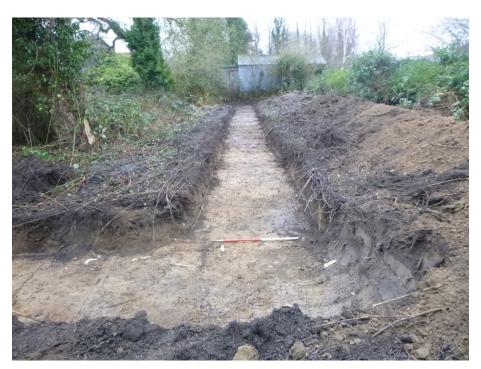
Trench 1 totalled 32m long and was L-shaped, aligned north/south and east/west. It cut through modern topsoil (L1, 0.25m thick) and subsoil (L2, 0.15-0.29m thick) onto natural (L3, identified at a depth of 0.46-0.54m below current ground level (bcgl)).

Shallow post-holes F2 and F4 may represent the remnants of an old fence line associated with the Victorian farmyard. Post-hole F2 was almost circular in plan, 0.28m by 0.22m and 0.07m deep, with moderately steep sides and a concave base. Charcoal inclusions were noted within the fill, but no finds were recovered. Posthole F4 was similar at 0.39m by 0.3m and 0.08m deep with concave and shallow sides. The feature produced animal bone and 19th-20th century glass.

Also identified in the trench was an undated pit/post-hole (F1) and a tree-throw. Pit/post-hole F1 was approximately oval in plan, 0.62m by 0.36m and 0.11m deep, with a concave base and moderately steep sides. It contained charcoal inclusions, but no finds were recovered. Tree-throw F3 was, *c* 2.8m by >1.1 but only 0.14m deep. The feature was irregular in plan with an undulating base and contained two fills. The upper fill was defined by containing numerous inclusions of charcoal along with a tiny fragment of prehistoric pottery, three sherds of probable Roman pottery and animal bone.

Photograph 1 Trench 1, looking south.

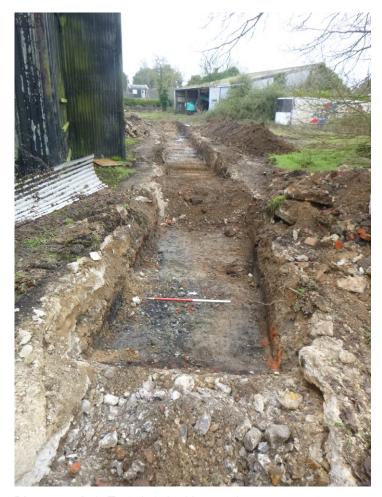
Photograph 2 Trench 3, looking north-west.

Trench 3 was also aligned west-north-west/east-south-east, and like T2 was excavated in two sections to avoid a service. It totalled 24m long and cut through L4 (0.4-0.57m thick) and L2 (0.03-0.12m thick) into L3 (encountered at between 0.52-0.60m bcgl). A patch of contaminated ground was identified in the centre of the trench.

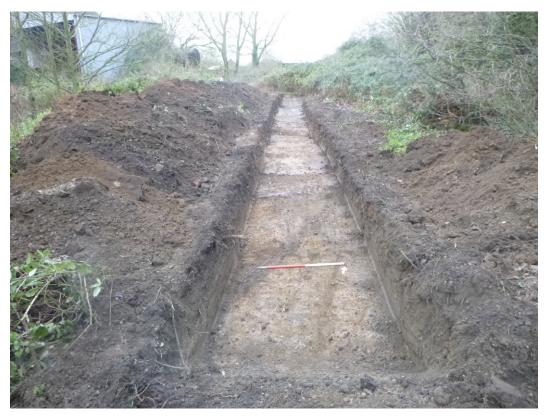
Trench 4 was aligned north-north-west/south-south-east and was 28m long. It cut through L1 (0.24-0.53m thick) and L2 (0.26-0.48m thick) onto L3 (encountered at between 0.72-0.79m bcgl). A sondage was excavated to confirm the identification of L3 as natural.

Curved ditch F6 entered the trench on a north-north-west alignment before curving to the south-east. It had a V-shaped base, moderately steep sides and was 0.95m wide and 0.25m deep. Modern brick and pipe pieces were found in the ditch along with fragments of mortar, animal bone and oyster shells were recovered. The ditch cut L5 (*c* 3m long), a layer which included oyster shell fragments, a sherd of prehistoric pottery, a sherd of Late Iron Age to early Roman pottery and some animal bone.

Photograph 3 Trench 4, looking north-north-west.

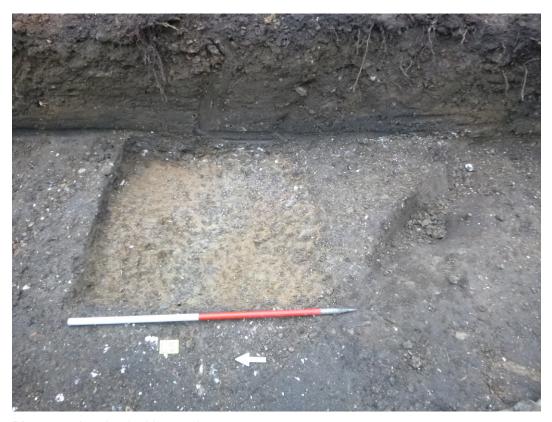
Photograph 4 L5, looking north-east.

The dump layer L5 (10) produced one sherd (16g) of Late Iron Age to early Roman shell and grog-tempered (fabric HD?) pottery. This layer also produced one sherd (13g) of prehistoric handmade pottery (HMO) which has a brown/orange exterior and black core with linear voids from burnt out organic temper.

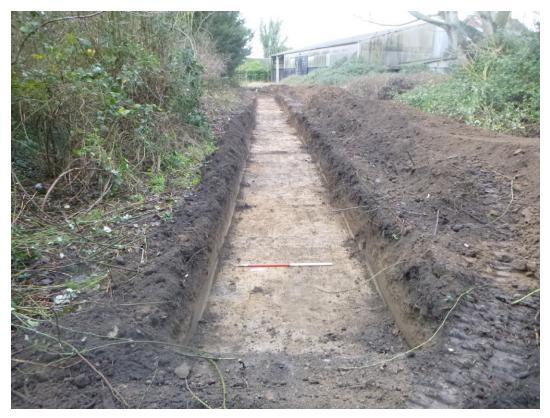
Photograph 5 Trench 5b, looking west-north-west.

Trench 5A was 9m long and aligned east/west. Trench 5B was 37m long and aligned west-north-west/east-south-east. They cut through L1 (0.3-0.4m thick) and L2 (0.23-0.26m thick) into L3 (encountered between 0.53-56m bcgl). There were three modern features in T5B. North/south gully F5 was 0.36m wide and 0.09m deep and produced pieces of modern window glass. Pit F8 (4m by >1.8m) was unexcavated due to the presence of modern contamination visible on the surface. Subrectangular pit F10 had vertical sides and a flat base (1.07m by 0.48m and 0.21m deep) and produced fragments of modern brick.

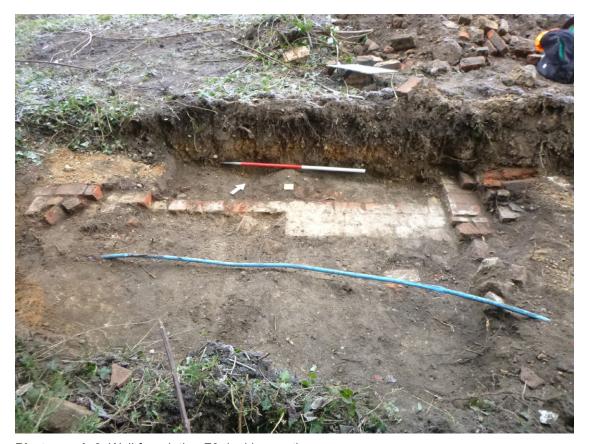
Dominating T5A was F9, comprised of two brick wall foundations, aligned east/west and north/south. As excavated the east/west stretch of wall 3.4m long and the north/south 0.3m. The east-west stretch was constructed of red unfrogged bricks and was three bricks wide (c 0.32m wide) with bricks arranged in running bond. Two courses of the foundation remained. Demolition debris, represented by a thin layer of mortar fragments, was present on the north-west side of this wall. The north/south stretch of wall also built of unfrogged bricks. It was two courses high, with the upper course comprised of a single row set in stack bond. Scattered individual bricks, pieces of slate and mortar fragments, presumed remnants of demolition, surrounded and partly covered this wall. Brick samples from the foundation were dated from the late 18th to 19th century.

Photograph 6 Wall foundation F9, looking north.

Bricks from the wall foundation (F9) dated from the late 18th to the 19th century. Tillingham Hall was completely re-built in the 19th century, and the wall foundation is part of the large, enclosed farmyard built to its north. The 1838 Tithe Map shows that this wall was a part of the eastern north/south range of buildings.
