**Historic building recording at Front Lodge, Moor
Place, Much Hadam,
Hertfordshire, SG10 6BS
November 2015**

**report prepared by
Mark Baister**

**commissioned by
Foxley Builders**

CAT Report 934
April 2016

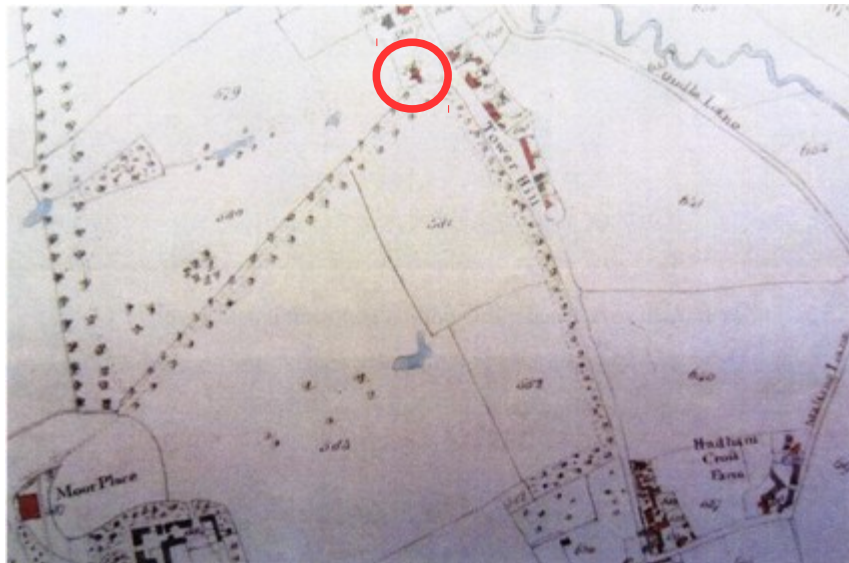
The Front Lodge was built sometime between 1838 and 1871. It replaced a previous north-south orientated lodge on the same site, which is shown on the parish tithe map of 1838 (Map 1).

Map 1 Parish Tithe map, 1838 (HALS ref DE/H/P31). Location of earlier north-south orientated lodge highlighted.

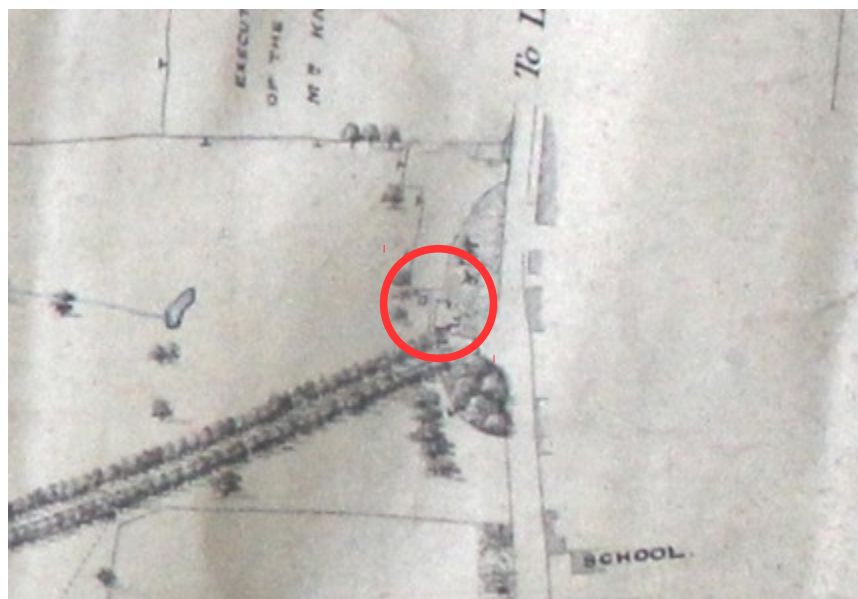
Map 2 1871 estate map (held in estate office), showing current lodge and outbuilding (prior to modern additions).

The lodge in its current form (excluding modern additions) first appears on an estate map of Moor Place from 1871 (Map 2). It is believed the present lodge was built by Money Wigram, who acquired Moor Place in 1860. The date of the earlier lodge is uncertain.

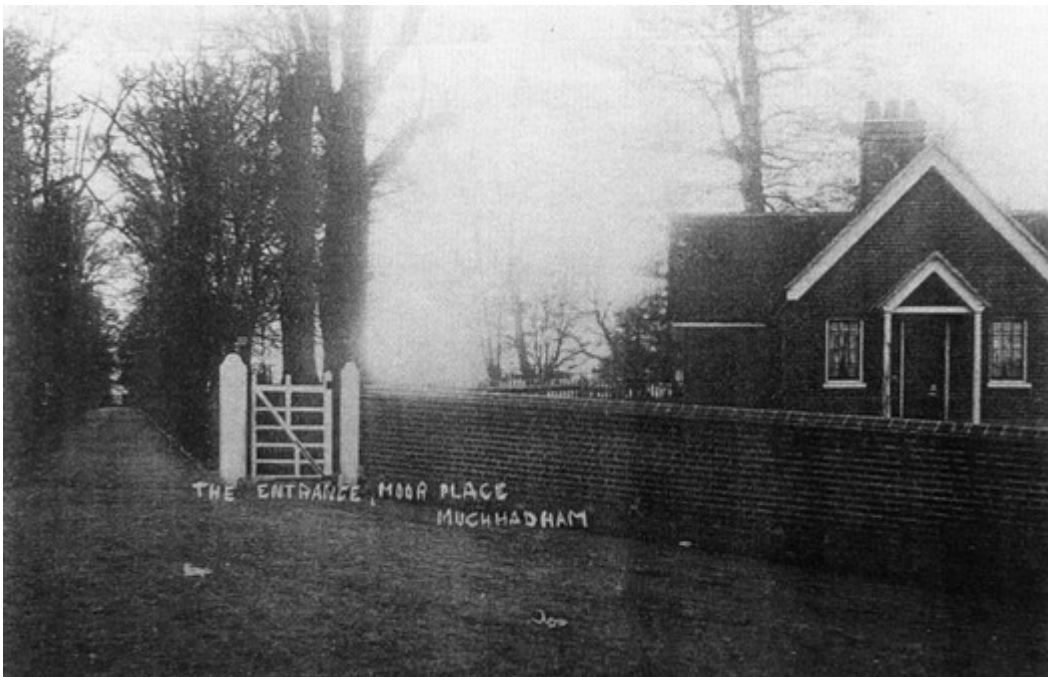
The original entrance to the lodge was located in the centre of the east elevation, underneath a porch (Plate 24, Fig 3). This entrance has since been replaced with a timber-framed sixteen light fixed window and is flanked on each side by timber-framed twelve-light casement windows. All of these windows are mid 20th-century replacements, probably

Plate 24 Early 20th-century photograph, showing the lodge with its original entrance and before the extension – view south-west (HALS DE/Gr/33/1/20).

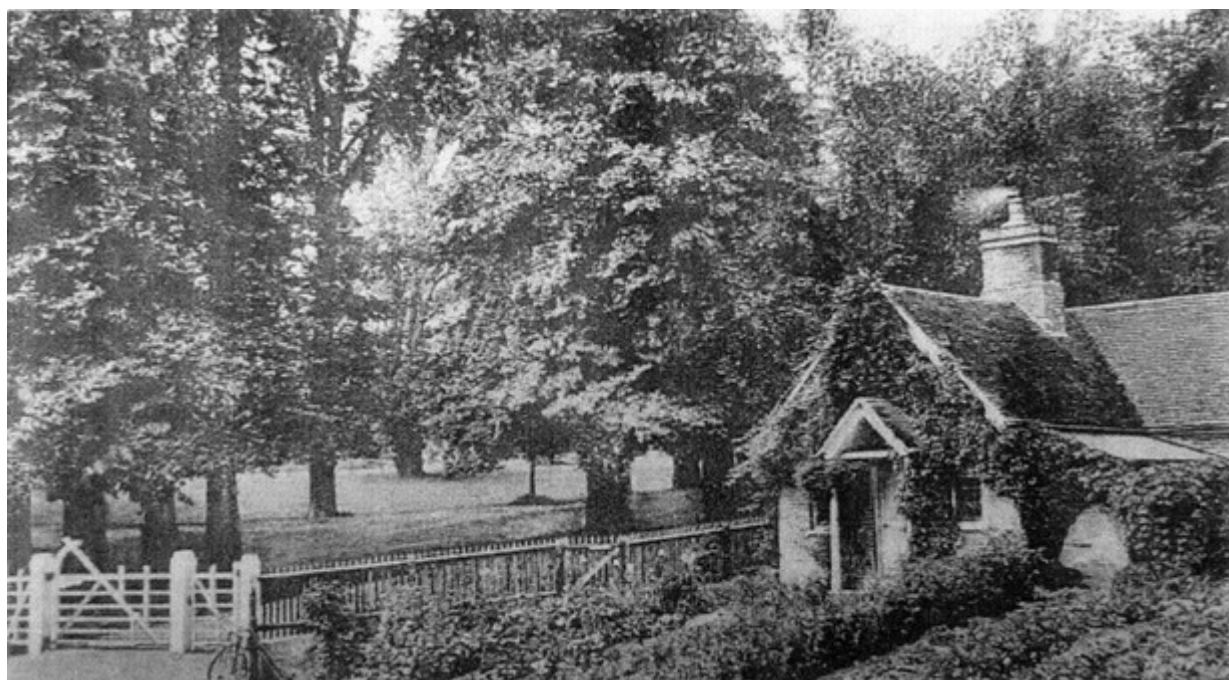
The whole lodge is roofed with plain tiles. The tiles on the 19th-century lodge are original to the building and pegged into place, but the tiles on the extension are modern (Plate 23). There is a square chimney stack located off-centre, to the south of the east-west ridge. An early 20th-century photograph (Plate 25) shows the chimney as originally only having one chimney pot. It has since been remodelled to have three. There is a fascia surrounding the entire roofline, and bargeboards at every gable end – these are visible on early 20th-century photos of the lodge (Plates 24 and 25). They are mimicked effectively on the mid 20th-century extension, to the extent that the join between the two is not noticeable.

Plate 25 Early 20th-century photograph showing the lodge with only one chimney pot – view south-west (Ruff, 2002).
