**Historic building recording at
the White Hart Hotel, 1 High Street,
West Mersea, Essex CO5 8QD**

August 2018 and April 2019

CAT Report 1324
May 2019

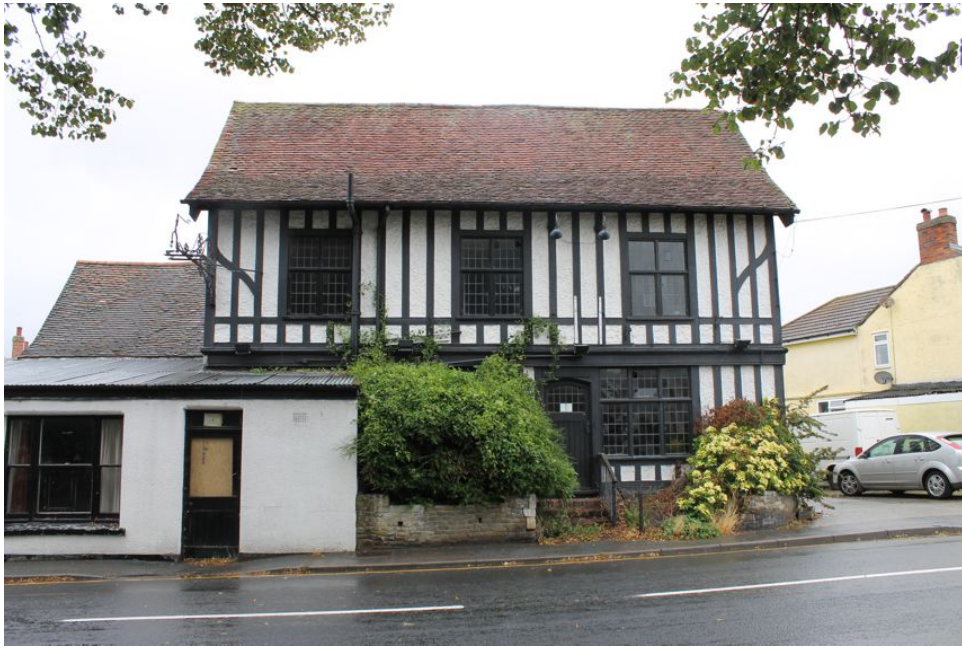
Photograph 11 South-east elevation of Structure C. Photograph taken facing south-west.

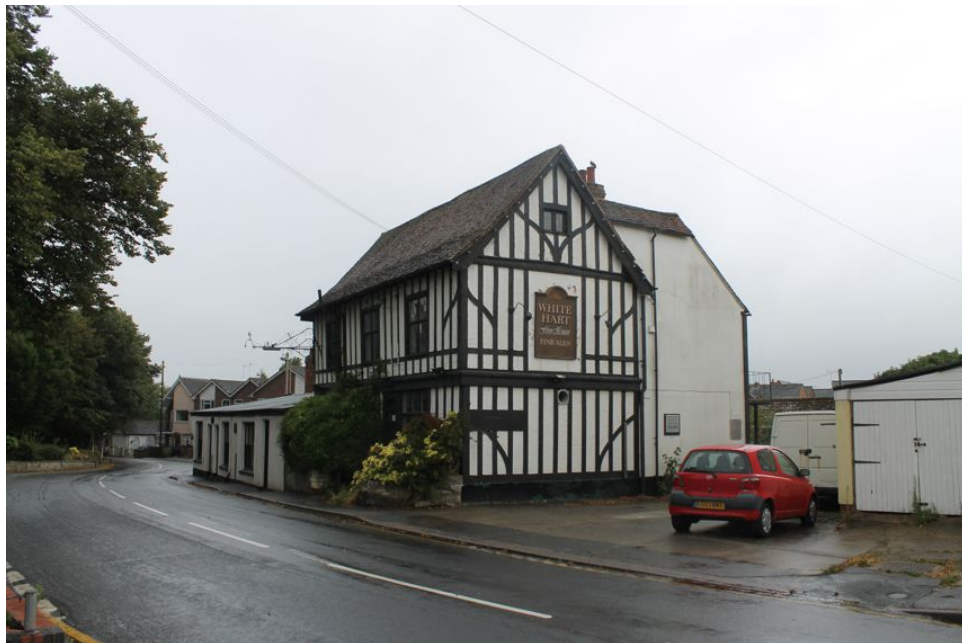
As on the other elevations, the faux timber-framing on Structure C continues here. The second-floor has a small two-light leaded casement window in the gable (Photograph 12).

Photograph 12 North-east elevation of the White Hart. Photograph taken facing south-east.

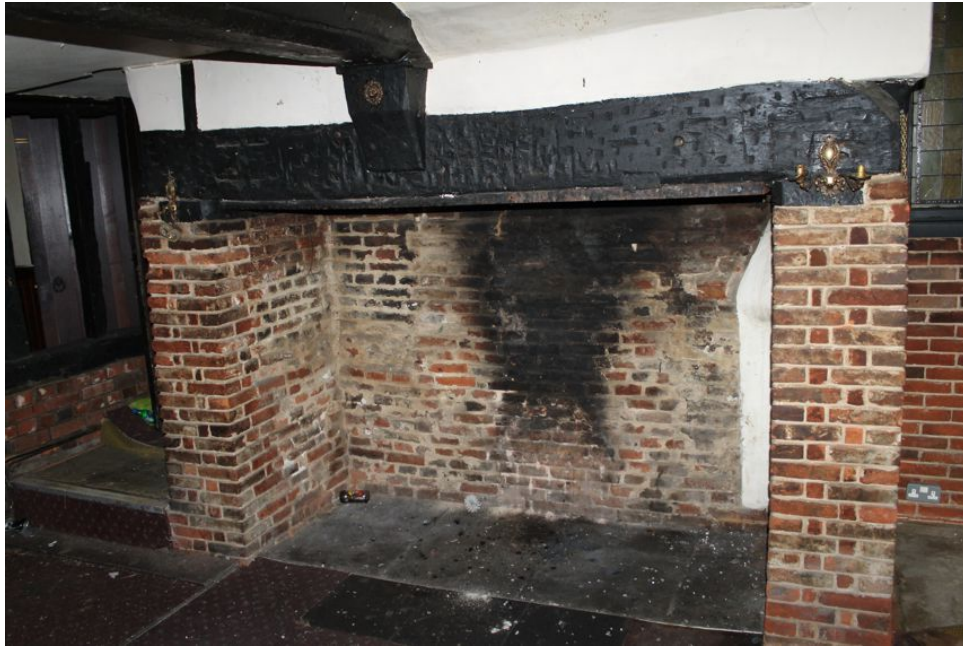
The flooring comprises timber floorboards (which do not appear particularly old) and the floor level is lower than adjacent Structures B and D. The floorboards had been removed at the time of the second visit and no earlier floor was visible beneath. The north-east ground-floor wall of Structure A is dominated by a large red brick fireplace, complete with an inglenook (Photograph 14). The original brickwork of the fireplace is laid in an irregular English bond and bonded in lime mortar. The brick dimensions are 235mm x 110mm x 45mm. The front of the two pillars on either side of the fireplace have been rebuilt (Photograph 15), presumably to support the large timber forming the current mantel-beam. This timber in turn supports the binding-beam of the floor above (Photograph 14). Clearly the rebuilding of the brickwork below this timber suggests it is a later addition to the fireplace, and the original mantel-beam may not have been as substantial.

Photograph 14 Large fireplace in north-east ground-floor wall of Structure A. Photograph taken facing north.

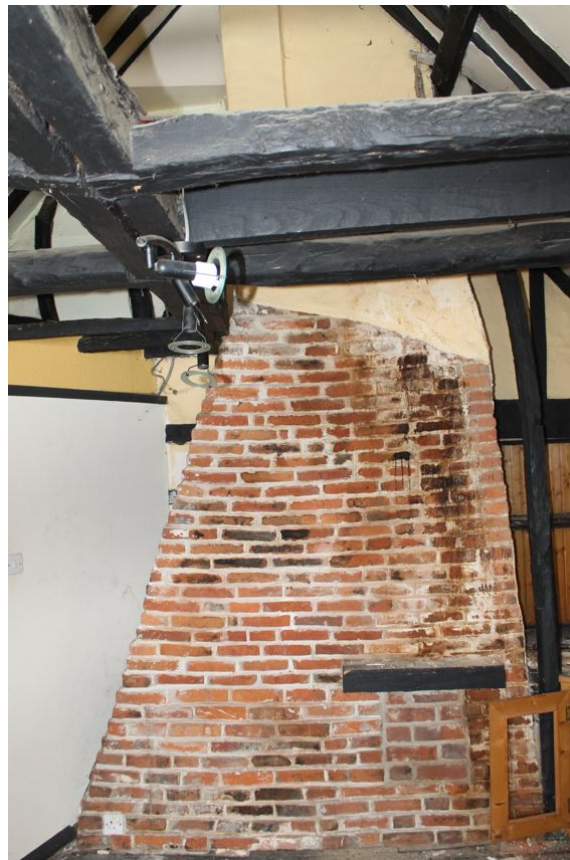
The first-floor of Structure A is more intact than the ground-floor, with all four walls fully surviving. An inserted modern wall divides this floor into a room to the south-east and a corridor to the north-west (Fig 5). The north-east wall of this floor is dominated by the brick chimney stack rising up from the fireplace below (Photograph 19). A small opening in the chimney has been bricked up. The chimney is not central to the building, angling to the south-east and projecting from that side of the central ridge-line (Photograph 6). This is on account of the roof construction, containing as it does a well-preserved central collar-purlin joining the two gable-ends (Photograph 20). By necessity the chimney stack has to avoid this obstacle.

Photograph 19 Chimney stack in north-east first-floor wall of Structure A. Photograph taken facing north-east.

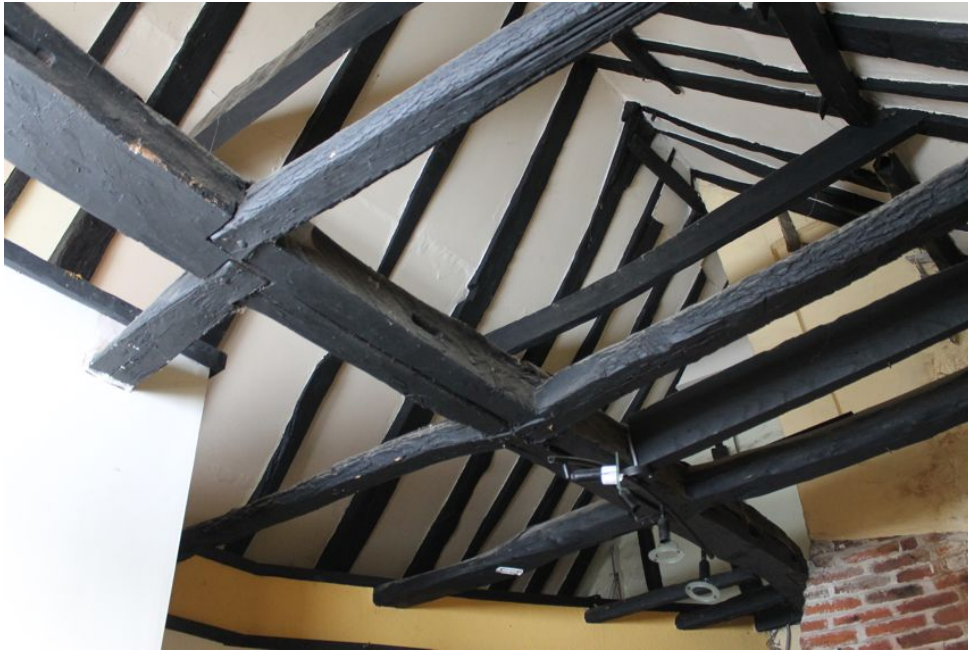
Photograph 20 Roof structure of Structure A, showing collar-purlin and braces. Photograph taken facing north.

Rather than supporting collars immediately above, the collar-purlin is jointed into multiple braces coming from the rafters on both roof pitches. Although not all of these braces survive, most of the ones that do are secured to the collar-purlin by simple mortice and tenon joints (Photograph 20). Six of the braces (in alternating sets of two) are instead connected onto the underside of the collar purlin with joggled lap-joints (Photograph 21) secured by two bolts (one original peg remains). All the surviving braces, regardless of how they are attached to the collar-purlin, have chiselled carpenter's marks on their underside (Photographs 22 and 23). These marks are sequential, going from the south-west of the building to the north-east, and appear original, as they account for gaps caused by missing braces.

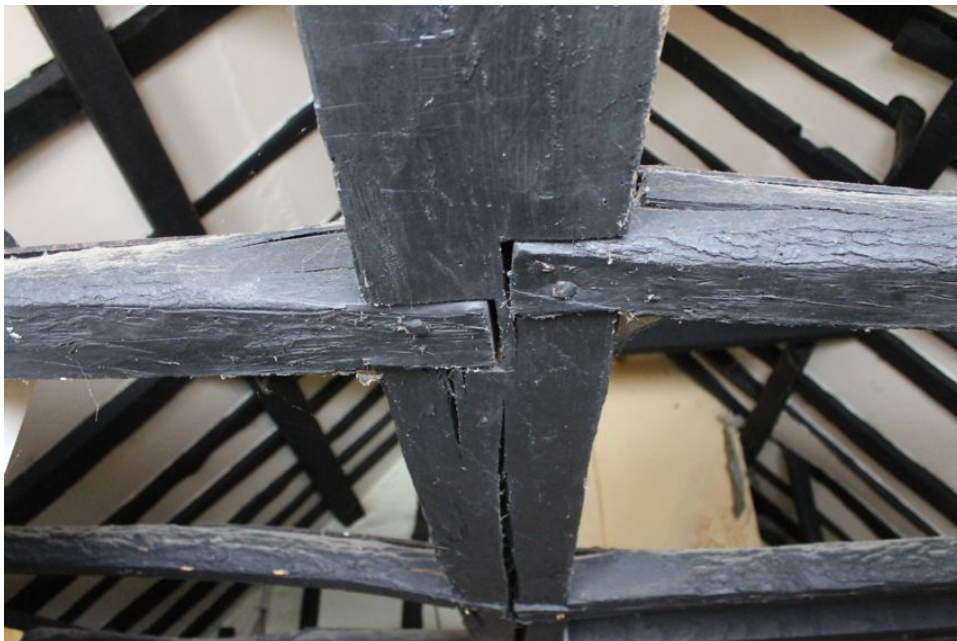
Photograph 21 Detail of underside of collar-purlin, showing joggled lap-joints. Photograph taken facing north-east.

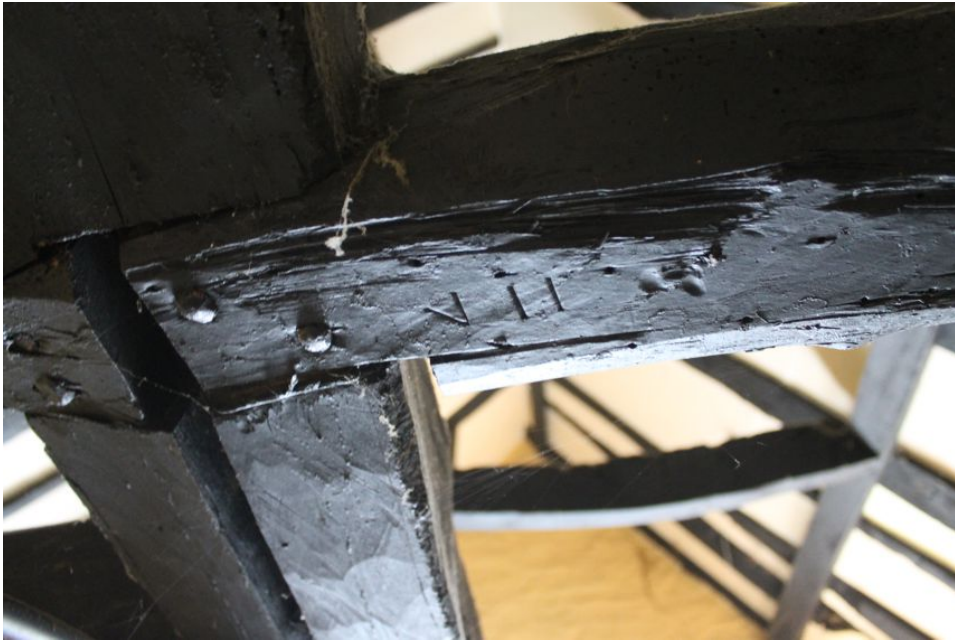
Photograph 22 Detail showing carpenter's mark "VII" on underside of brace to collar-purlin. Photograph taken facing north-east.

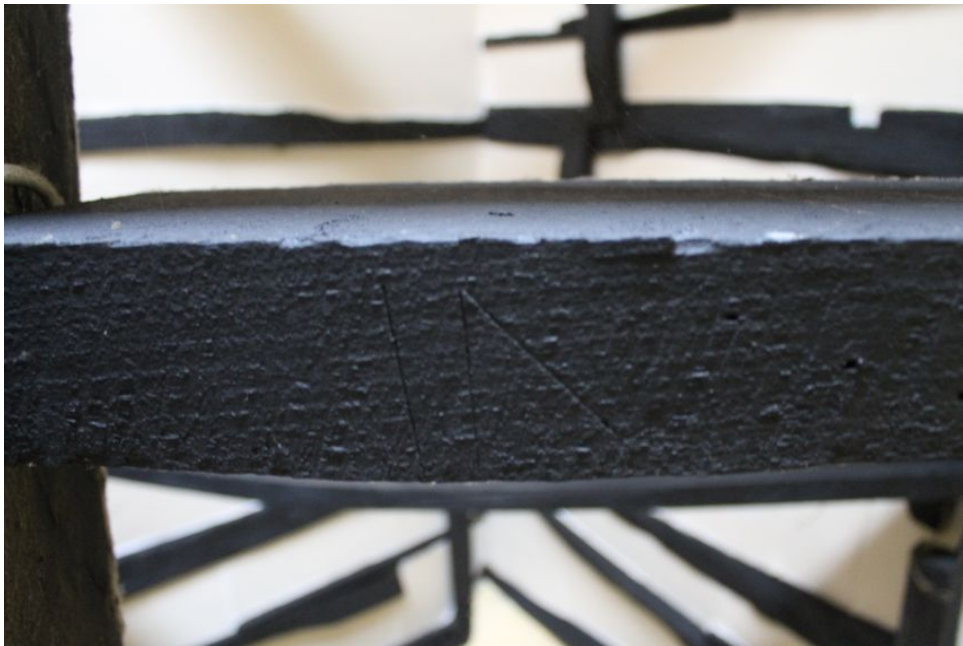
Photograph 23 Detail showing carpenter's mark "VI" on underside of brace to collar-purlin.

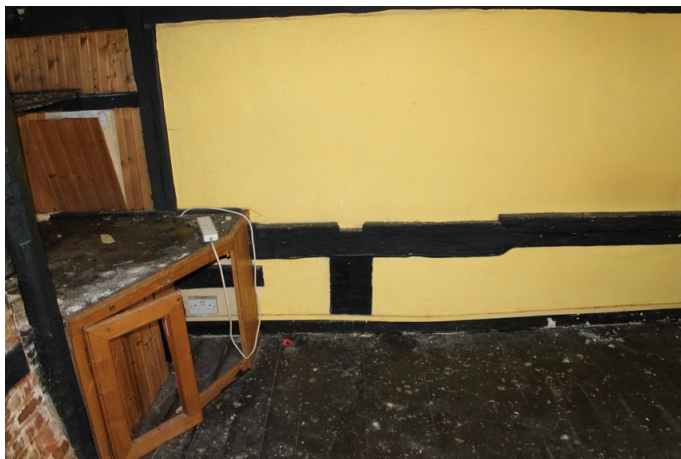
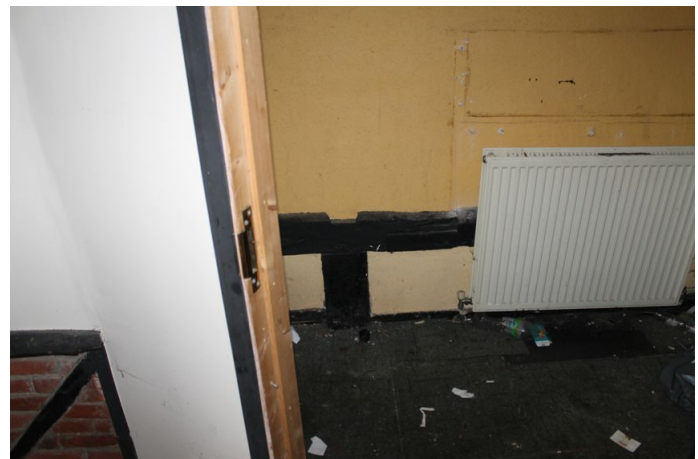
Projecting up from the floor-level on the south-east and north-west walls are two posts with empty lap-joints on their upper face. These would have supported a binding-beam and an earlier floor (Photograph 25 and 26). The floor-level would have been around 420mm higher than the current one, and would have been added to the building when the chimney was inserted (see discussion pg 34). The mortice for a brace supporting this binding-beam is visible on the ground-floor (see above).

Photographs 25 and 26 Empty lap-joints on south-east (left) and north-west (right) walls of Structure A that would have supported the original binding-beam and floor.

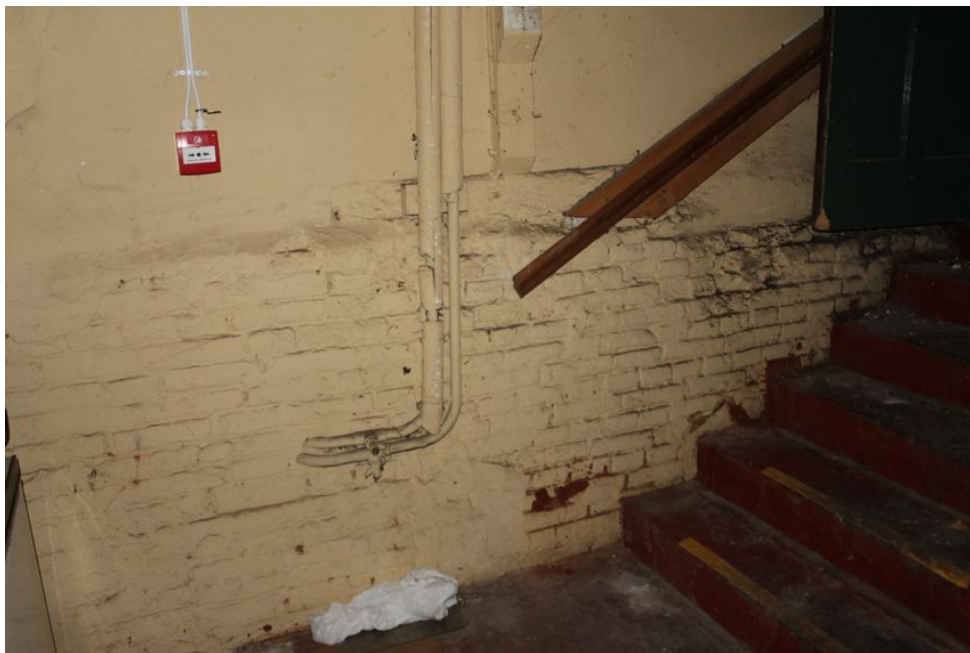
There is a cellar beneath Structure C, which is brick-built, laid in English bond and bonded with lime mortar. The red brick forming most of the cellar has dimensions of 220mm x 110mm x 60mm and is contemporary with the rest of the building. The south-west wall of the cellar is also laid in English bond, but is made of thinner and longer bricks, measuring 230mm x 115mm x 45mm (Photograph 29). These are very similar to the bricks making up the large fireplace in Structure A and appear to be the remnants of an earlier brick cellar associated with a since demolished phase of that building (see discussion pg 34). Supported on this earlier brickwork is a sill-beam and several substantial studs (Photograph 53) which seem to have been reused from elsewhere in Structure A, containing as they do vertical notches seen on the inside of studs around the rest of the building (see Structure A above). This segment of brickwork and timber-frame above is examined in detail in the discussion (pg 34).

Photograph 29 English-bond brickwork on south-west elevation of cellar, probably associated with Structure A. Photograph taken facing south-west.

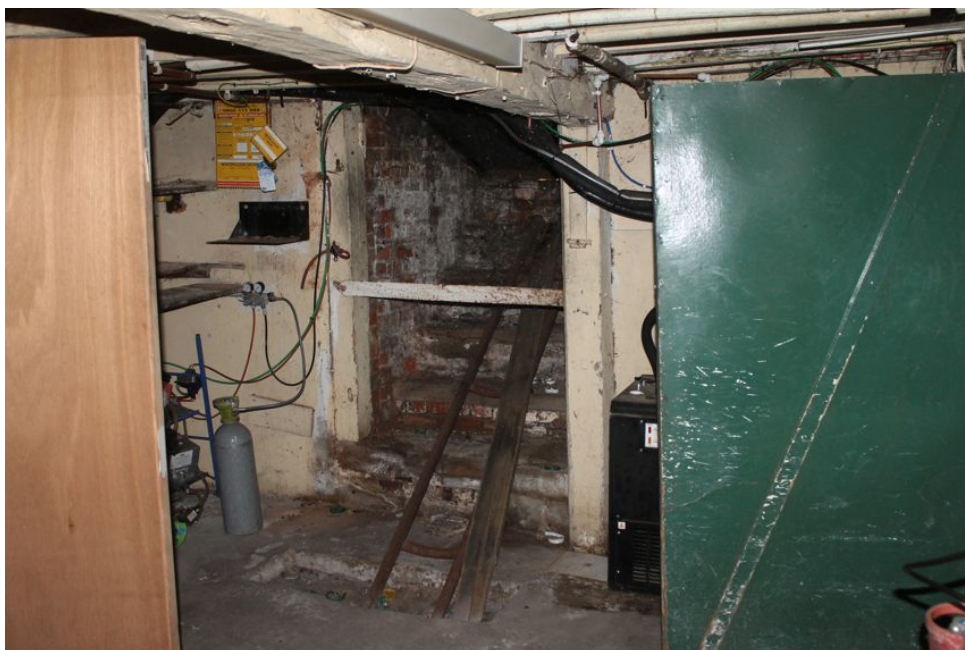
Photograph 30 Cellar below Structure C, showing barrel chute from pavement. Photograph taken facing east.

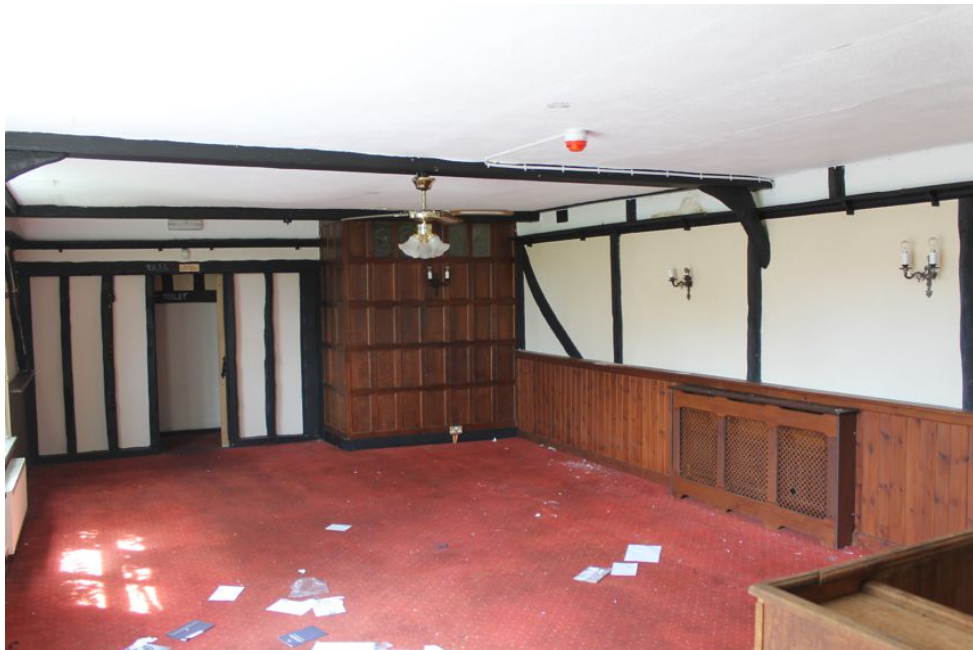
The ground-floor of Structure C is one large open space. The apparent 'timber-framing' visible in this room is in-fact made of a type of foam, and the stud-work and panelling visible to the south-west are all modern additions as well (Photograph 32).

Photograph 32 ground-floor of Structure C. Photograph taken facing west.

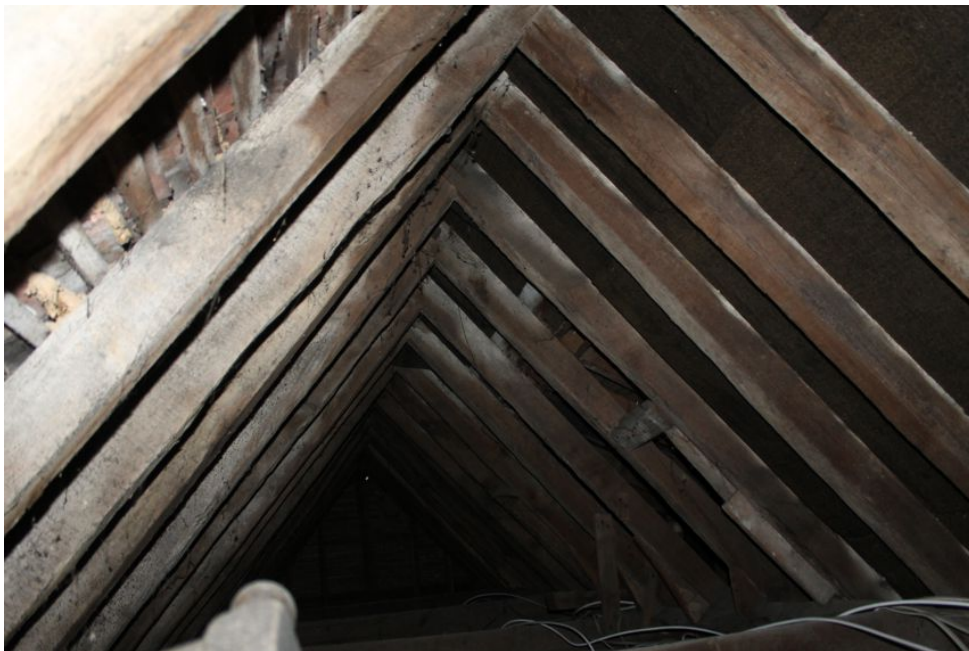
The second-floor of Structure C is a converted attic space, accessed from the first-floor of Structure D (Fig 6). It contains two modern divisions and a modern kitchenette, as well as a fireplace (Photograph 33). The fireplace and associated chimney were probably added to Structure C when this second-floor was inserted into the attic space. The roof timbers of Structure C were observed through a loft hatch and found to be machine-cut, with the rafters pegged at the apex and no ridgeboard (Photograph 34).

Photograph 34 Roof structure of Structure C. Photograph taken facing south-west.

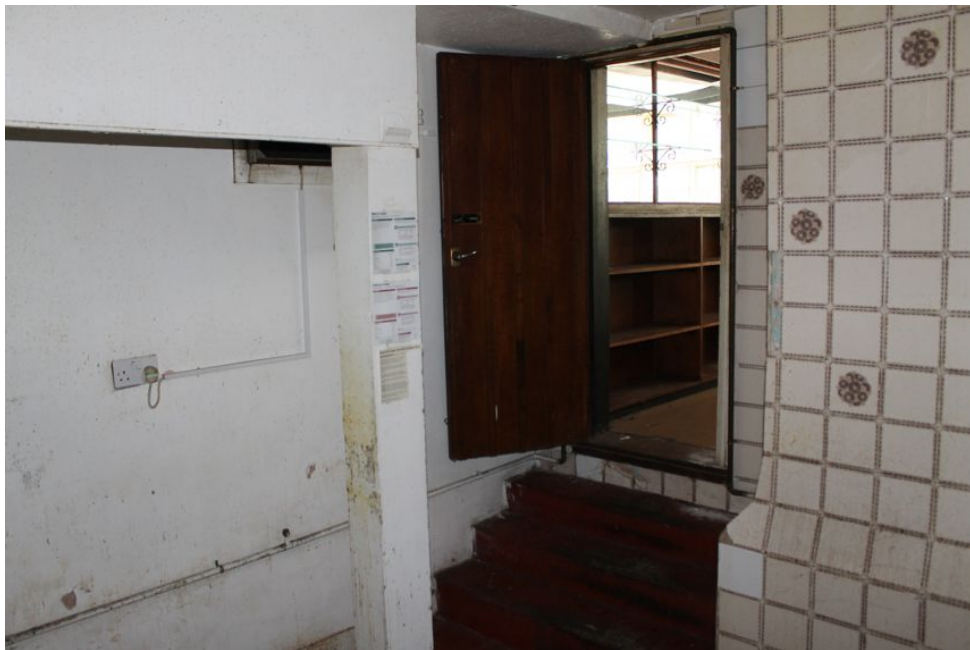
This building, like Structure C, has been heavily altered on the interior. The ground-floor is divided into three rooms, the southern one of which is an entrance hall at the rear of the White Hart. This room has multiple doors leading into Structure A, Structure B, the cellar of Structure C and has a staircase leading up to the first-floors of Structures C and D (Fig 4). The central and northern rooms on the ground-floor have been converted into a kitchen and have tiled floors and walls. Each room has a blocked up fireplace on its south-east wall. As with the first-floor, the floor level of the ground-floor of Structure D is significantly lower than that of Structure C (Photograph 35).

Photograph 35 Photo showing floor-level difference between Structure D and Structure C. Photograph taken facing east.

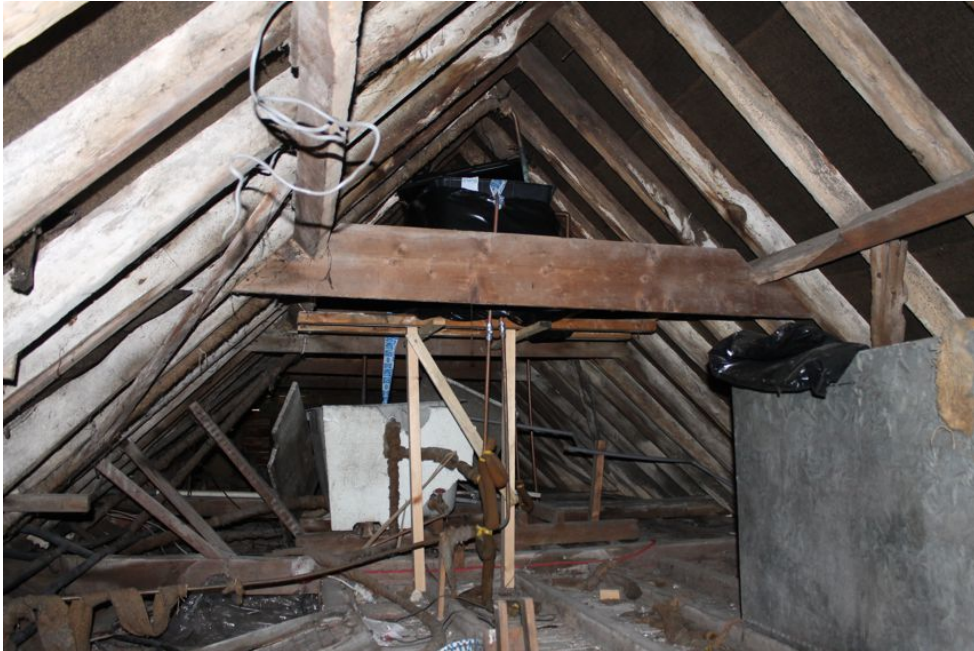
machine-cut timbers, with the rafters supported by collars and clasped purlins (Photograph 36). The rafters are pegged together at their apex, and no ridgeboard is present. A small section on the south-east pitch contains some sarking-boards, which may be original to the building.

Photograph 36 Roof structure of Structure D. Photograph taken facing south-west.

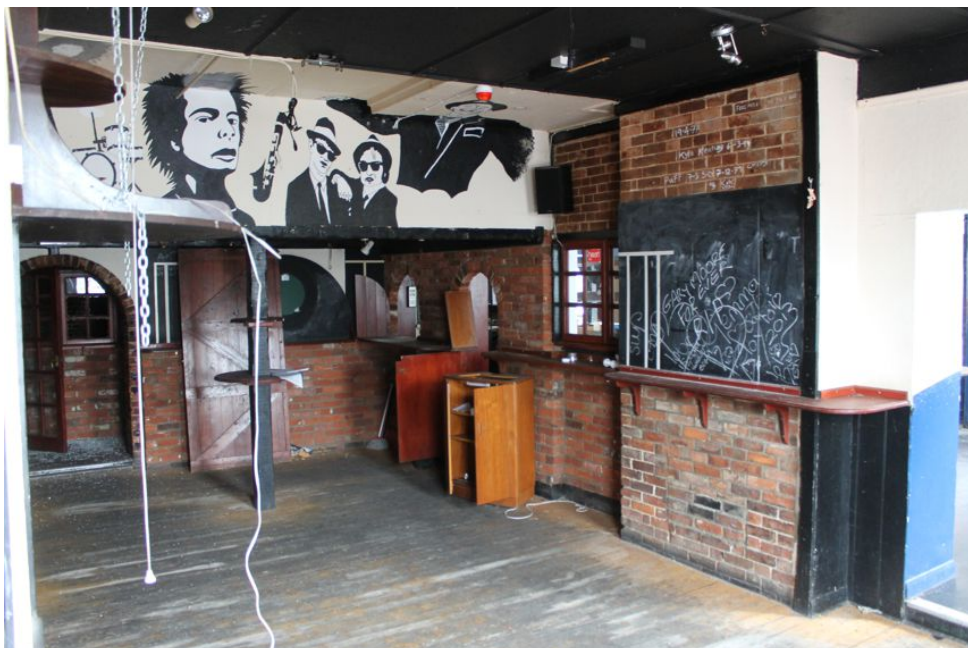
The interior of this single-storey building has several modern additions and alterations. Notably the ceiling has been lowered in the northern part of the building, and several machine-cut timbers that have been altered to look hand-sawn have been inserted to support tables in that area (Photograph 37).

Photograph 37 Interior of Structure E. Photograph taken facing east.

There is a fireplace in the south-east wall of the building that has been bricked up (Photograph 37).

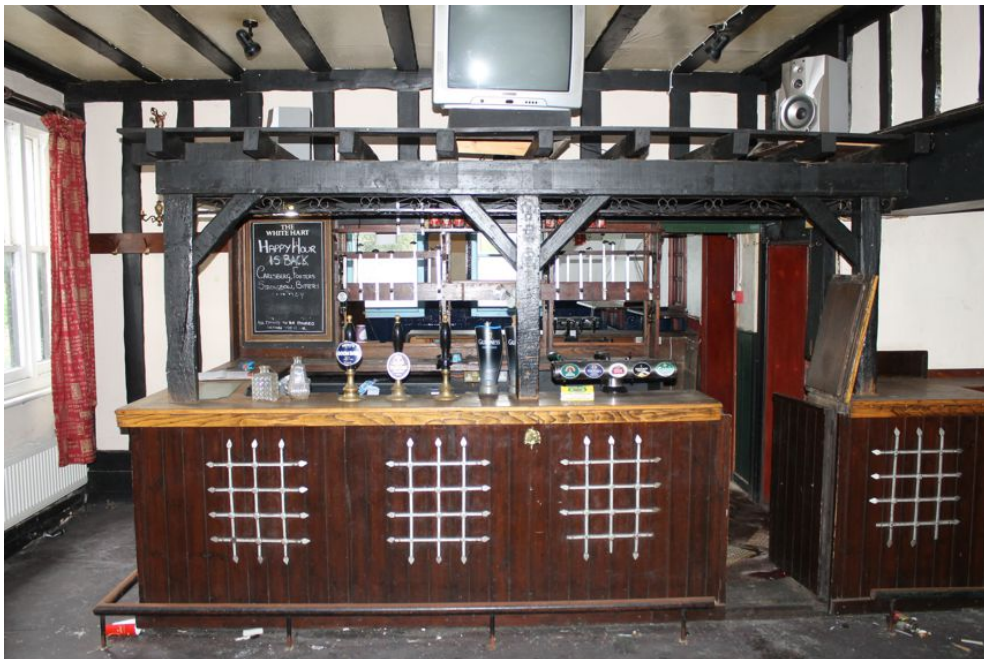
This single-storey building, like Structure E, has been extensively modernised on the interior with very little original features remaining. It has a bar in its centre that is partially constructed from some machine-cut timbers that have been altered to look hand-sawn (Photograph 38), but the blocked doorway in the south-east wall indicates that this bar is a modern insertion. To the north of this building is a section of “L”-shaped wall that contains some imitation stud-work, re-using several sections of legitimately hand-sawn timber, including a substantial timber that appears to have been re-used on multiple occasions, once as a tie-beam (Photograph 39). This section of imitation stud-work is partially supported by a wall made of re-used bricks, laid in stretcher-bond and bonded in lime mortar. The dimensions of these re-used bricks are 220mm x 45mm. The modern additions to this building were probably added at the same time as the toilet block was built (Structure G) and the modern additions were inserted into Structure E (see above). The second visit showed that the stud-work in the north of the building was originally machine-cut, but where visible had been carved to make it appear hand-sawn (Photograph 59).

Photograph 38 Inserted bar into Structure F. Faux timber-framing visible on walls. Photograph taken facing south-west.

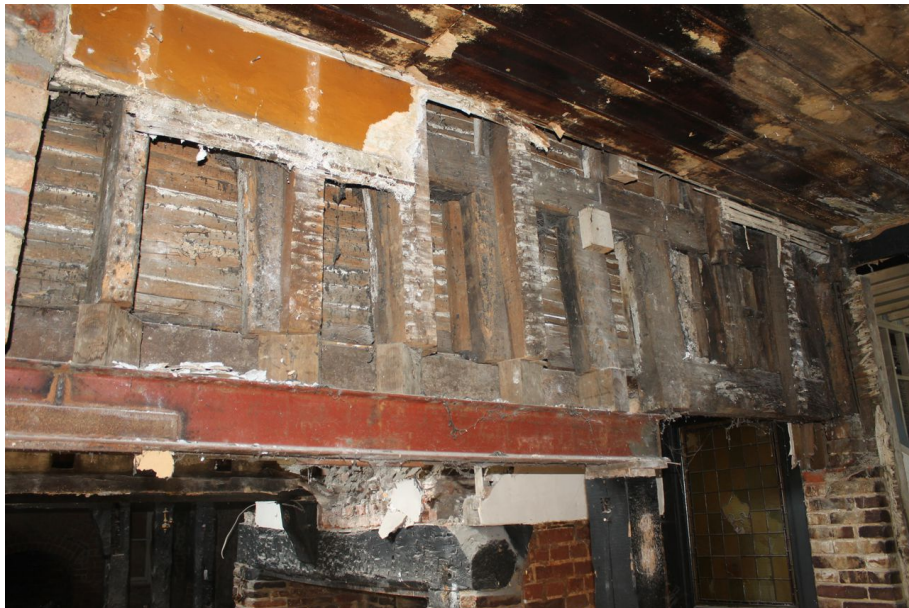
Photograph 42 Exposed partially surviving studs and girding-beam on south-east elevation of Structure A after soft strip. Photograph taken facing north.

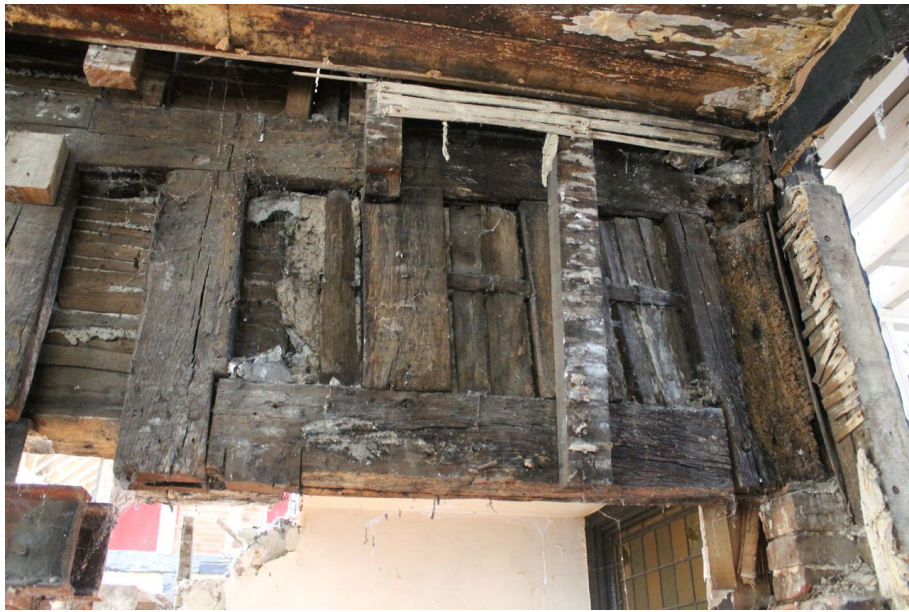
Photograph 43 Detail of timber panelling infill on south-east elevation of Structure A, above original doorway lintel. Photograph taken facing north-west.

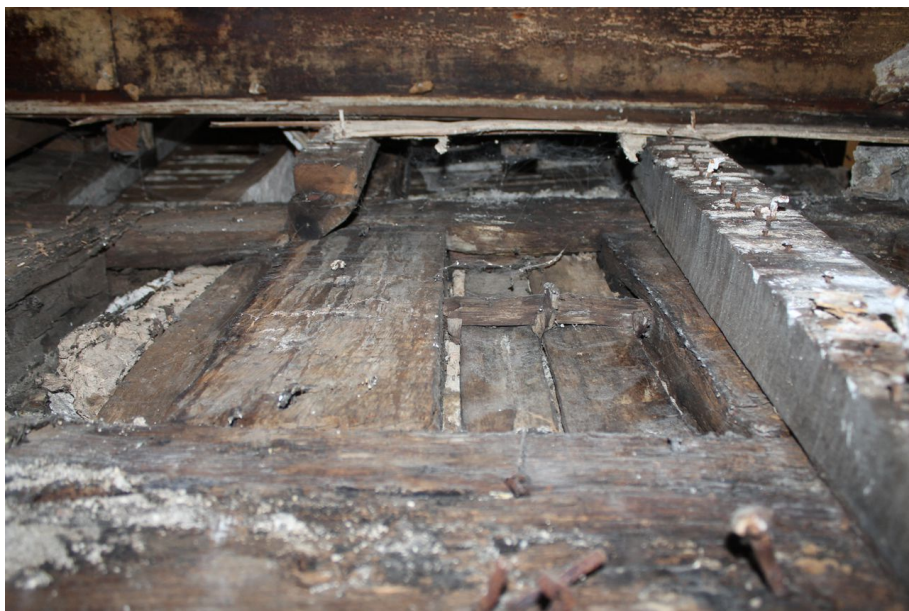
Photograph 44 Detail of timber panelling infill on south-east elevation of Structure A, showing grooves for planks and strap. Photograph taken facing north-west.

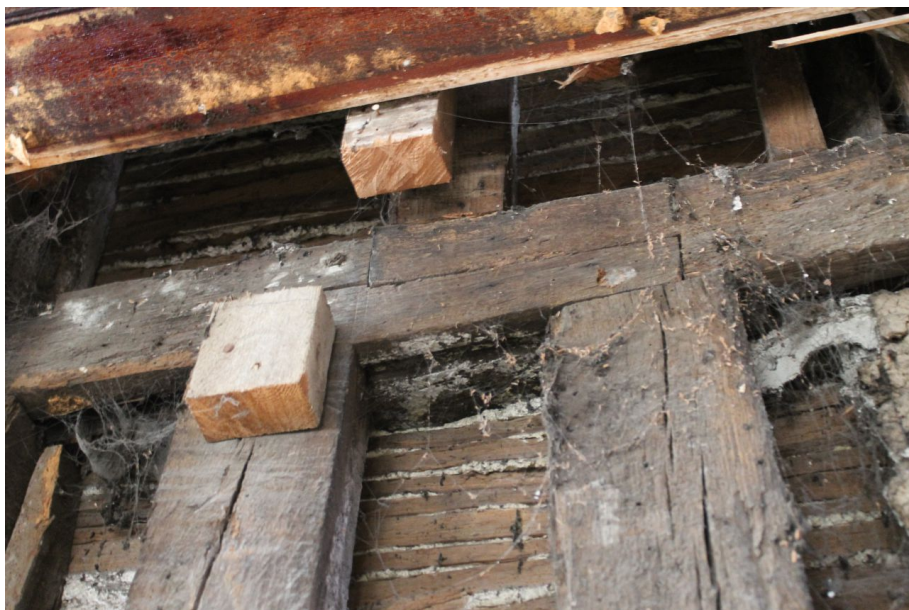
Photograph 46 Detail of scarf joint on south-east girding-beam of Structure A. Photograph taken facing north-west.

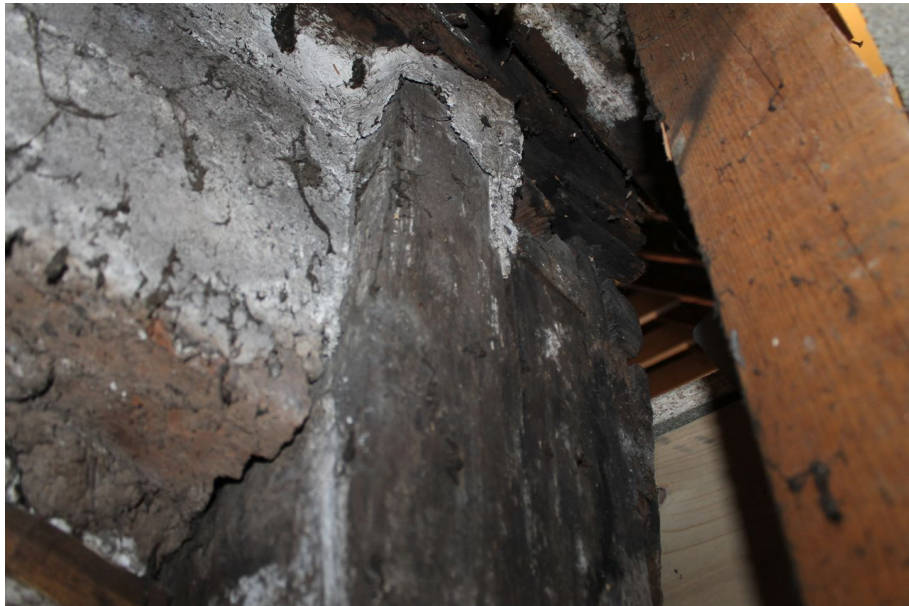
During the second visit, an empty mortice was visible on the north-east side of Structure A's northern corner-post, level with the structure's girding-beam (Photograph 48). This could have supported another girding-beam and suggests that originally Structure A had a wing extending to the north-east. Also visible was what appeared to be original timbers and plaster infill behind the chimney-stack (Photograph 49).

Photograph 48 Detail of mortice on northern corner-post of Structure A, possible for supporting girding-beam of northern wing. Photograph taken facing west.

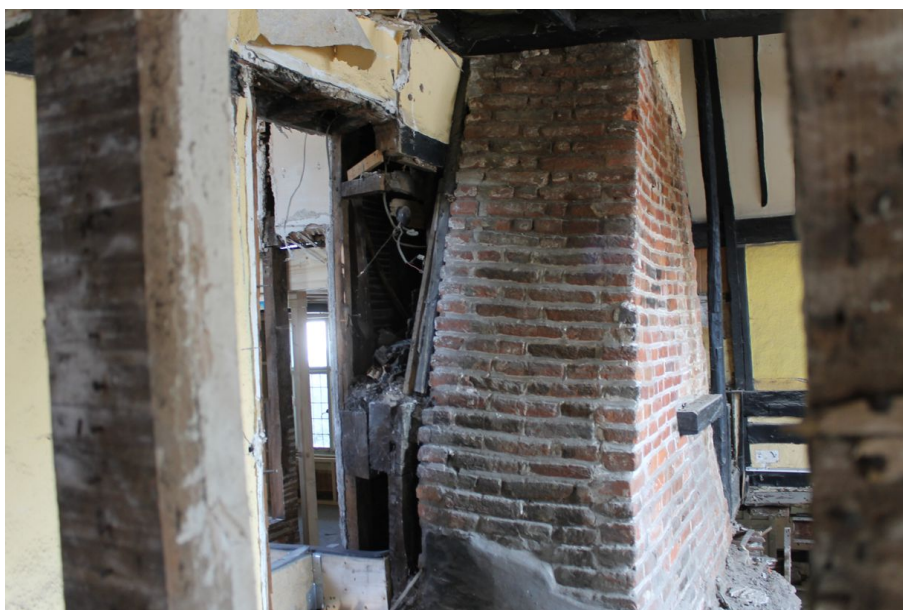
Photograph 49 Detail of north-west side of chimney stack, showing beams and surviving plaster behind in Structure A. Photograph taken facing east.

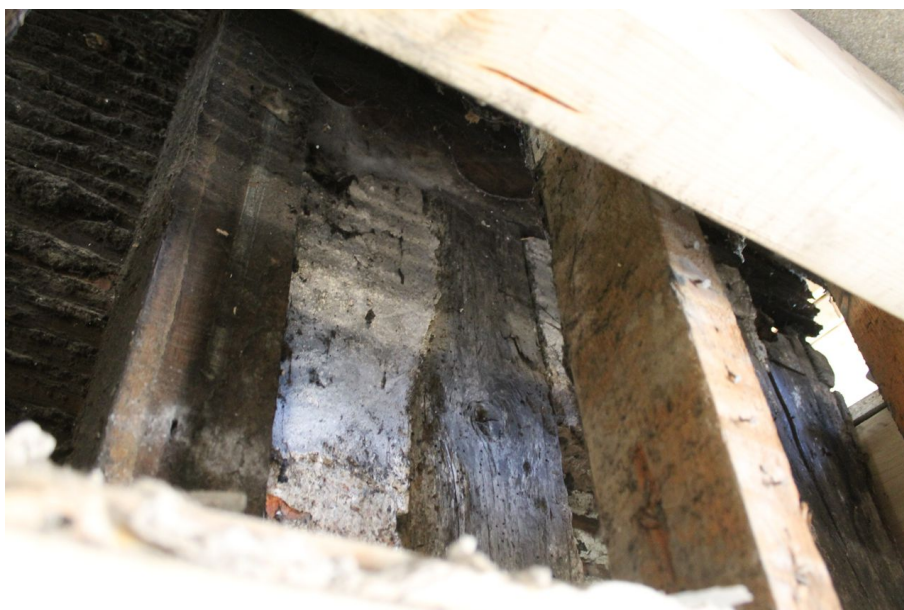
Photograph 50 Timber and plaster behind chimney stack in Structure A. Photograph taken facing west.

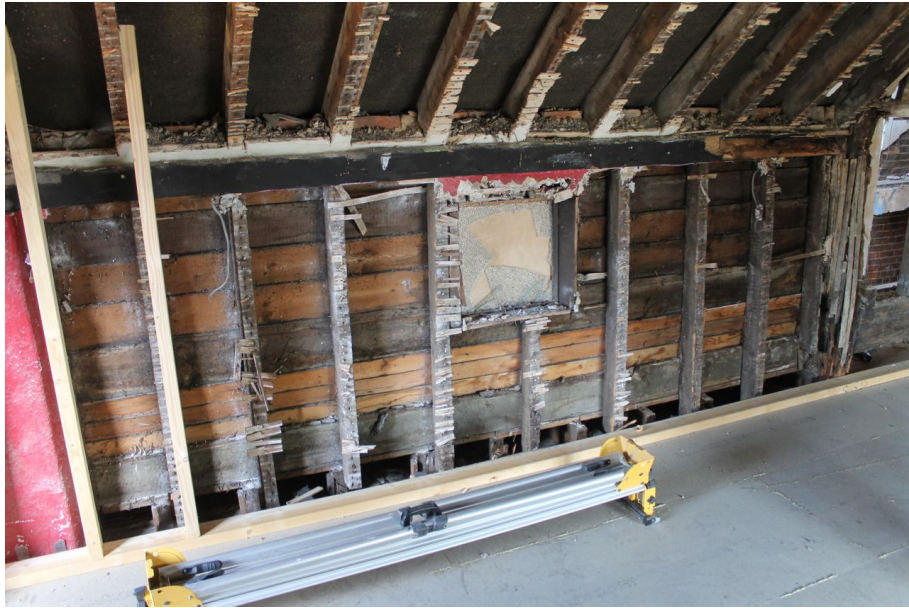
The first-floor has a smaller fireplace in the north-west wall. The interior walls and roof timbers of Structure B were exposed during the second visit, showing that the timber-frame is entirely machine-cut (Photograph 51) and that the brickwork on the ground-floor of the north-east elevation contains another blocked window (Photograph 52).

Photograph 51 Exposed machine-cut timber-frame of Structure B on north-east elevation, including inserted window. Photograph taken facing east.

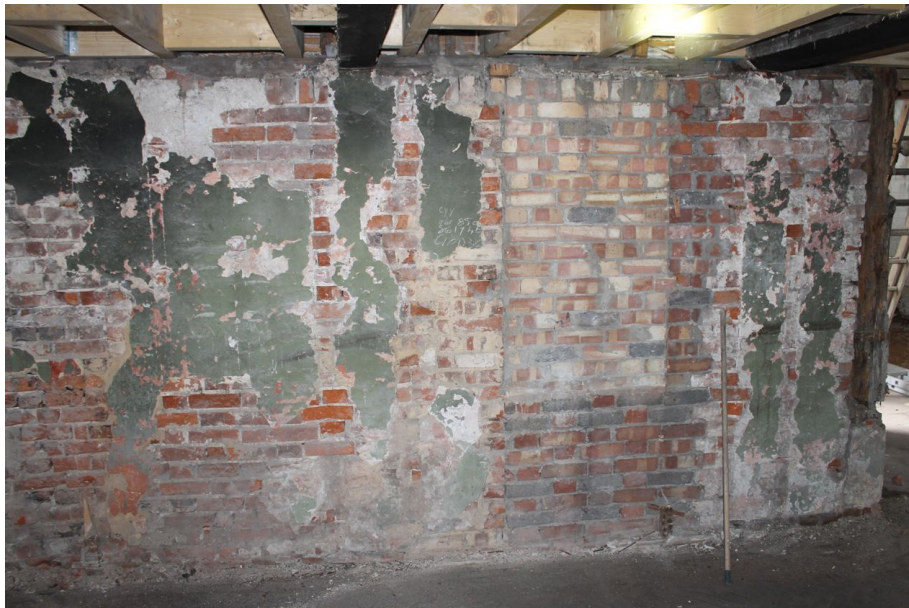
Photograph 52 Exposed brick wall on ground-floor of Structure B, north-east elevation. Photograph taken facing north-east.

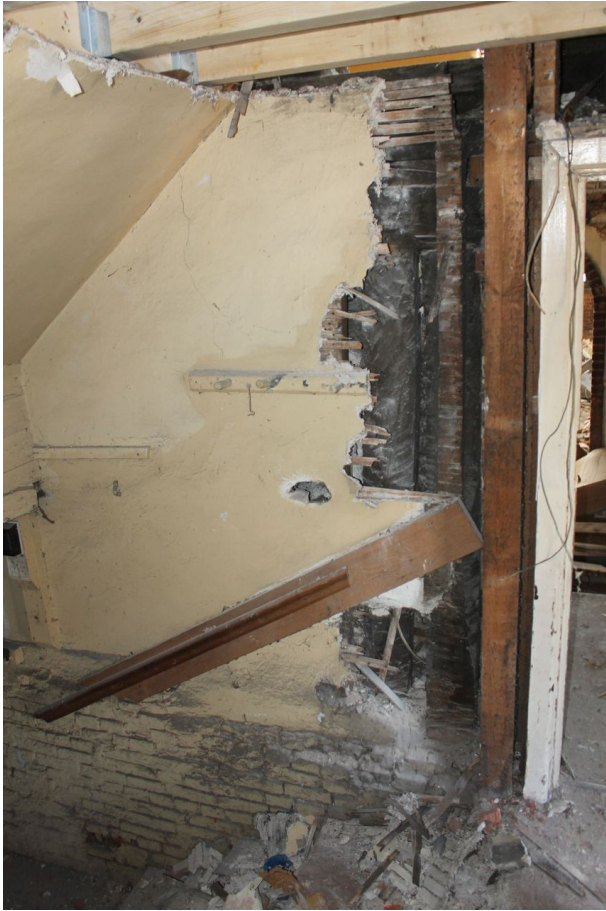
Photograph 53 Partially exposed sill-beam and reused studs behind fireplace in Structure A, supported on the 16th century cellar walls. Photograph taken facing south-east.

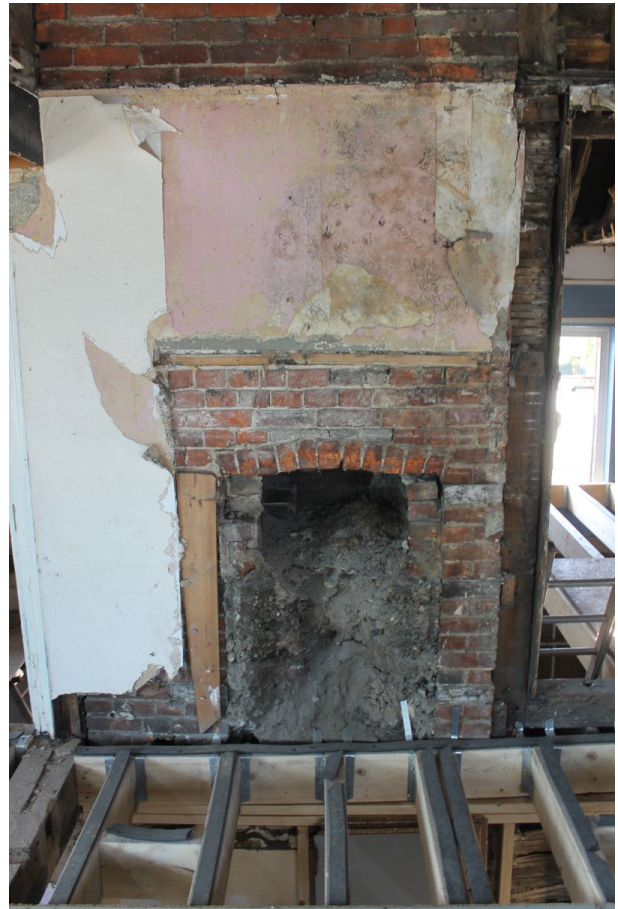
The first-floor of the building is much the same, all the room divisions are modern plasterboard and the apparent timber-framing is purely decorative. The building has clearly been heavily renovated since its construction. The floor level of the first-floor is significantly higher than that of the first-floor of the adjacent building to the north-west (Structure D). The two fireplaces at this level have been blocked up, but they seem to indicate that originally this floor was divided into two rooms, rather than three (Fig 5). During the second visit these fireplaces had been exposed (Photograph 54).

Photograph 54 Exposed fireplace in first-floor of Structure C. Photograph taken facing north-west.

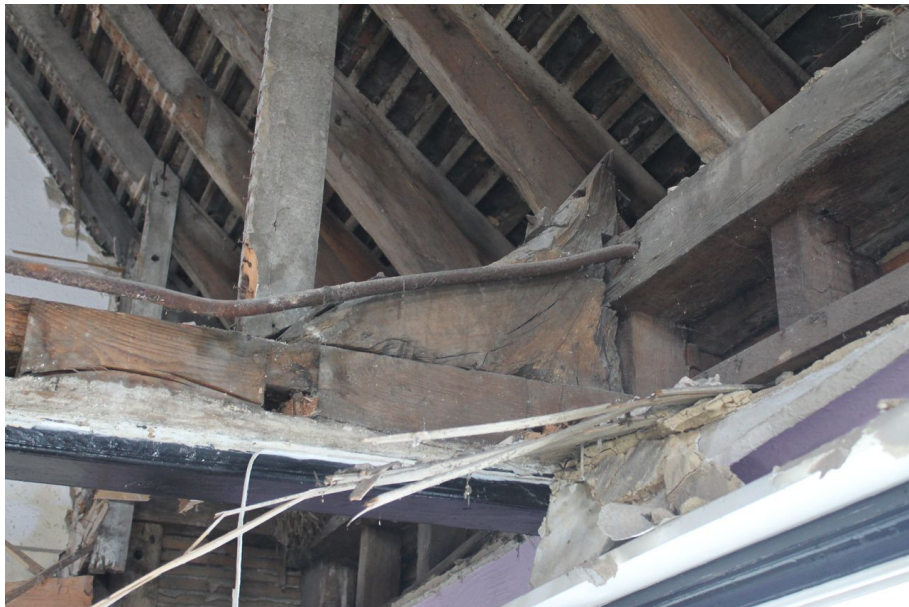
Photograph 55 Detail of inverted knee brace on south-eastern end of the northernmost tie-beam in Structure C. Photograph taken facing north-east.

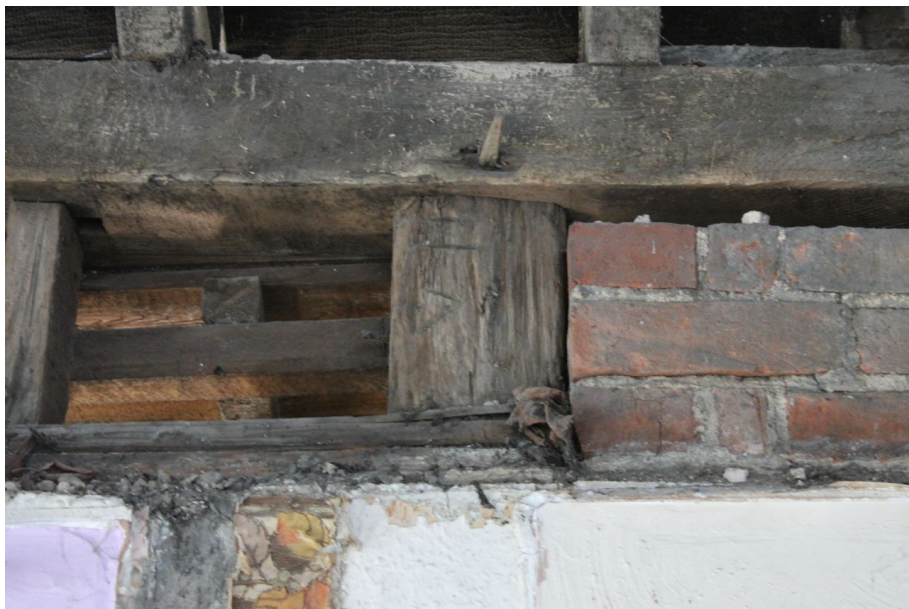
Photograph 57 Detail of carpenter's mark "VII" on stud/storey-post in north-west elevation of Structure C. Photograph taken facing north-west.

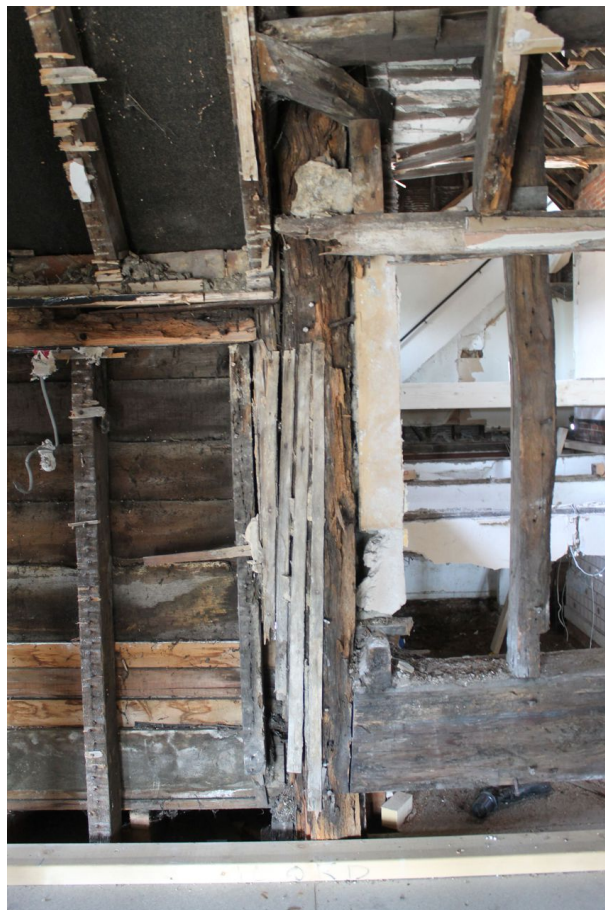
Like Structure C, during the second visit far more of the timber-frame of Structure D was visible, including several reused, hand-sawn, timbers (Photograph 58).

Photograph 58 Detail of west reused corner-post of Structure D, photo taken from within Structure B. Photograph taken facing north-east.
