**Historic building recording at
the White Hart Hotel, 1 High Street,
West Mersea, Essex CO5 8QD**

August 2018 and April 2019

CAT Report 1324
May 2019

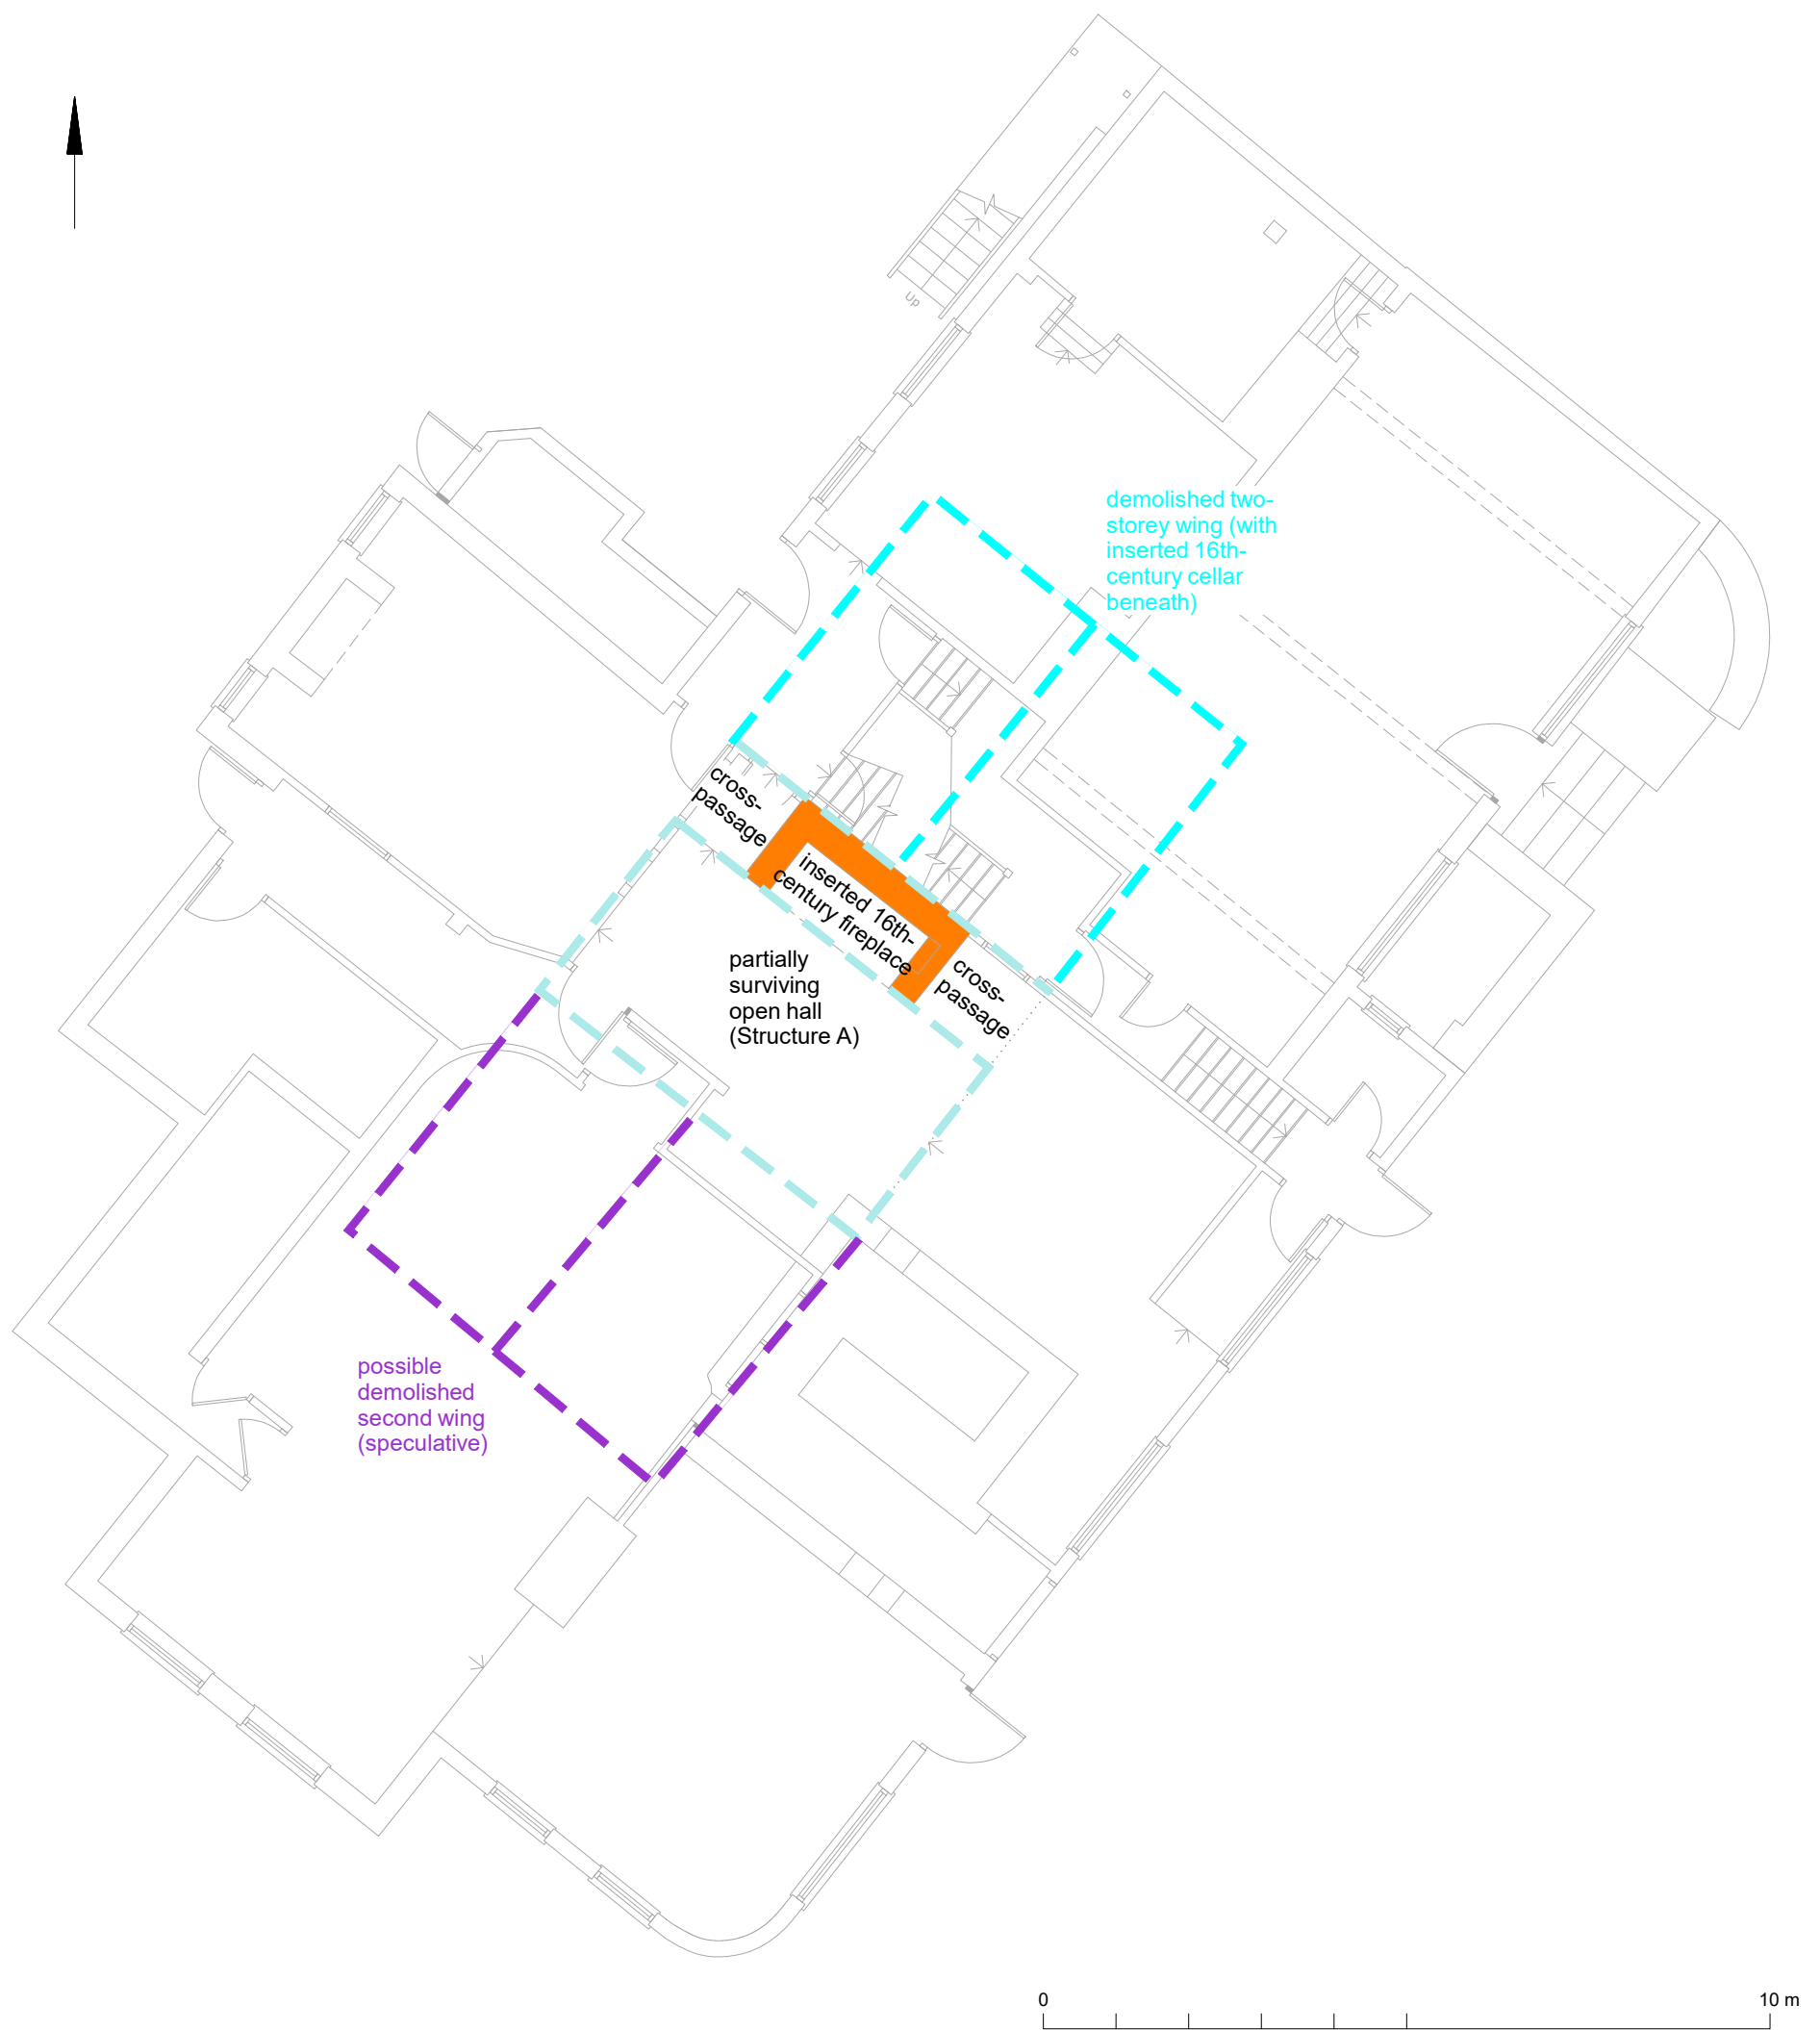
Fig 9 Plan of White Hart Hotel, showing possible original footprint of hall-house (Structure A).

Individually the pieces of evidence detailed above may not be conclusive, but together they at the very least form a compelling argument that Structure A is the remains of the open hall of a medieval hall-house. In all likelihood it was constructed in the 15th century, before having a substantial brick fireplace inserted into its cross-passage, a first-floor added to the hall and a cellar constructed beneath its northern wing in the 16th century. The large amount of later Victorian and modern alterations have resulted in extensive damage to Structure A's fabric, with essentially only the first-floor of the original open-hall surviving, and the cross-wing(s) having been completely demolished with the exception of part of the 16th-century cellar wall, which was incorporated into the cellar of Structure C (Fig 9).
