**Historic building recording at
161 Shrub End Road,
Colchester, Essex CO3 4RG**

December 2018

CAT project ref.: 18/12f
NGR: TL 9740 2351 (c)
Planning reference: 181865
CHER number: ECC4292
Colchester Museum accession code: COLEM 2018.129
OASIS project id: colchest3-336825

CAT Report 1384
February 2019

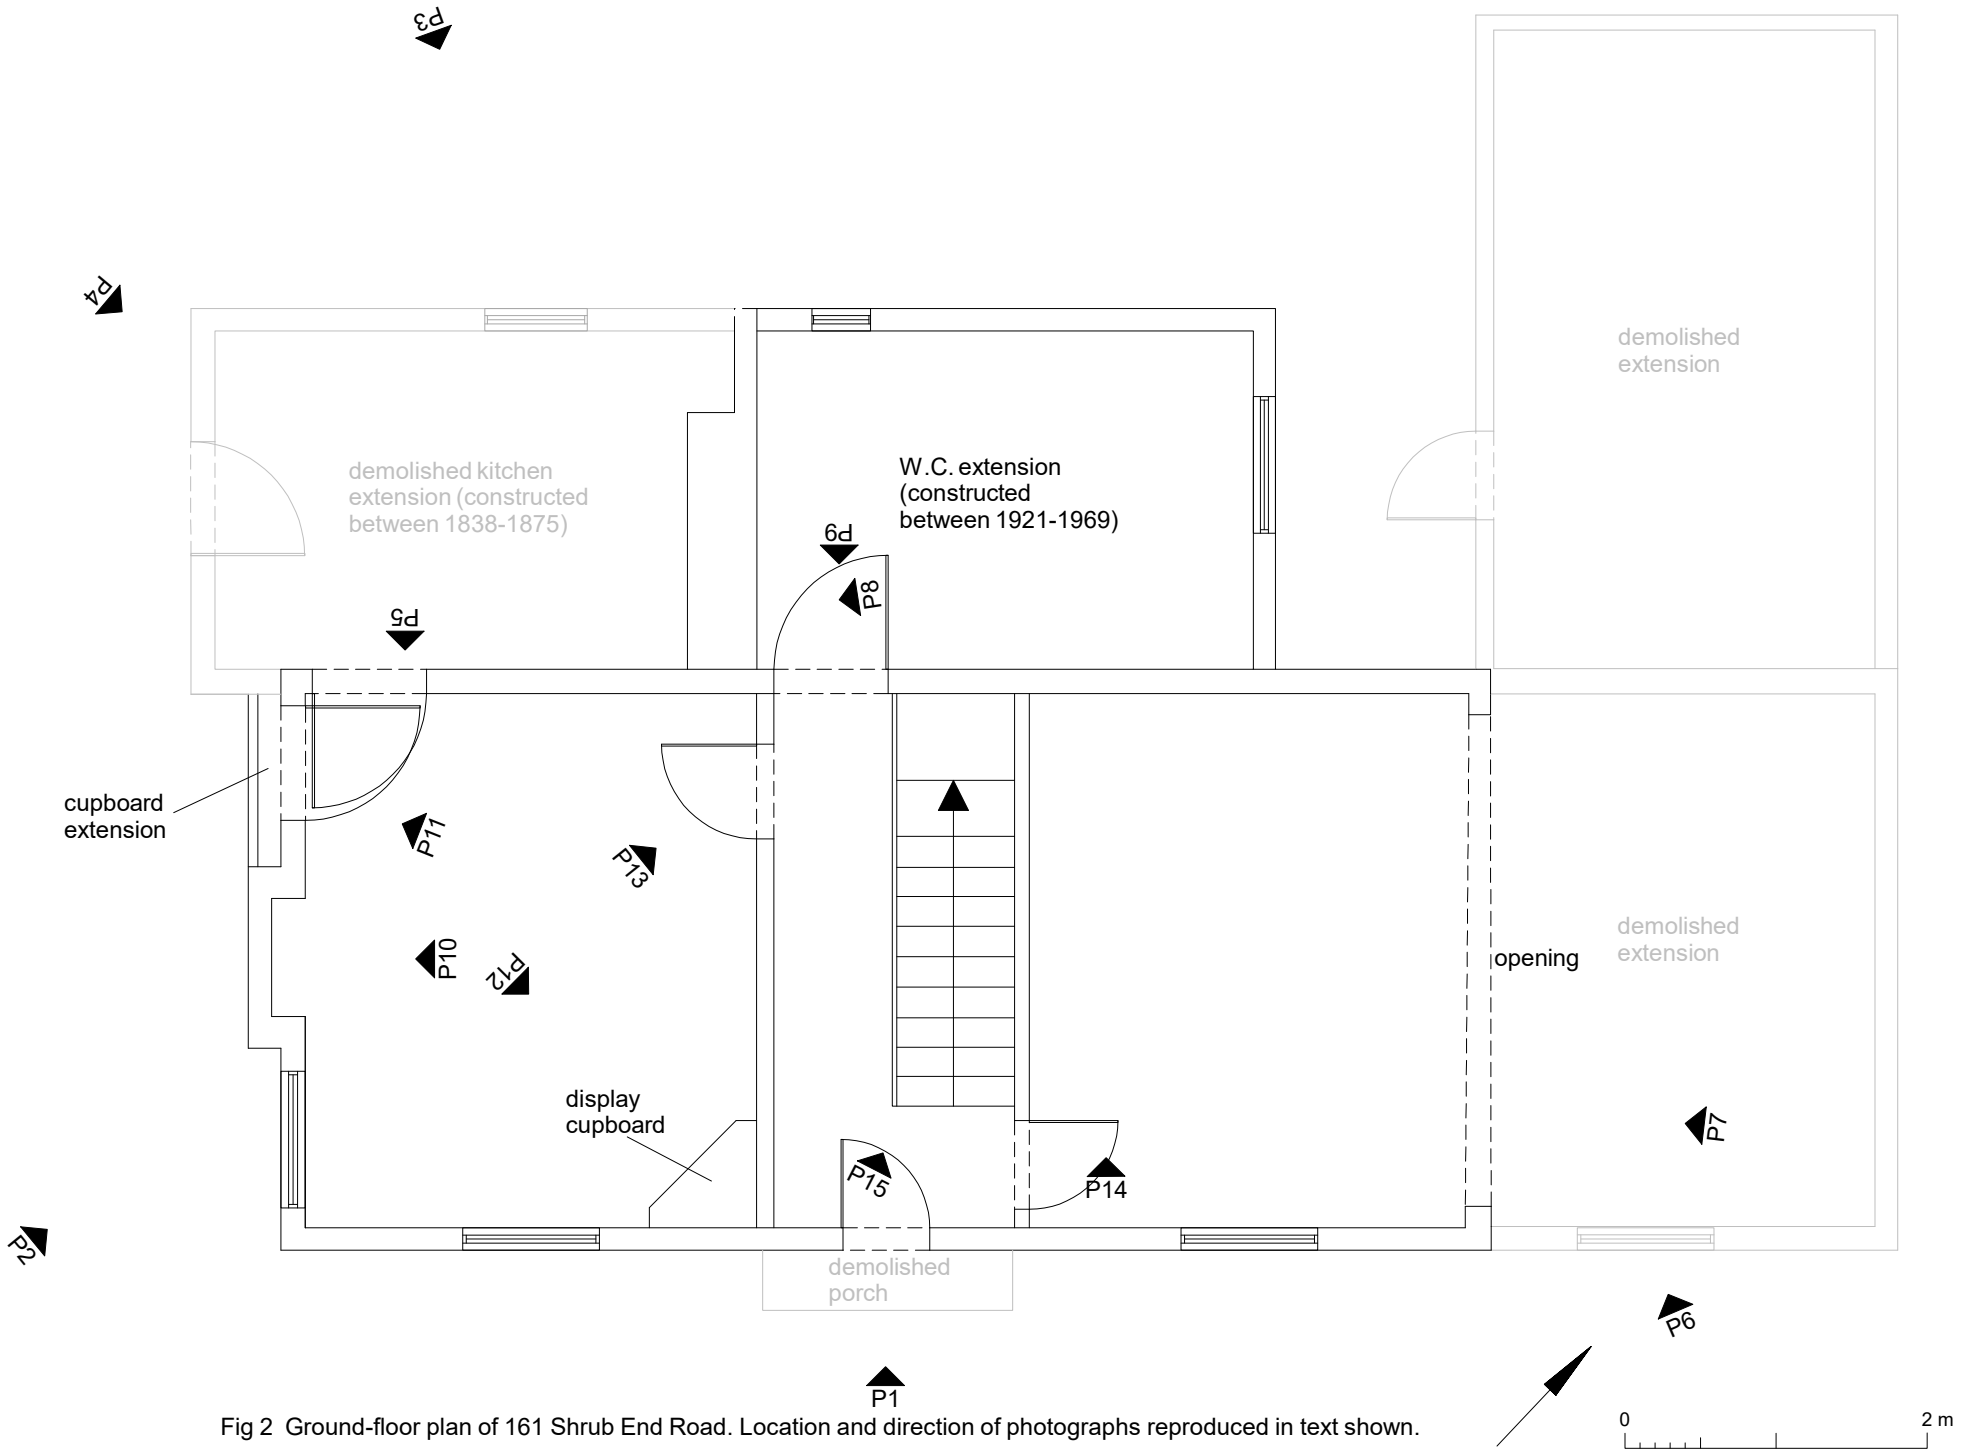
Fig 2 Ground-floor plan of 161 Shrub End Road. Location and direction of photographs reproduced in text shown.

The building has two brick chimney stacks rendered in concrete or plaster. One is at the south-western gable end of the main structure and is original to the building (Photograph 1). The other is at the south-eastern end of the W.C. extension, but appears to have been a part of the, now demolished, kitchen extension (Fig 2 and Photograph 3).

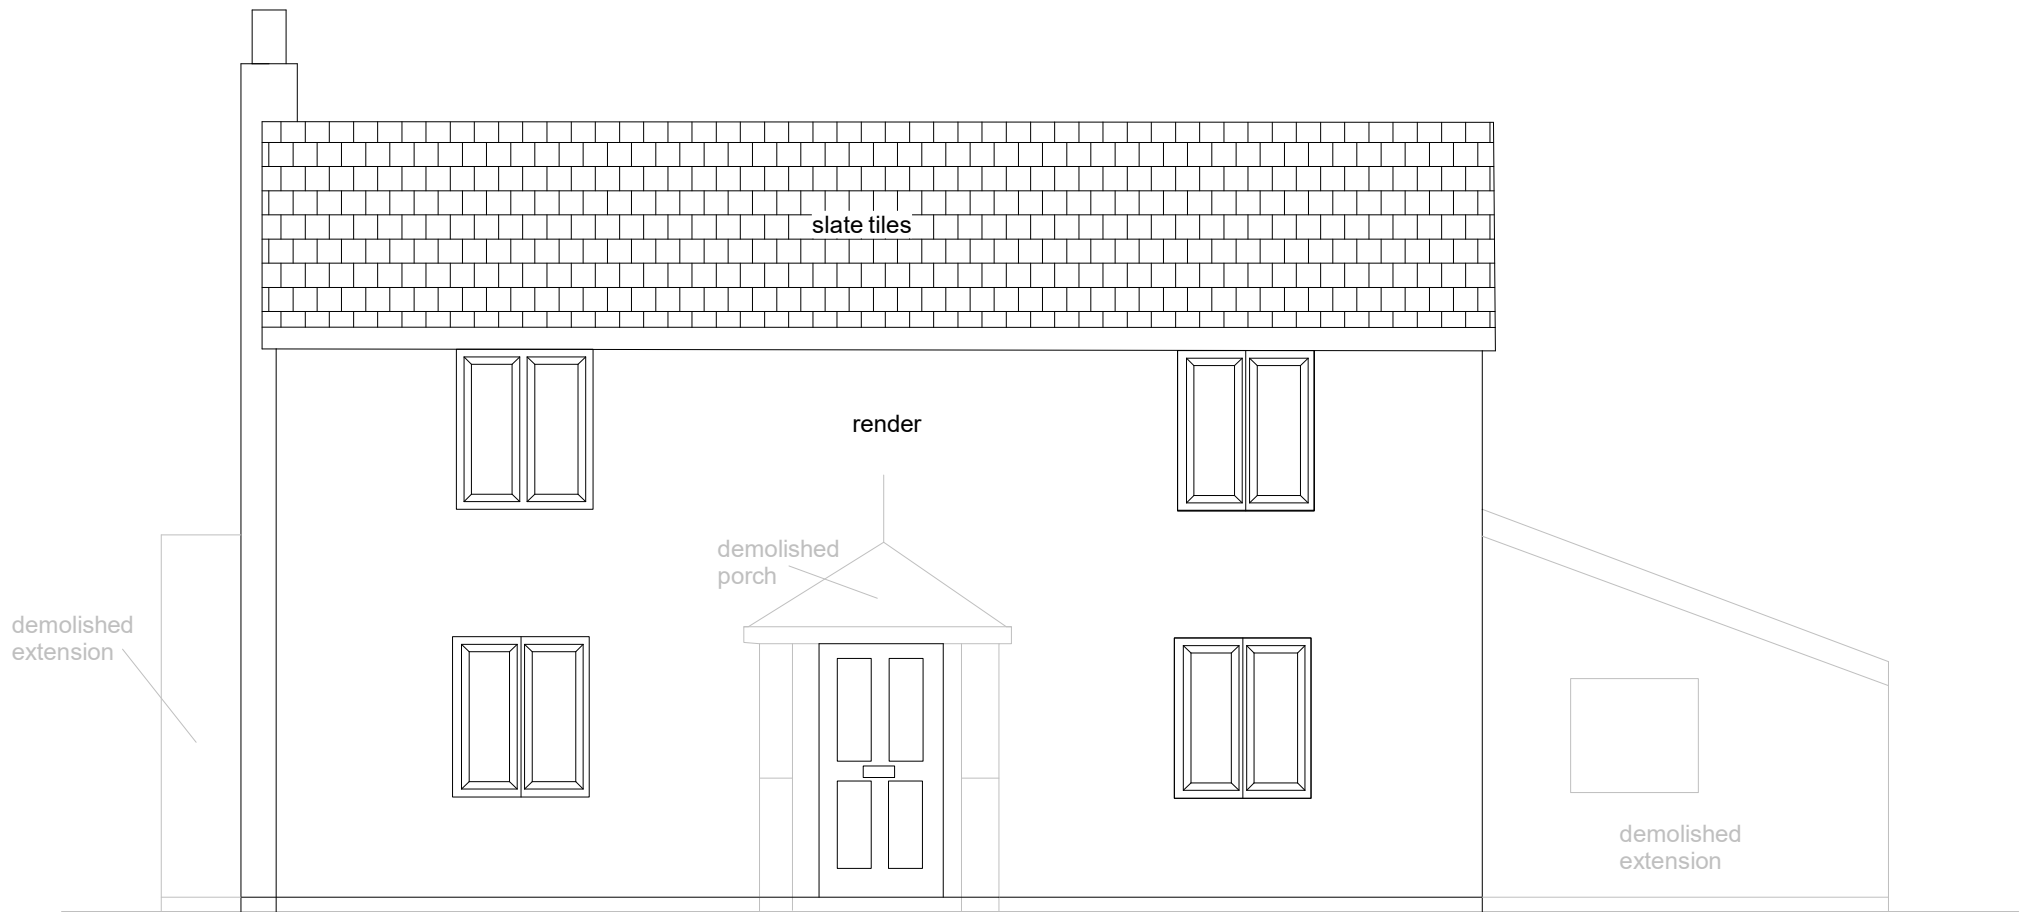
Fig 4 South-east elevation of 161 Shrub End Road.

The building is rendered on this elevation (Photograph 1). It has four windows, two on the ground-floor and two on the first-floor. A modern half-glazed PVC door provides access into the building from this elevation, although it is in an original doorway. The scar of the recently demolished porch is visible around the door; interestingly in the location of the porch the building is not rendered but weatherboarded (see pg 17).

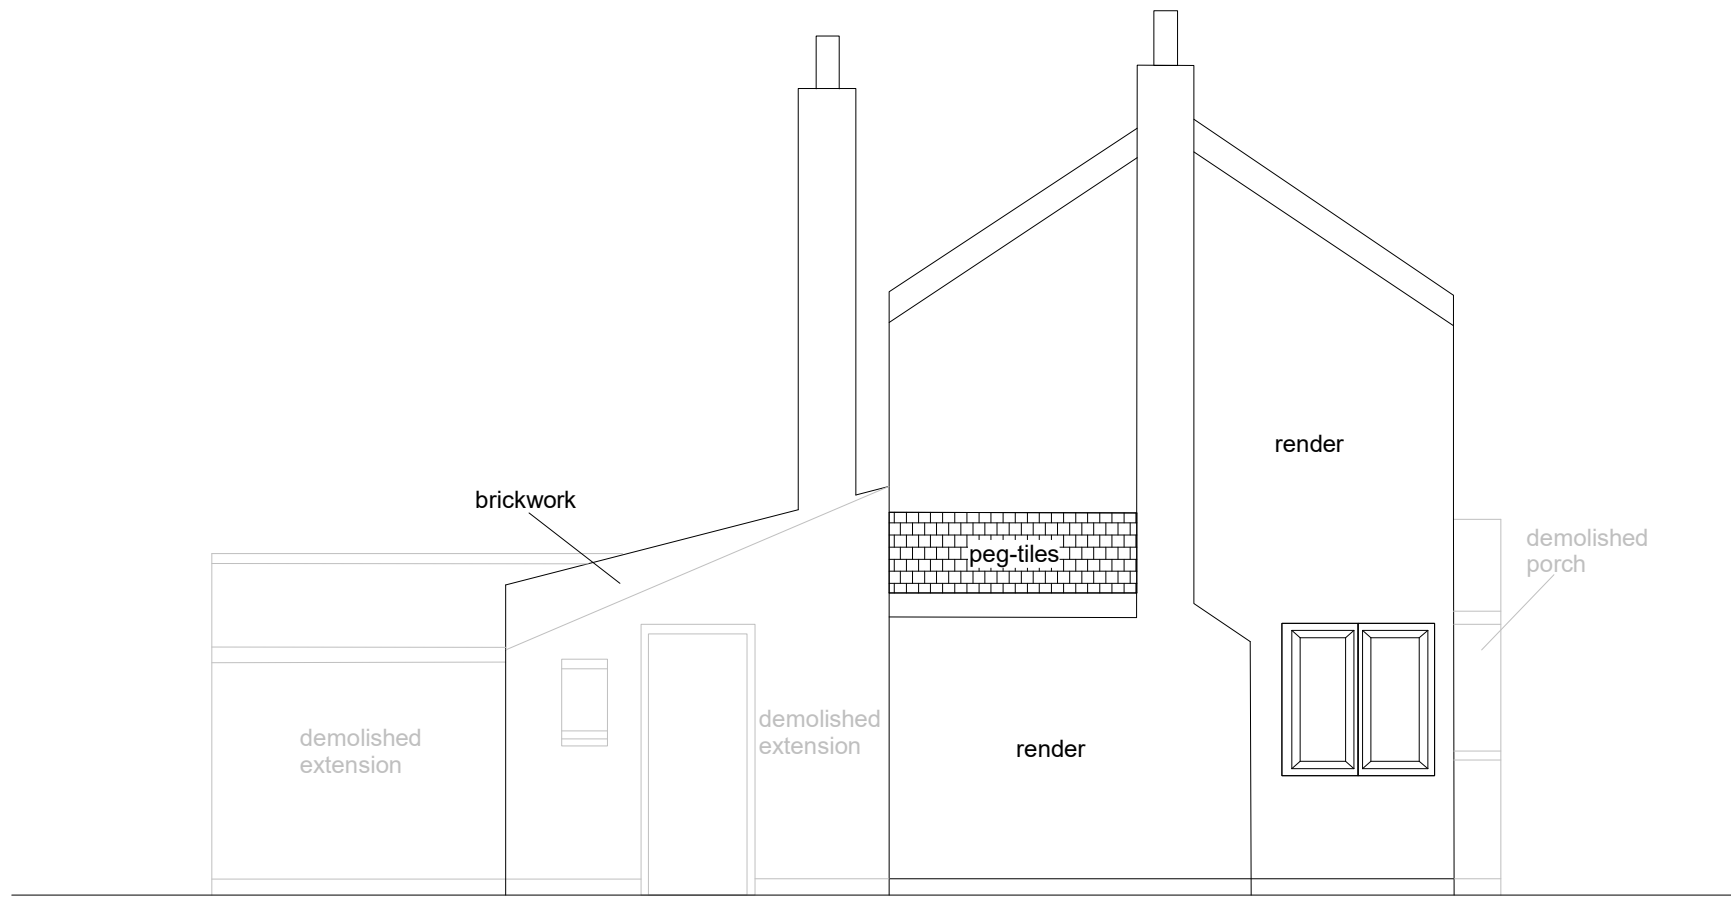
Fig 5 South-west elevation of 161 Shrub End Road.

The building is rendered on this elevation (Photograph 2). It has a single window on the ground-floor. The building's original chimney is on this elevation, as is the small cupboard extension, roofed in peg-tile. The south-west elevation of the W.C. extension comprises the surviving chimney and interior wallpaper of the recently demolished kitchen extension (Photograph 4).

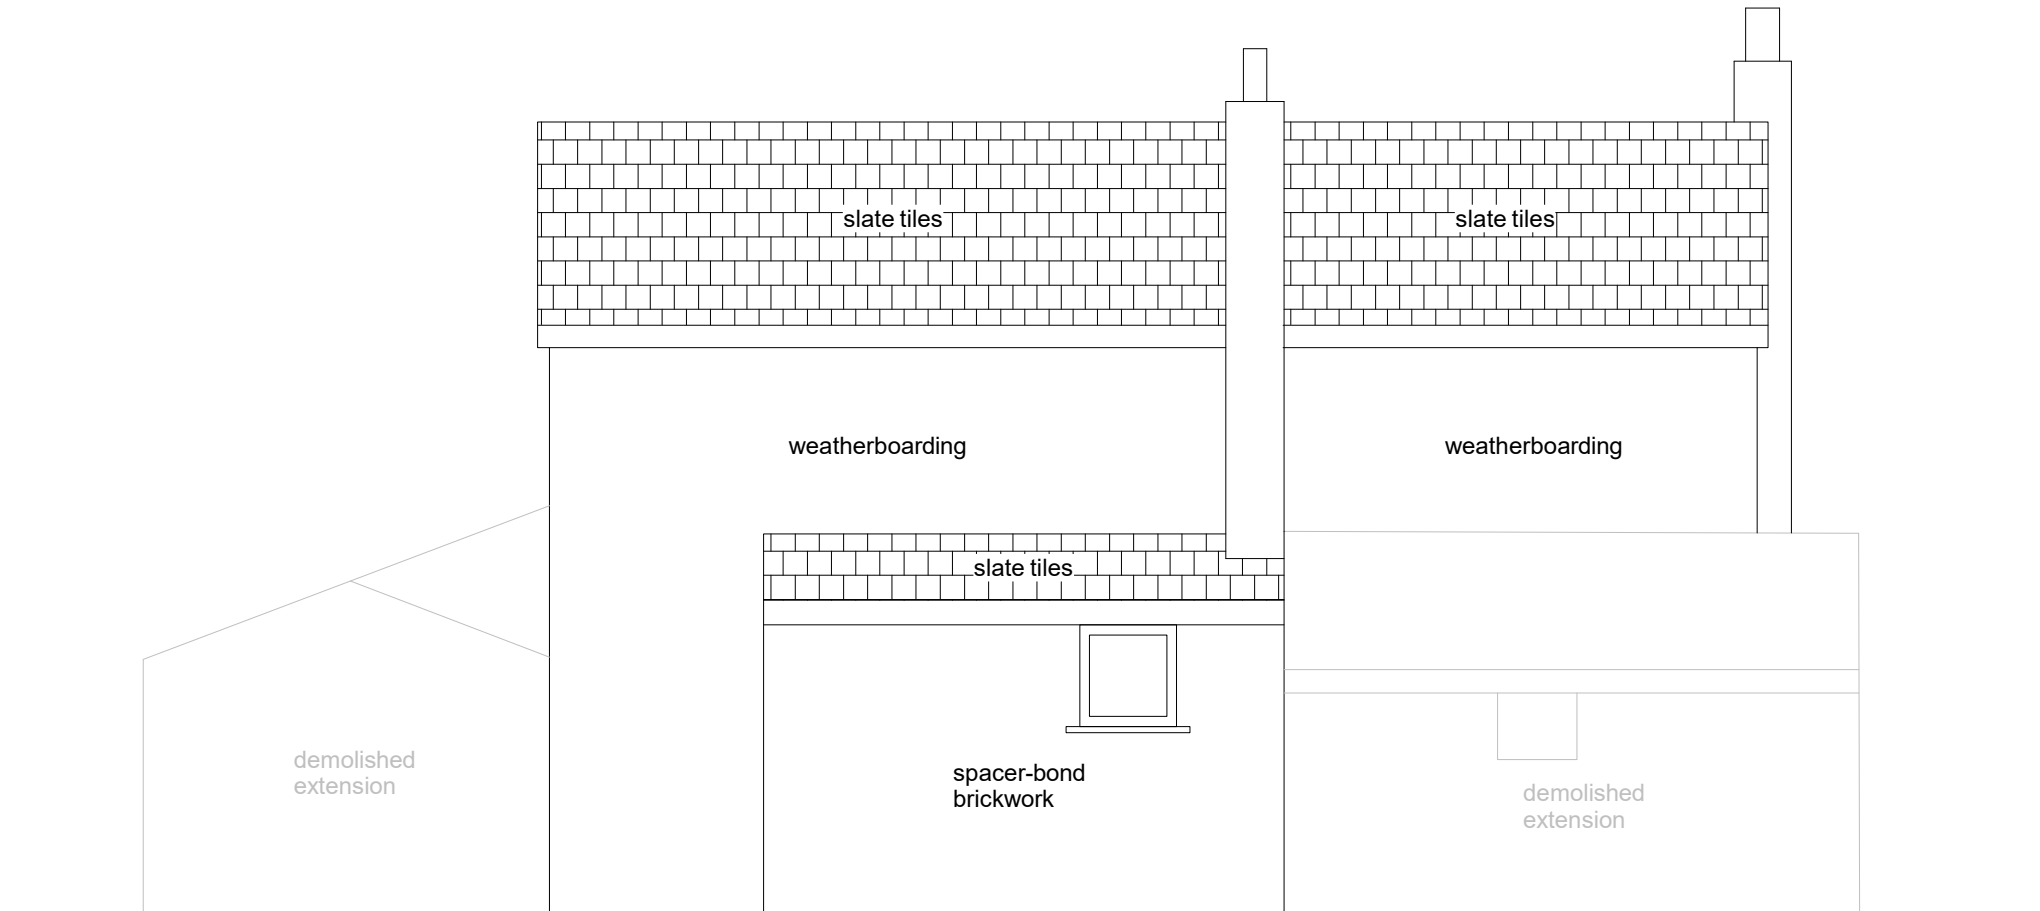
Fig 6 North-west elevation of 161 Shrub End Road.

The main building is weatherboarded on this elevation (Photograph 3). The brick-built W.C. extension is constructed of bricks measuring of 220mm x 100mm x 65mm and has a single modern plastic awning light on this elevation.
