**Historic building recording at
land adjacent to Domus,
The Causeway, Great Horkesley,
Essex, CO6 4EJ**

September 2019

CAT project ref.: 2019/08m
NGR: TL 97857 29899 (c)
Planning reference: 180699
CHER number: ECC4371
OASIS project id: colchest3-365279

CAT Report 1484
September 2019

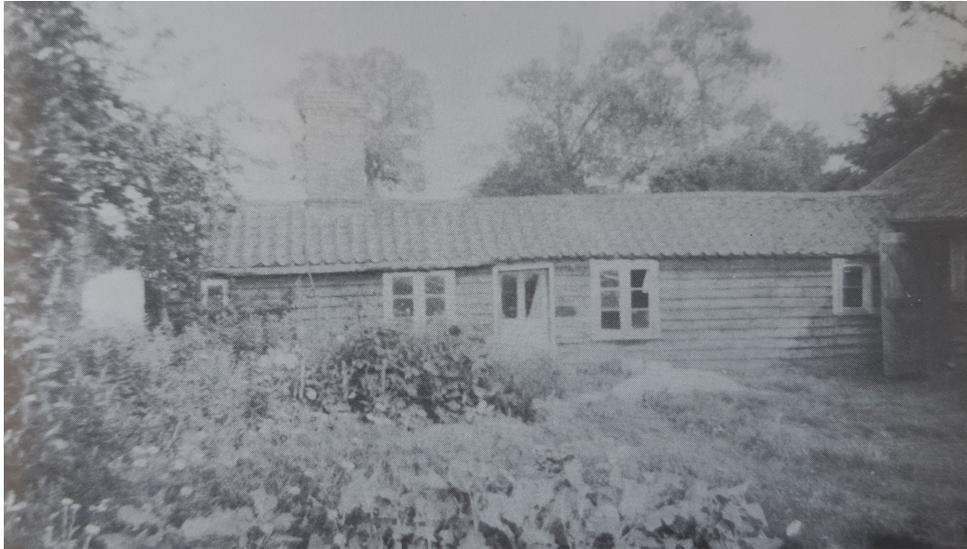
The east-west aligned building is now clearly identifiable as the current building standing on the site. Part of its north-south range survives as a porch attached to the eastern end of the current building (see descriptive record below). A photograph of the north-south range of the building from the early 20th century shows that it had a pantile roof, a chimney, traditional weatherboarding, casement windows and a half-glazed door (Photograph 1).

Photograph 1 Photograph from first half of 20th century showing north-south range of building prior to partial demolition. Only the very southern end of this building survives today (the right of this photo). Taken from May, 1992: photo 30.

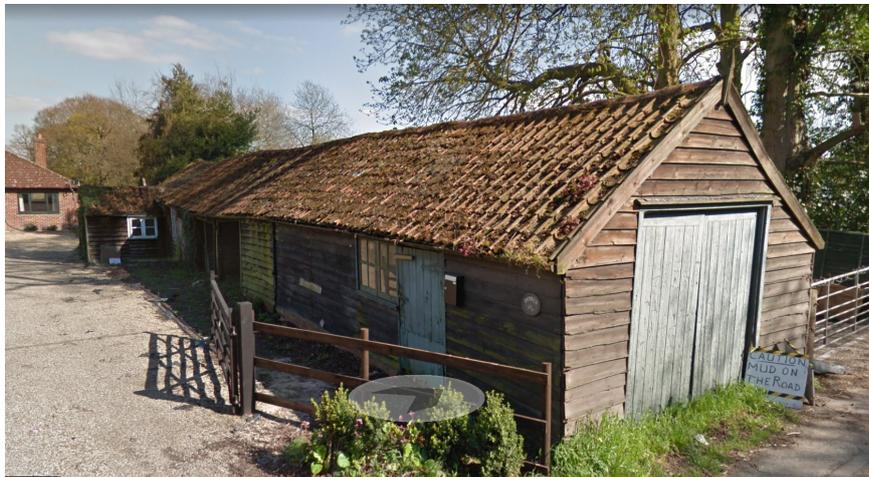
The building has a gabled roof that was until recently covered in pan-tiles (Photograph 2). The timber-frame was covered in traditional weatherboarding.

Photograph 2 Building prior to removal of roof and weatherboarding. Photograph taken facing south-east. Copyright Google 2019, image captured April 2019.

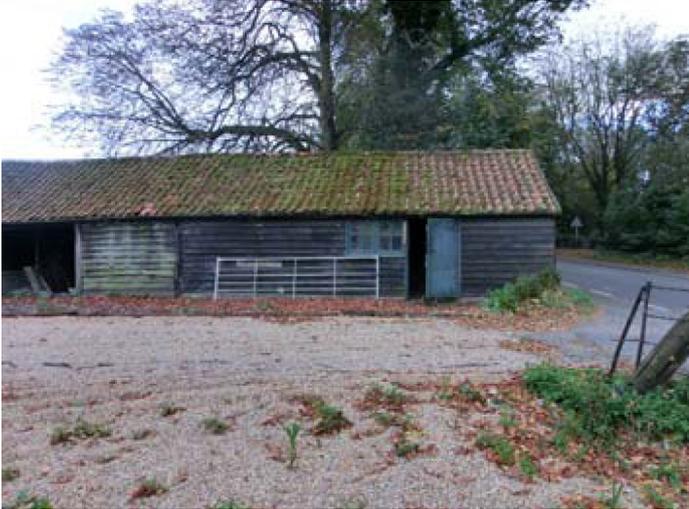
The northern elevation of the building had a vertically-planked door and an 8-light awning window between bays 1 and 2 to the west (Photograph 4). In bay 8 to the east was another vertically-planked door and a fixed 16-light window (Fig 3). The northern elevations of bays 5, 6 and 7 are open and were, until recently, the location of a sliding door (Photograph 5). The remnant of the north-south range extends as a 'porch' from bay 9, and has an entranceway on this elevation (Photograph 6). This 'porch' has a significantly lower ridgeline than the rest of the building.

Photograph 4 Northern elevation of western end of building, showing door and window in bays 1 and 2. Photograph taken facing south.

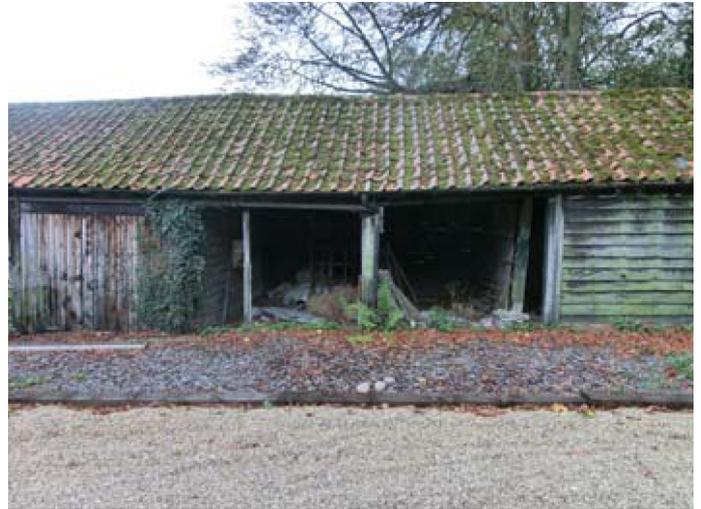
Photograph 5 Northern elevation of centre of building, showing openings in bays 5, 6 and 7. Photograph taken facing south.

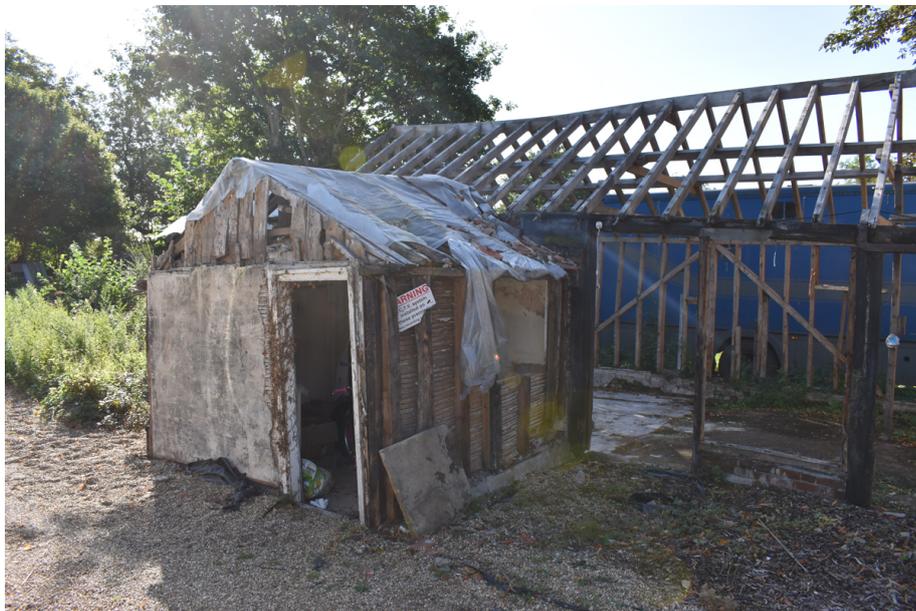
Photograph 6 'Porch' projecting north from bay 1. Photograph taken facing south-east.

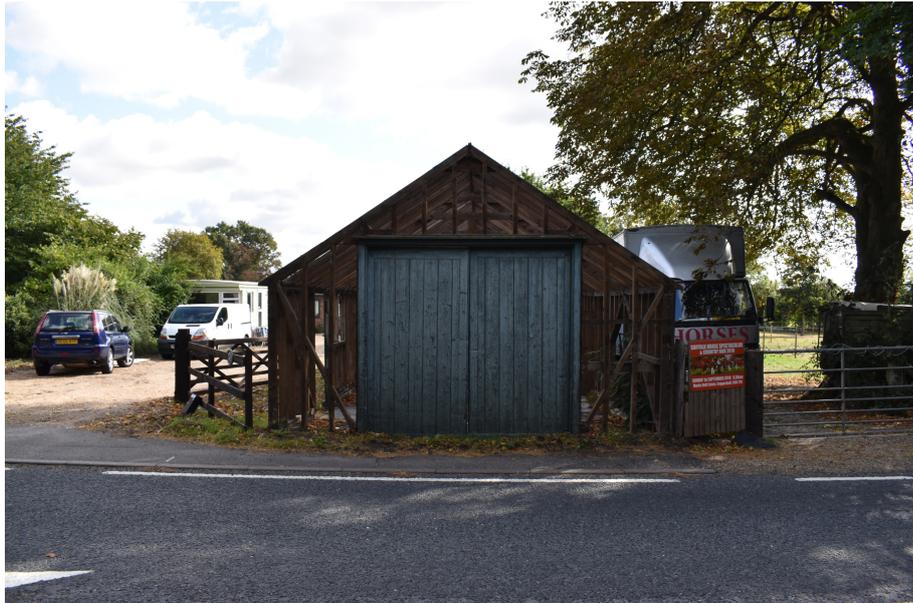
The west elevation of the building contains a pair of full-height vertically-planked double-doors (Photograph 7).

Photograph 7 West elevation of building, showing double-doors.
Photograph taken facing east.

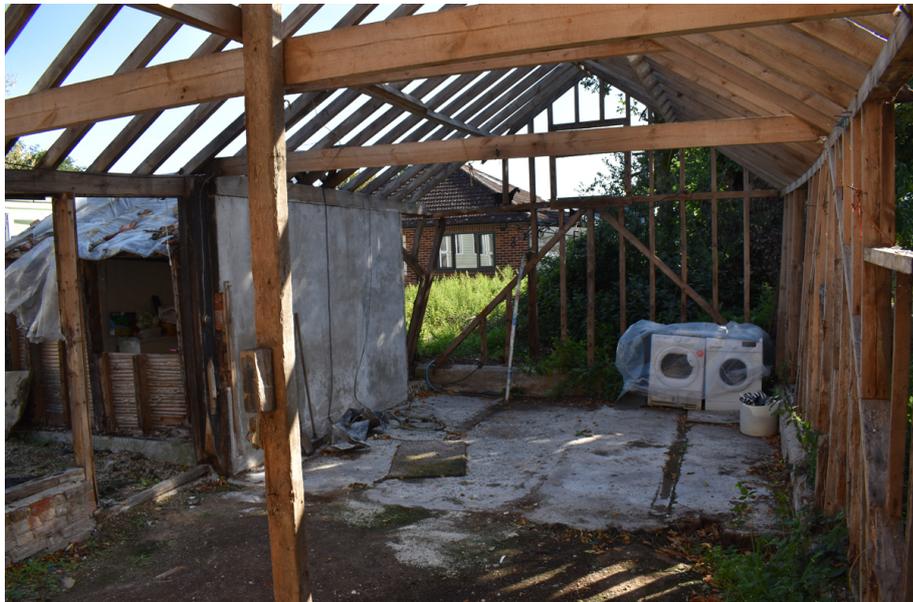
The roof of the building has pairs of rafters meeting at a ridgeboard, and supported by through-collars at bay intervals (Photograph 8). The trusses dividing bays 1-3 have no tie-beams, only the collars (Fig 2). The trusses within the rest of the building do have tie-beams, although there are no braces supporting them (Photograph 8).

Photograph 8 Interior shot of building showing bays 8 and 9. Photograph taken facing north-east.

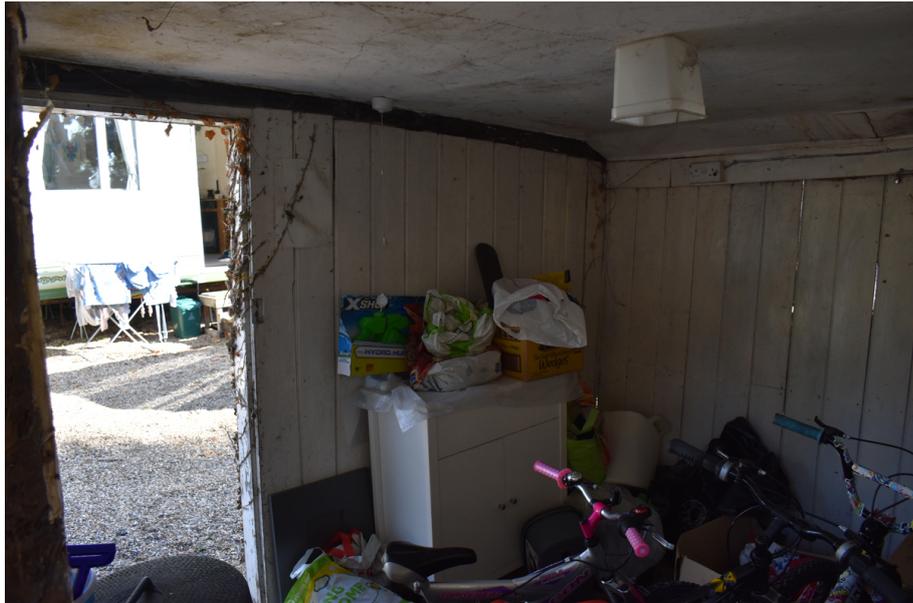
The interior of the 'porch' projecting from the north elevation of the building is covered with lath and plaster or timber-panelling, and is currently in use as a store-room (Photograph 13). The timber frame is partially visible and has no sill-beam. The 'porch' is separated from bay 9 by a red brick wall completely covered in concrete render (Photograph 14).

Photograph 13 Interior of 'porch', showing timber-panelling. Photograph taken facing north-east.

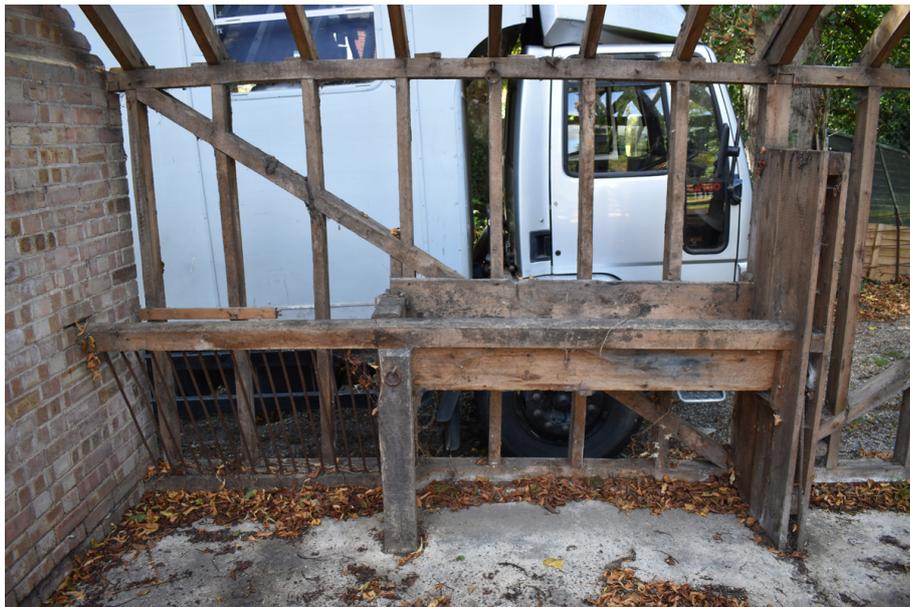
Nothing remains in the way of fixtures or fittings within the building, with the exception of a trough and hay rack in the south of bay 3 (Photograph 16).

Photograph 16 Trough and hay-rack in south of bay 3. Photograph taken facing south.

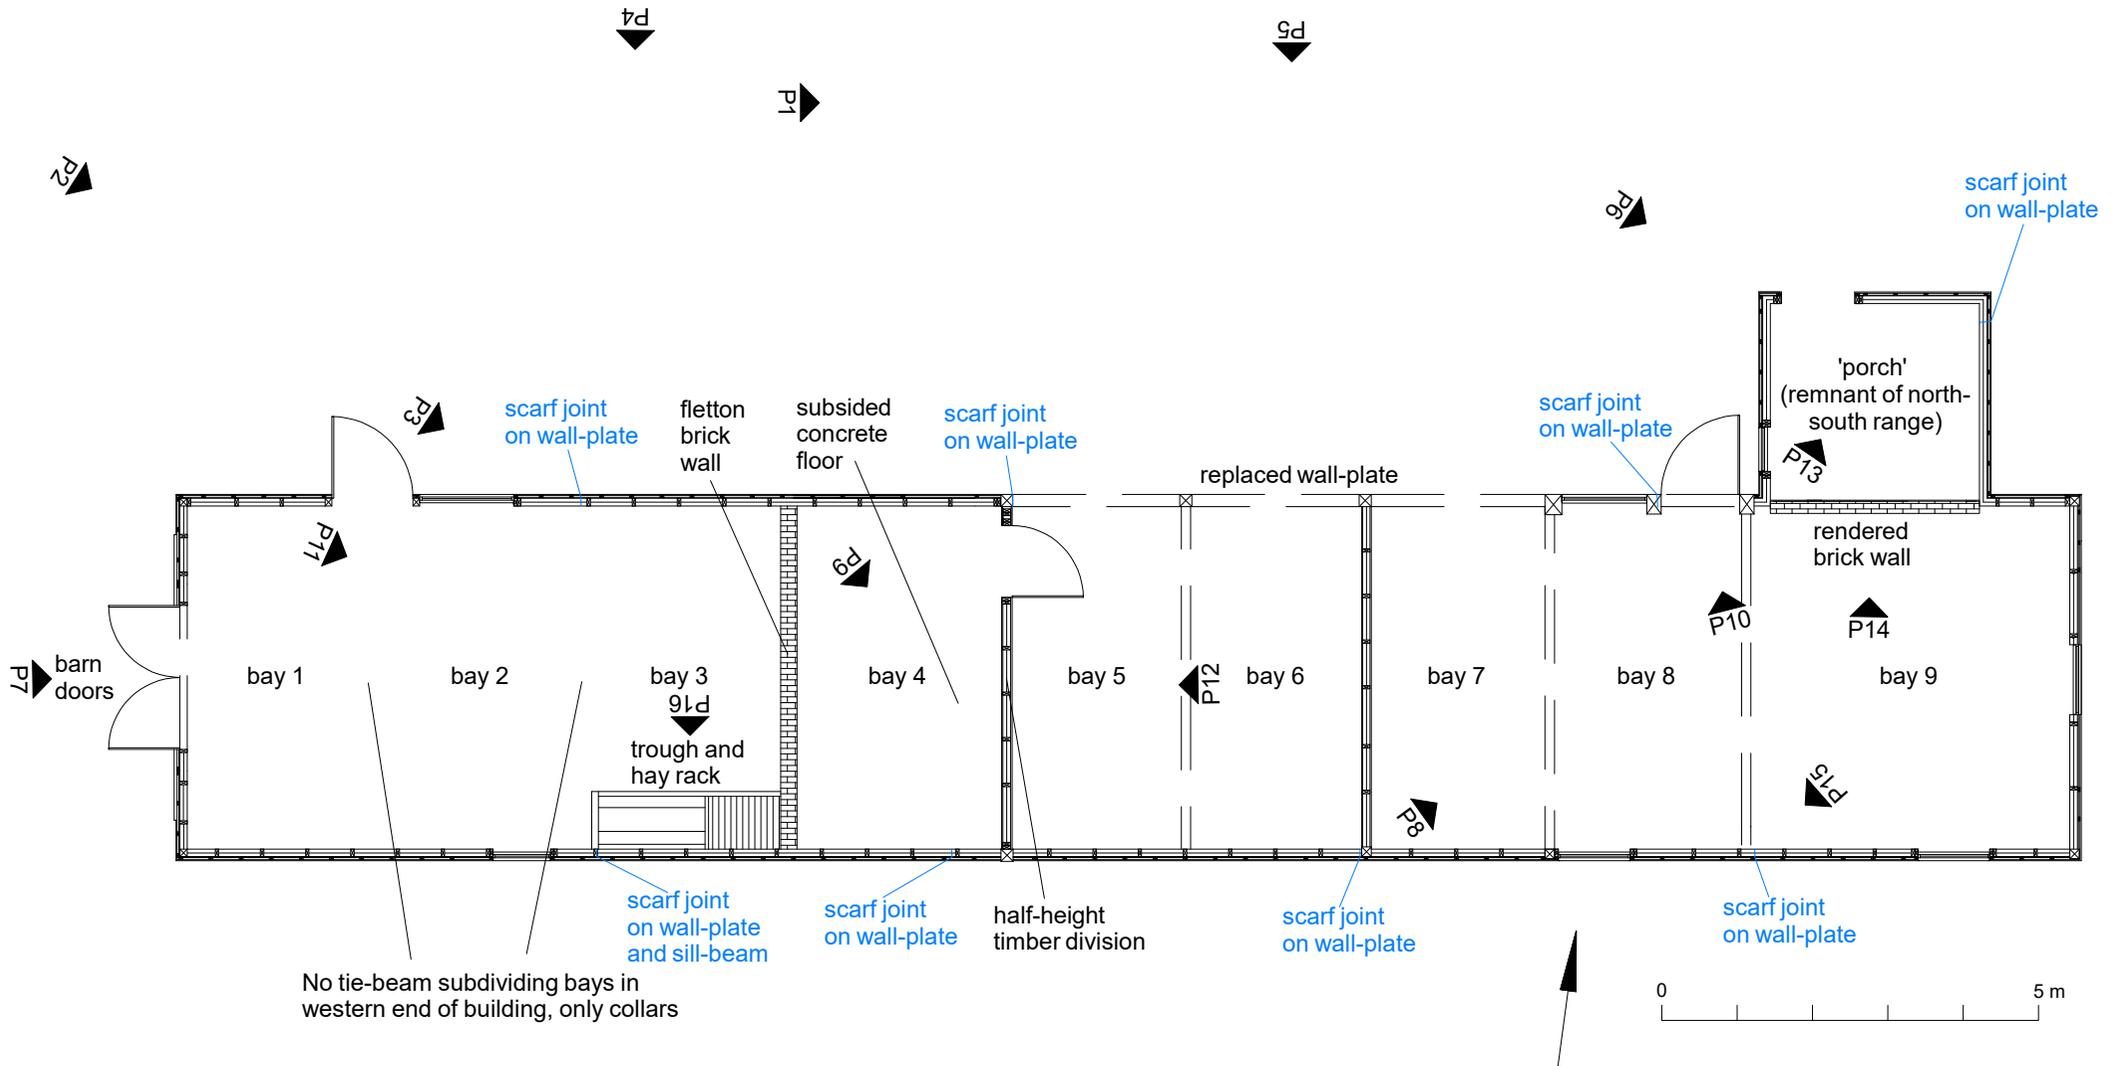
Fig 2 Plan of building, with location and direction of photographs reproduced in text shown.

The building is entirely constructed of machine-cut timber, with no evidence of any hand-sawn timber, either reused or contemporary, anywhere within its frame. The bays of the building all vary between 2.3m and 2.7m in width, with the exception of the easternmost bay, bay 9, which is 4.2m wide (Fig 2).

Part of the northern wall-plate of the building, from bay 5 to bay 9, appears to have been replaced (Photograph 10 and Fig 2). This probably coincided with the installation of a sliding door and the removal of much of the sill-beam on the northern elevation (see exterior description above).

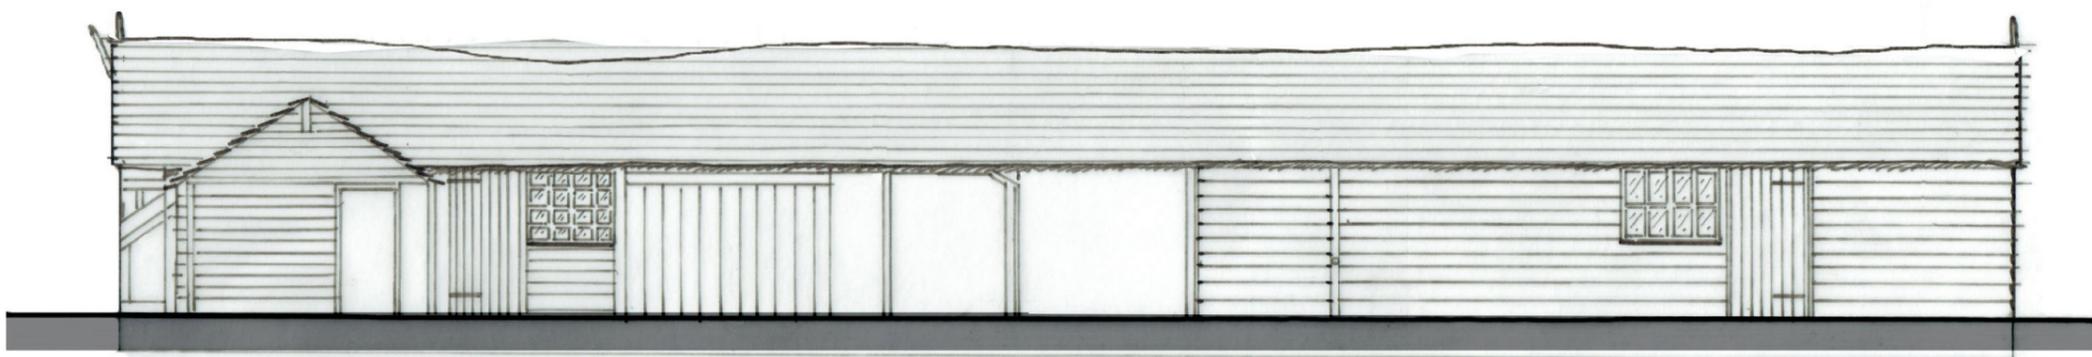
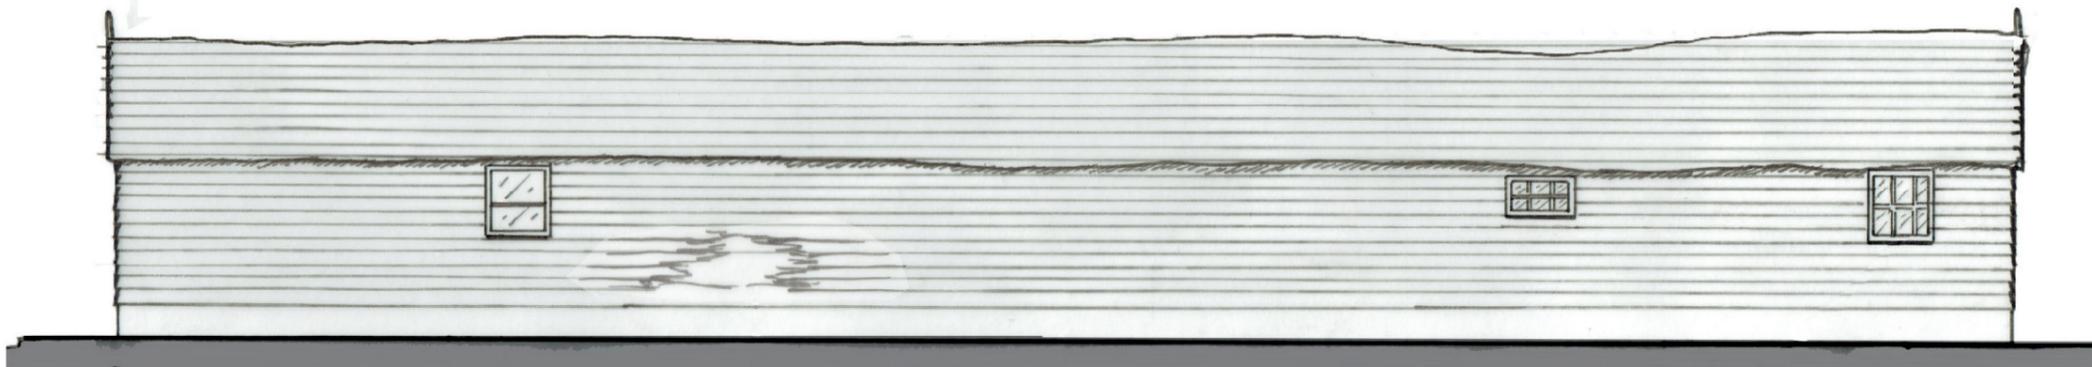
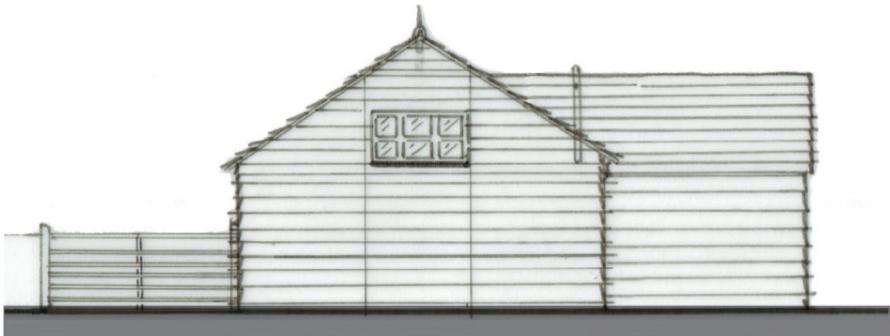
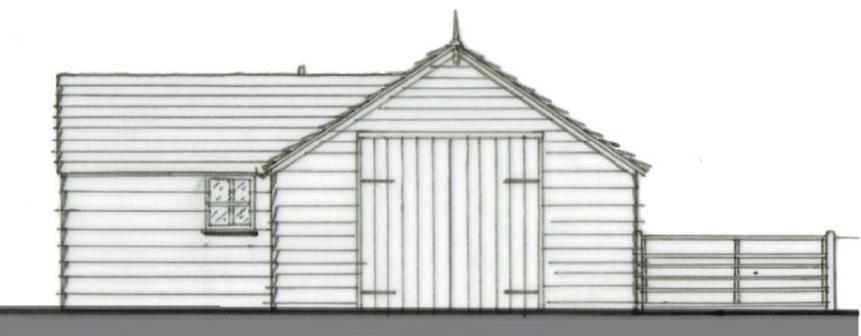
Fig 3 Elevations of building.

The eastern elevation of the building had a fixed six-light window in the gable, but no other features (Fig 3).

The southern elevation of the building had no features except for three windows, a six-light one in bay 9, a six-light one in bay 8 and a two-light one in bay 2 (Fig 3).
