**Historic building recording at Spaynes Hall,
Cherry Lane, Great Yeldham,
Essex, CO5 4HH**

June 2021

CAT Report 1679
June 2021

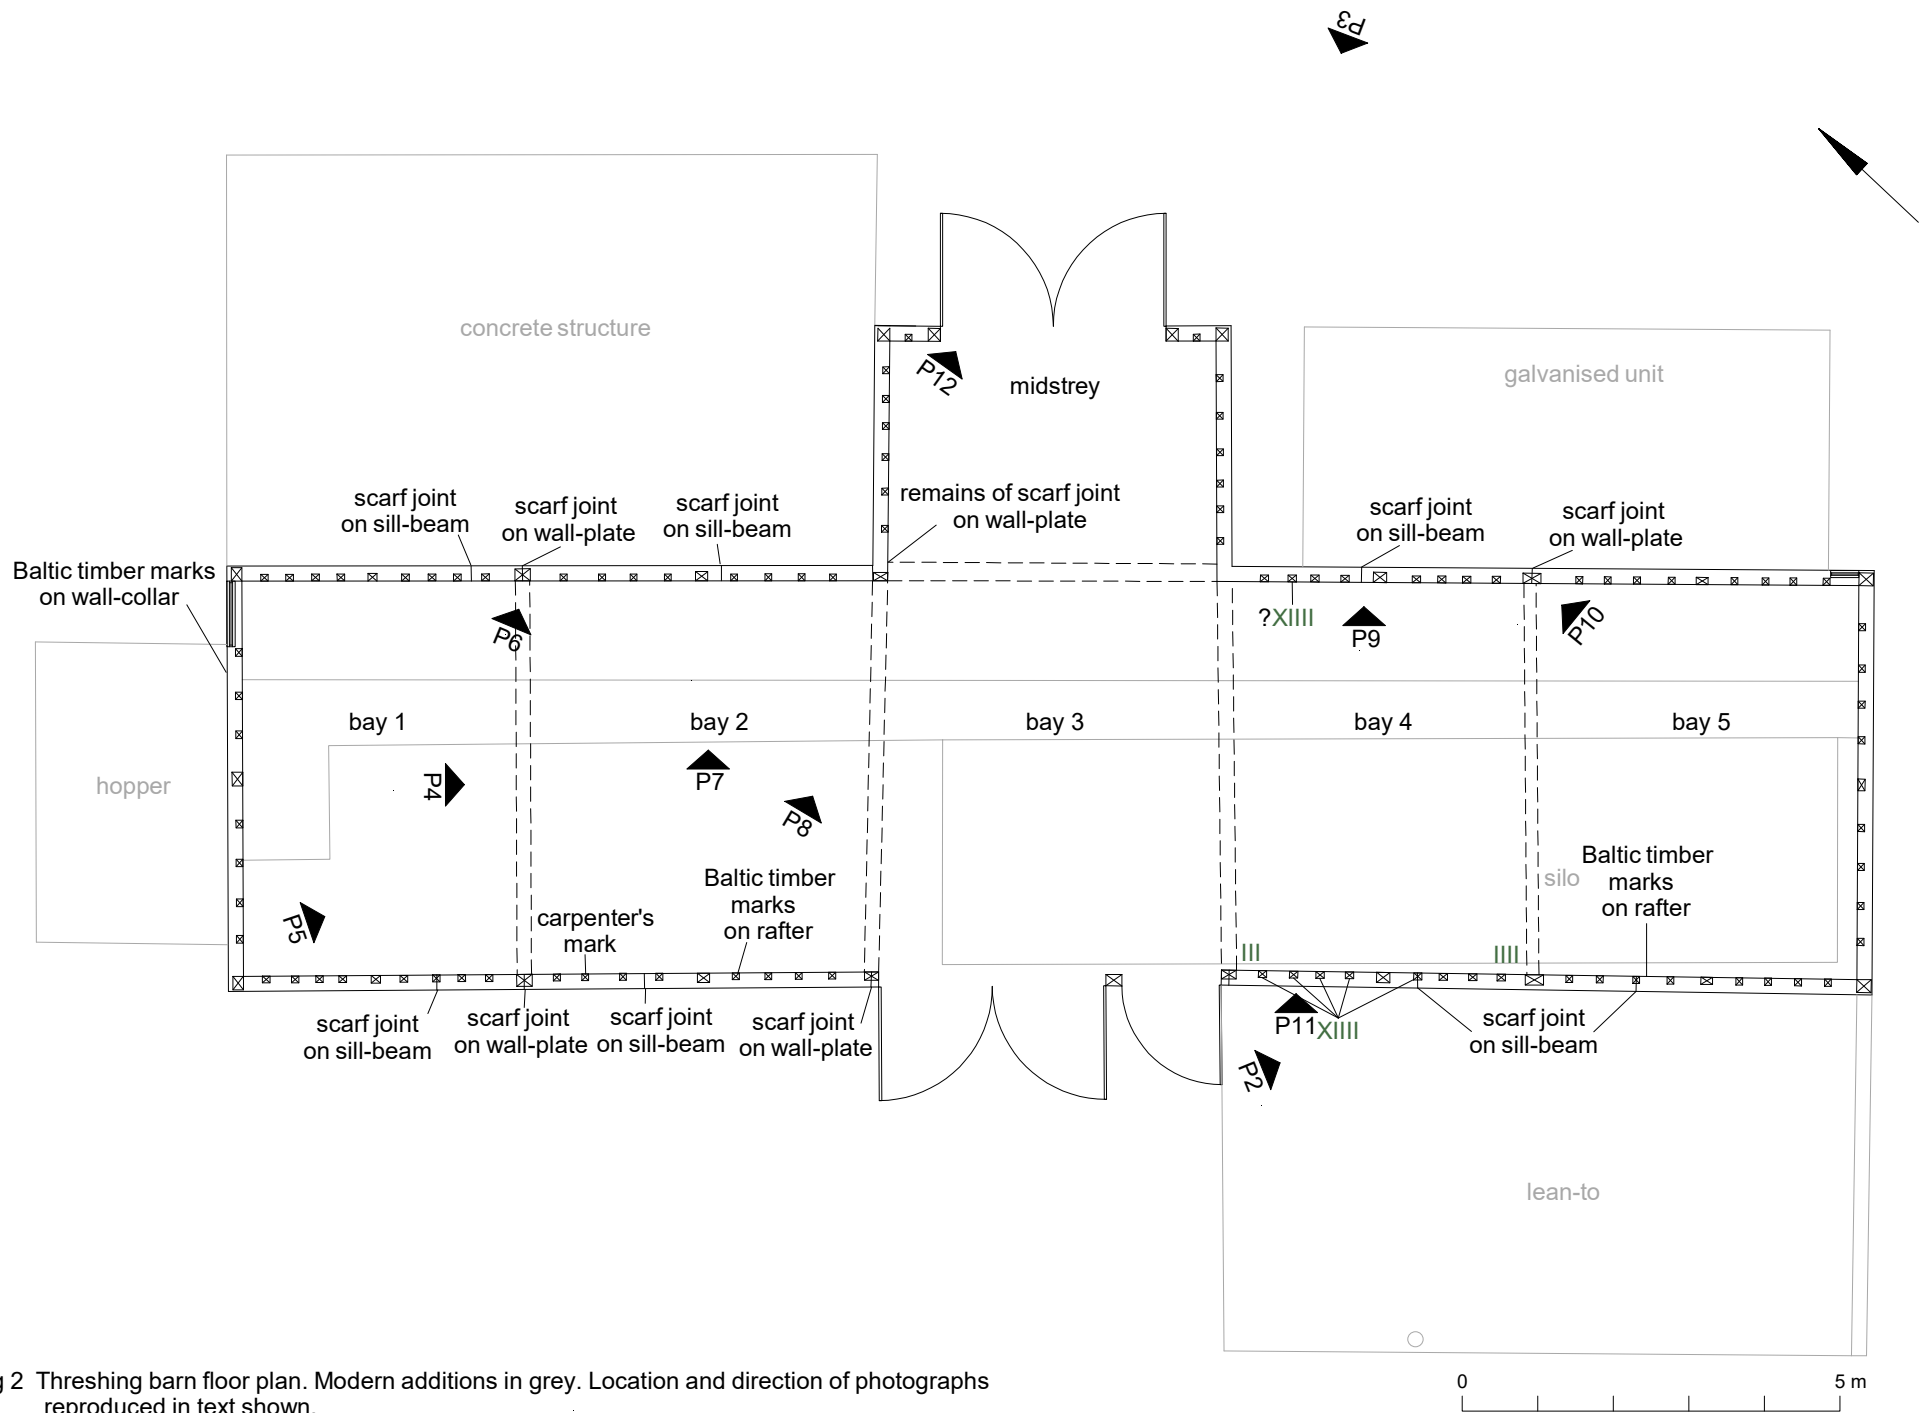
Fig 2 Threshing barn floor plan. Modern additions in grey. Location and direction of photographs reproduced in text shown.

The threshing barn is timber-framed structure, aligned north-west/south-east with a midstrey projecting from the north-east elevation. The barn measures 21.8m by 8.6m and covers an area of approximately 137m squared (fig 2).

The building consists of five bays which have been labelled 1-5, from north-west to south-east (Fig 2). Bays 3, 4 and 5 contain a large modern silo which obscures the majority of the timber-frame.

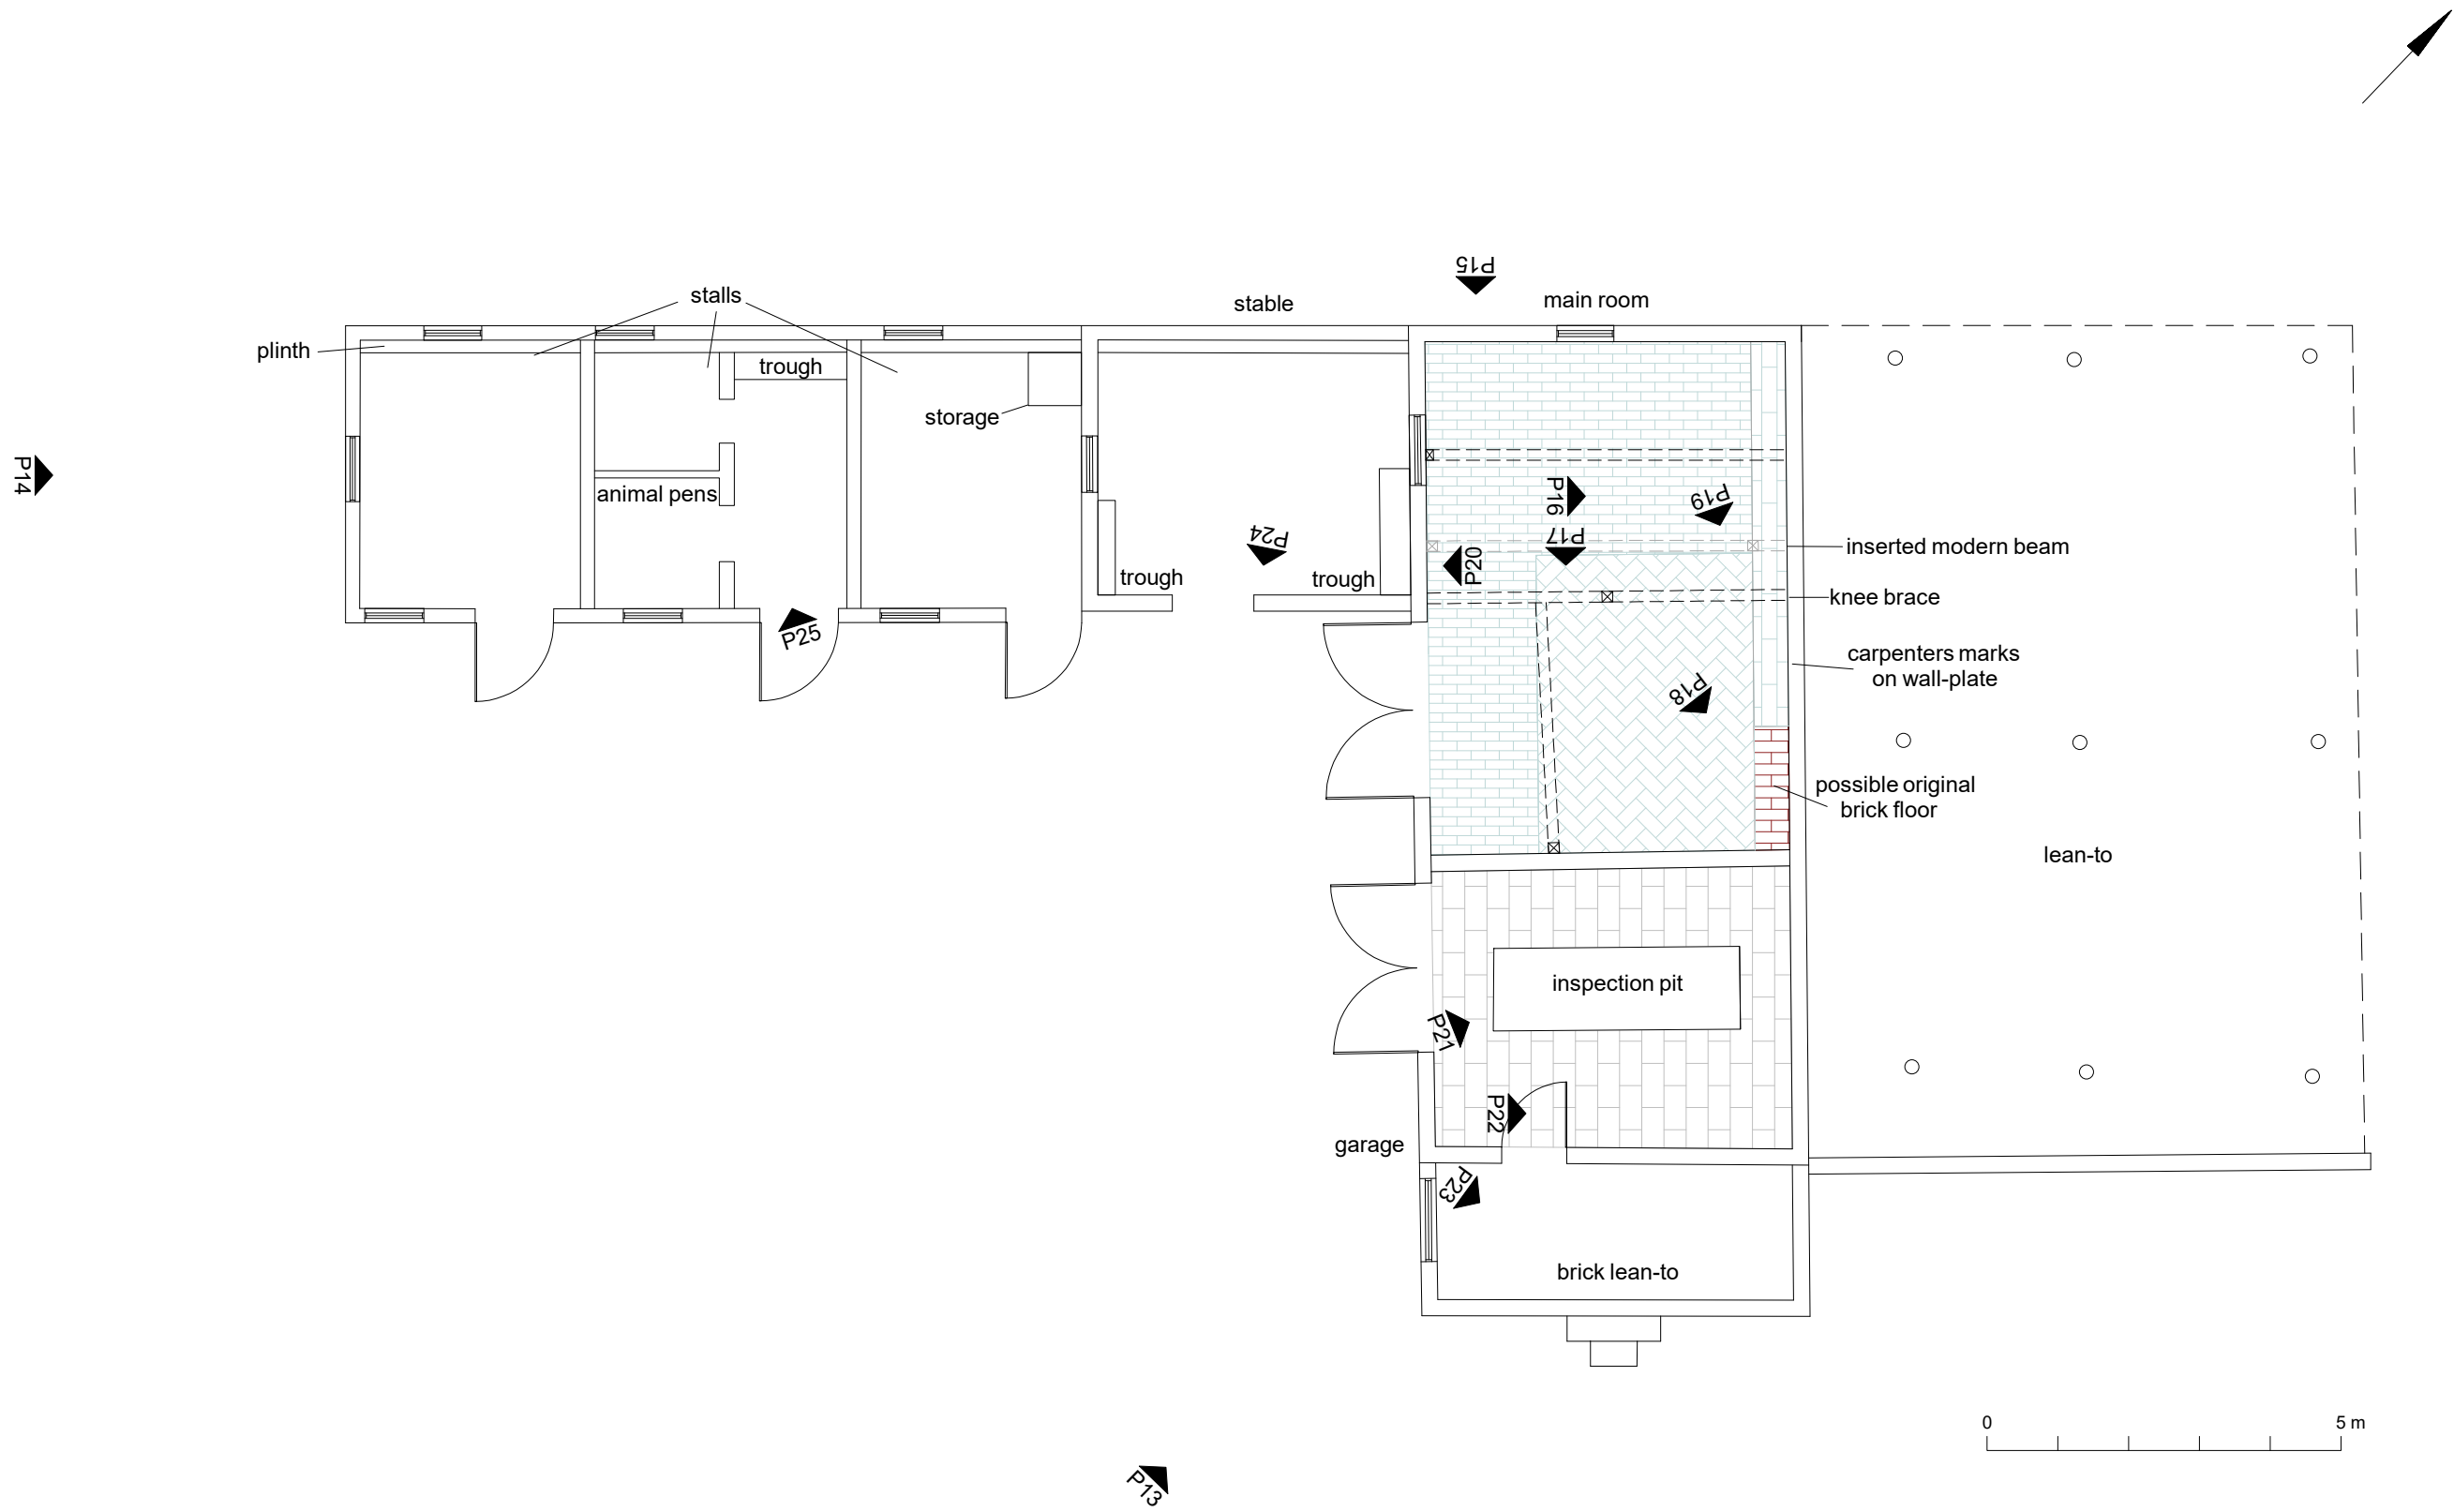
Fig 3 Coach House floor plan. Location and direction of photographs reproduced in text shown.

The coach house has been divided into six areas for ease of description: the main room, the garage, the upper-floor, the stable, the brick lean-to and the stalls (fig 3). The original structure consists of the main room and garage.

The coach house is a timber-framed and brick building with multiple later extensions. The original structure is on a north-west/south-east alignment and measures 11.86m by 5.55m, covering an area of 65.82m squared (fig 3). The original structure is constructed of Flemish-bond brickwork (brick dimensions 230 x 110 x 65mm) on the south-west and south-east elevations and timber-framed on the north-west and north-

The main room of the coach house has a floor made of pavior bricks (fig 3) (195 x 105 x 50mm). The majority of which is laid flat, except one area which is in a herringbone pattern. On the north-eastern side is a strip of pavior bricks laid on edge. In the eastern corner of the room is an area floor made of red brick (230 x 100 x 50mm), this sits below the pavior bricks and could be the original coach house floor.

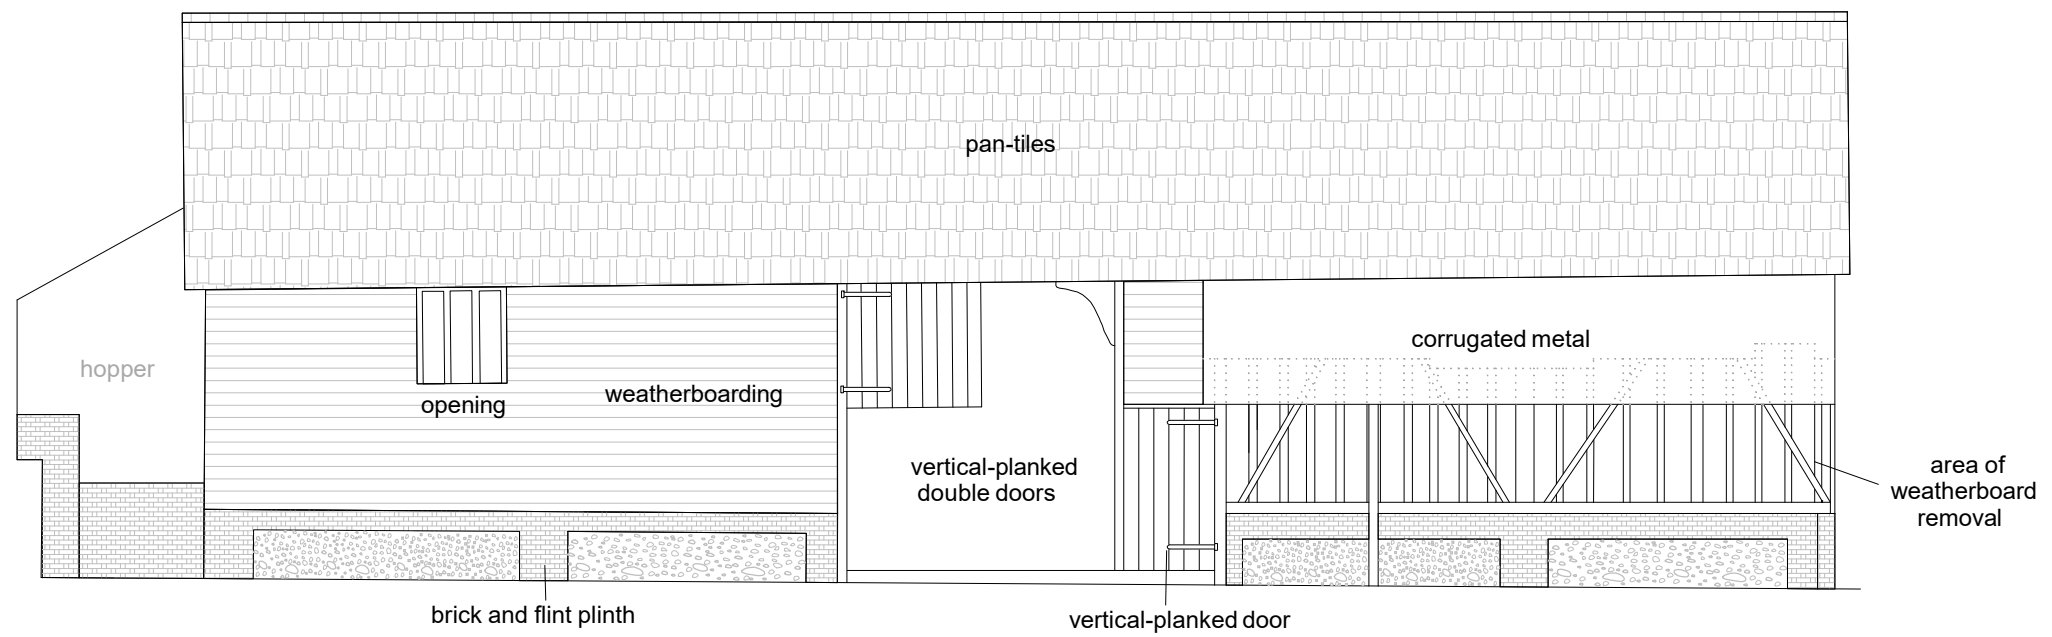
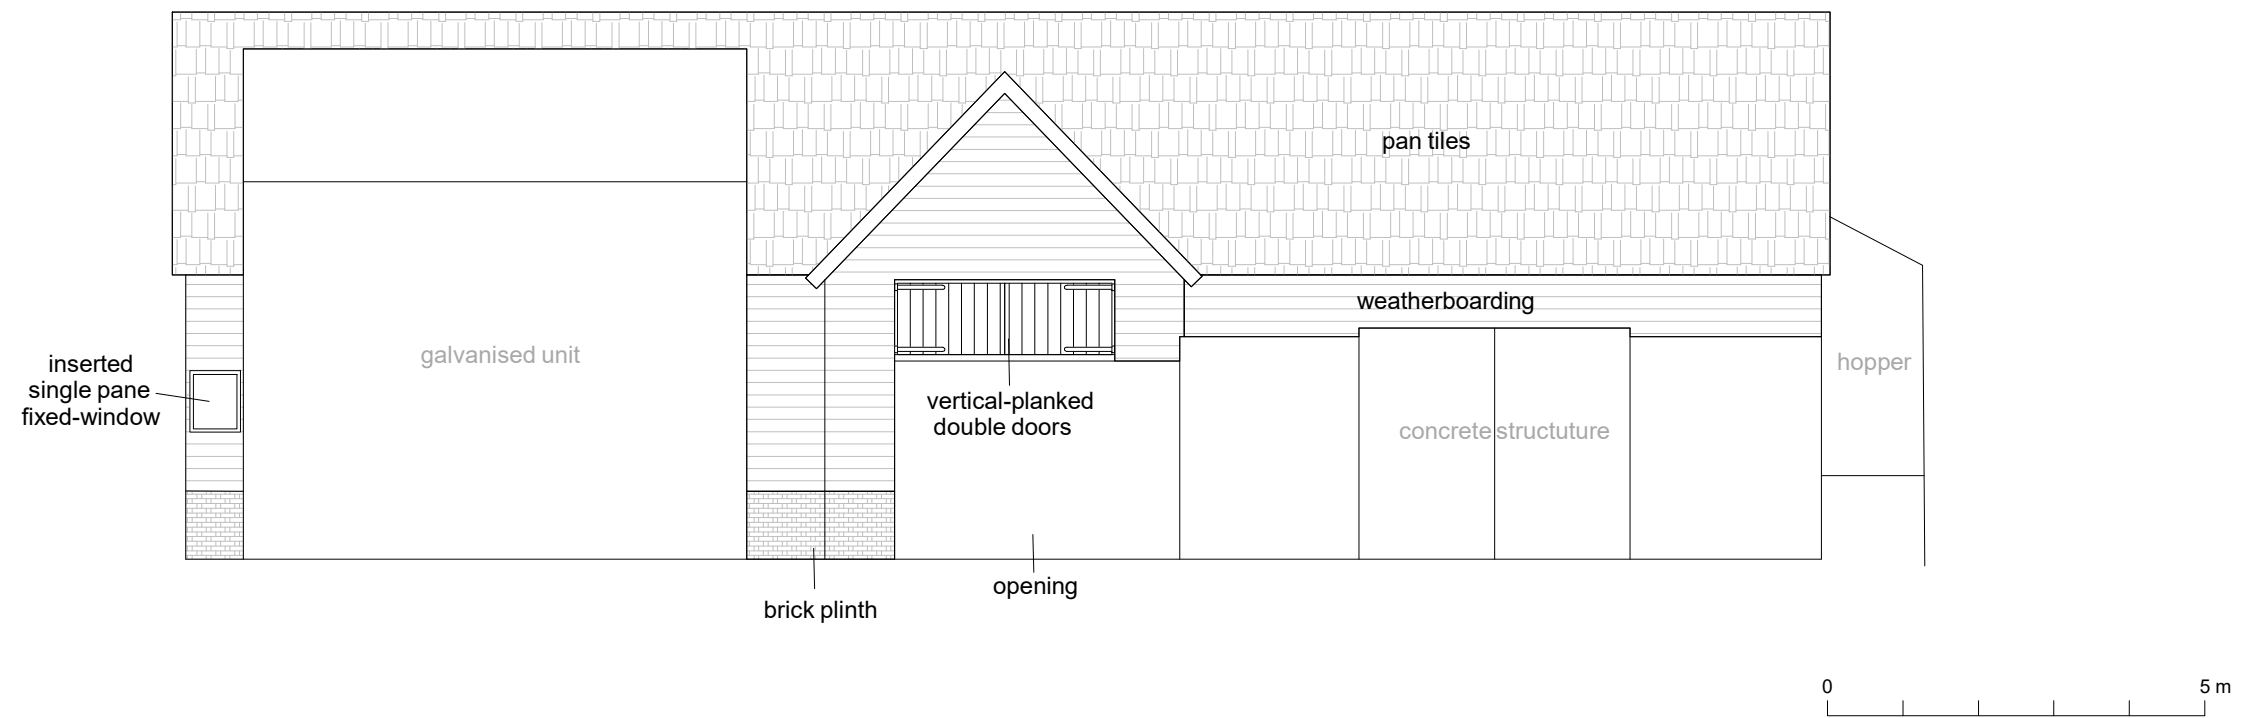
Fig 4 South-west (top) and north-east (bottom) elevations of threshing barn.

The south-west elevation of the threshing barn has a large central opening with half of one vertical-planked door surviving. To the south-east of this entrance is a smaller single door, which is also vertically-planked and likely a later installation. Also present on this elevation is a rectangular opening in the upper register. There is a modern lean-to, roofed in corrugated metal, on the southern end of the this elevation, partially obscuring the barn. A large amount of weatherboarding has been removed in the lean-to (fig 4), revealing the timber-frame of bays 4 and 5 and a number of carpenter's marks (discussed below).

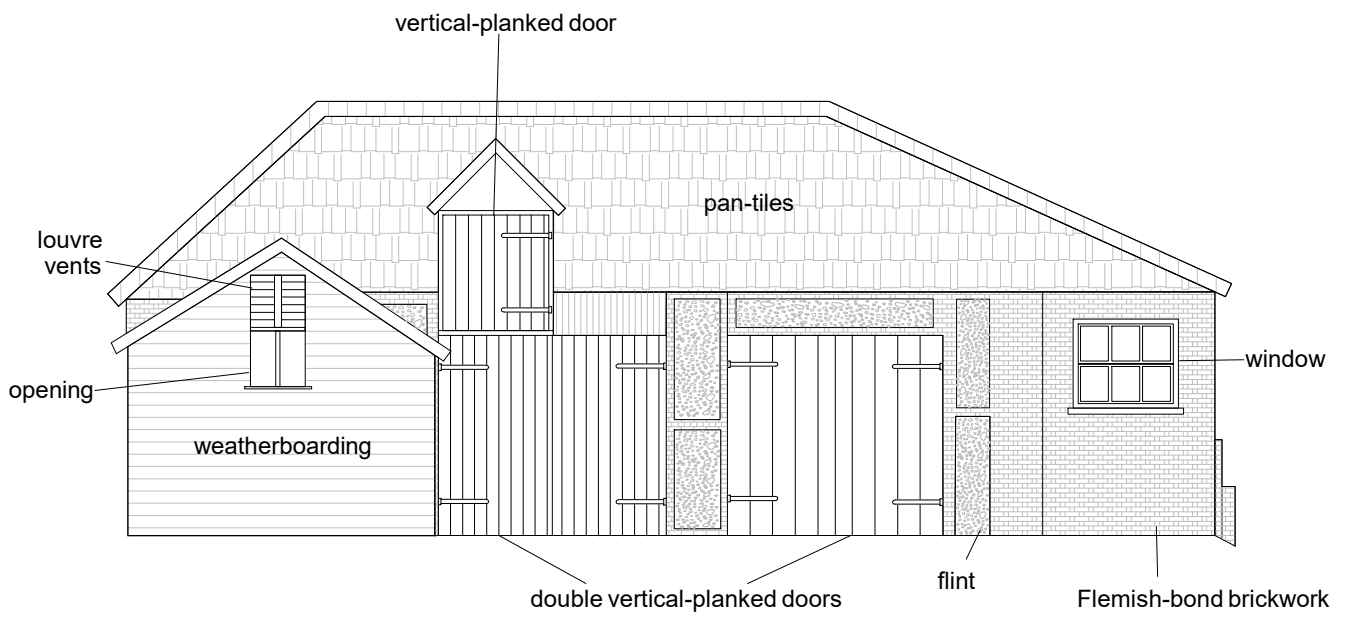
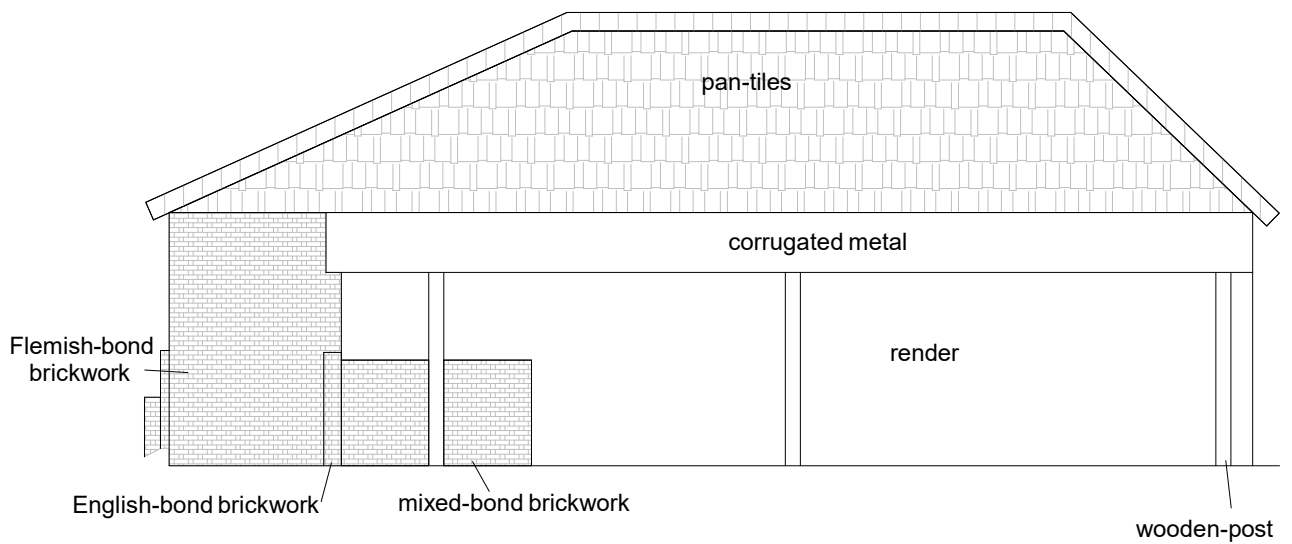
Fig 7 South-west (top) and north-east (bottom) elevation of coach house.

Later additions to the coach house include a small brick lean-to on the south-east elevation and a brick stable projecting from the south-west elevation. Both are constructed of Flemish-bond with bricks measuring 230 x 110 x 65mm. Modern timber stalls have also been added to the south-west elevation of the brick stall (fig 4). These are covered in black weatherboarding with a slate roof.

On the south-west elevation is a door which has been blocked and replaced with an eight-light fixed window. To the south of this is the mount for a gas lamp, complete with gas pipe.
