**CAT Report 1803
September 2022**

**Historic building recording of a building at Skilletts
Farm, School Road, Pentlow, CO10 7JR**

**CAT project ref.: 2022/03c
ECC code: PLSB22**

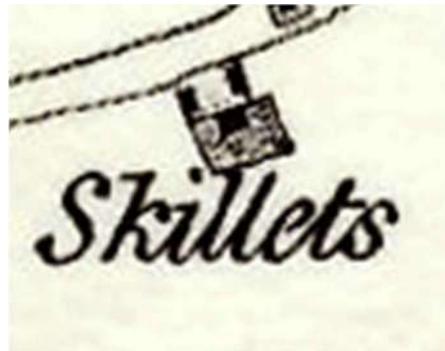
Plate 2: Close up of Skilletts as shown on the 1777 Chapman and André map

The construction of the building can be accurately dated to between 1850 and 1870 based on the use of shallow frogged bricks in the construction (c. >1850) and dated graffiti on the external wall of the stable. However, cartographic evidence shows a building in the rough location of the existing building as early as 1777 (see Plate 2 - below). The 1841 tithe map shows a building in the right location to be the building, but it appears to be quite a lot smaller than the existing building. It seems likely that this was either rebuilt or constructed anew with additional stabling towards the road in the mid to late 19th century. This may account for the unusual assortment of bricks and bond styles on the rear wall of the building. It would also account for the variation in roof height and the fact that while the stable and cartlodge appear to have been built at the same time as the cattle shed, the roof abuts the cattle shed rather than being structurally integral to it.

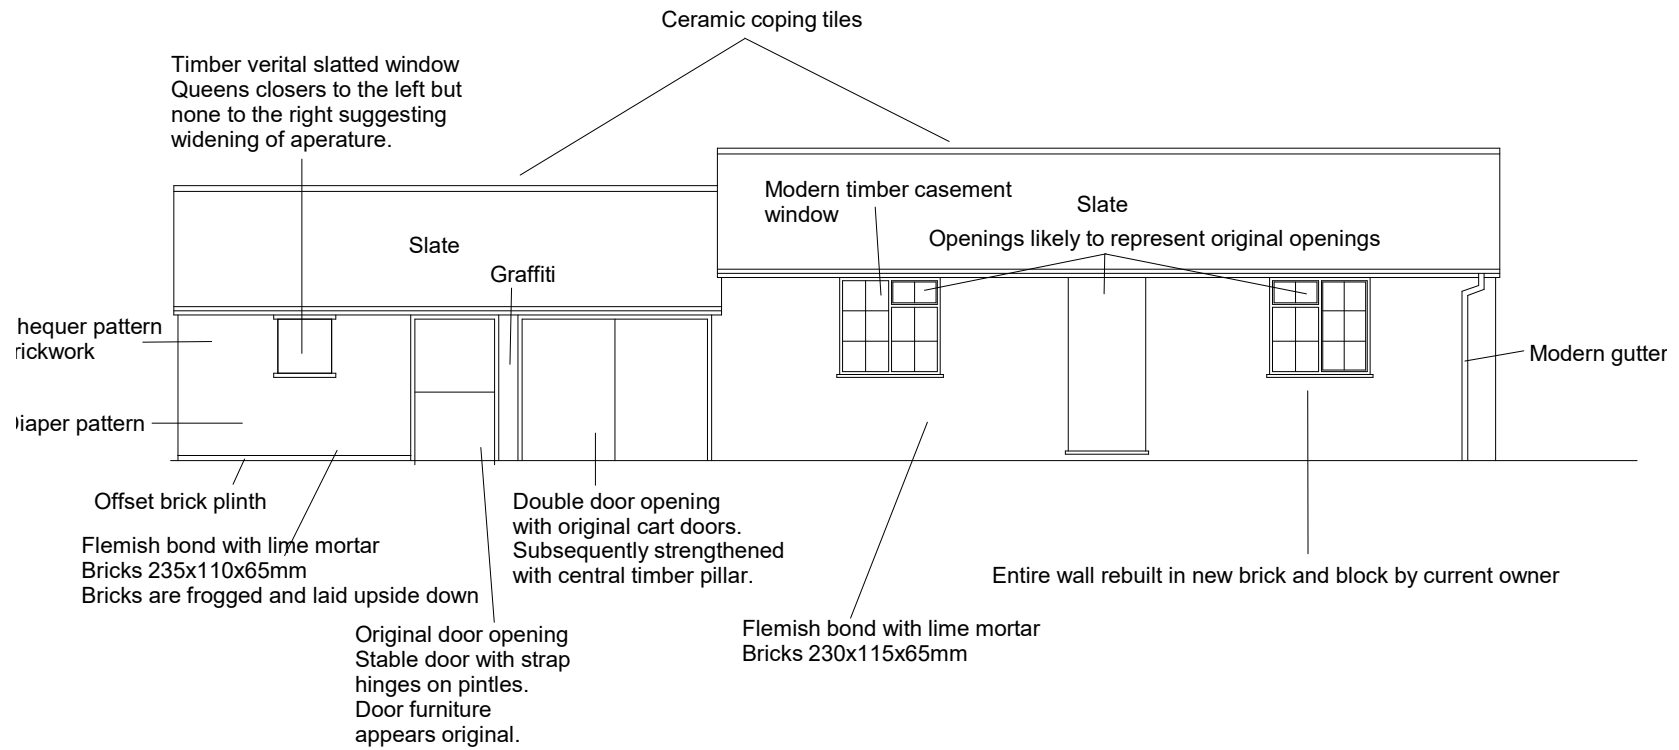
Fig 4 Western elevation

The cattle shed to the south has been partially rebuilt, with the western façade now constructed of new bricks (230x115x65mm) in Flemish bond in front of a course of breeze blocks. Its window and door openings are thought to be in the original positions but have been rebuilt and have modern casement windows. There is no door in the door opening.

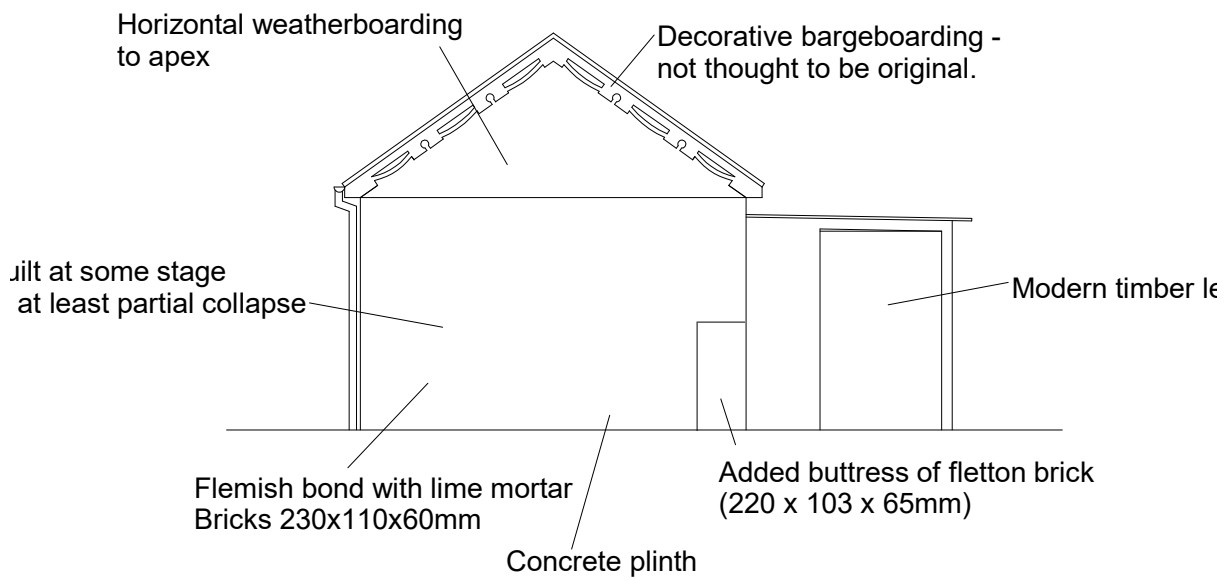
Fig 5 Southern elevation

The southern side of the building has been rebuilt on a concrete plinth, but seemingly using original bricks (230x110x60mm). A fletton brick (220x103x60mm) buttress was constructed against the eastern corner of the northern wall – this is probably to support the wall as it gradually collapsed outwards. There is horizontal weatherboarding from the top of the brick wall to the apex of the roof bordered by decorative barge boards – it is unlikely that either of these elements is original.

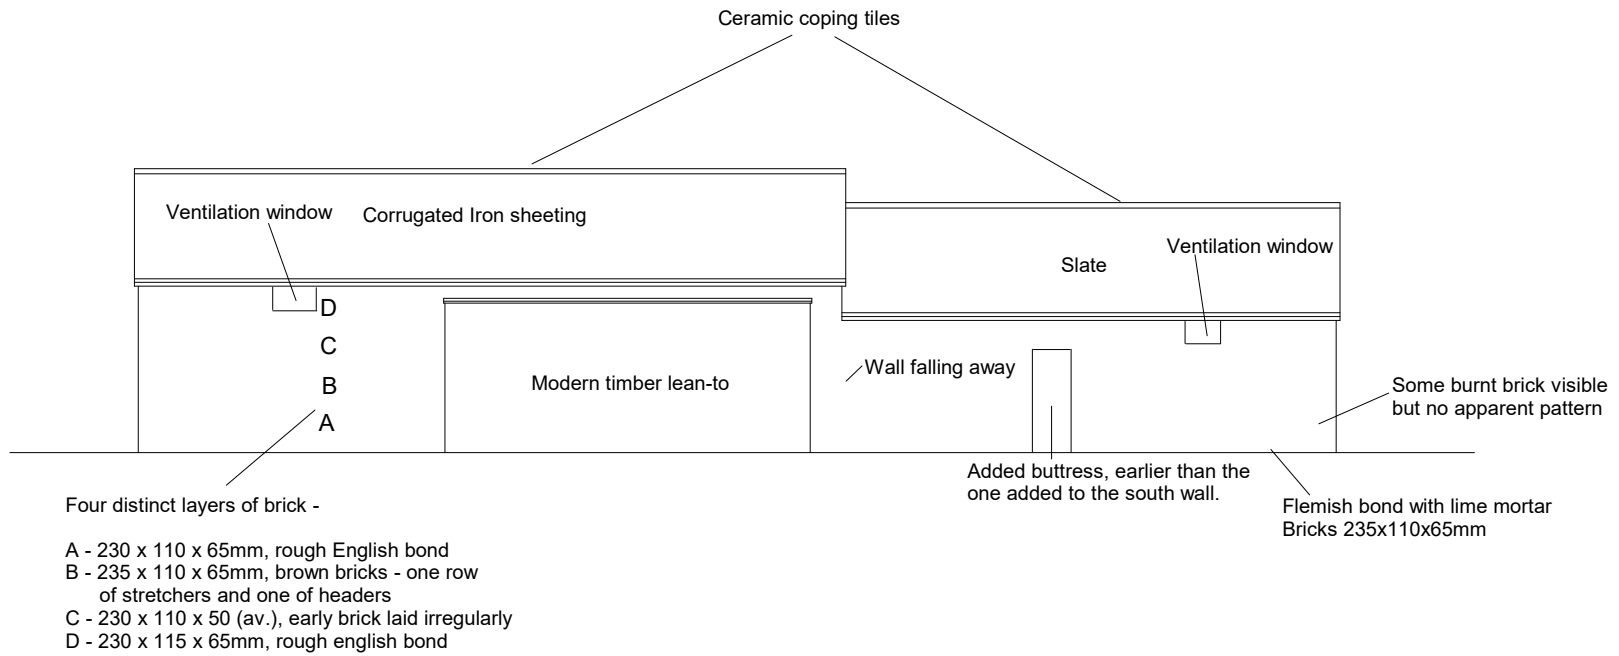
Fig 6 Easten elevation

The northern corner of the eastern wall of the cattle shed appears to have been rebuilt at the same time as the northern wall. The rest of the cattle shed wall appears to be original though is unusual as far as it was not built in any coherent style, with irregular bonds and at least four distinct size bricks (see Fig. 6). The lowest courses of bricks are in a rough English bond (230x110x65mm), above these is a double line of dark brown bricks (235x110x65mm). Six courses of early brick (230x110x50mm) laid irregularly were above this and the top courses of brick (230x115x65mm) were rough English bond.

A modern timber lean-to shed covers half of the cattle shed wall. There are three small, shuttered windows along the eastern wall of the building – these are all right at the top of the wall and were probably for ventilation rather than light. The roof on the eastern side of the cattle shed is corrugated iron sheeting. This is presumably an addition after the collapse of the original slate roof in this area, though the corrugated sheeting is fixed below the ceramic coping tiles.

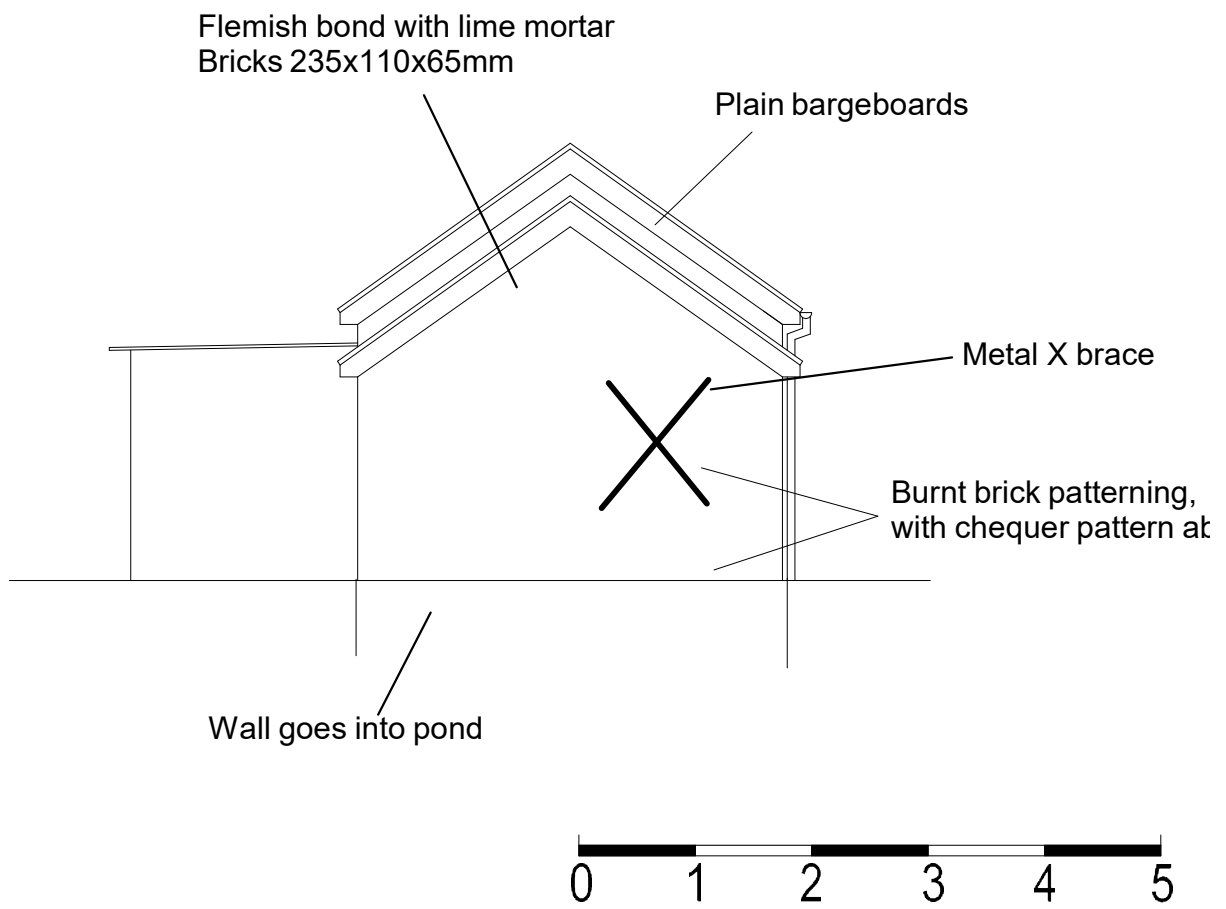
Fig 7 Northern elevation

The northern wall of the building extends into the pond to the north of the building. It is brick to the apex and laid in Flemish bond with lime mortar. Like the western wall of the stable and cart lodge, the upper part of the wall has burnt-brick chequer patterning. The lower part of the wall has the symbols X ♦ X above V W laid into it in burnt bricks. A metal brace overlays the right-hand X. The barge boards on the end of the cattle shed and the end of the stable are plain.

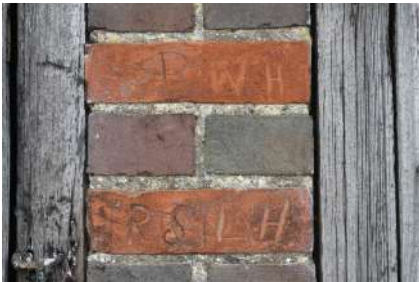
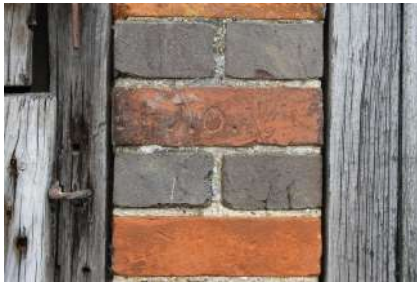
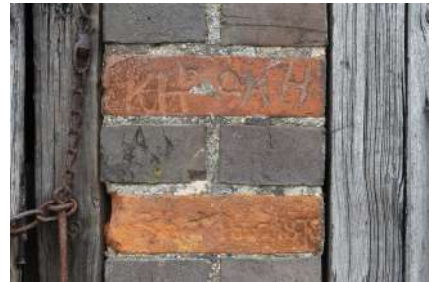
There is some graffiti on the bricks between the stable door and the double door. This gives a *terminus ante quem* of 1870 for the building.

PLSB22_Photograph_14Graffiti between stable and cartlodge

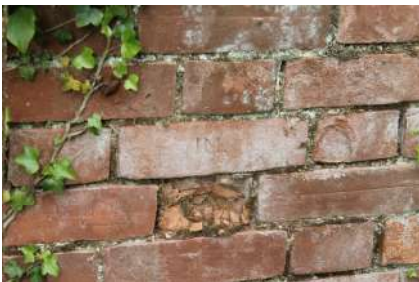
PLSB22_Photograph_27Graffiti on east wall
