**CAT Report 1901  
reissued September 2023**

**Historic building recording at 50 Moulsham Street,  
Chelmsford, Essex, CM2 0HY**

**February 2023**

**CAT project ref.: 2023/01e  
CAT Report 1901**

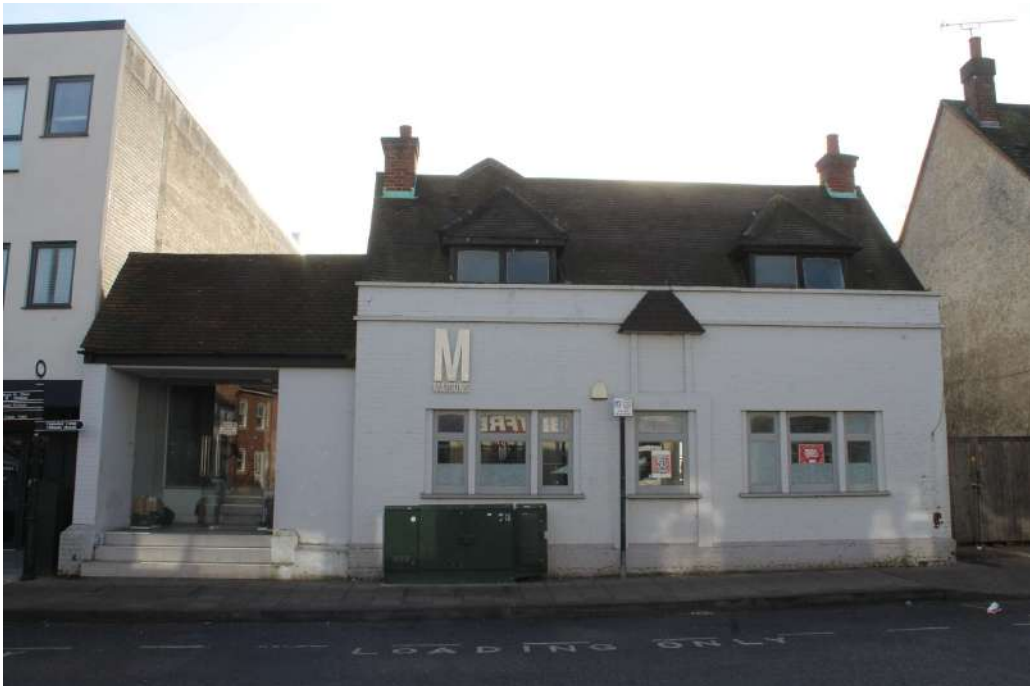
**Photograph 2** North-west elevation. Photograph taken facing south-east.

The north-west elevation of range 10 has been completely rebuilt in brick (brick dimensions: 210 x 100 x 60mm) laid in English bond and painted grey. It has a short rectangular parapet topped with coping tiles and a string course. Photograph 1, from c 1930, indicates this replacement façade mimics an earlier version with a doorway flanked by windows.

The doorway in the centre appears to have been purposely built to look as though it has been blocked and replaced with a window, denoted by protruding brickwork. The chamfered plinth remains uninterrupted, indicating there has never been a gap in the wall. Above this is a false dormer roof, clad in peg-tile, intended to imitate the dormer windows on the roof. It is possible this blind window was once used to hold a pub sign. Flanking the blocked doorway are two sets of windows, both comprising three two-light windows. All of the windows have a top awning opening and a timber-frame.

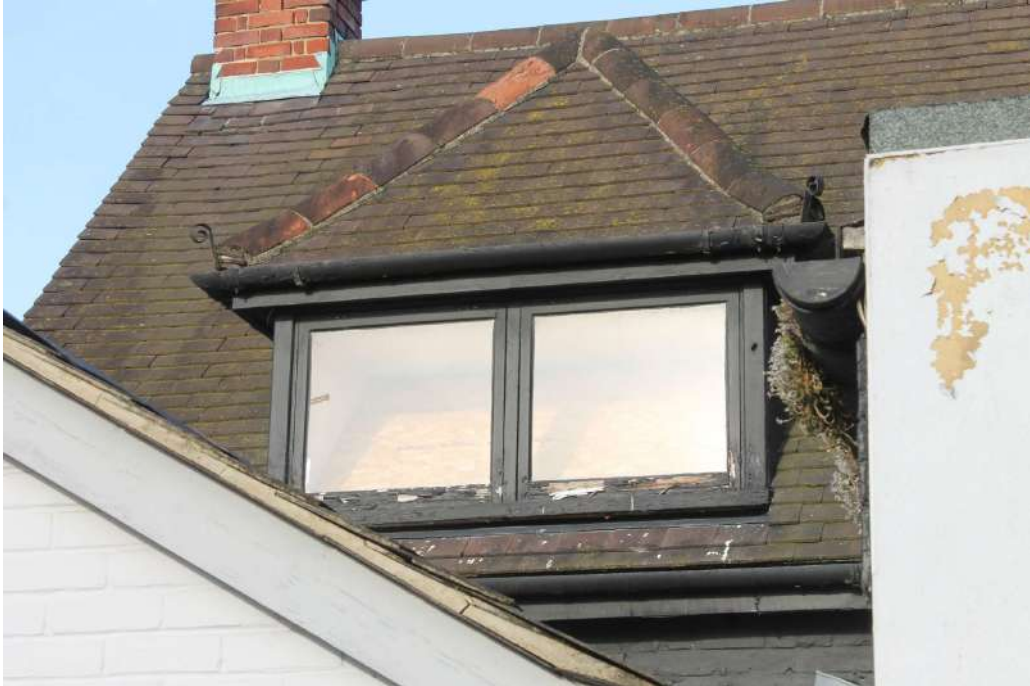
**Photograph 3** Detail of window on south-east courtyard elevation. Photograph taken facing north-west.

The south-east courtyard elevation comprises ranges 7, 8 and 10. Range 10 has been rebuilt in red brick (brick dimensions: 215 x 105 x 60mm) laid in Flemish bond and painted black. Range 8 is modern brick (brick dimensions: 215 x 100 x 60mm), painted grey, laid in stretcher bond. It has a bay window made up of four two-light windows, the centre two of which have a casement opening, and modern door with six-lights. Range 7 is rendered and painted grey.

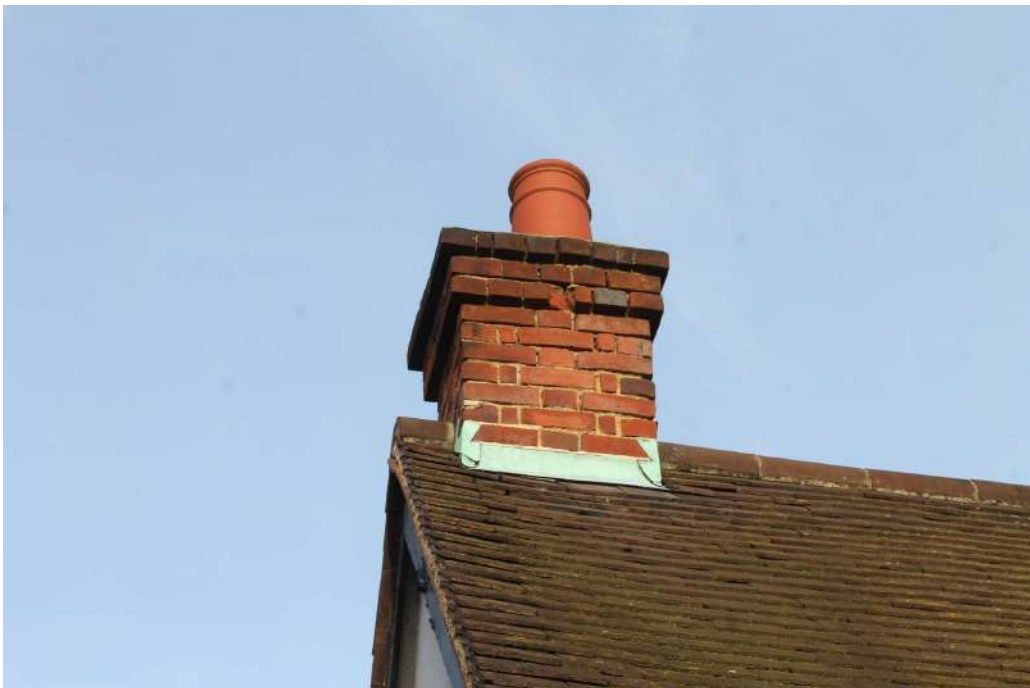
**Photograph 4** Detail of southern chimney stack. Photograph taken facing north.

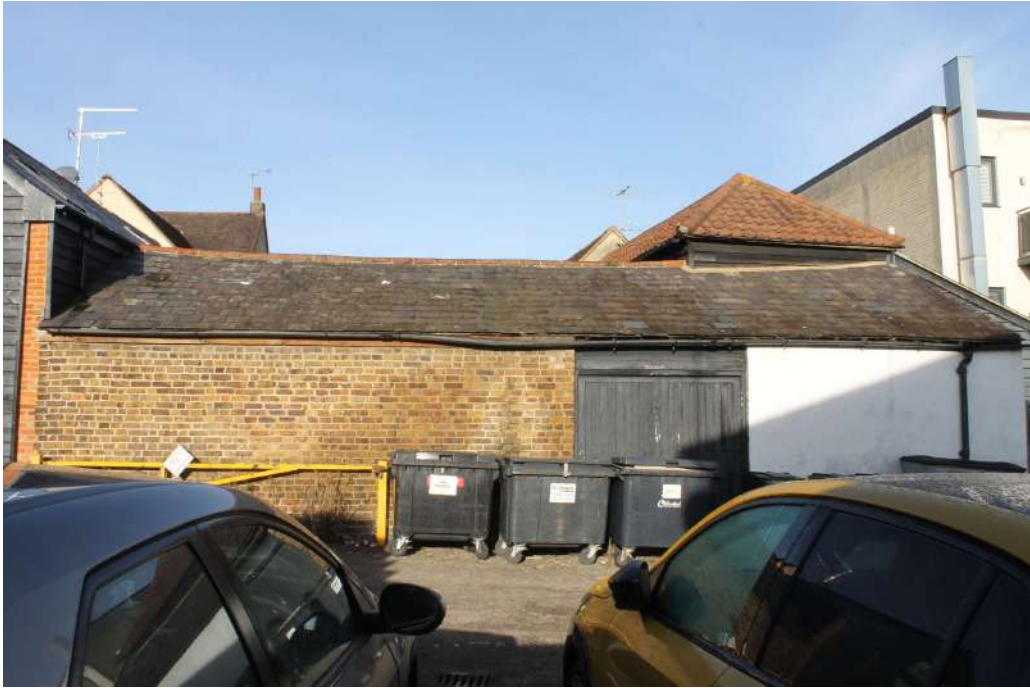
**Photograph 6** South-east elevation. Photograph taken facing north-west.

At the south-west end, the south-east elevation of range 3 is constructed of yellow brick (brick dimensions: 220 x 110 x 65mm) laid in a rough Flemish bond. At the north-east end it is rendered and painted grey. A set of timber double-doors, painted black, separate the two materials. After the demolition of range 3, some original weatherboarding was uncovered on the south-east elevation of range 2.

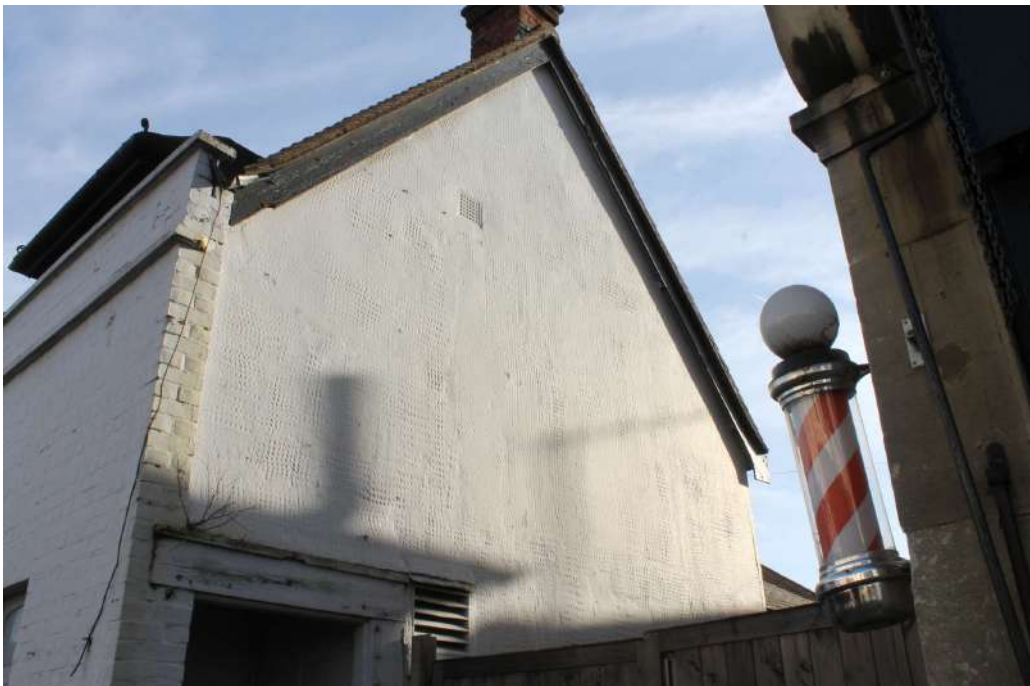
On the south-west elevation, range 10 is rendered and has a single recessed doorway, which has been inserted. The doorway has concrete steps and timber surround, which has wooden pegs holding it in place.

**Photograph 7** South-west elevation. Photograph taken facing east.

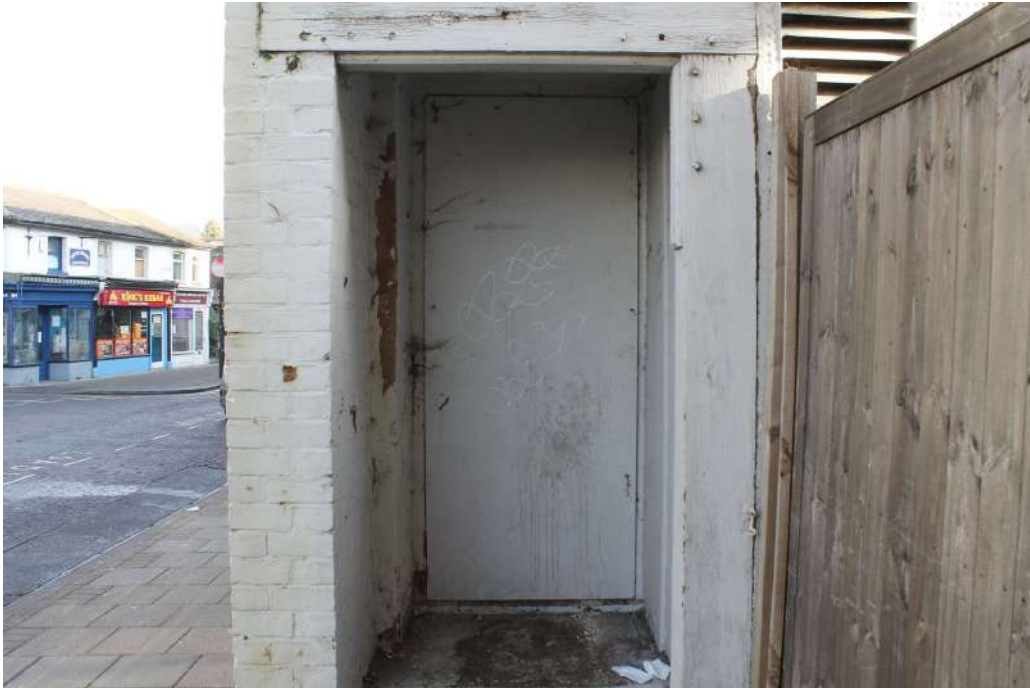
**Photograph 8** Detail of doorway on south-west elevation of range 10. Photograph taken facing north-east.

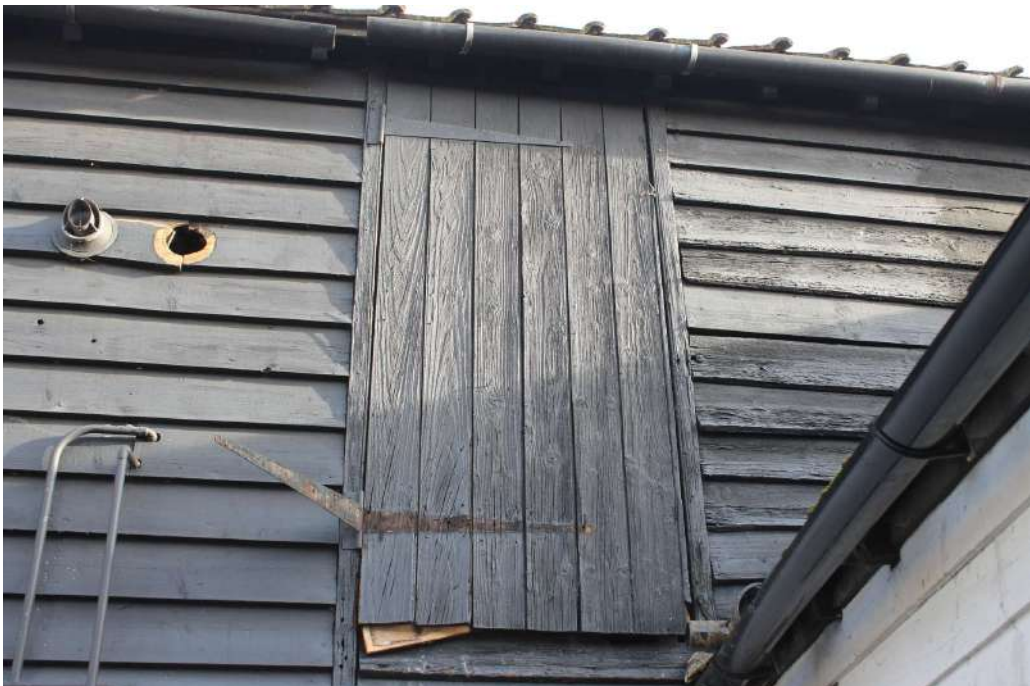
**Photograph 9** Detail of door on south-west elevation. Photograph taken facing east.

Range 2 is rendered and painted grey on the ground floor with black weatherboard on the first floor. Range 4 is rendered and painted grey. Damage to the render has revealed the brickwork beneath along with a brick plinth (although not enough to determine the brick bonding or dimensions). There are three doors on this elevation – one each on the ground floors of range 2 and 4 and one on the first floor of range 2.

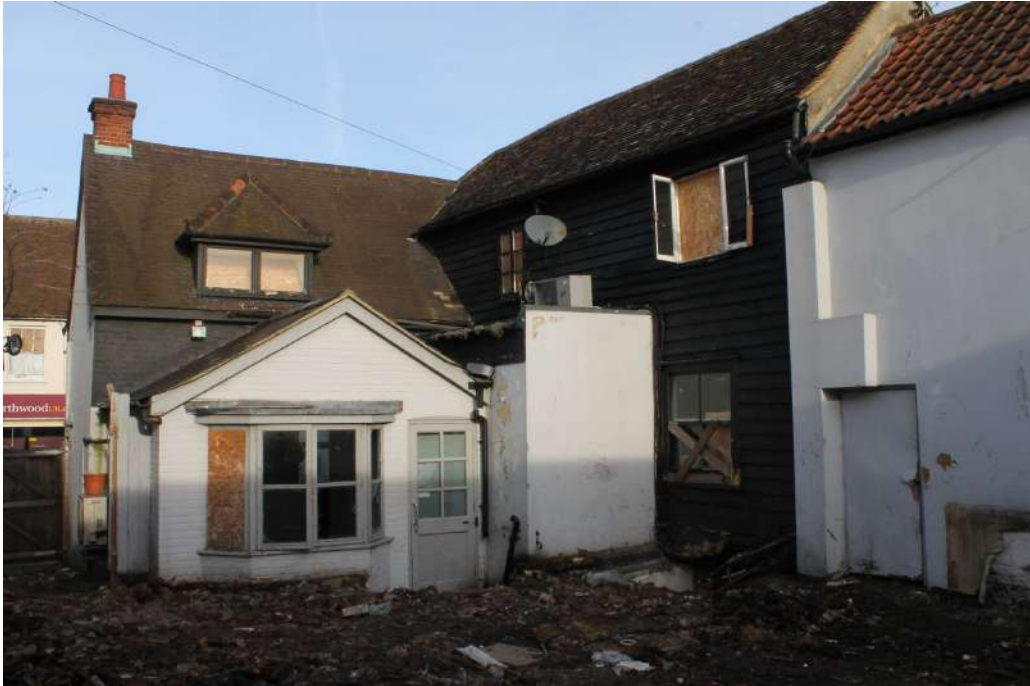
**Photograph 10** South-west and south-east courtyard elevation. Photograph taken facing north.

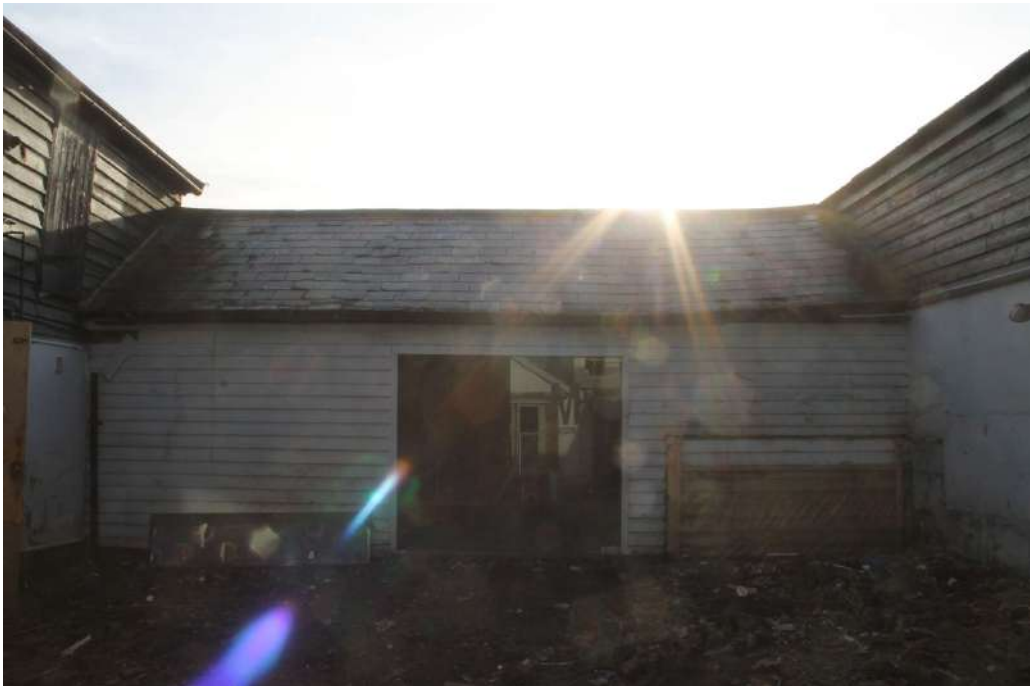
**Photograph 11** North-west courtyard elevation. Photograph taken facing south-east.

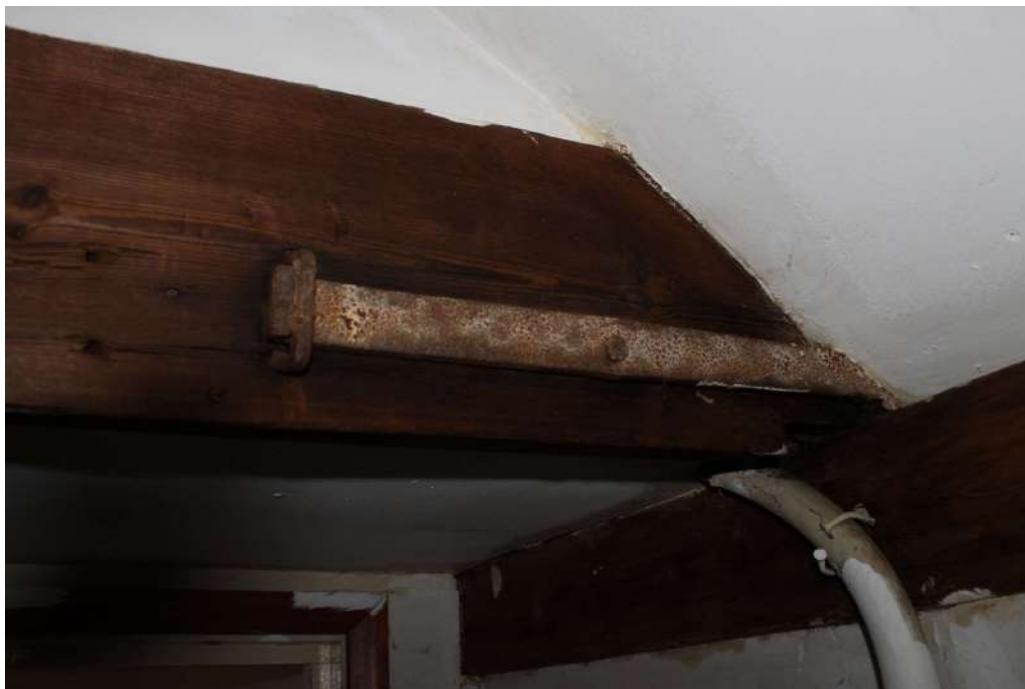
**Photograph 13** Detail of iron strap joint on tie-beam in range 2. Photograph taken facing north.

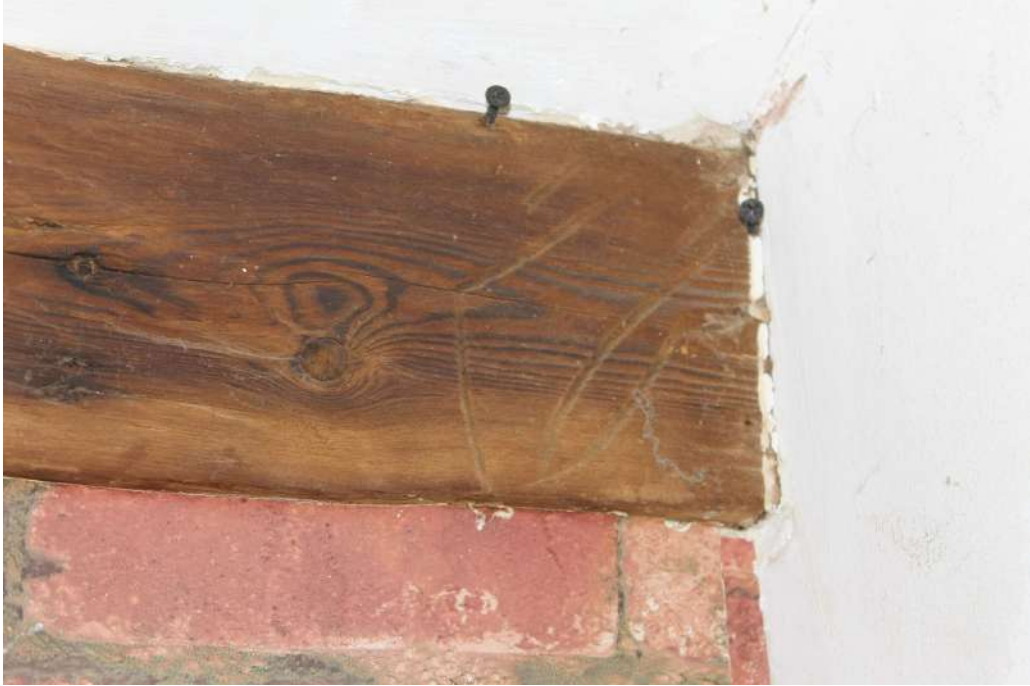
**Photograph 14** Detail of Baltic timber mark on wall-plate of range 2. Photograph taken facing west south-west.

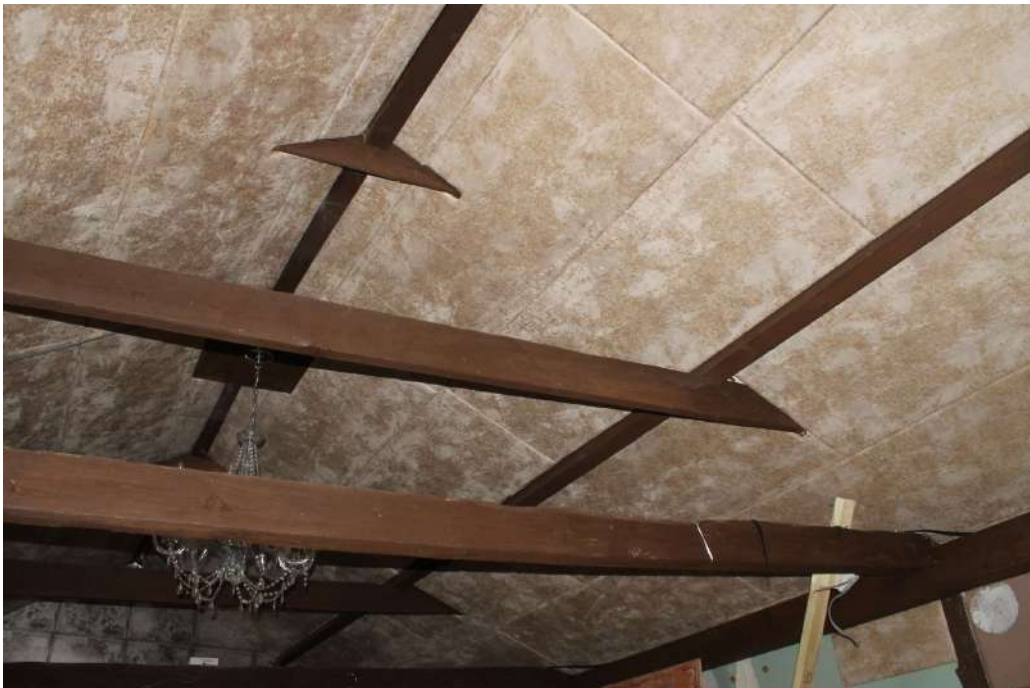
The roof of the range 3 is constructed from machine-cut timbers. It has two tie-beams both of which have a corresponding upper and lower collar. Both tie-beams are secured in place with iron straps, which are fixed with iron staples. There is a single clasped purlin on each roof pitch, both which have a splayed scarf-joint. A Baltic timber mark is present on the southern-most tie-beam. It can be assumed the structure also comprises pairs of rafters, which rise from the wall-plates, to meet at the ridge-board, but this is obscured by the modern ceiling covering.

**Photograph 17** Detail of roof structure in range 3. Photograph taken facing north-east.

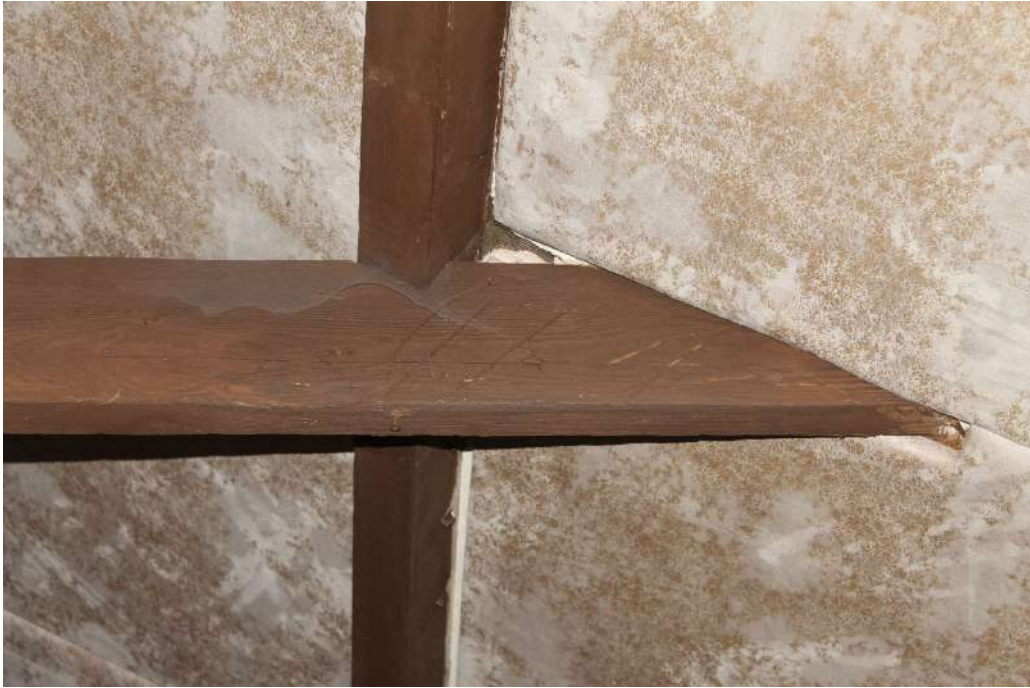
**Photograph 18** Detail of Baltic timber mark on southern tie-beam in range 3. Photograph taken facing north-east.

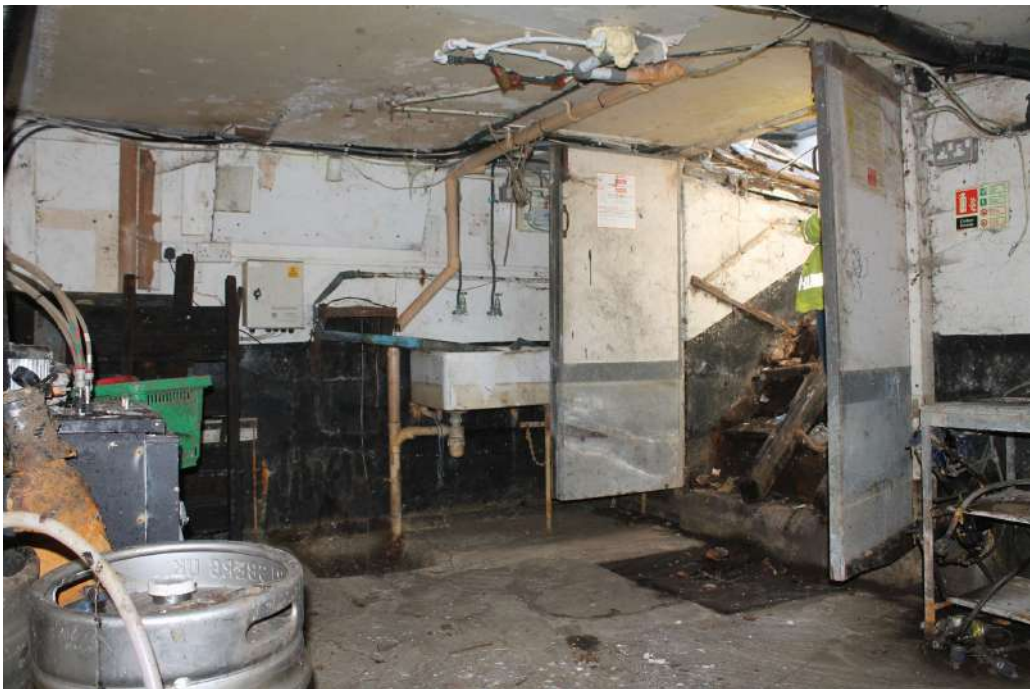
**Photograph 19** Internal view of cellar. Photograph taken facing south.

The north-west wall of the cellar is constructed from bricks laid in stretcher bond (brick dimensions: 220 x ?? x 65mm) while the other walls, and the floor, are concrete. There is an iron I-beam in the centre of the cellar ceiling.

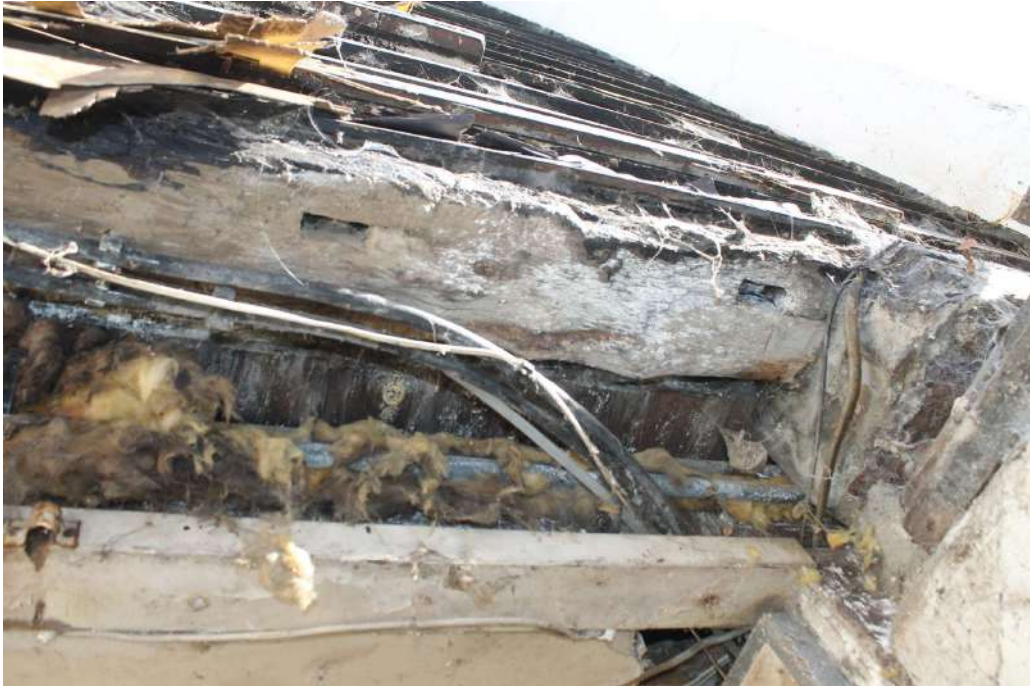
The cellar is accessed via a set of brick steps in the courtyard. The steps are constructed from red brick laid on edge (brick dimensions: 220 x 100 x 65mm) except the bottom-most step which is concrete. There is a timber barrel-run on the stairs, next to a dilapidated timber ladder. At the bottom of the run is a timber landing pad. The sill-beam above the cellars entrance has empty mortices, a sign it has been reused.

**Photograph 20** Detail of mortices in reused beam in cellar entrance.

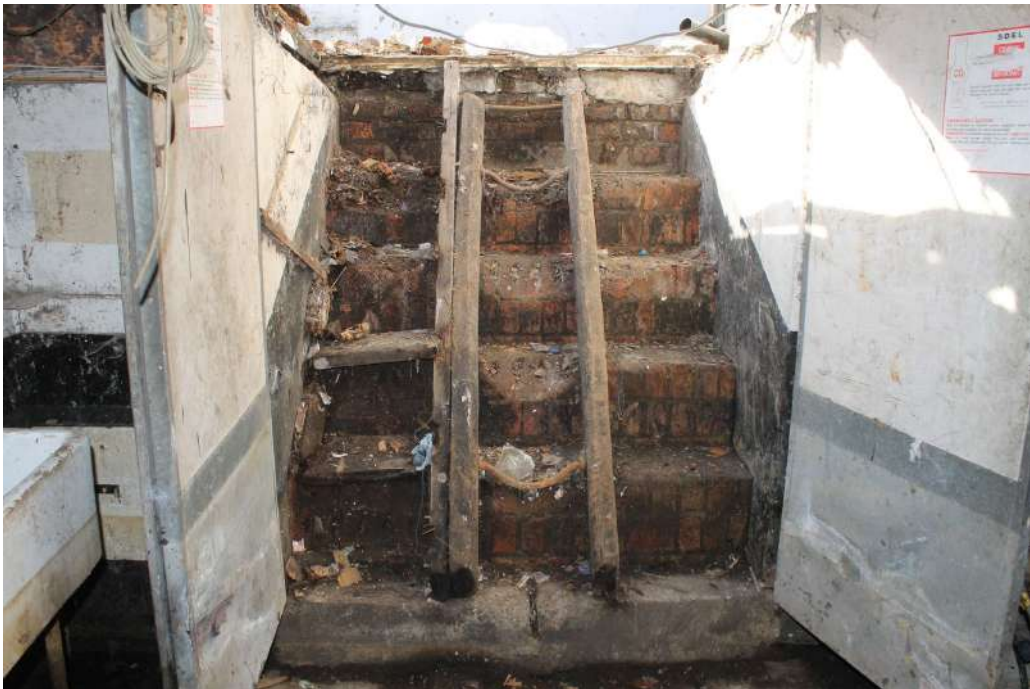
**Photograph 21** Detail of cellar steps with barrel-run. Photograph taken facing south-west.

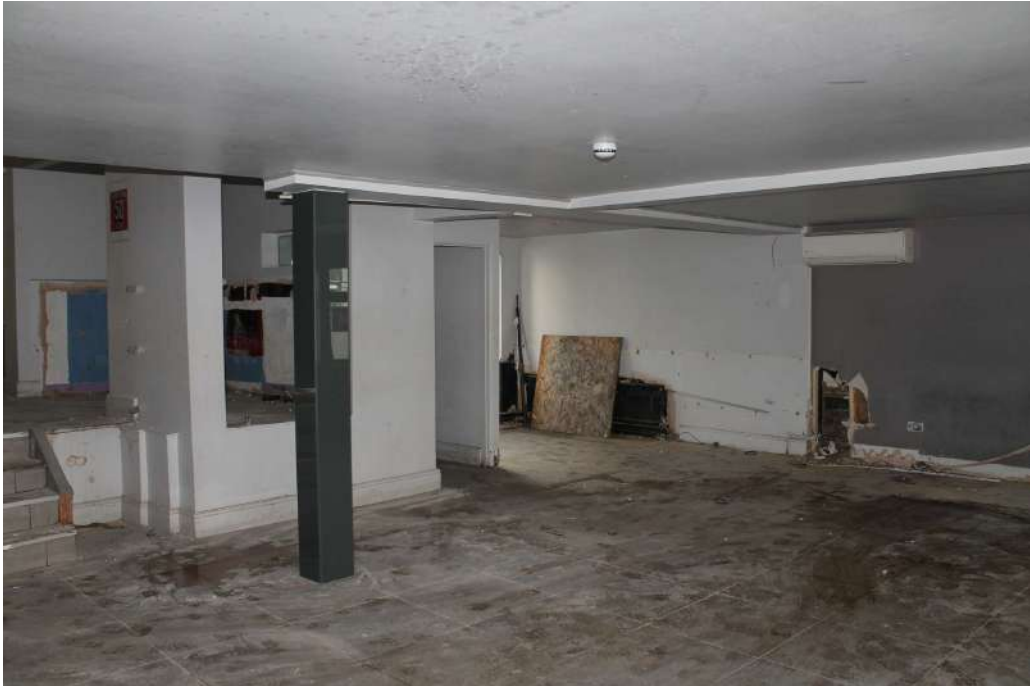
**Photograph 22** Internal view of range 10, showing modern interior. Photograph taken facing south.

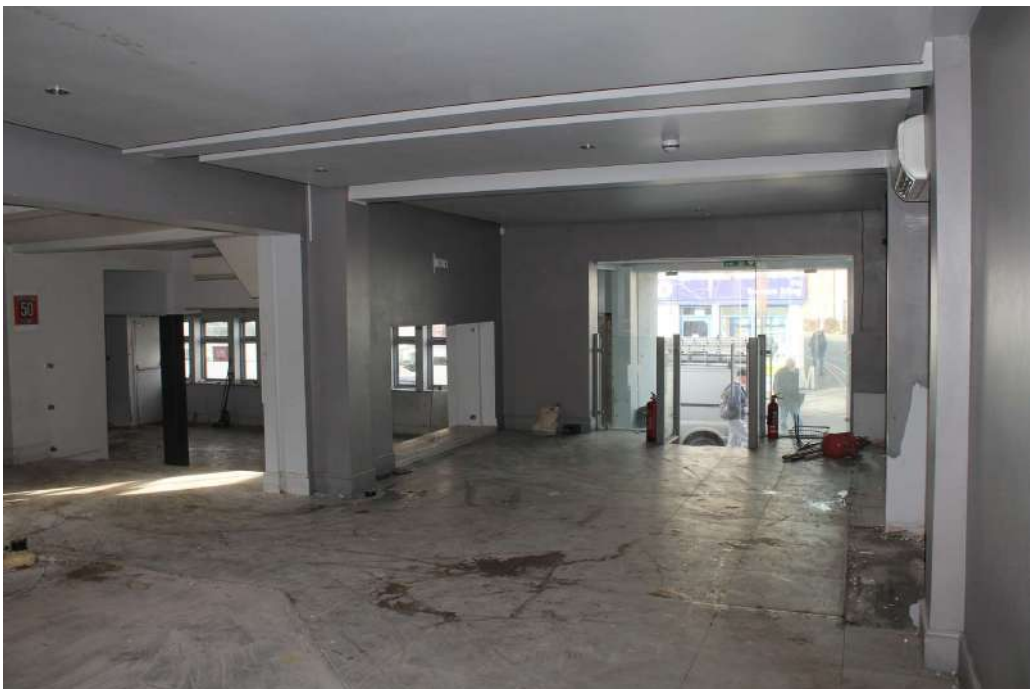
**Photograph 23** Internal view of range 6 and range 5, showing modern interior. Photograph taken facing west.

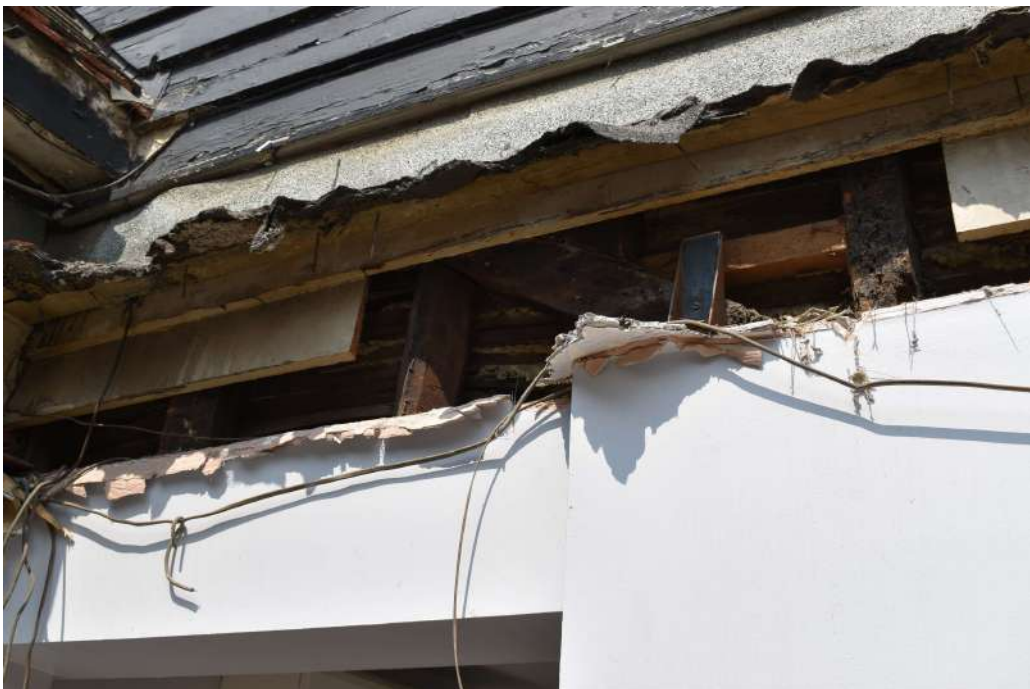
Removal of range 7 has exposed some of the timber-frame of range 6. The timbers appear to be hand-sawn, with through-bracing, covered with laths and horsehair plaster.

**Photograph 25** Detail of timber-framing in south-west wall of range 6. Photograph taken facing north.

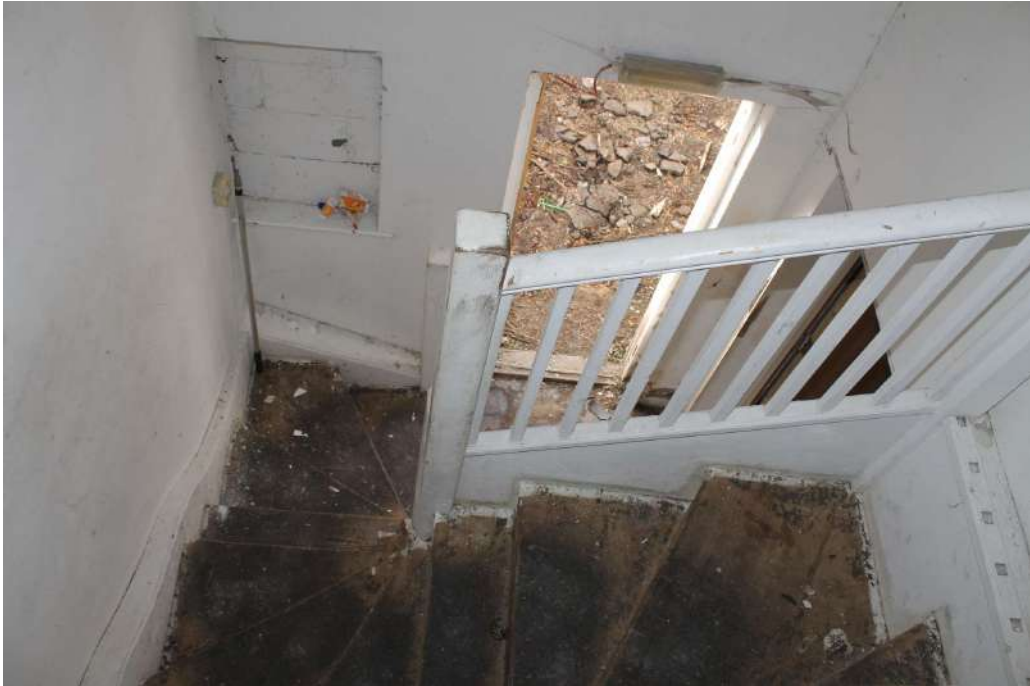
A replacement or inserted staircase is located within range 2. The balusters and newel posts are all plain and rectangular in shape. Also located in range 2 is a possible

**Photograph 26** Internal view of stairwell in range 6. Photograph taken facing south-west.

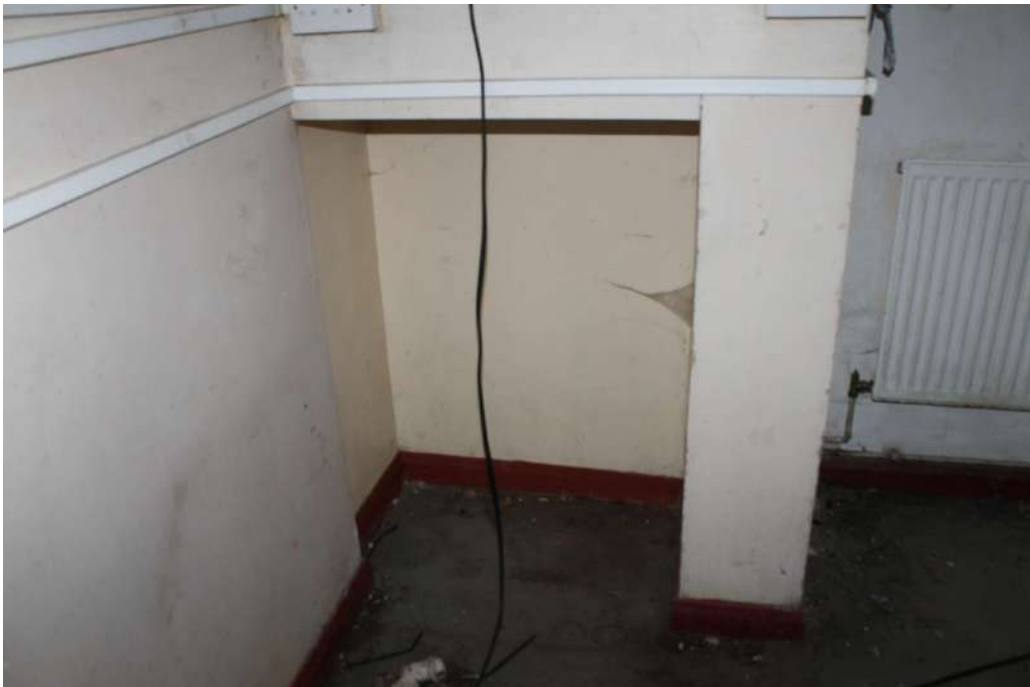
original fireplace. Whilst the alcove which would have housed the fire still remains, there is no surround and the chimney breast does not continue on the first floor.

**Photograph 27** Detail of fireplace in range 2. Photograph taken facing north-east.

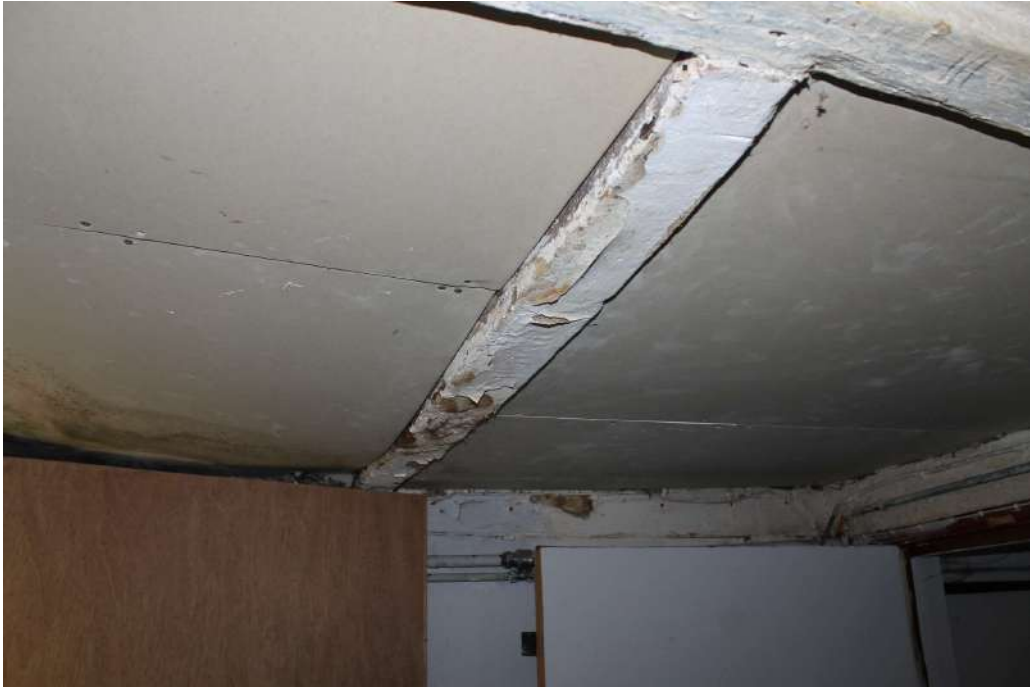
Some possible original timber floor-joists are visible in the ceiling of range 4. They are all machine-cut.

**Photograph 28** Detail of floor joists in ceiling of range 4. Photograph taken facing west.

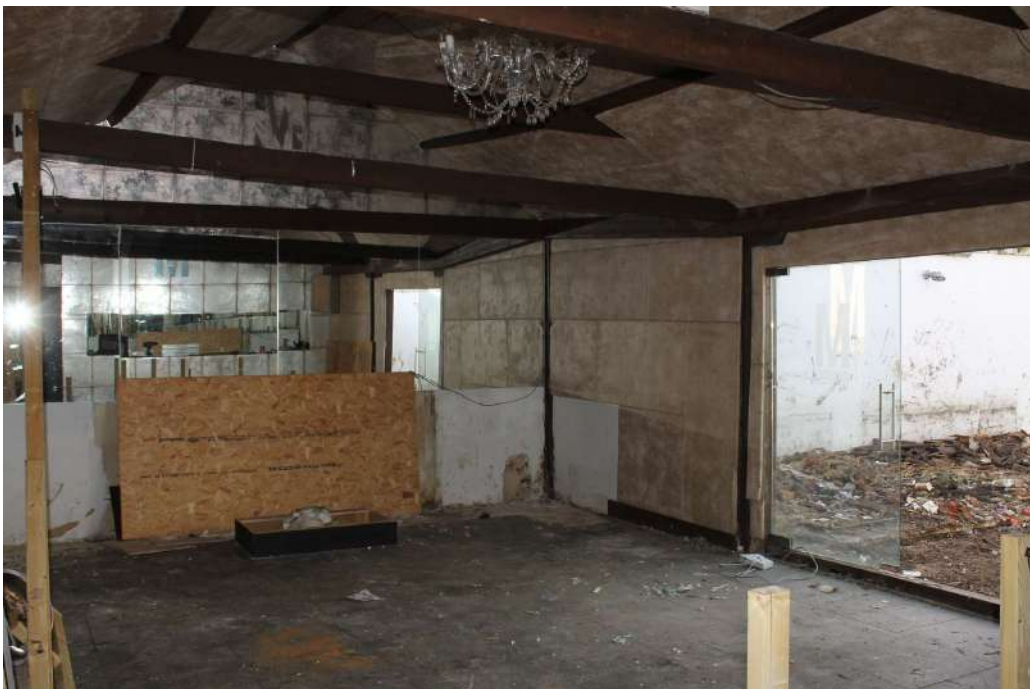
The south-east wall of range 3 is of yellow brick (as seen from the exterior) while the other walls are timber-framed. While the exact structure of the timber-frame could not be determined, mapping indicates the building was originally open-fronted.

**Photograph 29** Internal view of range 3. Photograph taken facing west.

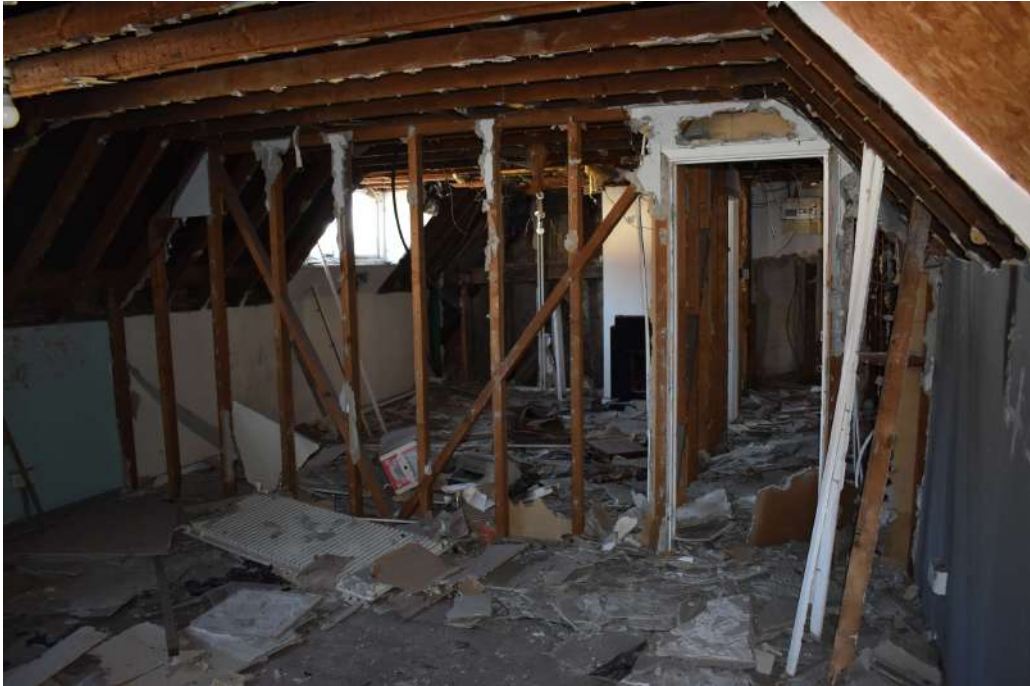
**Photograph 30** Internal shot of range 10. Photograph taken facing north-east.

The north-east, south-east and south-west walls of range 10 have surviving timber-framing on the first floor. Whilst the timber-frame has suffered areas of repair and reinforcement from modern machine-cut timbers, what remains of the original frame is all hand-sawn.

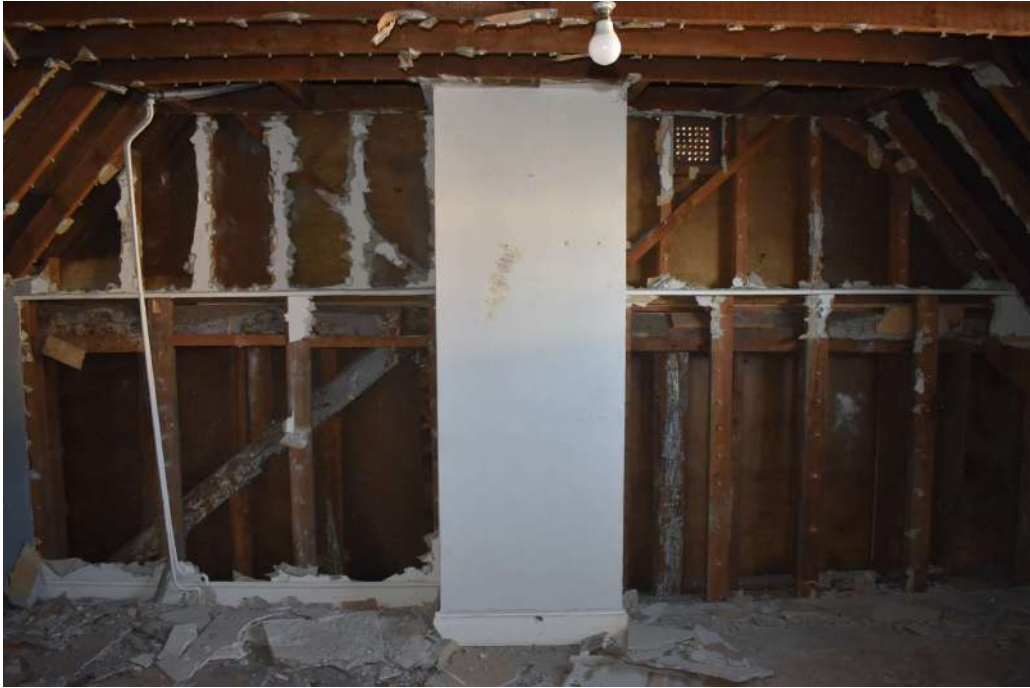
**Photograph 32** Detail of timber-frame in south-western wall of range 10. Photograph taken facing south-west.

The timber-frame has through-bracing visible in the north-eastern and south-western walls. Some of the timbers in the frame show signs of reuse, in the form of empty mortices and notches in the wood. Towards the top of the north-east wall, some laths with horsehair and straw plaster are located.

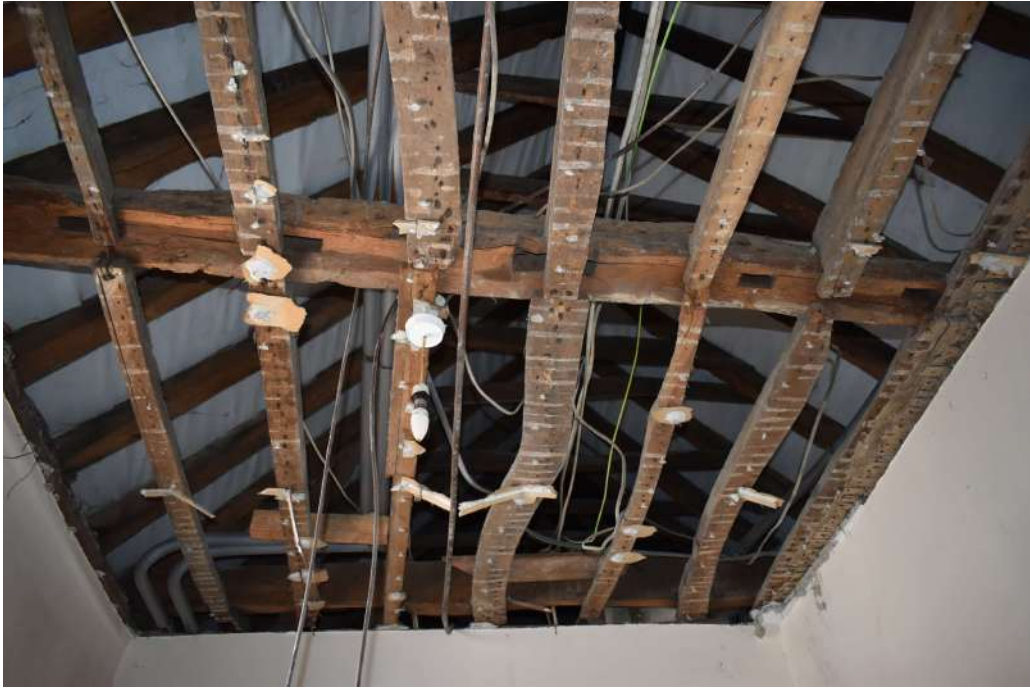
**Photograph 34** Detail of ceiling joists and tie-beam in range 6. Photograph taken facing north-west.

Soft strip demolition also revealed range 6 to be of timber construction, although much of the frame was obscured by a layer of laths. The frame comprised hand-sawn timbers with through-bracing.

A tie-beam revealed in range 6 has a number of equally sized and spaced mortices, a possible this is an indication that an original dividing wall may have been removed or the timber is reused. It's possible this may have been a dividing wall from a smoke bay as there appears to be some smoke blackening to the timbers in the roof to the south of this tie-beam. The ceiling joists uncovered appear to be later additions – although some are somewhat sinuous others are machine-cut. This is also an indication that the laths are a later addition as these have been attached to the underside the later joists.

bracing. The roof structure of range 6 also comprises original timbers. The construction of the roof is fairly simple – the lack of purlins but use of a ridge-board indicates a probable early to mid-18th century date. Some of the timbers in the roof of range 6 appear to have signs of blackening from smoke, an indication the roof structure must have been open at some point. The empty mortices observed in an exposed tie-beam may indicate a partition for a smoke-bay when the building was originally constructed.

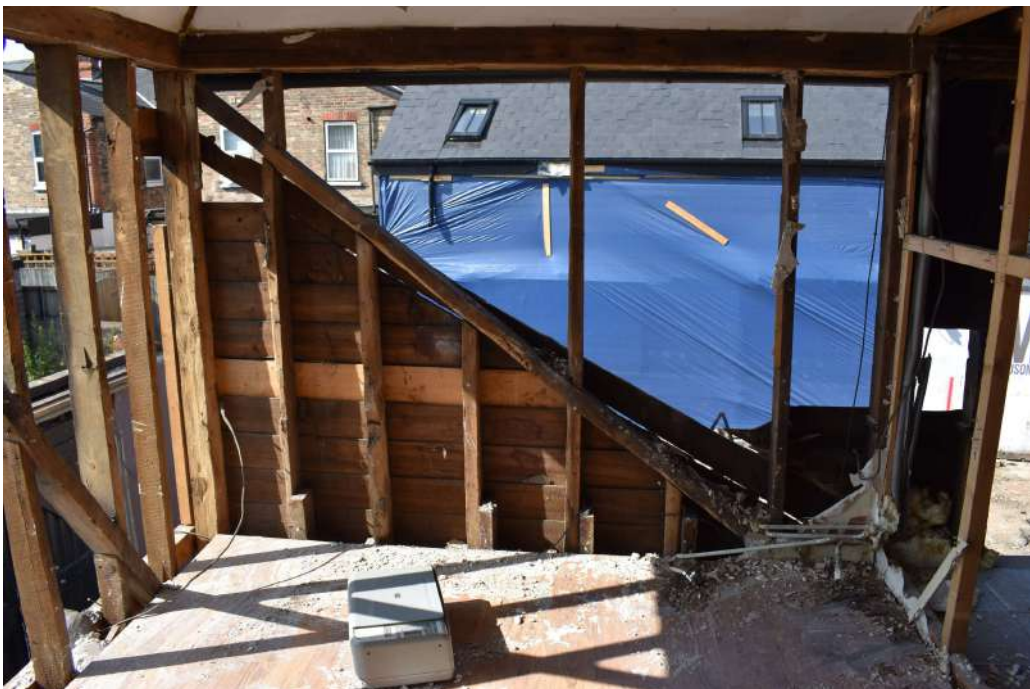
**Photograph 36** Interior of bedroom 4, showing timber-frame. Photograph taken facing south-west.

The first floor of range 2 has been exposed as timber-framed, comprising mainly machine-cut timbers with a small quantity of hand-sawn timber. Stud walls have been inserted into range 2 to create a bedroom and store area.

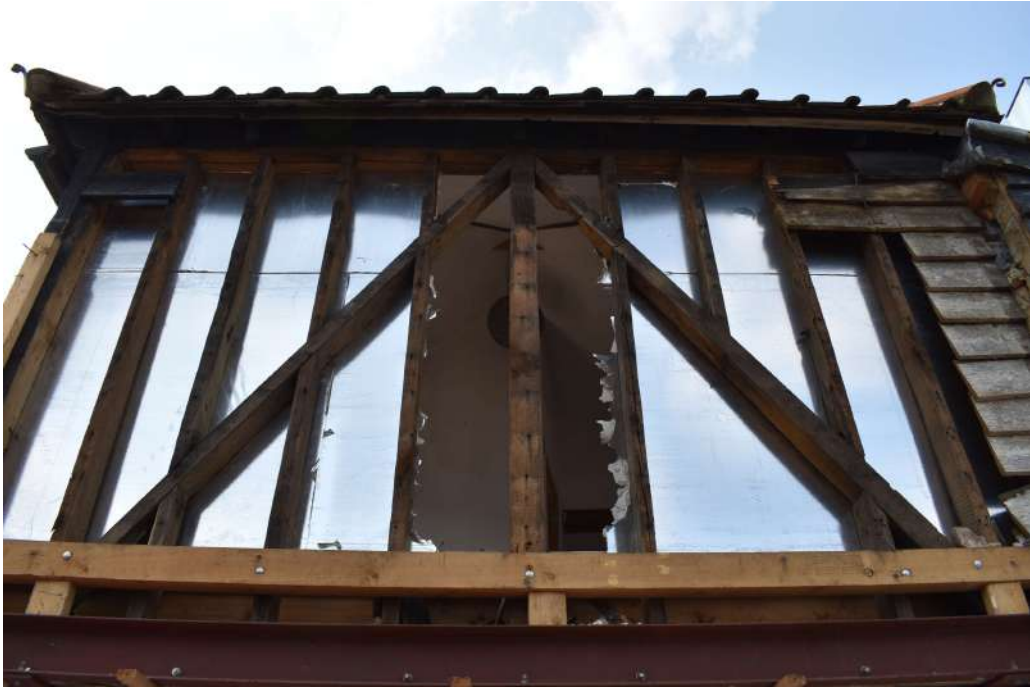
**Photograph 37** Detail of timber-framing in first floor of range 2. Photograph taken facing north-west.

From the little original timber-frame exposed in ranges 2 and 3, both appear to have an early-mid 19th century construction date. The timbers used in both buildings are machine cut, two of which exhibit Baltic timber marks. The importing of timber into Britain from the Baltic began in the 17th century but increased dramatically during the 19th (Vandenabeele et al 2016). The decline of local oak and other hardwood timbers in Britain was mainly due to an increase in shipbuilding and the economic pressures and needs of the Industrial Revolution. Because suitable trees take a significant time to mature in densely populated countries like Britain, land could usually be far more profitably used for farming rather than producing timber. The production of timber is a much more viable industry in the more sparsely-populated countries around the Baltic Sea.
