**CAT Report 1949
issued June 2023**

**Historic building recording of Wild Oaks,
East Hanningfield Road, Sandon, Essex, CM2 7TQ**

**CAT project ref.: 2023/04f
ECC code: SAWO23a**

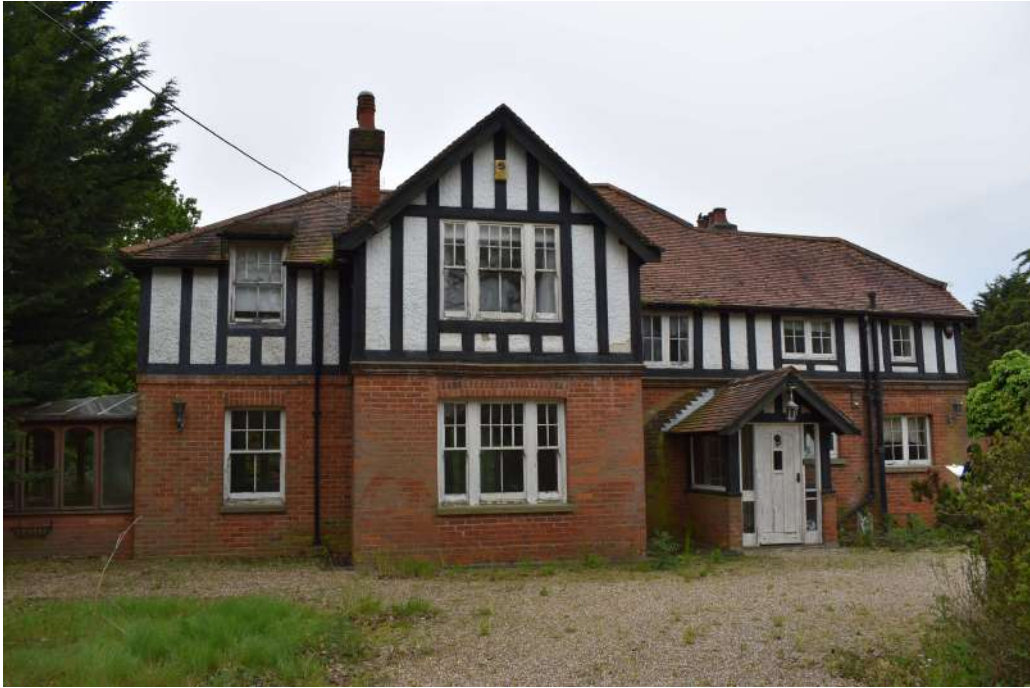
The western range of this elevation has two casement windows on the ground floor, one twelve-light and one eight-light. A further three casement windows are present on the first floor, a four-light, an eight-light and a twelve-light. There is a later porch with a gabled-roof clad in plain-tile. The gable has imitation timber-framing and the door is flanked with thin rectangular fixed windows. The porch is supported on plinth of red brick laid in Flemish bond (brick dimensions: 220 x 105 x 65mm). Within the porch, the brick archway of the original front door can be seen.

Photograph 2 Northern elevation. Photograph taken facing south-west.

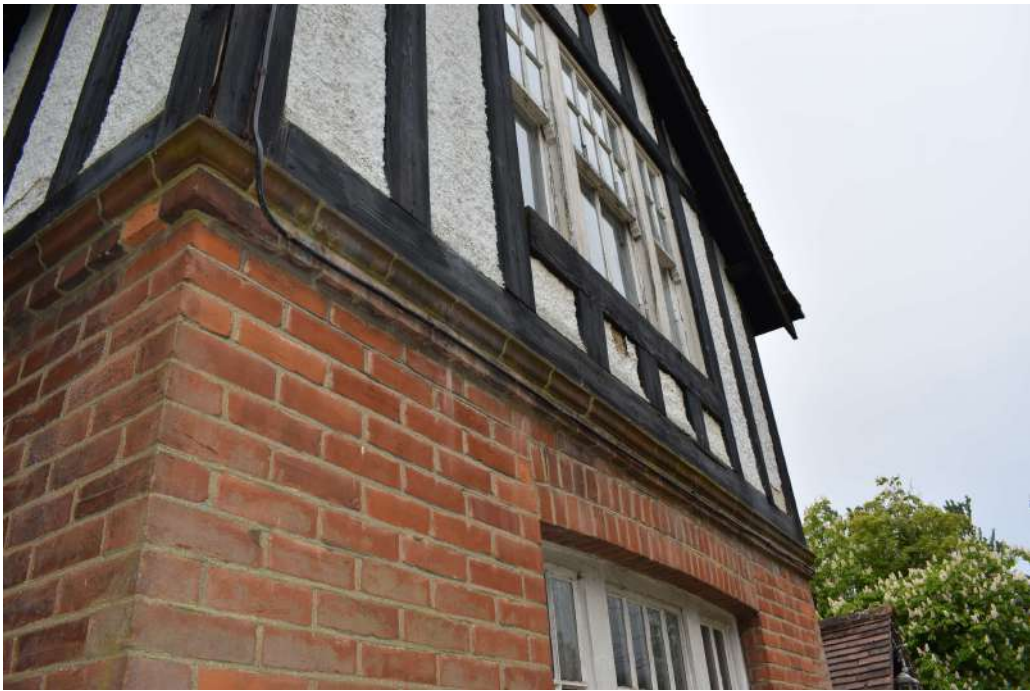
The northern elevation is the street-fronting façade, although the building is set back from the road with a large front garden. The first floor of this elevation is clad in imitation timber-framing, infilled with roughcast render, in a mock-Tudor fashion. The timber is painted black and the render white. At the top of the first floor, there are two courses of oversailing brickwork, comprising a course of moulded bricks overlaying a course of plain bricks laid in header bond.

Photograph 3 Detail of moulded oversailing brickwork of northern elevation. Photograph taken facing south-west.

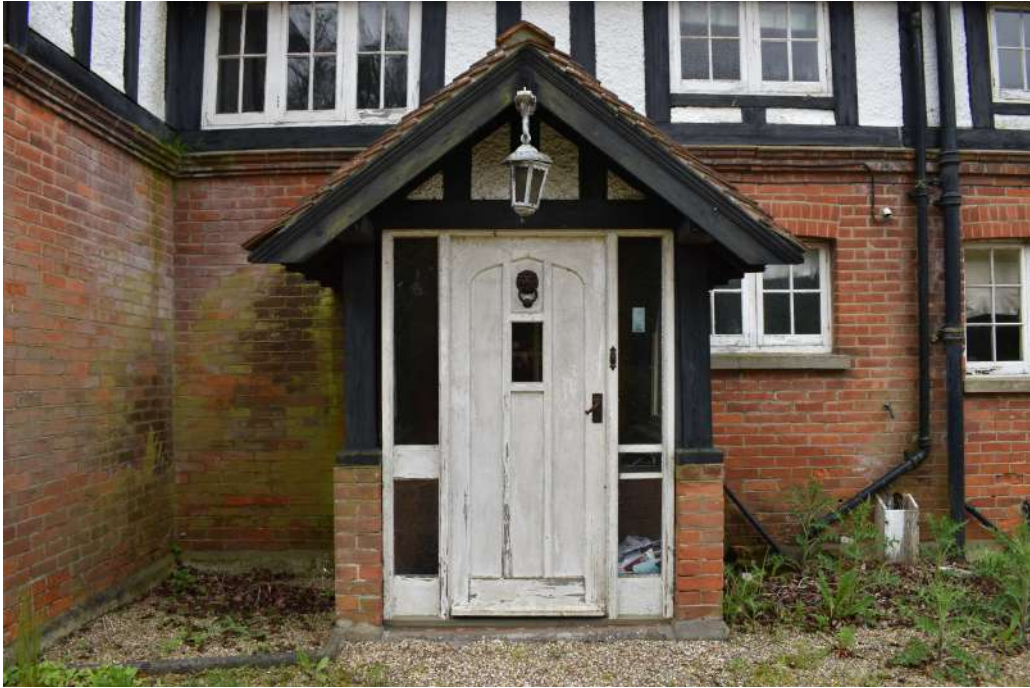
Photograph 4 Detail of porch of northern elevation. Photograph taken facing south south-west.

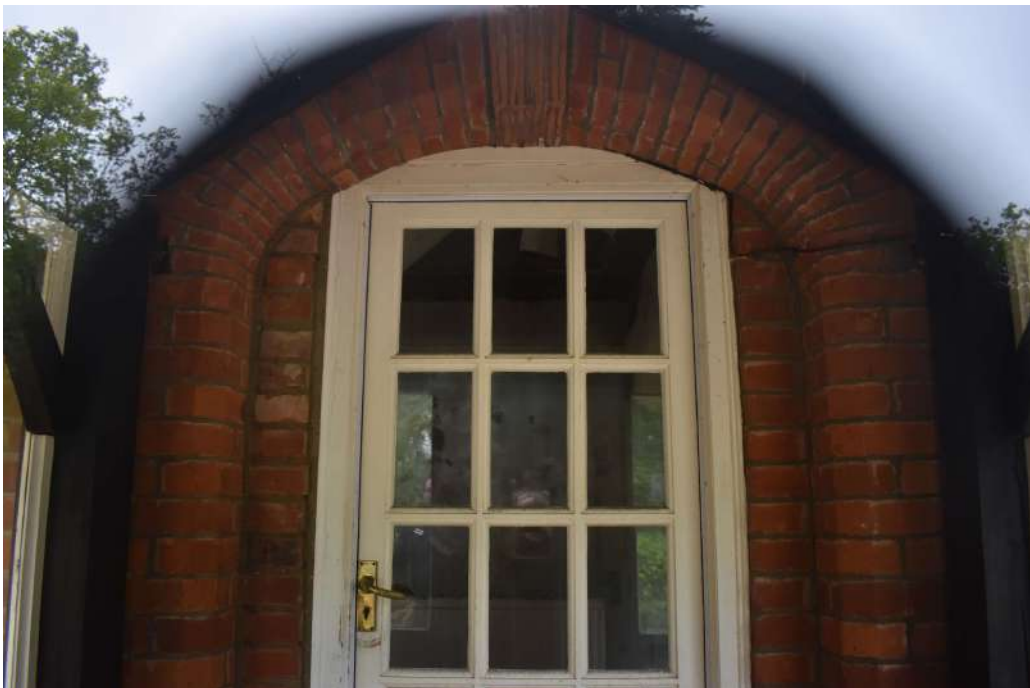
Photograph 5 Detail of doorway arch on northern elevation. Photograph taken facing south south-west.

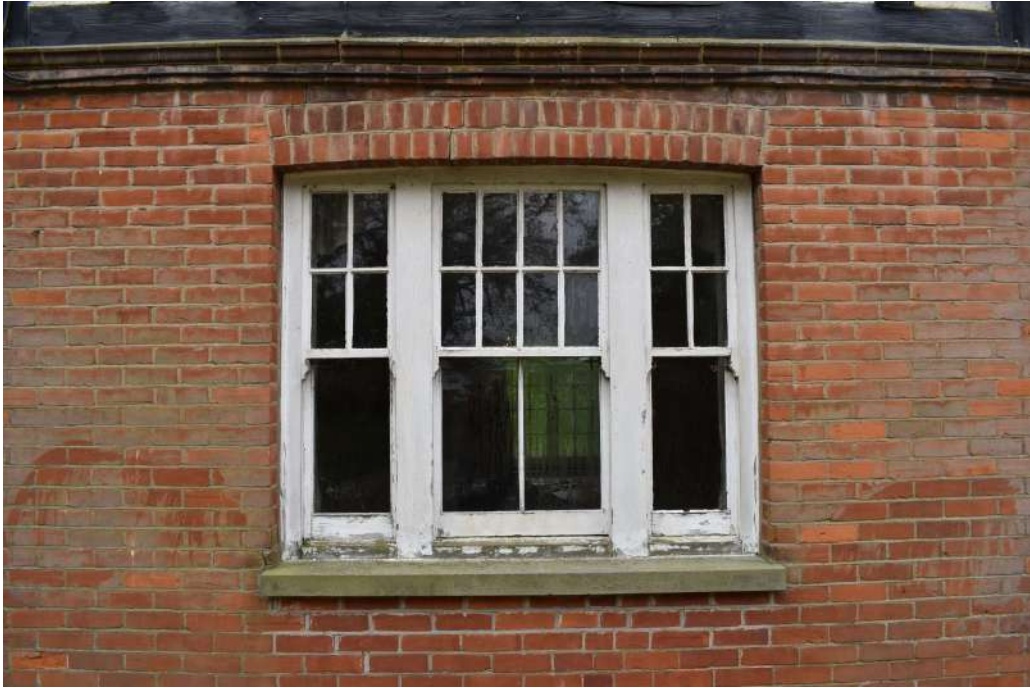
Photograph 6 Detail of ground floor window of northern elevation. Photograph taken facing south south-west.

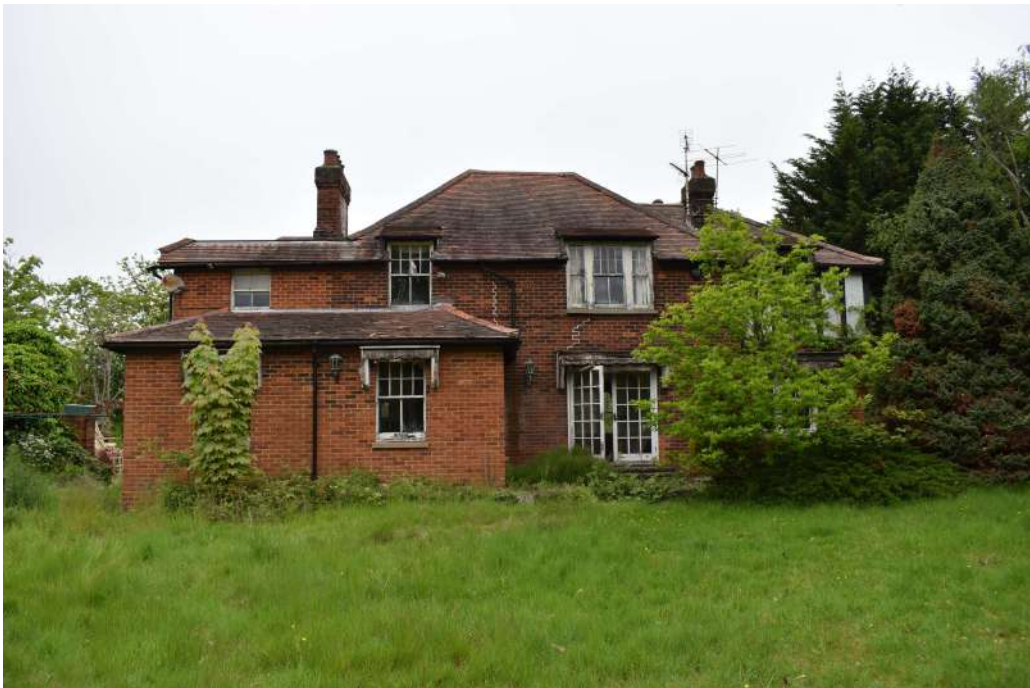
Photograph 8 Southern elevation. Photograph taken facing north north-east.

The southern elevation of the building is largely plain brickwork, with the exception of the eastern range which continues the imitation timber-framing and oversailing brickwork. All of the windows and doors on the ground floor of this elevation have timber-framed canvas awnings.

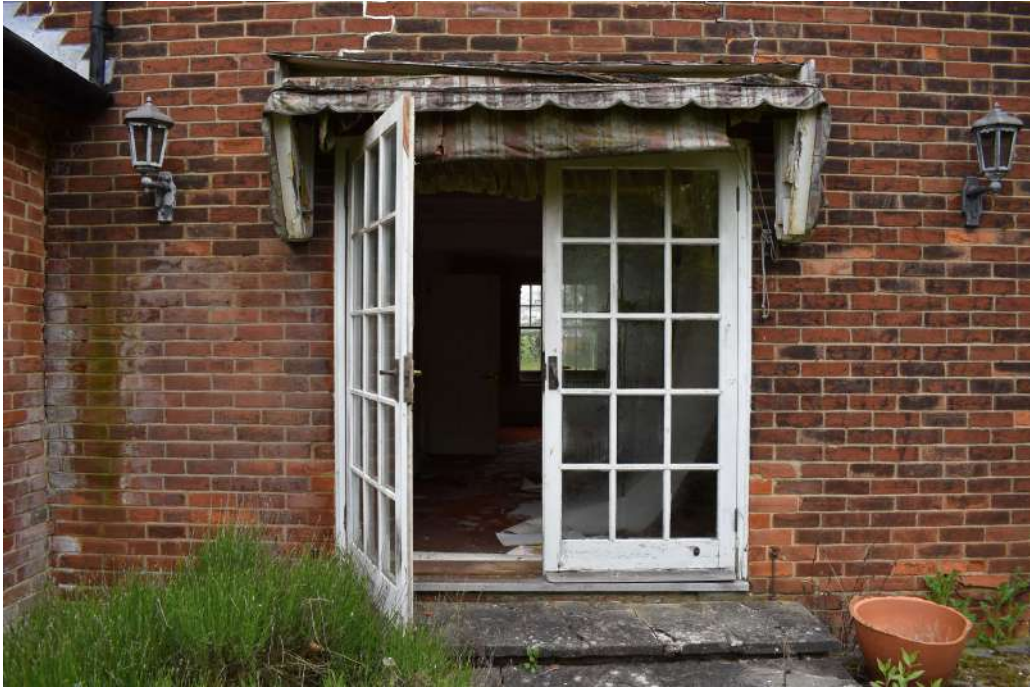
Photograph 9 Detail of doorway on southern elevation. Photograph taken facing north north-east.

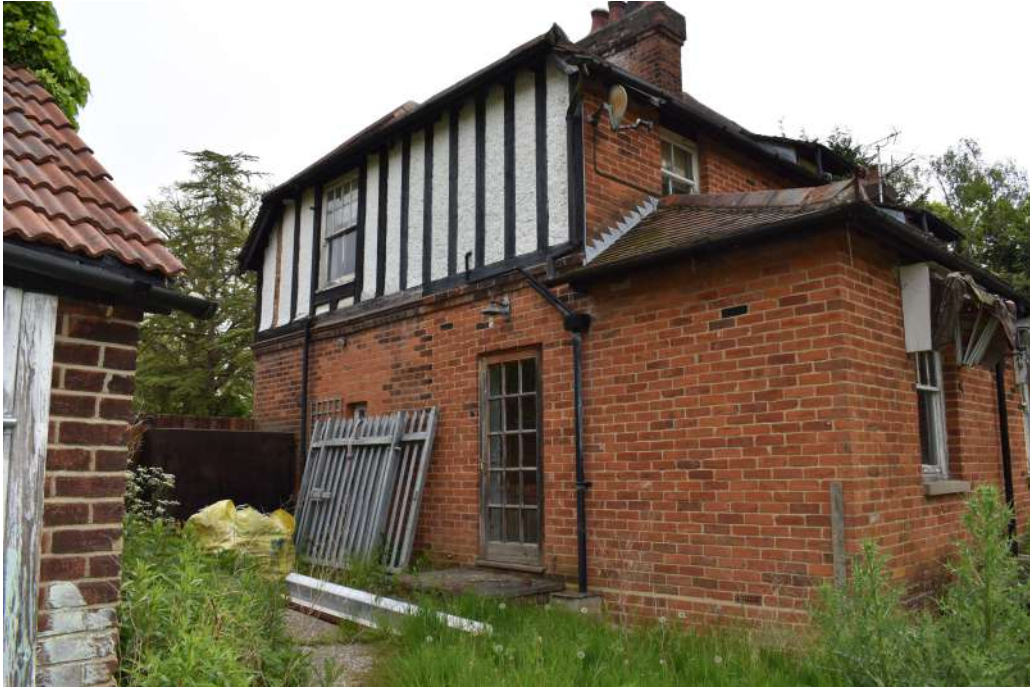
The western elevation has the imitation timber-framed on the first floor with oversailing brickwork below. The change from moulded to plain brickwork denotes where the modern extension starts. An imitation timber post has been removed from this elevation to reveal the brickwork beneath. There is a four-light casement window on the ground floor and a ten-light horned-sash window on the first floor. A single 15-light door is present on the ground floor.

Photograph 10 Western elevation. Photograph taken facing north-east.

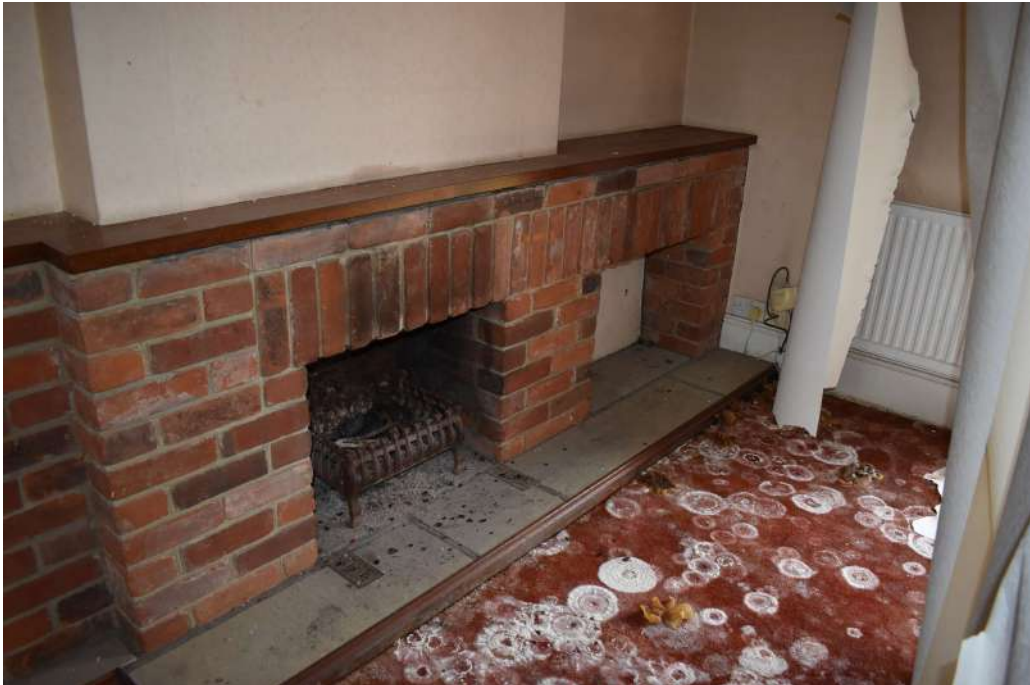
There is fireplace on the eastern wall of the lounge. The chimney-breast is original to the building but the brick surround is a later addition. It is constructed from red brick laid in Stretcher bond. The brickwork surrounds the fireplace opening, but also extends past it. To the south of the fireplace is a log alcove and to the north a decorative terracotta tile has been incorporated into the brickwork. Further north on the same wall is another chimney-breast. There is an inserted door between the chimney-breasts. An east/west beam is present in the ceiling of the lounge, indicating a dividing wall has been removed.

Photograph 12 Detail of fireplace in lounge. Photograph taken facing south-west.

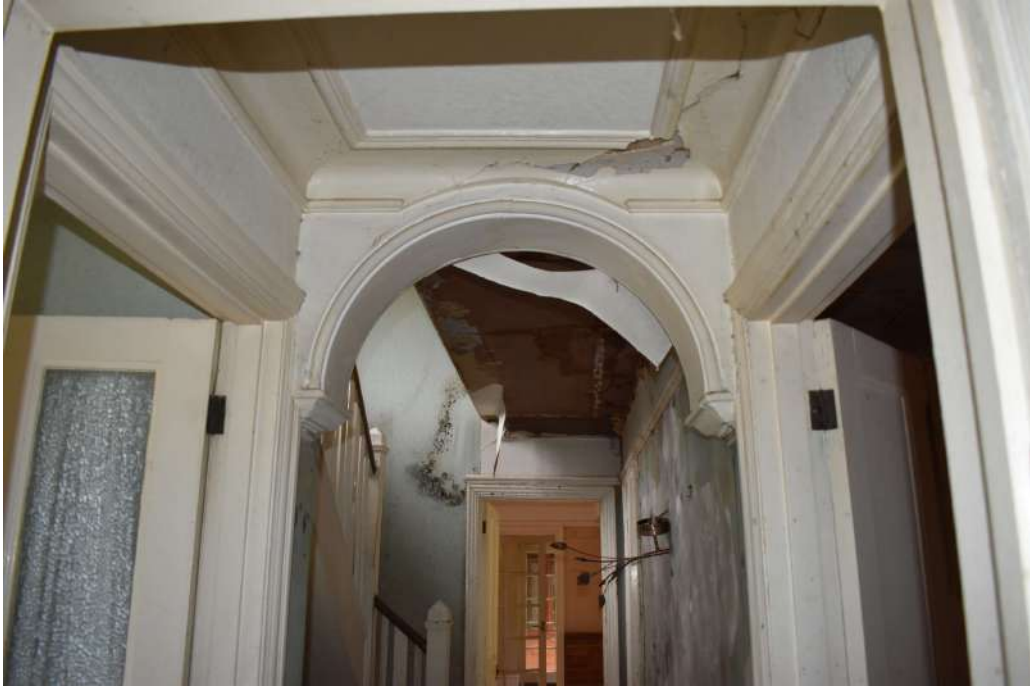
The original staircase is located in the hall, it is a straight flight staircase with a winder. The balusters are flat, rectangular and plain. The newel posts are also fairly plain and are topped with a pyramidal finial. There is also an original timber arch in the hall.

Photograph 15 Detail of timber arch in hall. Photograph taken facing east south-east.

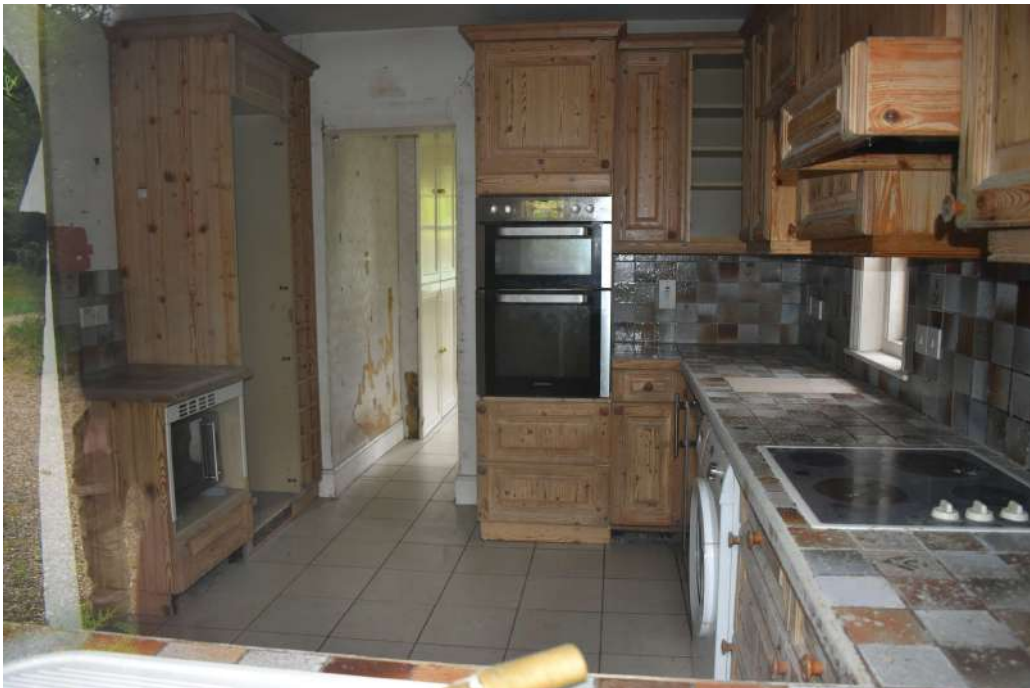
Photograph 16 Interior of kitchen. Photograph taken facing south south-west.

The kitchen is separated into two rooms by the original outer wall. The doorway between the two rooms is possibly an original opening. On the eastern wall of the kitchen is a chimney-breast, which would have originally been external.

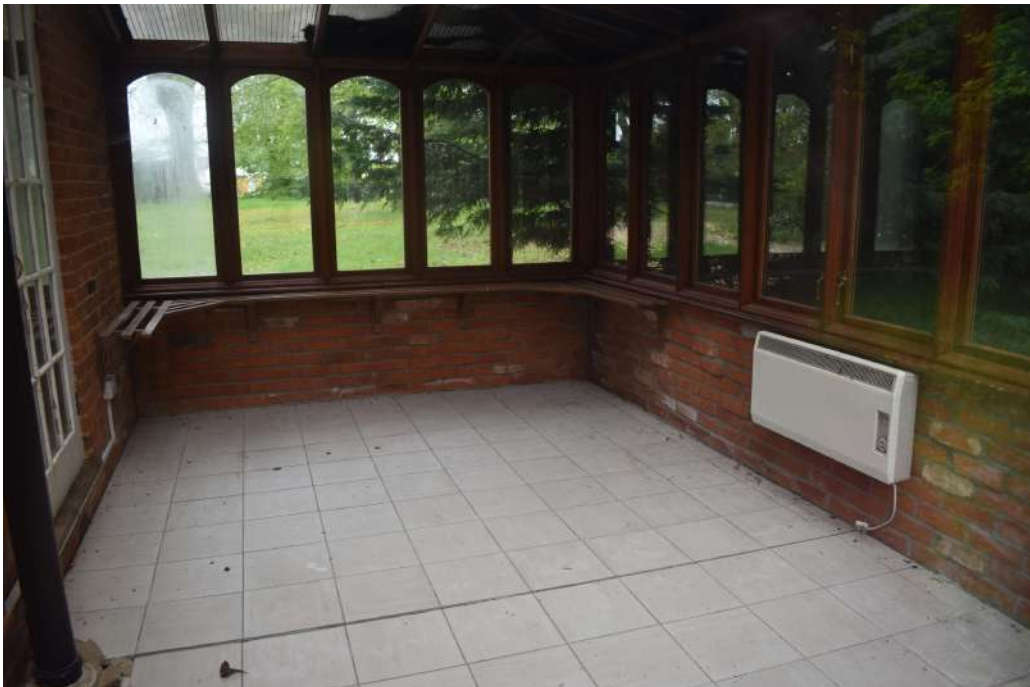
The conservatory had plain brick walls with wooden benches on the northern wall and a small radiator on the eastern wall.

Photograph 18 Interior of conservatory. Photograph taken facing north north-east.
